## ENGINE EXAMINATION REPORT

| ENGINE MODEL | IO-520-M1B |
| AIRCRAFT MAKE & MODEL | Cessna 310R |
| FILE NUMBER | 16-697 |

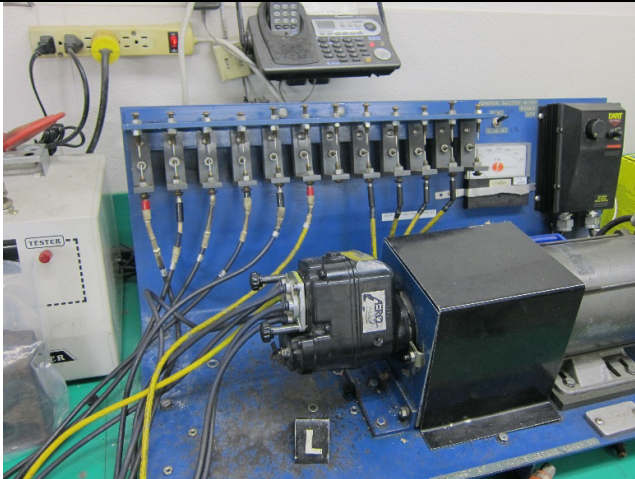
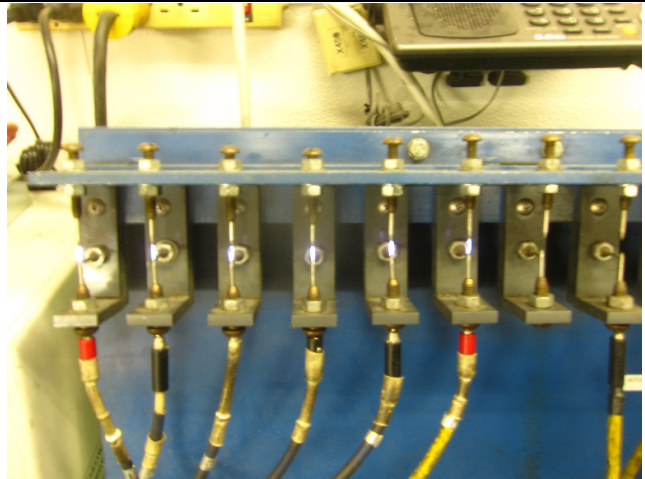
| Condition: | The left magneto displayed minor thermal damage signatures and displayed impact damage signatures to the flange. The magneto was placed on a test bench and was tested at multiple RPM settings. The magneto was capable of producing a spark on all six posts in the correct order at all tested RPM settings. There were no anomalies noted with the magneto. | | |

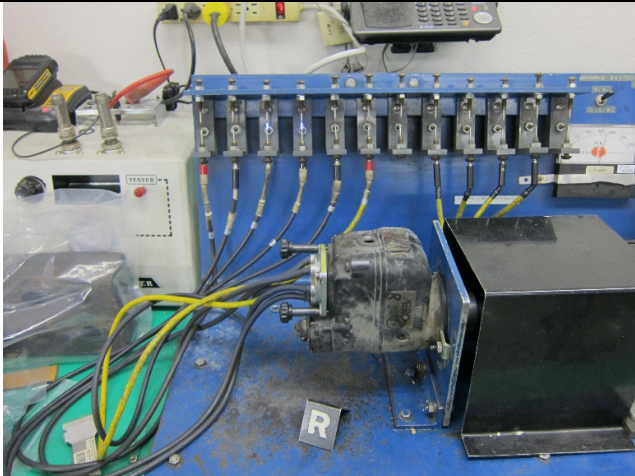
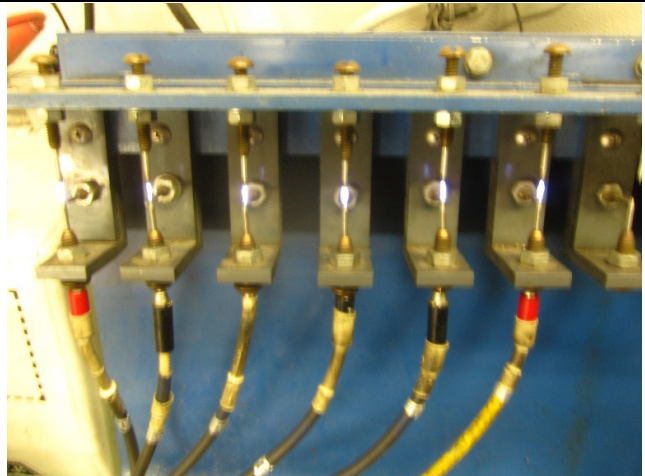
| Condition: | The right magneto displayed minor thermal damage and minor impact damage signatures. The magneto was placed on a test bench and was tested at multiple RPM settings. The magneto was capable of producing a spark on all six posts in the correct order at all tested RPM settings. There were no anomalies noted with the magneto. | | |
