# Continental Motors

## ENGINE EXAMINATION REPORT

| ENGINE MODEL | IO-520-M1B |
| AIRCRAFT MAKE & MODEL | Cessna 310R |

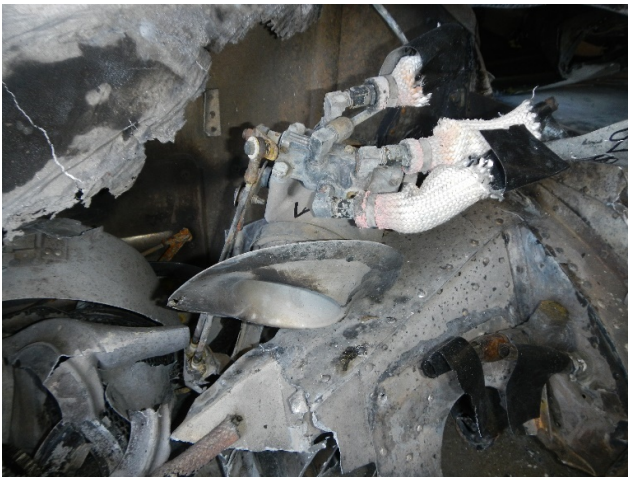
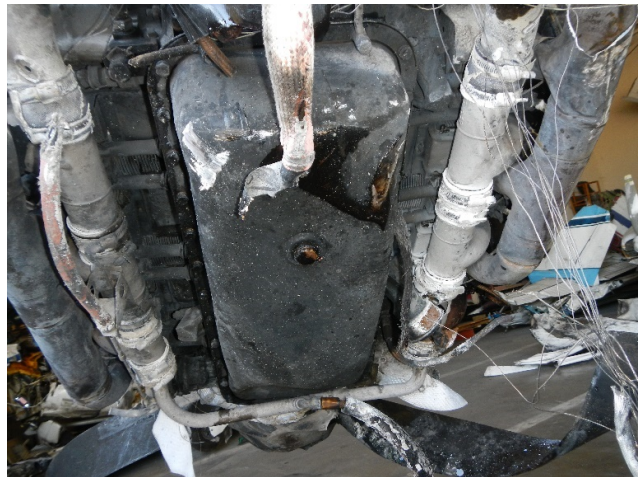
#### INDUCTION SYSTEM

Condition: The intake air box was burned and impact damaged. The throttle body was separated from the wye plenum, which was thermally destroyed. The intake tubes and risers were thermally damaged.

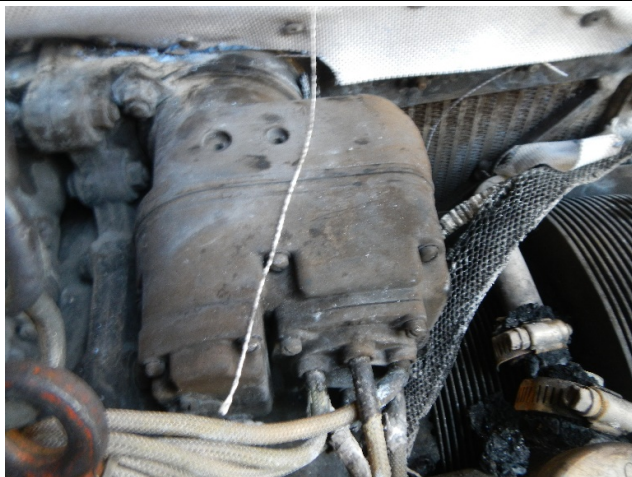
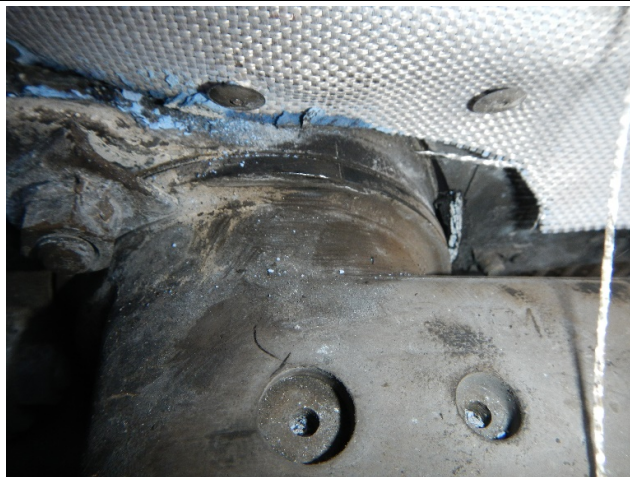
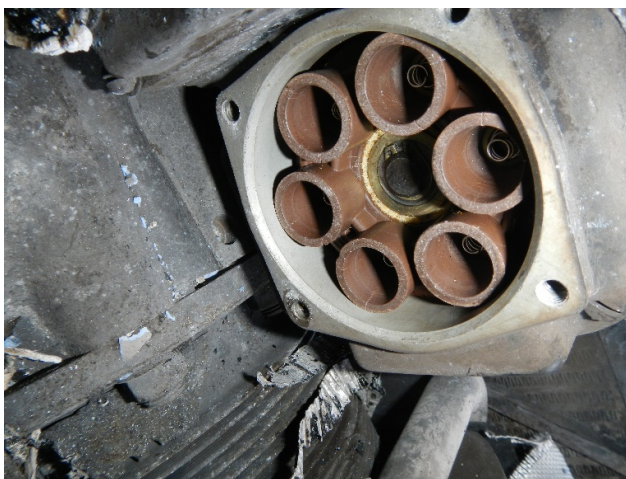
#### LEFT MAGNETO

Condition: The magneto remained secured to the topside of the engine and manual manipulation of the housing did not result in any slipping or rotation of the magneto on its mounting pad. It was soot covered and the vent plug was partially melted. The ignition harness remained in place on the magneto. The vent cover was removed from the housing and the distributor gear was intact and rotated during crankshaft rotation, with no pre-accident anomalies noted. The magneto was removed from the engine and its drive shaft was manually rotated with no binding noted. The magneto was retained for further testing.

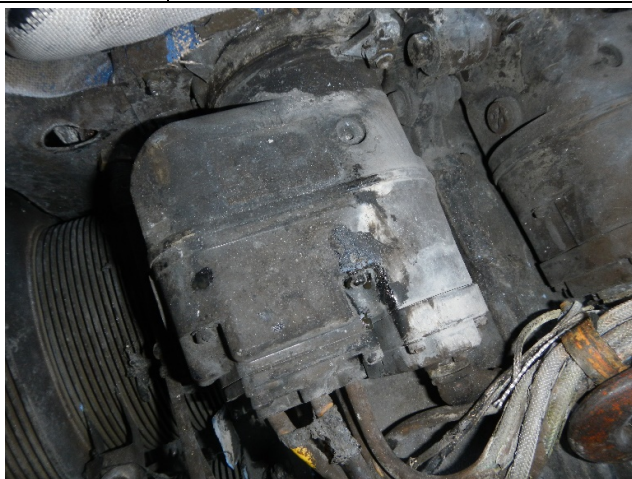
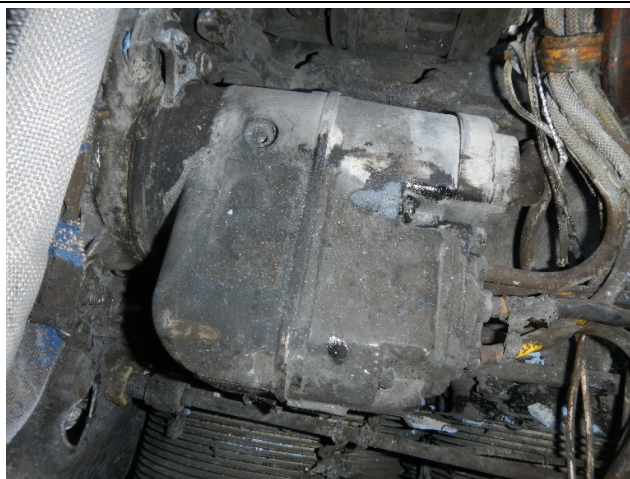
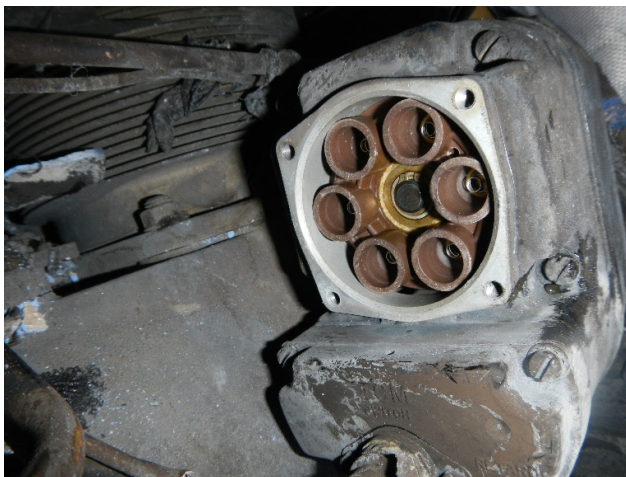
### RIGHT MAGNETO

The magneto remained secured to the topside of the engine and manual manipulation of the housing did not result in any slipping or rotation of the magneto on its mounting pad. It was soot covered and the vent plug was partially melted. The ignition harness remained in place on the magneto. The vent cover was removed from the housing and the distributor gear was intact and rotated during crankshaft rotation, with no pre-accident anomalies noted. The magneto was removed from the engine and its drive shaft was manually rotated with no binding noted. The magneto was retained for further testing (see Appendix A of this report for more details).

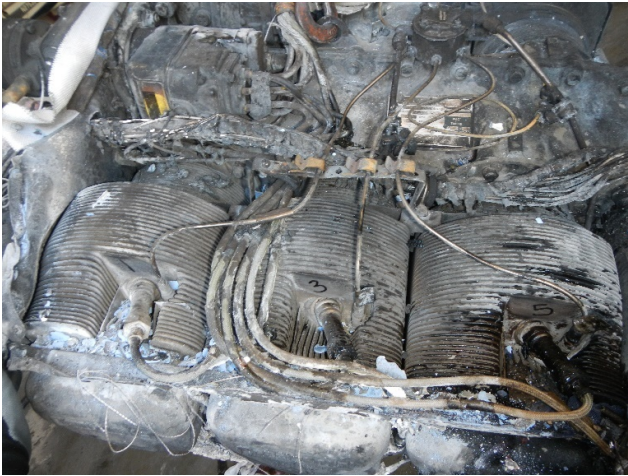
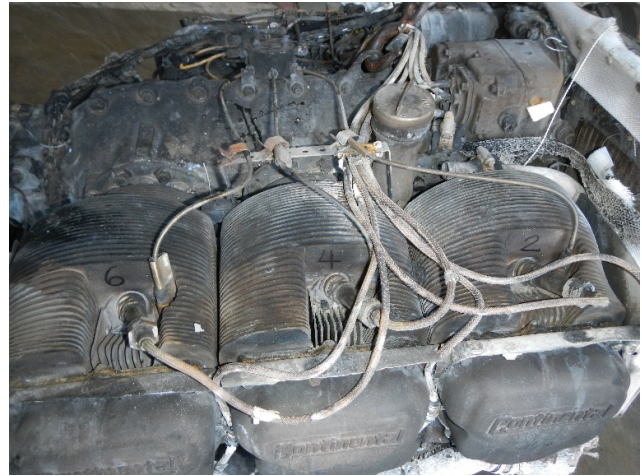
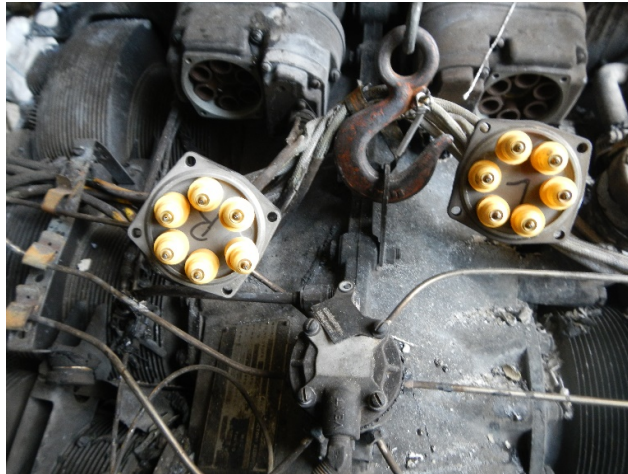
### IGNITION HARNESS

Condition: The ignition harness remained attached to both magnetos and each lead remained attached to their respective ignition harness. The leads were thermally damaged beyond functional testing. No pre-accident anomalies were noted with the ignition harness.

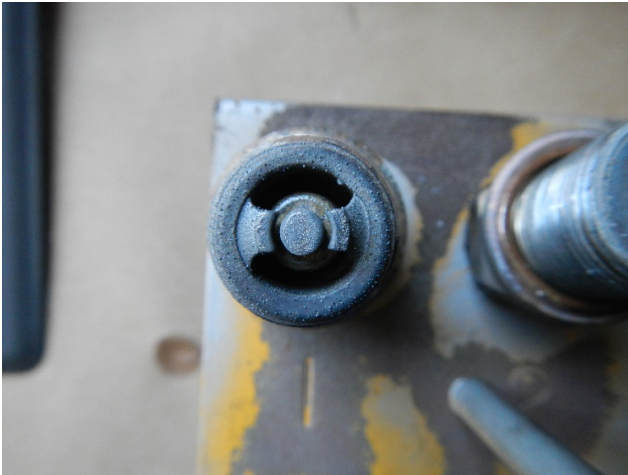
## SPARK PLUGS

Condition: The sparkplugs remained secured to their respective cylinder and each ignition terminal remained attached to its sparkplug. The top sparkplugs were removed from the cylinders and each displayed a normal worn condition with no evidence of carbon or lead fouling. The bottom sparkplugs were examined/photographed via lighted borescope.

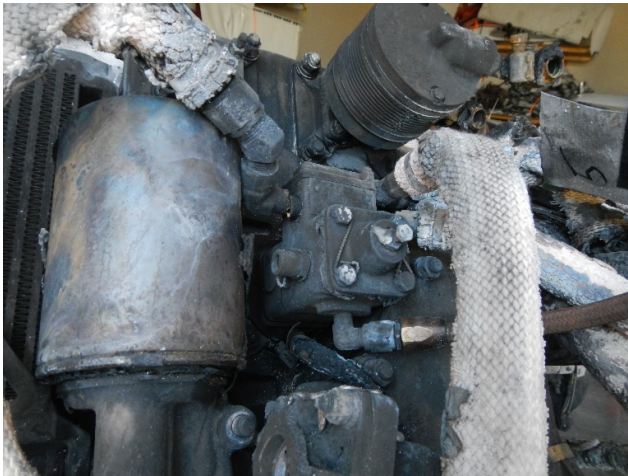
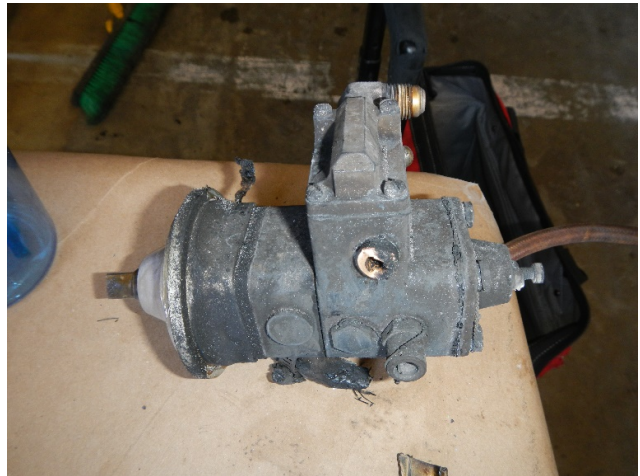
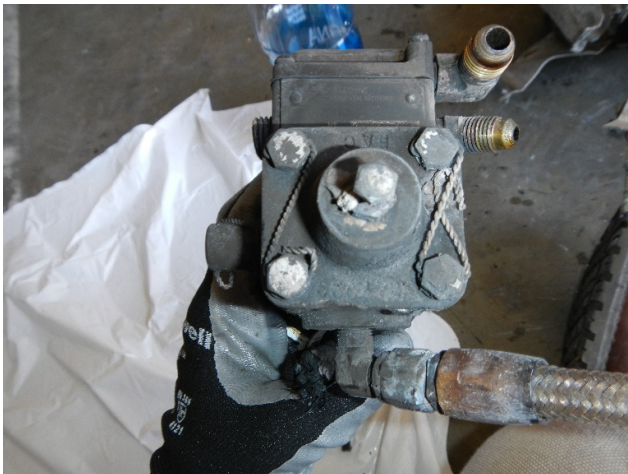
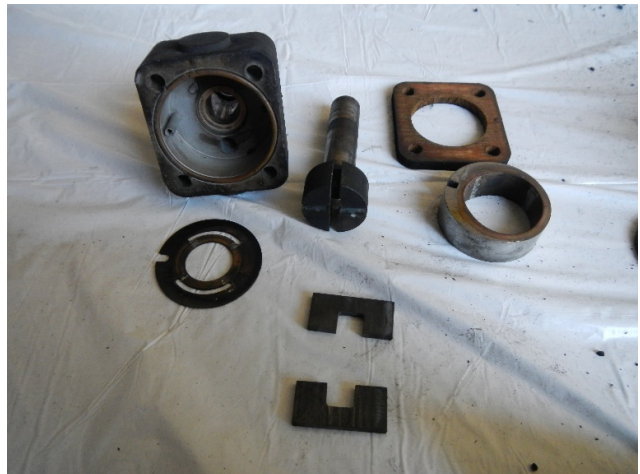
#### FUEL PUMP

**Condition:** The engine-driven fuel pump remained secured to the backside of the engine and all of the fuel lines remained secured to their respective fittings, though the fuel inlet fitting was fractured. The pump was removed and the drive coupling was intact. The pump could not be functionally tested due to the thermal damage, but disassembly revealed that the pump vanes were intact and no pre-accident anomalies were observed with the pump's internal components.

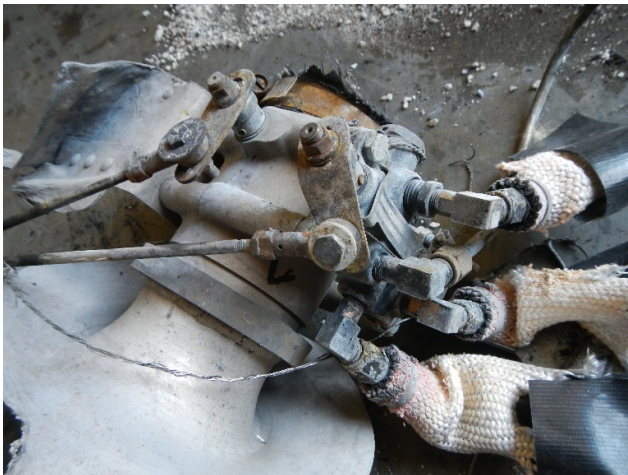
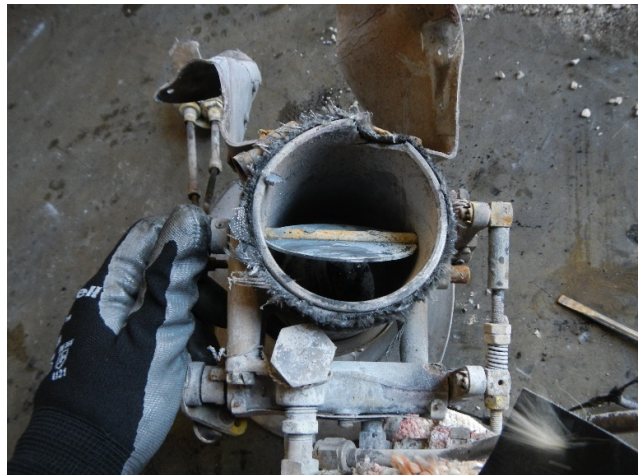
### THROTTLE BODY METERING UNIT

Condition: The throttle body/fuel metering unit was separated from the wye plenum and remained secured to the engine nacelle via the throttle and mixture control cables. The fuel lines leading to and from the fuel metering unit remained secured to their respective fittings, though the lines were cut by recovery personnel. The mixture control lever was bent however, manual manipulation of the mixture and throttle control levers resulted in a coinciding movement in their control cams. The fuel inlet screen was removed and no obstructions were observed.

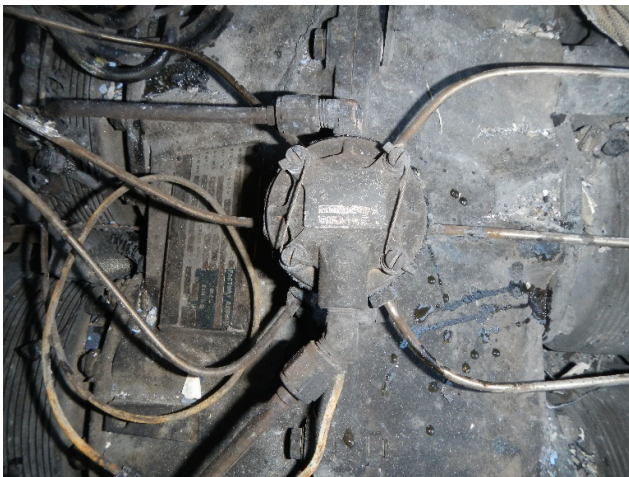
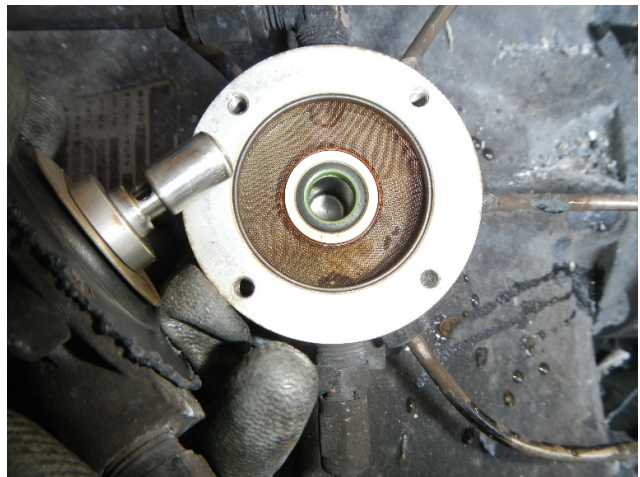
## FUEL MANIFOLD VALVE

**Condition:** The fuel manifold valve remained secured to the topside of the engine and all lines to and from the manifold valve remained secured in place. The manifold valve was thermally damaged and re-solidified resin from the diaphragm was beaded up around the housing and the cap. The cap was removed and the diaphragm was intact and the plunger was in place. The screen was clear and there was a small amount of burnt debris noted behind the screen.

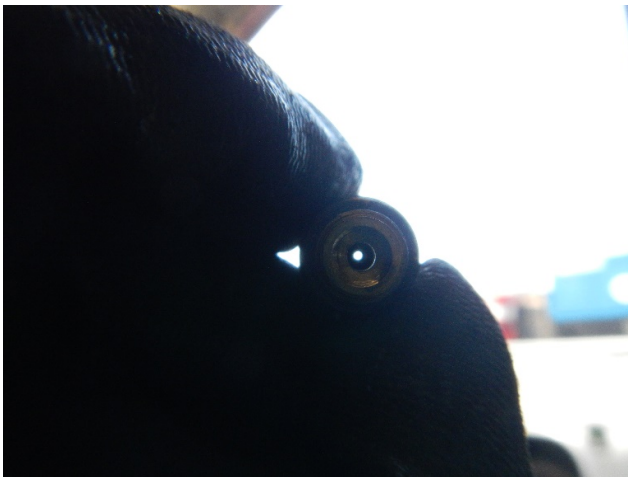
### FUEL NOZZLES AND LINES

Condition: The fuel injector nozzles remained secured to their respective cylinders and the fuel injection lines remained intact. The nozzles were removed and there were no obstructions or blockages noted in any of the nozzles.

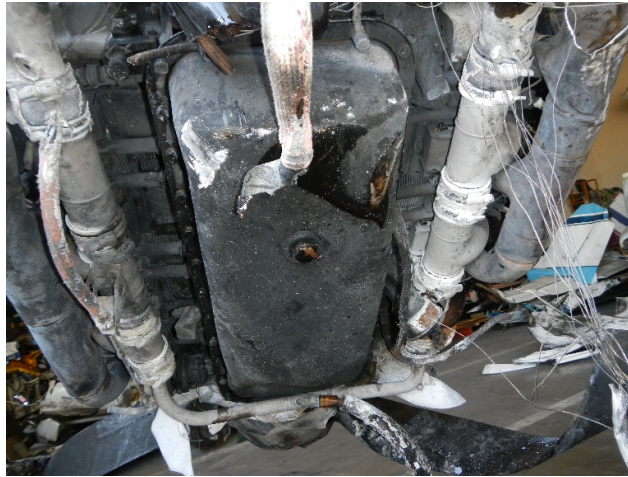
#### OIL SUMP

Condition: The oil sump remained secured to the bottom side of the engine and sustained slight deformation damage. The oil drain plug remained in place with no pre-accident anomalies noted.

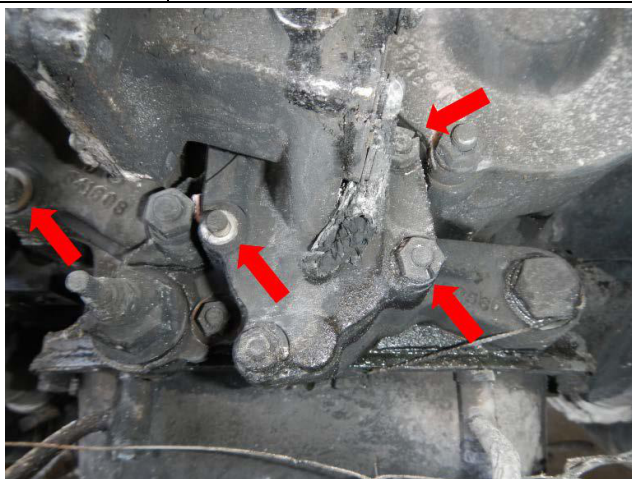
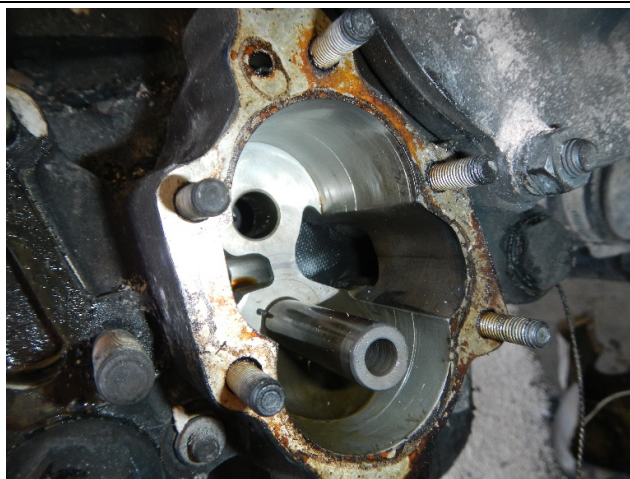
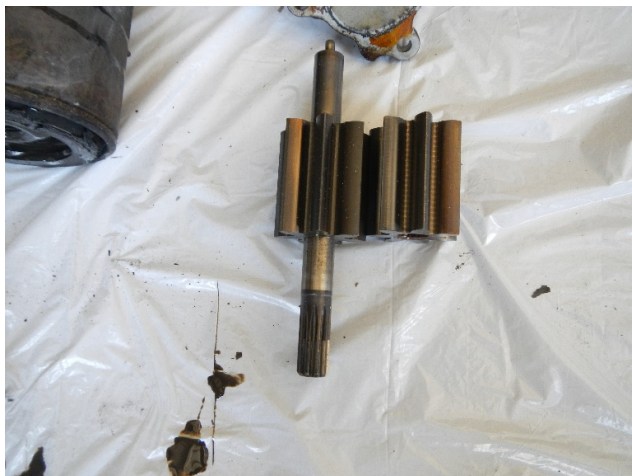
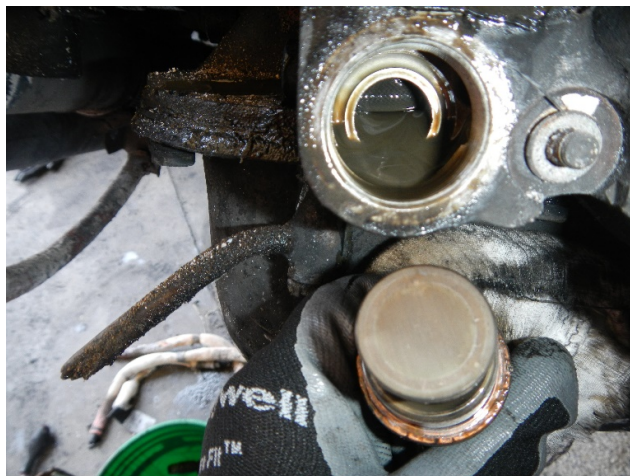
### OIL PUMP

The oil pump remained attached to backside of the engine and some of the housing nuts were split and missing (see red arrows in 1<sup>st</sup> photo below). There was no evidence of a pre-accident oil leak on the engine nacelle or wing and it is presumed that the cracked hardware was due to post-crash thermal exposure. Disassembly of the oil pump revealed residual oil in the housing and circumferential scores on the pump walls indicating hard particle passage at some point in the engine's history. The gears were intact with no signs of operational distress noted. The oil pressure relief valve and valve seat did not display any sign of abnormal seating.

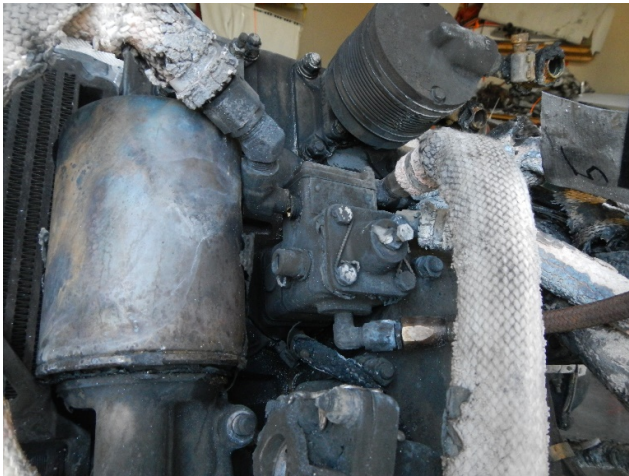
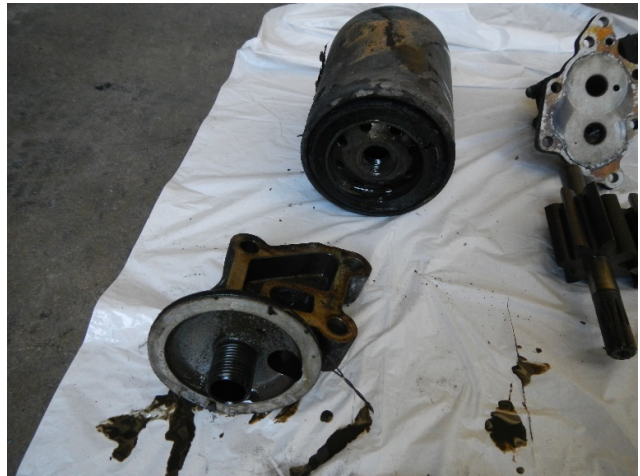
**PAGE 19 of 32****OIL FILTER**

The oil filter remained in place on the oil filter adapter and the safety-wire was intact. The oil filter was thermally damaged and no pre-accident anomalies were noted.

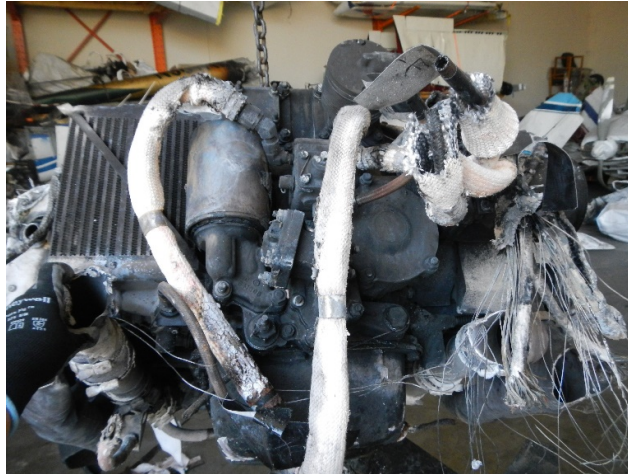
**OIL COOLER**

The oil cooler remained attached to the engine with no pre-accident anomalies noted.

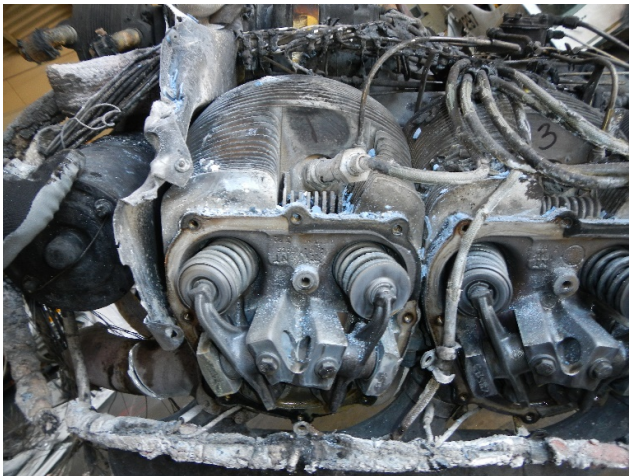
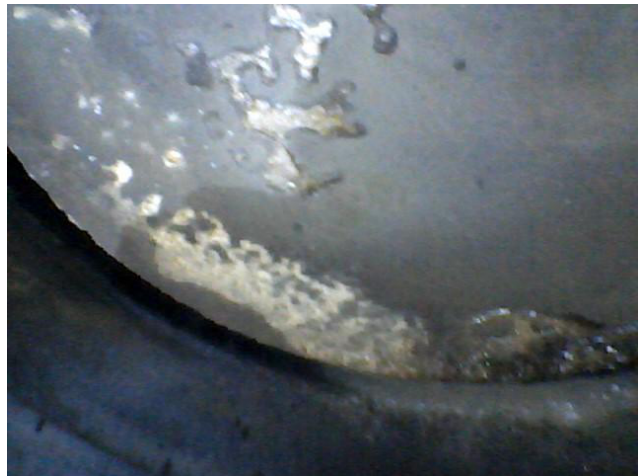
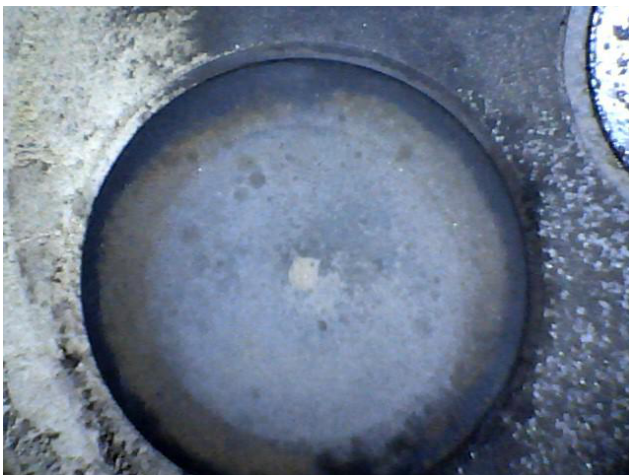
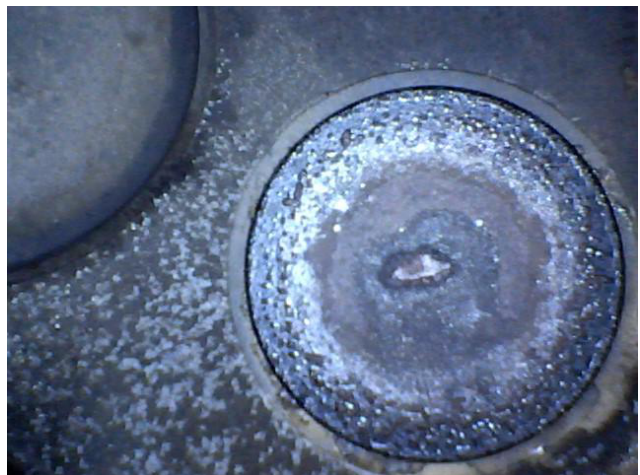
#### CYLINDER #1

**Condition:** The cylinder remained attached to the engine and the original torque putty appeared to be intact on the attaching hardware (the serial number matched that on the build record). The cylinder was soot covered with no other signs of pre-accident anomalies. The rocker cover was removed and no pre-accident anomalies were observed with the rockers or valve springs. A borescope inspection of the cylinder's internal components did not reveal any pre-accident anomalies with the barrel, piston, valves or valve seats. A thumb compression test resulted in compression and confirmed connecting rod, piston, and rocker arm movement.

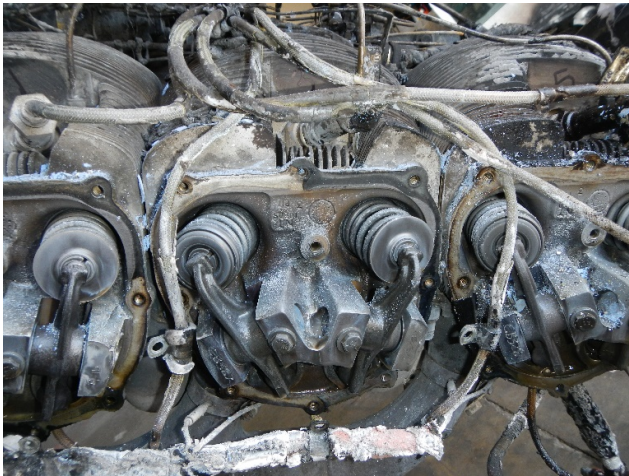
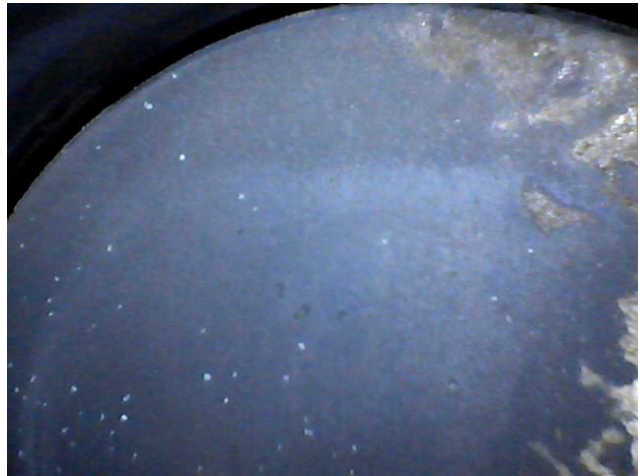
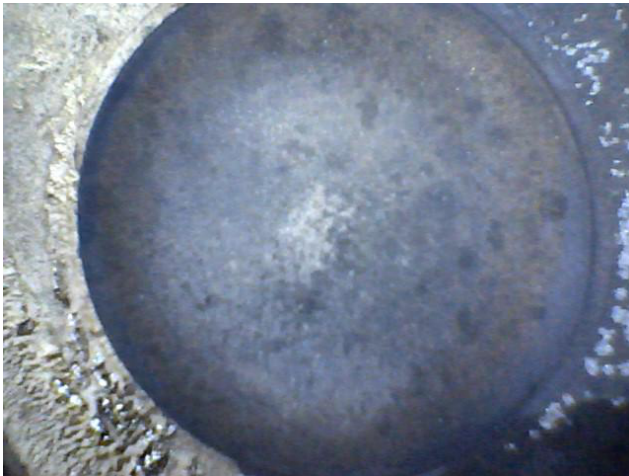
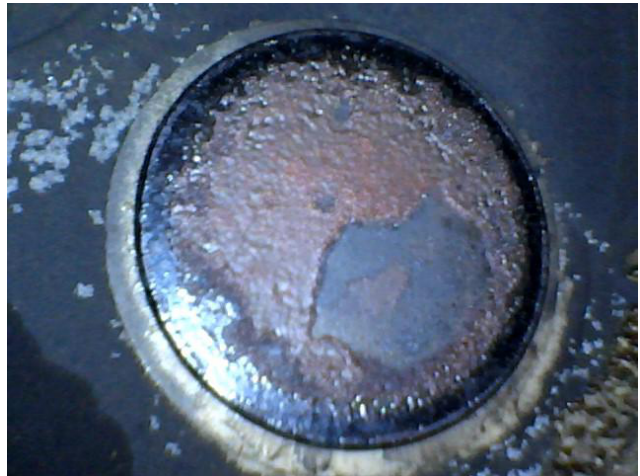
### CYLINDER #3

Condition: The cylinder remained attached to the engine and the original torque putty appeared to be intact on the attaching hardware (the serial number matched that on the build record). The cylinder was soot covered with no other signs of pre-accident anomalies. The rocker cover was removed and no pre-accident anomalies were observed with the rockers or valve springs. A borescope inspection of the cylinder's internal components did not reveal any pre-accident anomalies with the barrel, piston, valves or valve seats. A thumb compression test resulted in compression and confirmed connecting rod, piston, and rocker arm movement.

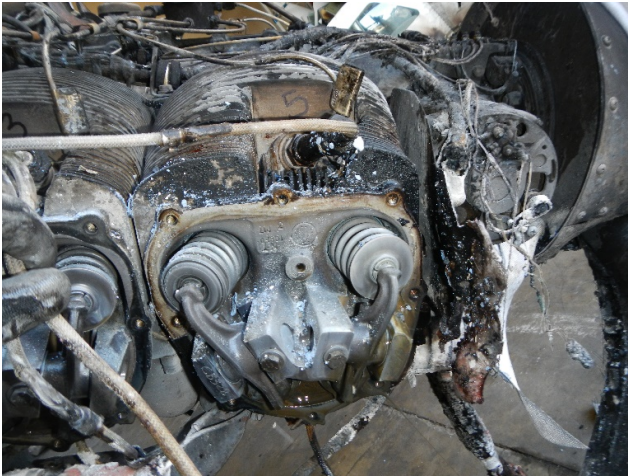
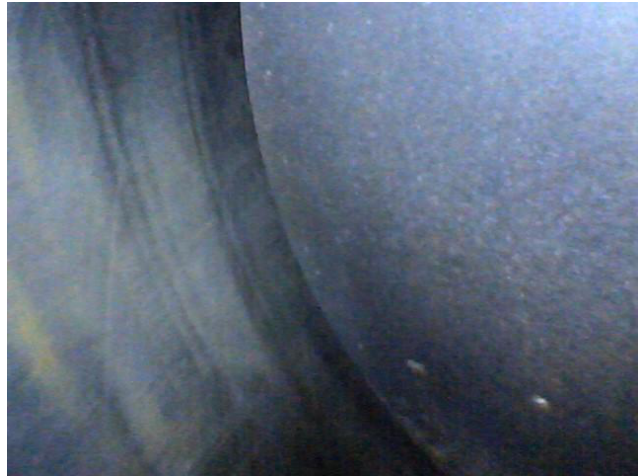
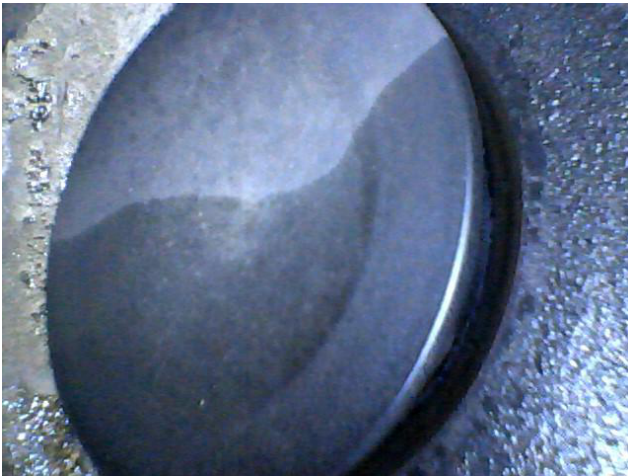
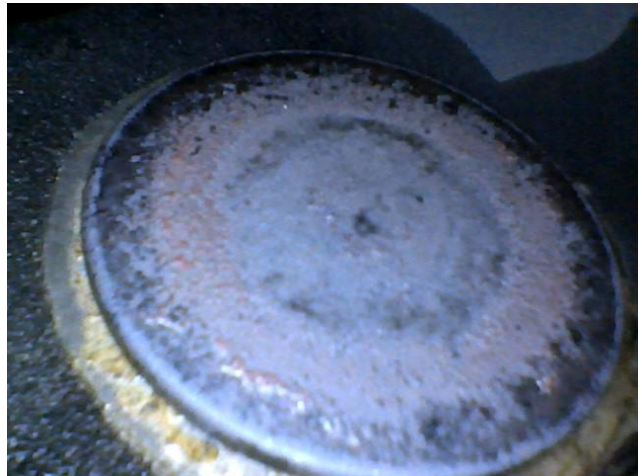
### CYLINDER #5

Condition: The cylinder remained attached to the engine and the original torque putty appeared to be intact on the attaching hardware (the serial number matched that on the build record). The cylinder was soot covered with no other signs of pre-accident anomalies. The rocker cover was removed and no pre-accident anomalies were observed with the rockers or valve springs. A borescope inspection of the cylinder's internal components did not reveal any pre-accident anomalies with the barrel, piston, valves or valve seats. A thumb compression test resulted in compression and confirmed connecting rod, piston, and rocker arm movement.

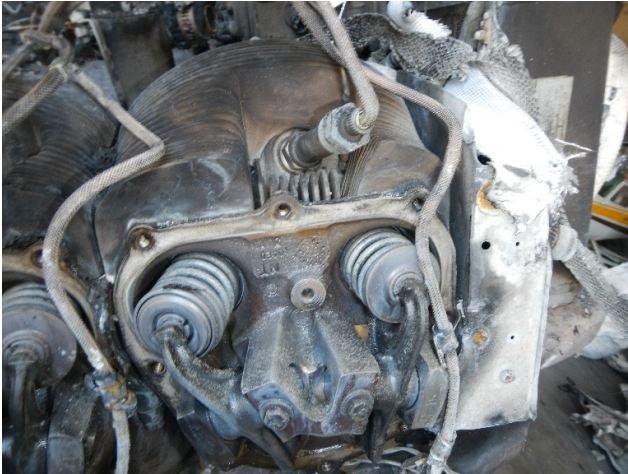
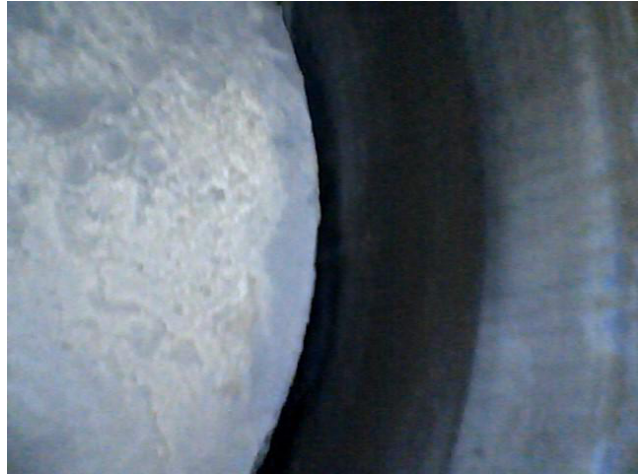
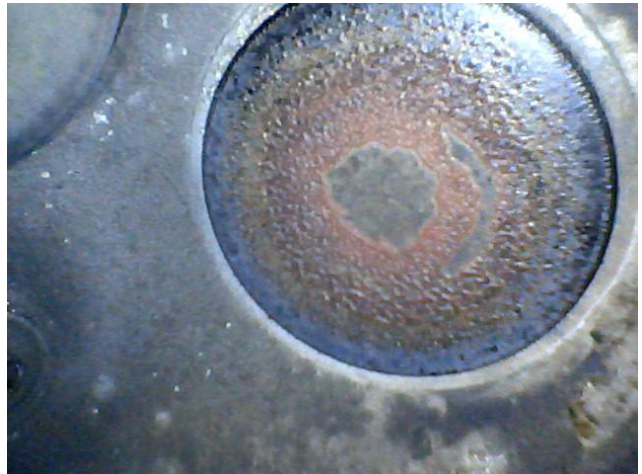
### CYLINDER #2

Condition: The cylinder remained attached to the engine and the original torque putty appeared to be intact on the attaching hardware (the serial number matched that on the build record). The cylinder was soot covered with no other signs of pre-accident anomalies. The rocker cover was removed and no pre-accident anomalies were observed with the rockers or valve springs. A borescope inspection of the cylinder's internal components did not reveal any pre-accident anomalies with the barrel, piston, valves or valve seats. A thumb compression test resulted in compression and confirmed connecting rod, piston, and rocker arm movement.

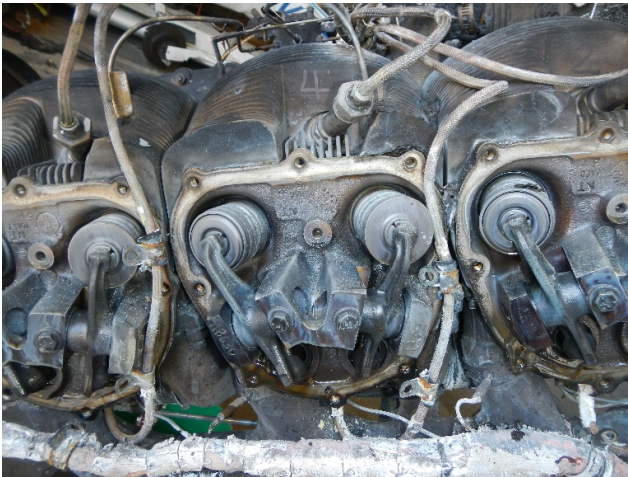
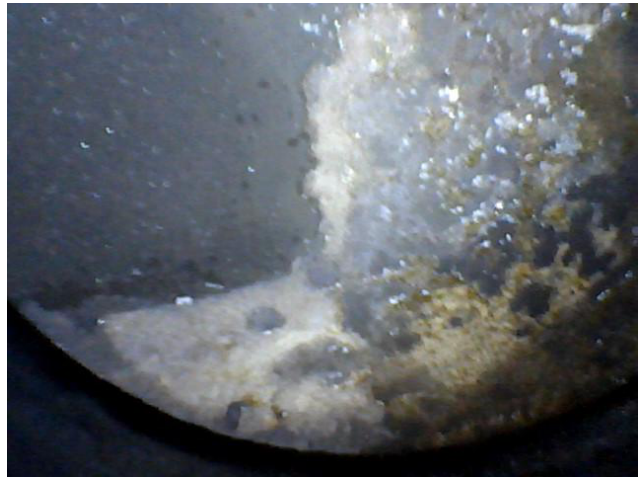
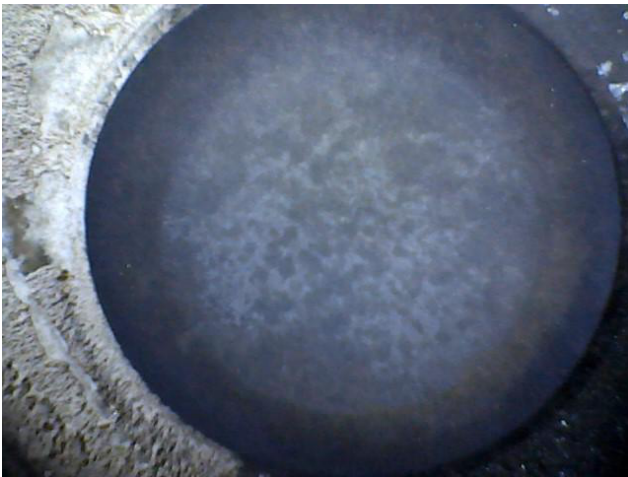
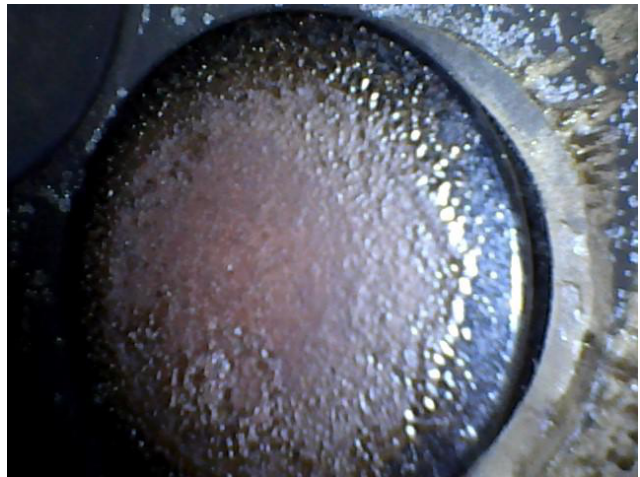
### CYLINDER #4

Condition: The cylinder remained attached to the engine and the original torque putty appeared to be intact on the attaching hardware (the serial number matched that on the build record). The cylinder was soot covered with no other signs of pre-accident anomalies. The rocker cover was removed and no pre-accident anomalies were observed with the rockers or valve springs. A borescope inspection of the cylinder's internal components did not reveal any pre-accident anomalies with the barrel, piston, valves or valve seats, though the barrel was rust covered in isolated areas. A thumb compression test resulted in compression and confirmed connecting rod, piston, and rocker arm movement.

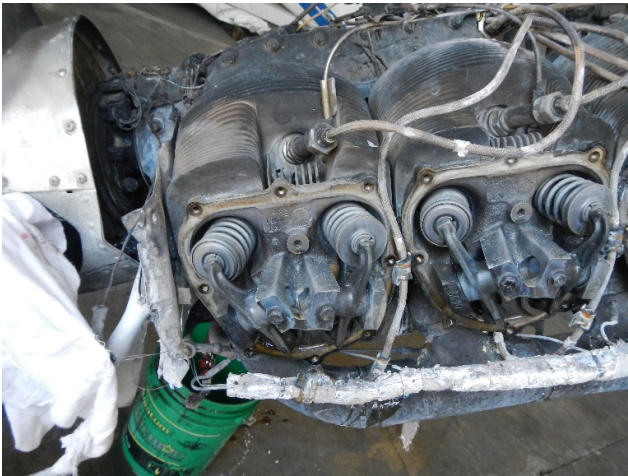
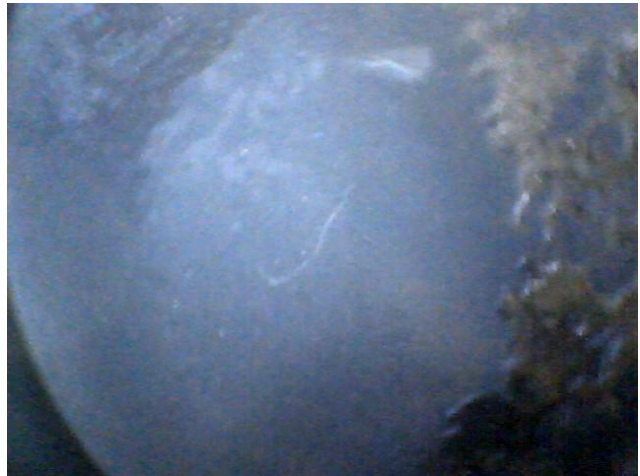
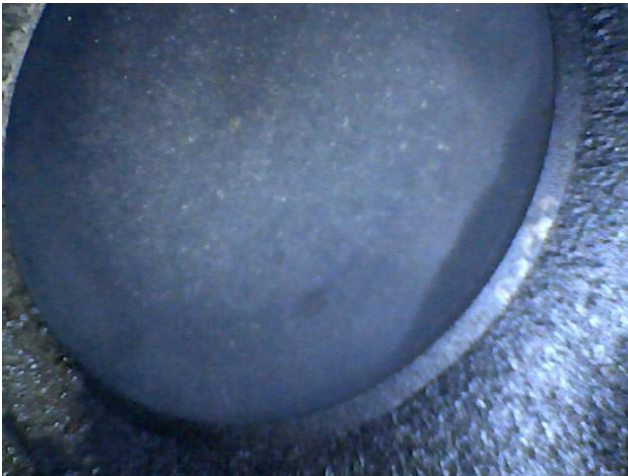
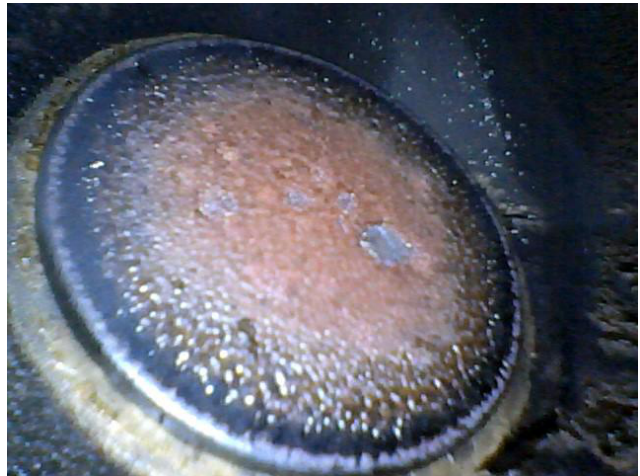
### CYLINDER #6

Condition: The cylinder remained attached to the engine and the original torque putty appeared to be intact on the attaching hardware (the serial number matched that on the build record). The cylinder was soot covered with no other signs of pre-accident anomalies. The rocker cover was removed and no pre-accident anomalies were observed with the rockers or valve springs. A borescope inspection of the cylinder's internal components did not reveal any pre-accident anomalies with the barrel, piston, valves or valve seats. A thumb compression test resulted in compression and confirmed connecting rod, piston, and rocker arm movement.

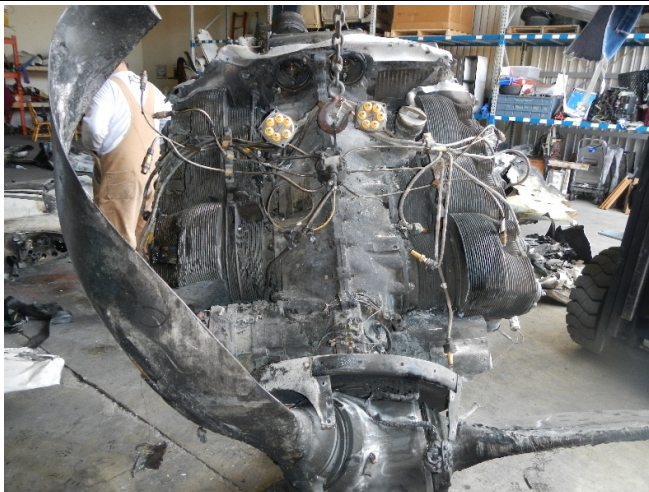
#### CRANKCASE

The crankcase remained intact with no pre-accident anomalies noted.

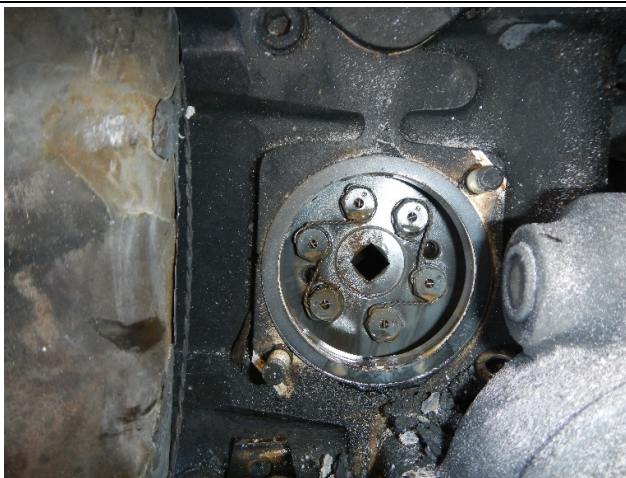
#### CRANKSHAFT

Though the crankshaft was not viewed in its entirety, crankshaft continuity was confirmed from the propeller flange aft to the crankshaft gear and out to each connecting rod/piston during a thumb compression test. The crankshaft gear bolts were safety-wired and in place. There was no binding noted during crankshaft rotation.

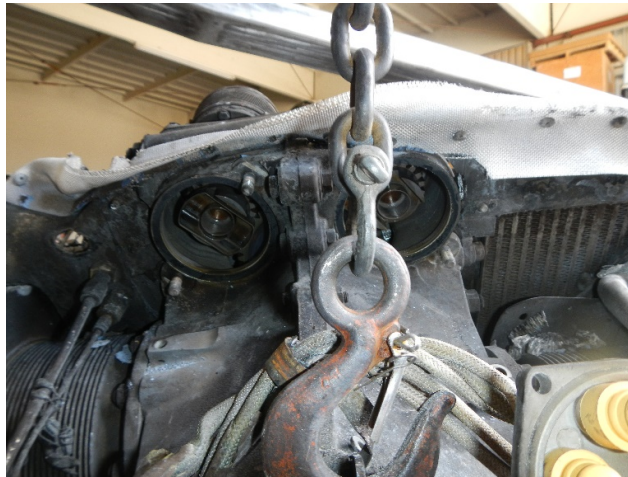
**ACCESSORY  
GEARS**

Condition: The accessory gears rotated during crankshaft rotation, with no pre-accident anomalies noted.

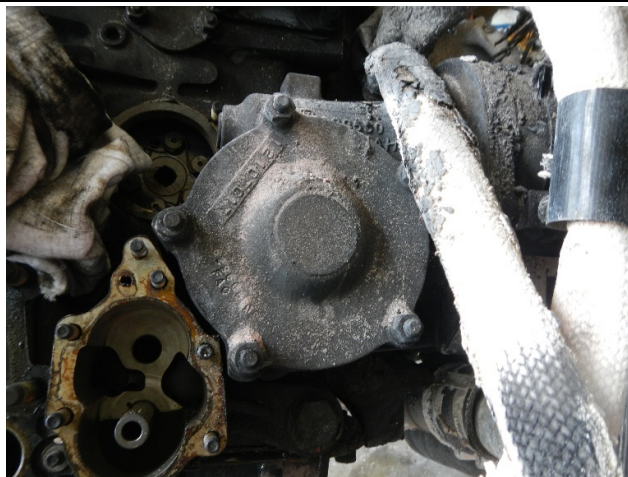
#### STARTER ADAPTER

The starter adapter remained intact and in place. No anomalies were noted during crankshaft rotation.

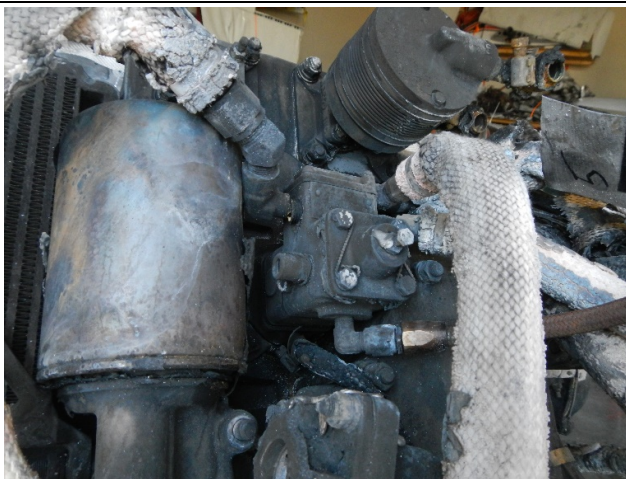
**VACUUM  
PUMP**

The vacuum pump remained attached to the accessory pad on the backside of the engine and was not examined as part of the investigation.

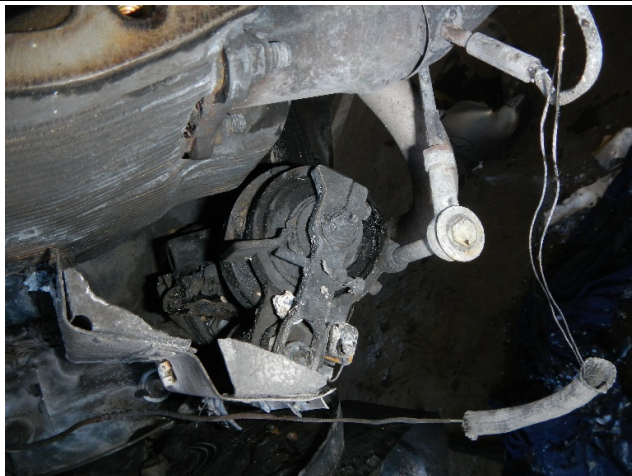
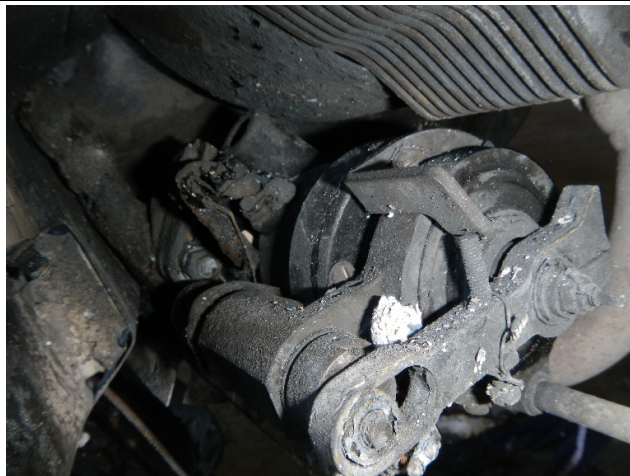
The propeller governor remained secured to the front left side of the engine and the control cable remained attached to the control lever. The propeller synchrophaser switch was in the off position in the cockpit. The burnt remains of the propeller synchrophaser mechanism remained attached to the propeller governor.

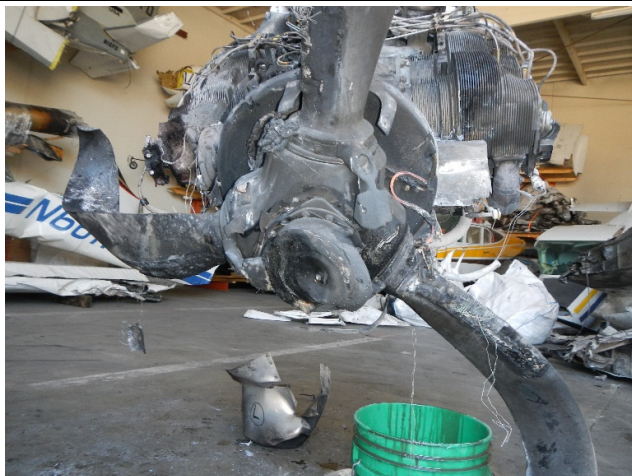
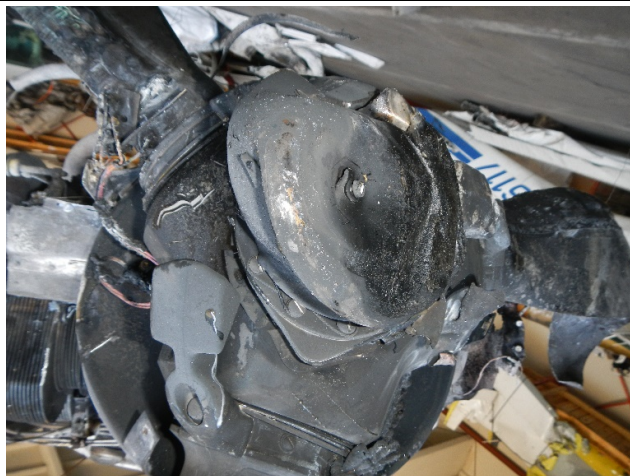
**PROPELLER**

The propeller remained attached to the engine crankshaft and all three propeller blades remained attached to the hub, though one was loose in the hub. The propeller piston was crushed aft and deformed. The internal spring was visible. All three blade tips were curled toward low pitch and one blade was bent forward. The propeller will be sent to the manufacturer for a more detailed examination under NTSB or FAA supervision.

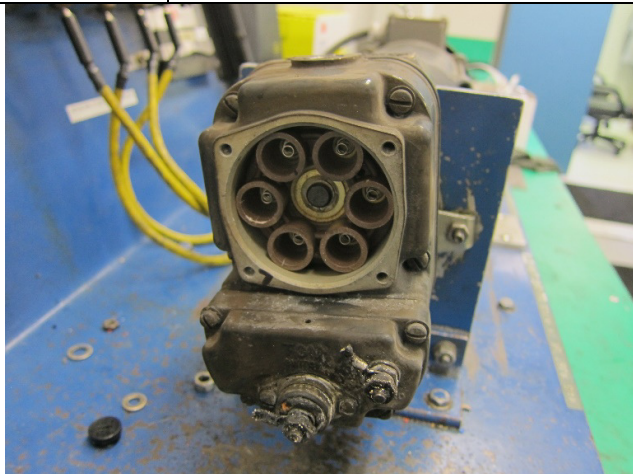
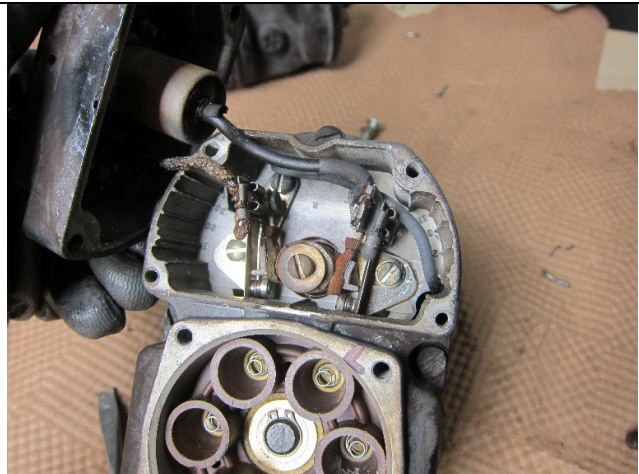
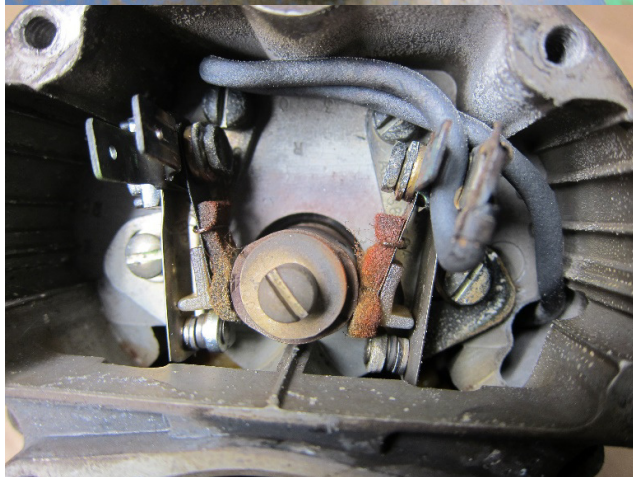
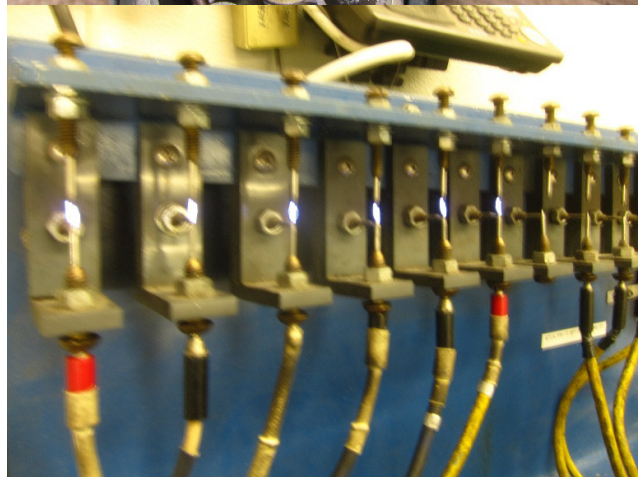
| LEFT MAGNETO | Manufacturer: CMI | P/N: Illegible | S/N: Illegible |
|---|---|---|---|
| Condition: | <p>The left magneto displayed thermal damage to the magneto. The magneto was placed on a test bench and the magneto was unable to produce a spark. The magneto cap was removed and the points were visually inspected. The points and associated components displayed thermal damage; the cam was unable to open the points which were consistent with thermal damage. The points were cleaned and adjusted to allow for the cam to open the points. The capacitor was tested and it was noted to be shorted to ground which was consistent with the thermal damage to the capacitor. A functional magneto cap with capacitor was installed and the magneto was placed on the test bench. The magneto was capable of producing a spark on all six posts in the correct order at all tested RPM settings. There were no pre-impact anomalies noted that would have prevented normal operation.</p> | | |
