# Continental Motors

## ENGINE EXAMINATION REPORT

| ENGINE MODEL | IO-520-M1B |
| AIRCRAFT MAKE & MODEL | Cessna 310R |

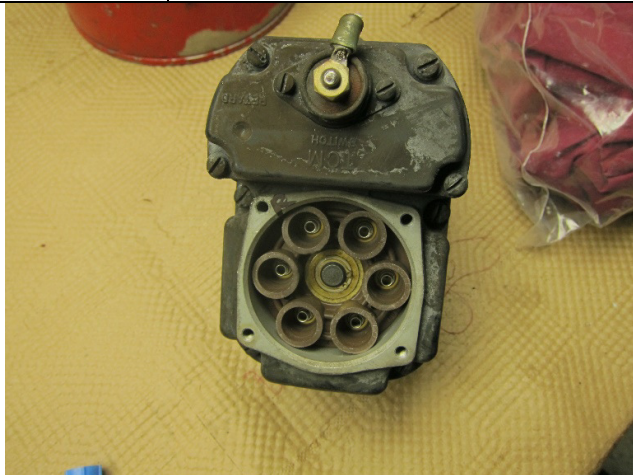
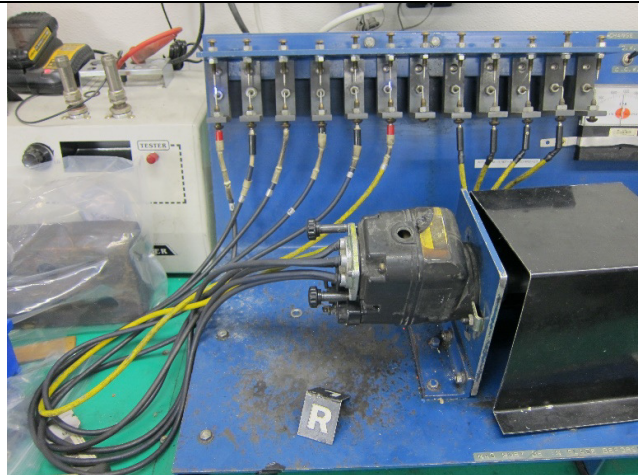
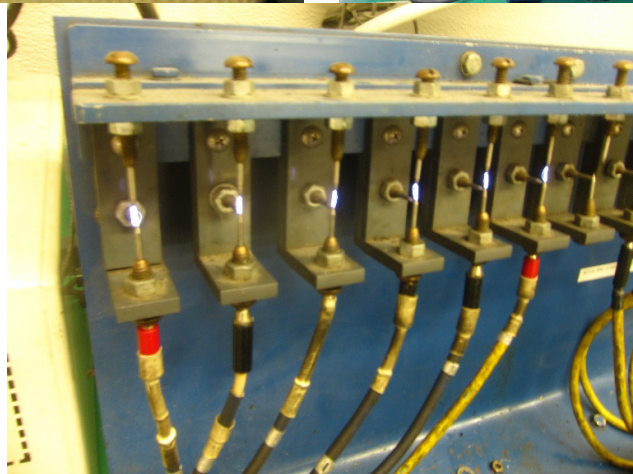
| RIGHT<br>MAGNETO | Manufacturer: CMI | P/N: Illegible | S/N: Illegible |
|---|---|---|---|
| Condition: | <p>The magneto displayed thermal damage to the magneto. The magneto was placed on a test bench and the magneto was unable to produce a spark. The magneto cap was removed and the capacitor was tested; the capacitor was noted to be shorted to ground which was consistent with the thermal damage. A functional magneto cap and capacitor was installed on the magneto and the magneto was placed on the test bench. The magneto was capable of producing a spark on all six posts in the correct order at all tested RPM settings. There were no pre-impact anomalies noted that would have prevented normal operation.</p> | | |
