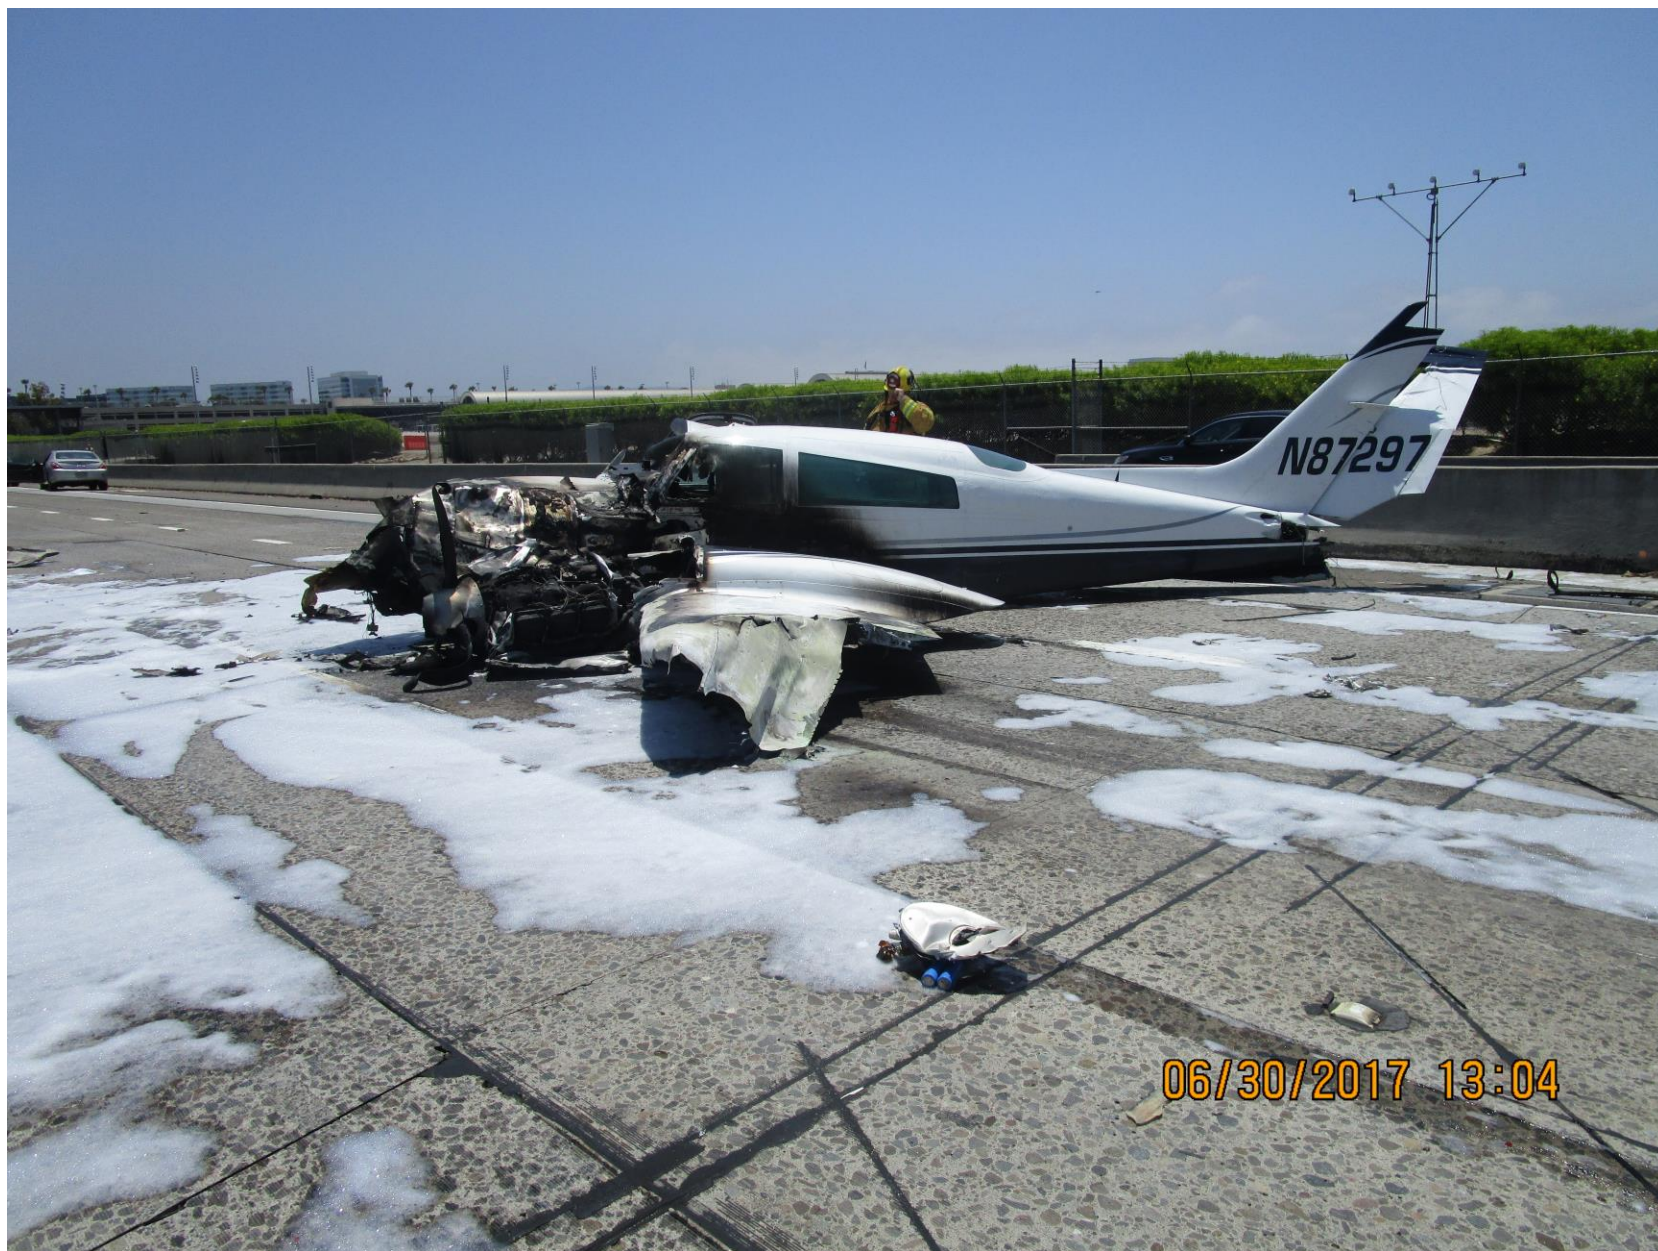
**Photo 1 – Accident site, main wreckage.**

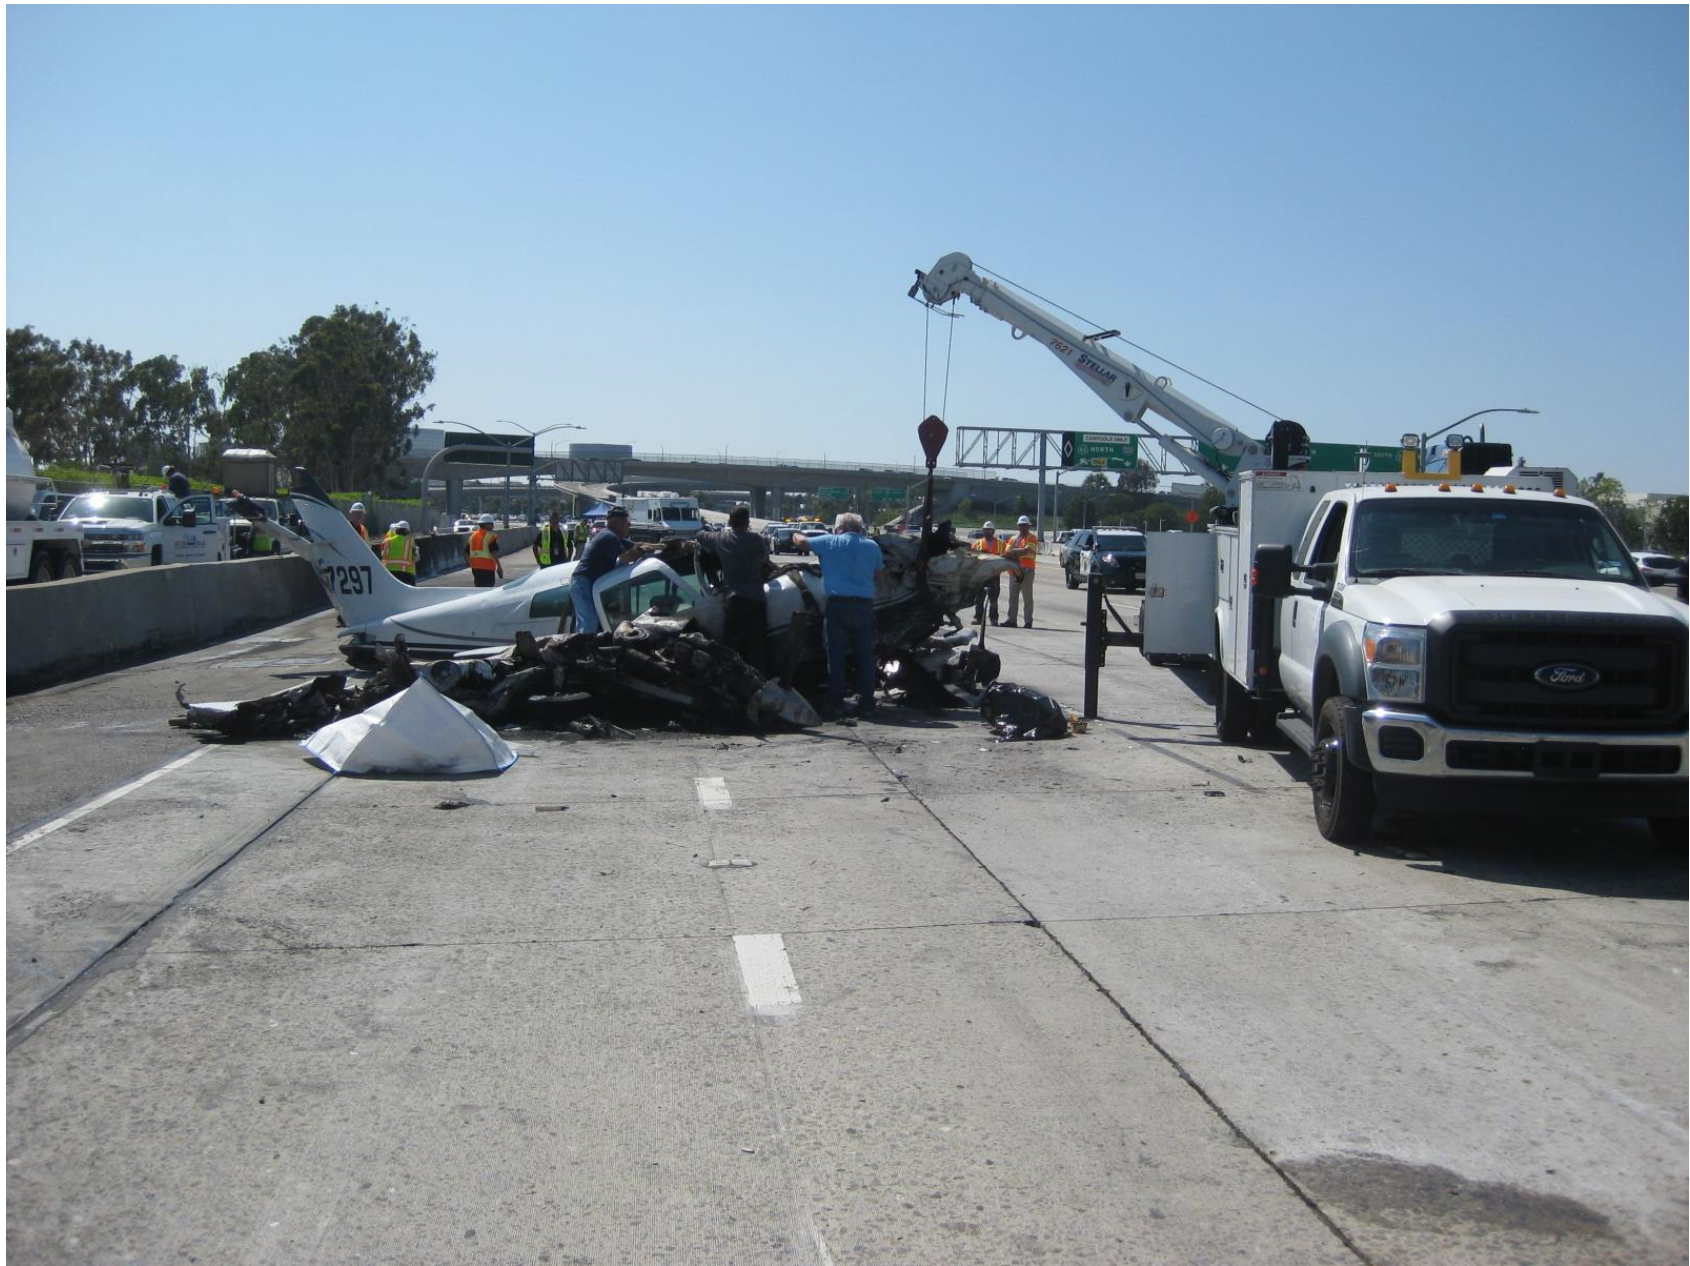
**Photo 2 – Accident site, wreckage recovery efforts.**

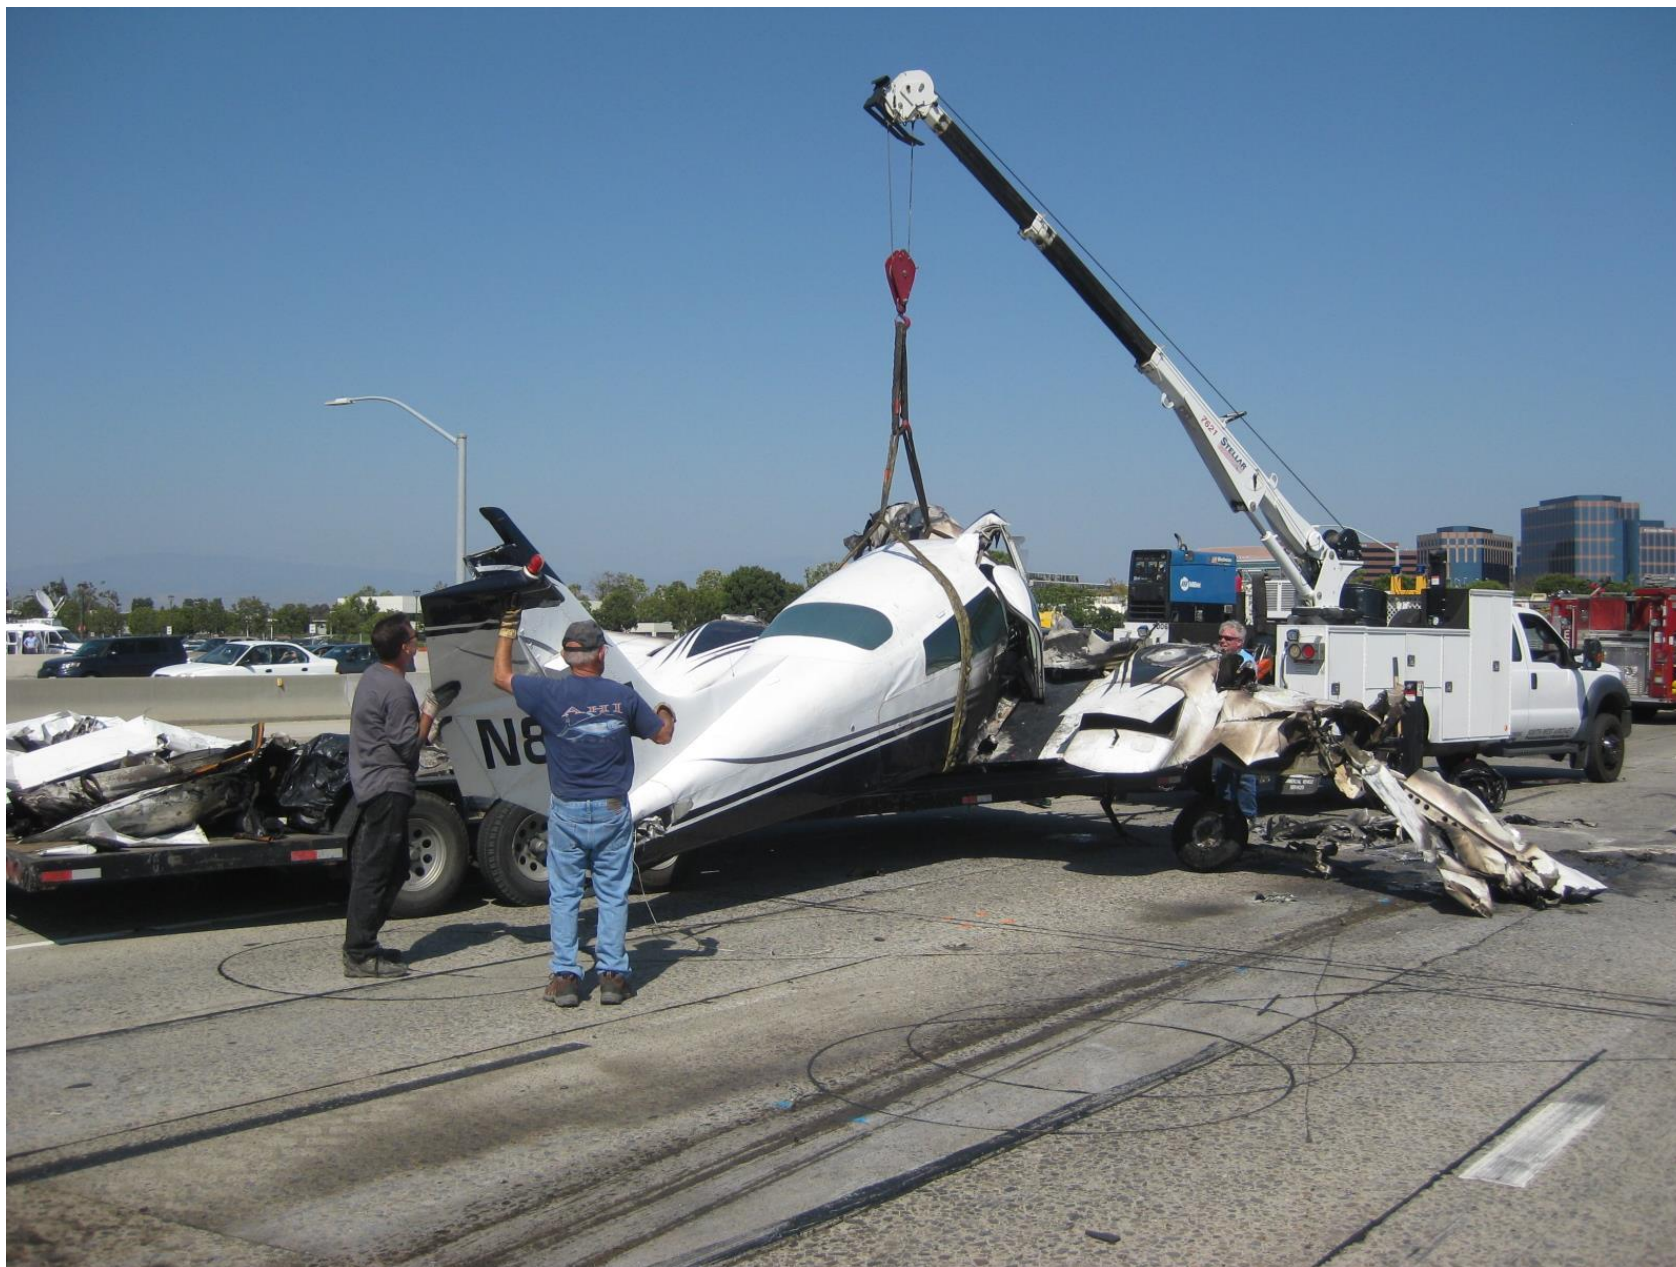
**Photo 3 – Accident site, wreckage recovery efforts.**

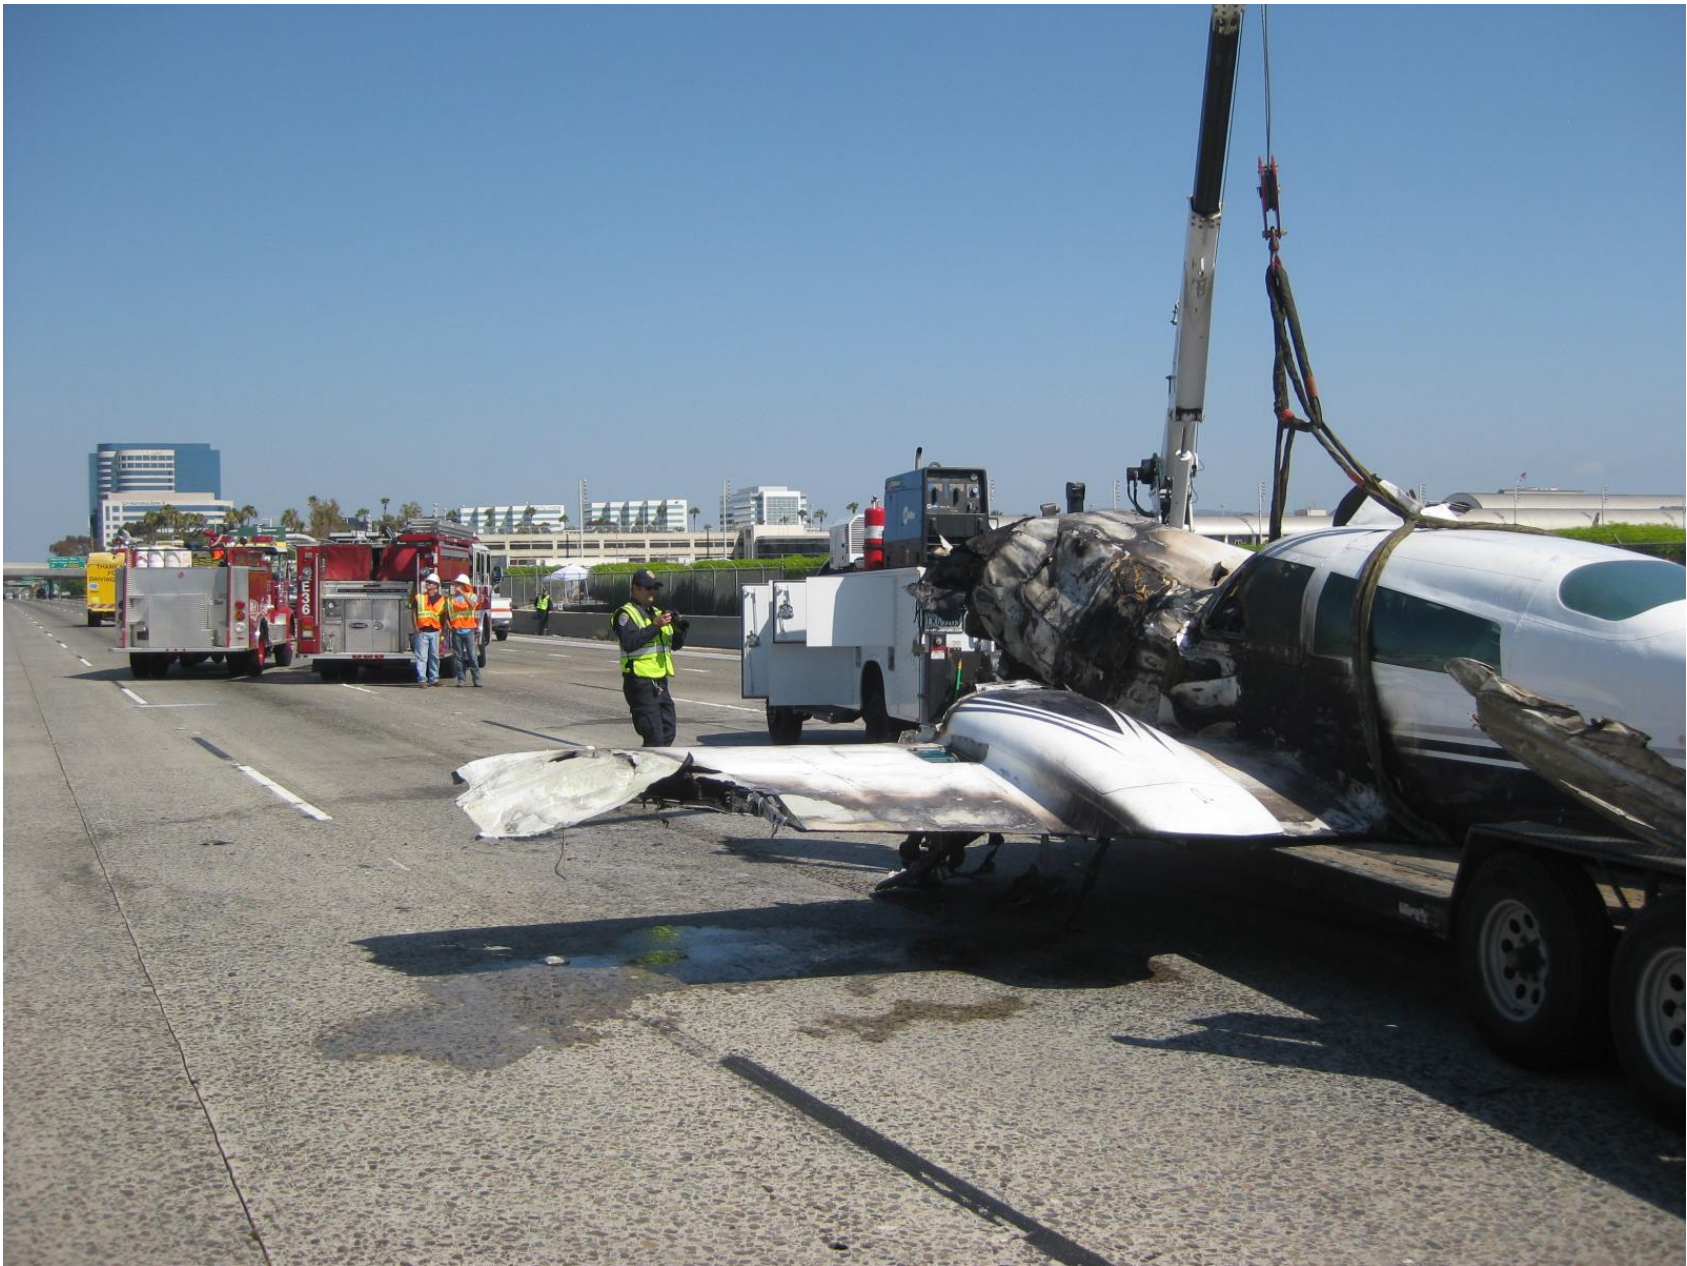
**Photo 4 – Accident site, wreckage recovery efforts.**

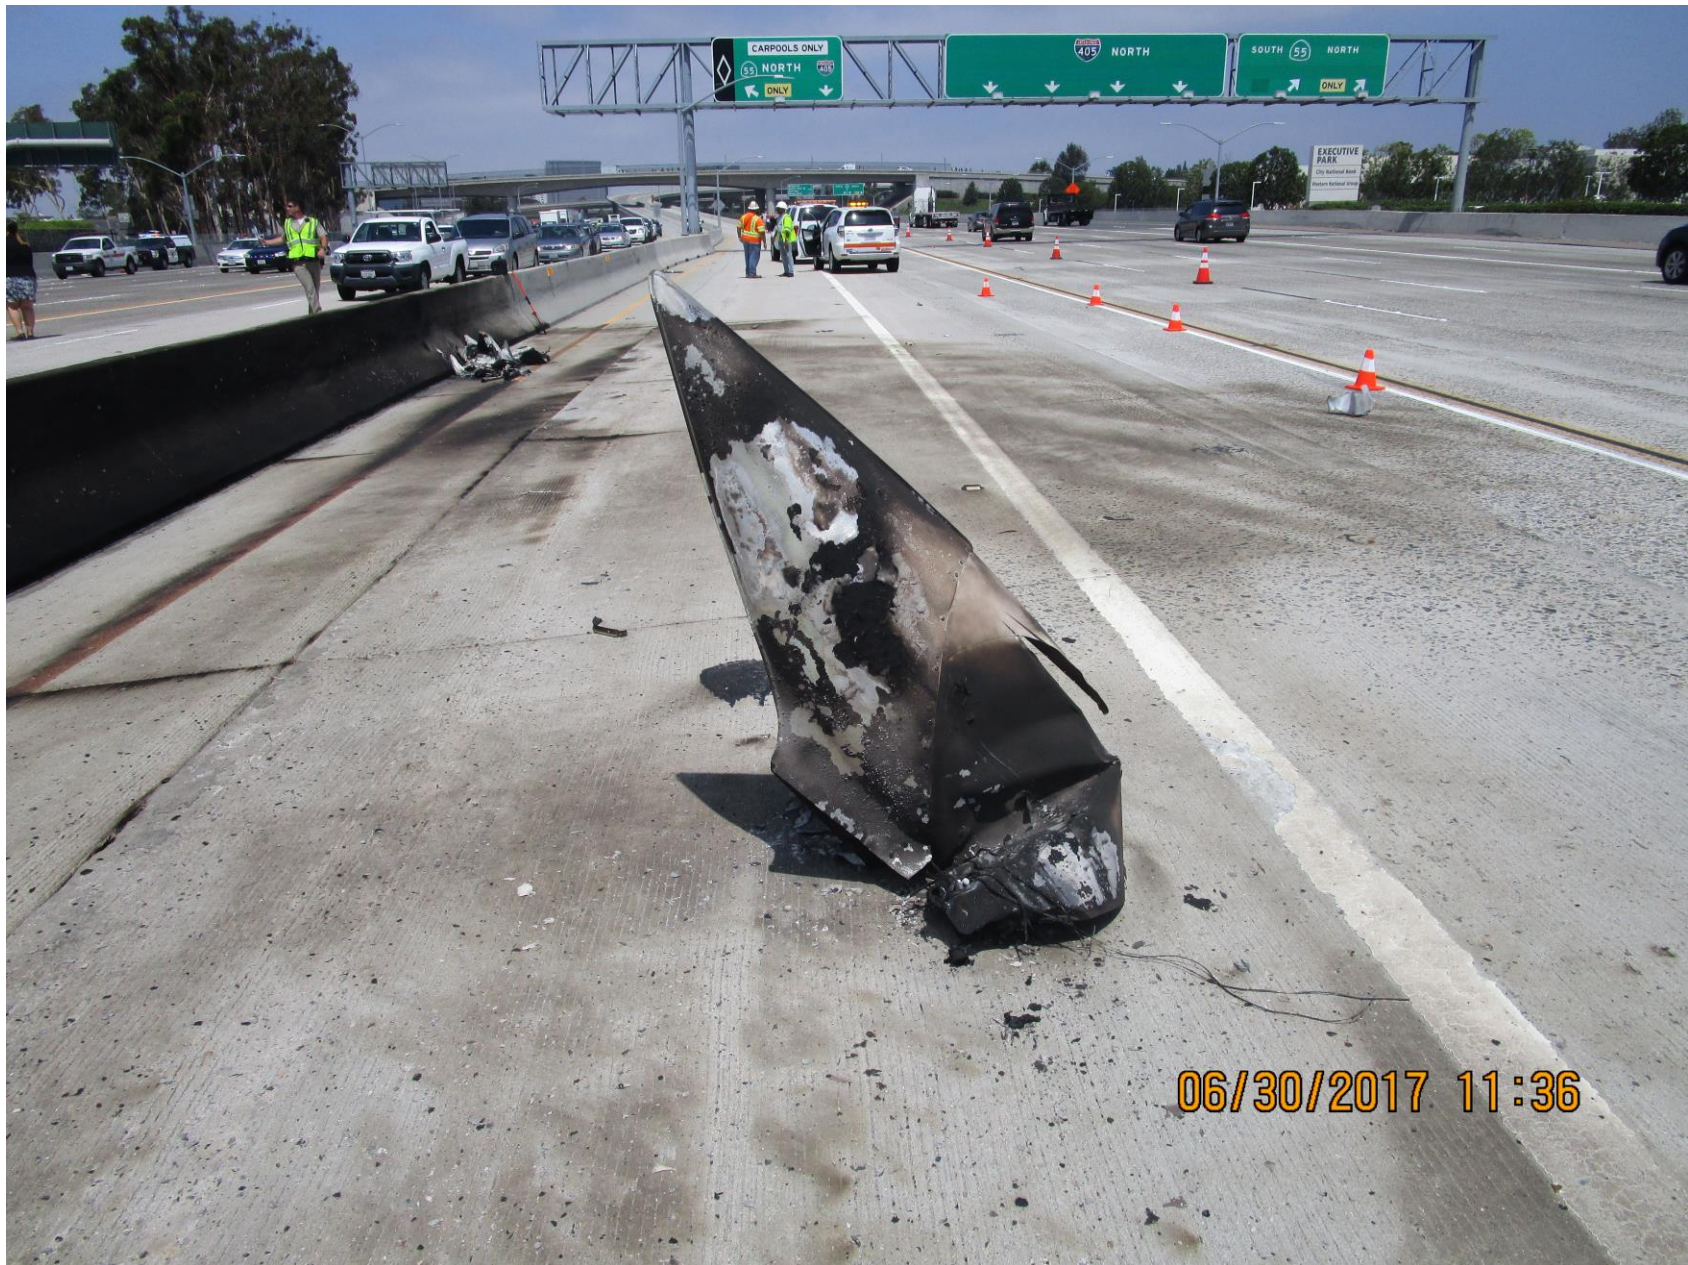
**Photo 5 – Accident site, left wing tip tank.**

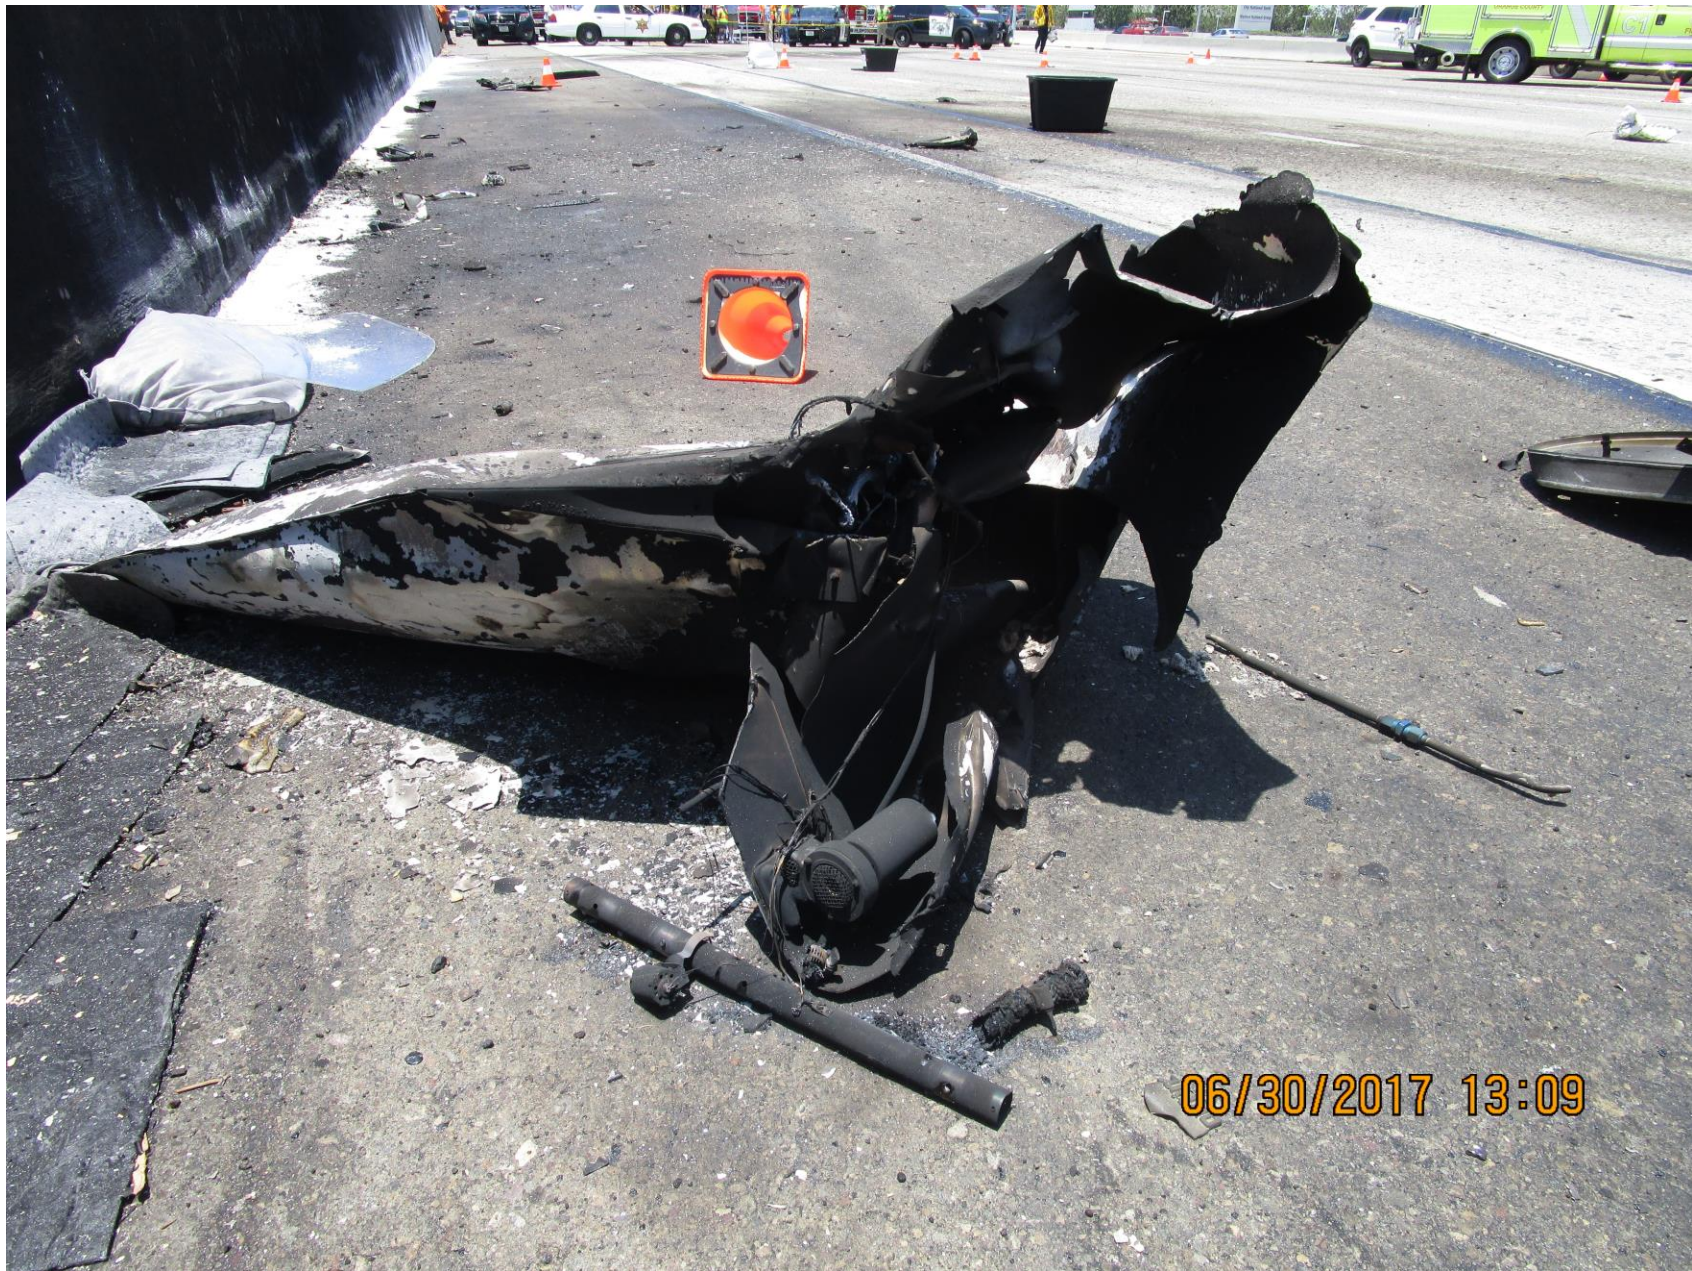
**Photo 6 – Accident site, right wing tip tank.**

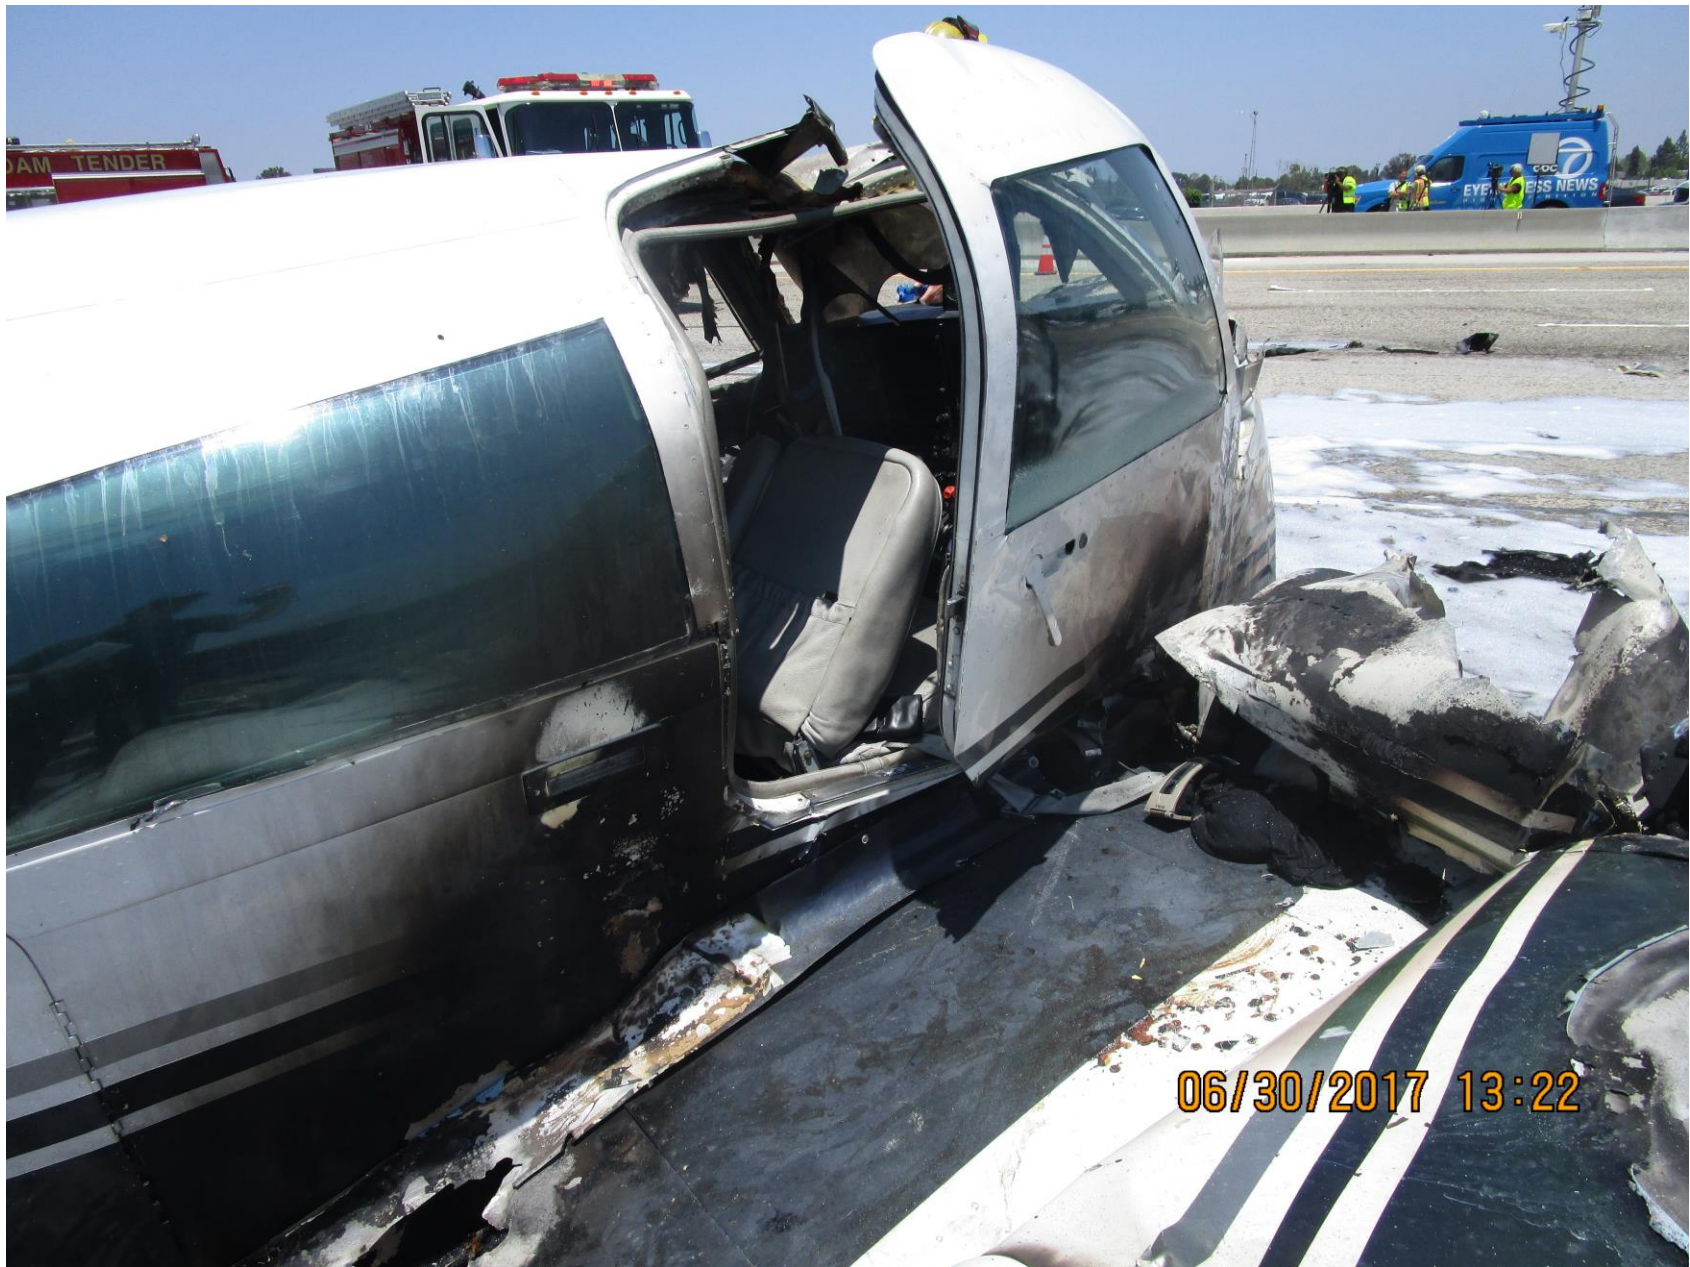
**Photo 7 – Accident site, cabin entry door and right wing.**

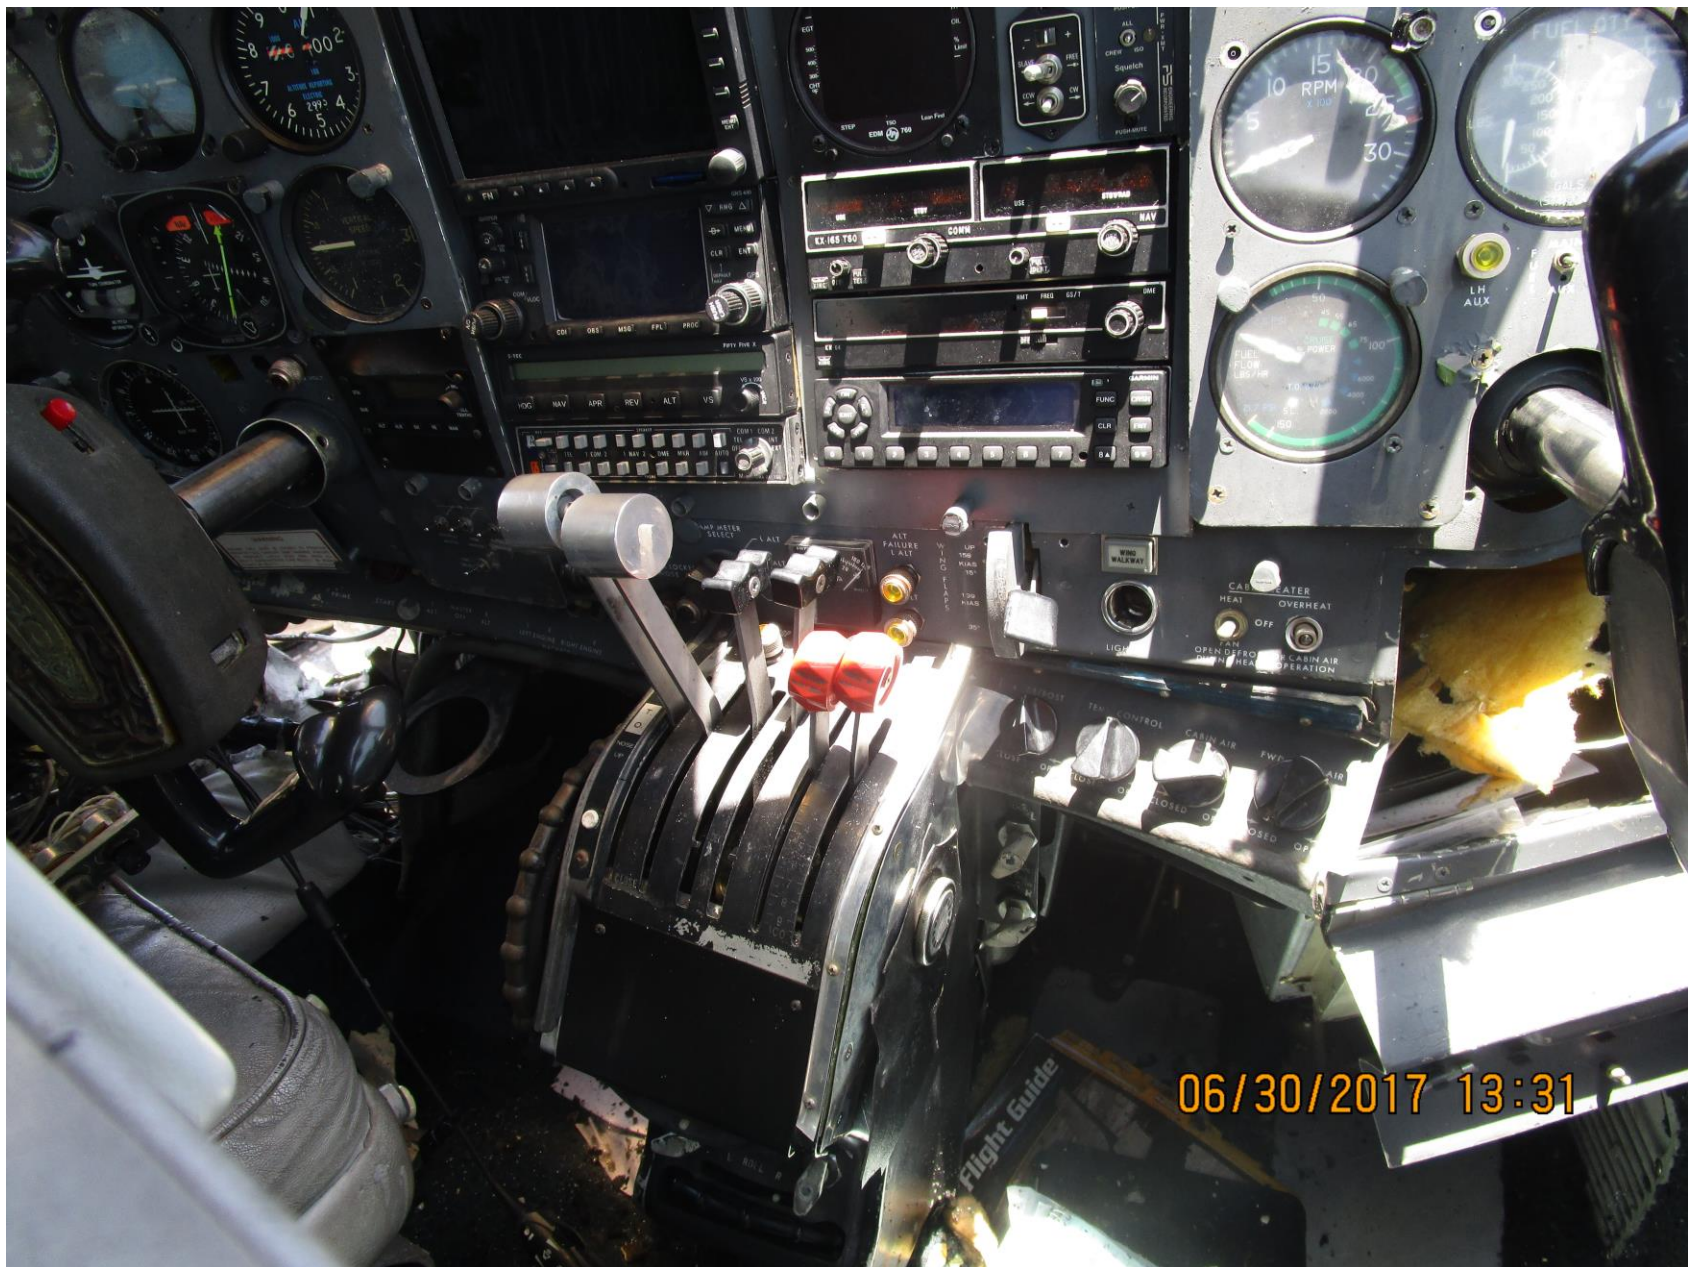
Photo 8 – Accident site, cabin instrument panel.

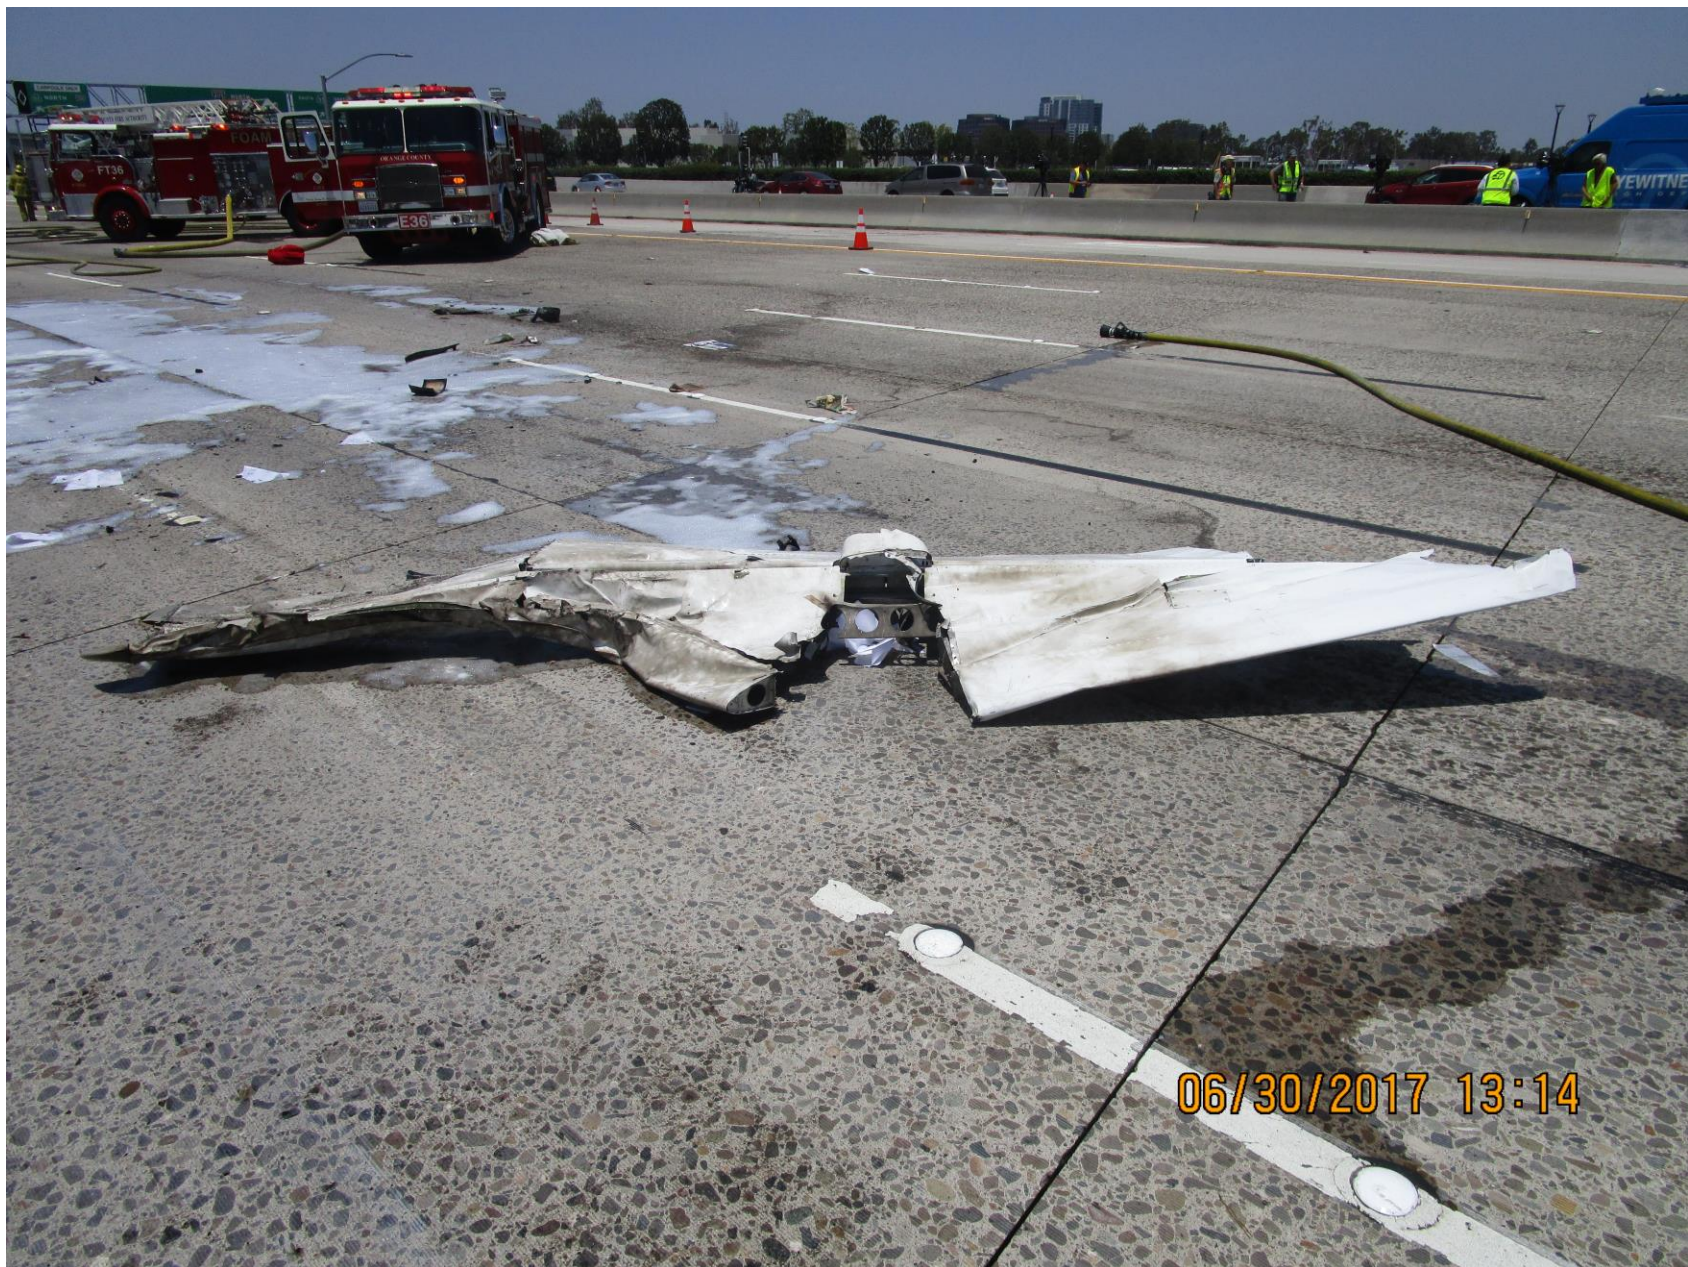
**Photo 9 – Accident site, horizontal stabilizers and elevators.**
