## **NATIONAL TRANSPORTATION SAFETY BOARD**

### **ENGINE EXAM REPORT**

WPR17LA137

Aircraft: Cirrus Design Corporation SR-22, Registration Number: N744TC, Serial #: 3640

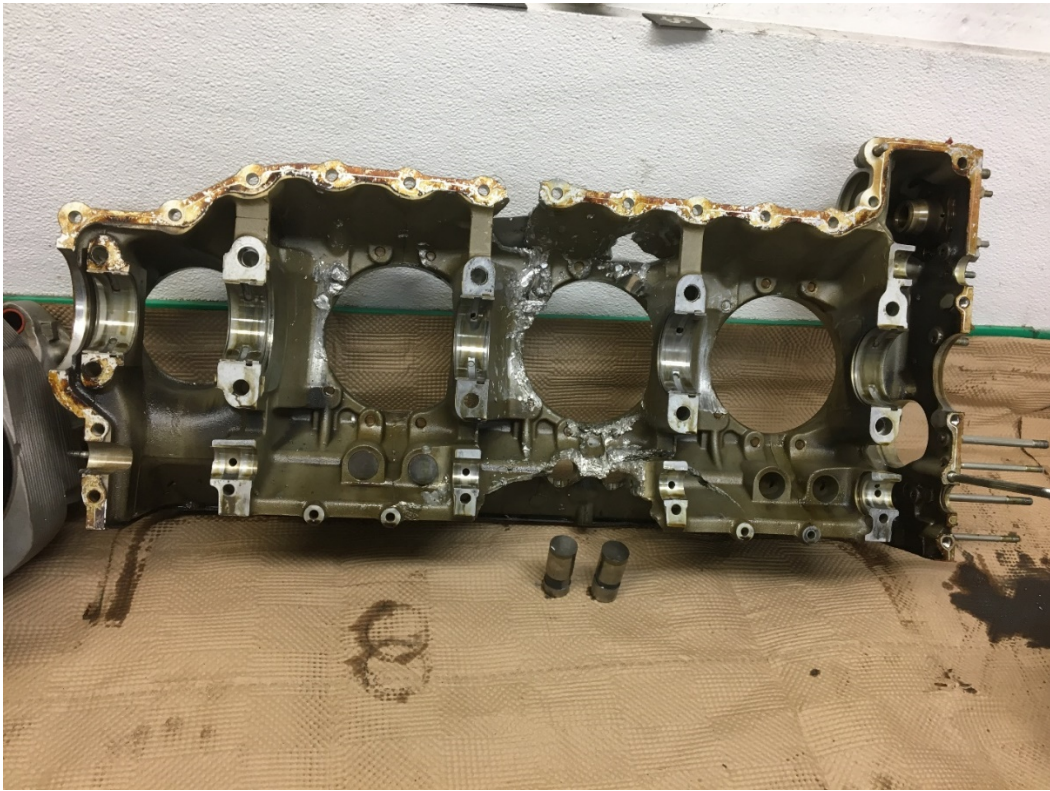
The case was separated. Gouging was evident on the forward counterweights and connecting rod journal. There were no blockages noted in the oil passages that fed the crankshaft and connecting rod journals. The camshaft sustained damage in the area that coincided with the fractured connecting rods, and the number three lifter housing was fractured, the lifters were not in place. There were no pre-accident anomalies noted on the lifter faces or camshaft lobes.

*Figure 1 Right Side Crankcase Half*

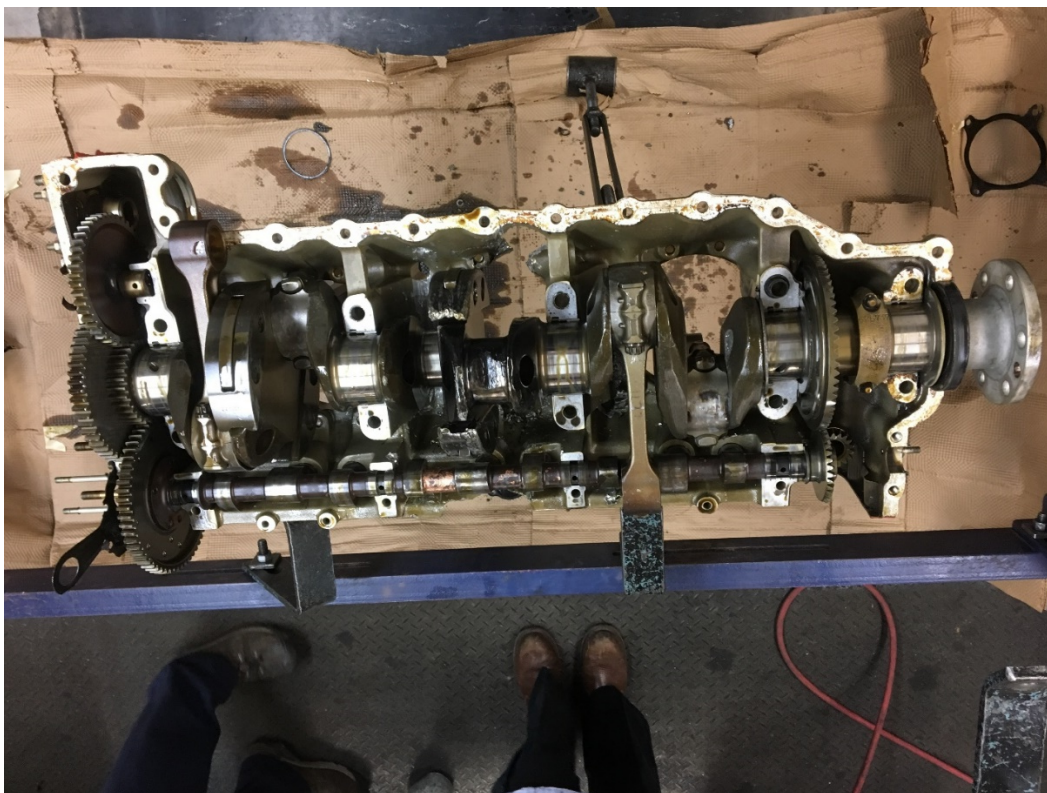
*Figure 2 Left Side Crankcase Half*

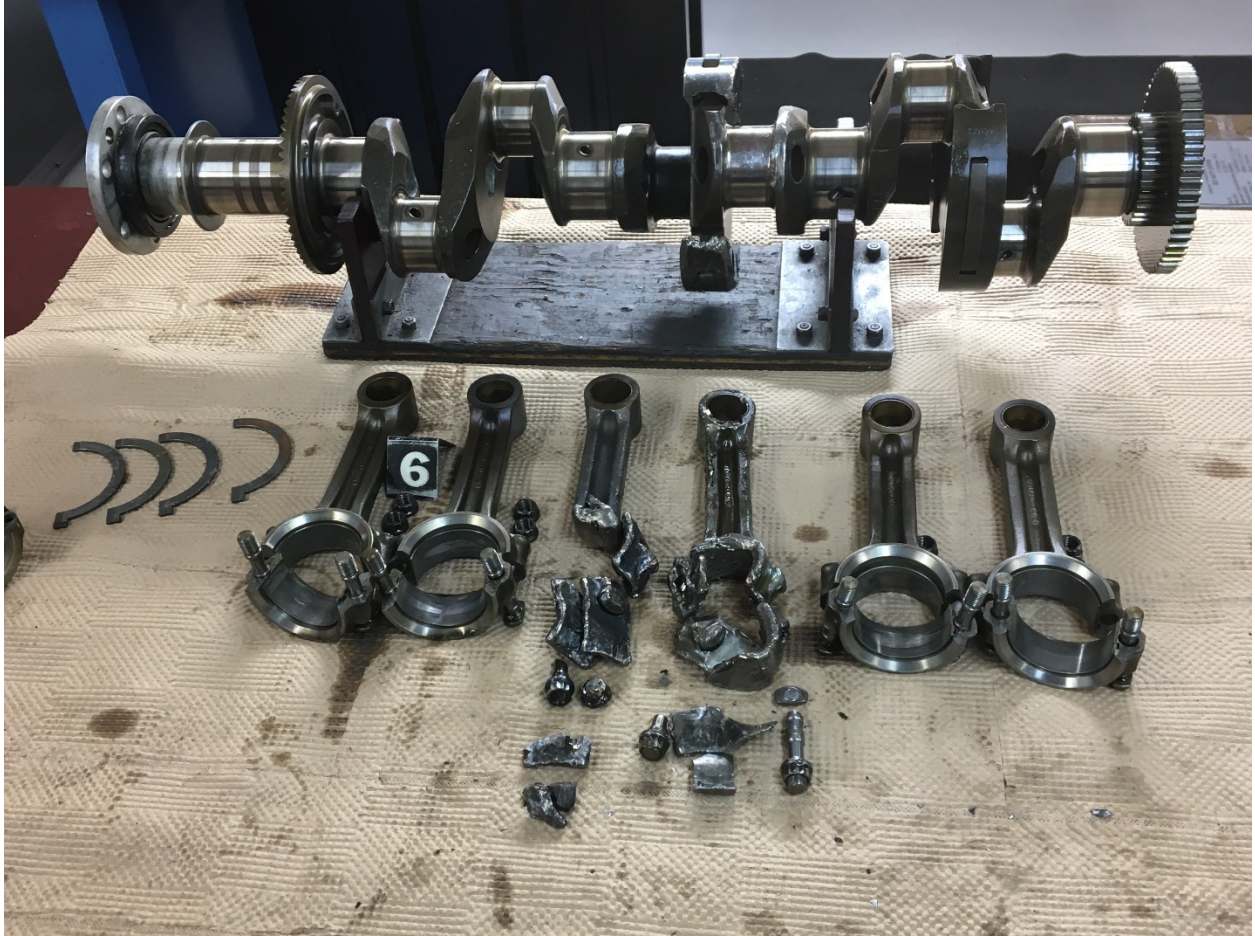
CMI personnel had to saw off part of the numbers three, four, and six cylinder bases to facilitate removal due to deformation caused by fractured connecting rods and removed the cylinders. The numbers three and four connecting rods were fractured and separated from their connecting rod journals. The number four connecting rod, rod bearing, and journal displayed thermal discoloration consistent with oil starvation.

*Figure 3 Crankshaft and Connecting Rods*

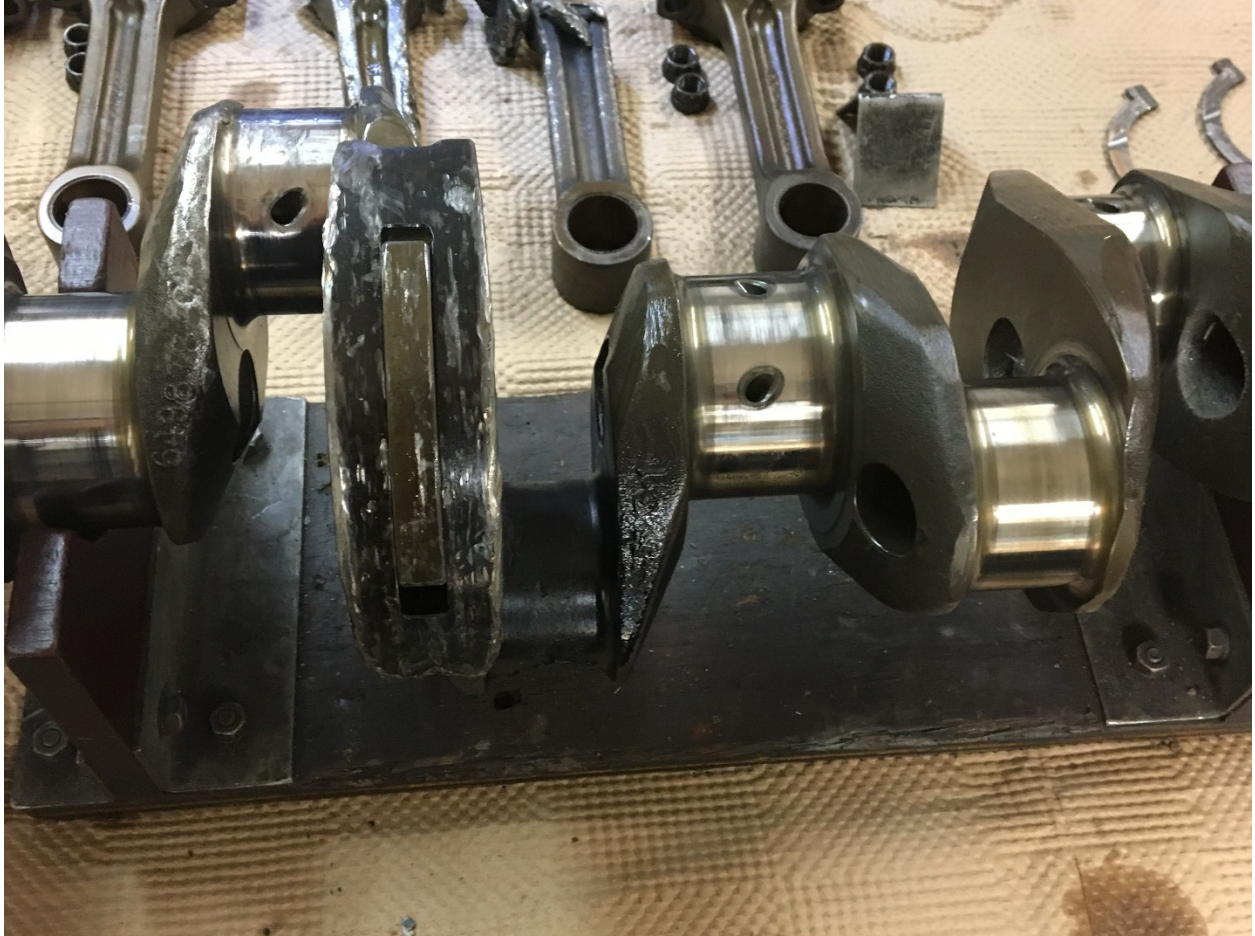
*Figure 4 Crankshaft at Number Four Connecting Rod*

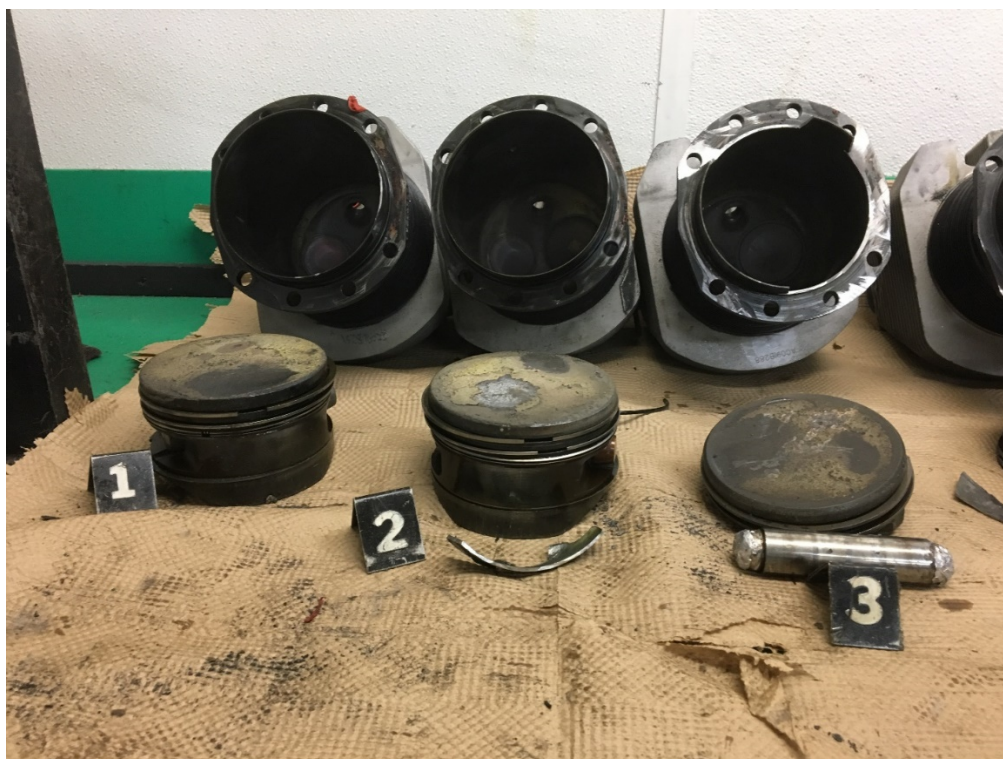
The piston face for cylinder number three had a single semicircular dimple imprint consistent with a valve strike while the piston face for cylinder number four had two imprints. The number three piston cylinder skirt was fractured below the oil control ring and the piston pin had separated.

*Figure 5 Cylinders One, Two, and Three*

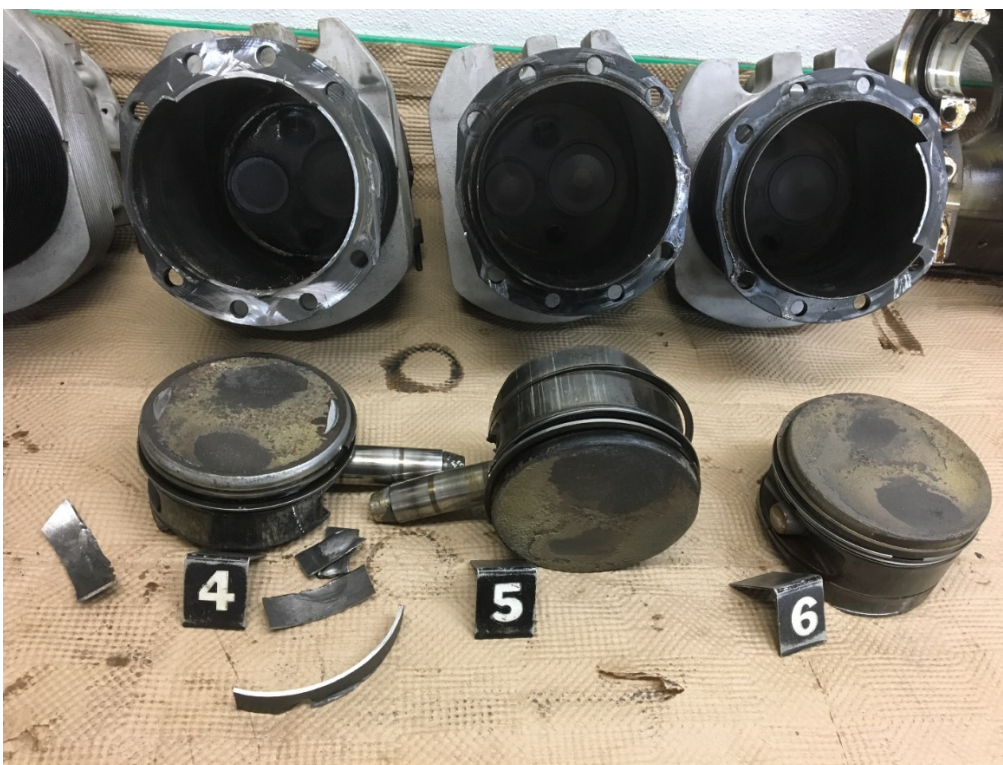
*Figure 6 Cylinders Four, Five, and Six*

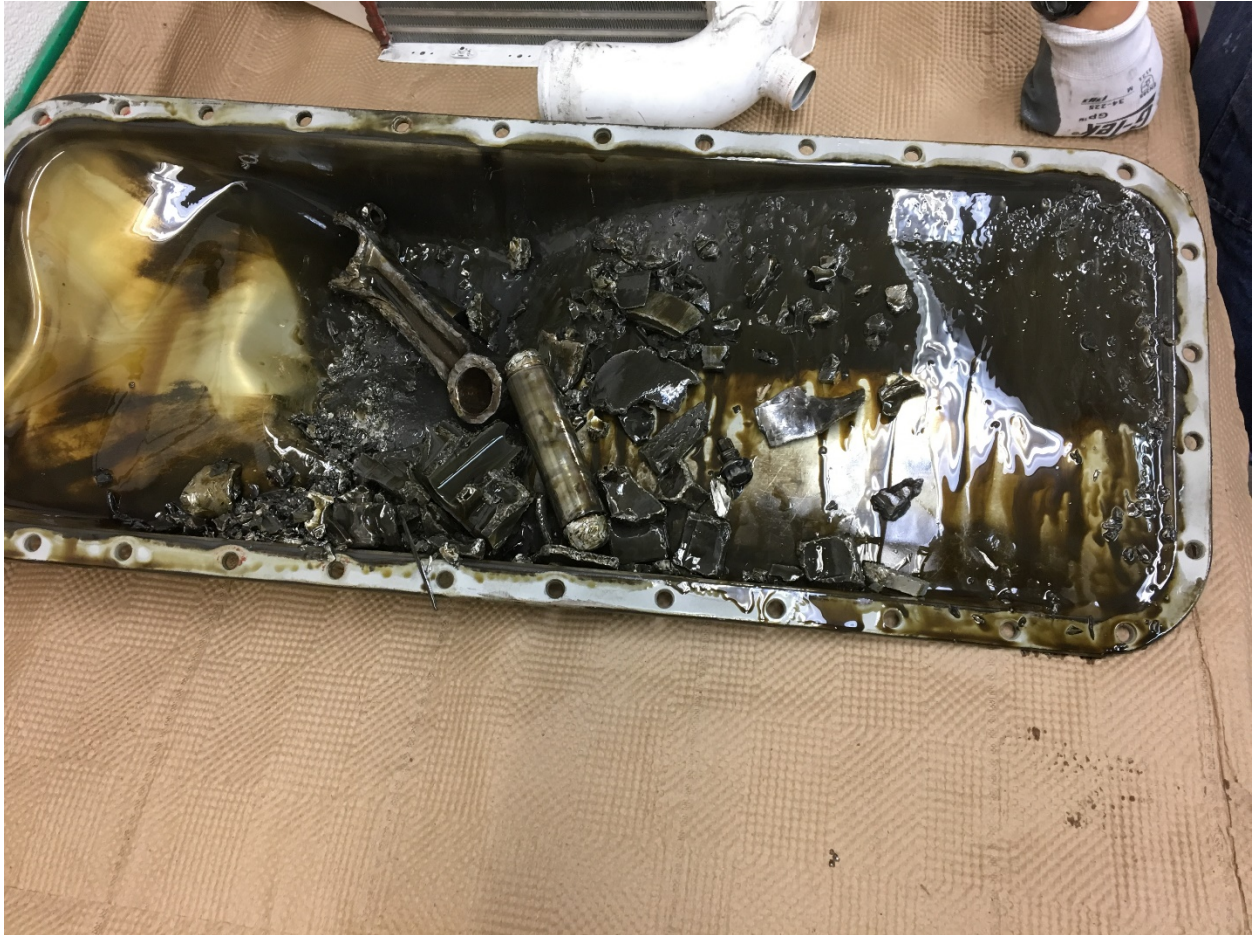
The oil sump was removed, and it contained many pieces of debris including fragments of the number three connecting rod and number four rod bearing.

*Figure 7 Oil Pan with Debris*

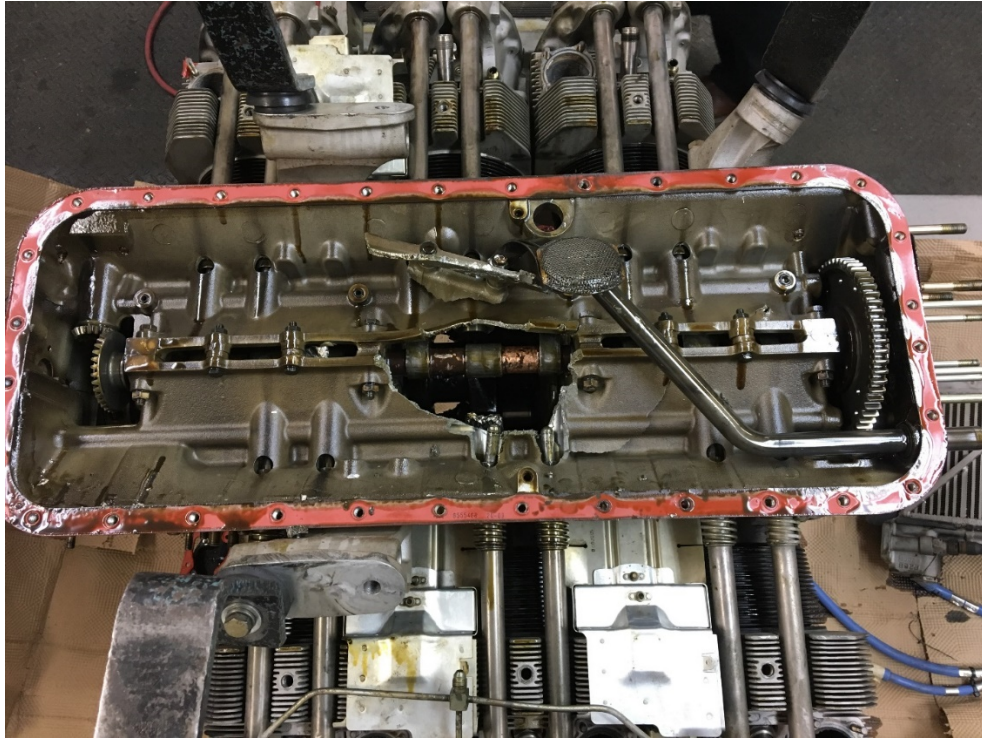
The crankcase had fractured and a section containing two of the mounting bolts for the oil sump screen separated, and the screen was displaced. The screen was clean and open.

*Figure 8 Bottom of Crankcase*

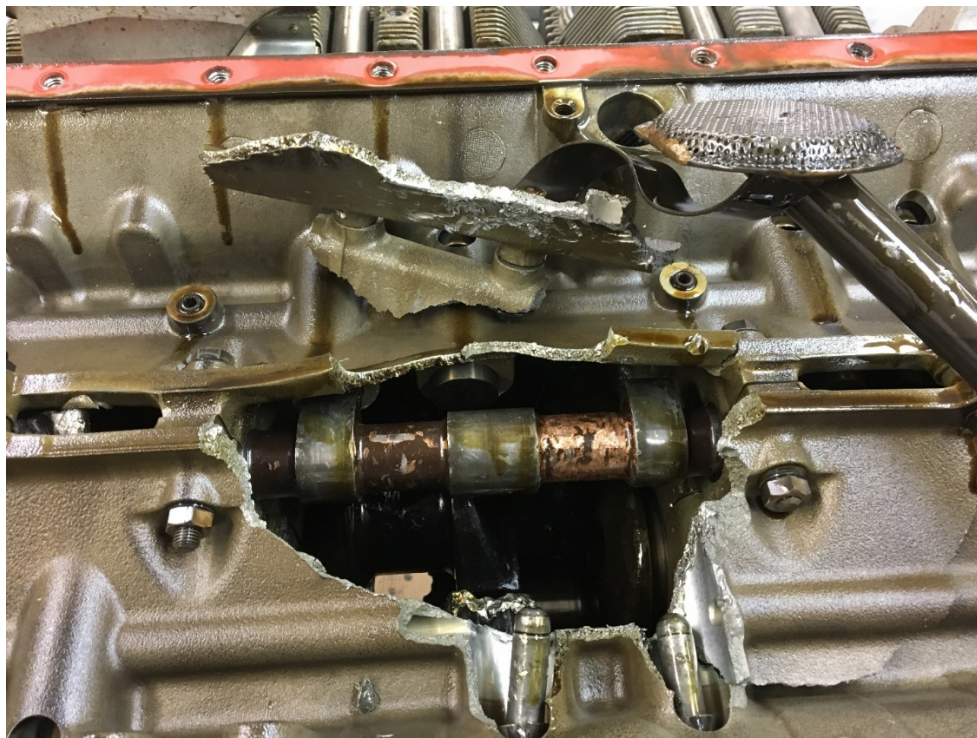
*Figure 9 Closeup of Displaced Oil Sump Screen*

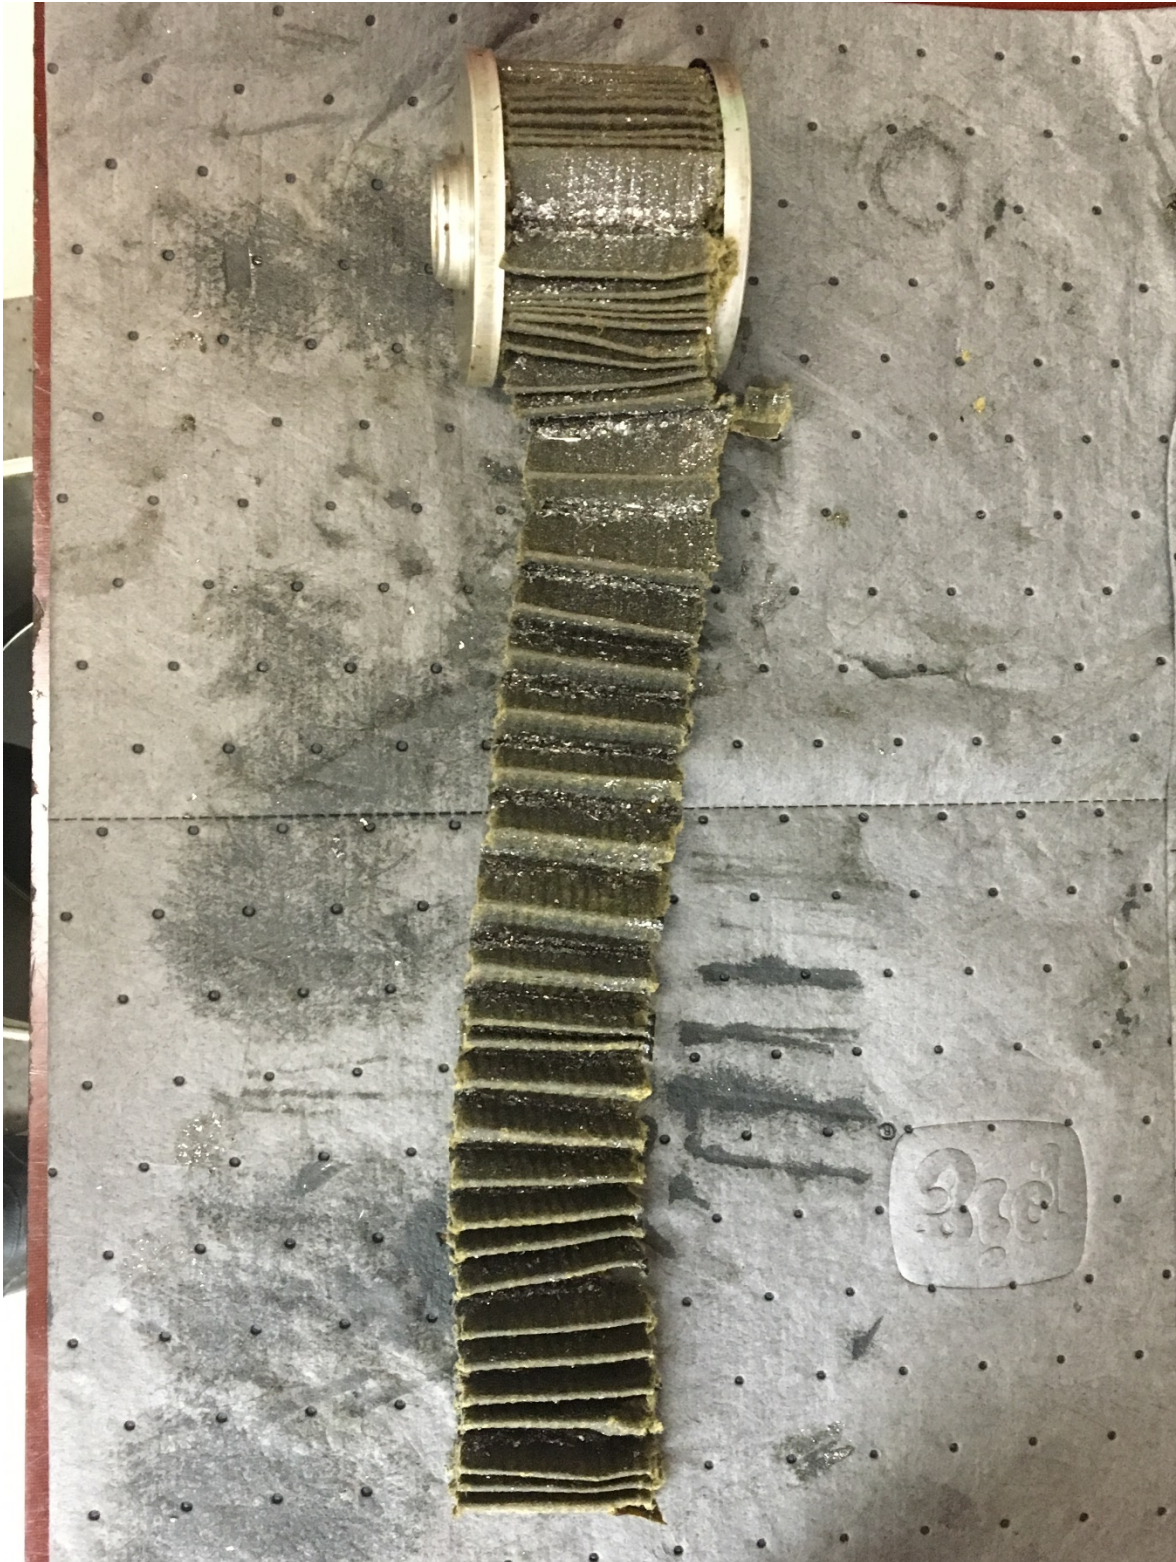
The governor screen was clean. The oil filter contained shiny metallic debris.

*Figure 10 Oil Filter*

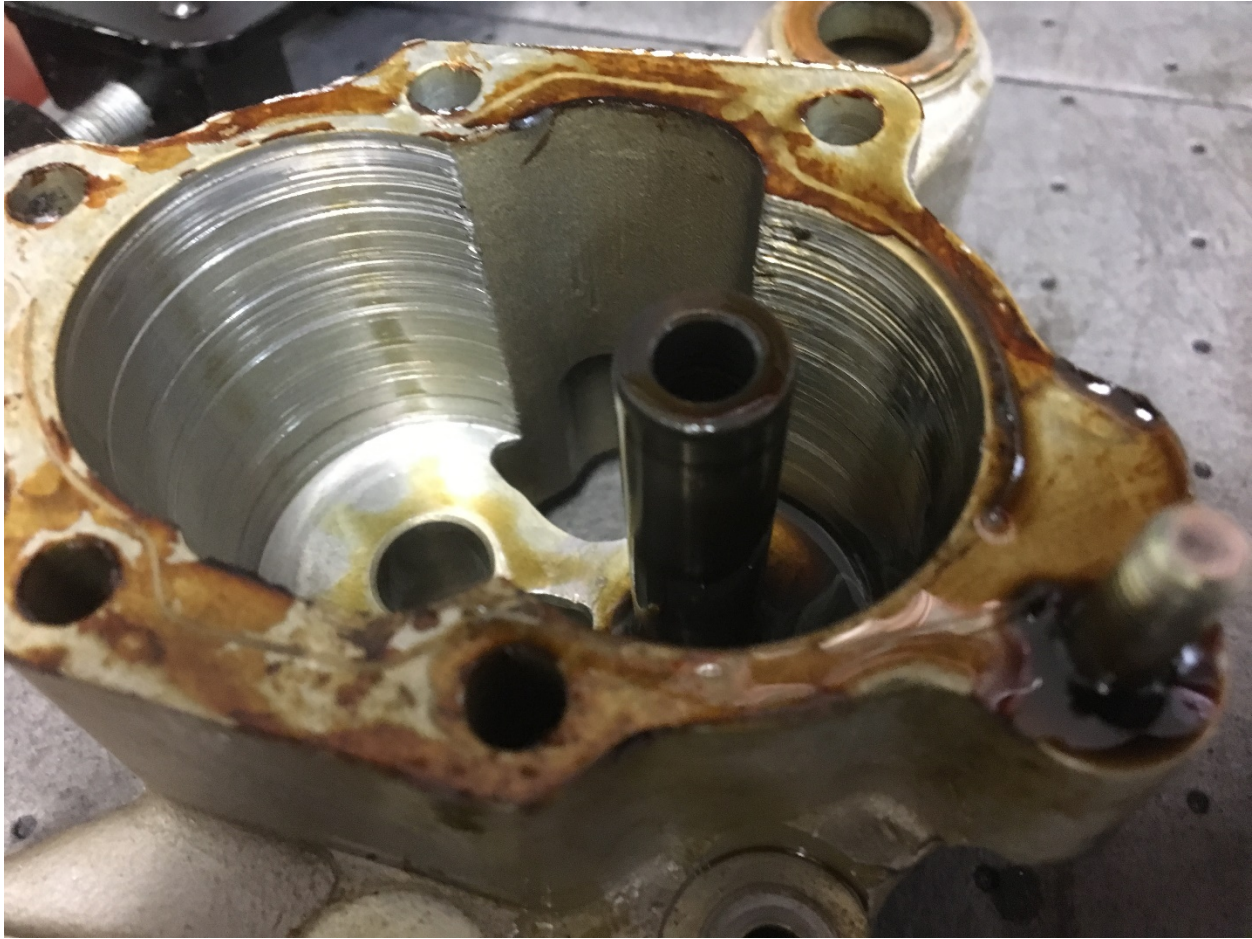
The oil pump exhibited rotational scoring; the scavenge pump was unremarkable.

*Figure 11 Oil Pump*

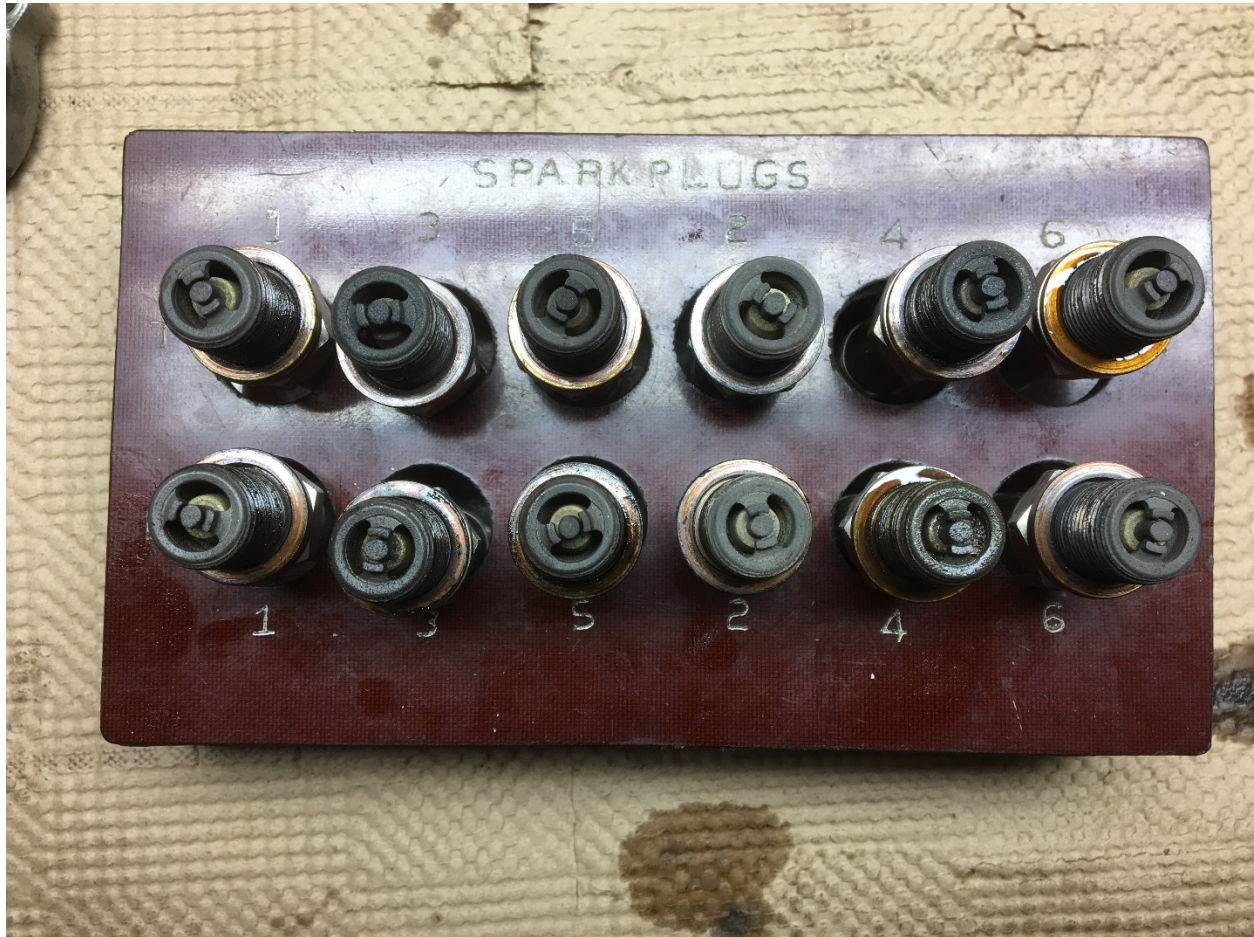
CMI personnel removed the spark plugs; all center electrodes were elliptical and clean with no mechanical deformation except for the number four bottom plug, which was wet and contained debris. The spark plug electrodes were gray, which corresponded to normal operation according to the Champion Aviation Check-A-Plug AV-27 Chart.

*Figure 12 Spark Plugs*

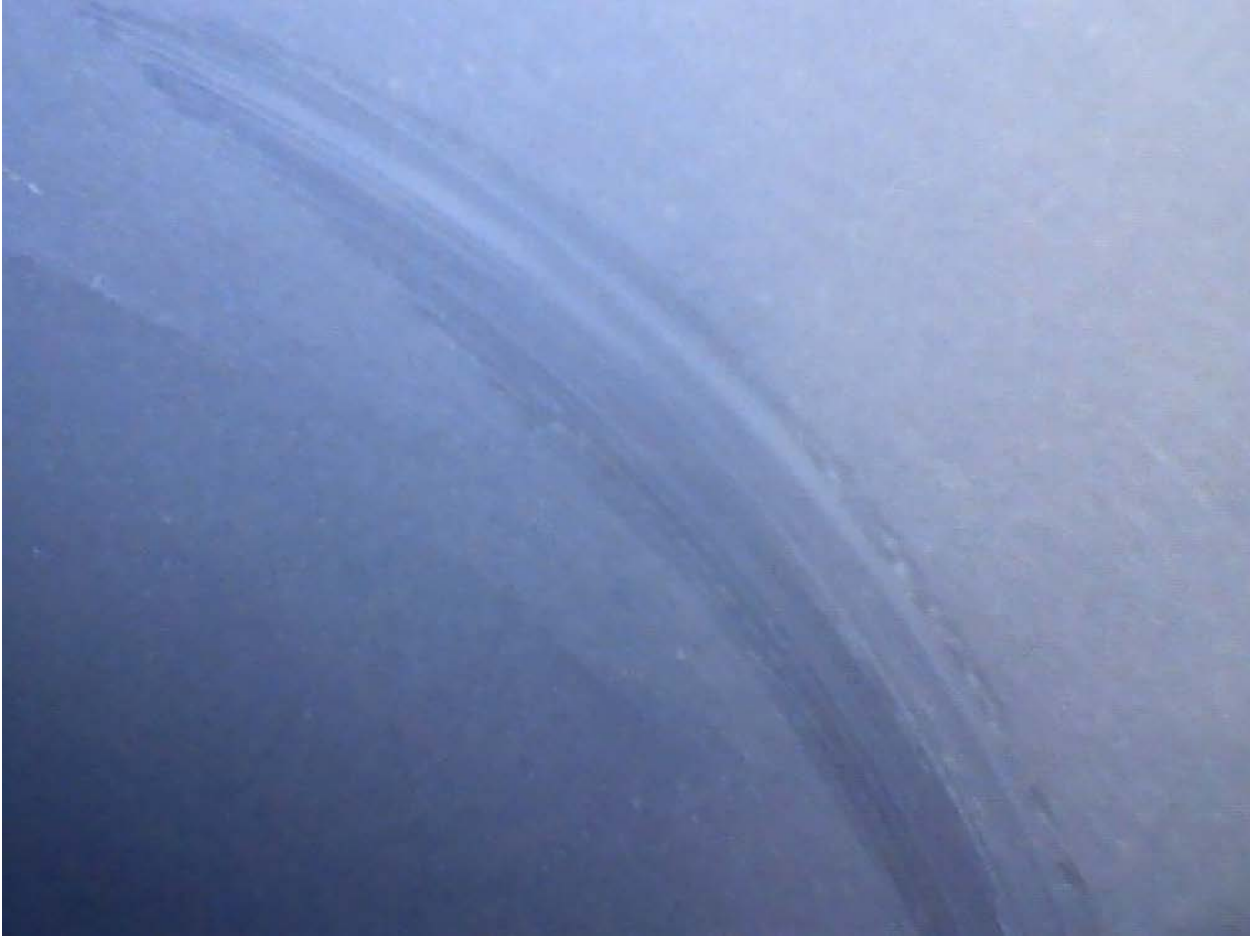
Examination of the right exhaust pipe with a lighted borescope revealed some circumferential scrape marks and material transfer on its internal surfaces.

*Figure 14 Scrape Mark 2 Inside Right Exhaust*

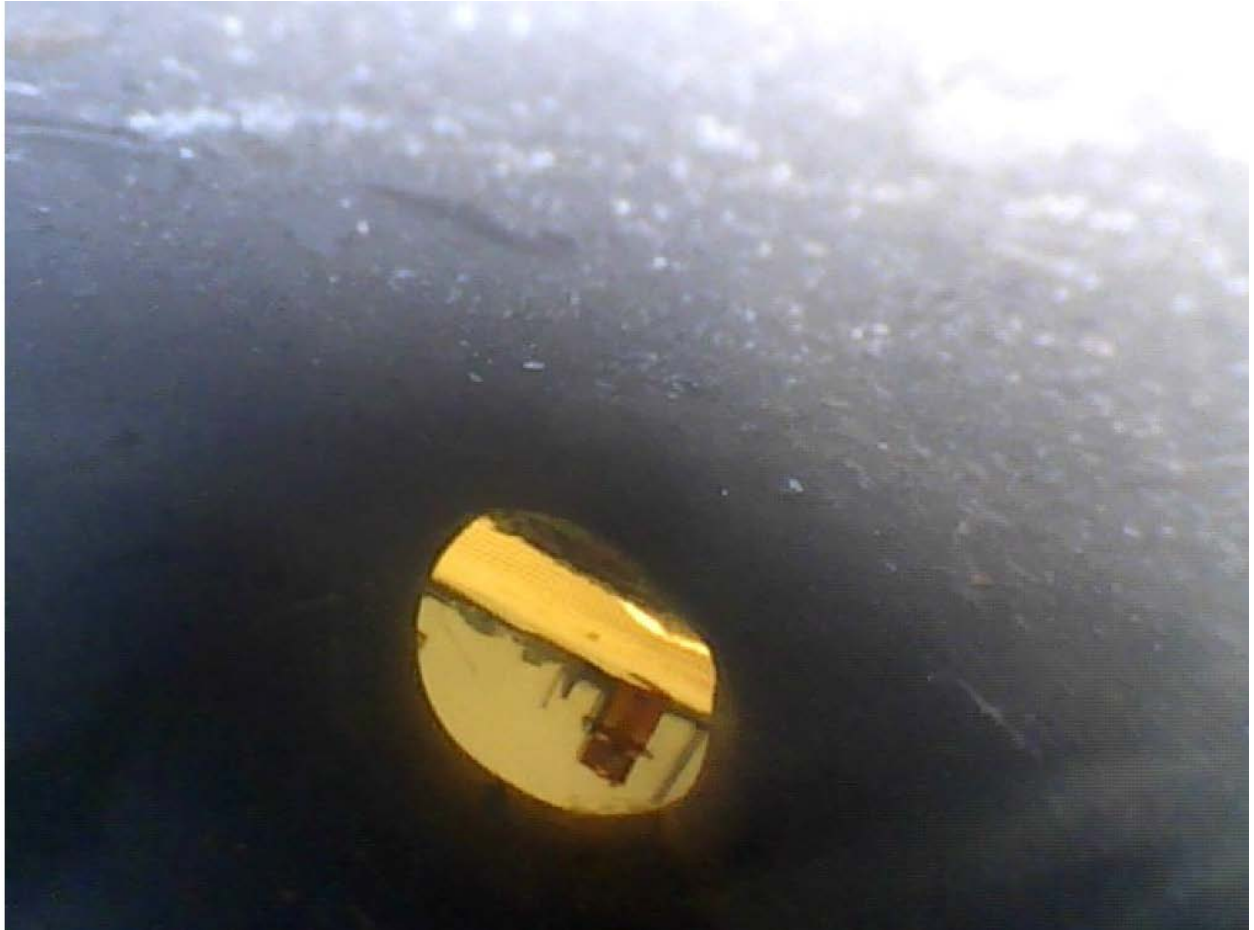
*Figure 15 Scrape Mark 3 Inside Right Exhaust*

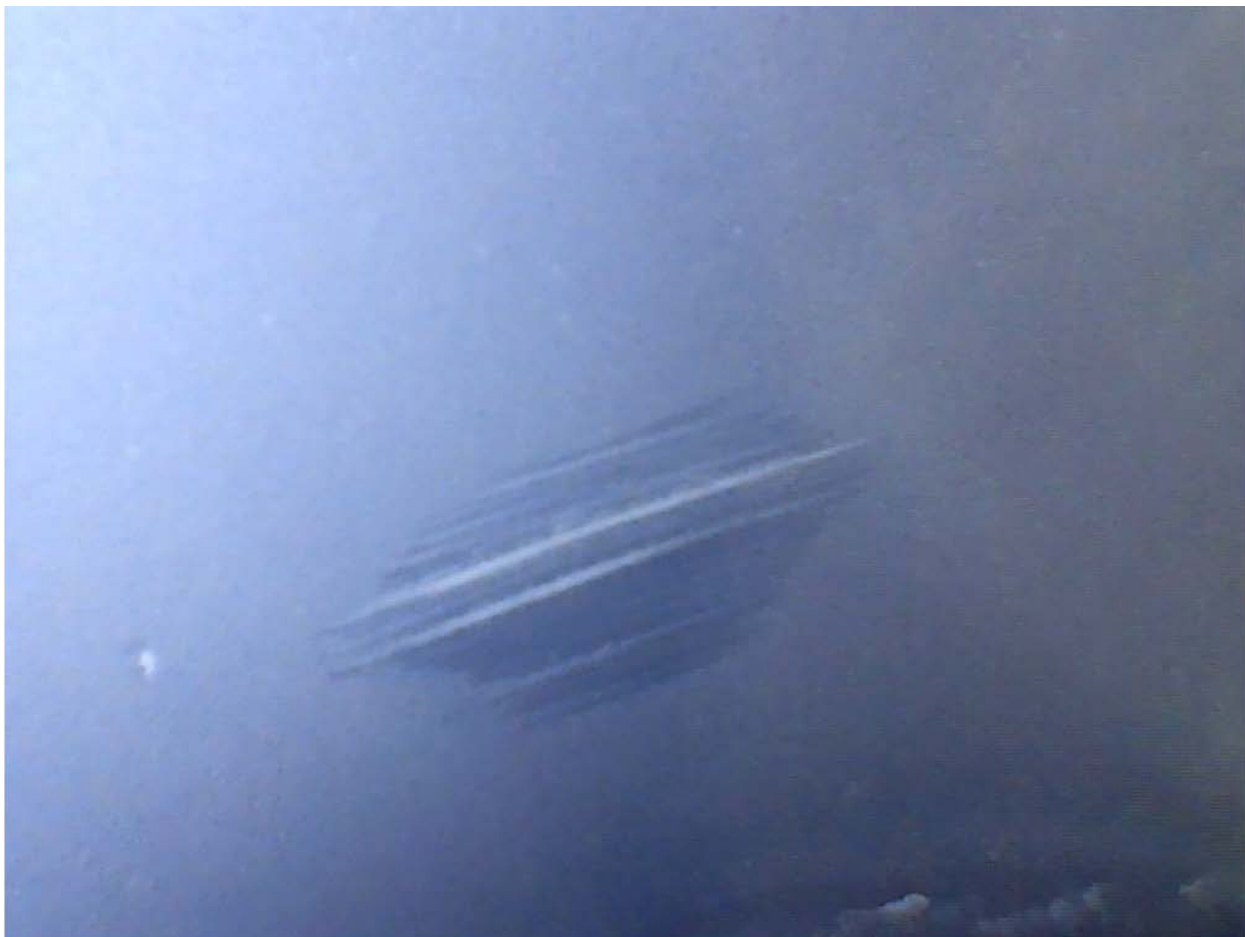
*Figure 16 Scrape Mark 4 Inside Right Exhaust*

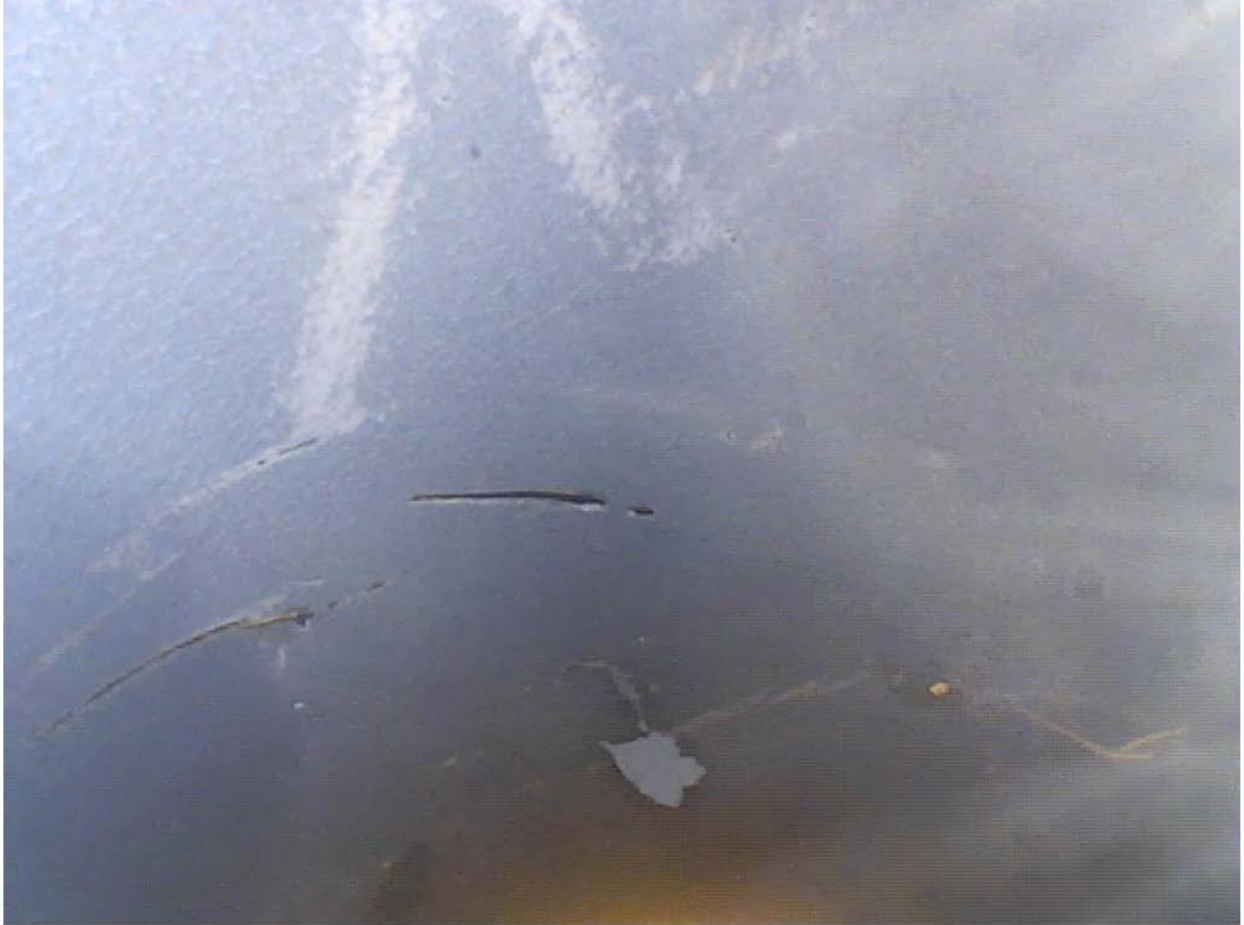
*Figure 17 Scrape Mark 5 Inside Exhaust*

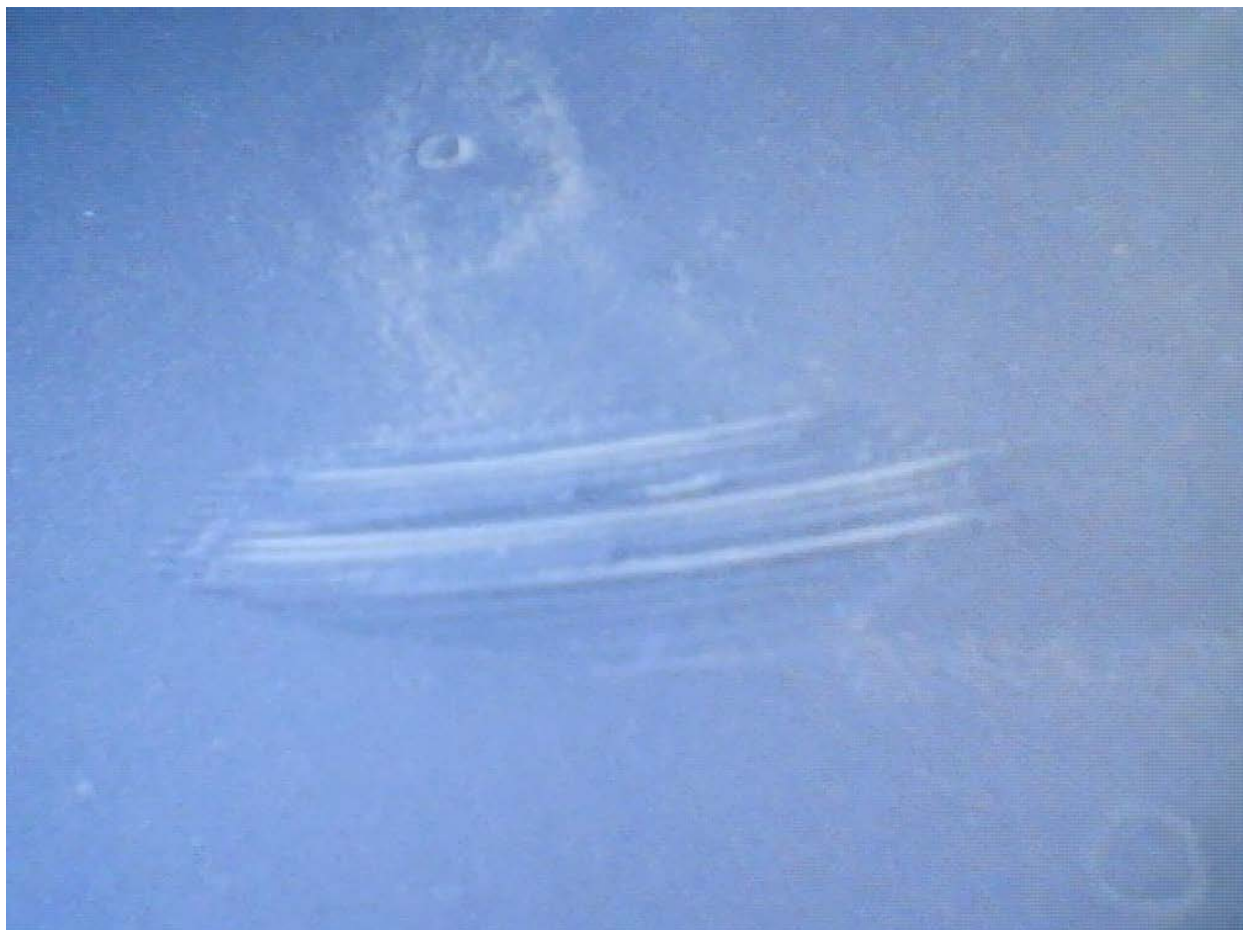
*Figure 18 Scrape Mark 6 Inside Right Exhaust*
