## **NATIONAL TRANSPORTATION SAFETY BOARD**

### **TURBOCHARGER EXAM REPORT**

WPR17LA137

Aircraft: Cirrus Design Corporation SR-22, Registration Number: N744TC, Serial #: 3640

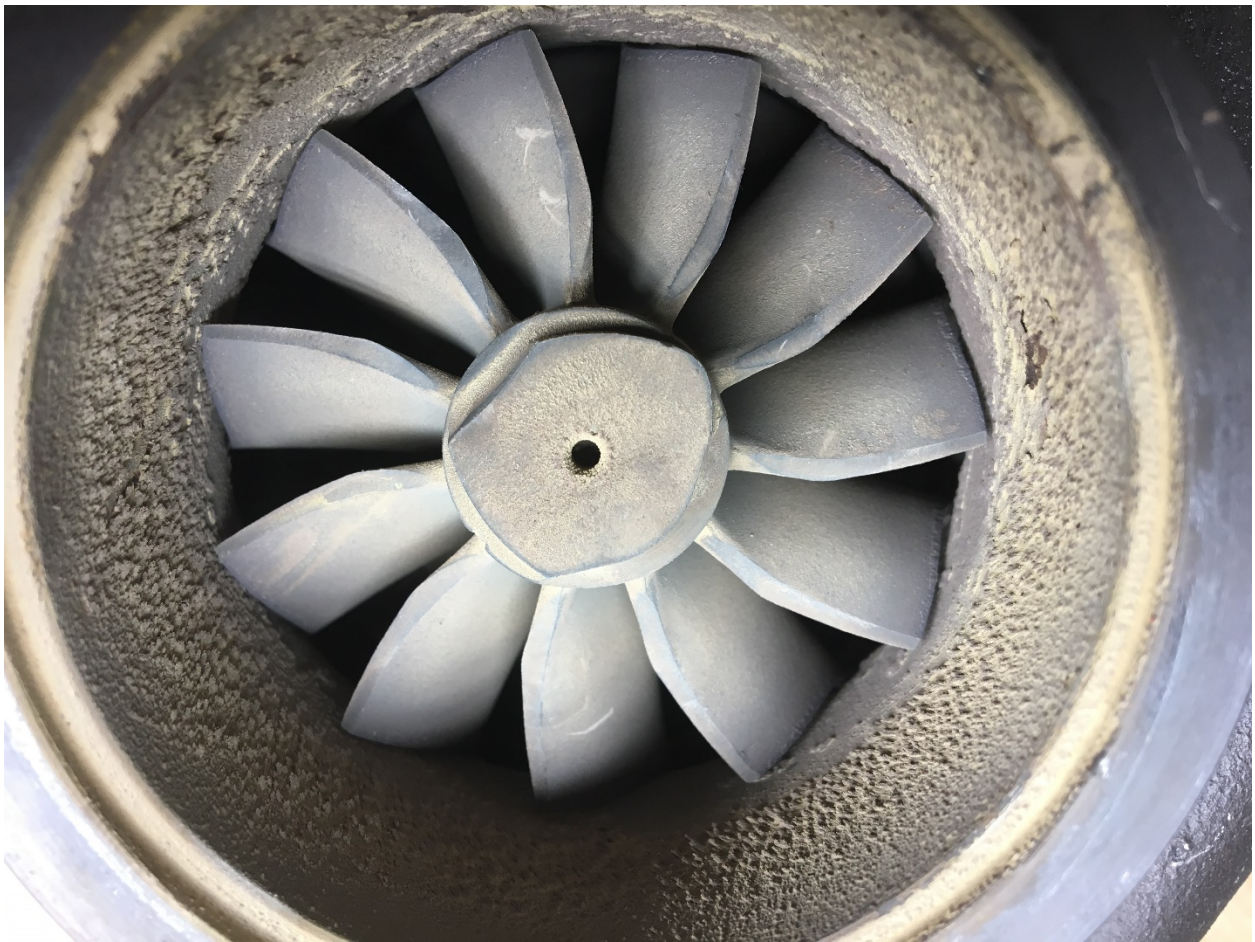
The left turbocharger compressor and turbine blades rotated freely by hand. The compressor blades were not discolored, and the housing was darker than the right turbocharger. The internal lubrication passages were present with no indication of concern. The CHRA assembly (nose only) exhibited moderate coking. The piston rings on the turbine wheel were present and in good condition, and the journal bearings' radial holes were clear.

The turbine bearing displayed signs of scoring on the outer diameter and contact (the oil chamfers hole was missing). The turbine housing displayed signs of excessive exhaust deposits. It was determined that the turbocharger was in a functional condition.

*Figure 4 Left Turbocharger Housing Exducer*

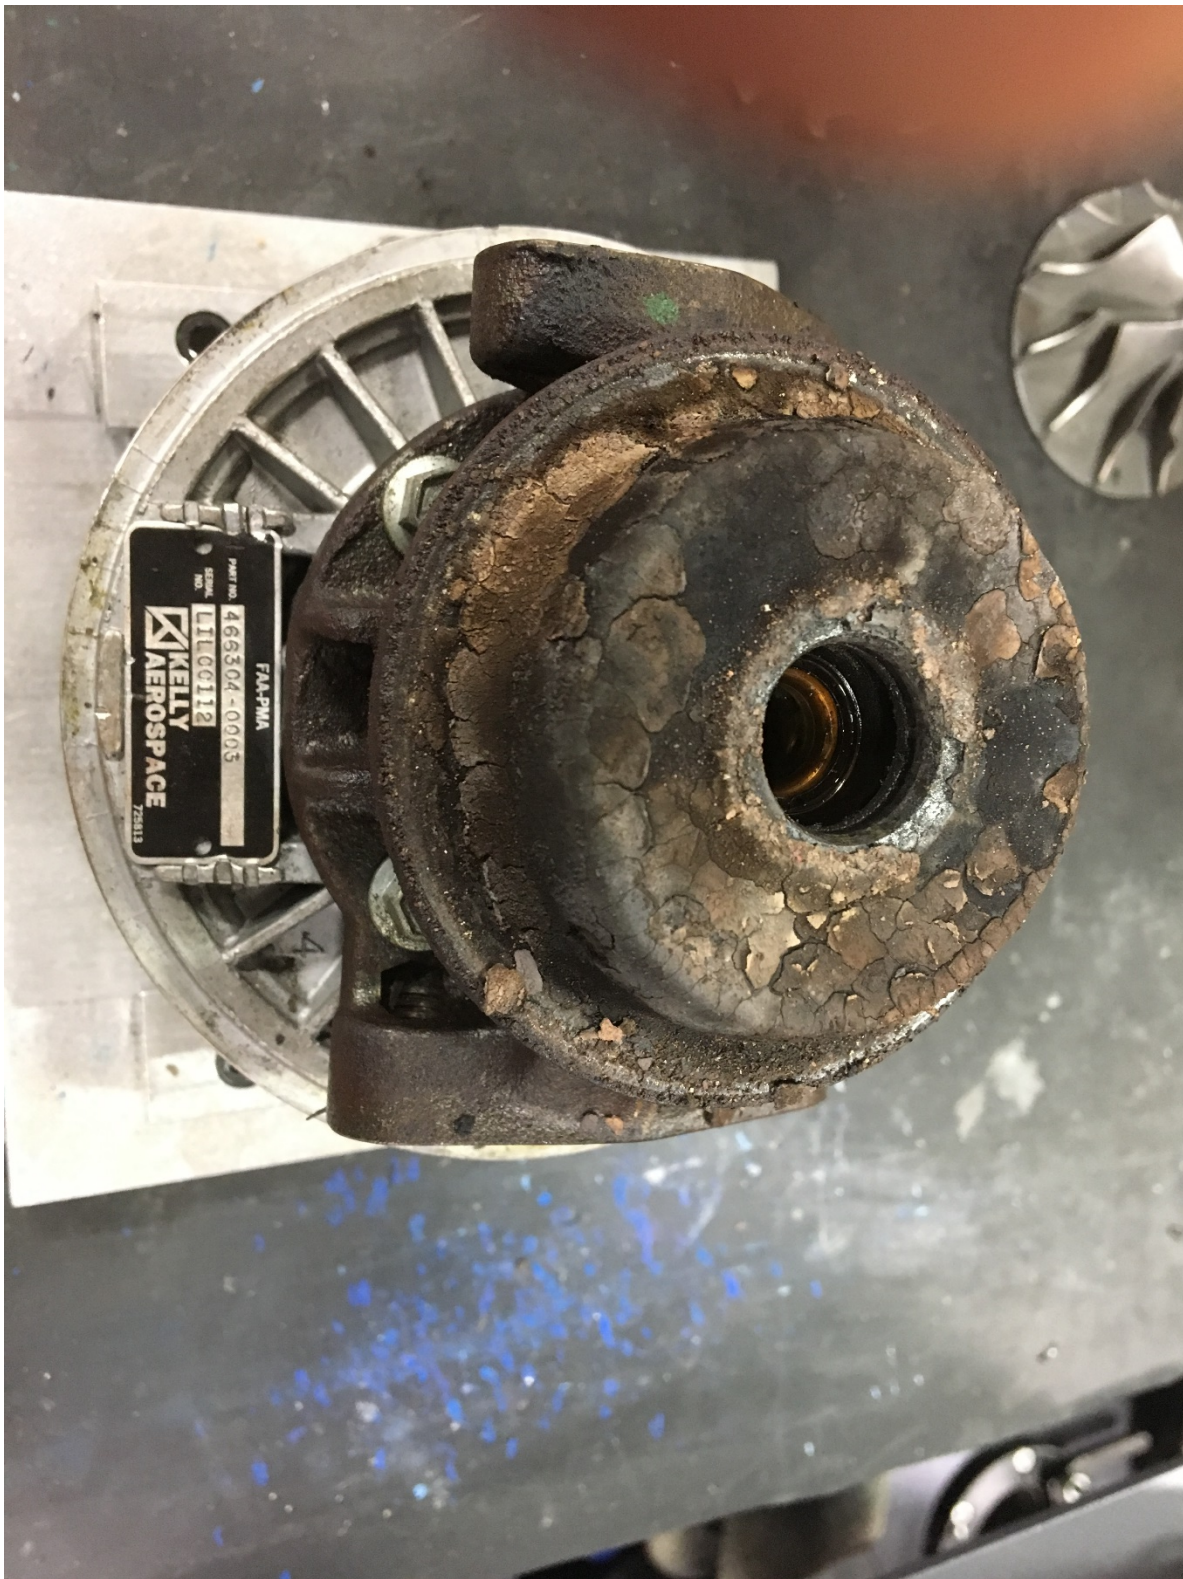
*Figure 5 Left CHRA Assembly Nose Coking*

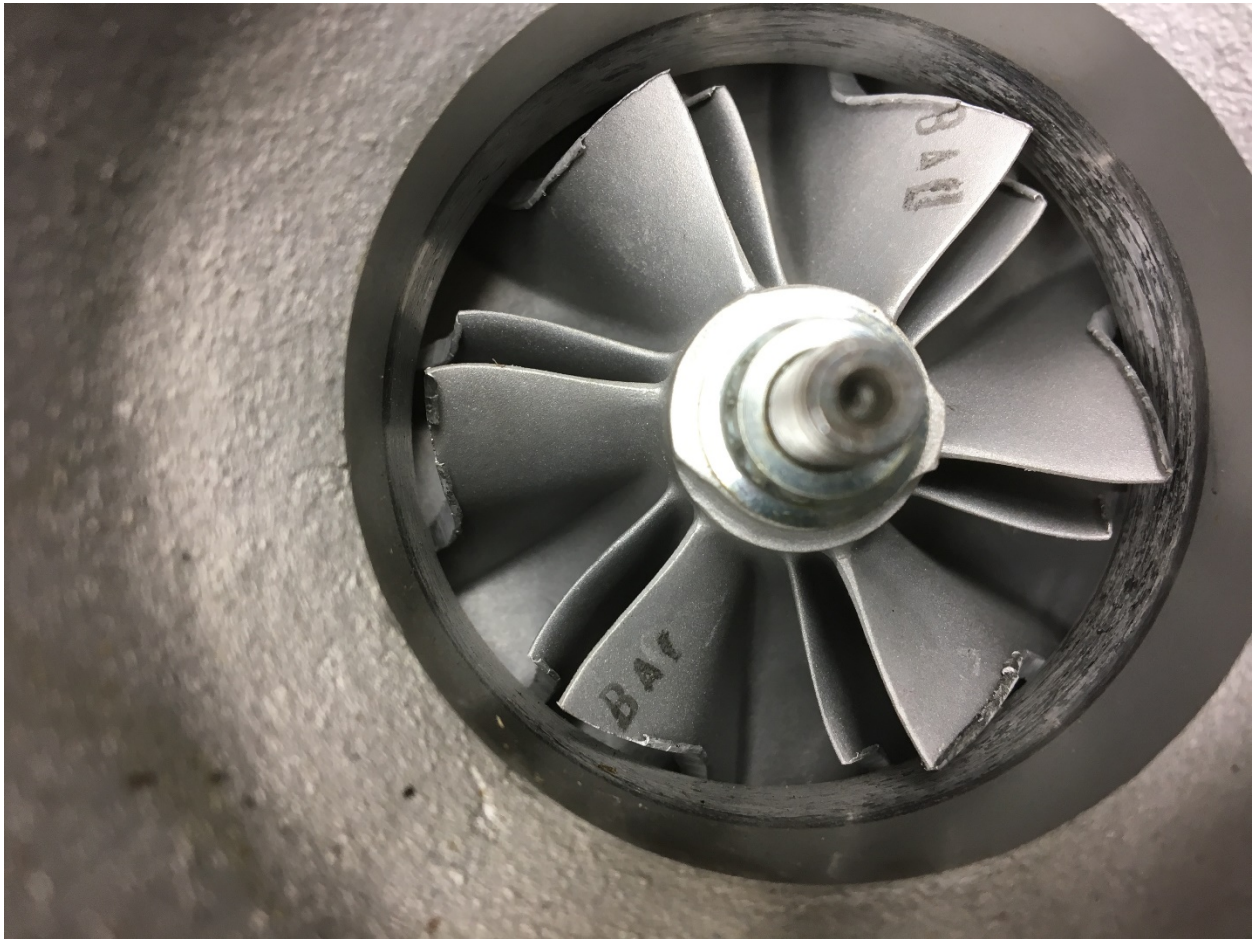
The right turbocharger compressor vanes wobbled on the shaft and were not discolored. There were compressor wheel rub marks on the compressor housing. The compressor blades were heavily bent opposite the direction of rotation and damaged.

*Figure 6 Right Turbo Compressor Blades*

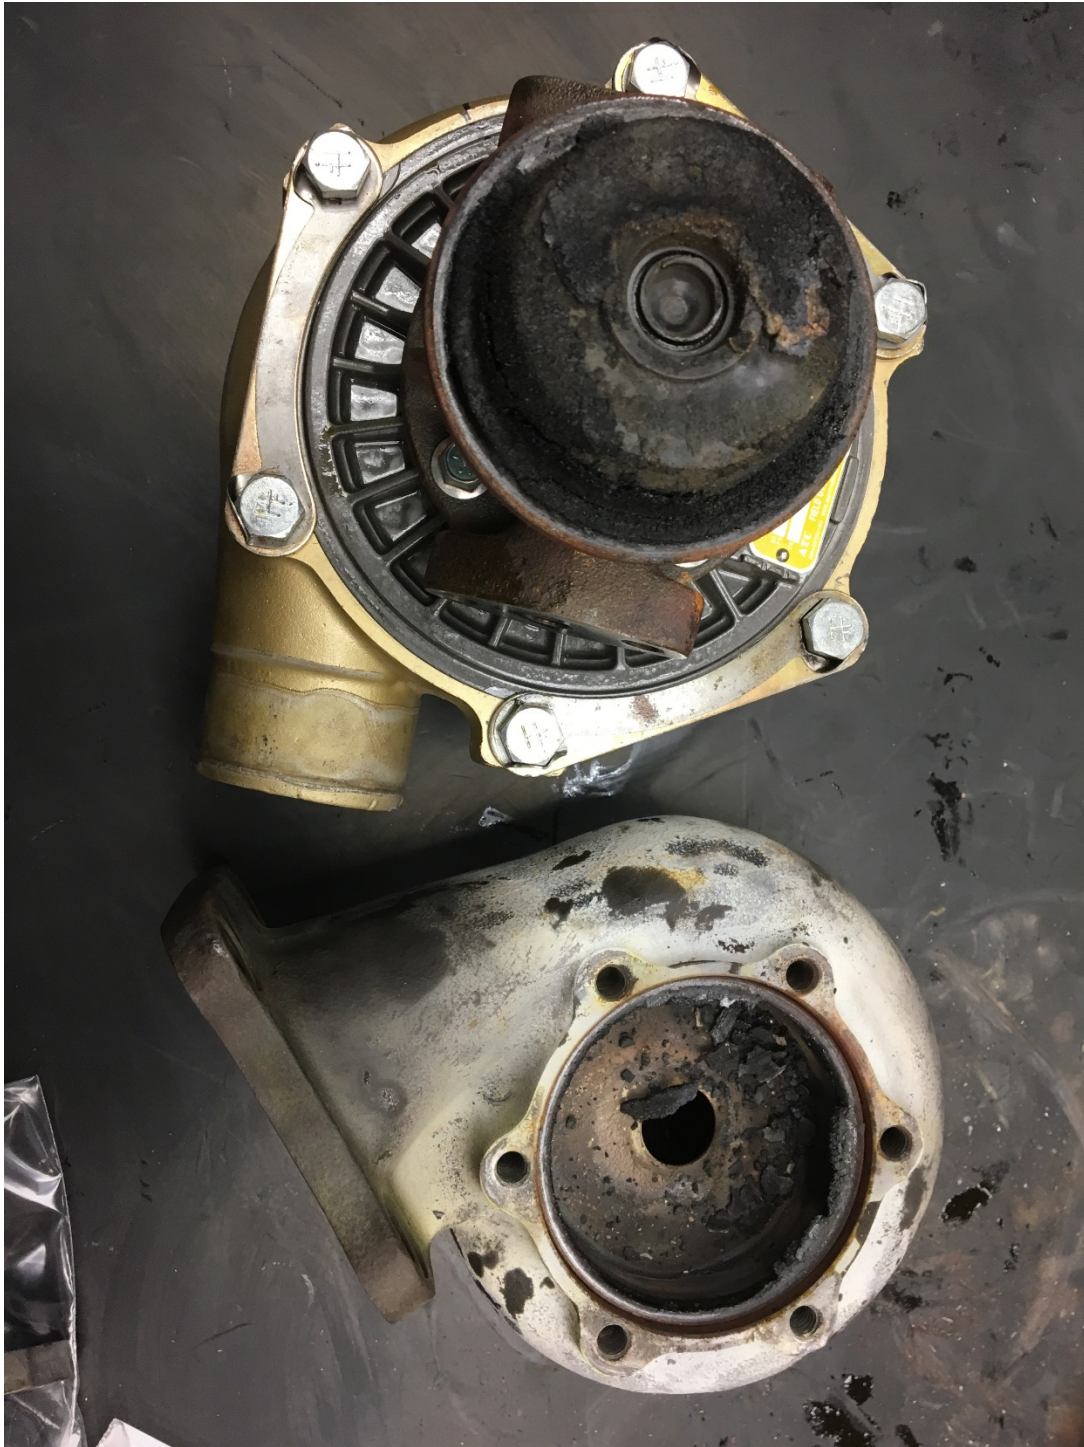
The CHRA assembly exhibited moderate coking (nose only).

*Figure 7 Right Turbocharger CHRA Nose Assembly*

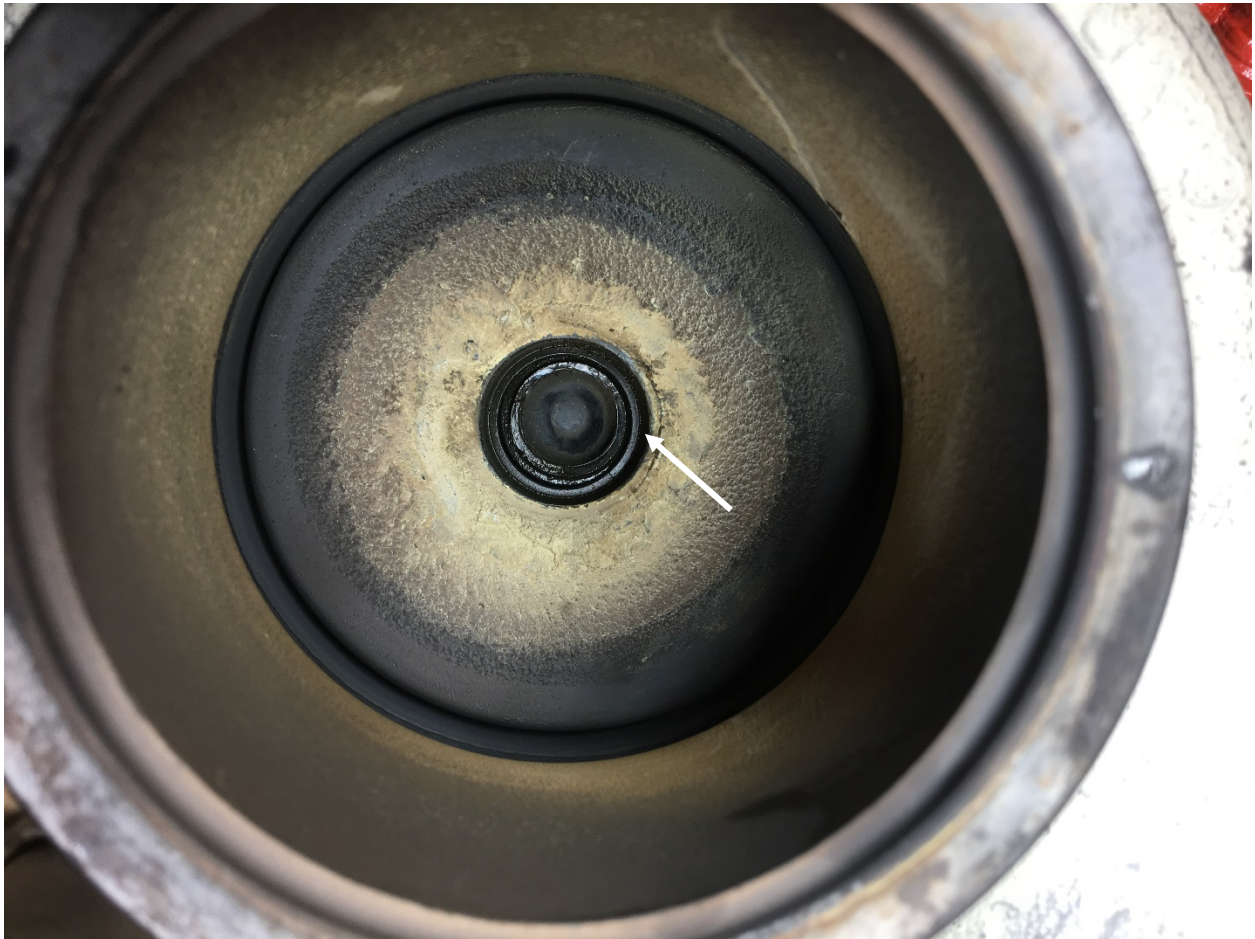
The right turbocharger turbine wheel was not located, and the housing was white. There was little to no rub or contact damage noted on the turbine wheel housing. A wheel of the specified dimensions would not be able to exit the unit without interference with the housing. The piston ring was still in place in the center housing seal bore. The turbine wheel head separated from the turbine shaft at the outboard edge of the piston ring groove. The shaft fractured circumferentially at a piston ring groove as indicated by the white arrow in the picture below. The fracture surface was smeared when viewed through a microscope so that type of fracture could not be determined. The turbine wheel assembly had a manufacture date code of 1106 (November 2006). Time on this component is not recorded so time in service could not be determined.

*Figure 8 Right Center Housing Bore with White Arrow Pointing at Fractured Piston Ring Groove*

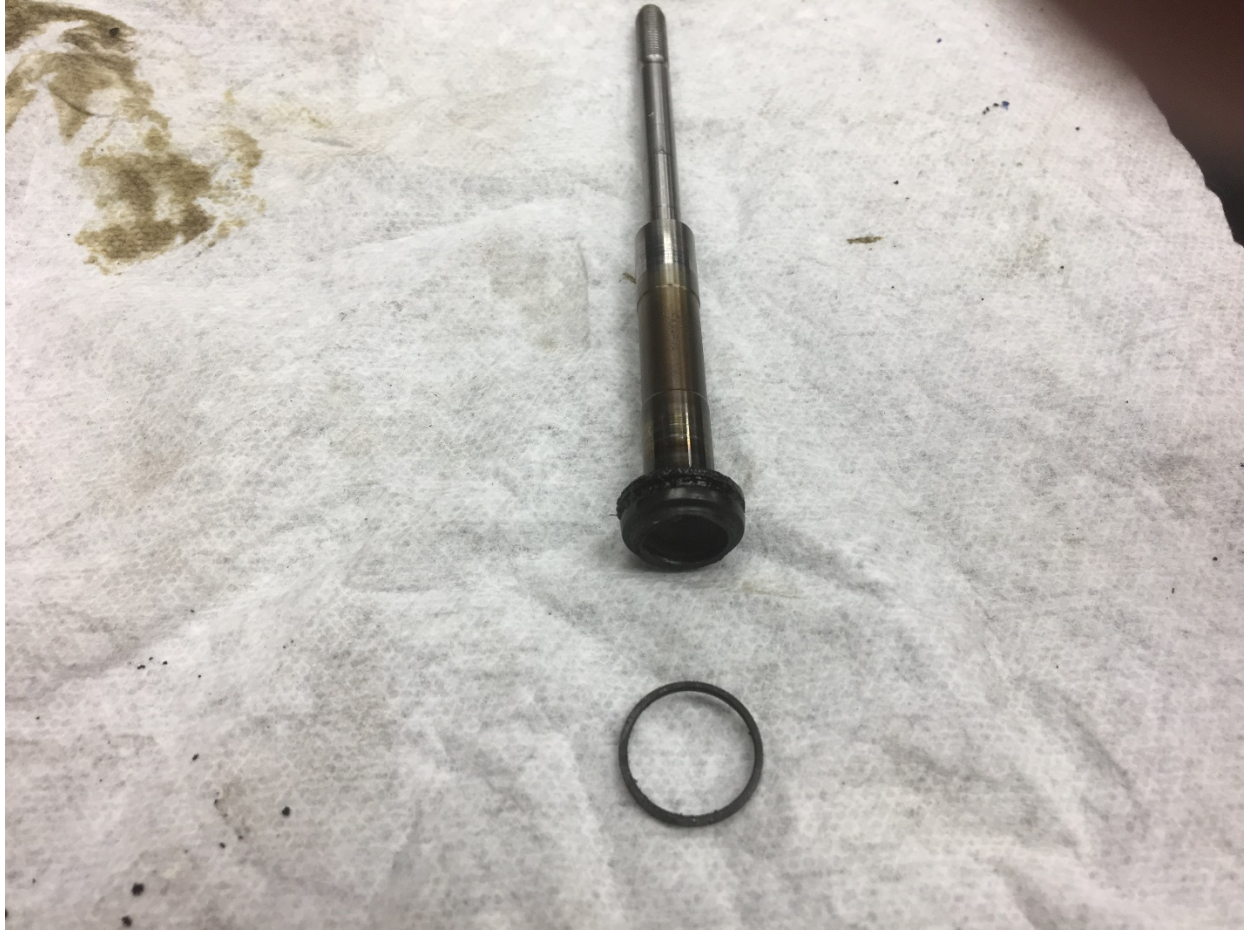
*Figure 9 Turbine Shaft Fractured End*

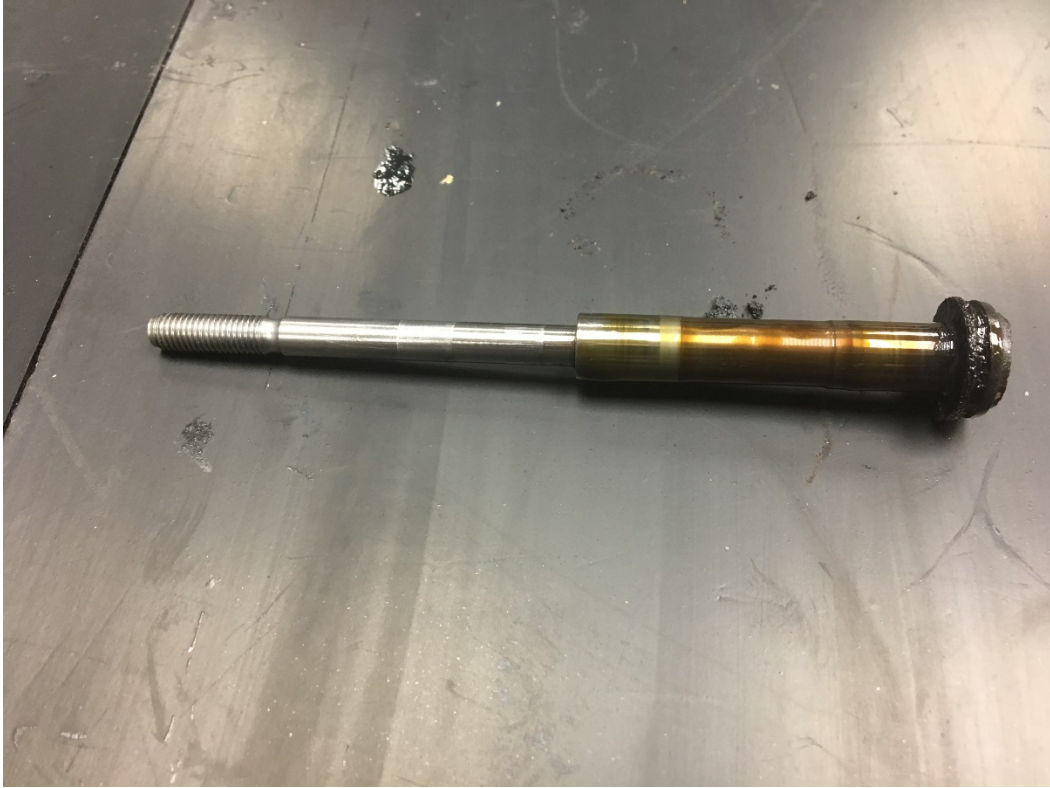
*Figure 10 Side View of Turbine Shaft*

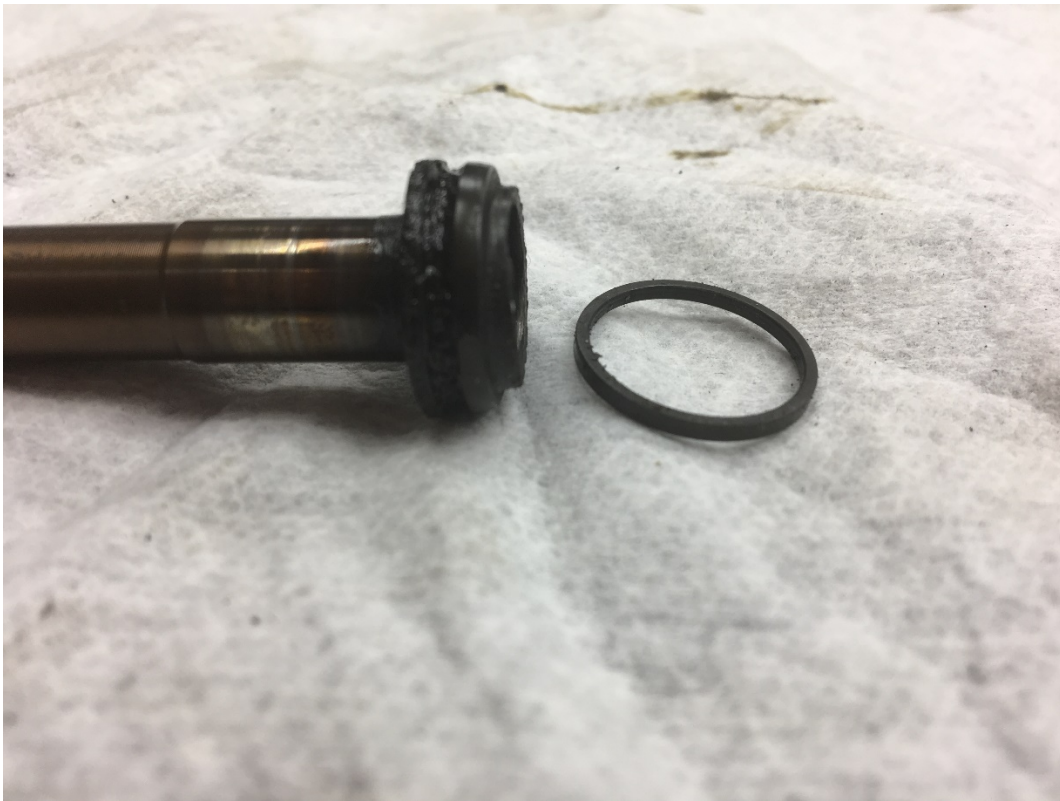
*Figure 11 Close-up of Fractured End*

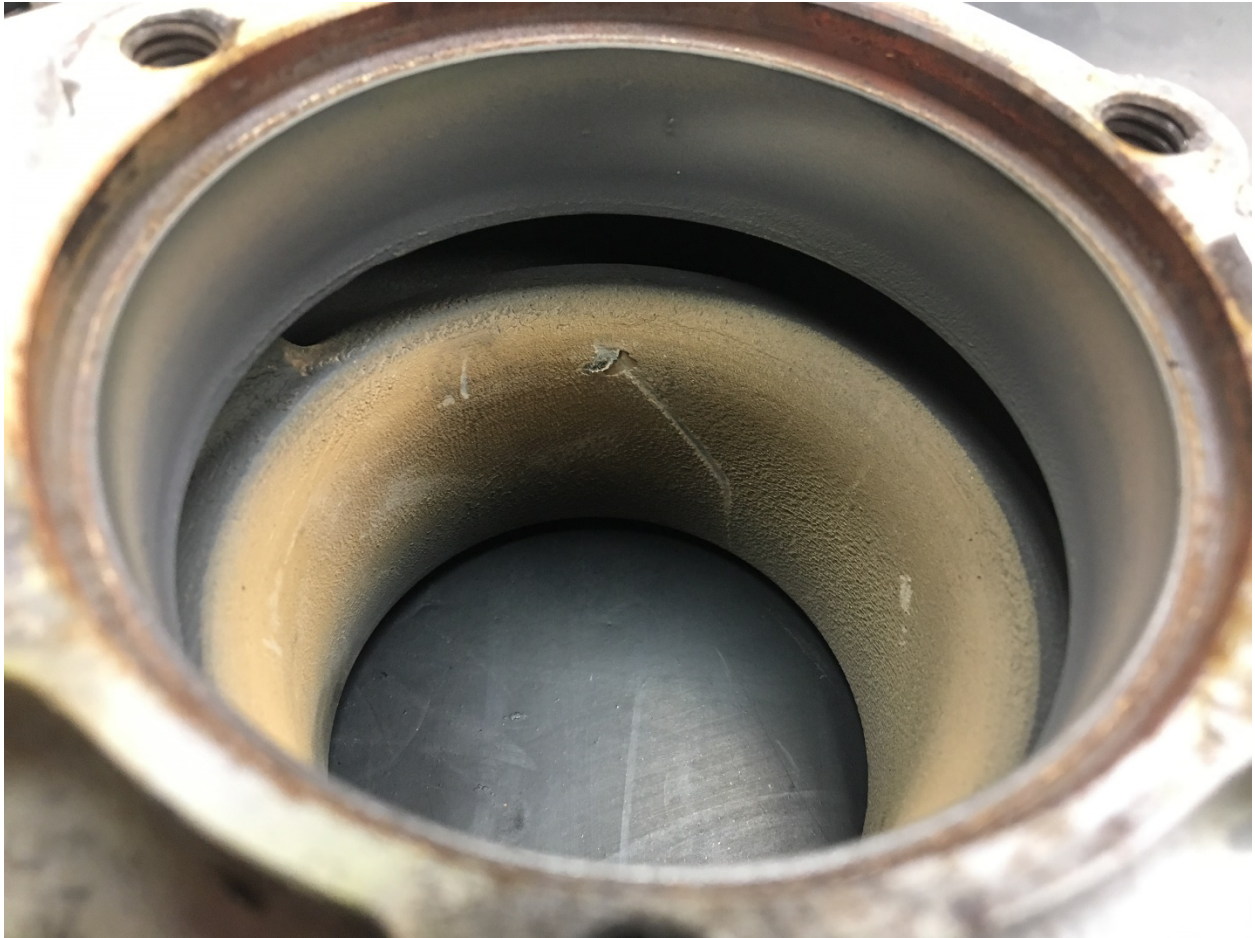
There was one slight witness mark on the turbine housing.

*Figure 12 Turbine Housing with Witness Mark*

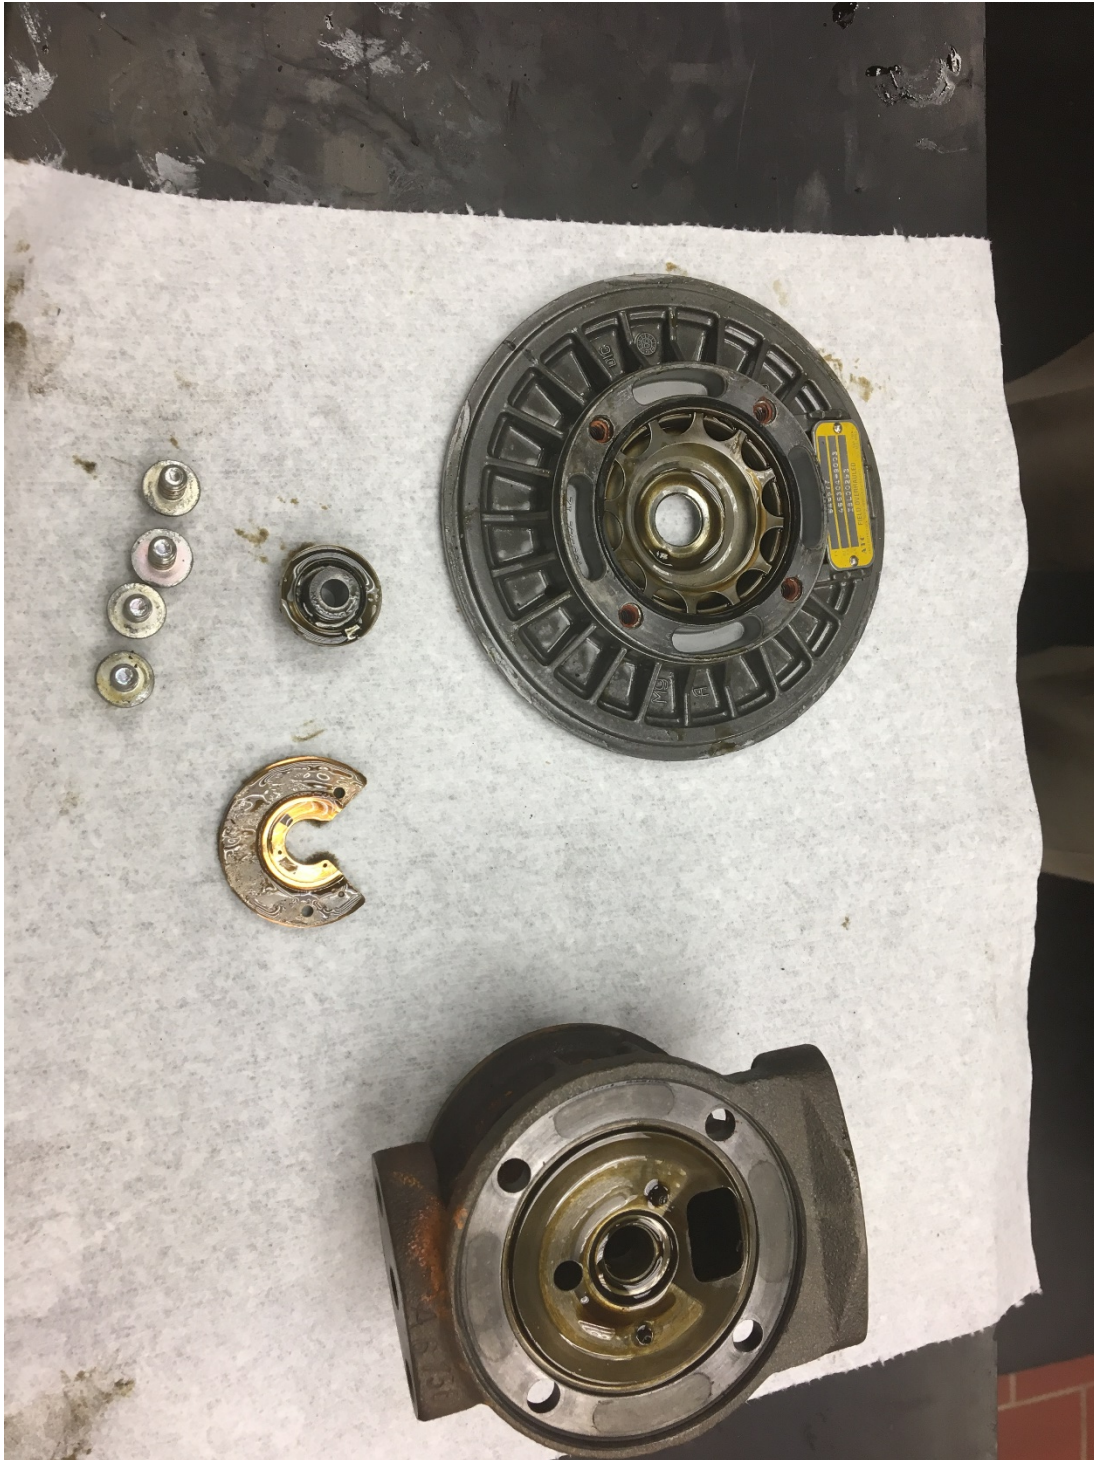
The turbine wheel piston rings were present and worn. The journal bearings had to be pressed out of the housing. The radial holes in the thrust collar had pieces of backplate located in the path. There were scratches and scoring on the end plates along with evidence of rubbing on the backplate seal bore.

*Figure 13 Thrust Collar and Backplate*

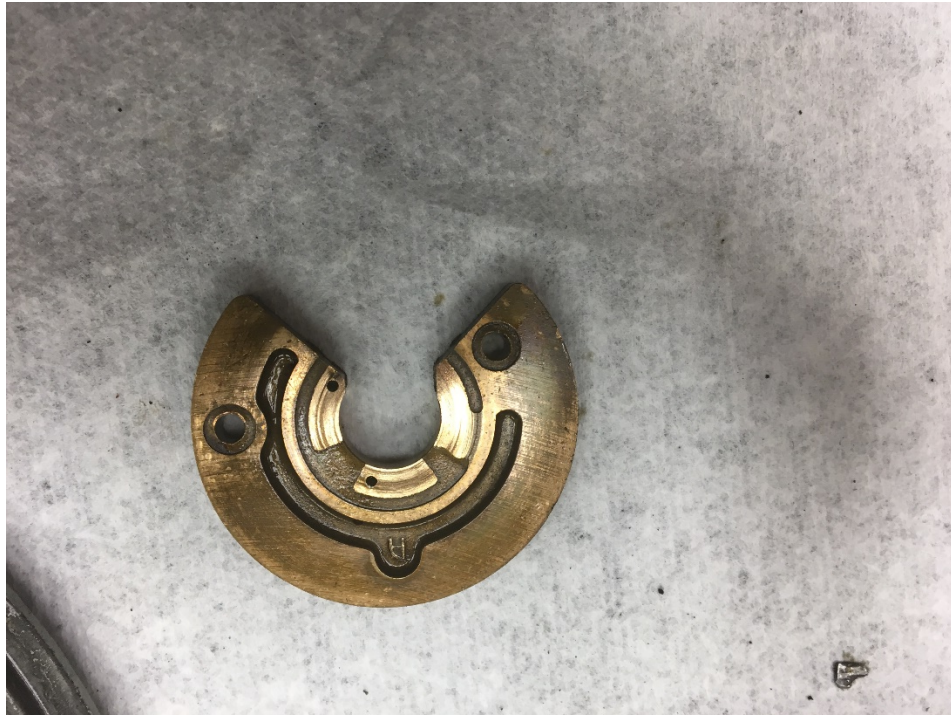
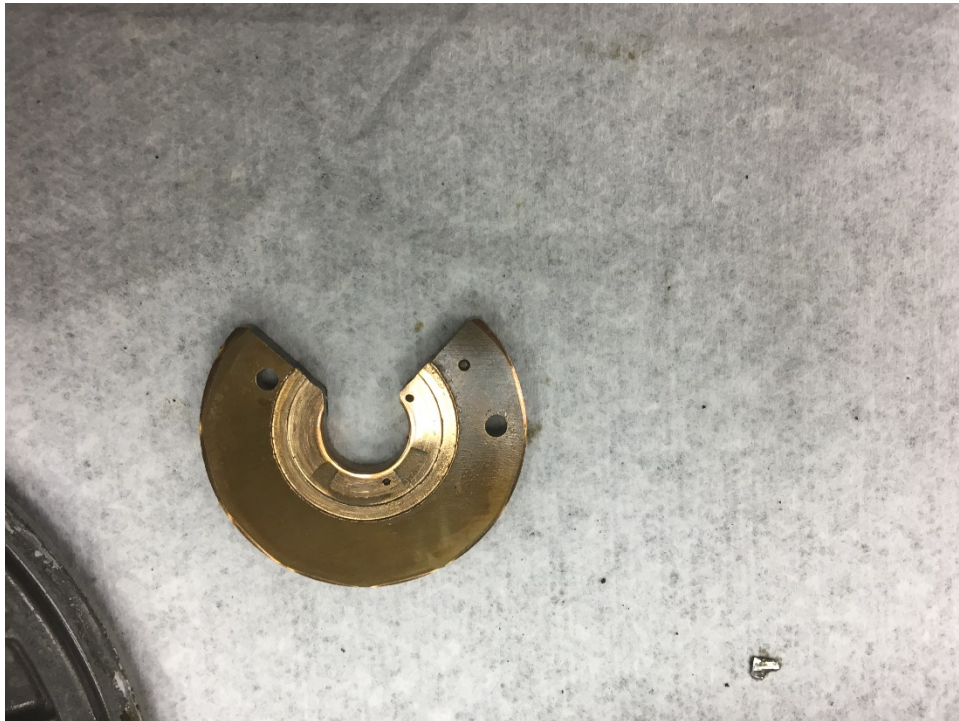
There was scoring on the inboard thrust bearing; all pads were wiped.

*Figure 14 One Side of Thrust Bearing*

*Figure 15 Opposite Side of Thrust Bearing*
