# Continental Motors

## ENGINE EXAMINATION REPORT

| FILE NUMBER | 16-698 |

The #3 and #4 connecting rods were fractured and separated from the connecting rod journals. The #4 connecting rod and connecting rod bearings and the crankshaft's #4 connecting rod journal displayed thermal discoloration consistent with oil starvation. The #2 connecting rod bearings also displayed incipient signatures consistent with lubrication distress. The #3 connecting rod and bearing were mechanically damaged. Approximately 2.0 quarts of oil was observed on the oil quantity dipstick following the event. Examination of the engine components and engine-related systems revealed no evidence of a pre-impact oil leak. Additionally, the right turbocharger was missing its turbine wheel and the shaft was fractured outboard of the turbine piston ring. The bearings displayed signatures consistent with lubrication interruption. The impeller contacted the inlet housing and the impeller blades displayed distortion in the opposite direction of rotation. Review of recorded engine data revealed that the oil pressure displayed a fluctuation followed by a steady reduction.

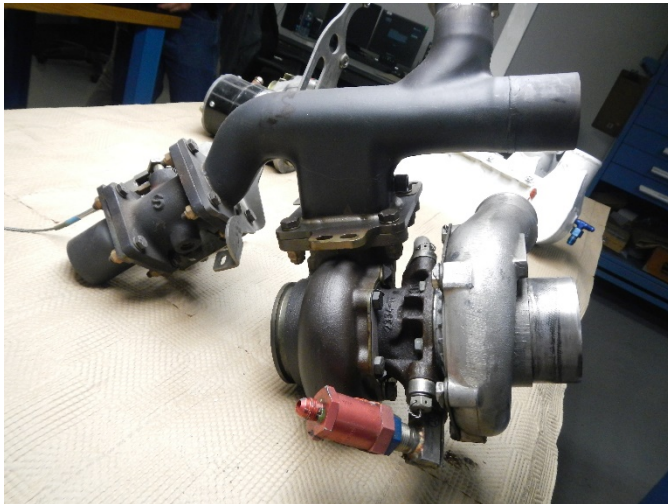
Condition: The exhaust system was removed from the engine prior to shipment. There were no pre-impact anomalies noted with the exhaust risers or manifolds. The right side exhaust pipe was flattened at the exhaust end. The inside of the tailpipes were inspected using a lighted borescope. The right tailpipe displayed areas of circumferential scoring and gouging consistent with high rotational speed mechanical contact.

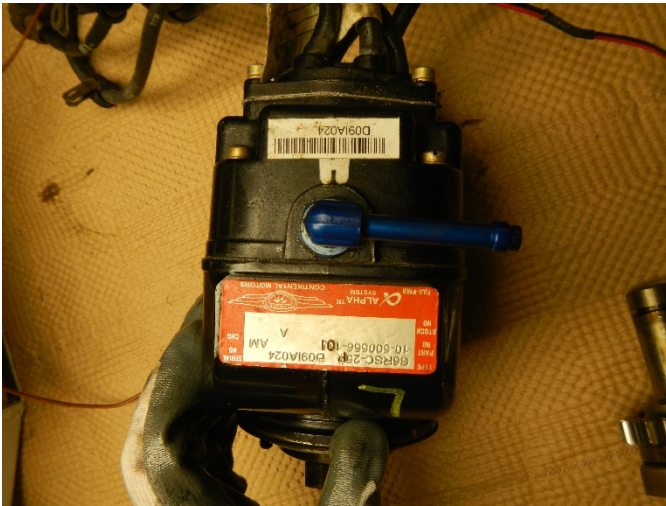
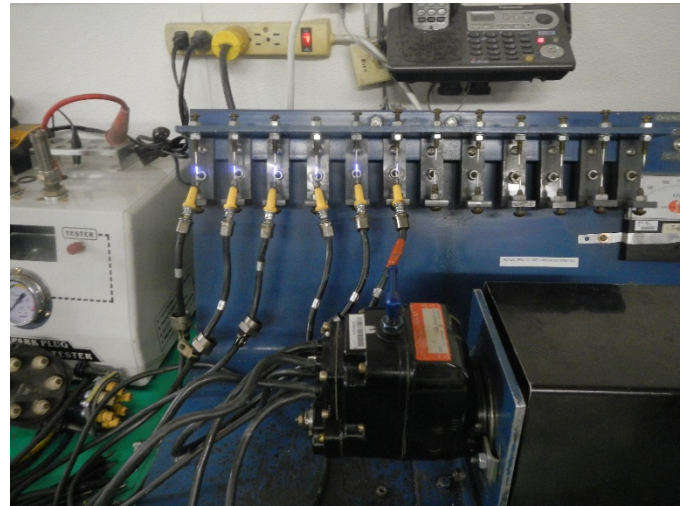
| LEFT MAGNETO | Manufacturer: Continental Motors S6RSC-25P | P/N: 10-500556-101 | S/N: D09IA024 |
|---|---|---|---|
| Condition: | The magneto remained secured to the topside of the engine with no pre-accident anomalies noted. The ignition harness remained in place. The magneto, with the harness still attached, was removed and placed on a test stand. The magneto was functionally tested through various speeds and it produced a spark across a 7-mm gap in firing order. No pre-accident anomalies were noted with the unit. | | |

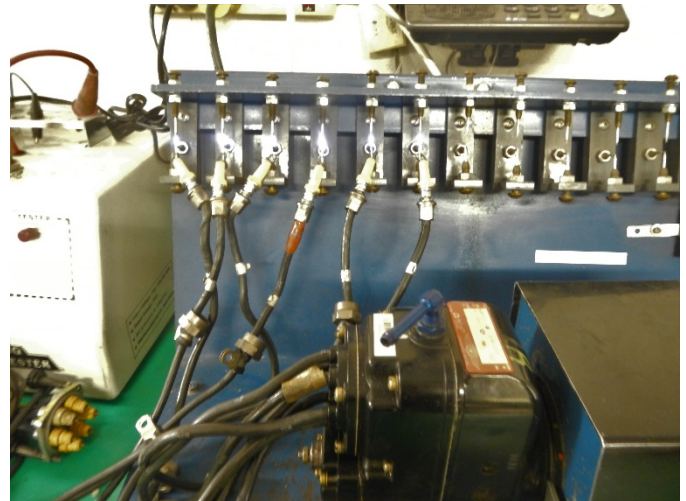
| RIGHT MAGNETO | Manufacturer: Continental Motors S6RSC-25P | P/N: 10-500556-101 | S/N: D09KA076 |
|---|---|---|---|
| Condition: | The magneto remained secured to the topside of the engine with no pre-accident anomalies noted. The ignition harness remained in place. The magneto, with the harness still attached, was removed and placed on a test stand. The magneto was functionally tested through various speeds and it produced a spark across a 7-mm gap in firing order. No pre-accident anomalies were noted with the unit. | | |

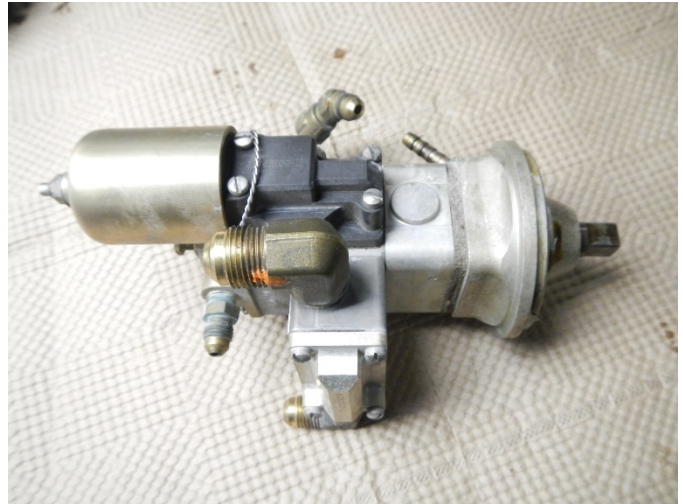
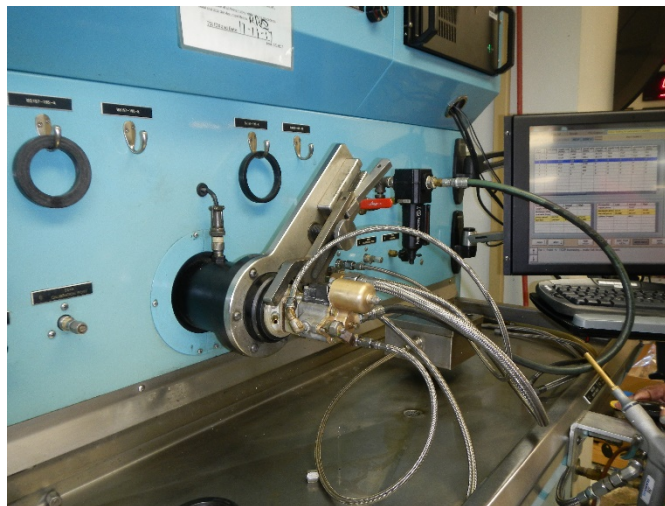
The fuel pump remained secured to the backside of the engine and the fuel lines remained in place. The fuel pump was placed on a production test stand and run through various test parameters for an equivalent pump model. Since it was a modified pump for an STC-modified engine, it did not meet Continental Motors production specifications throughout the entire test range. However, the pump was functional with no pre-accident anomalies noted. A leak was observed at the diaphragm area, but no fuel staining was observed on the housing.

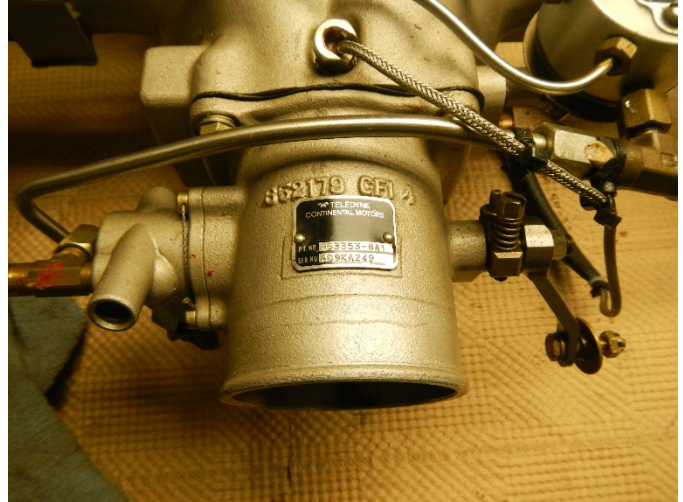
The throttle body remained attached to the topside of the engine with no pre-event anomalies noted. The unit was placed on a production test stand and run through various test parameters for an equivalent pump model. Though the fuel metering unit did not meet all of the specified test specifications, the differences can be attributed to in service adjustments. The throttle body and fuel metering unit proved functional throughout the tested ranges.

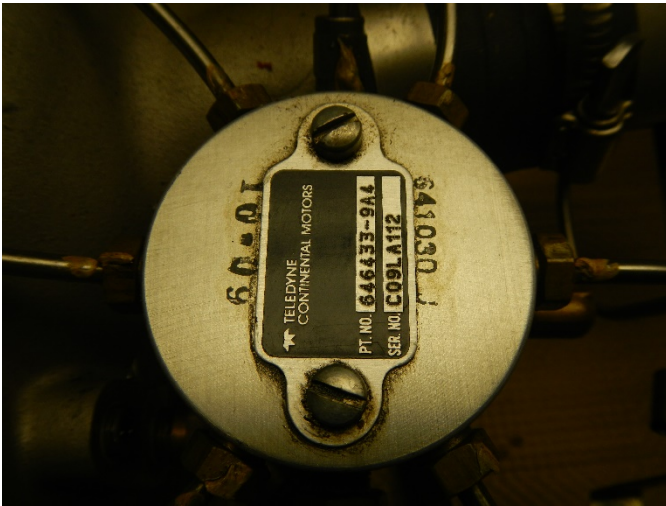
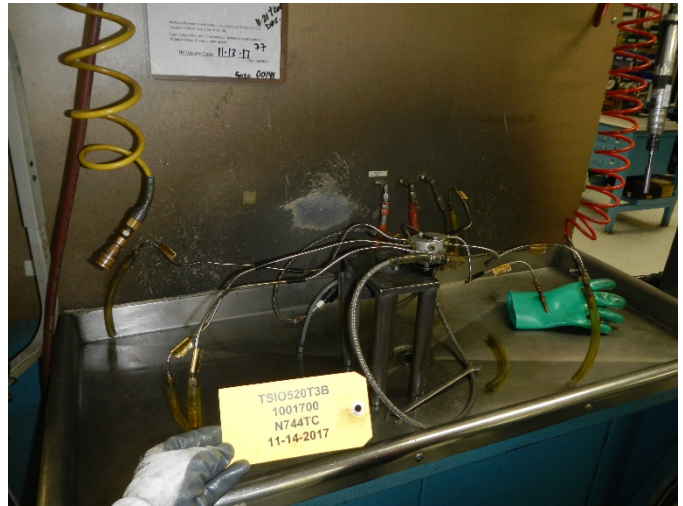
The fuel manifold valve remained secured on the topside of the engine with all fuel lines attached. The unit was tested on a production test stand throughout various test parameters. The unit metered fuel throughout the test, though it did not meet production specifications. The differences could be attributed to the nozzle jets installed with the STC modification.

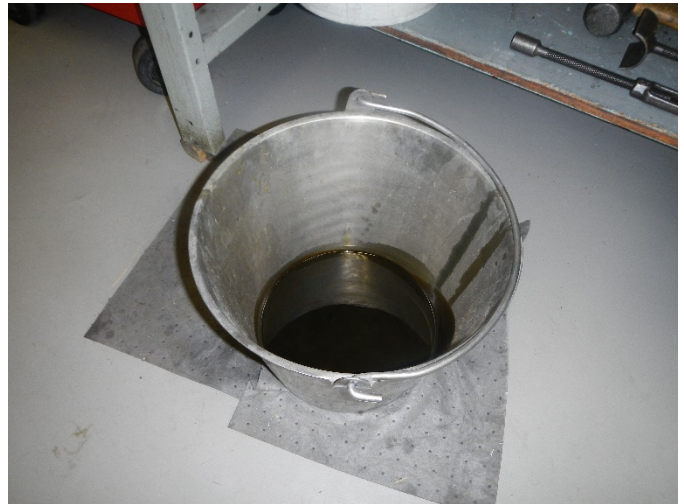
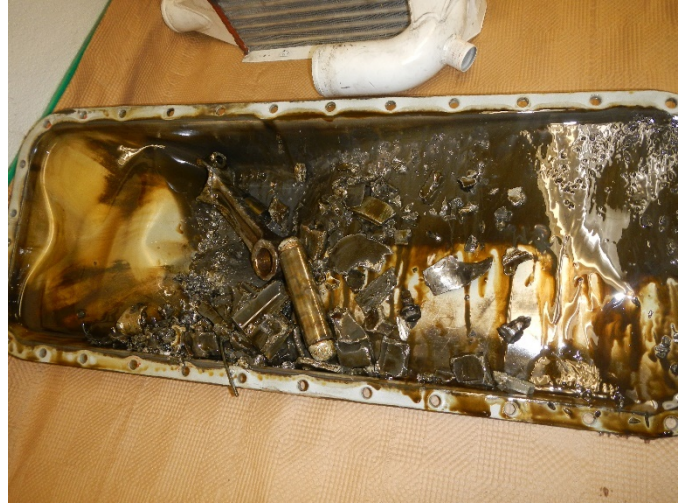
**Condition:** The oil sump remained intact and attached to the bottom side of the engine, but it displayed a small puncture in an area relating to significant deformation damage. Photographs taken prior to engine removal from the airframe show a little over 2 quarts of oil registered on the oil dipstick. Approximately 1.5 quarts of oil was drained from the sump after it was shipped to the factory. The sump contained fractured crankcase components, lifters, multiple connecting rod pieces, a piston pin, and connecting rod bearings.

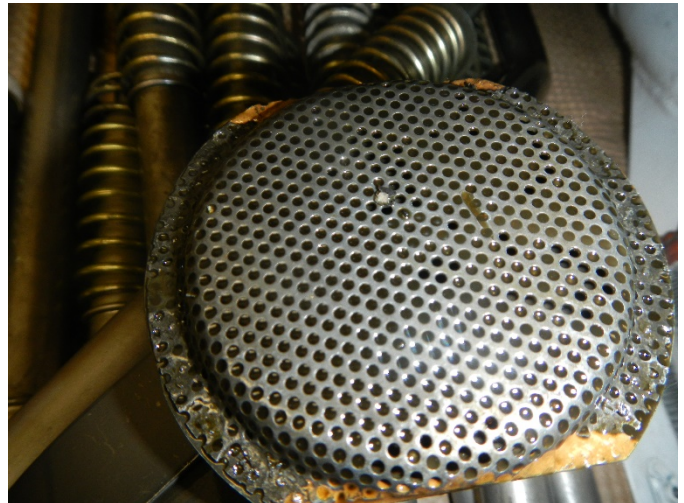
The oil pickup tube and screen remained intact, but the tube was deformed like the sump. The screen contained some small metallic particles, but it did not appear blocked.

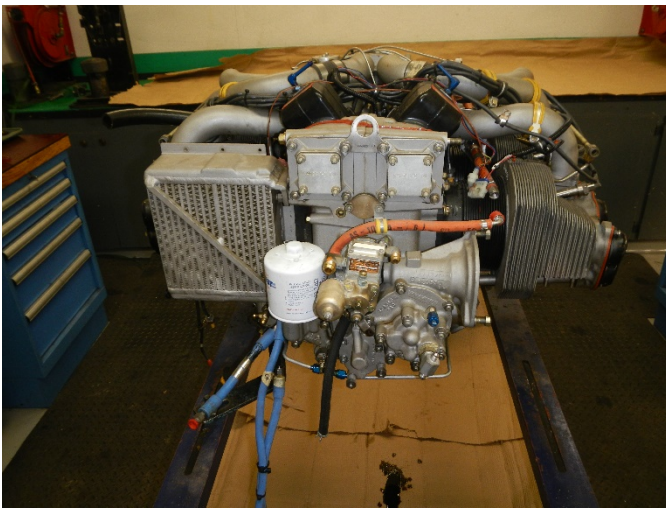
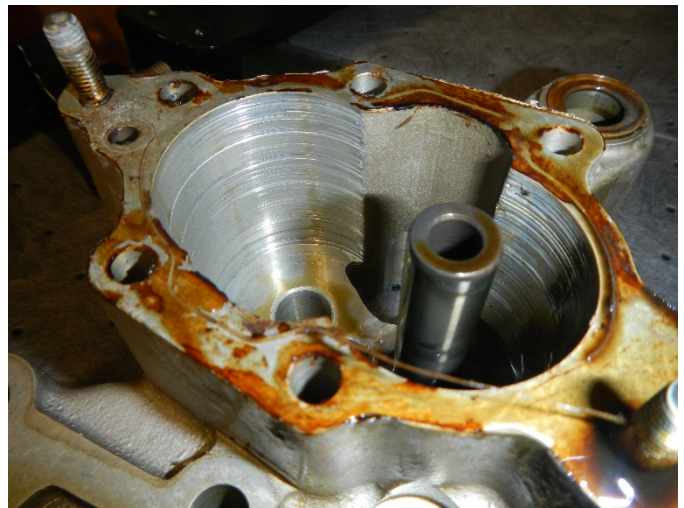
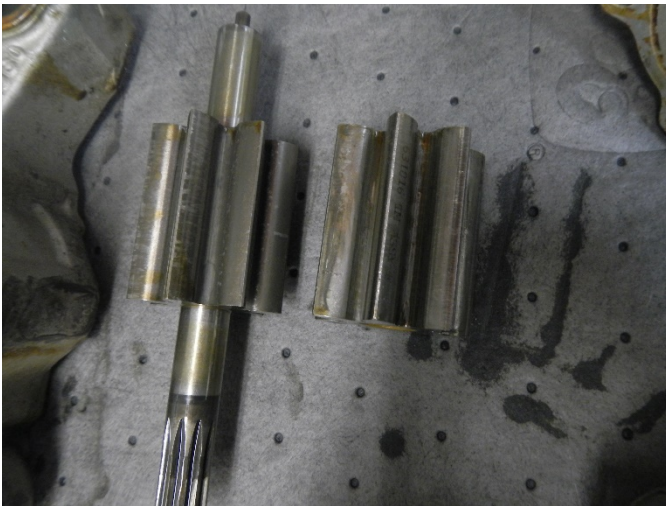
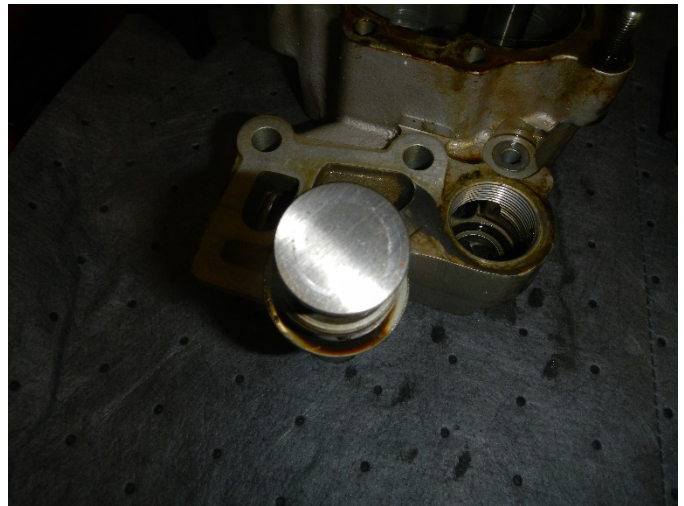
The oil pump remained secured to the backside of the engine with no external anomalies or oil leaks noted. Disassembly of the pump revealed evidence of hard particle passage with circumferential scoring noted on the pump walls. The oil pressure relief valve face displayed some pitting consistent with material between the valve face and valve seat.

The scavenge pump remained secured to the backside of the starter adapter with no external anomalies or oil leaks noted. Disassembly of the scavenge pump revealed residual oil coating all the components with no signs of hard particle passage on any of the scavenge pump components.

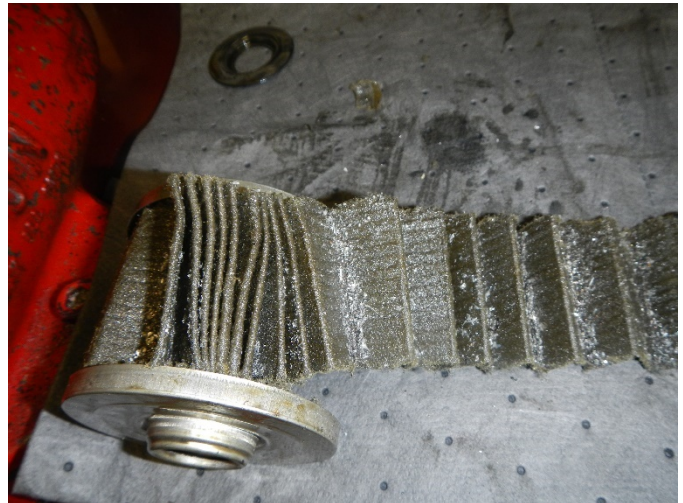
The oil filter remained attached to the adapter and safety-wire secured it in place. There were no signs of pre-event oil leaks. The oil filter was removed and cut open. Metal contaminants were found throughout the filter's pleats.

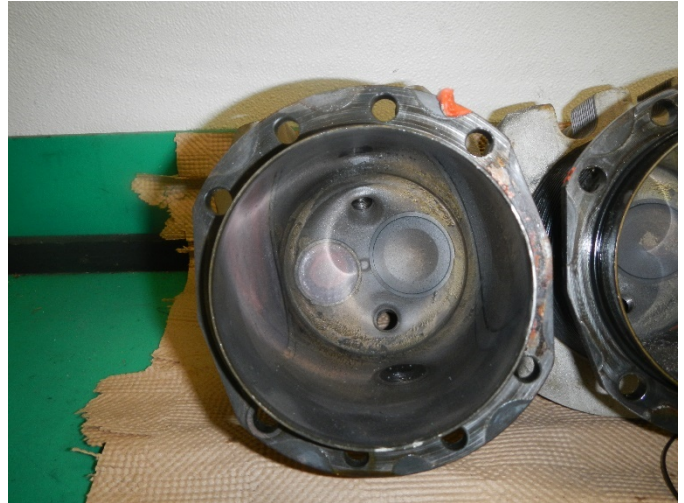
Condition: The cylinder remained secured to the engine and the original torque putty was present on the cylinder attaching hardware. There were no pre-accident anomalies noted with the cylinder components.

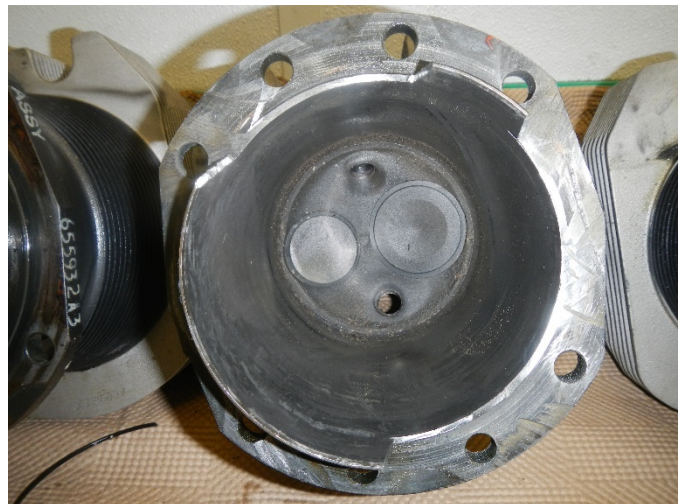
Condition: The cylinder remained secured to the engine and the original torque putty was present on the cylinder attaching hardware. The cylinder skirt had to be cut due to mechanical damage that interfered with the crankcase cylinder bay. There were no pre-accident anomalies noted with the cylinder components.

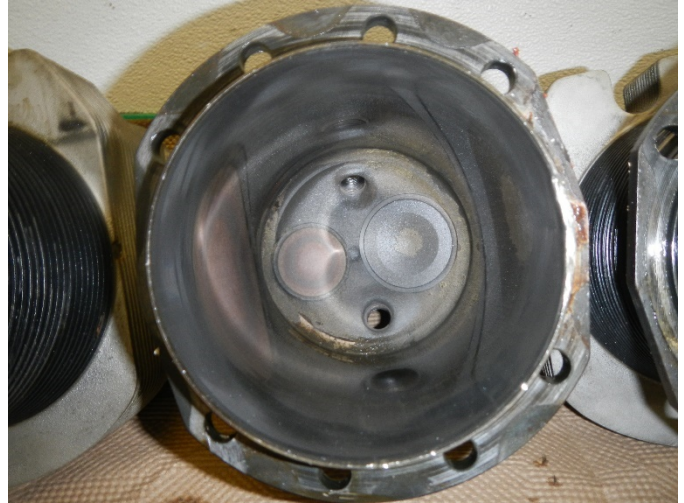
Condition: The cylinder remained secured to the engine and the original torque putty was present on the cylinder attaching hardware. There were no pre-accident anomalies noted with the cylinder components.

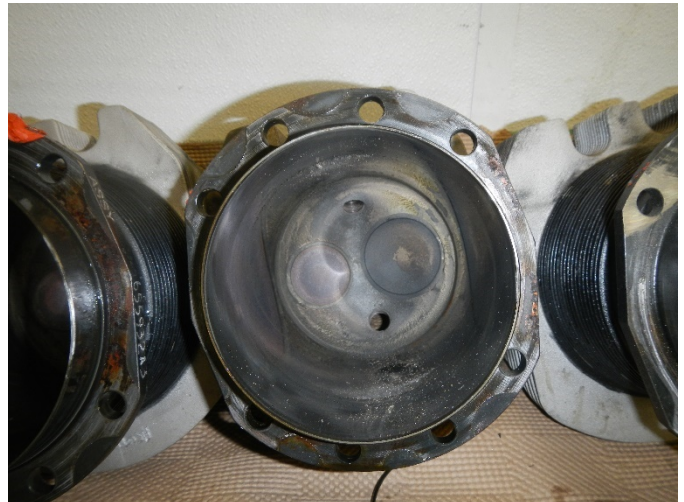
Condition: The cylinder remained secured to the engine and the original torque putty was present on the cylinder attaching hardware. There were no pre-accident anomalies noted with the cylinder components.

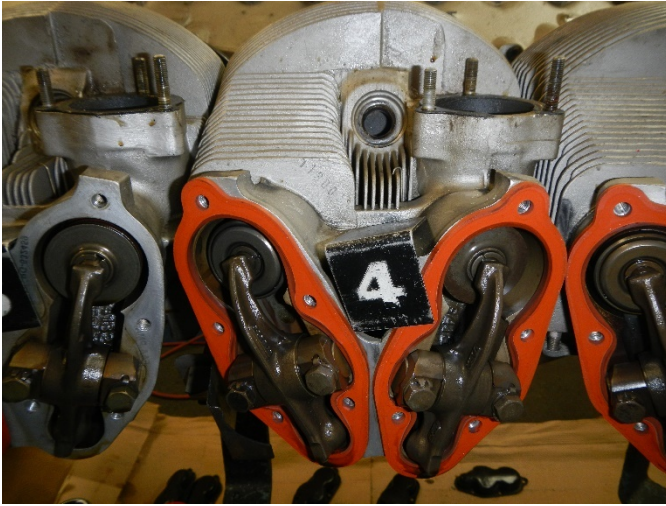
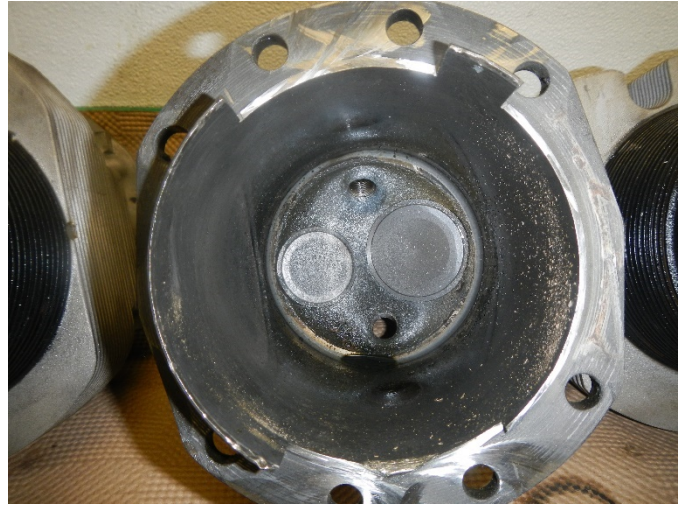
Condition: The cylinder remained secured to the engine and the original torque putty was not present on the cylinder attaching hardware. The cylinder skirt had to be cut due to mechanical damage that interfered with the crankcase cylinder bay. There were no pre-accident anomalies noted with the cylinder components.

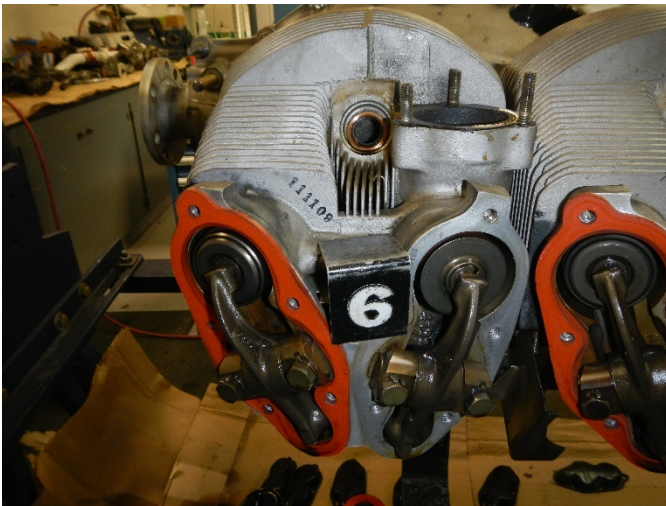
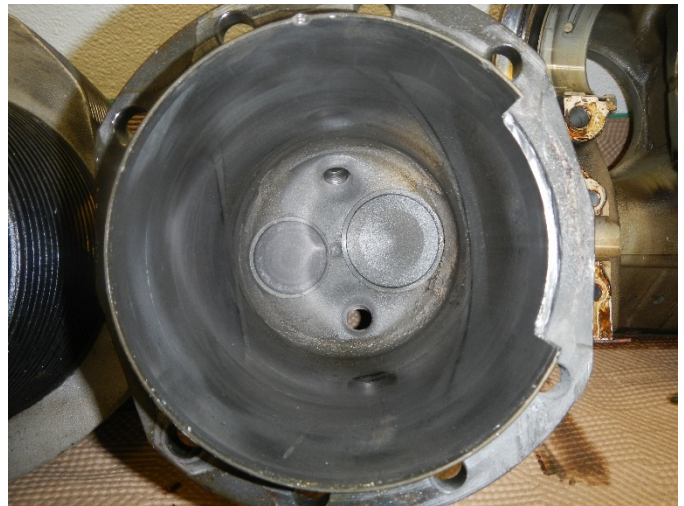
Condition: The cylinder remained secured to the engine and the original torque putty was present on the cylinder attaching hardware. The cylinder skirt had to be cut due to mechanical damage that interfered with the crankcase cylinder bay. There were no pre-accident anomalies noted with the cylinder components.

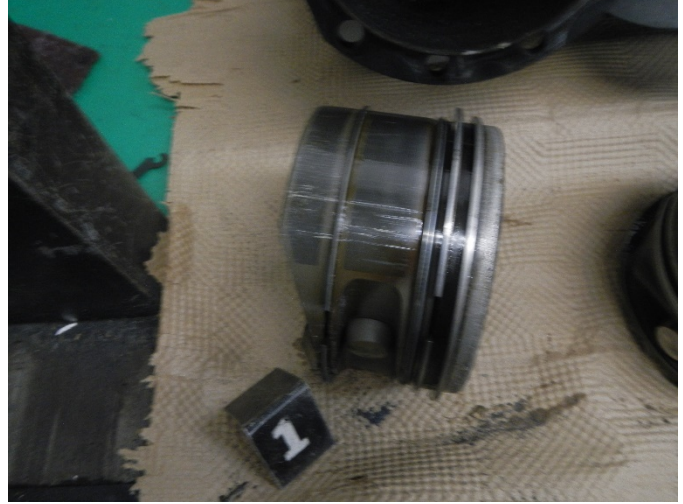
The piston face displayed normal combustion deposits and did not display any signs of pre-accident anomalies. The piston skirt displayed some scoring damage and light mechanical damage was noted.

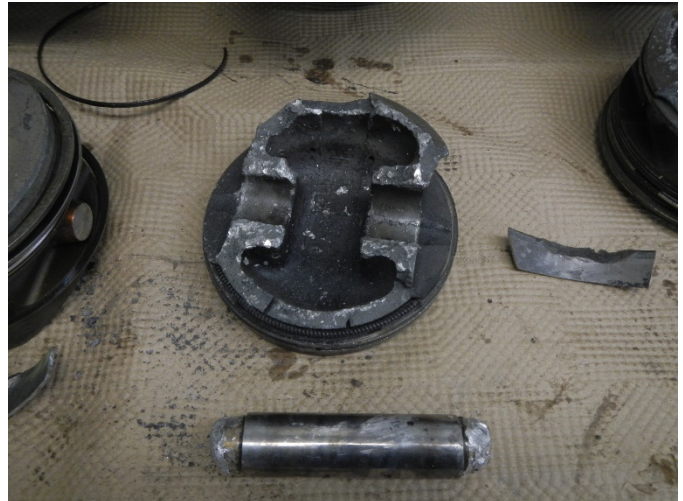
The piston face displayed two crescent shaped impact marks consistent with a valve strike. However, the face displayed normal combustion deposits with no signs of piston erosion. The piston skirt was fractured below the oil control ring land and the piston pin was separated.

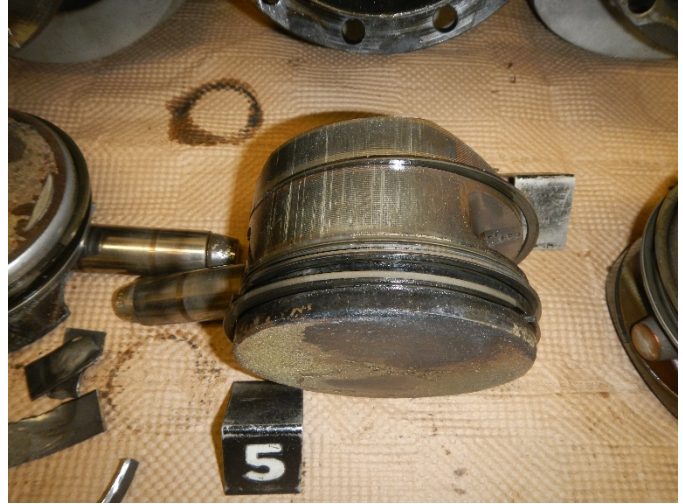
The piston face displayed normal combustion deposits and did not display any signs of pre-accident anomalies. The piston skirt displayed some scoring damage and light mechanical damage was noted.

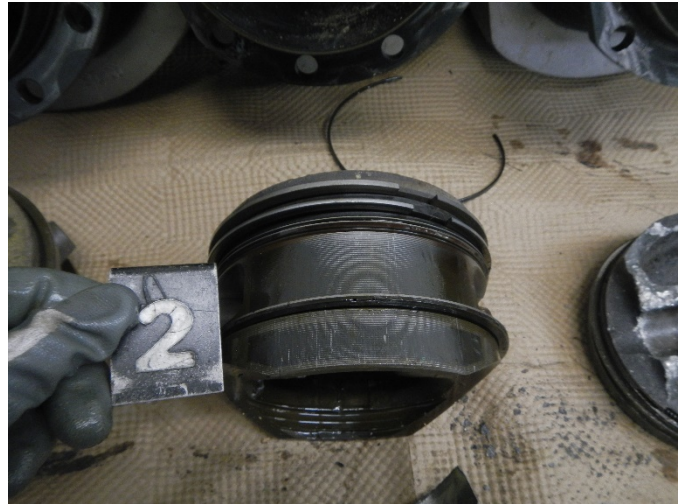
The piston face displayed normal combustion deposits and did not display any signs of pre-accident anomalies. The piston skirt displayed some scoring damage and light mechanical damage was noted.

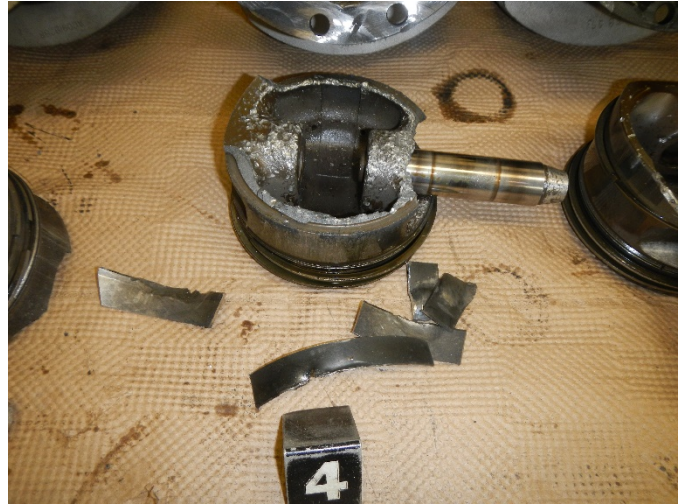
Condition: The piston face displayed two crescent shaped impact marks consistent with a valve strike. However, the face displayed normal combustion deposits with no signs of piston erosion. The piston skirt was fractured below the oil scraper ring and the piston pin boss was mechanically damaged. The fractured connecting rod remained attached to the piston pin.

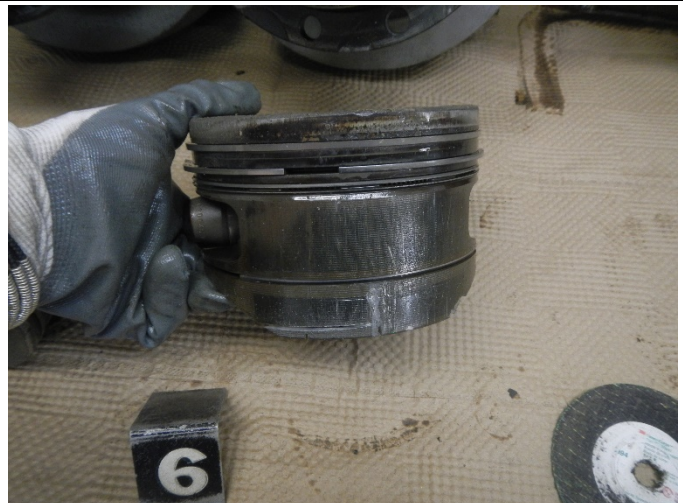
Condition: The piston face displayed normal combustion deposits and did not display any signs of pre-accident anomalies. The piston skirt displayed some scoring damage and light mechanical damage was noted.

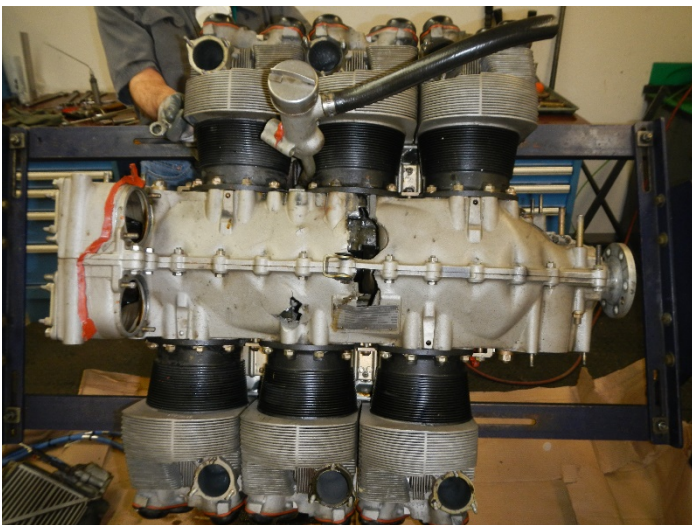
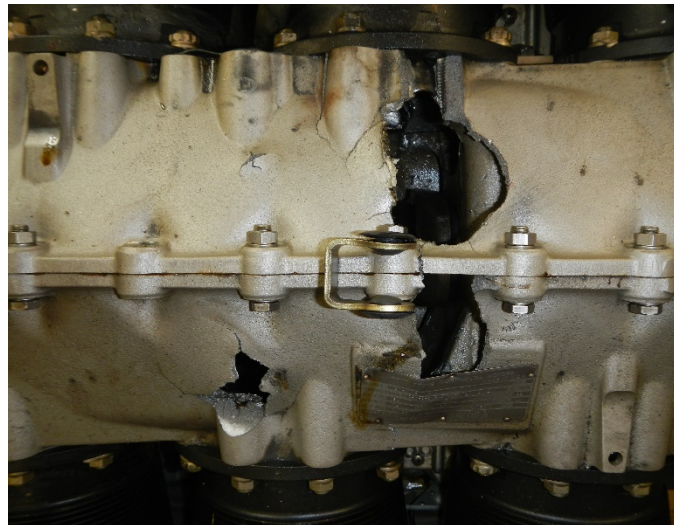
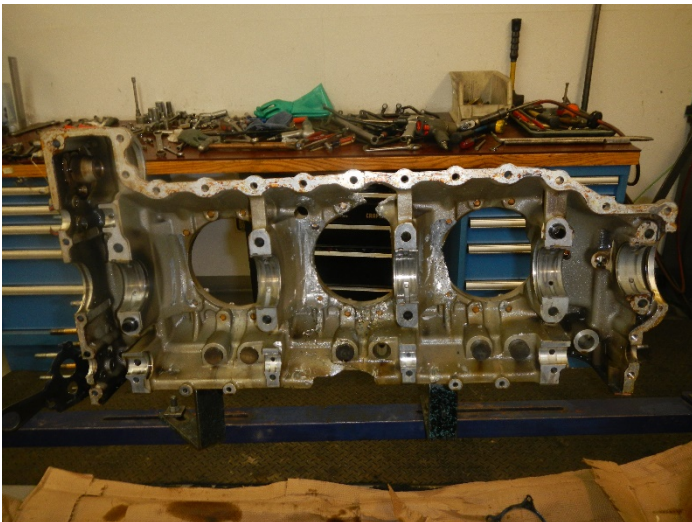
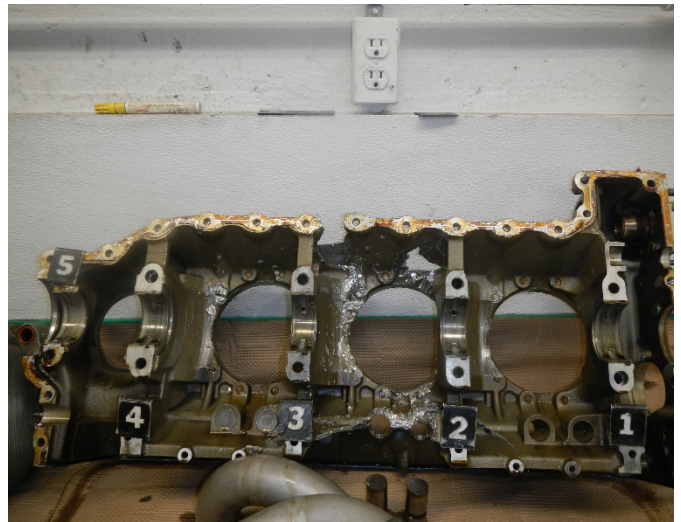
The crankcase halves remained attached and displayed three holes on the topside that were in line with the #3 and #4 cylinders. A few of the cylinder attaching studs for the #3 and #4 cylinders were mechanically damaged/missing. The break-away torque for the cylinder through-bolts and deck studs was measured during disassembly. There were no pre-event anomalies noted with the undamaged items. Mechanical damage was noted in all the cylinder bays and the #3 and #4 lifter bosses. The oil passages that fed the crankshaft and connecting rod journals were visually examined when the case halves were separated. No blockages were noted.

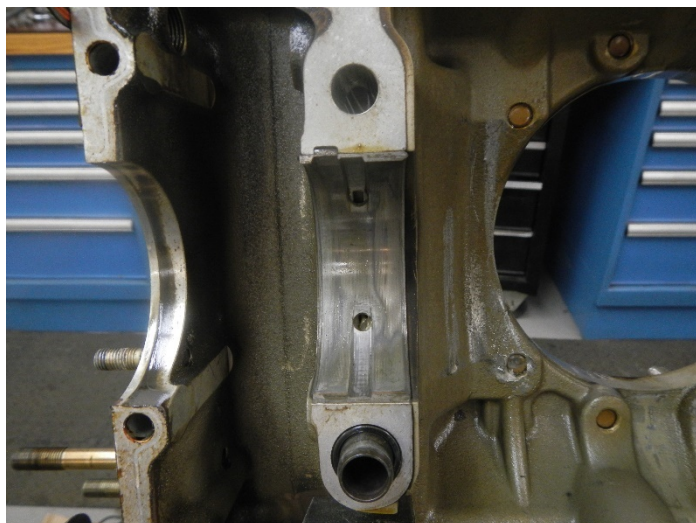
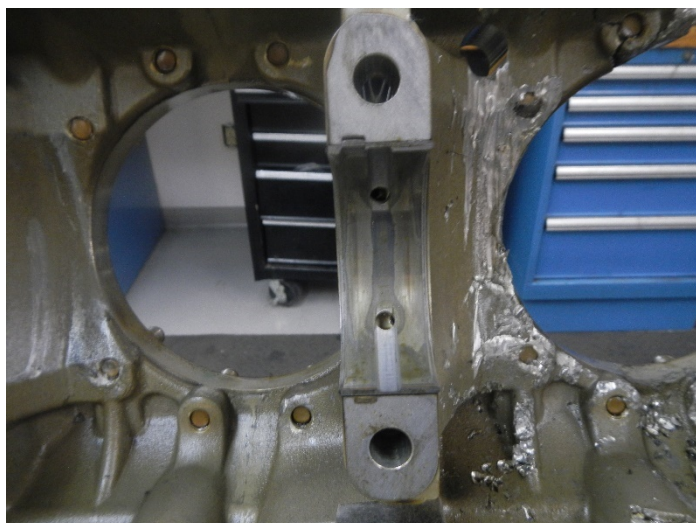
The main bearings remained in place with no signs of pre-event anomalies noted. The photographs below depict the left and right bearing halves from 1 through 5.

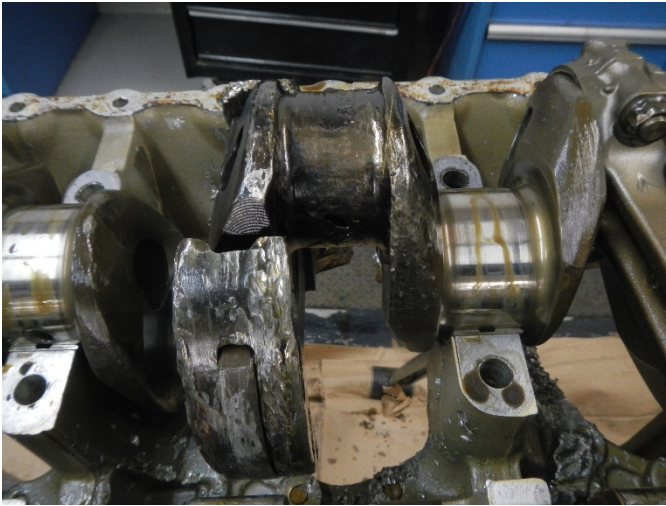
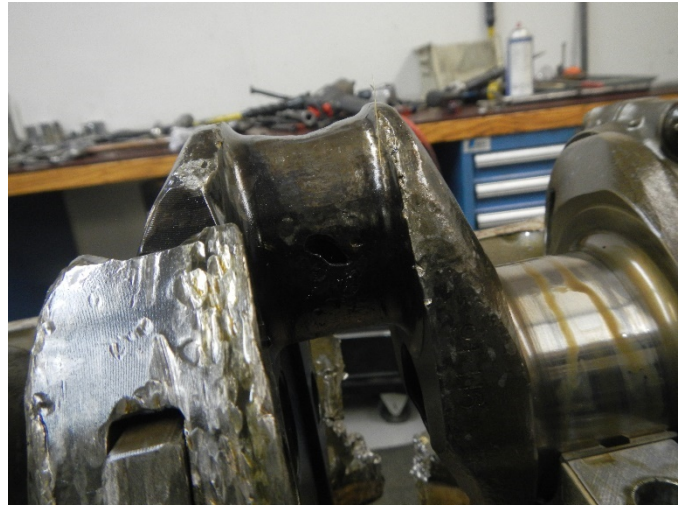
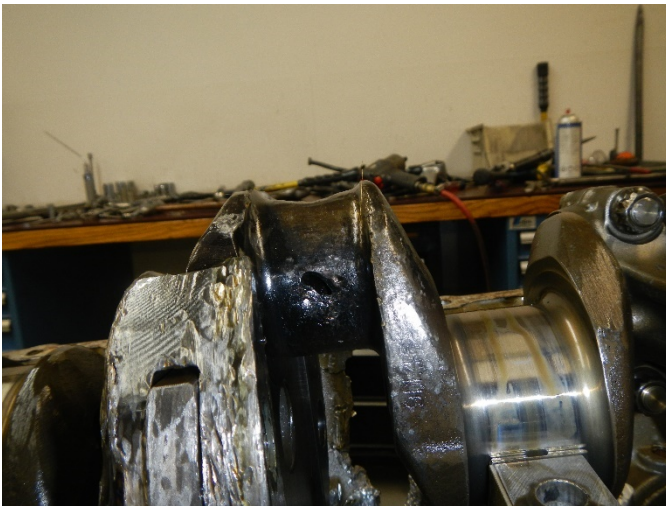
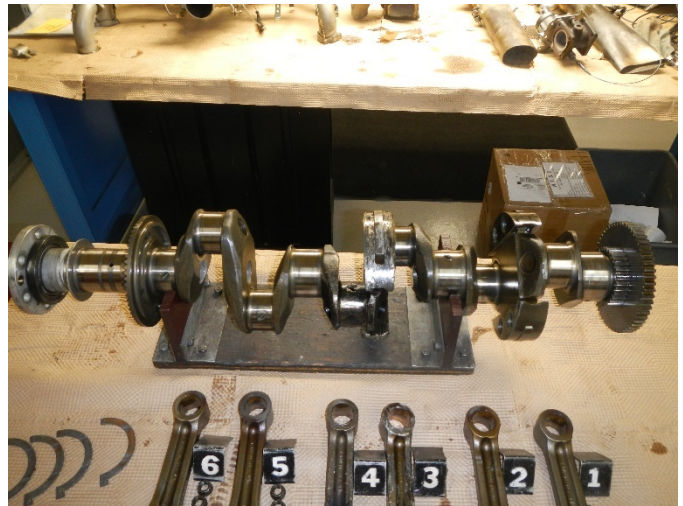
The crankshaft was intact, but sustained mechanical damage to the counterweights, hangar blades, and crankshaft cheeks from the fractured #3 and #4 connecting rods. The #4 connecting rod journal was thermally discolored and displayed deformation damage. The oil feed tube for the #4 connecting rod was clear and free from obstructions. The crankshaft gear remained intact and secured in place.

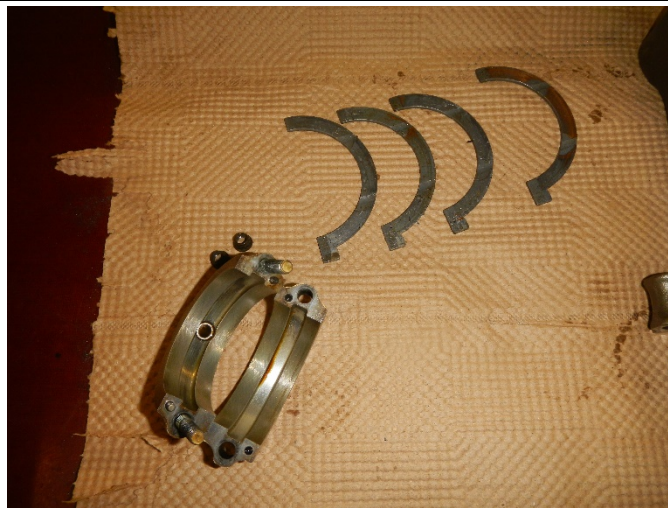
The transfer collar remained in place with no pre-accident anomalies noted.

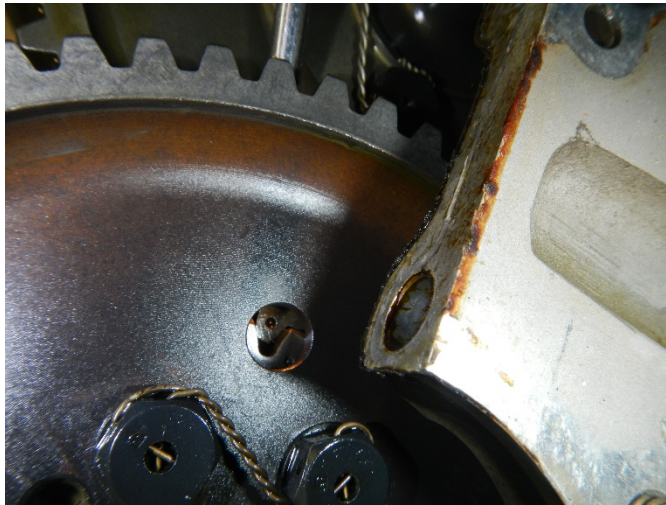
The internal timing was properly set.

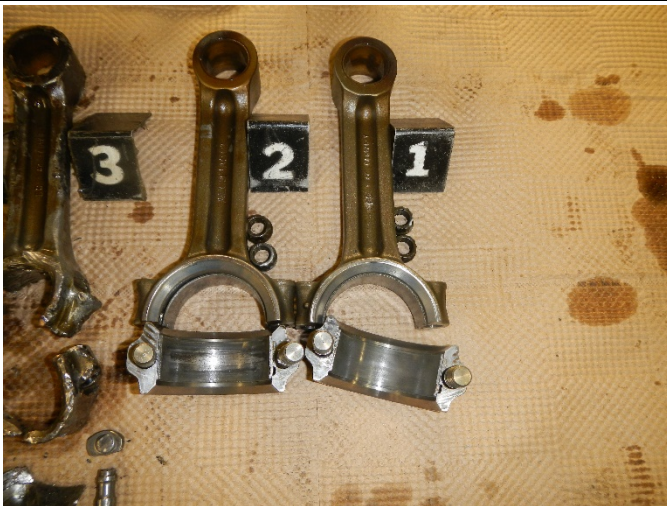
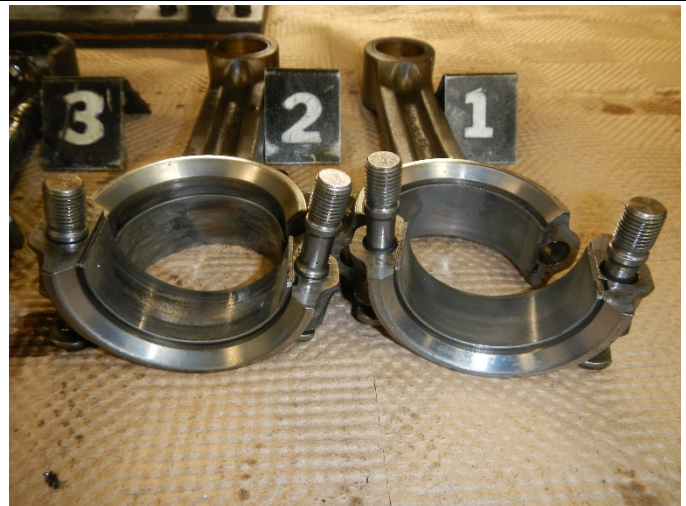
The connecting rod remained secured to the crankshaft with no pre-accident anomalies noted.

The bearing remained in place and did not display any pre-accident anomalies.

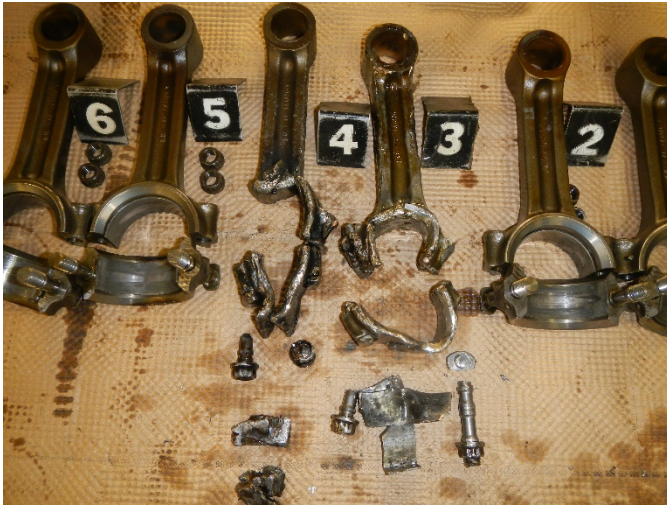
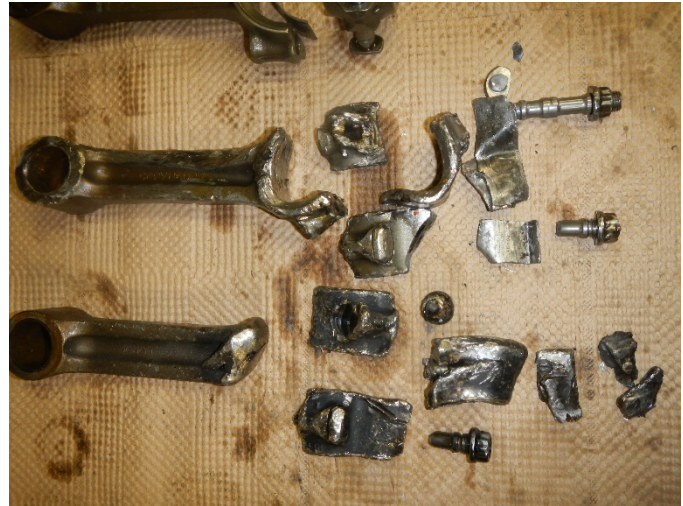
**Condition:** The connecting rod was fractured and separated from the crankshaft and its piston pin; it was located in the oil sump. The rod displayed mechanical damage that distorted the rod cap and rod shoulders. There were no signs of thermal discoloration.

**Condition:** The bearing was mechanically damaged and found in the oil sump.

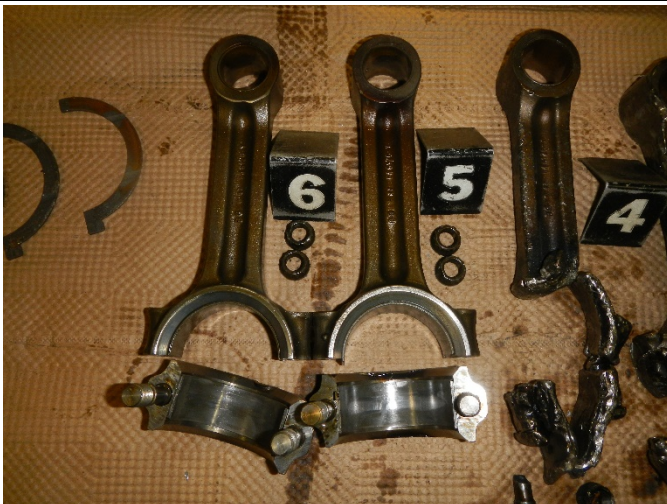
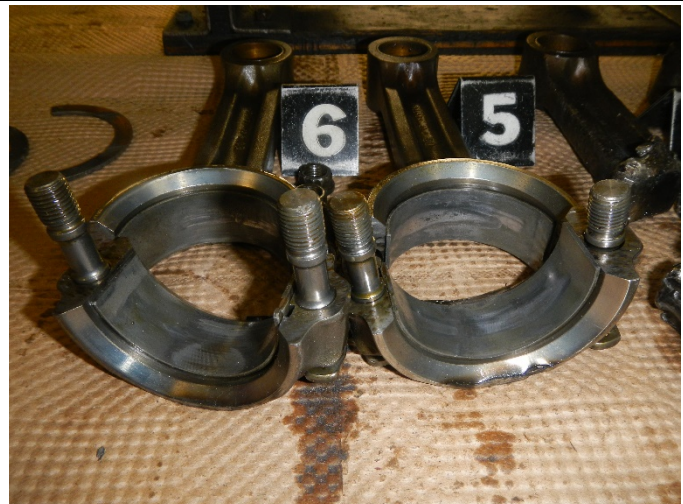
**Condition:** The connecting rod displayed mechanical damage to its rod cap, but the rod remained intact and attached to the crankshaft.

**Condition:** The bearing remained in place and displayed distortion in areas that were mechanically deformed on the rod cap.

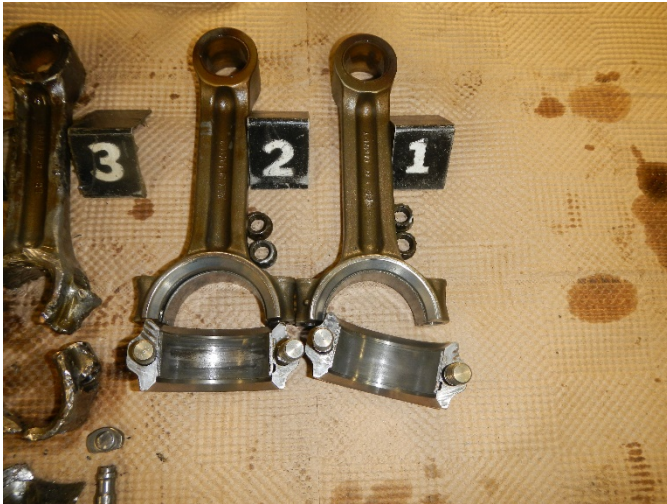
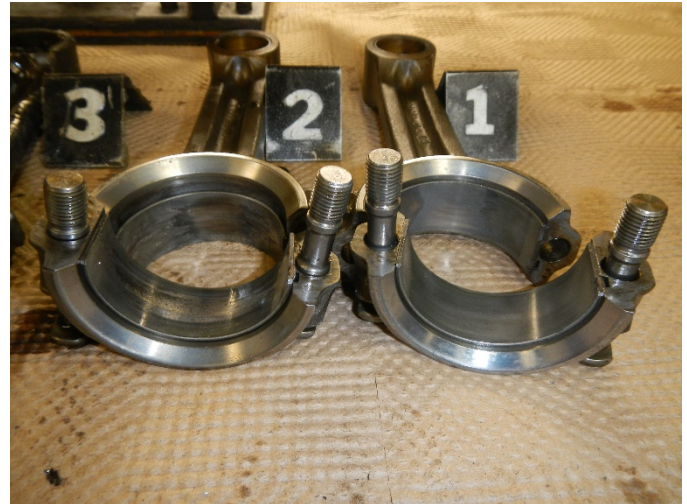
**Condition:** The connecting rod remained attached to the crankshaft and the piston pin. The rod sustained mechanical damage to the I-beam toward the piston pin end.

**Condition:** The bearing remained in place, but displayed incipient oil starvation signatures. The oil passage to the bearing was clear.

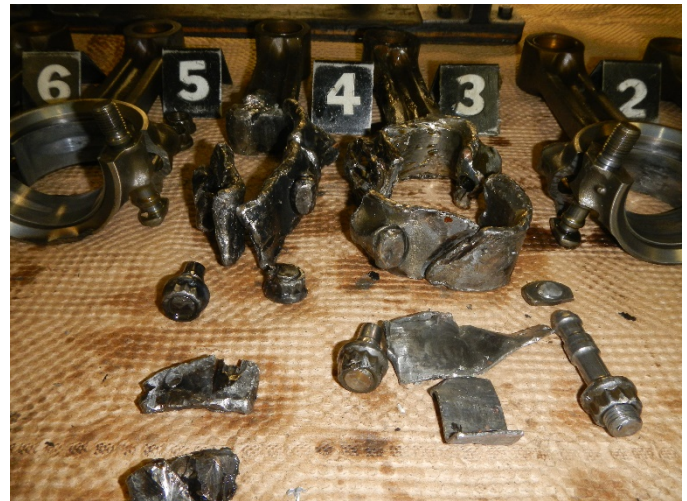
**Condition:** The connecting rod was fractured and separated from the crankshaft but remained attached to the piston pin. The connecting rod displayed multiple fractures and thermal discoloration consistent with oil interruption.

**Condition:** The thermally discolored remains of the bearing were found in the oil sump. The pieces were discolored black and sustained significant distortion and fragmentation. The oil passage to the bearing was clear.

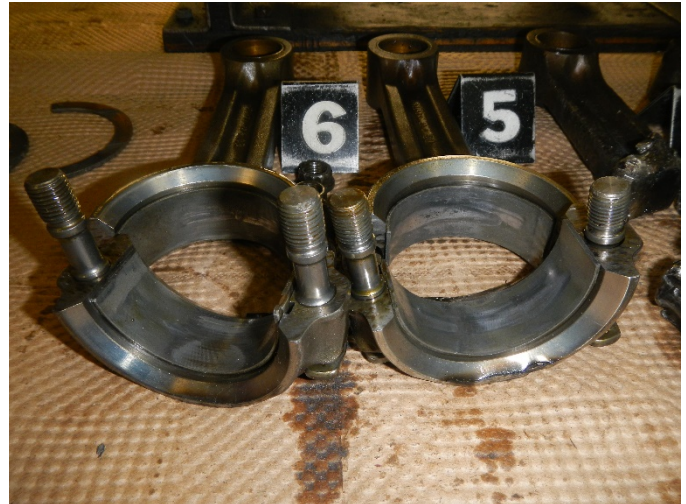
The connecting rod displayed mechanical damage to its rod cap, but the rod remained intact and attached to the crankshaft.

The bearing remained in place with no sign of thermal discoloration.

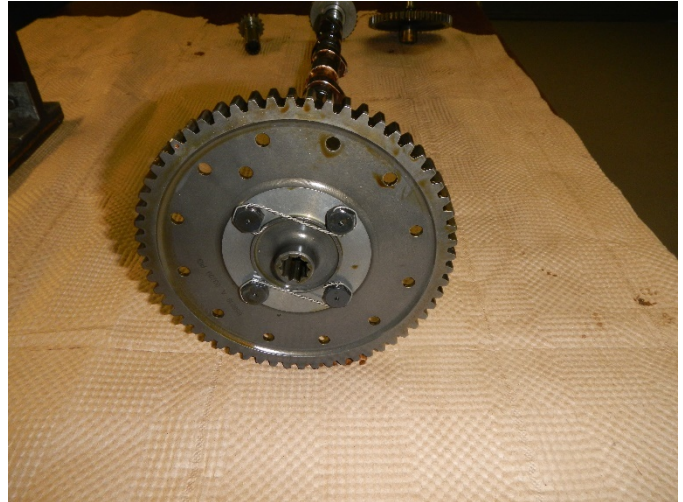
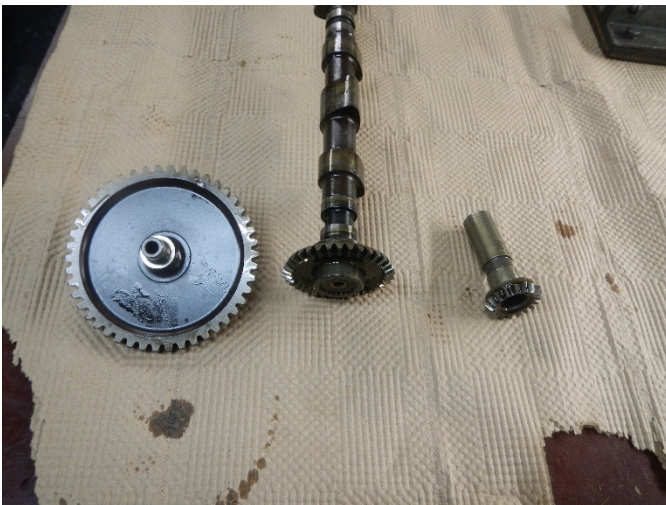
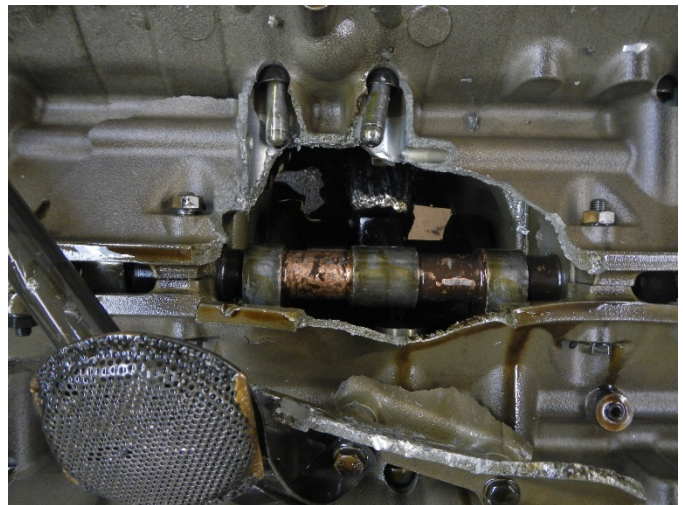
The camshaft sustained mechanical damage in an area that coincided with the fractured connecting rods. The #3 lifter housing area was fractured and lifters were not in place. There were no pre-accident anomalies noted with the lifter faces or camshaft lobes. The camshaft and beveled gear remained in place with no pre-accident anomalies noted.

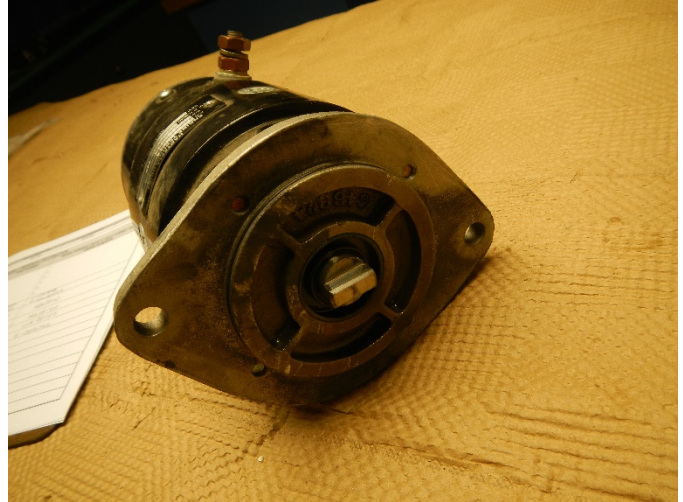
Condition: The starter motor remained in place with no pre-accident anomalies noted. The starter shaft rotated freely during manual manipulation.
