# Continental Motors

## ENGINE EXAMINATION REPORT

| FILE NUMBER | 16-698 |

The #3 and #4 connecting rods were fractured and separated from the connecting rod journals. The #4 connecting rod and connecting rod bearings and the crankshaft's #4 connecting rod journal displayed thermal discoloration consistent with oil starvation. The #2 connecting rod bearings also displayed incipient signatures consistent with lubrication distress. The #3 connecting rod and bearing were mechanically damaged. Approximately 2.0 quarts of oil was observed on the oil quantity dipstick following the event. Examination of the engine components and engine-related systems revealed no evidence of a pre-impact oil leak. Additionally, the right turbocharger was missing its turbine wheel and the shaft was fractured outboard of the turbine piston ring. The bearings displayed signatures consistent with lubrication interruption. The impeller contacted the inlet housing and the impeller blades displayed distortion in the opposite direction of rotation. Review of recorded engine data revealed that the oil pressure displayed a fluctuation followed by a steady reduction.

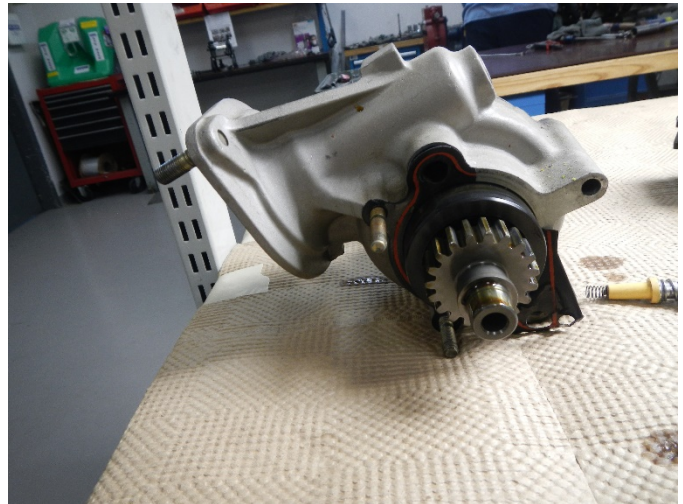
Condition: The starter adapter remained in place on the backside of the engine with no external signs of operational distress. Removal of the unit revealed no pre-accident anomalies.

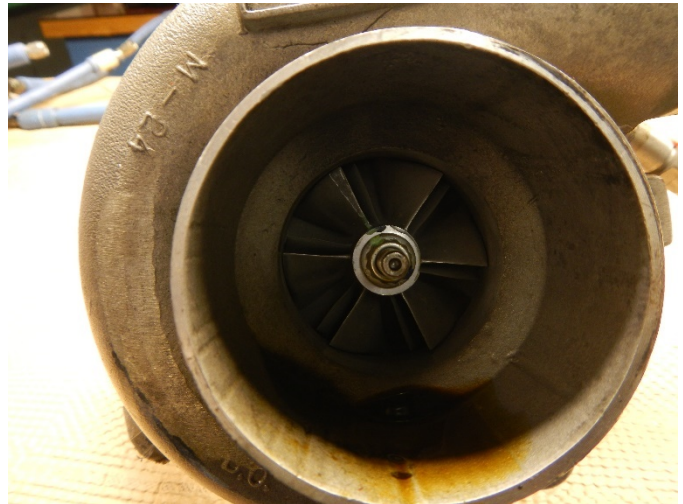
| TURBO #1 | Manufacturer: Kelly Aerospace | P/N: 466304-0003 | S/N: LIL00112 |
|---|---|---|---|
| Condition: | The left turbocharger remained secured to the exhaust transition but the transition was removed from the engine prior to shipment. Oil was observed in the impeller inlet and on the outside of the turbine wheel housing. Residual oil drained from the bearing. The impeller wheel rotated freely with a coinciding rotation of the turbine when manually manipulated. The bearing oil supply inlet screen and check valve were tested and inspected. The check valve unseated with 14 psi of air pressure applied, and the inlet screen was found clear. The turbocharger was disassembled at the HET facility. There was no evidence of foreign object damage on the compressor or turbine wheels and the housings did not display any pre-event anomalies. The turbine and compressor bearings were removed and the oil holes were clear and unobstructed. The turbine bearing displayed some discoloration and circumferential wear on its OD. See the HET examination report for more information. | | |

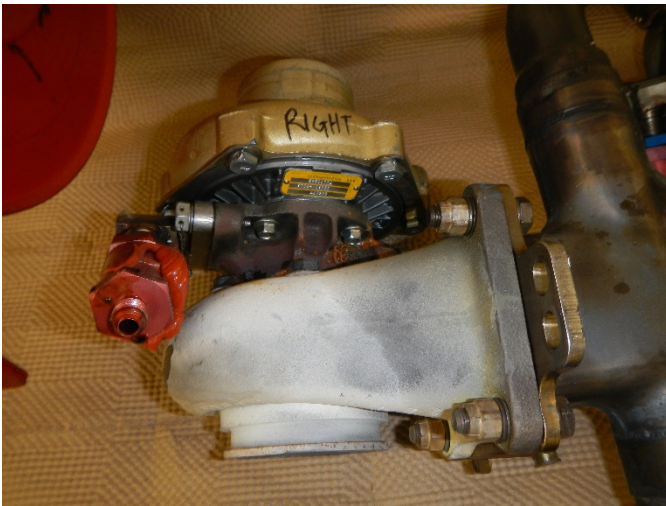
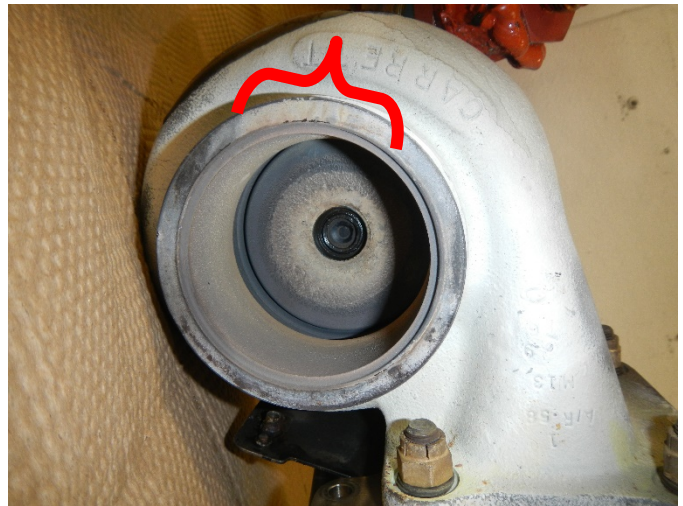
The right turbocharger remained secured to the exhaust transition but the transition was removed from the engine prior to shipment. The turbocharger's turbine wheel was missing and there was little-to-no rub or contact damage noted on the turbine wheel housing (it should be noted that a normally sized turbine wheel would not be able to exit the unit without interfering with the housing). The turbine housing was discolored with what appeared to be a pale colored exhaust residue; however, the source of the discoloration was not determined. There was an area on the housing's exhaust tailpipe mating flange that was similar in appearance, as noted with the red bracket in the second photograph. The v-band coupling remained with the tailpipe and was removed from the turbocharger prior to shipment.

The impeller and impeller housing displayed damage consistent with rotational contact. The bearing oil supply inlet screen and check valve were tested and inspected. The check valve unseated with 15 psi of air pressure applied, and the inlet screen was found clear. Disassembly of the unit revealed that the bearings' oil holes contained displaced bearing material and both the turbine and compressor bearings were worn. The bearing housing lubrication passages were clear. The turbine wheel was separated from the turbine shaft at the outboard edge of the piston ring groove. The piston ring remained in place. There was no evidence of oil leakage in the turbine housing. See the HET examination report for more information.

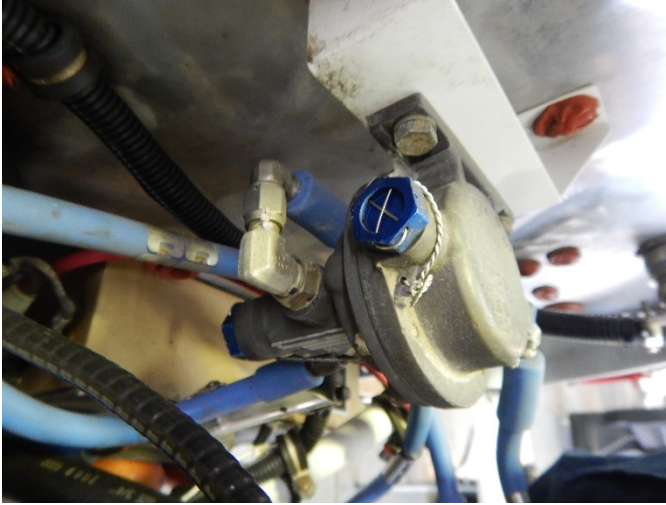
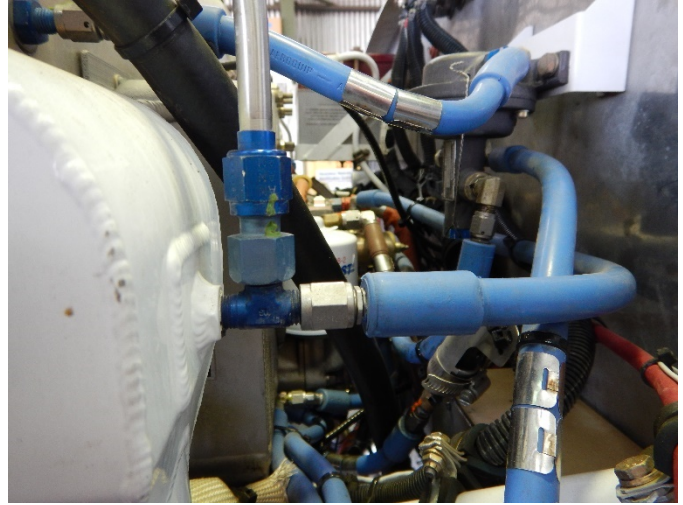
**Condition:** The controller was removed prior to shipment. The oil lines to and from the controller remained attached with no signs of pre-event oil leaks. NOTE: The photographs below were taken prior to engine removal from the aircraft.

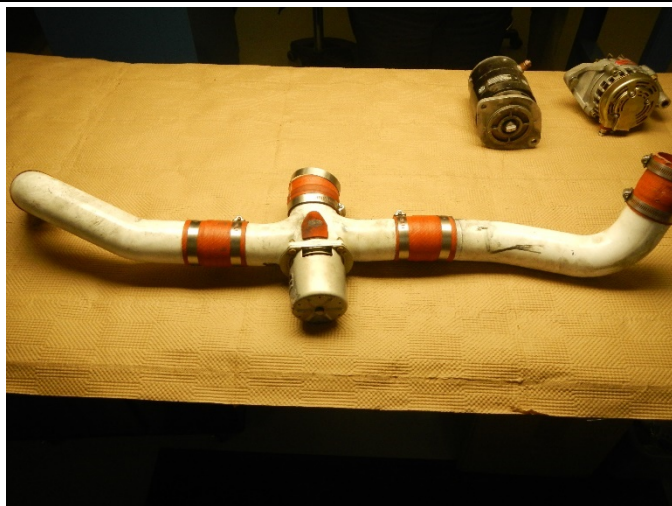
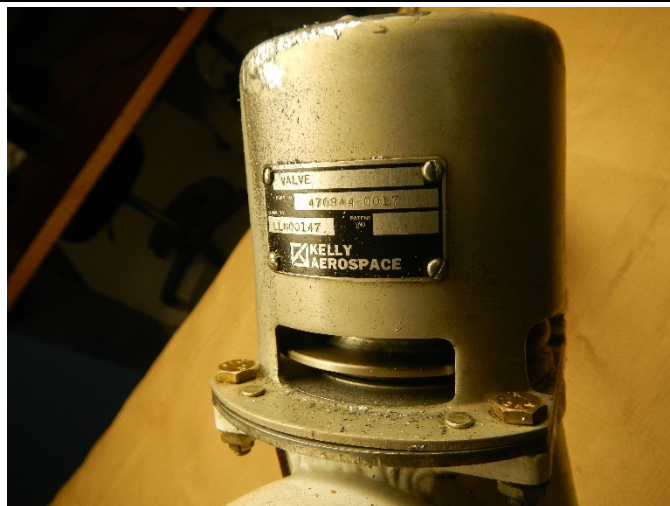
The overboost valve remained attached to the previously removed intake system components. It was functionally tested at the HET facility with no pre-accident anomalies noted.

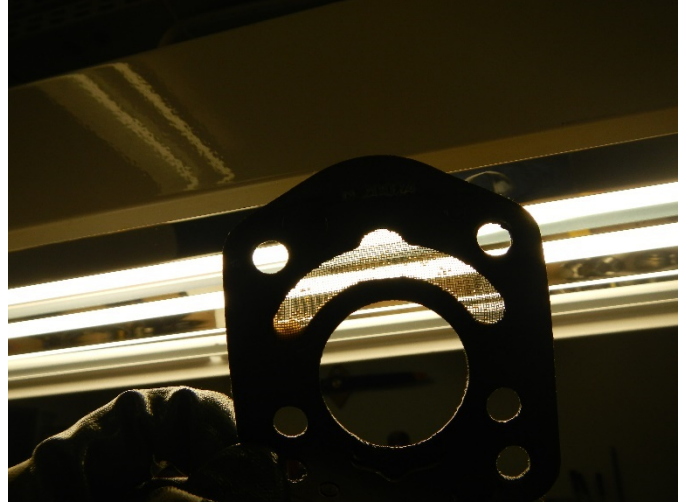
The propeller governor remained attached to the front left side of the engine with no pre-accident anomalies noted. The governor was removed and the inlet screen was clear. Manual rotation of the drive shaft resulted in free rotation of the pump with residual oil observed in the housing.
