# Continental Motors

## Component Examination Report

| Aircraft Make/Model: | Robinson R44 II | Aircraft S/N: | 12538 |
| Occurrence Date: | 07/02/2017 | NTSB Accident # | WPR17LA140 |

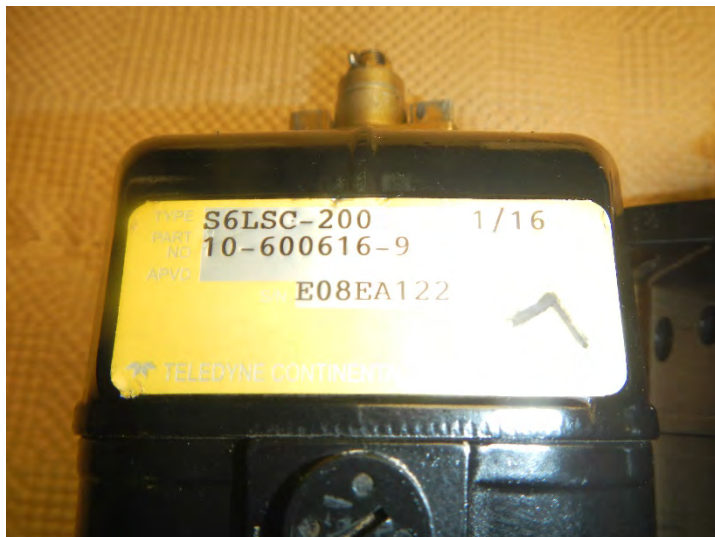
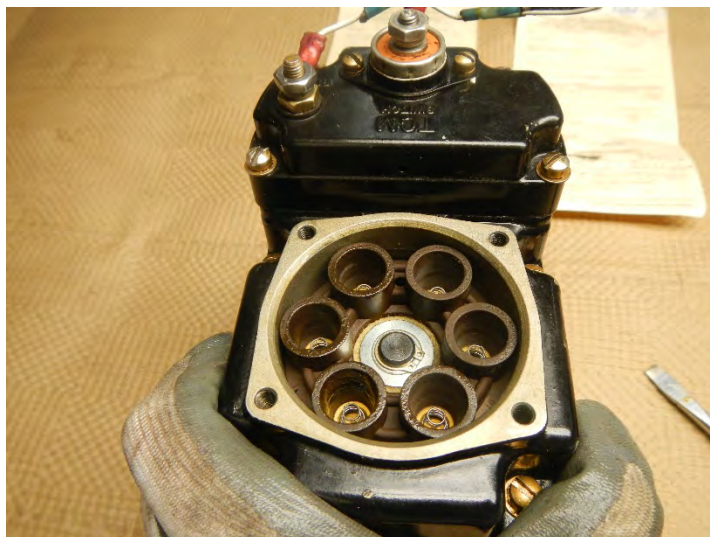
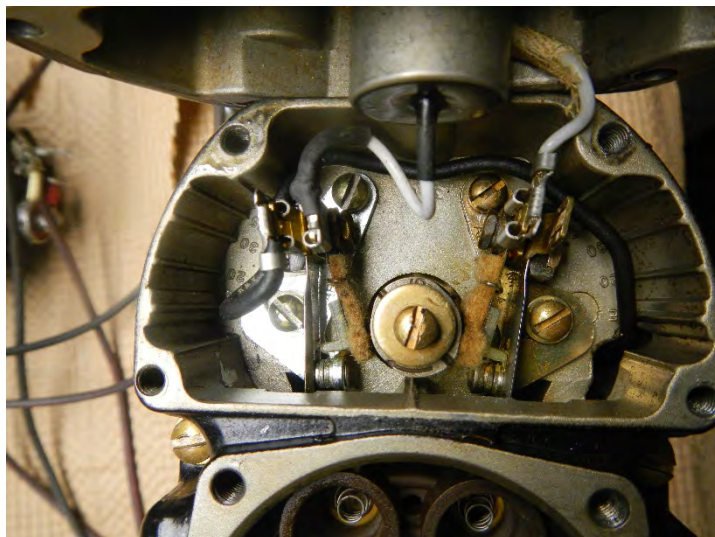
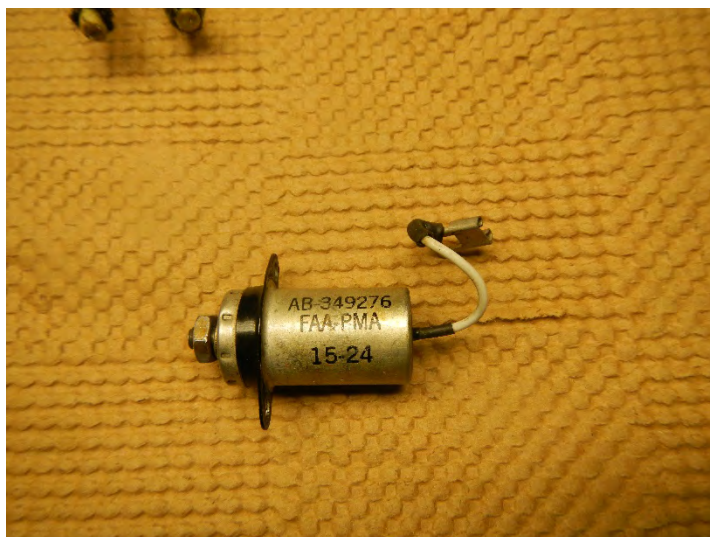
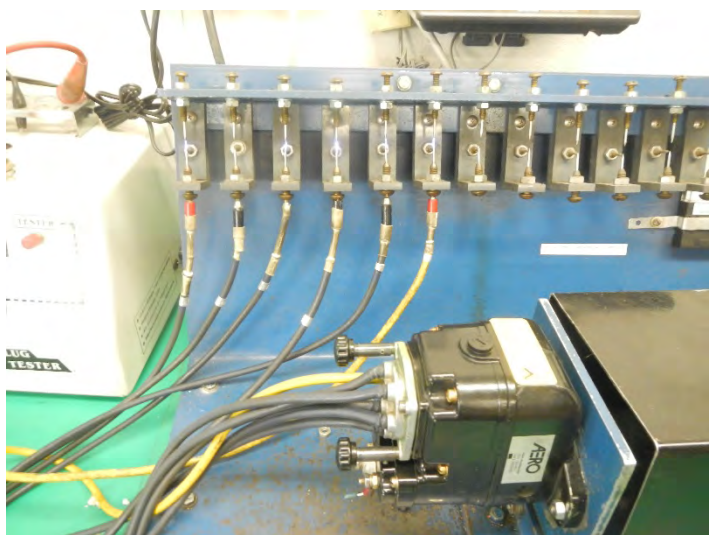
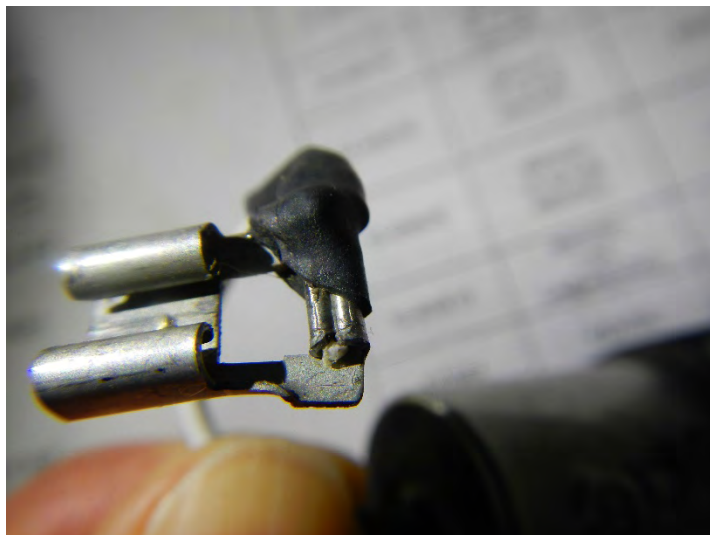
## LEFT MAGNETO

The magnetos were removed from the shipping box. The left magneto's point cap was removed and both sets of points were found loose (they had been removed and reinstalled during the previous NTSB exam). The point gap was re-established and the screw was tightened. The magneto was placed on the test stand with intermittent results. The magneto point cap was again removed. The capacitor was removed from the magneto and was replaced with an exemplar unit taken of a reclamation magneto. The magneto was placed on the test bench for a second time and it produced a spark across a 4mm gap from each terminal in firing order throughout normal test ranges. The left magneto's capacitor was tested in accordance with Continental Motors' Quality Work Instructions. Corrosion on the flag connector prevented the capacitor from testing within specifications. The insulation inboard of the flag connector was cut open and the test was repeated with satisfactory results using the exposed wire.

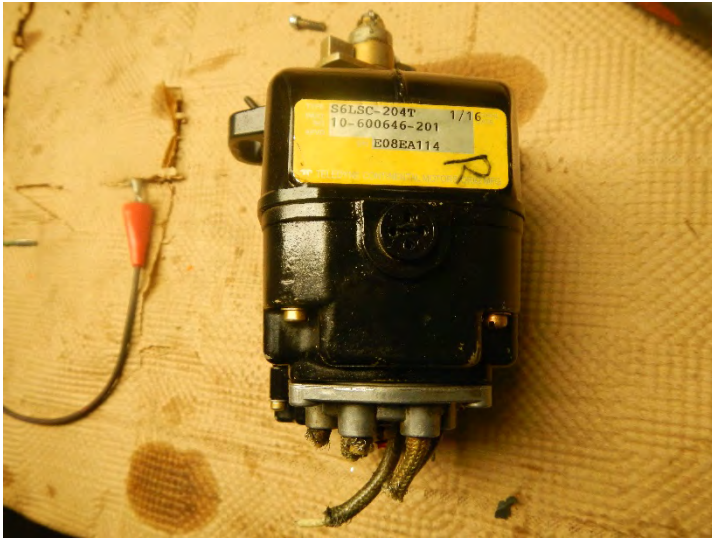
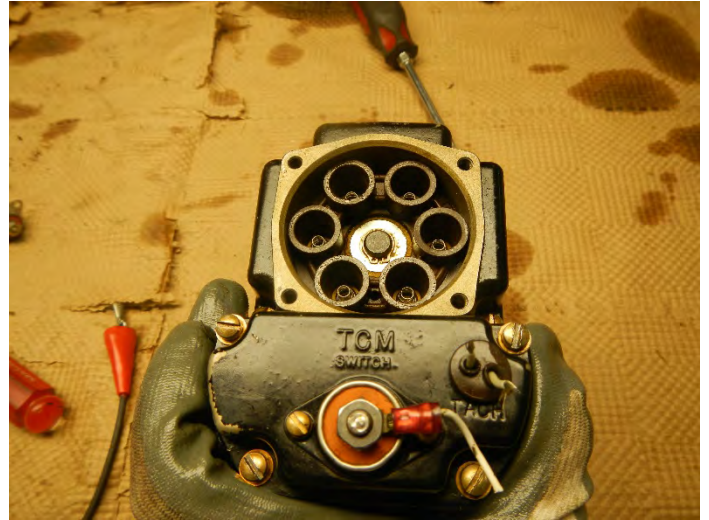
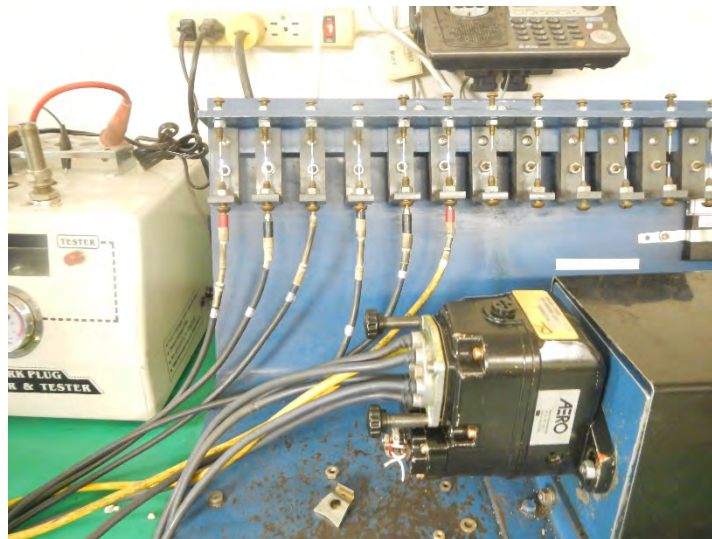
## RIGHT MAGNETO

The right magneto was placed on a test bench with an exemplar ignition harness and run through various speeds. The magneto produced a spark across a 4mm gap from each terminal in firing order. No pre-accident anomalies were noted.
