## **NATIONAL TRANSPORTATION SAFETY BOARD**

# **MAGNETO EXAMINATION**

**WPR17LA140**

Location: Bella Vista, California  
Date: July 2, 2017  
Aircraft: Robinson R44, N488AS  
NTSB IIC: Elliott Simpson

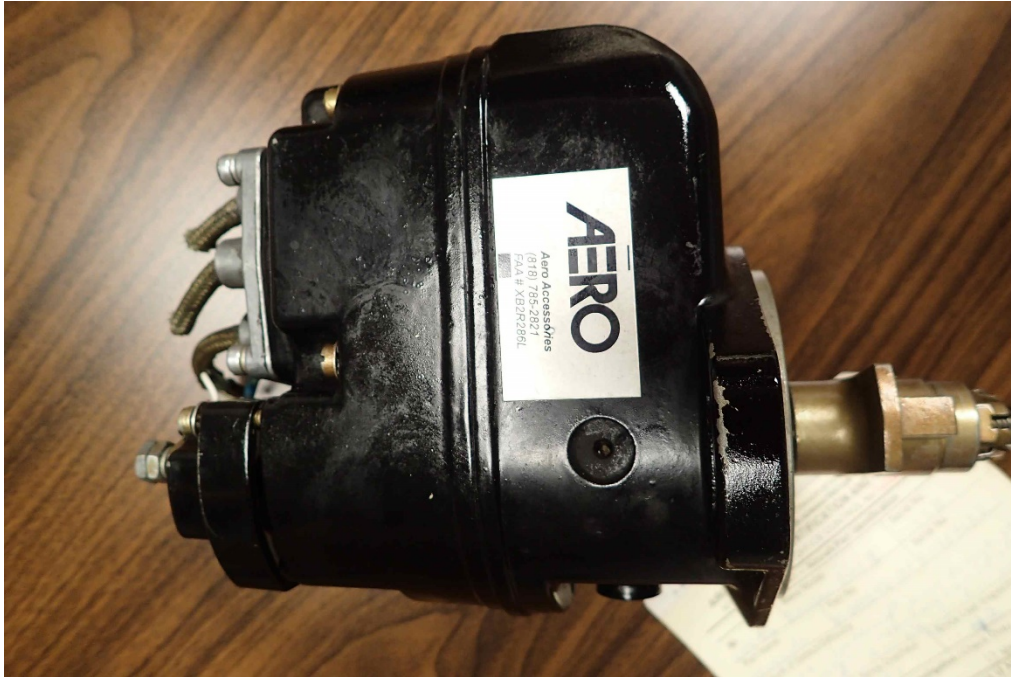
Photo 1 –Left Magneto

The external case of the magneto appeared undamaged (Photo 1). The points cover had already been removed prior to the examination, and all the spade connectors had been disconnected.

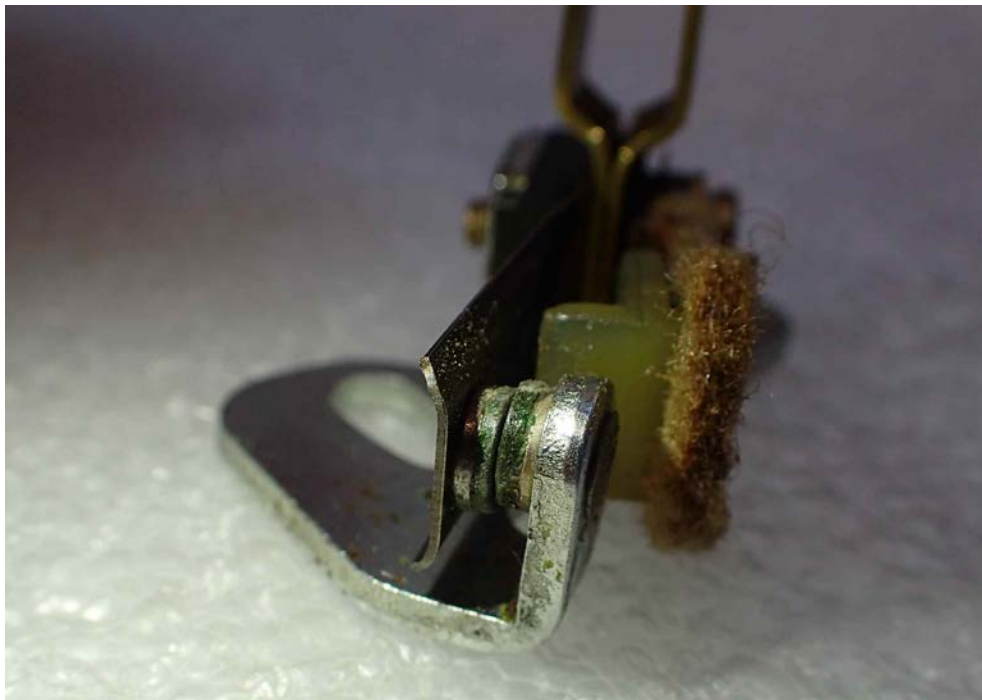
Photo 2 – Primary Points

Both the points and retard points moved with rotation of the input shaft, and appropriate point gaps were observed. Green-colored deposits (Photo 2) were on the points contact surfaces and the E-gap was measured at 0.013 in (nominal 0.018 +/- 0.006 in).

The points cover was re-attached and the magneto was installed in a test stand and run at speeds of between 150 and 1,400 rpm. None of the output leads produced a spark.

Both sets of points were removed, and the green-colored deposits were removed with sand paper. The points were then re-installed and gapped, and again run at varying speeds, but this time intermittent sparks were observed at a speed range of 150 through to 600 rpm. After about 30 seconds, all sparks ceased at all speeds.

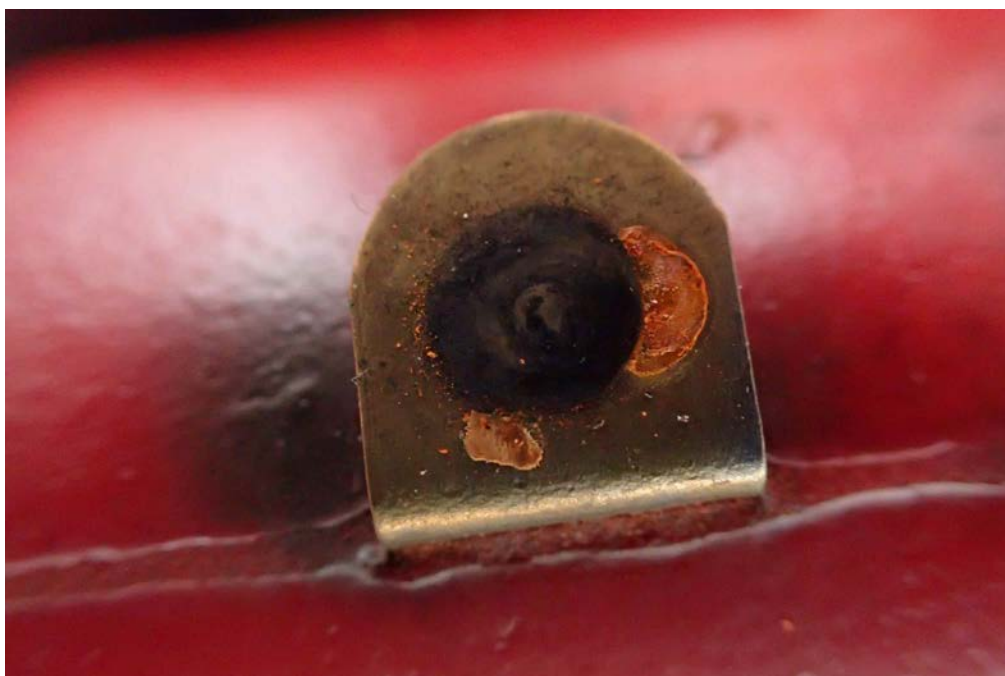
Photo 3 – Coil Contact

The magneto was then disassembled, and orange-colored corrosion was present on the copper coil contact stem (Photo 3). The carbon brush of the timing wheel moved with sprung resistance when pressed, and grooves were noted on its contact surface (Photo 4). The gear was then removed and the wiper arm exhibited black deposits similar to carbon dust to its transfer surface (Photo 5). No play was observed in gear bearing. The deposits were removed and the unit re-assembled and tested in the test stand, with no improvement in results.
