# NATIONAL TRANSPORTATION SAFETY BOARD

MATERIALS LABORATORY FACTUAL REPORT

Report No. 17-086

Place : Ronan, Montana  
Date : July 7, 2017  
Vehicle : Robinson R44 II  
NTSB No. : WPR17LA143  
Investigator : Stephen Stein, AS-WPR

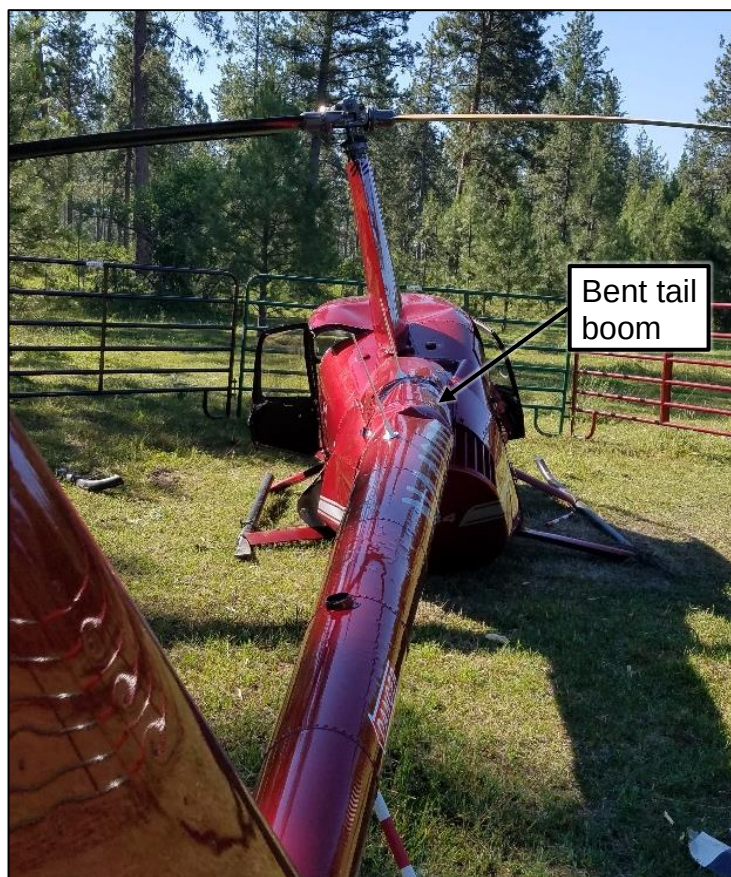
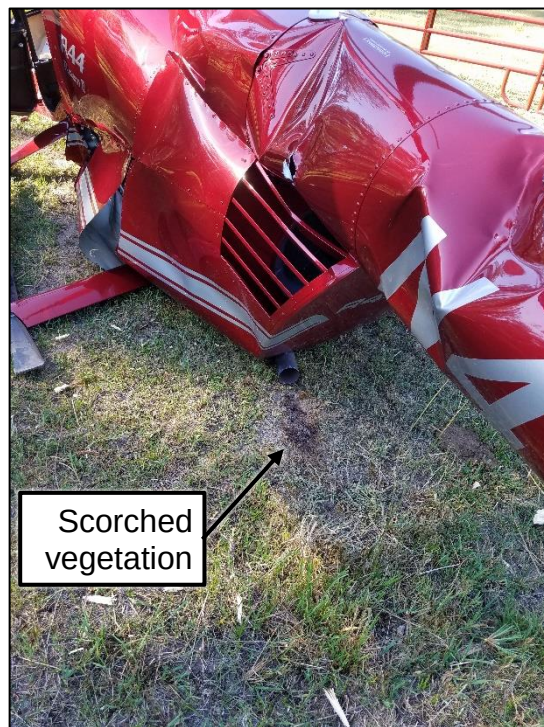
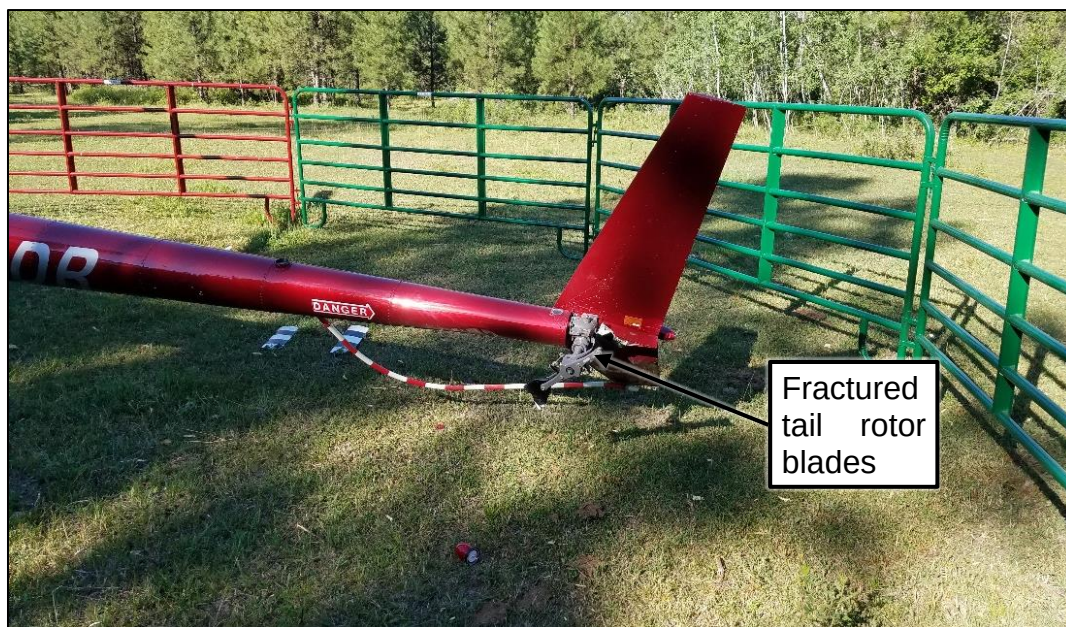
Photographs of the tail end of the helicopter as it came to rest on scene are shown in figure 1. The tail boom was bent at the forward end just aft of the fuselage with the aft end shifted to the left relative to its original position. Both tail rotor blades were fractured at a similar location near the root end of each blade. Sliding contact marks and paint transfer corresponding to blade contact within the radius of blade rotation were present on the lower left side of the tail boom. As indicated in the upper left image in figure 1, vegetation adjacent to the engine exhaust was scorched consistent with continued engine operation after the helicopter came to rest.

Figure 1. Views of the helicopter on scene showing the bent tail boom (upper left image), scorched vegetation near the exhaust (upper right image), and left side of the tail assembly (lower image). Images were provided courtesy of the FAA.

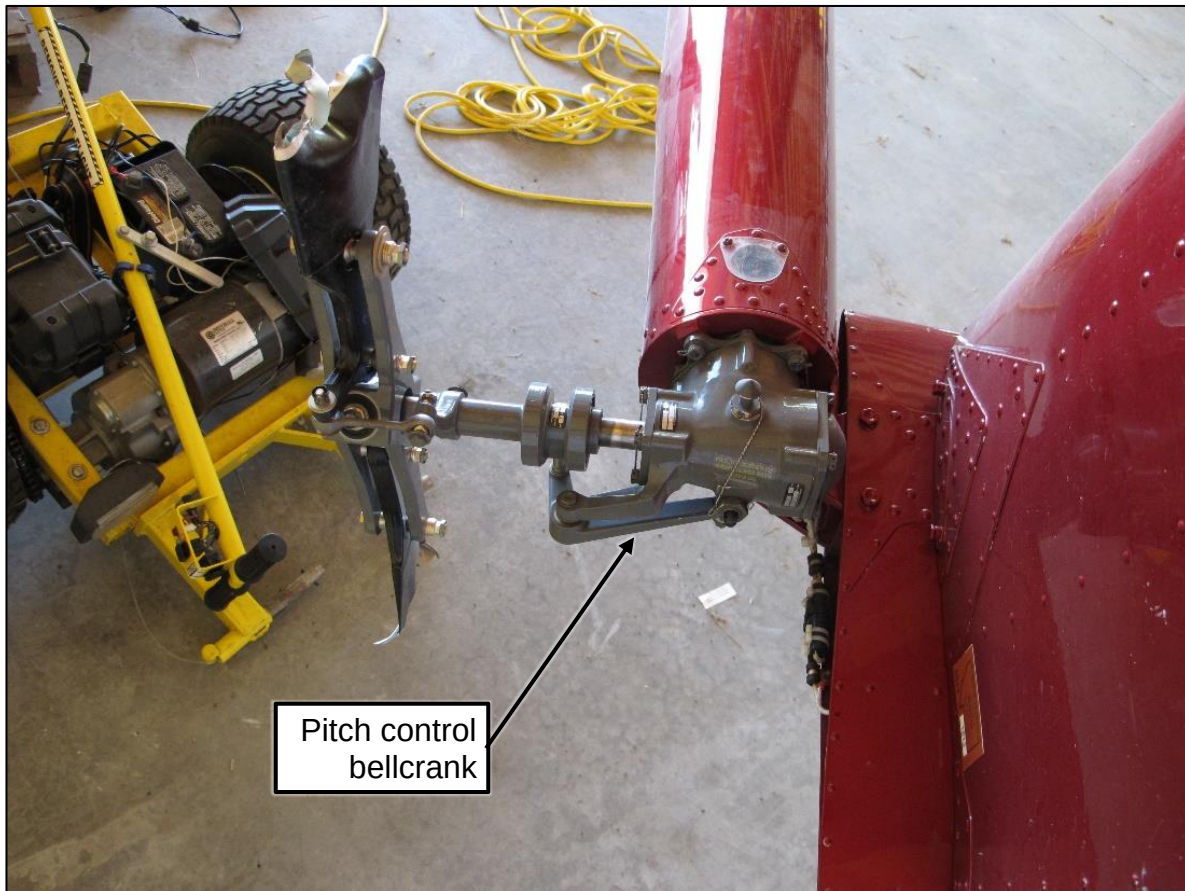
The helicopter was moved to a hangar facility where it was examined by the NTSB investigator in charge with representatives from the Federal Aviation Administration (FAA) and Robinson Helicopter Company. A photograph of the tail rotor assembly before the teardown began is shown in figure 2. The pitch control tube was attached to the inboard end of the pitch control bellcrank, and the bellcrank position corresponded to a tail rotor blade pitch associated with thrust to the left (yaw to the right).

Figure 2. View of the tail rotor assembly looking forward and downward as photographed at the hangar before teardown. The pitch position of the blade is consistent with thrust to the left.

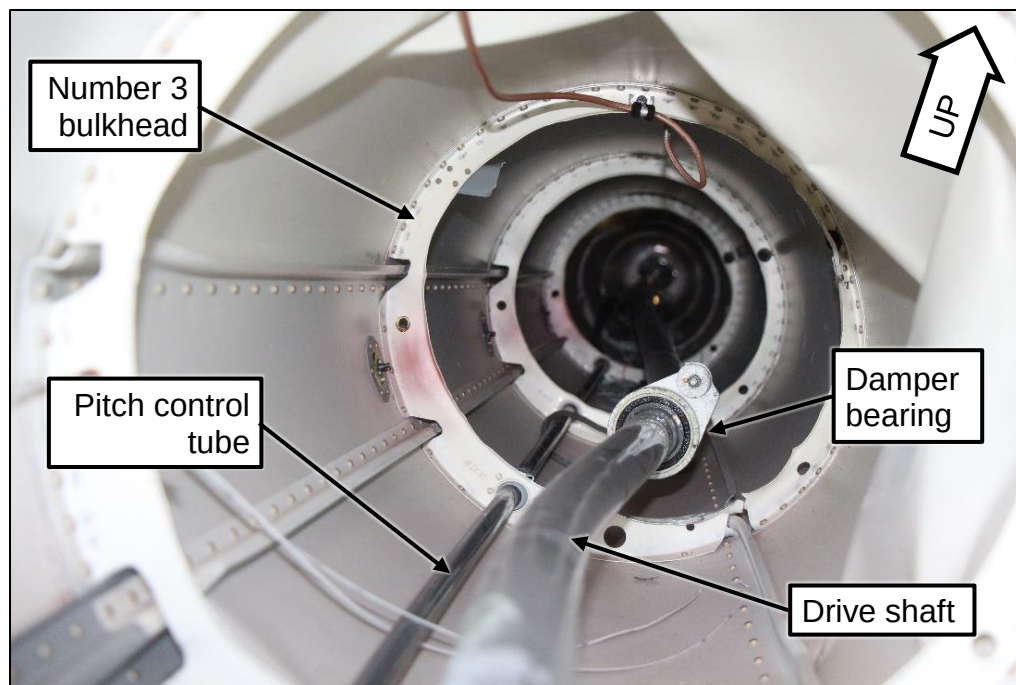
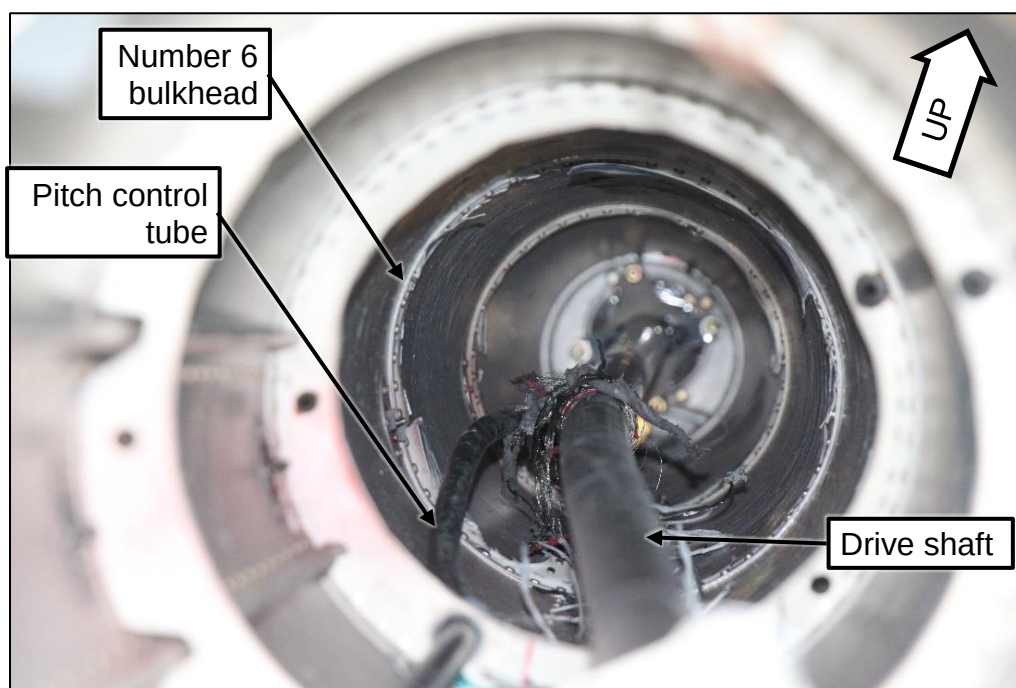
The cowling at the forward end of the tail boom was removed, and views of the interior of the tail boom are shown in figure 3. The damper bearing was attached to the drive shaft but was fractured from its support bracket assembly attached to the number 3 bulkhead. The drive shaft was intact but was bent, and insulated wires were wrapped around the shaft aft of the number 6 bulkhead. Although not visible in the pictures, the pitch control tube (located at the bottom of the tail boom) was fractured just aft of the

number 3 bulkhead. The control tube was also bent at locations aft of the number 5 bulkhead. The numbers 6 and 7 bulkheads were crushed and fractured.

Figure 3. Views of the tail boom interior looking aft showing the damper bearing and number 3 bulkhead (upper image) and the damage further aft (lower image).

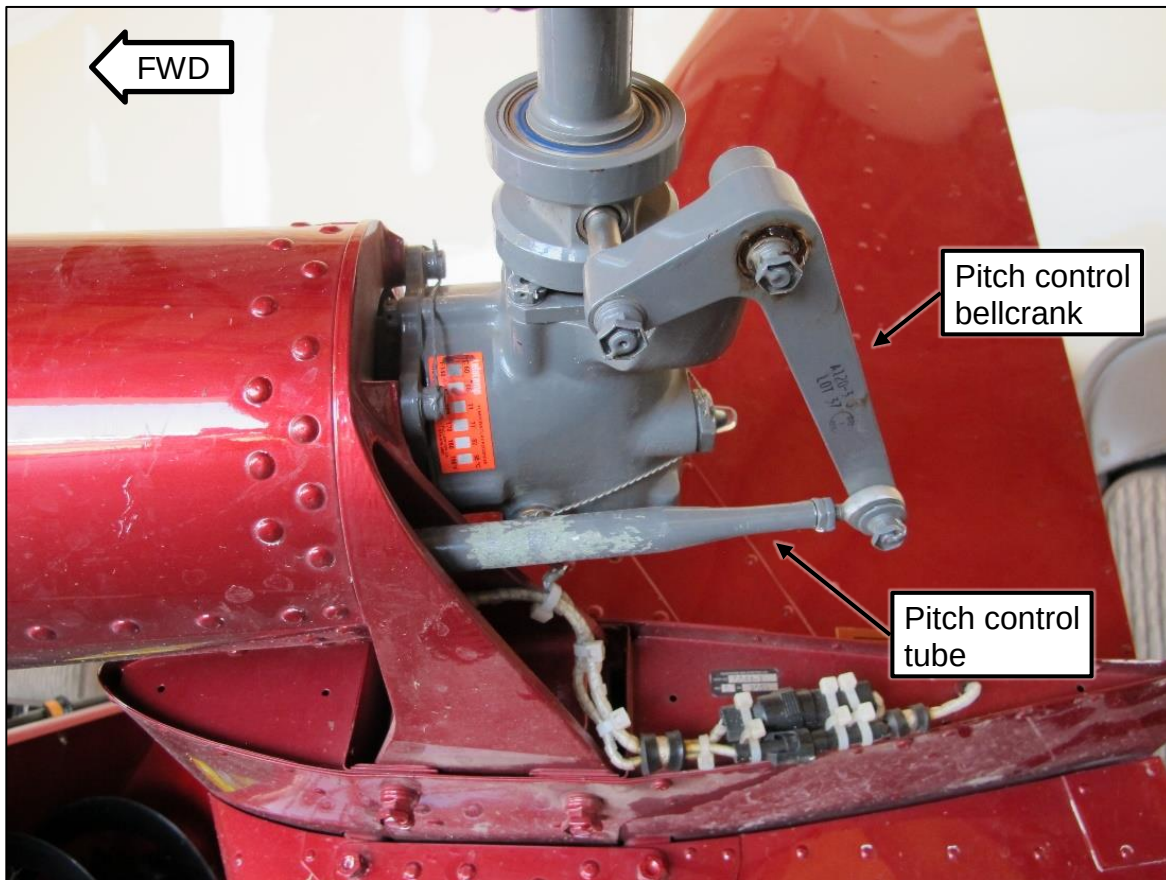
During the teardown, the tail rotor blade pitch position was changed to the position corresponding to maximum thrust to the right, and a view of the pitch control bellcrank in the maximum right thrust position is shown in figure 4. In this position, the pitch control tube had translated approximately 5.5 inches aft of the position shown in figure 2.

Figure 4. View of the lower side of the tail rotor assembly with the tail rotor blade pitch moved to the maximum right thrust position.

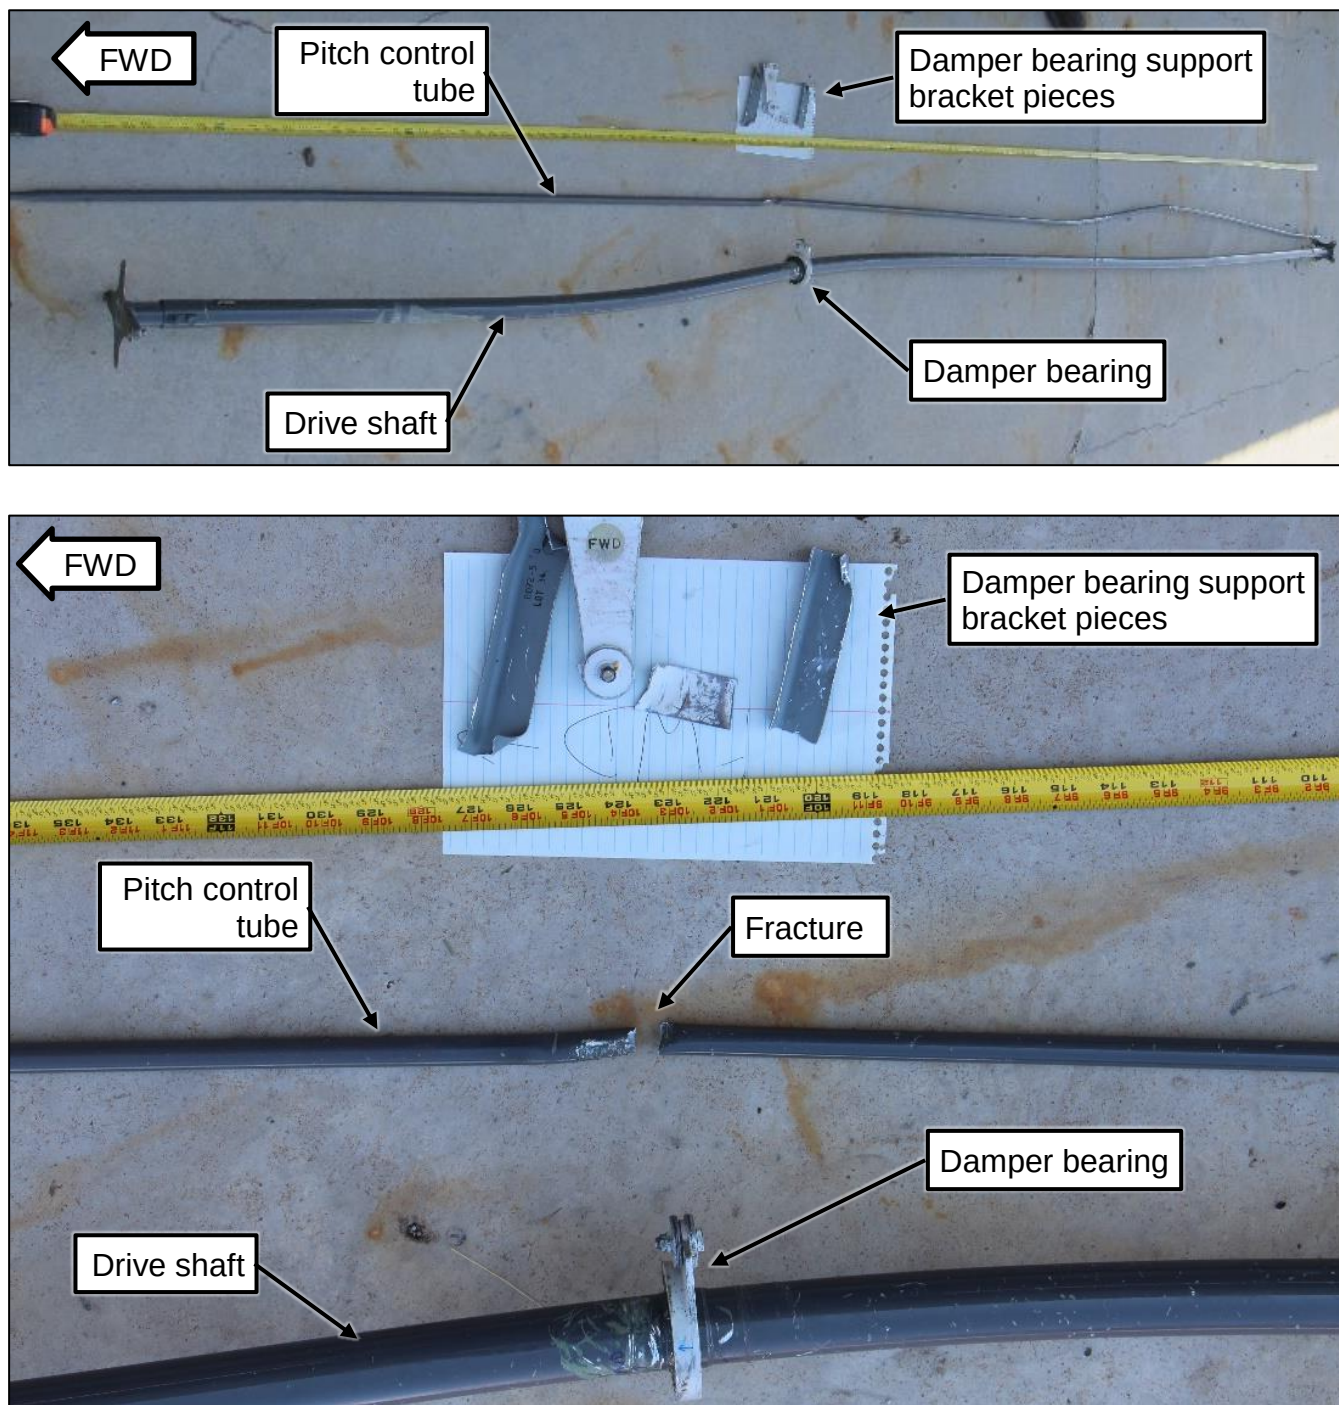
An overall view of the tail rotor drive shaft and pitch control tube after disassembly from the helicopter is shown in figure 5. The pitch control tube is shown placed next to the drive shaft where the longitudinal relative positions corresponded approximately with the tail rotor blade pitch position as found at the start of the teardown (left thrust position). The drive shaft had an "S"-shaped bend mostly near the forward half of the shaft length, and the pitch control tube was bent in two places near the aft end. As shown in the lower image in figure 5, the pitch control tube was fractured at a location corresponding to the position of the damper bearing. The tube forward of the fracture was crushed and had transverse sliding contact marks within approximately 1 inch of the fracture.

Figure 5. Photograph of the drive shaft, pitch change control tube, damper bearing, and damper bearing support bracket pieces after disassembly from the helicopter (upper image) with a closer view of the area associated with the damper bearing (lower image).

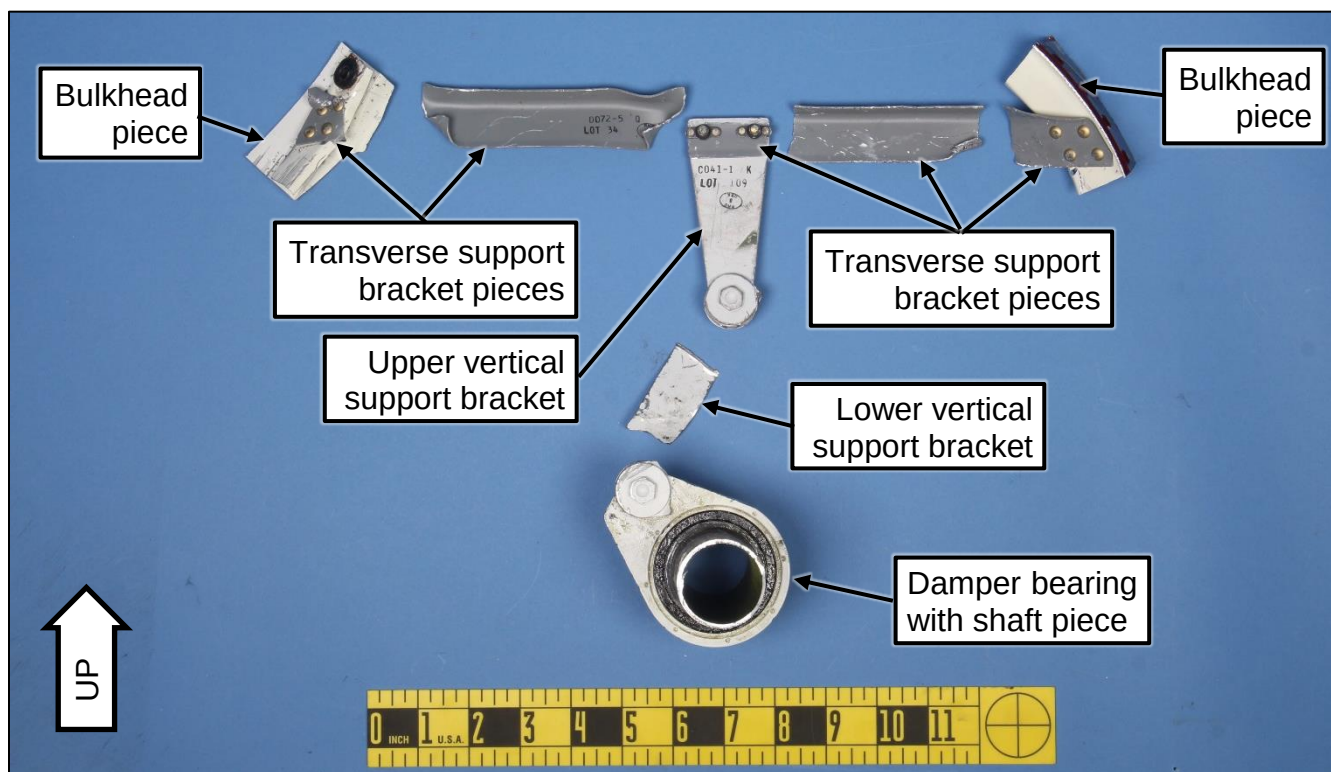
Overall views of components submitted for examination are shown in figures 6 and 7. As assembled, the damper bearing is attached to a lower vertical support bracket that is in turn attached to an upper vertical support bracket. The upper end of the upper vertical support bracket is attached to the center of a transverse support bracket, and the ends of the transverse support bracket are attached to the aft side of the number 3 bulkhead. As shown in figure 6, the transverse support bracket was fractured in several locations, and the lower support bracket was fractured in two locations. A cut section of the tail rotor drive shaft was included as found in the damper bearing, and the drive shaft piece rotated freely within the damper bearing.

As installed, the tail rotor drive shaft is located directly below the upper vertical support bracket as shown in figure 6. However, the end pieces of the lower vertical support bracket that remained attached to the upper vertical support bracket and the damper bearing flange were rotated about each attachment bolt axis. Figure 8 shows relative positions of the components with mating fractures of the separated lower vertical support bracket piece aligned to mating fractures on the rotated end pieces. With mating fracture surfaces aligned in close proximity, the damper bearing and drive shaft were rotated counterclockwise (as viewed looking forward) relative to the lower end of the upper vertical support bracket.

Figure 6. Overall view of the aft sides of the submitted pieces of the number 3 bulkhead, damper bearing support bracket, damper bearing, and drive shaft piece. The pieces are displayed in their approximate relative positions as installed on the helicopter, where the drive shaft is aligned directly below the upper vertical support bracket.

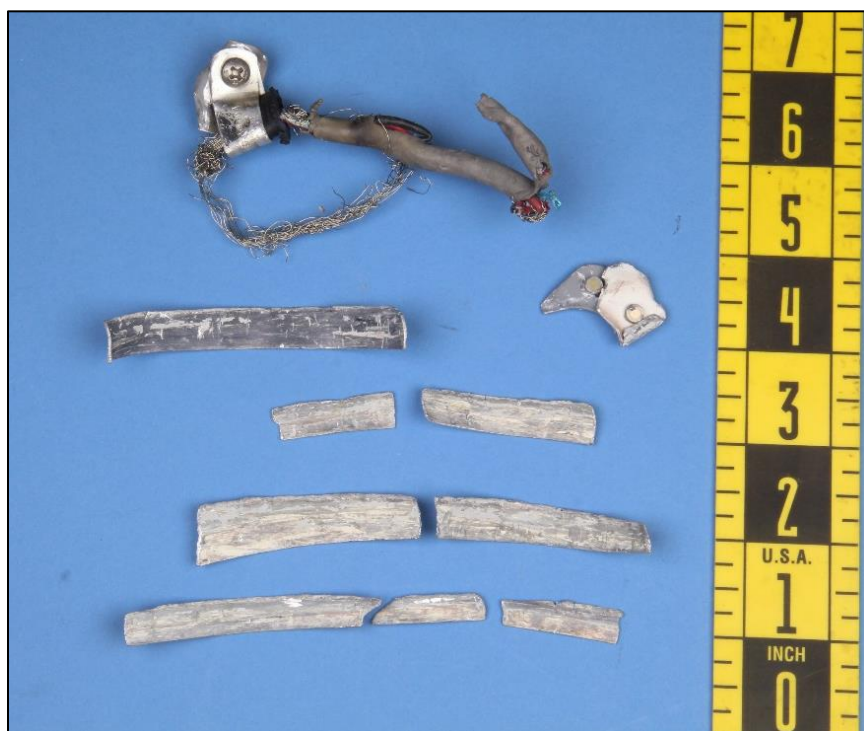
Pieces from the numbers 6 and 7 bulkheads shown in figure 7 had sliding contact damage consistent with contact with the drive shaft. A piece of the bulkhead remained attached to the Adel clamp, and the black bushing material within the clamp was displaced relative to its normal installed position. The insulated wire was fractured and damaged with exposed conductors. Pieces of wire of similar construction were photographed wrapped around the drive shaft during the teardown (see figure 3, lower image).

Figure 7. Submitted bulkhead pieces, Adel clamp, and insulated wire from the numbers 6 and 7 bulkhead area.

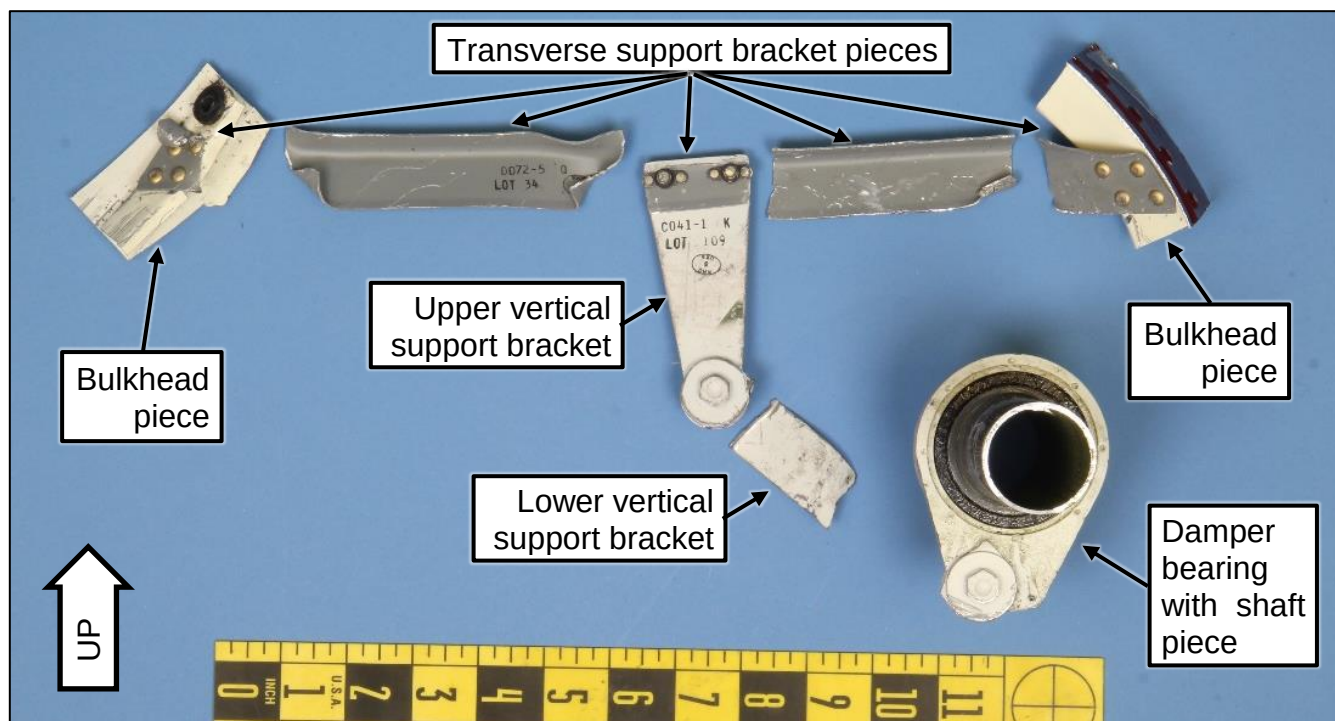
Figure 8. Submitted pieces shown in figure 6 displayed with mating fractures of the lower vertical support bracket pieces aligned in close proximity. As shown, the drive shaft and damper bearing were rotated counterclockwise relative to their normal installed position.

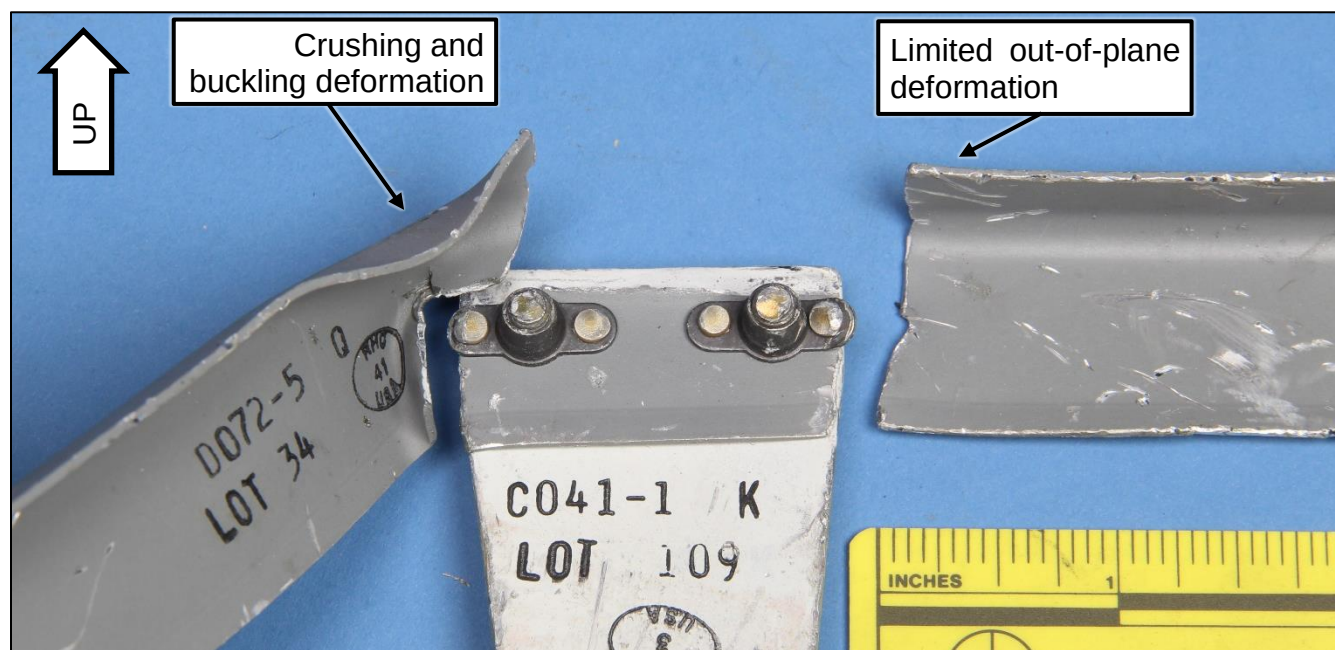
A closer view of the fractures adjacent to the upper end of the upper vertical support bracket are shown in figure 9. To the right of the vertical support bracket, the fracture through the transverse support bracket had little out-of-plane deformation consistent with a primary fracture under a primarily tension load. The fracture surface was partly damaged by post-fracture contact damage. However, observable fracture features were on slant planes with matte gray fracture features, features consistent with ductile overstress fracture. To the left of the vertical support bracket, the upper flange of the transverse bracket was bent with an "S" shape and the vertical flange was bent matching edges of the vertical bracket, consistent with a secondary fracture under a compression and bending load.

Figure 9. Closer view of mating fractures in the transverse support on either side of the upper vertical support bracket showing little out-of-plane deformation at the right side of the vertical support bracket consistent with a tension fracture and crushing and buckling deformation at the left side consistent with compression.

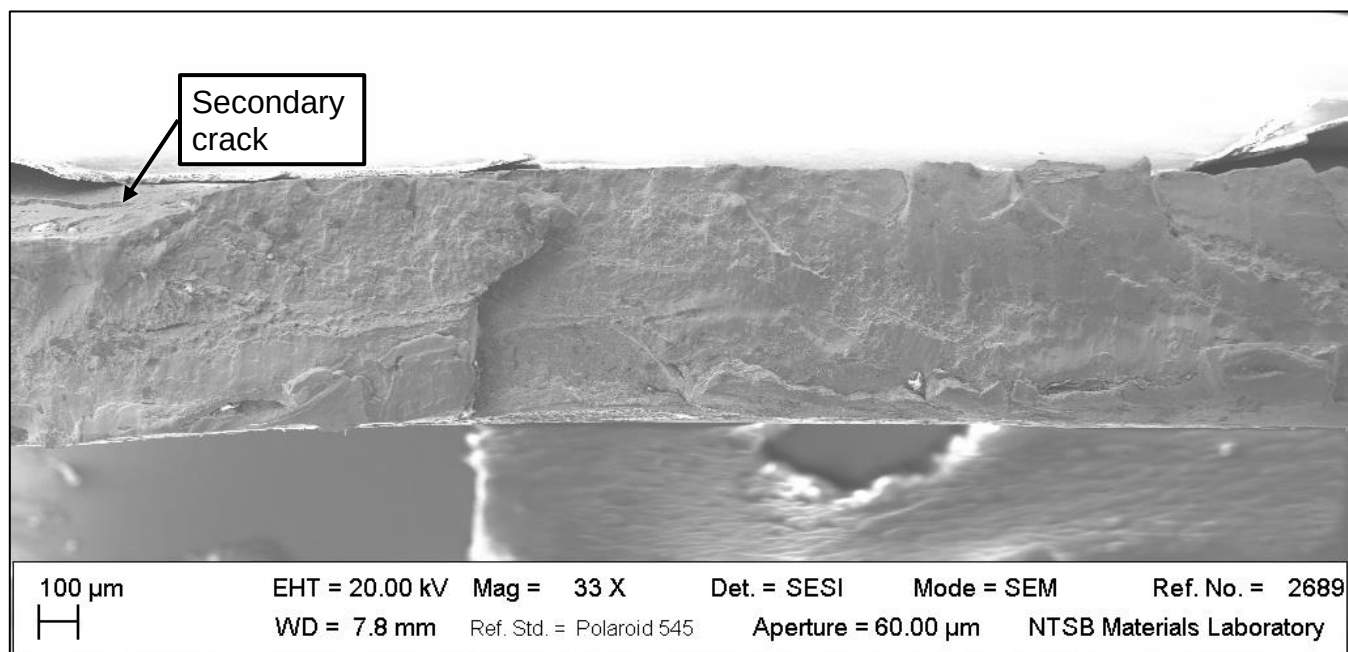
The fracture surfaces on the separated piece of the lower vertical support bracket were further examined using a scanning electron microscope (SEM). An SEM image of one of the relatively flat areas on the fracture surface is shown in figure 10. At each end of the piece, fracture surfaces showed multiple areas with curving boundaries emanating from multiple origins at both the forward and aft sides of the bracket piece. Closer views of two of the flat regions at the forward and aft sides of the fracture at the lower end of the piece are shown in figure 11. Curving lines within the flat regions were consistent with progressive crack growth. However, the flat regions had relatively widely spaced crack propagation marks consistent with a relatively high stress concentration associated with fracture. Deformation was also observed adjacent to the flat regions, including secondary crack features such as those indicated in figures 10 and 12. The deformation

and crack progression marks were consistent with overstress fracture under cyclic load conditions. No evidence of fatigue crack growth was observed.<sup>1</sup>

Figure 10. SEM image of fracture features at the lower end of the lower vertical support bracket.

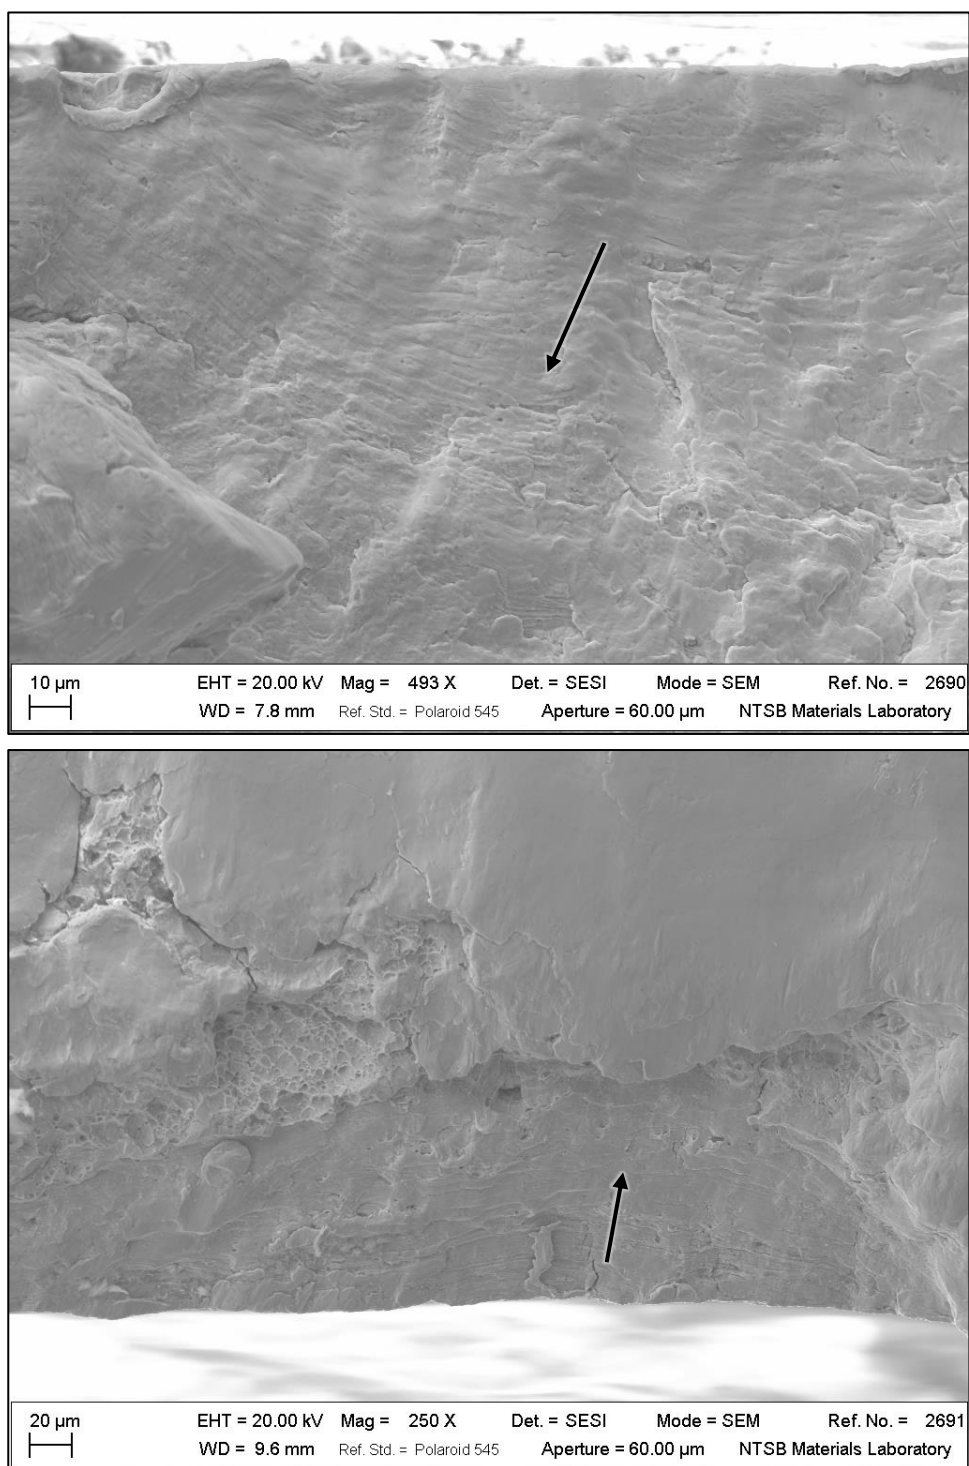
Figure 11. Closer SEM view of fracture features on the lower end of the lower vertical support bracket. Arrows indicate the propagation direction of cyclic overstress crack growth.

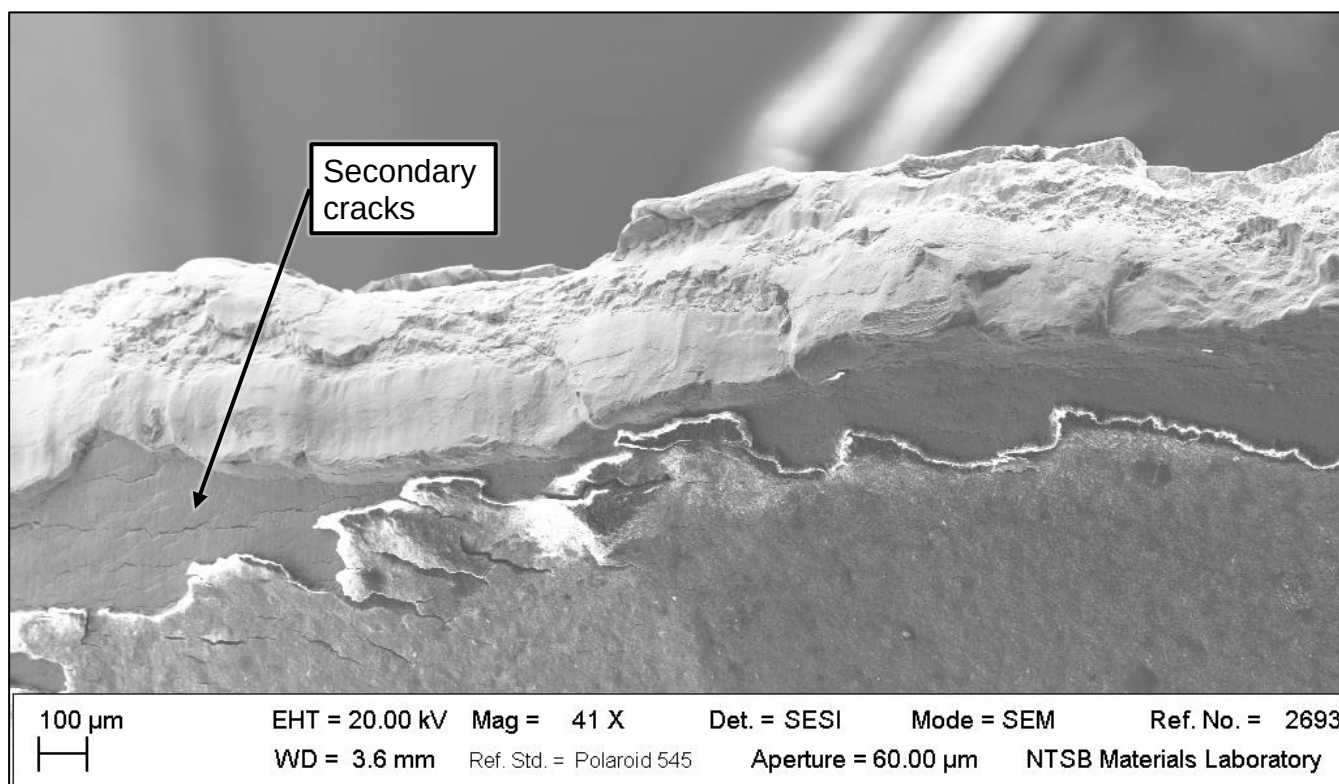
Figure 12. Secondary cracks adjacent to the fracture surface consistent with cyclic overstress fracture.
