**NATIONAL TRANSPORTATION SAFETY BOARD**

**HELICOPTER EXAMINATION**

**WPR17LA143**

## **Robinson R-44; N442DR**

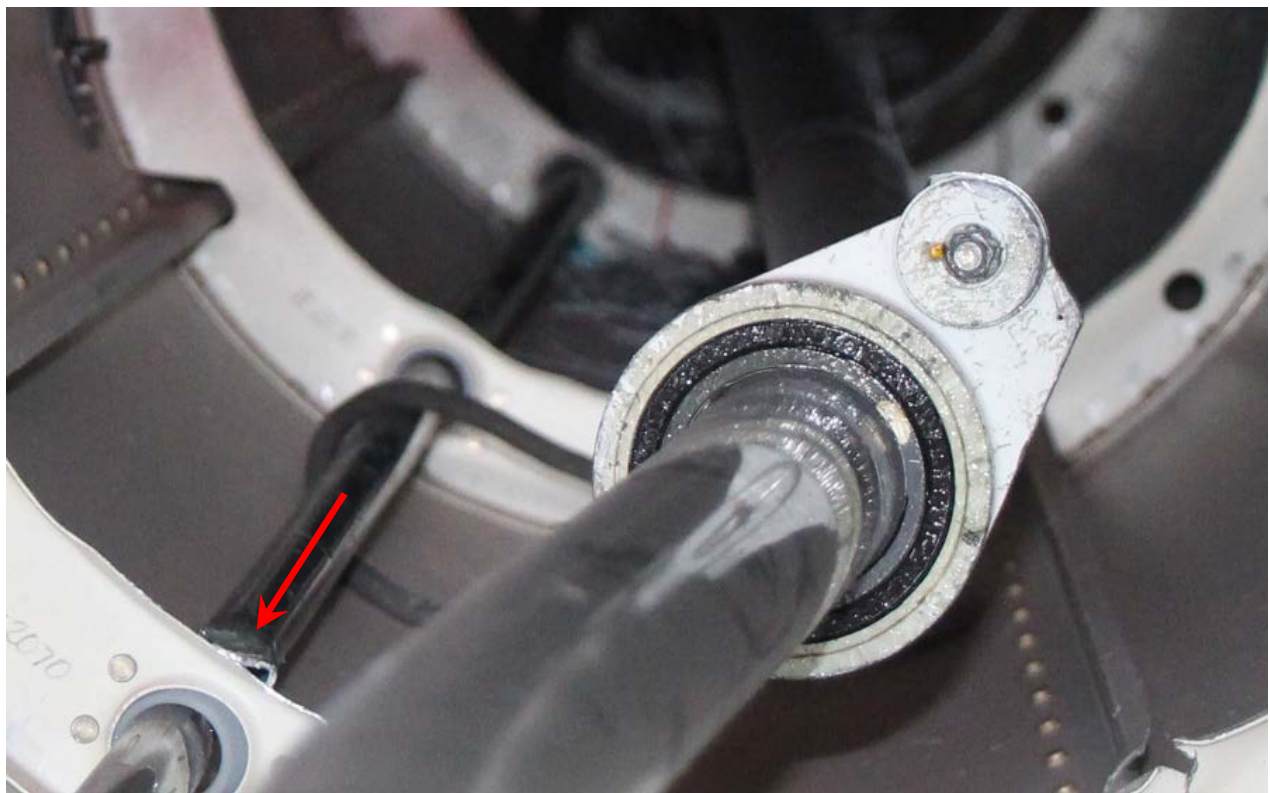
Bays no. 1 and 2 were impact damaged and bay nos. 4, 5, and 6 displayed multiple dents and protrusions from within the inside diameter of the tailcone. Multiple dents were observed on the lower left side of the tailcone accompanied by a white paint transfer mark consistent with tail rotor blade contact. The damper bearing hangar bracket separated into pieces (Figure 1), which

Figure 1 – Damper Bearing Secured to Bent Drive Shaft Without Hangar Bracket (red arrow shows severed -17 push/pull tube)

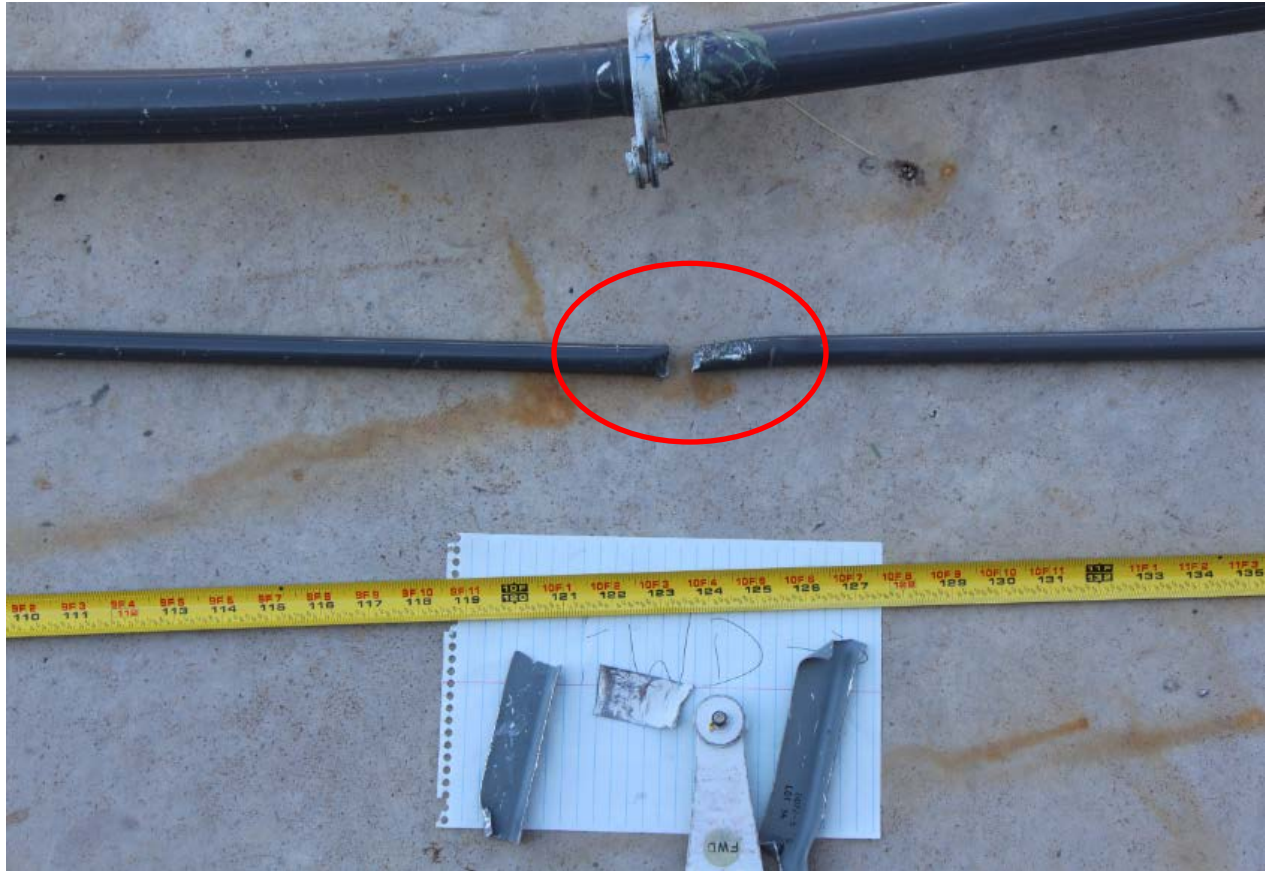
allowed the bearing to rotate inside the tail cone and fracture the -17 push/pull tube (Figure 2) and damage the inside diameter of the tail cone (Figure 3). Rotational scoring was observed throughout the inside diameter of the tailcone cavity. The no. 3 bulkhead was damaged and the 6, 7 bulkhead were both fragmented and deformed (Figures 4 and 5). The tailcone strobe light had separated from its housing.

Figure 2 – Separated -17 Push/Pull Tube (noted by red circle), Damper Bearing, and Hangar Bracket Pieces

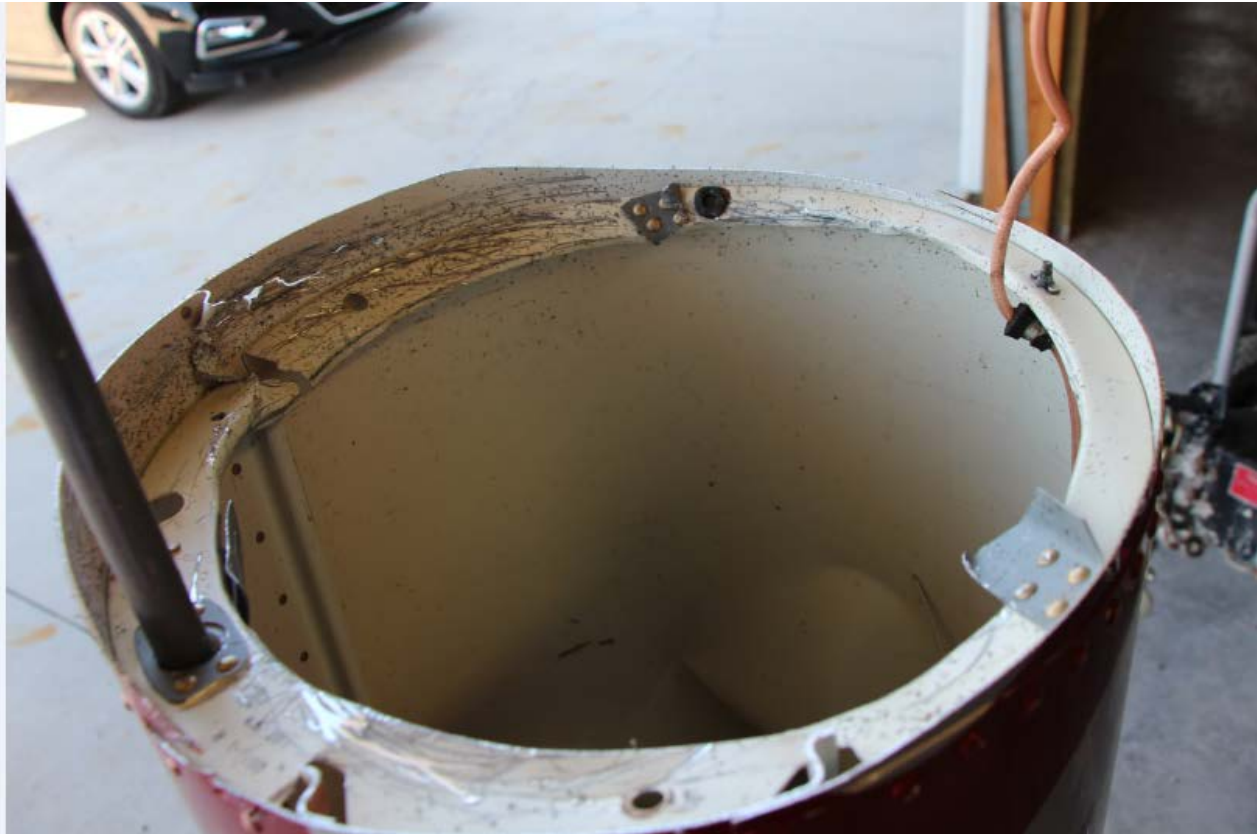
Figure 3 – Inside Diameter of Tailcone, No. 3 Bulkhead

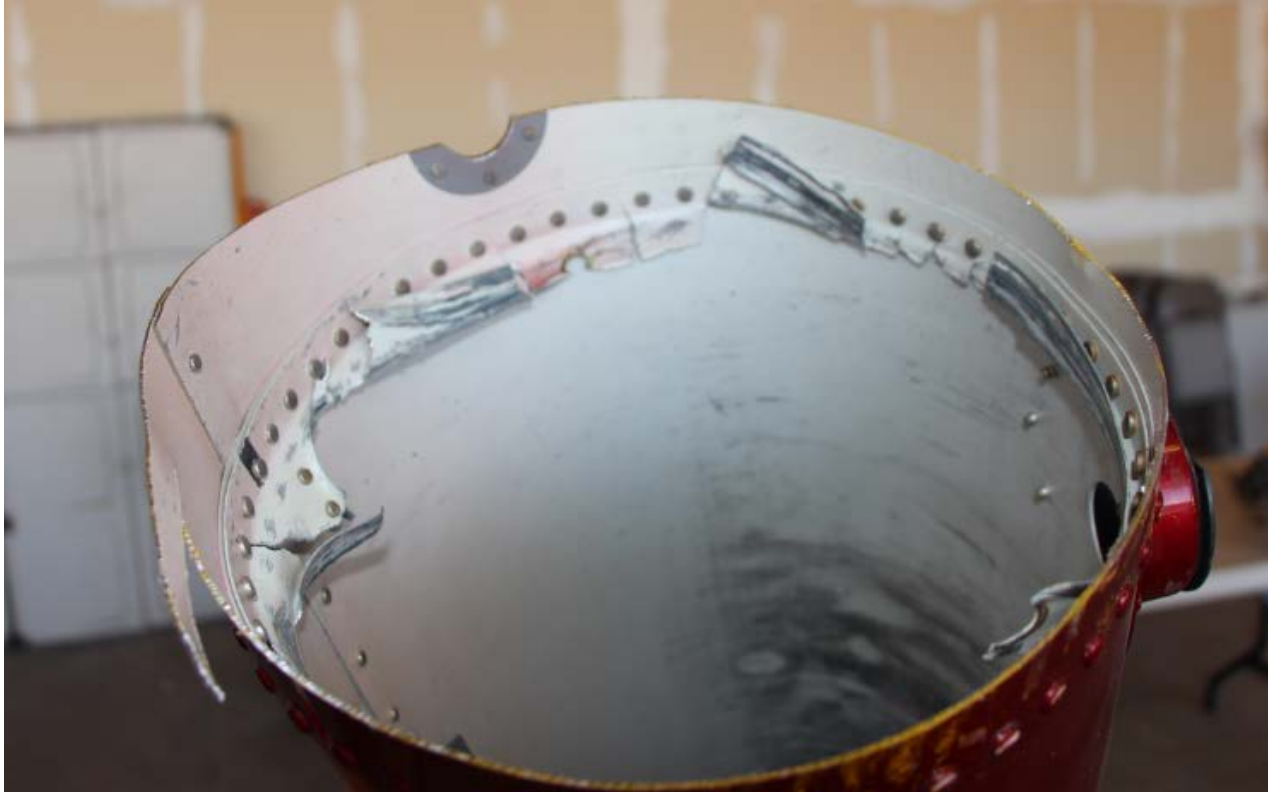
Figure 4 – Inside Diameter of Tailcone, No. 6 Bulkhead

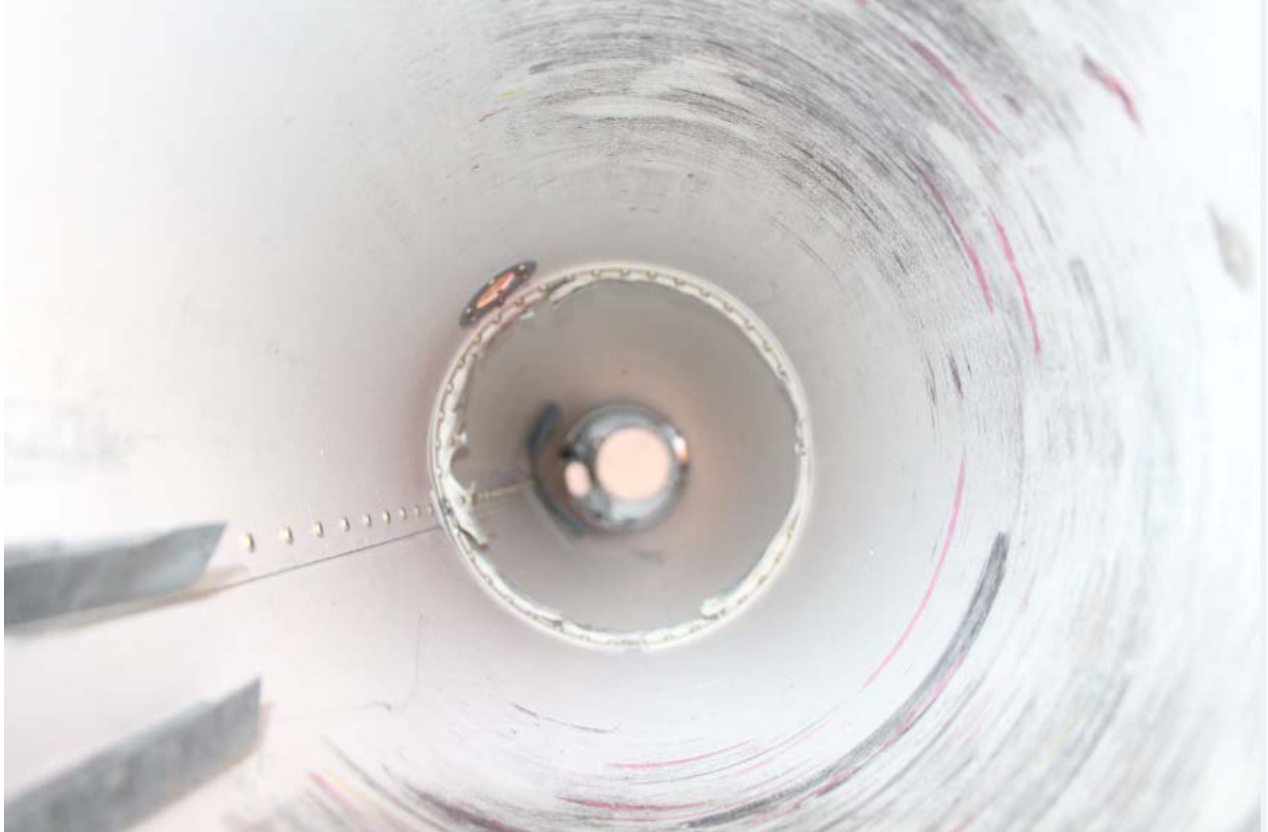
Figure 5 – Inside Diameter of Tailcone, No. 7 Bulkhead

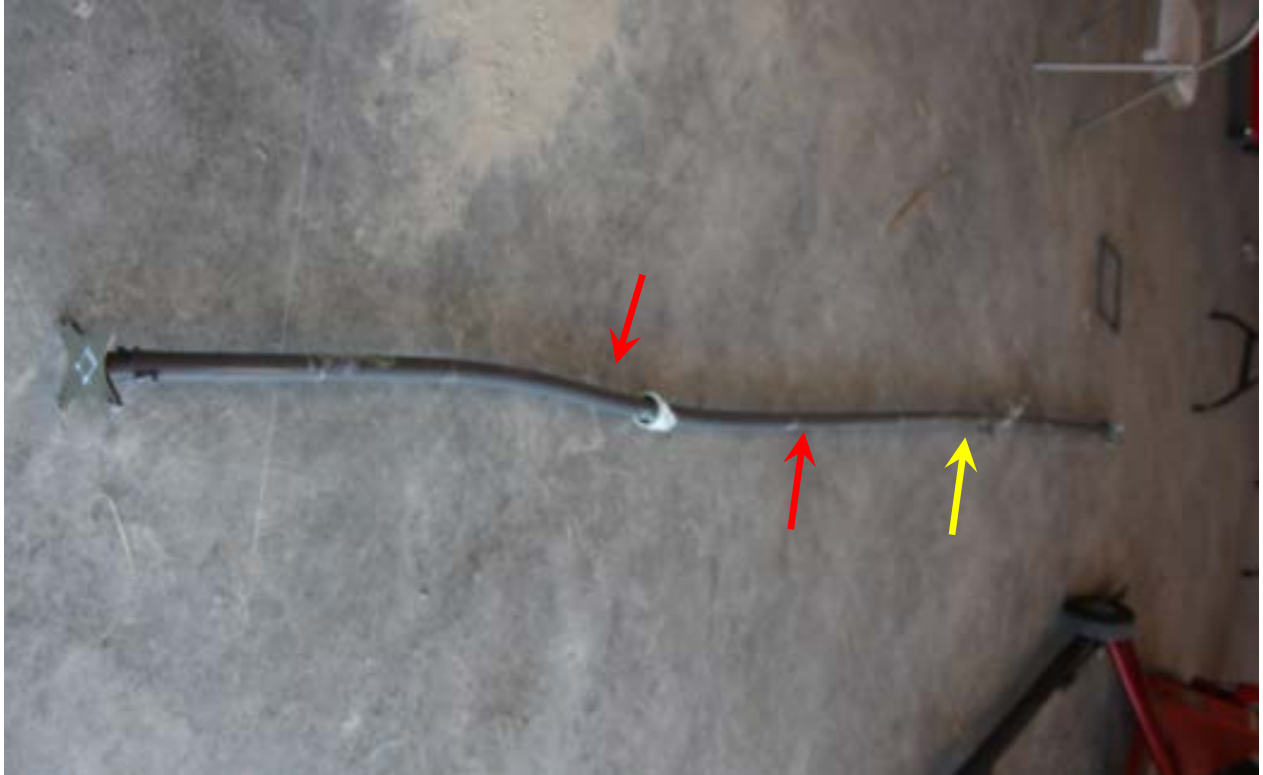
The drive shaft exhibited two notable bends in the forward section and one bow in the aft section (Figure 6). The forward flex plate displayed rub marks adjacent to the yokes. Both the forward and aft flex couplings were straight. The damper bearing support was fractured (Figure 7) and the bearing had shifted about 1/10 in. The damper bearing rotated freely. Gouge marks were observed throughout the drive shaft and strobe light wires were found wrapped around the aft section of the shaft near the no. 6, 7 bulkhead accompanied by a dent in the shaft. The strobe light adel clamp had separated from the bulkhead and the strobe wire was wrapped around the circumference of the drive shaft (Figure 8).

Figure 6 – Bends in Tail Rotor Drive Shaft (indicated by red arrows) and Bow (indicated by yellow arrow)

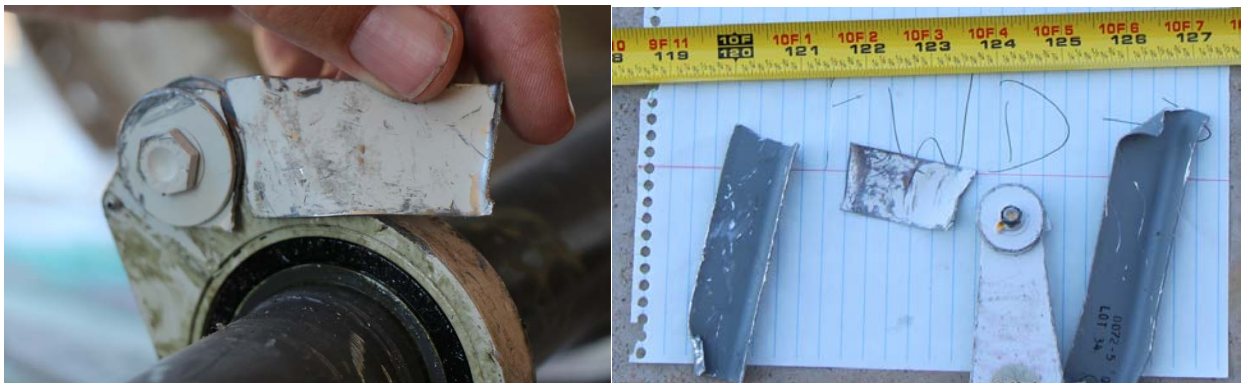
Figure 7 – Broken Hangar Bearing Support Bracket

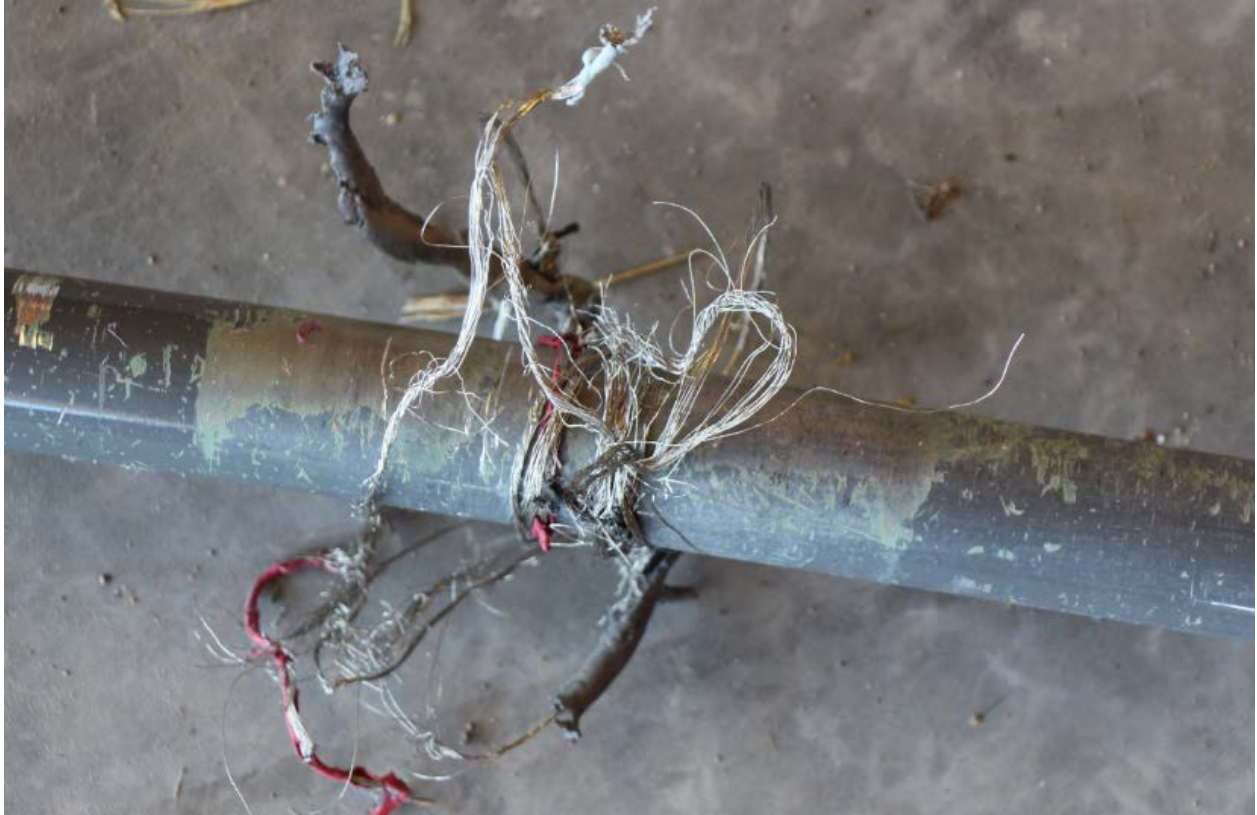
Figure 8 – Strobe Wire Wrapped Around Circumference of Drive Shaft
