# NATIONAL TRANSPORTATION SAFETY BOARD

## MATERIALS LABORATORY FACTUAL REPORT

Report No. 18-014

Place : Page, AZ  
Date : July 12, 2017  
Vehicle : Cessna U206F, N71001  
NTSB No. : WPR17LA144  
Investigator : Samantha Link (AS-WPR)

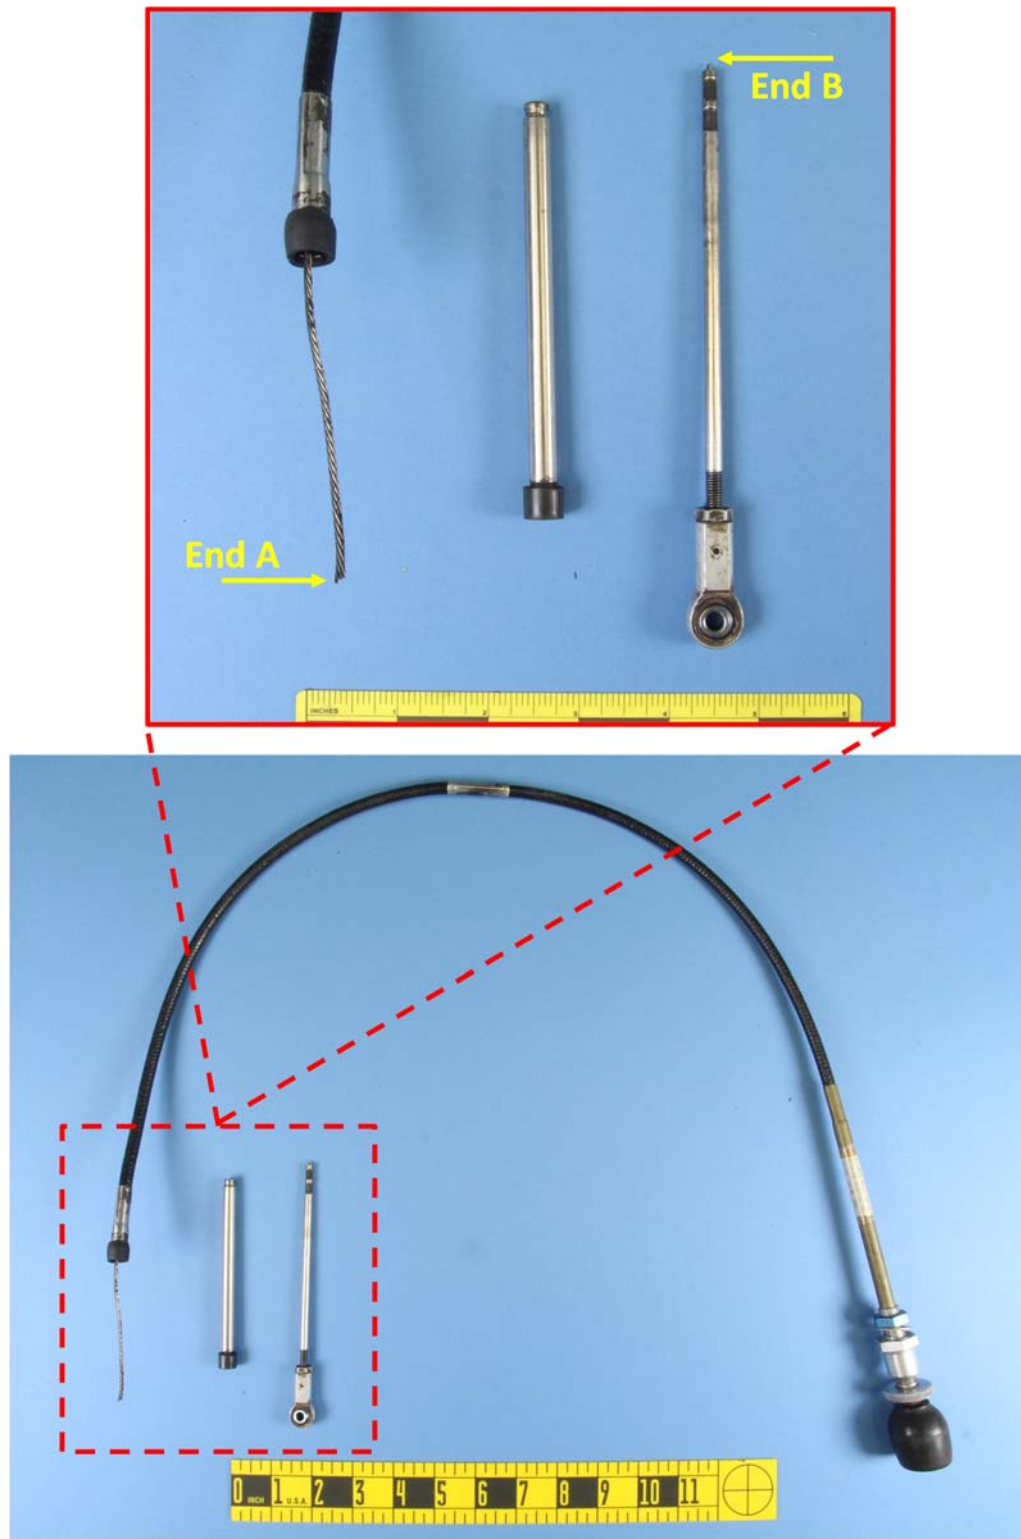
The throttle control cable was submitted with the wire strands separated, as shown in Figure 1. The two cable halves were labeled End A and End B, with End A associated with the longer length of cable and End B associated with the cable inside the rod end piece. The separation of the strands was in-line with one end of the rod end piece. Figure 2 shows the location of the separation.

Figure 1: Overall (bottom) and close-up (top) photos of the separated throttle control cable. The two ends were labeled End A and End B, as shown.

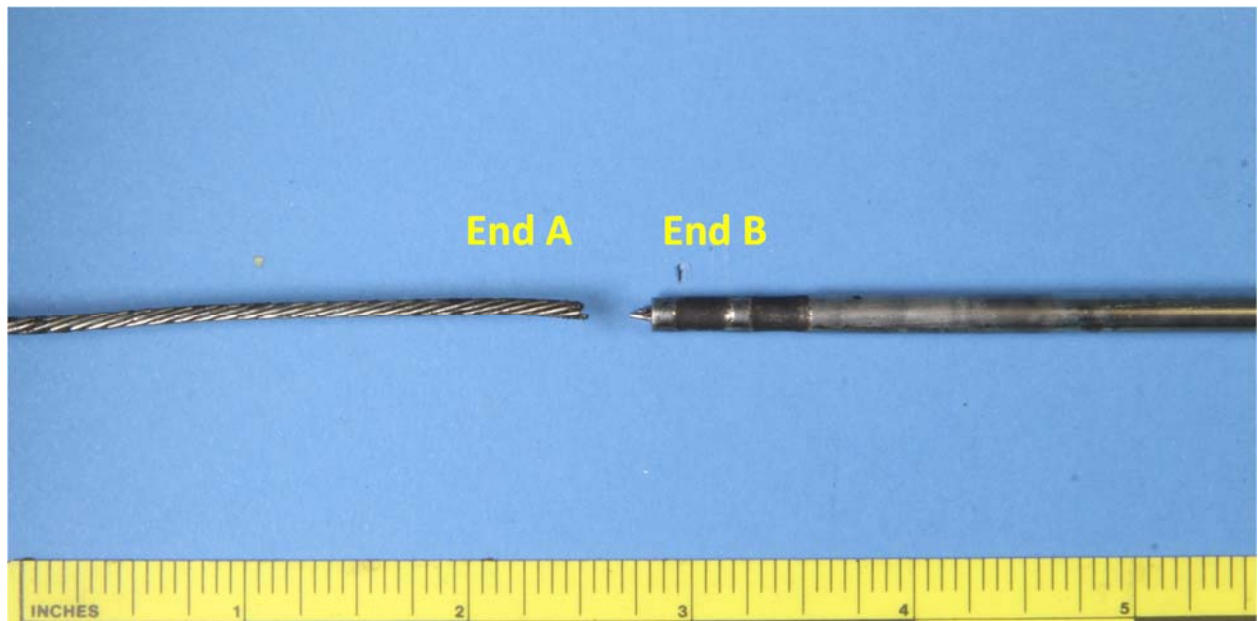
Figure 2: Close-up photo showing the location of the throttle control cable separation was in-line with one end of the rod end piece.

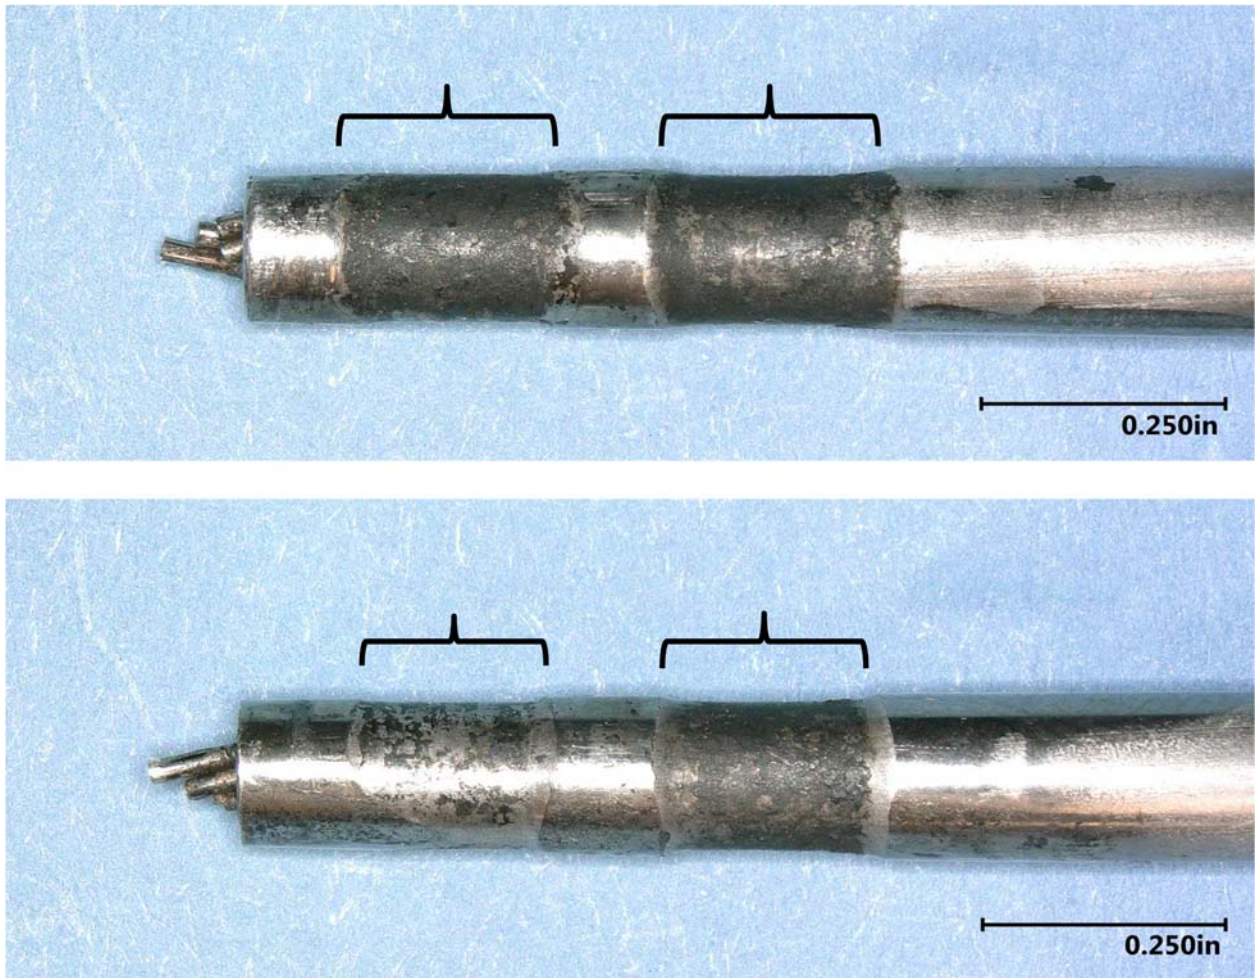
Digital microscope images of diametrically opposite sides of the rod end piece are shown in Figure 3. The end opposite the rod end is shown, which was internal to the cable assembly. Two circumferential bands of wear were visible on the end, as indicated by the black brackets. The bands were heavier on one side of the piece, and the band closest to the end had less damage compared to the other band. Corresponding wear was observed on the inner surface of the mating guide piece.

Figure 3: Digital microscope images of two circumferential bands of wear (black brackets) on the rod end piece. The views shown are diametrically opposite each other.

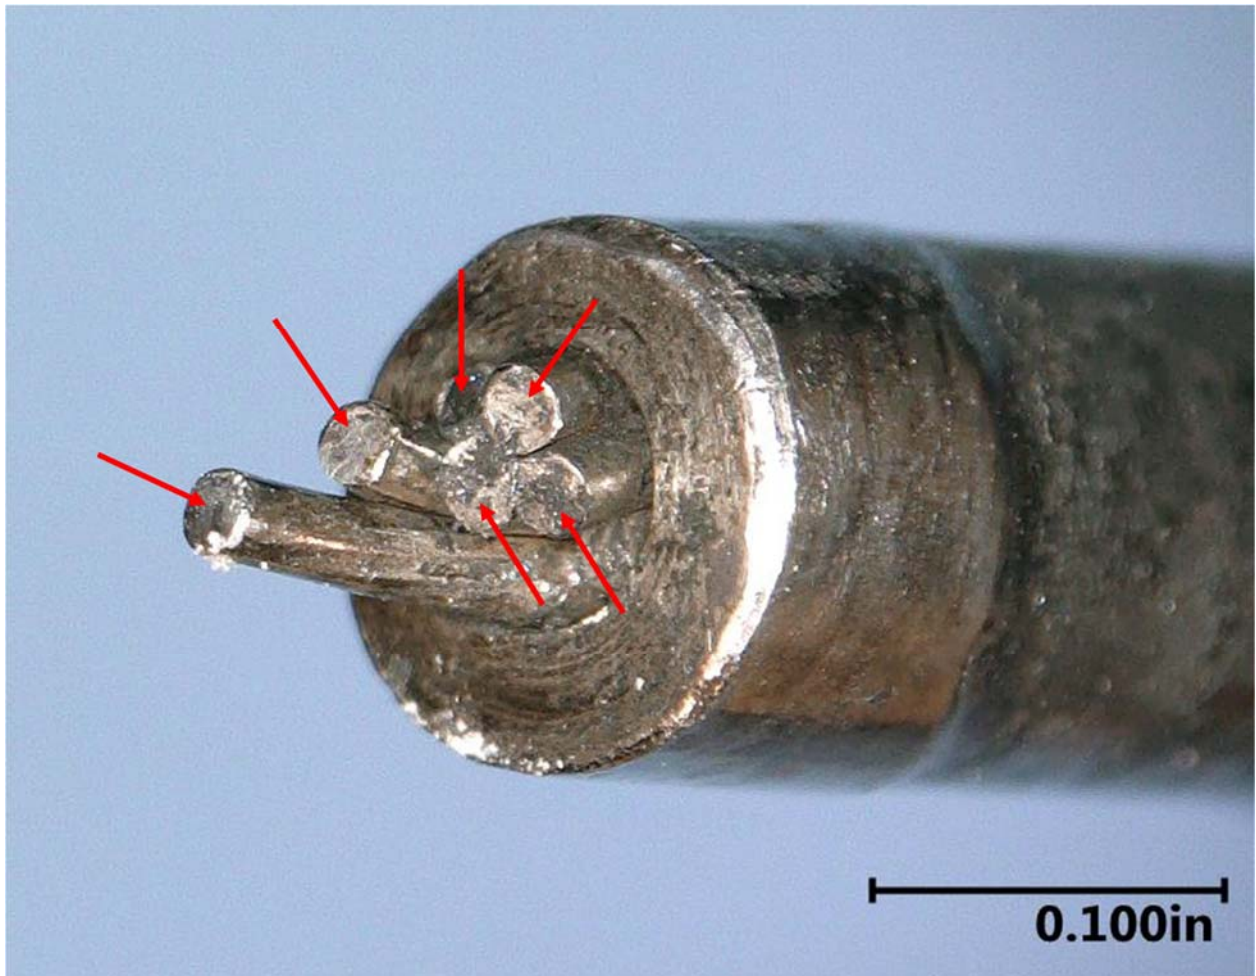
The wire strands of End B are shown in Figure 4, while the wire strands of End A are shown in Figure 5. The fracture surfaces were flat and perpendicular to the axes of the strands. No necking or thinning of the individual strands consistent with overstress separation was observed.

Figure 4: Digital microscope image of the separated wires (red arrows) on End B as viewed at an angle.

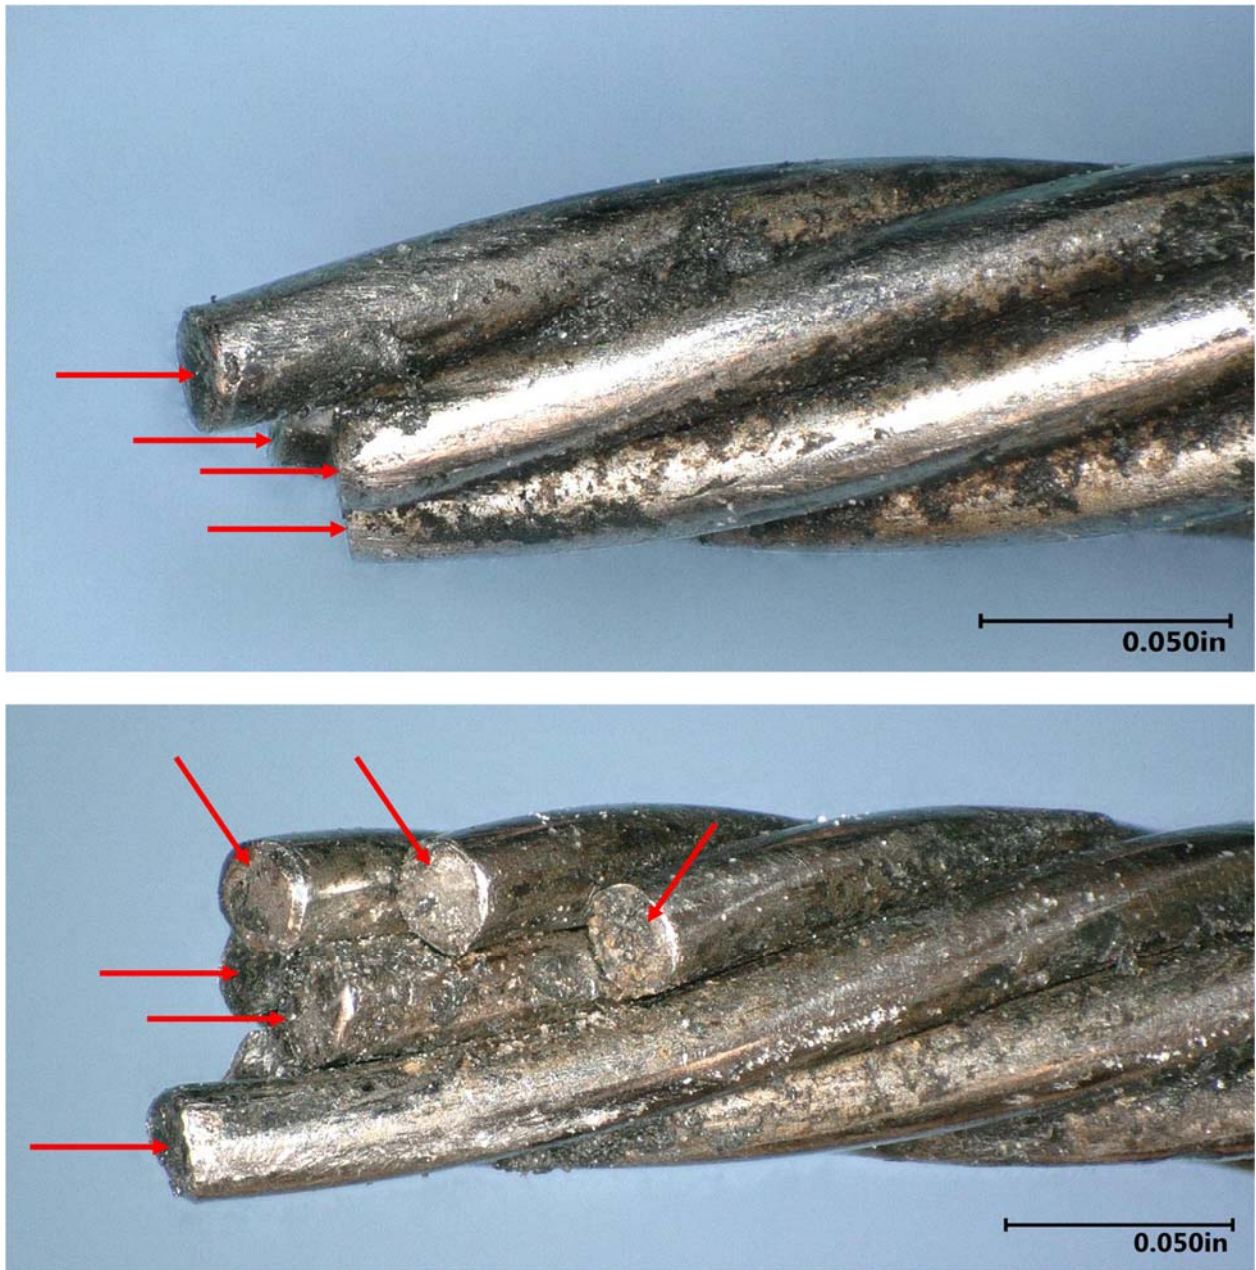
The flat fracture surfaces on the wires and their perpendicular orientation to the wire axes, along with the lack of necking or other deformation, is consistent with a progressive fracture mechanism such as fatigue. Consequently, the throttle control cable likely failed due to fatigue.

Figure 5: Digital microscope images of the separated wires (red arrows) on End A as viewed perpendicular (top) and at an angle (bottom).

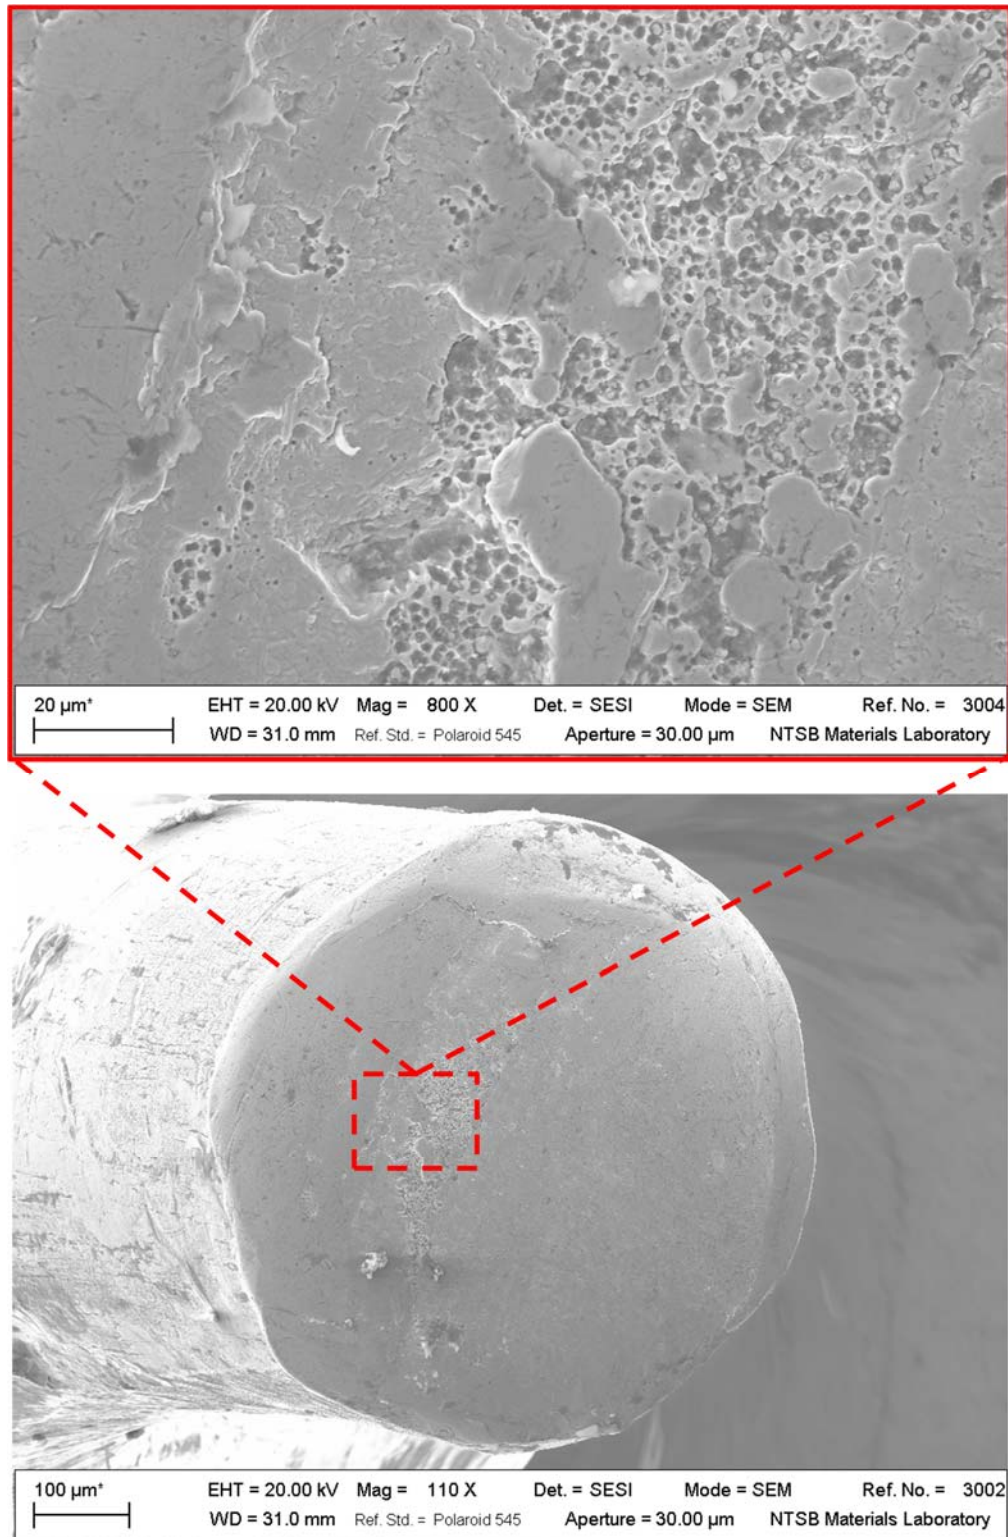
Several wires were sectioned from End A and examined using a Zeiss Auriga 40 field emission (FE) scanning electron microscope (SEM). Figure 6 shows the fracture surface on one exemplar wire. Post separation impact damage obscured the fracture surface features on the wires. Some mushrooming of the fracture surface edges consistent with hammering of the ends was observed, likely resulting from contact of the mating fracture surfaces after separation. A few areas of pitting consistent with corrosion were observed on top of the smearing damage on the fracture surfaces.

Figure 6: SEM images of an exemplar separated wire sectioned from End A.
