## **RECORD OF CONVERSATION**

**Date: July 7, 2017**  
**Person Contacted: Daniel Teske (Federal Aviation Administration Inspector)**  
**NTSB Accident Number: WPR17LA144**

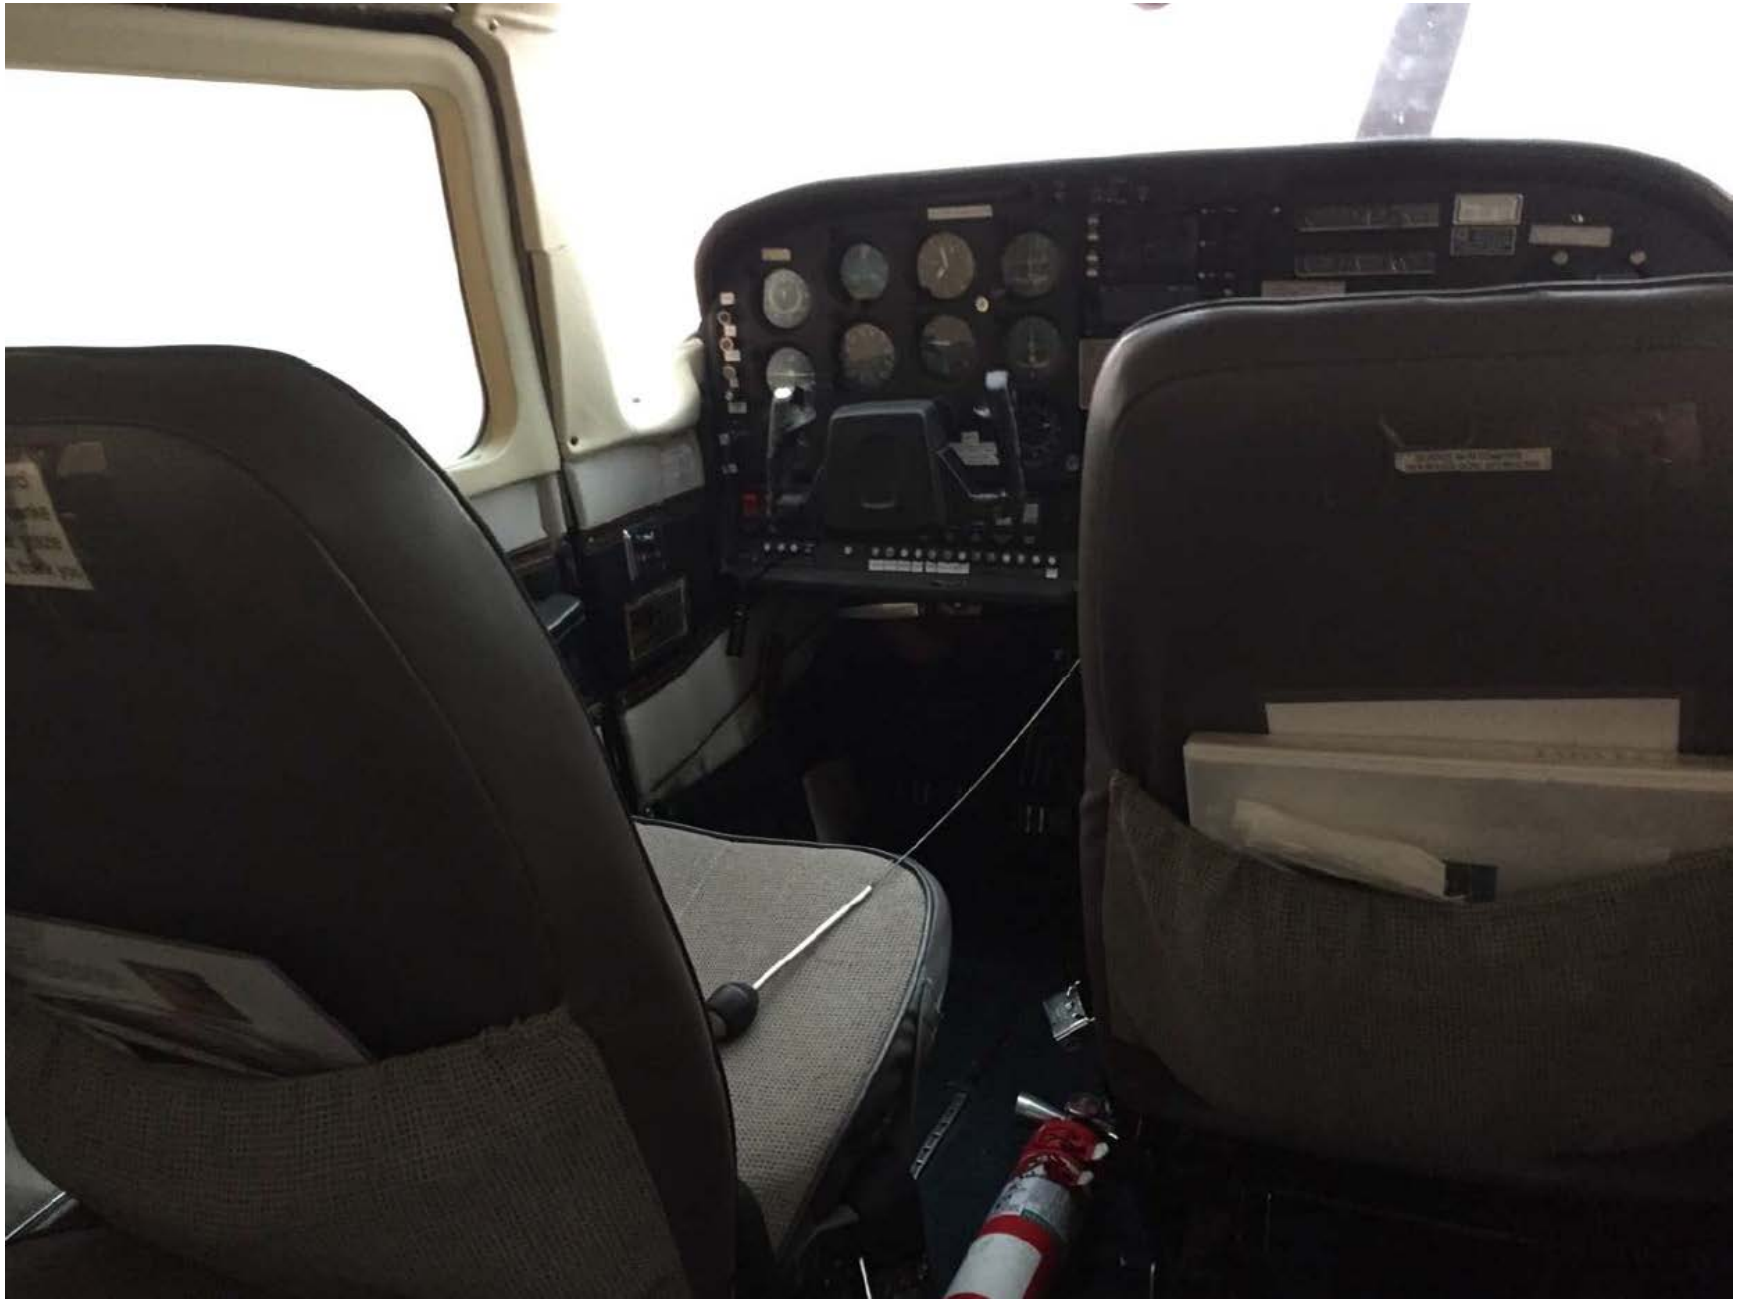
*Figure 1: Throttle Control and Cable within Cockpit*

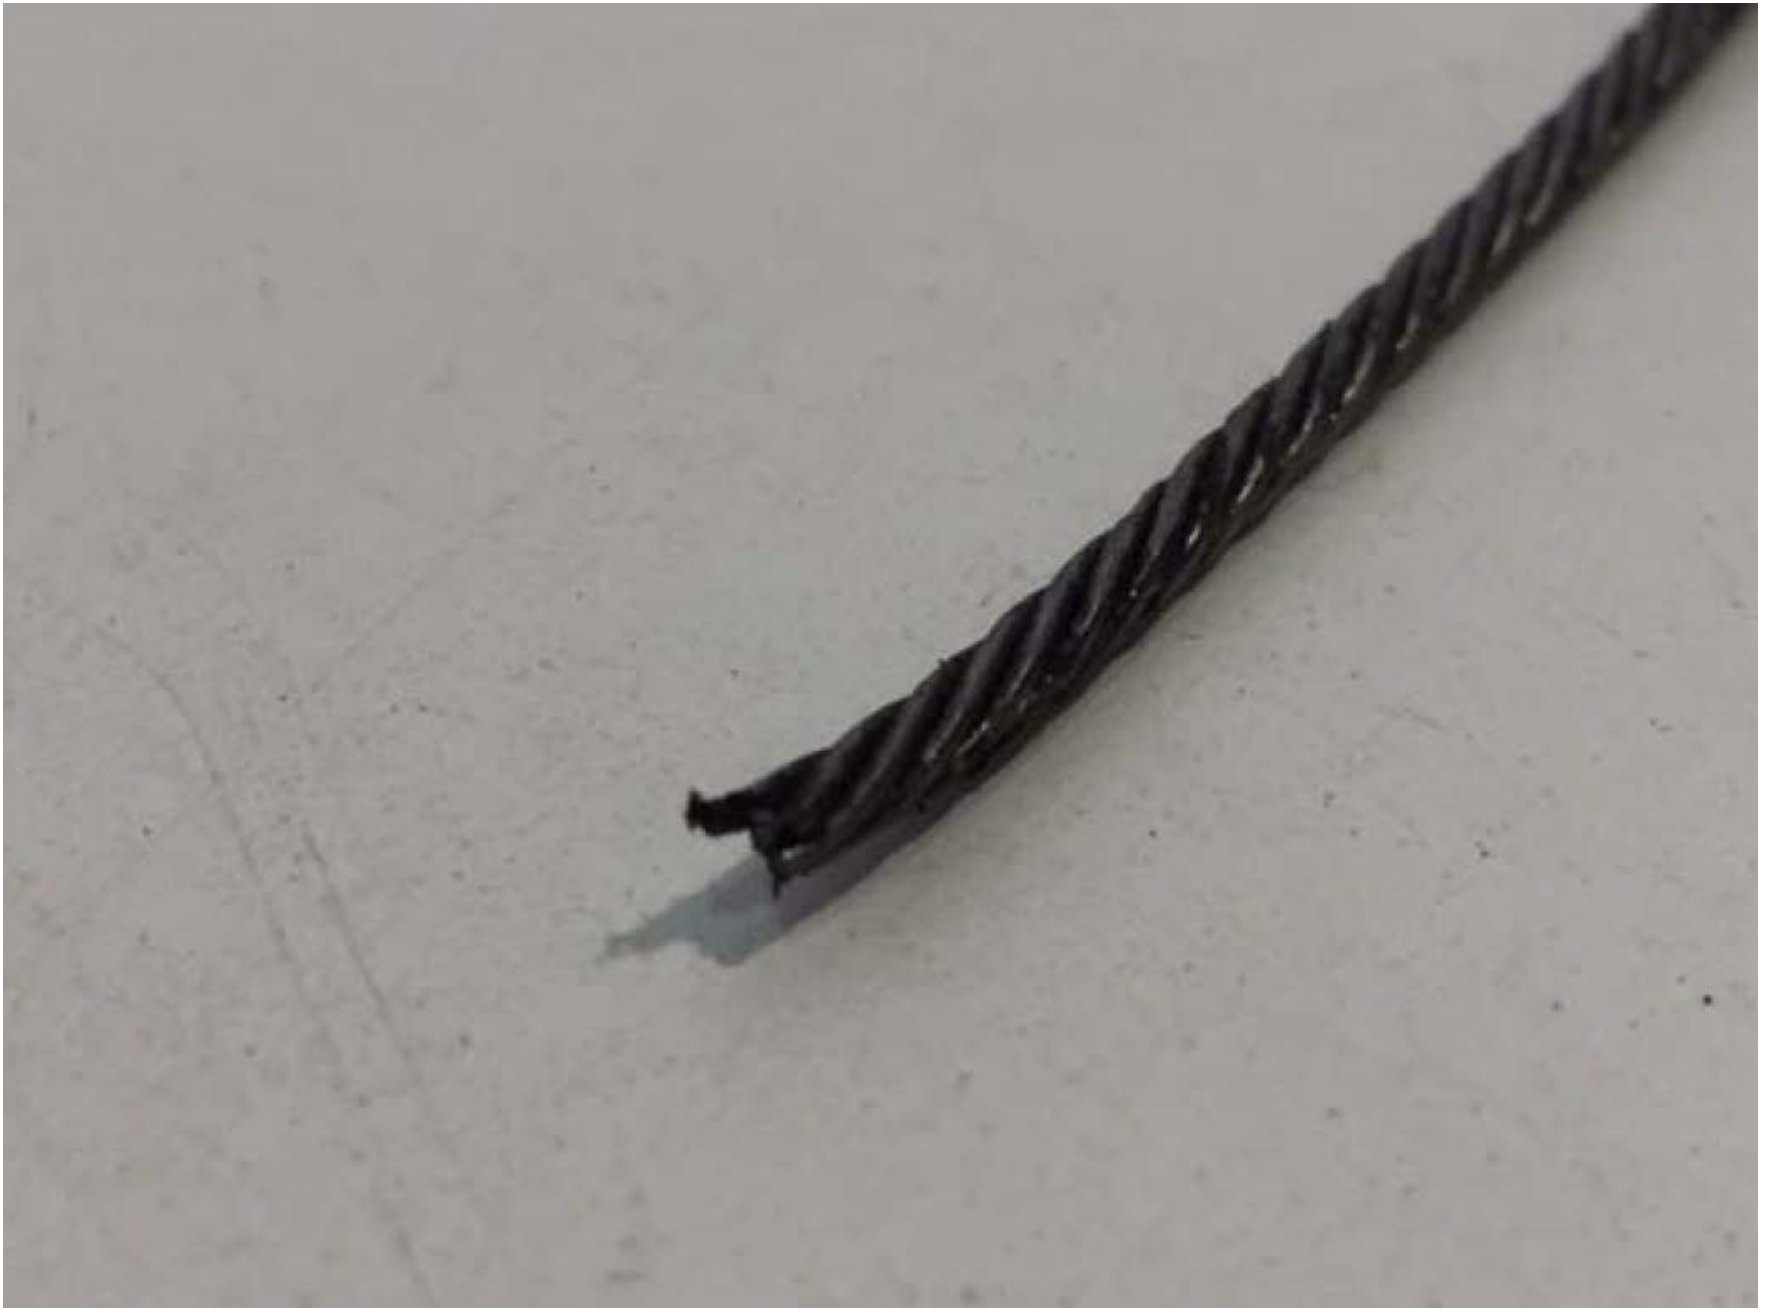
During a telephone conversation with Mr. Teske, he reported that the throttle cable broke inside the connector to the throttle body control arm. It appeared the break occurred slightly inside of the connector which made it difficult to see any weaknesses or damage to the cable.

The throttle cable was last installed onto the airplane in 1996, logbooks did not show that it has been replaced more recently.

*Figure 2: Throttle Cable Fracture*

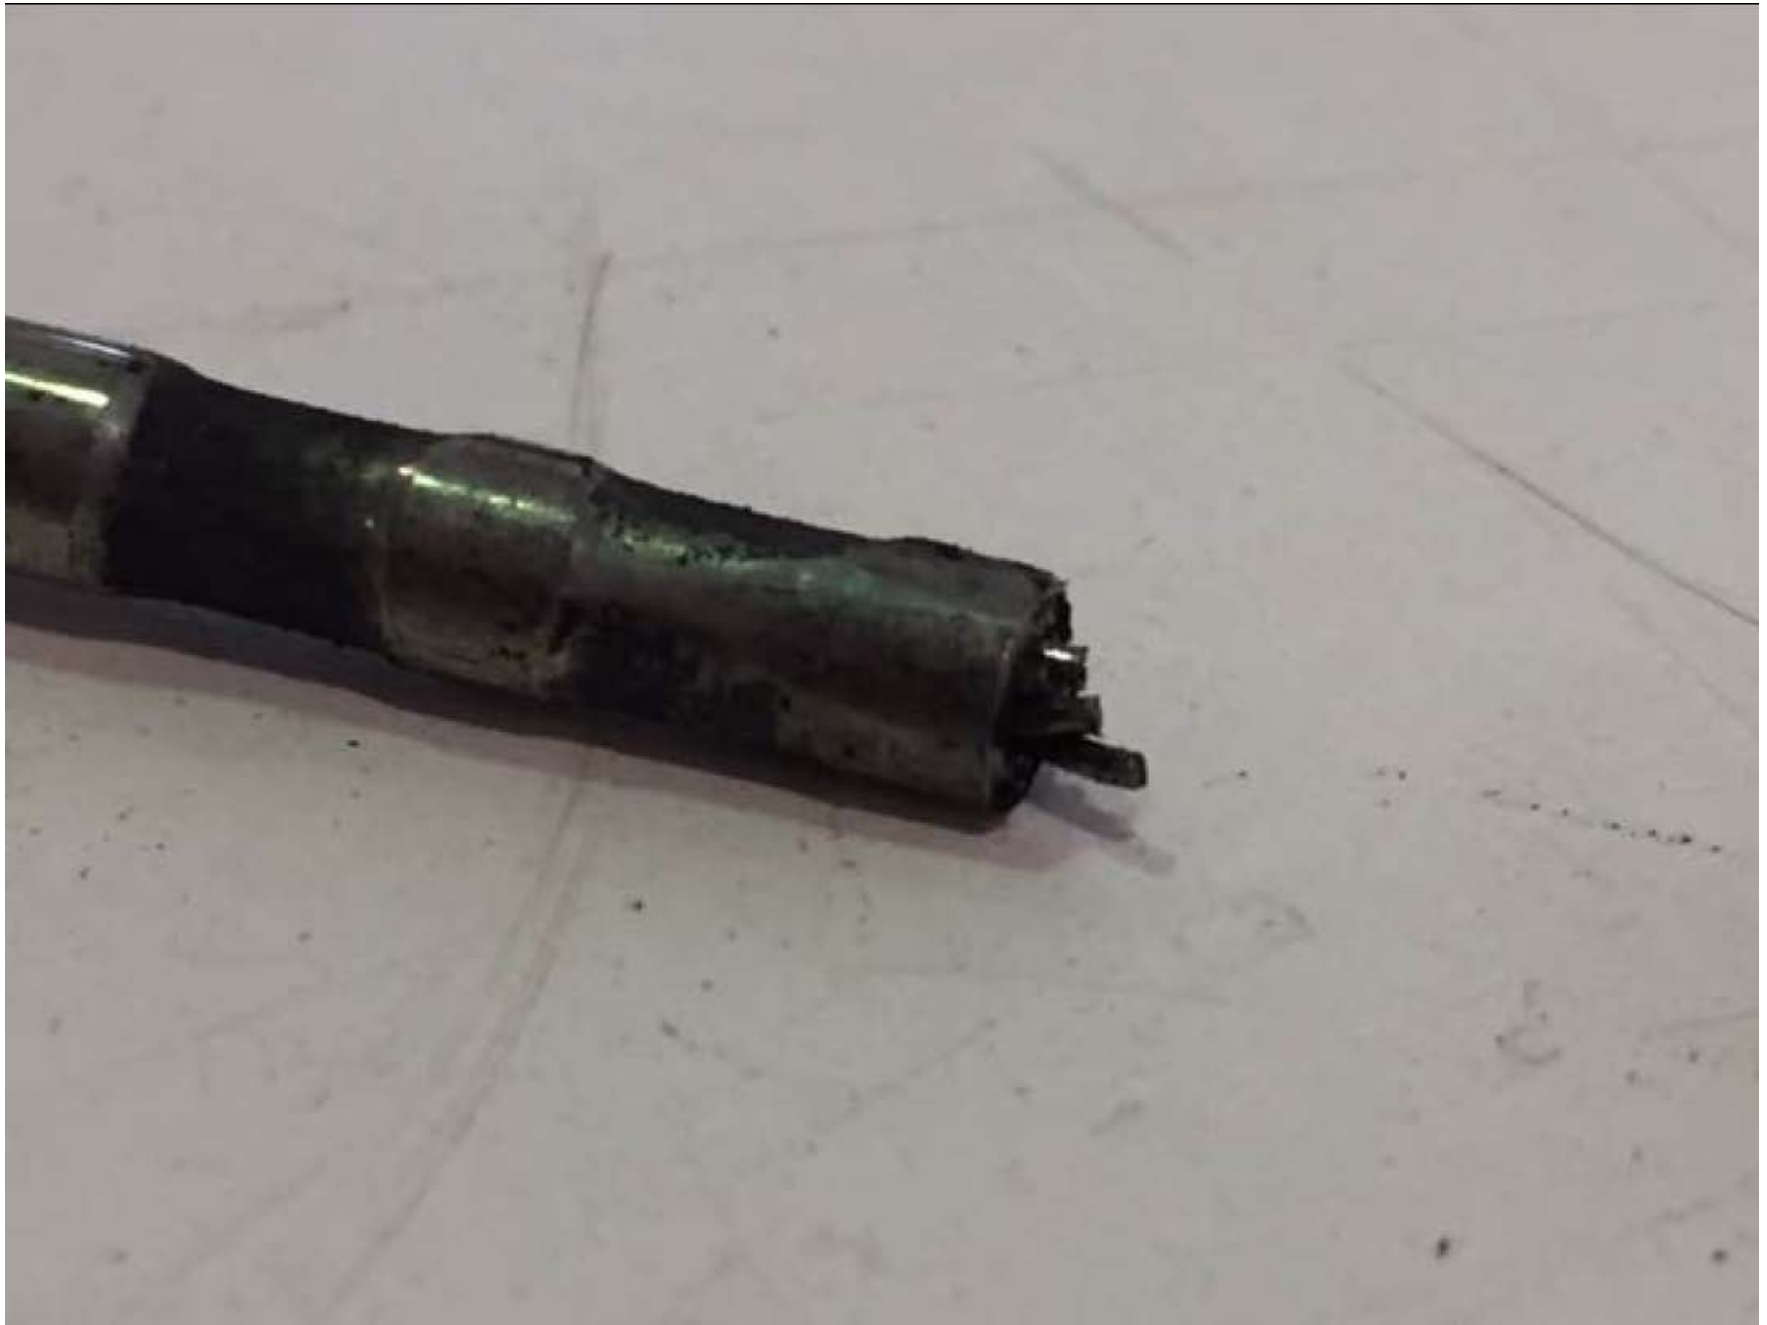
*Figure 3: Throttle Control Rod End*

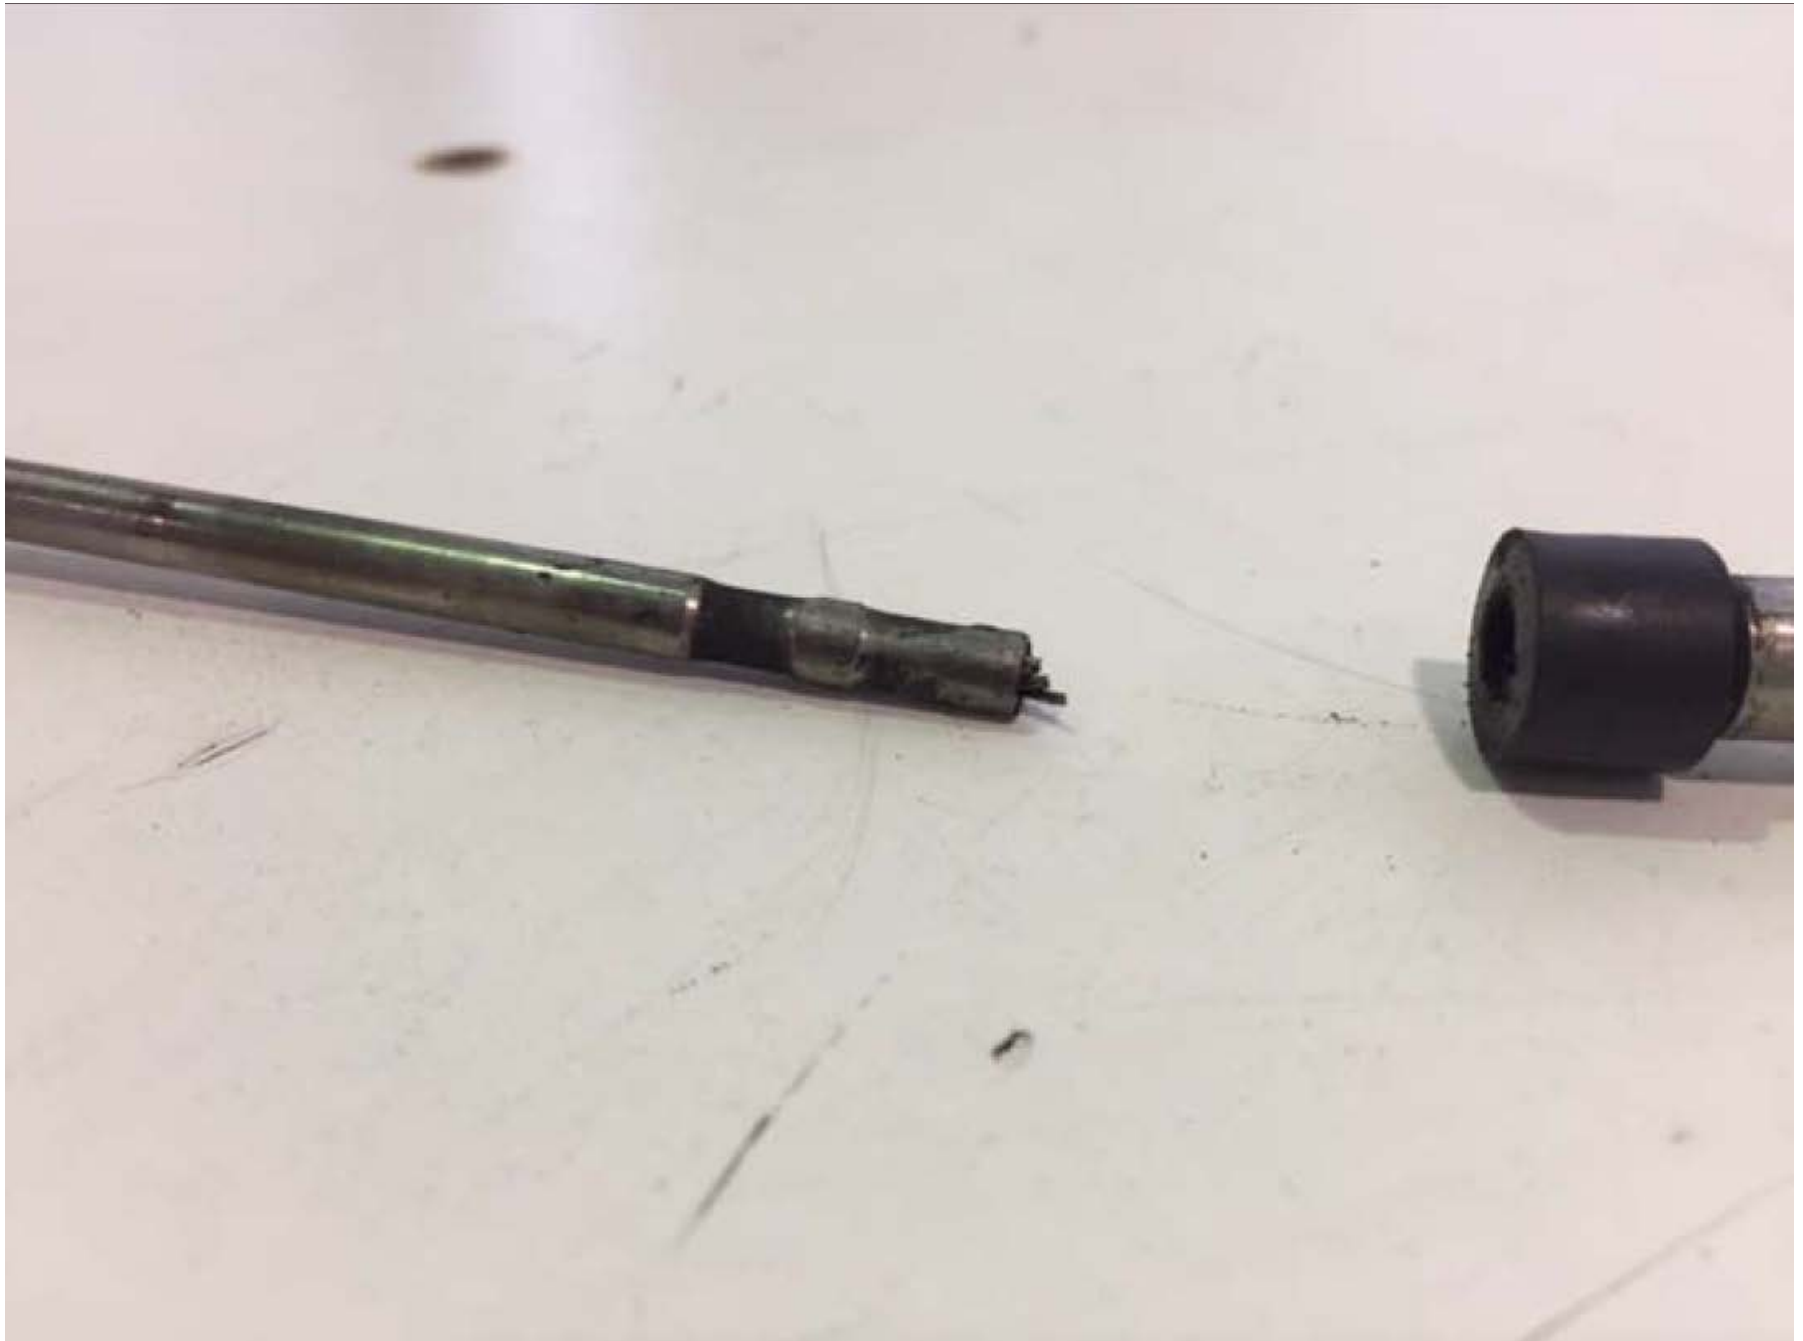
*Figure 4: Throttle Control rod End and sleeve*

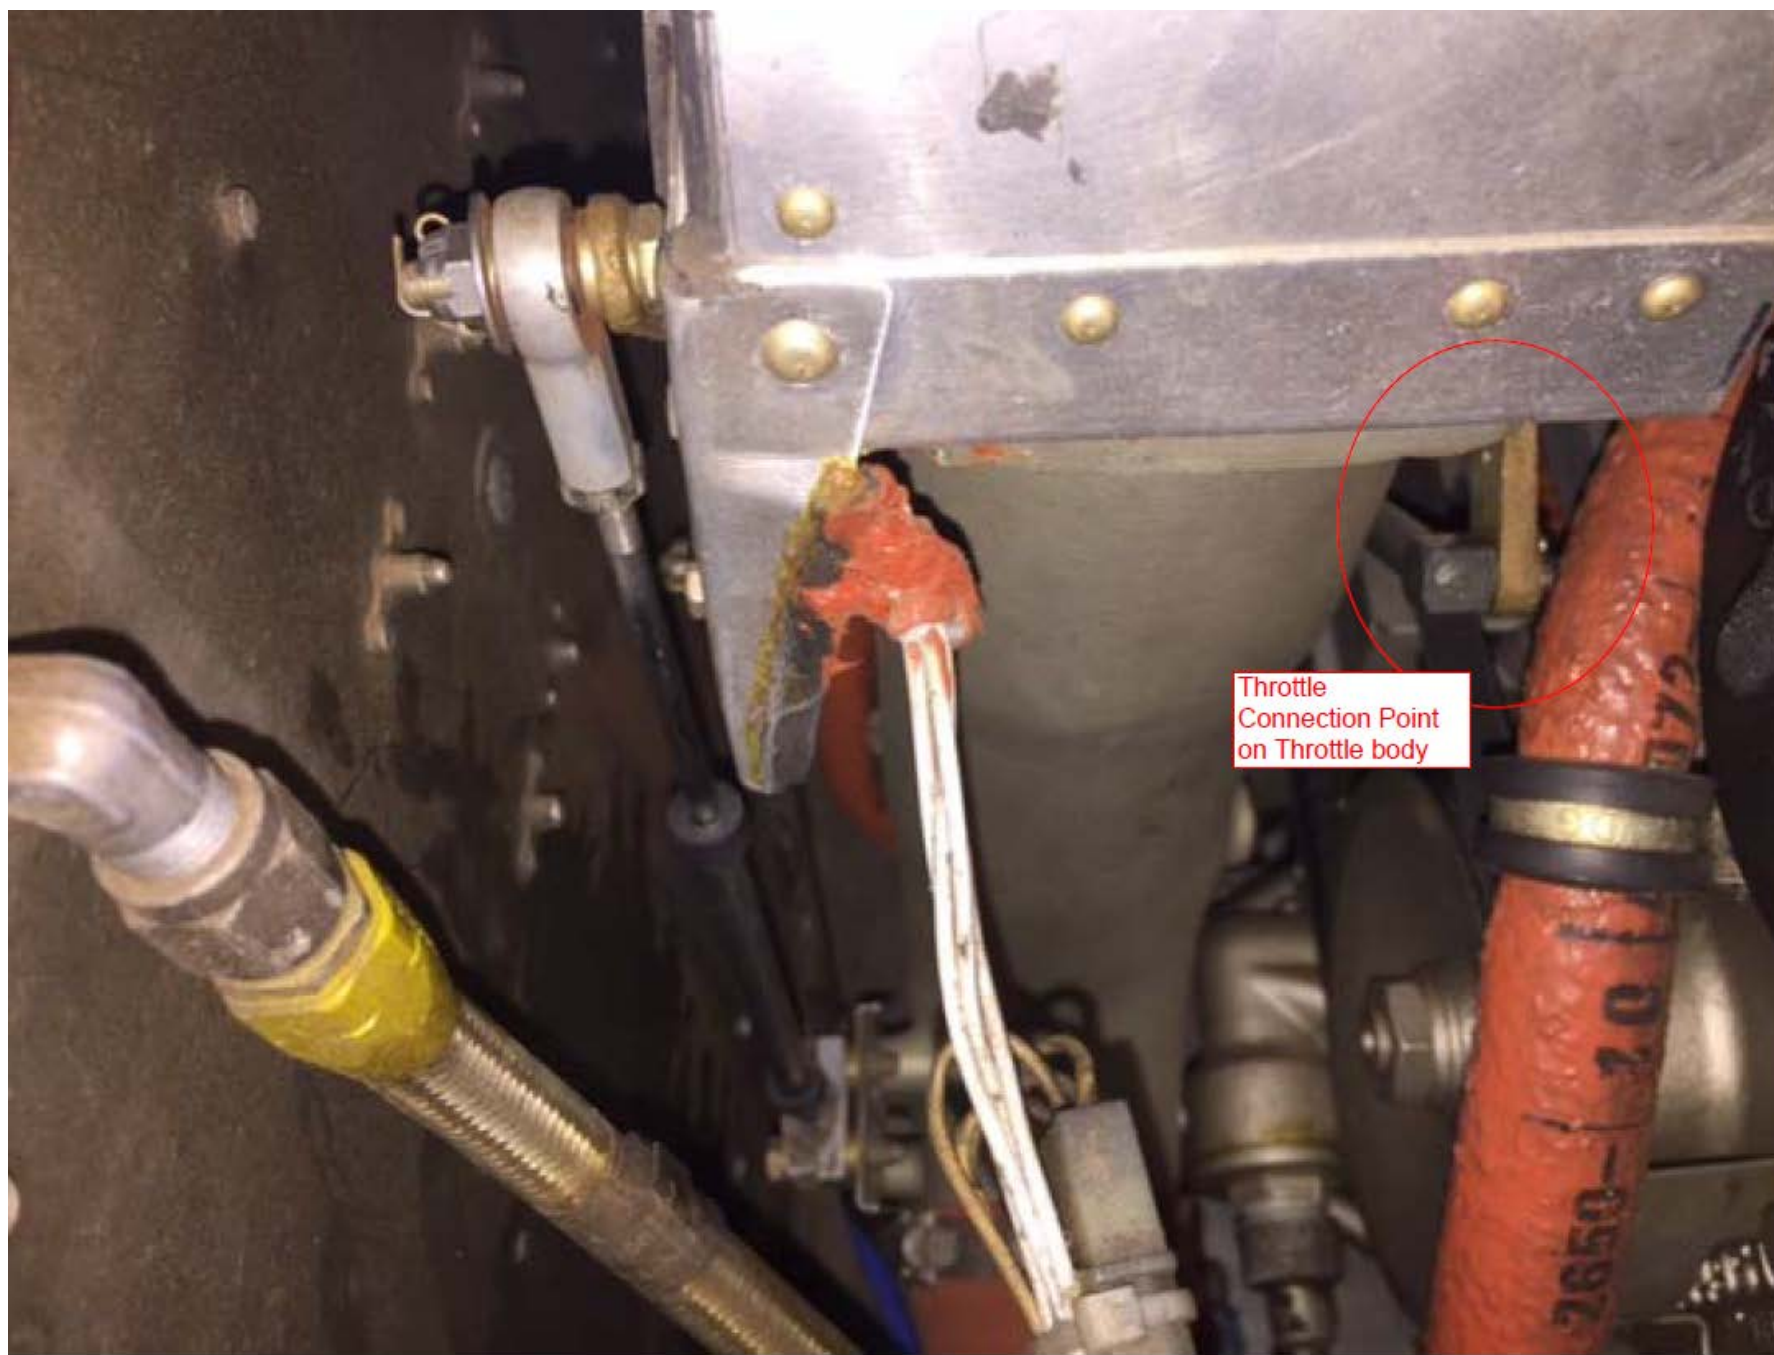
Figure 5: Throttle Connection Point on Throttle Body

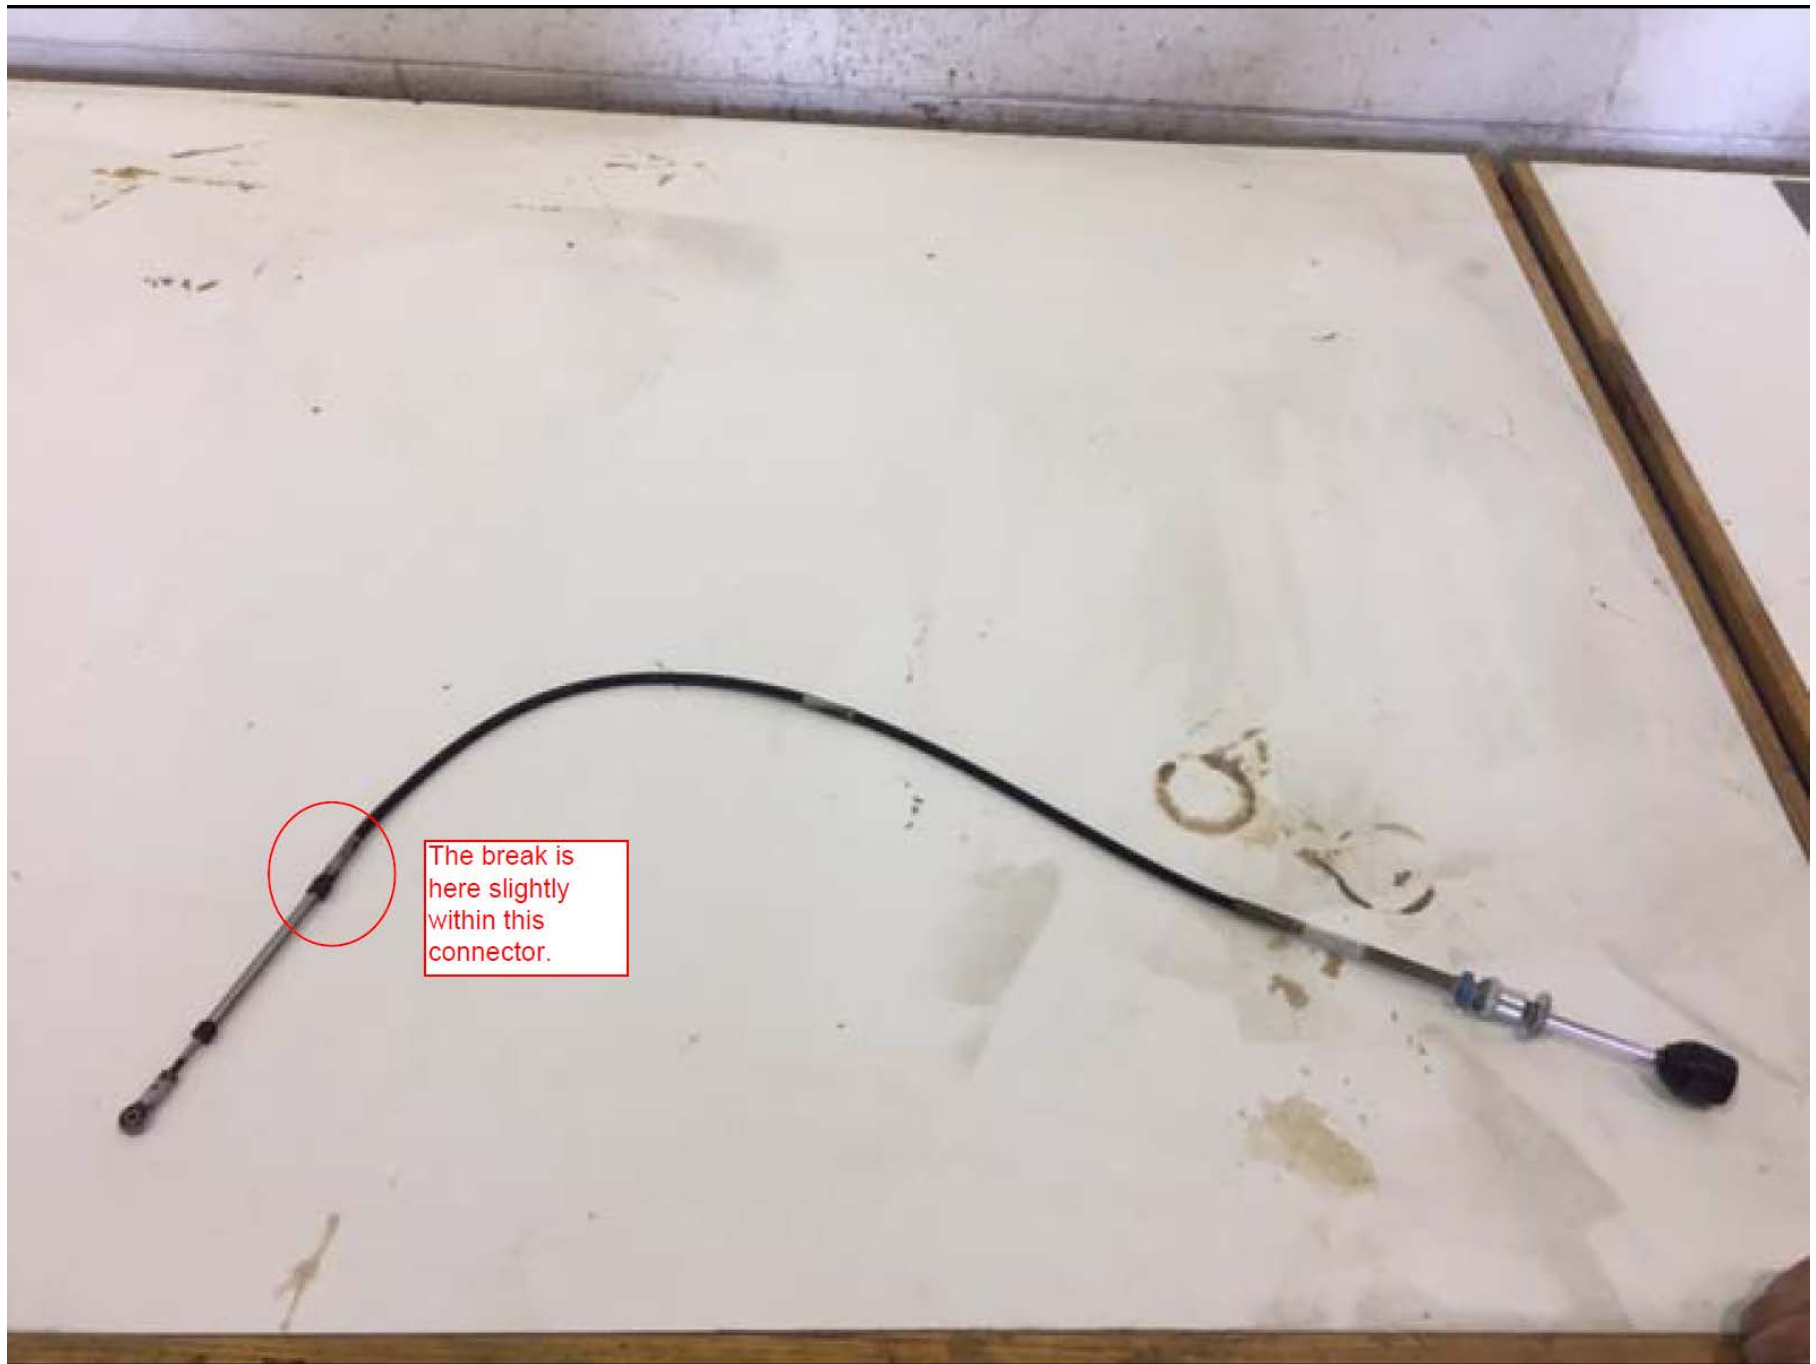
Figure 6: The Throttle Control Assembly
