## RECORD OF COMMUNICATION

**Date: August 30, 2018**  
**Person Contacted: Mr. Jack Norris (builder/owner/pilot)**  
**NTSB Accident Number: WPR17LA148**

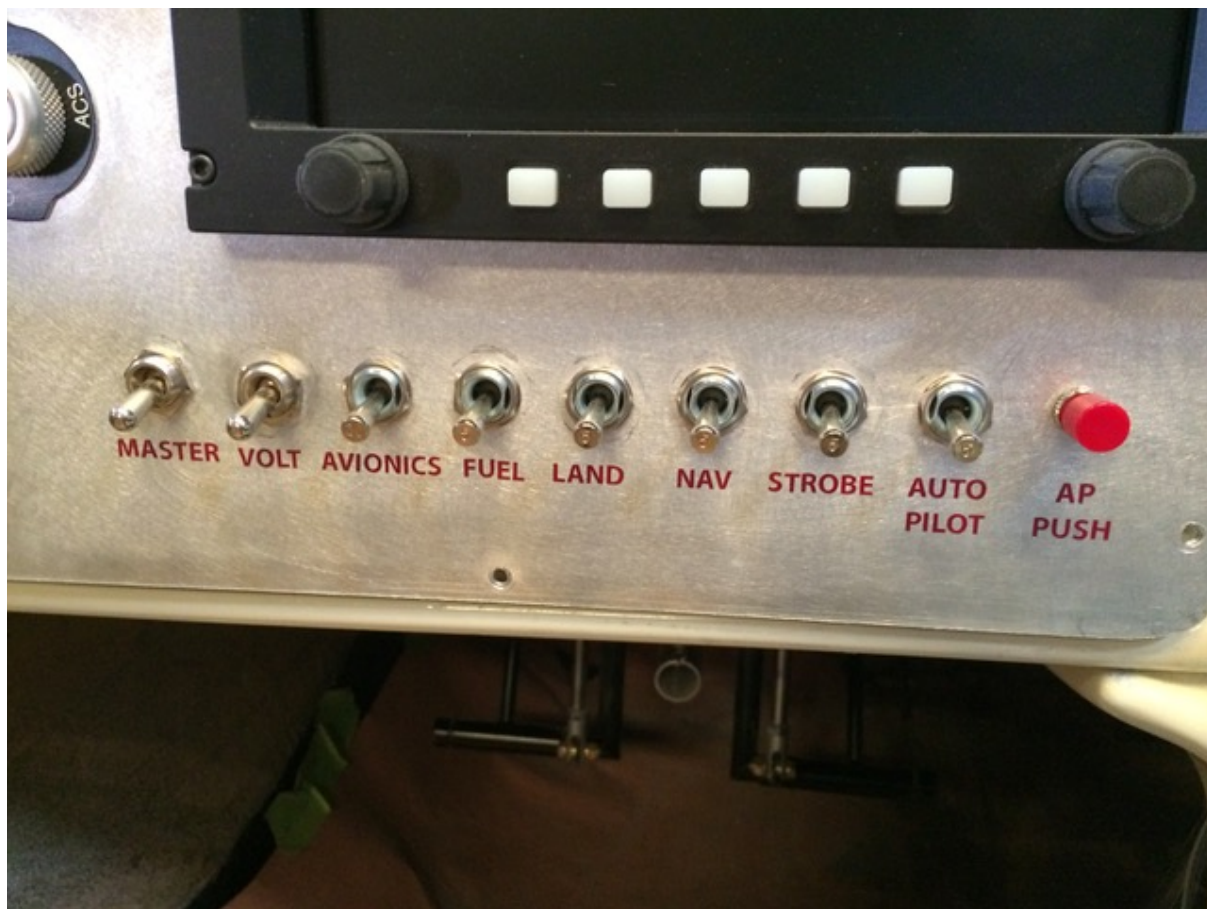
- a. The Electric Fuel pump switch was just below the EFIS and bordered by the Avionics and Landing Light switches.
- b. I've included the photo below. The electric pump was located inside the firewall at the lower right hand side. I've included a picture on the outside of the firewall. The electric pump is the the directly opposite the fuel gascolator (blue) below the battery.
