## **NATIONAL TRANSPORTATION SAFETY BOARD**

### **AIRFRAME AND ENGINE EXAMINATION (Rev A)**

**WPR17LA148**

Location: New River, Arizona  
Date: July 10, 2017  
Aircraft: Arion Lightning, N273DB, Serial # 171  
NTSB IIC: Michael Huhn

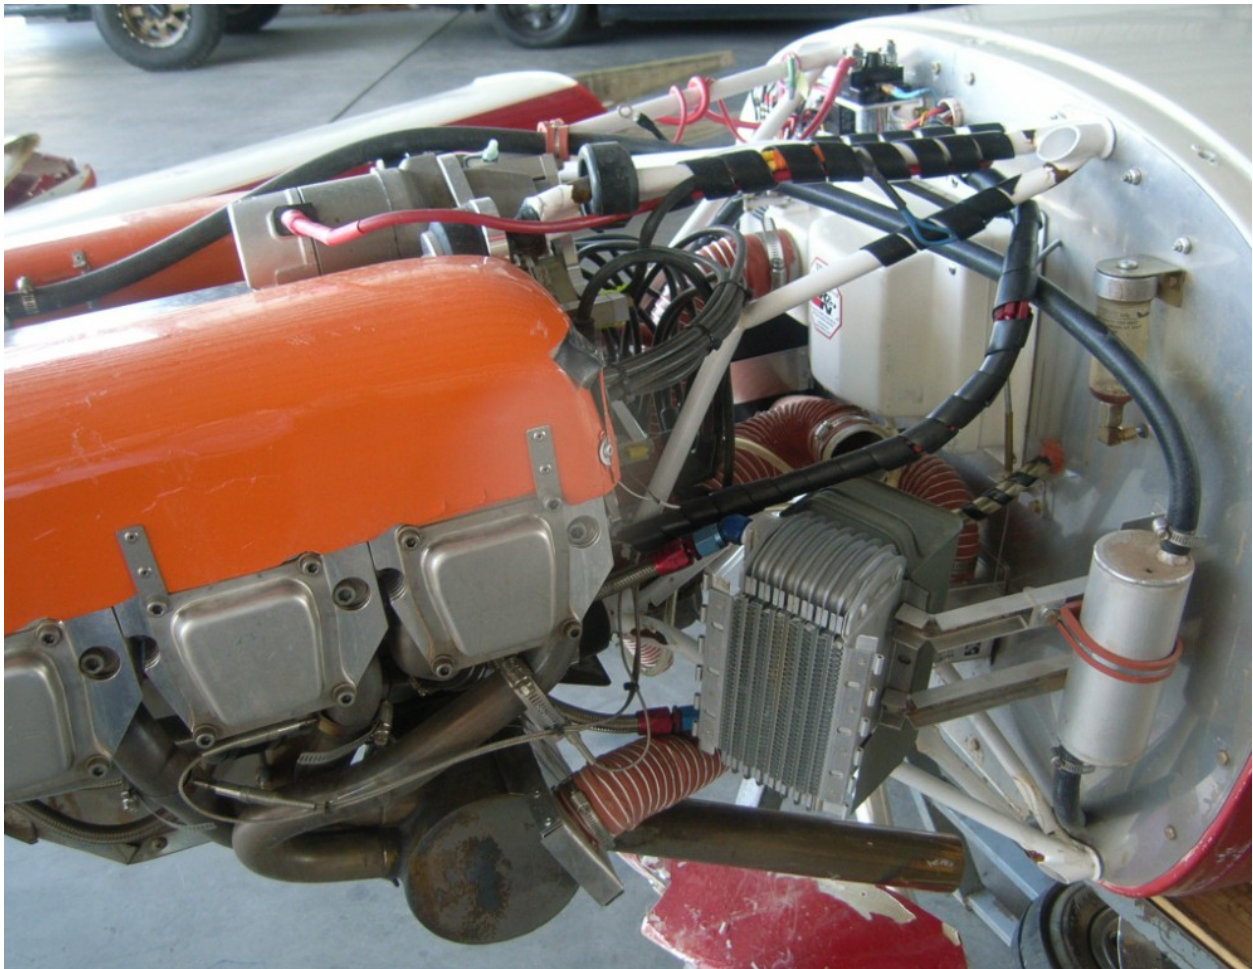
The engine was a Jabiru model 3300A, serial number 33A 2708. This is a 6 cylinder, horizontally opposed, normally aspirated, air-cooled engine. The engine showed no external indications of internal or thermal distress, or impact damage. All components, except for the propeller, spinner, and engine mounts, were essentially undamaged. All through-bolts and through-bolt nuts were checked for security, and no anomalies were observed.

Figure 1 - Engine Left Side

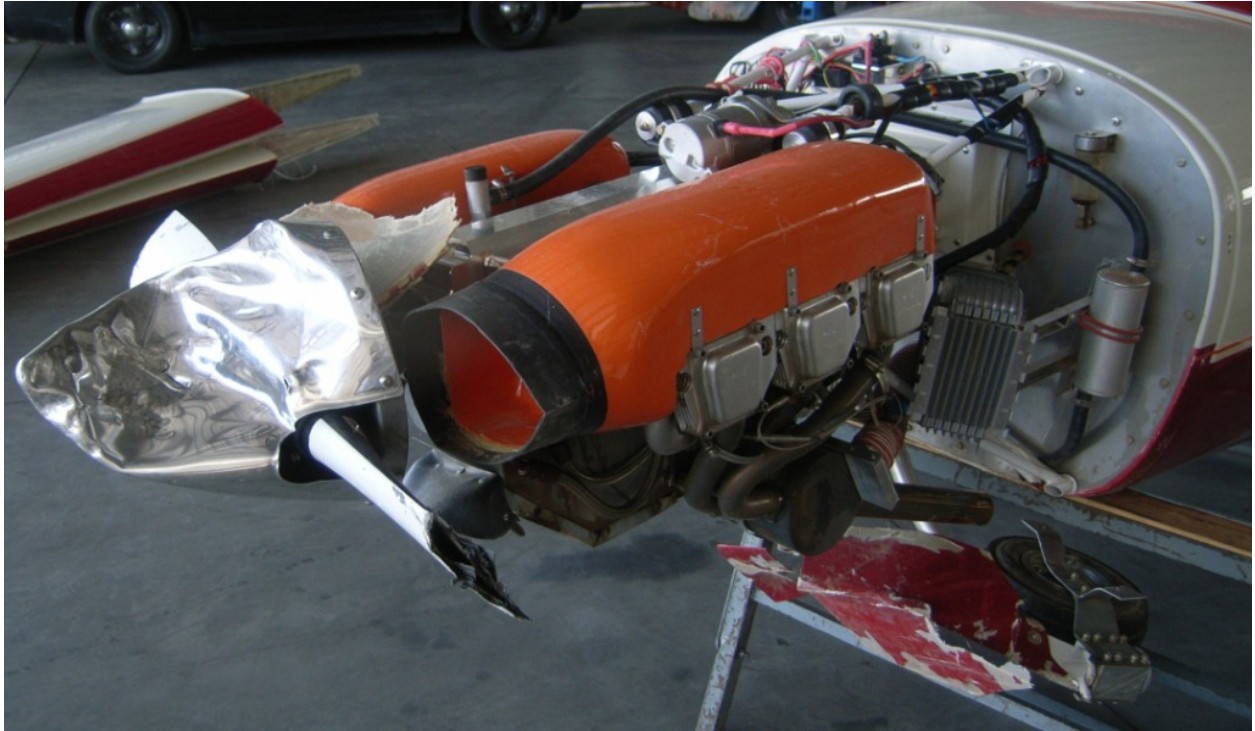
**Figure 2 - Engine Front Left**

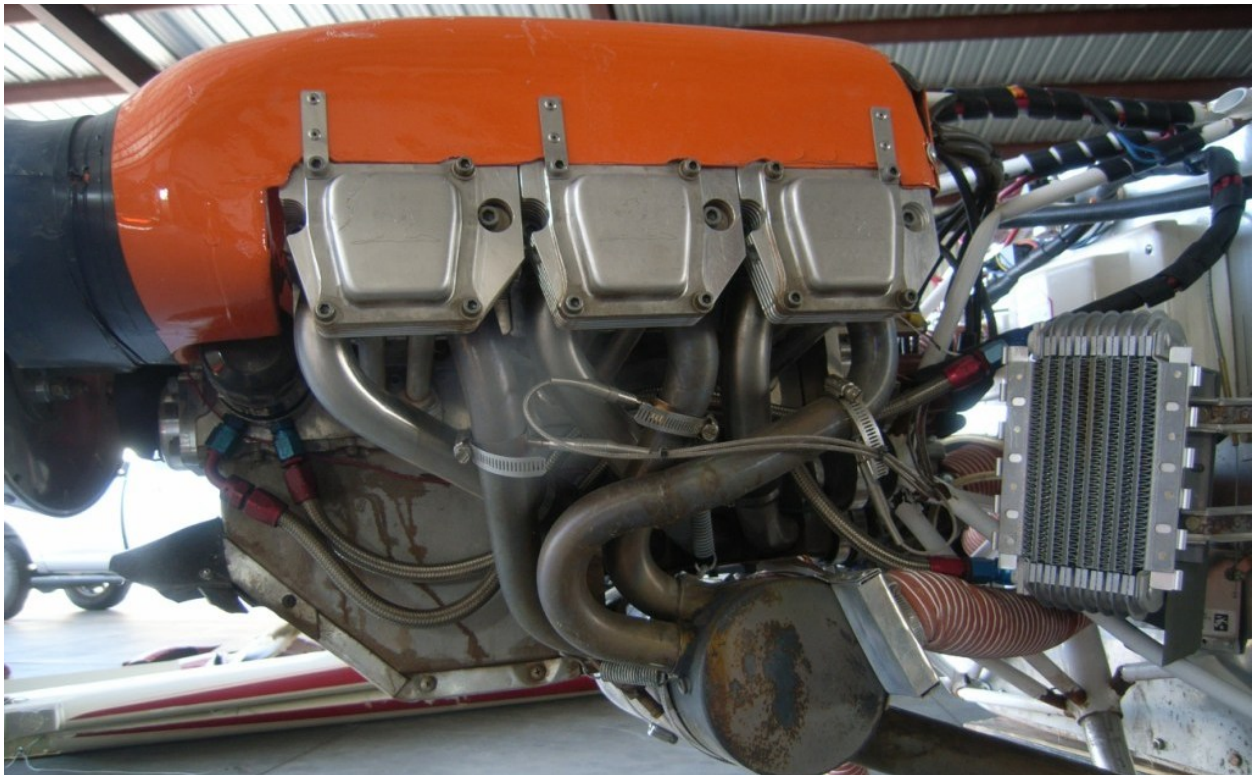
**Figure 3 - Engine Left Lower Side**

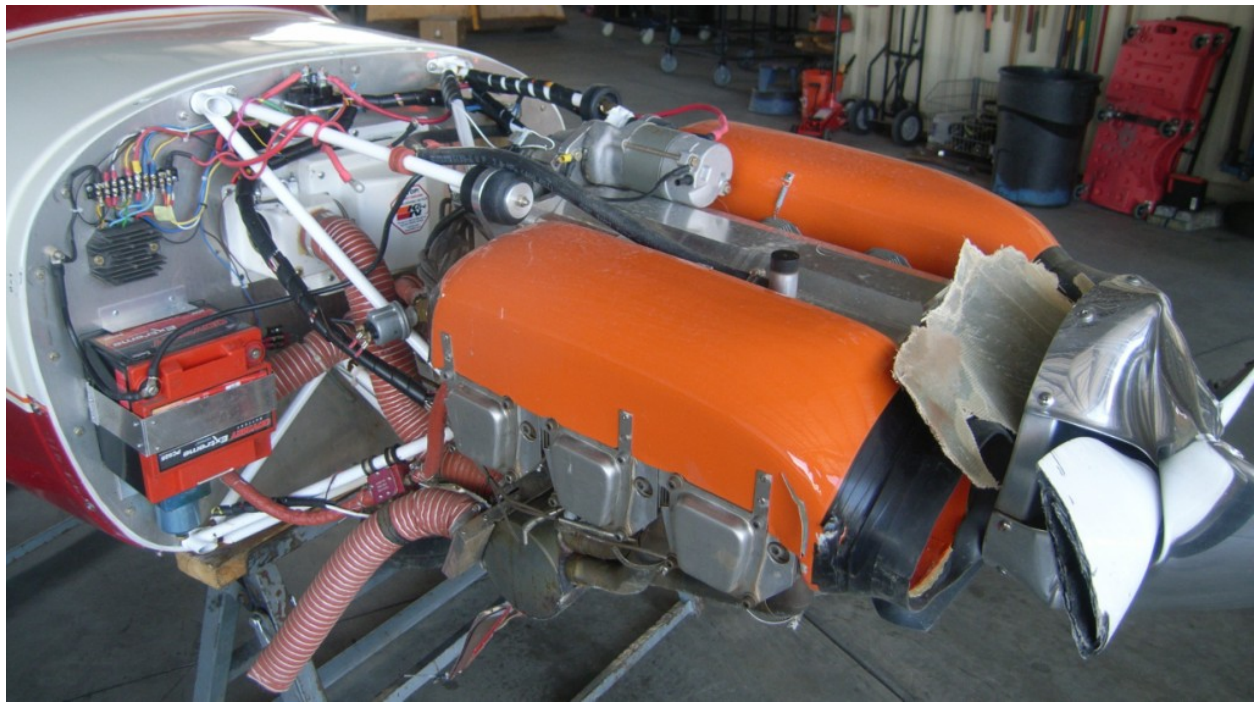
**Figure 4 - Engine Front Right**

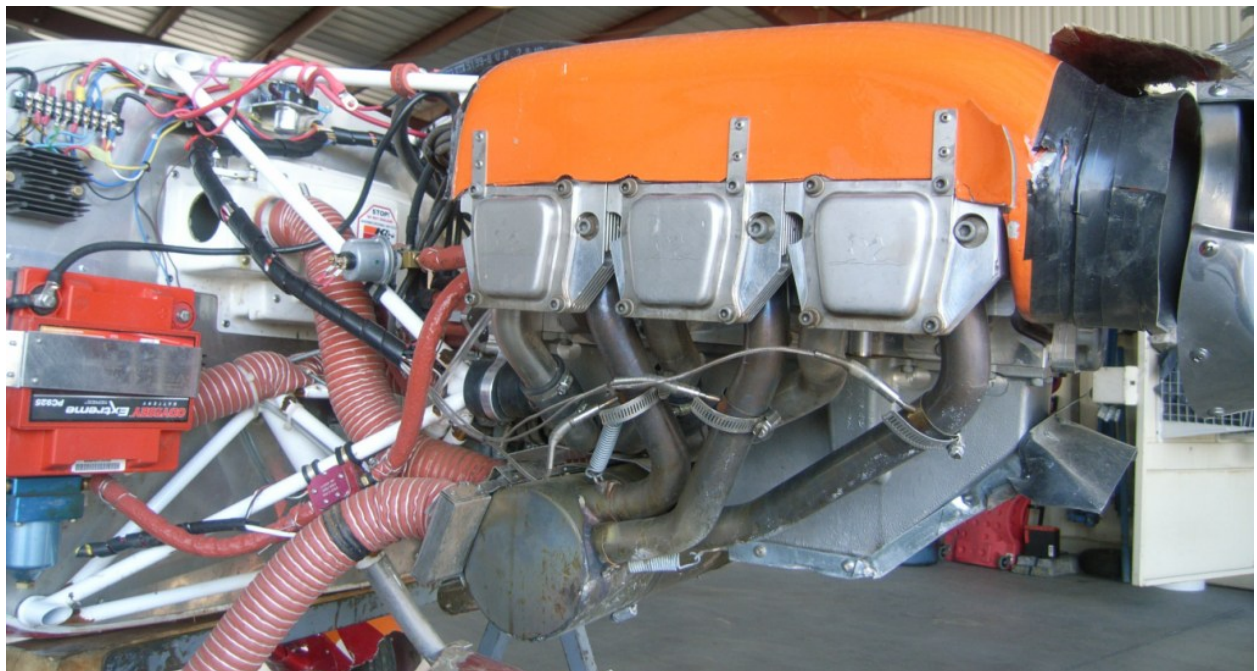
**Figure 5 - Engine Lower Right**

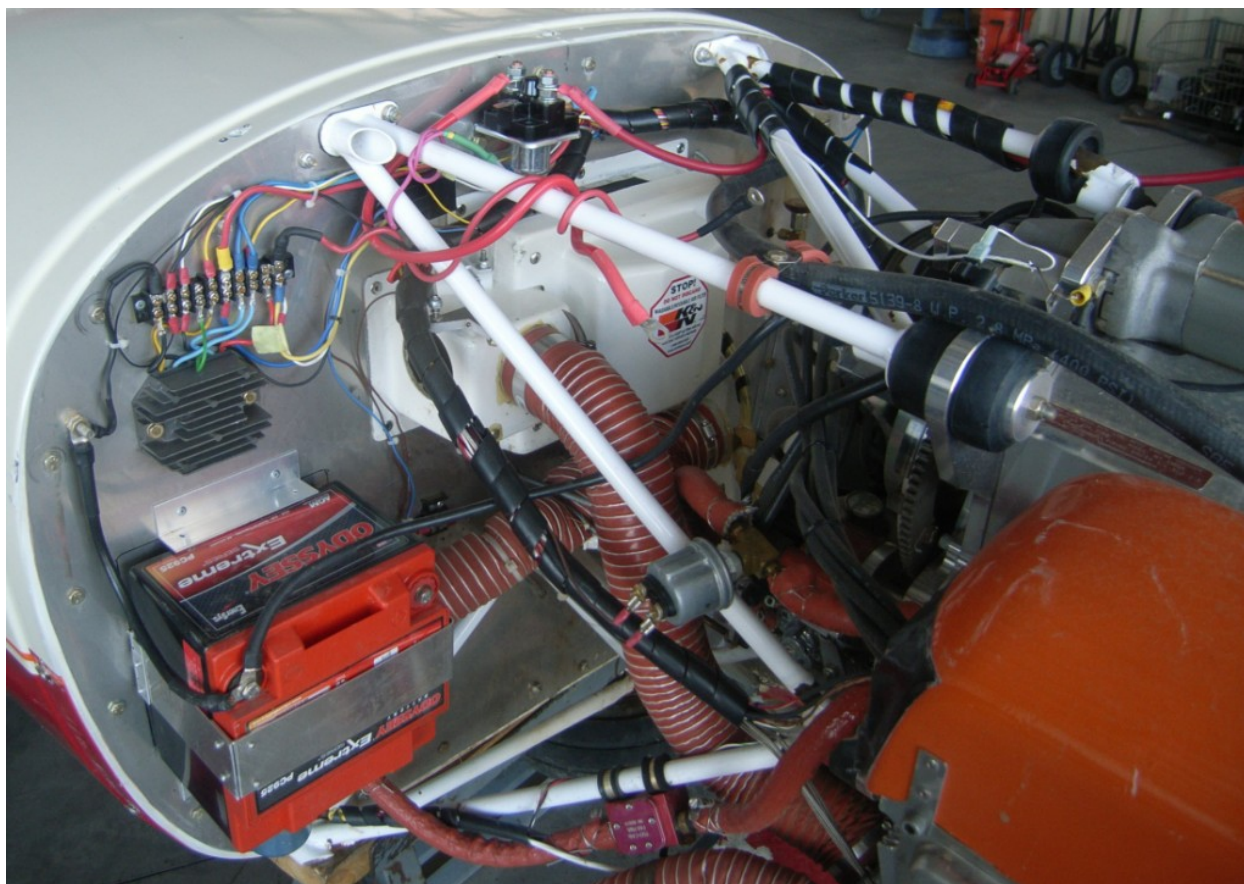
Figure 6 - Firewall

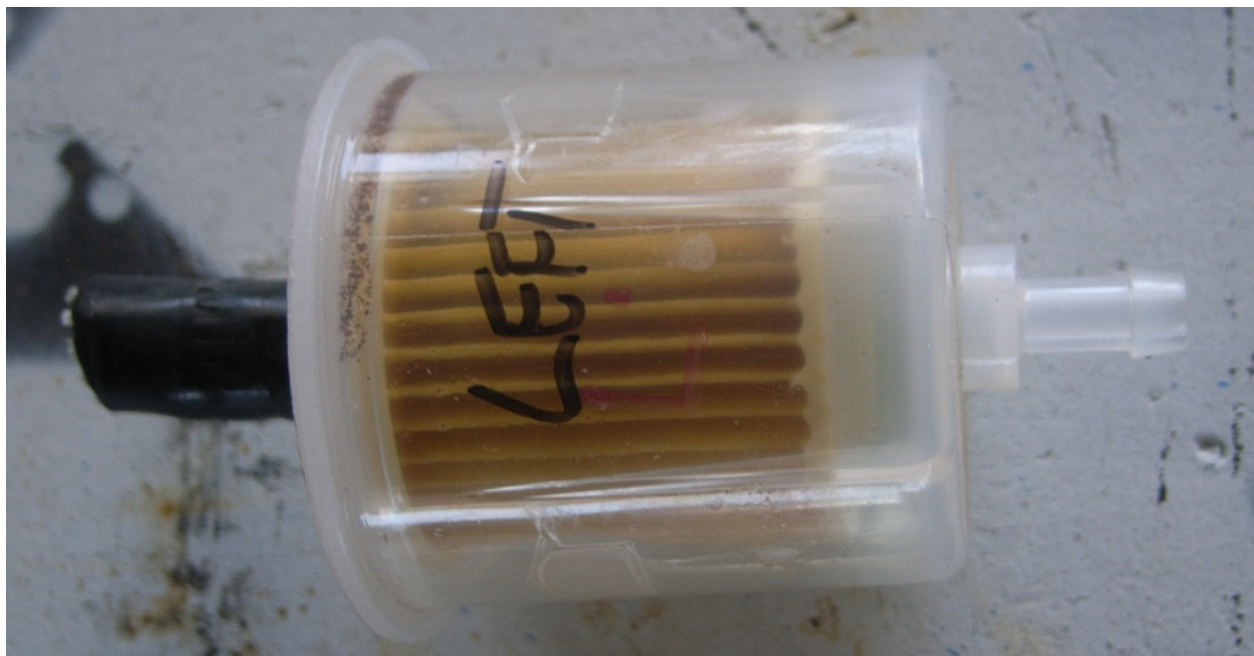
The two in-line fuel filters were transparent, and no contamination was visible in either. Both were securely attached to their respective lines, oriented in the proper flow direction.

The Jabiru IM stated that "A Fuel filter capable of preventing the passage of particles larger than 0.1mm (100um) must be installed between the fuel tank outlet and the fuel pump. The filter must be present in the system for the fuel flow test. The size of the filter should give consideration to allow adequate flow with a used filter." No manufacturer identification or part numbers were observed on the installed filters, and their filtration limits were not determined.

**Figure 7 - Left In-Line Fuel Filter**

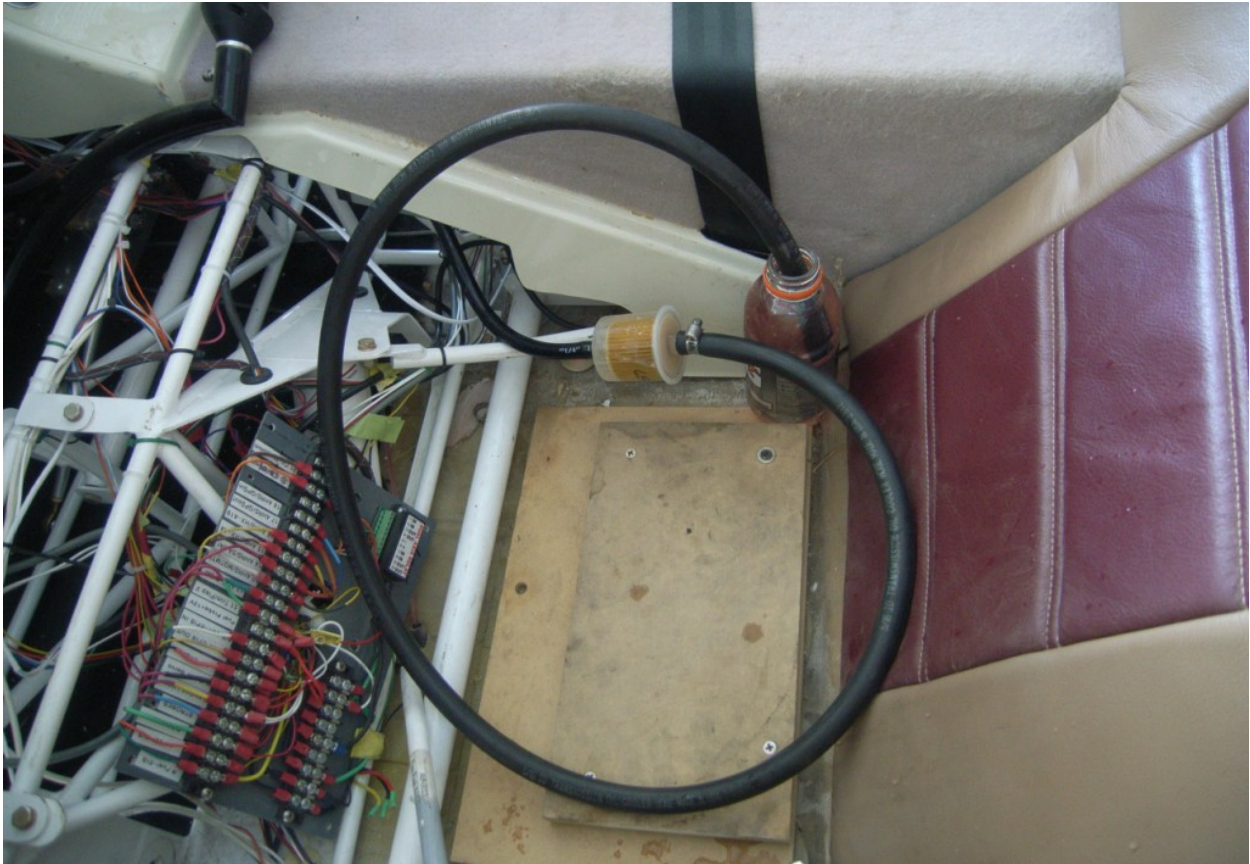
The electric fuel pump was tested and operated normally. The pump also allowed liquid to flow freely through it when it was not operating. The flow rate (power ON or OFF) was not measured.

**Figure 8 - Setup to Test Electric Fuel Pump**

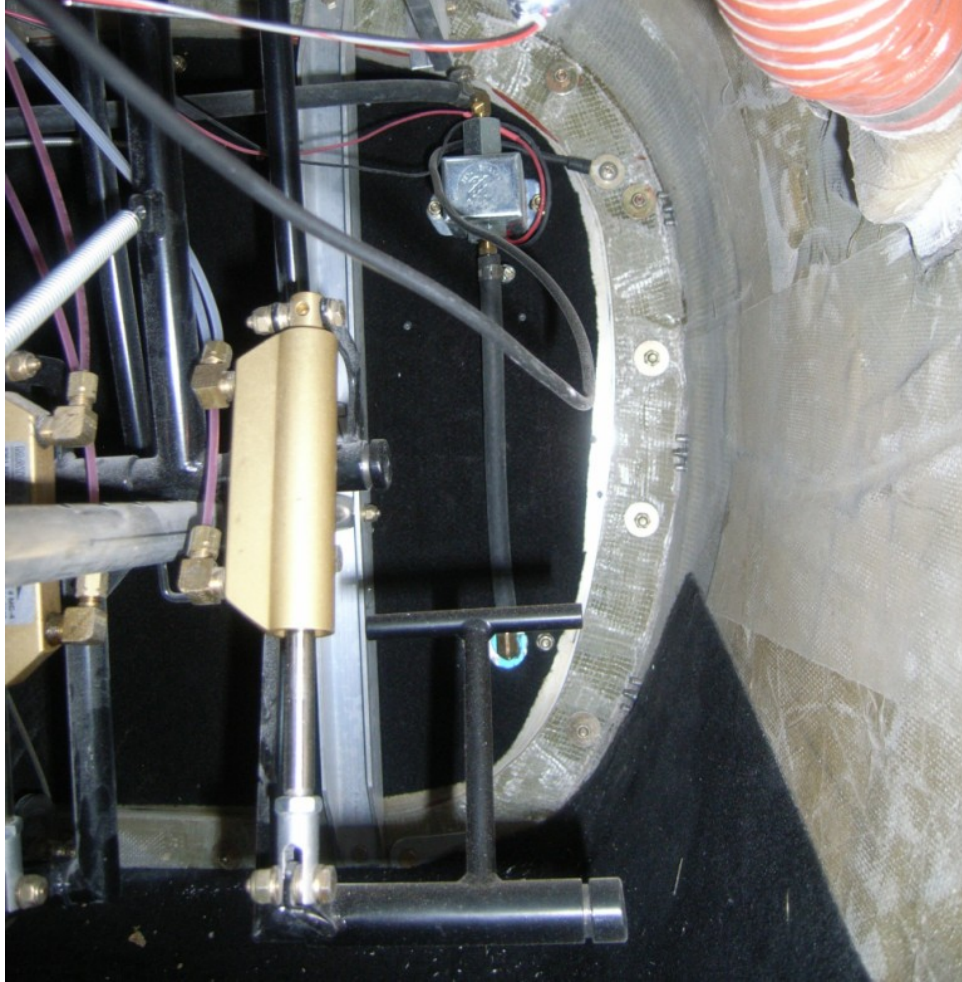
**Figure 9 - Aft Face of Firewall (with electric fuel pump)**

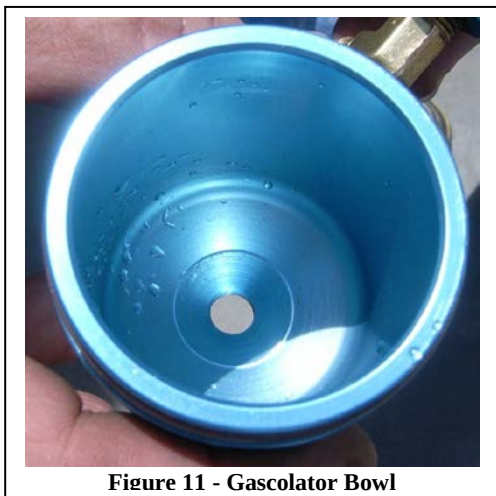
The gascolator allowed liquid to flow through it. It was removed and opened, and the chamber and screen were both observed to be pristine, with no evidence of contamination or corrosion.

**Figure 11 - Gascolator Bowl**

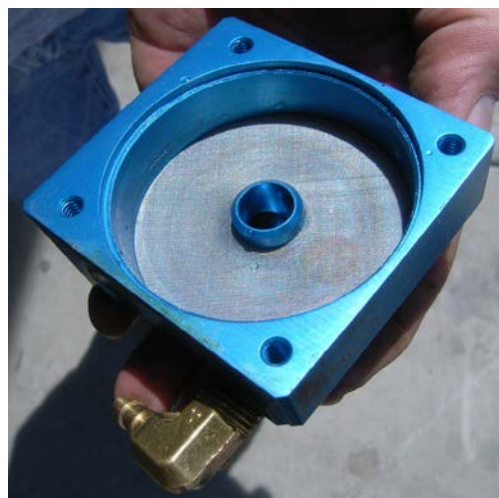
**Figure 10 - Gascolator Screen**

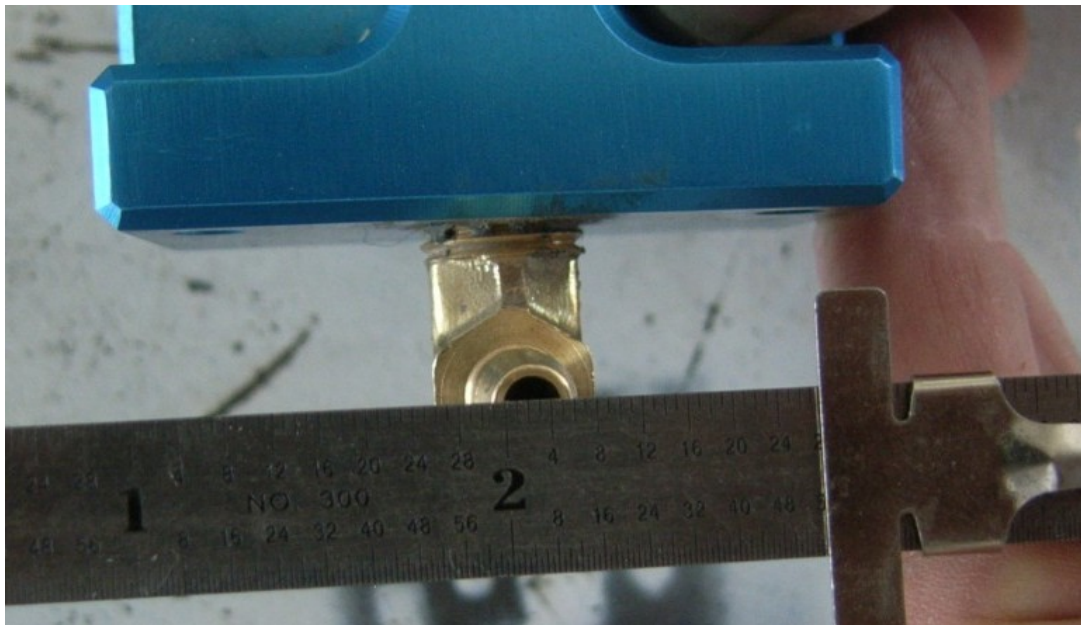
The Jabiru IM stated that "Fuel lines are nominally 6mm [0.236 inches] bore." The IDs of all fuel lines were not measured, but the ID of the gascolator fittings was 5/32" (0.156 inches).

**Figure 12 - Gascolator Outlet ID**

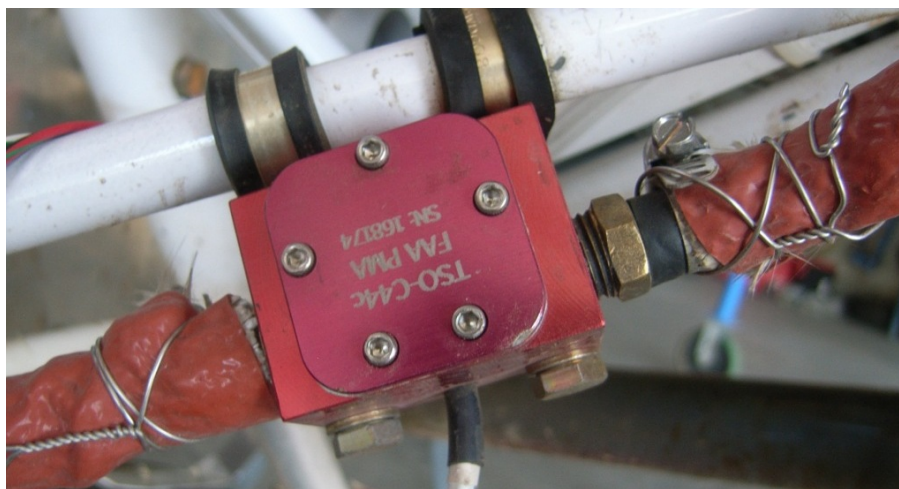
All fuel lines forward of the firewall were shrouded in fire-resistant sheathing. The Electronics International FT-60 fuel flow transmitter was found to allow liquid to pass through it, but the flow capability was not measured or otherwise quantified. According to the Jabiru Installation Manual (IM), "Where a Fuel Flow Meter is to be installed to the aircraft Jabiru Aircraft recommend that the flow transducer is not installed on the engine side of the firewall. Most transducers are made of either plastic or light aluminium and are not fire resistant. Regulations and common sense both require that every part of the fuel system on the engine side of the firewall must be fire resistant."

**Figure 13 - FT60 Fuel Flow Transmitter**

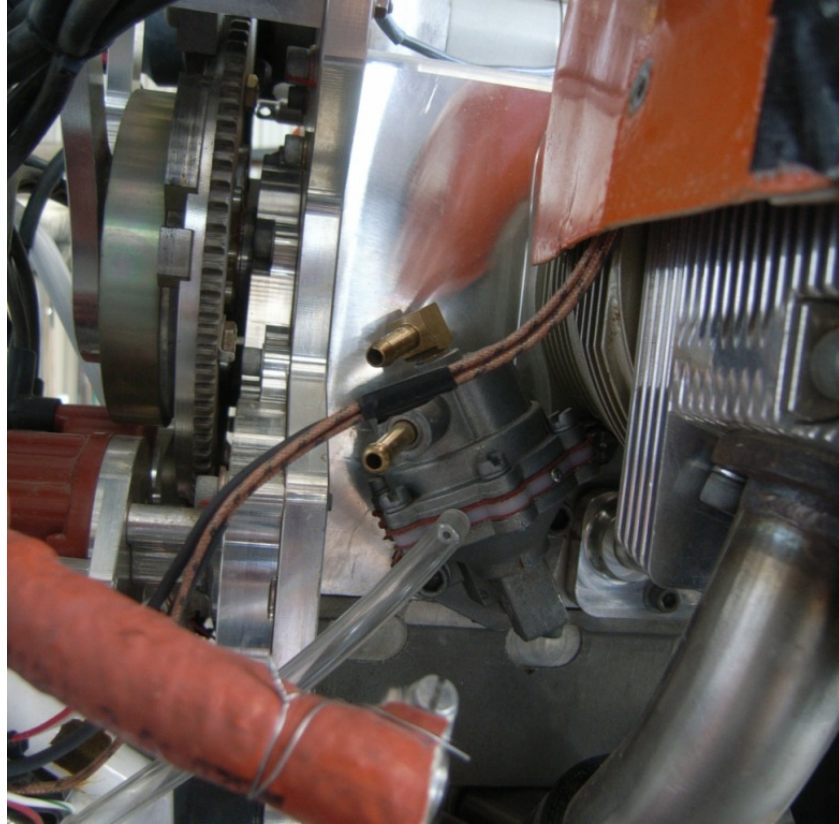
The EDP bore no part number, but based information from the Jabiru Overhaul Manual, this was a "Type 1" pump. The EDP was disconnected and removed from the engine. There was a paper gasket and a nylon/plastic spacer between the pump and the engine case; the gasket abutted the EDP, and the spacer abutted the engine case.

Figure 14 – EDP (In situ)

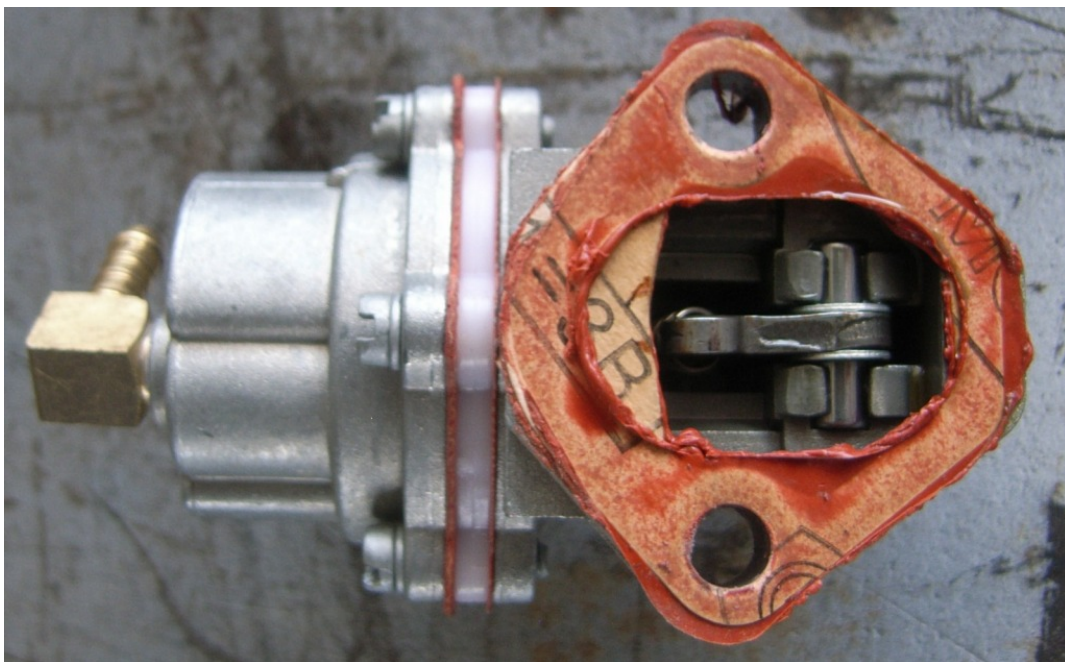
The pump was a rocker/diaphragm type, driven by a pushrod that was actuated by a cam on the crankshaft. The pump rocker was undamaged, well-lubricated, and free to pivot. The pushrod was free to translate and rotate in its bore, was well lubricated, straight, with no visible scoring or damage. The crankshaft cam for the EDP pushrod was well lubricated, with no visible scoring or damage. The EDP was set aside for additional examination and testing.

Figure 15 - EDP Removed (rocker visible)

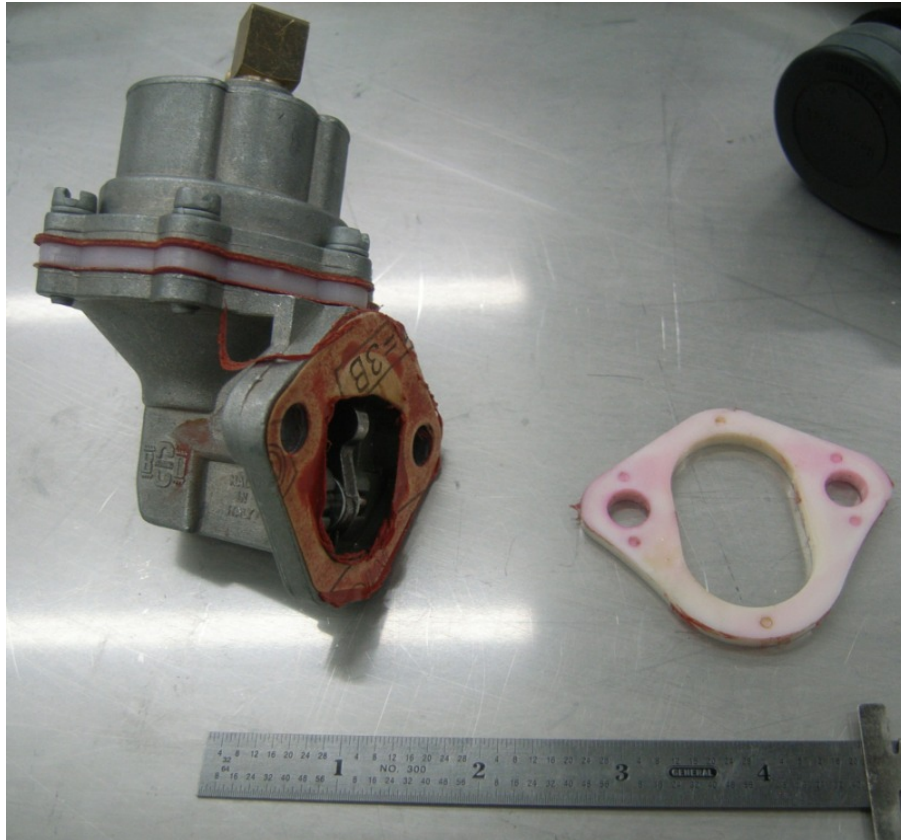
Figure 16 - EDP with Gasket and Spacer

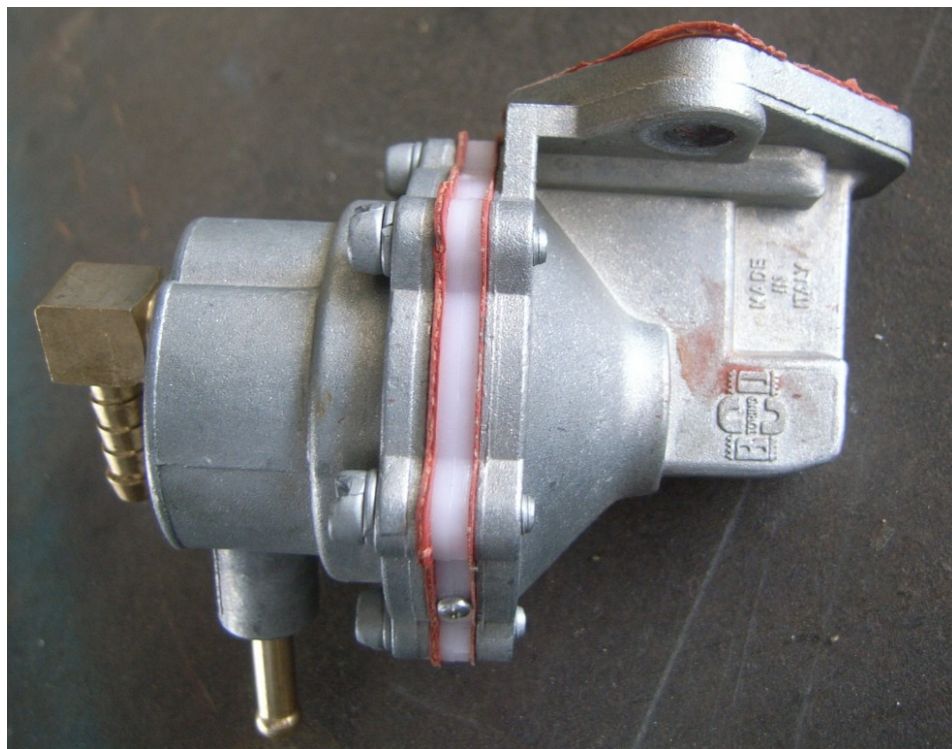
Figure 17 - EDP

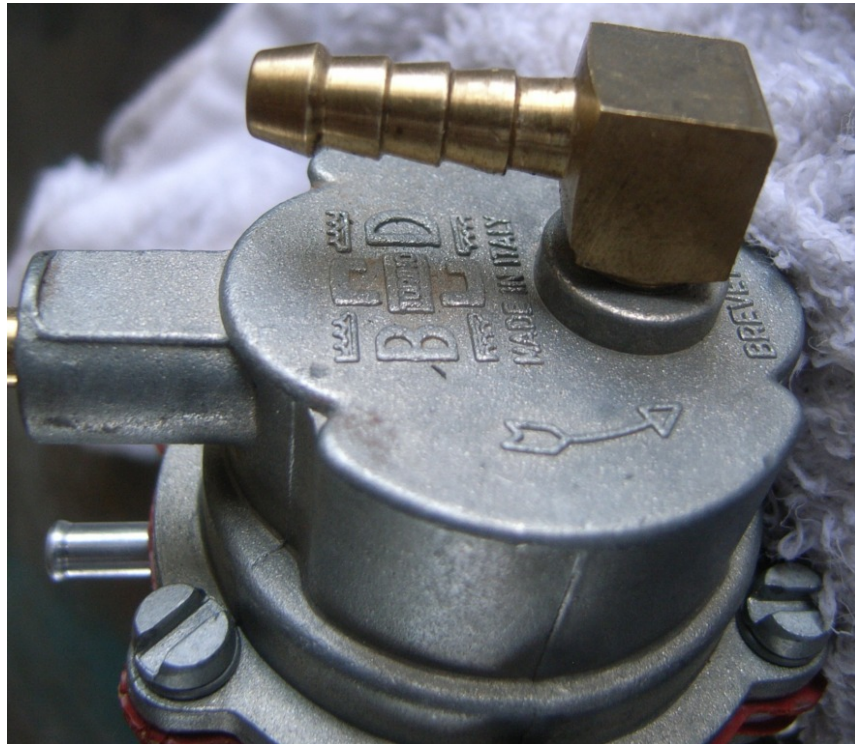
Figure 18 - EDP with Stamped Case Top

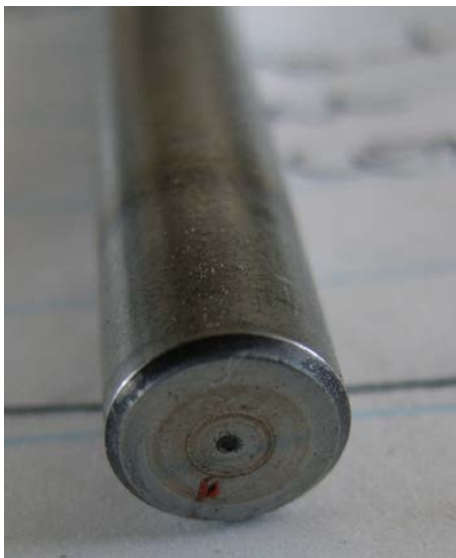
Figure 20 - EDP Pushrod End 1

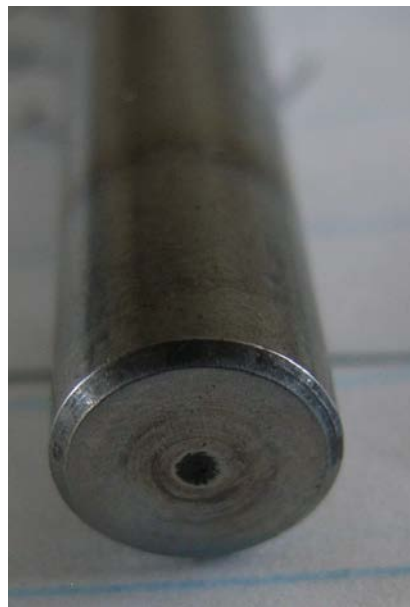
Figure 19 - EDP Pushrod End 2

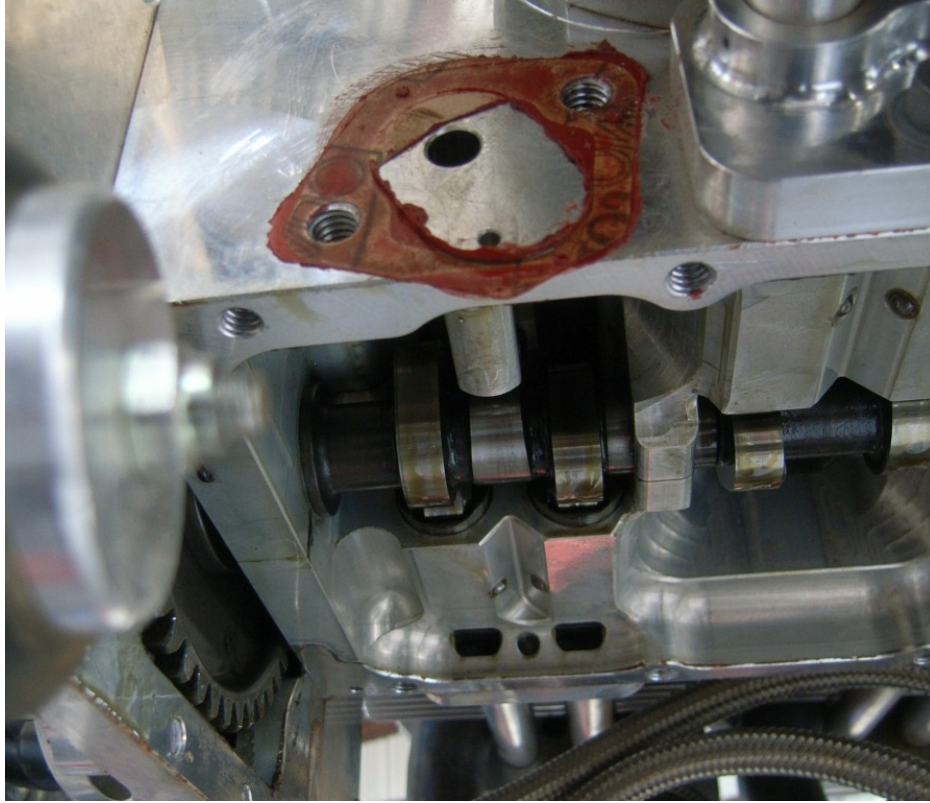
**Figure 21 - EDP Mount Pad and Pushrod Cam on Crankshaft**

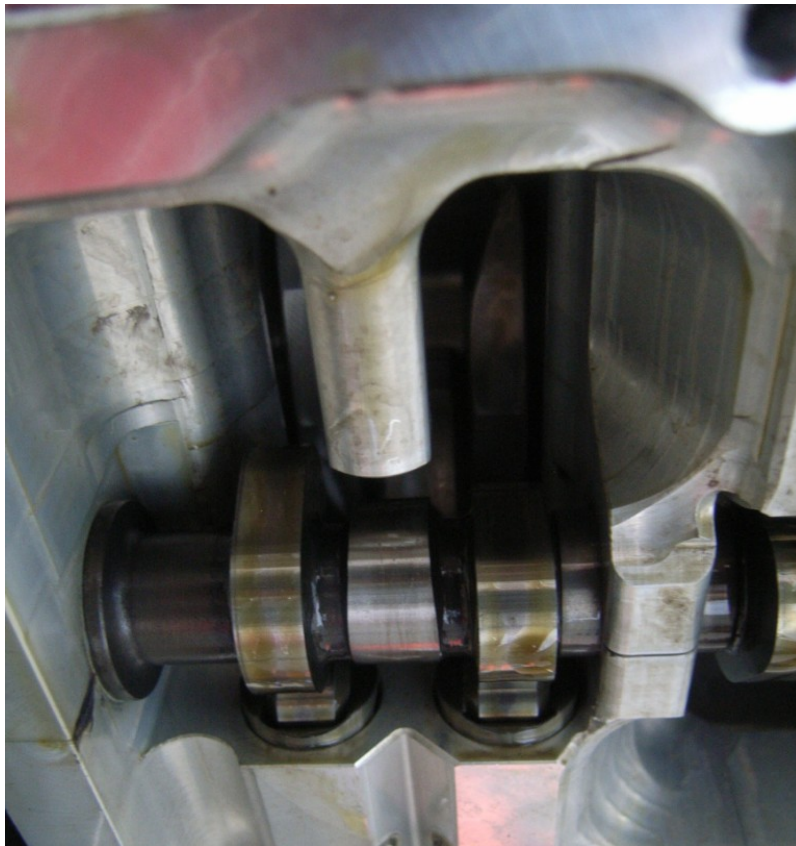
**Figure 22 - EDP Pushrod Cam on Crankshaft**

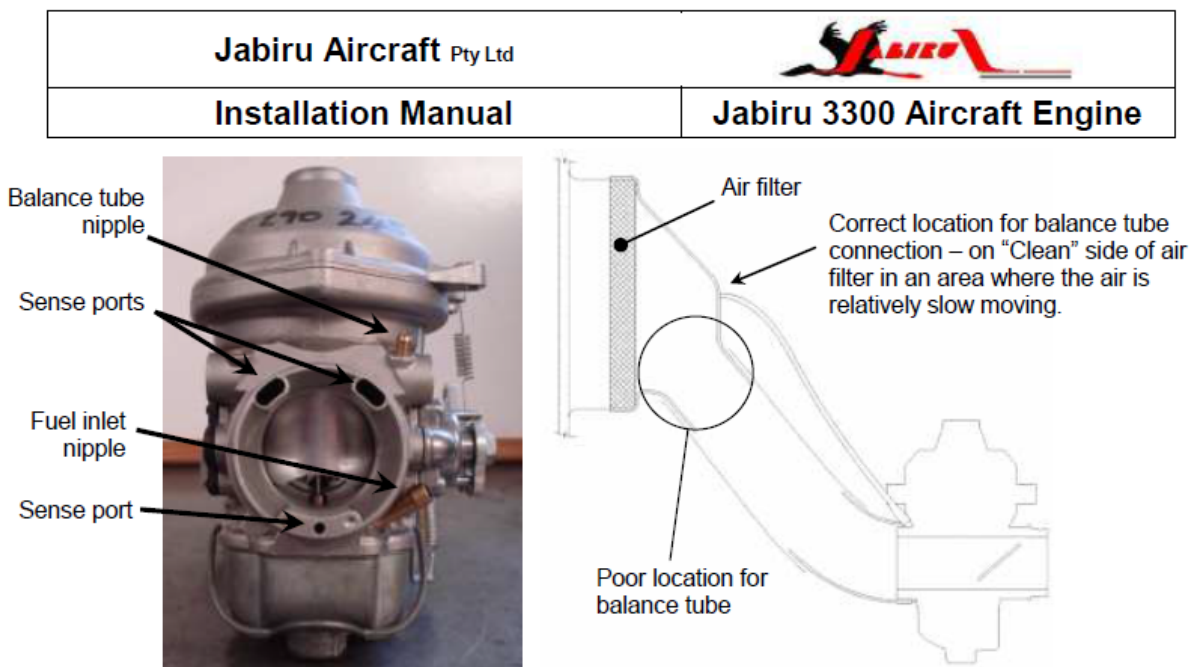
- Line A was routed from a port on the lower right front of the carburetor (adjacent to the bowl-body juncture) to the bottom (90°) port on the HACman. This carburetor port could not be definitively associated with a port or nipple in the Jabiru IM (Fig 23). This line was comprised of two sections of tubing joined by a plastic connector located about 12" from the carburetor end. Overall length of the two sections was about 49".

- Line B was routed from a carburetor port just above and aft of the choke linkage pivot point on the carburetor body to one in-line end of a brass and plastic T fitting. This carburetor port appears to be the "balance tube nipple" depicted in the Jabiru IM (Fig 23). Line B was about 10" long.

Figure 23 - IM Excerpt re Balance Tube Port Location

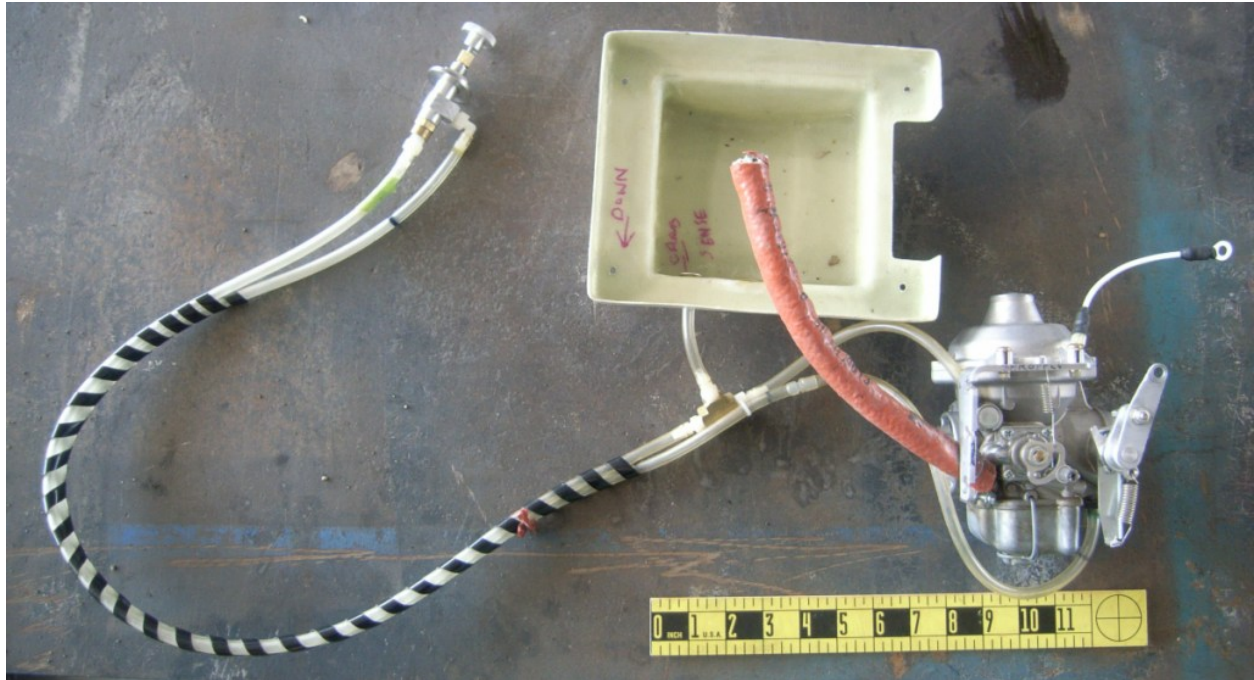
The balance tube was not installed in accordance with the IM. Instead, an aftermarket cockpit control device (labeled "Mixture"), and its associated plumbing, was connected to the carburetor and cockpit. The device was known as a "HACman" (for high altitude compensation-manual). The plumbing consisted of several sections of clear plastic flexible lines arbitrarily designated as A through D for this investigation and discussion.

The HACman port (one end of Line C) that was installed on the "clean" side of the air filter box did not appear to be mounted in accordance with the IM; while the IM recommended a location that was in slow-moving air, the actual port was installed adjacent to the filter exit, in a region that would likely be relatively fast-moving airflow. (Figs 24 & 31)

Figure 24 - Carburetor, Airbox Cover, and HACman

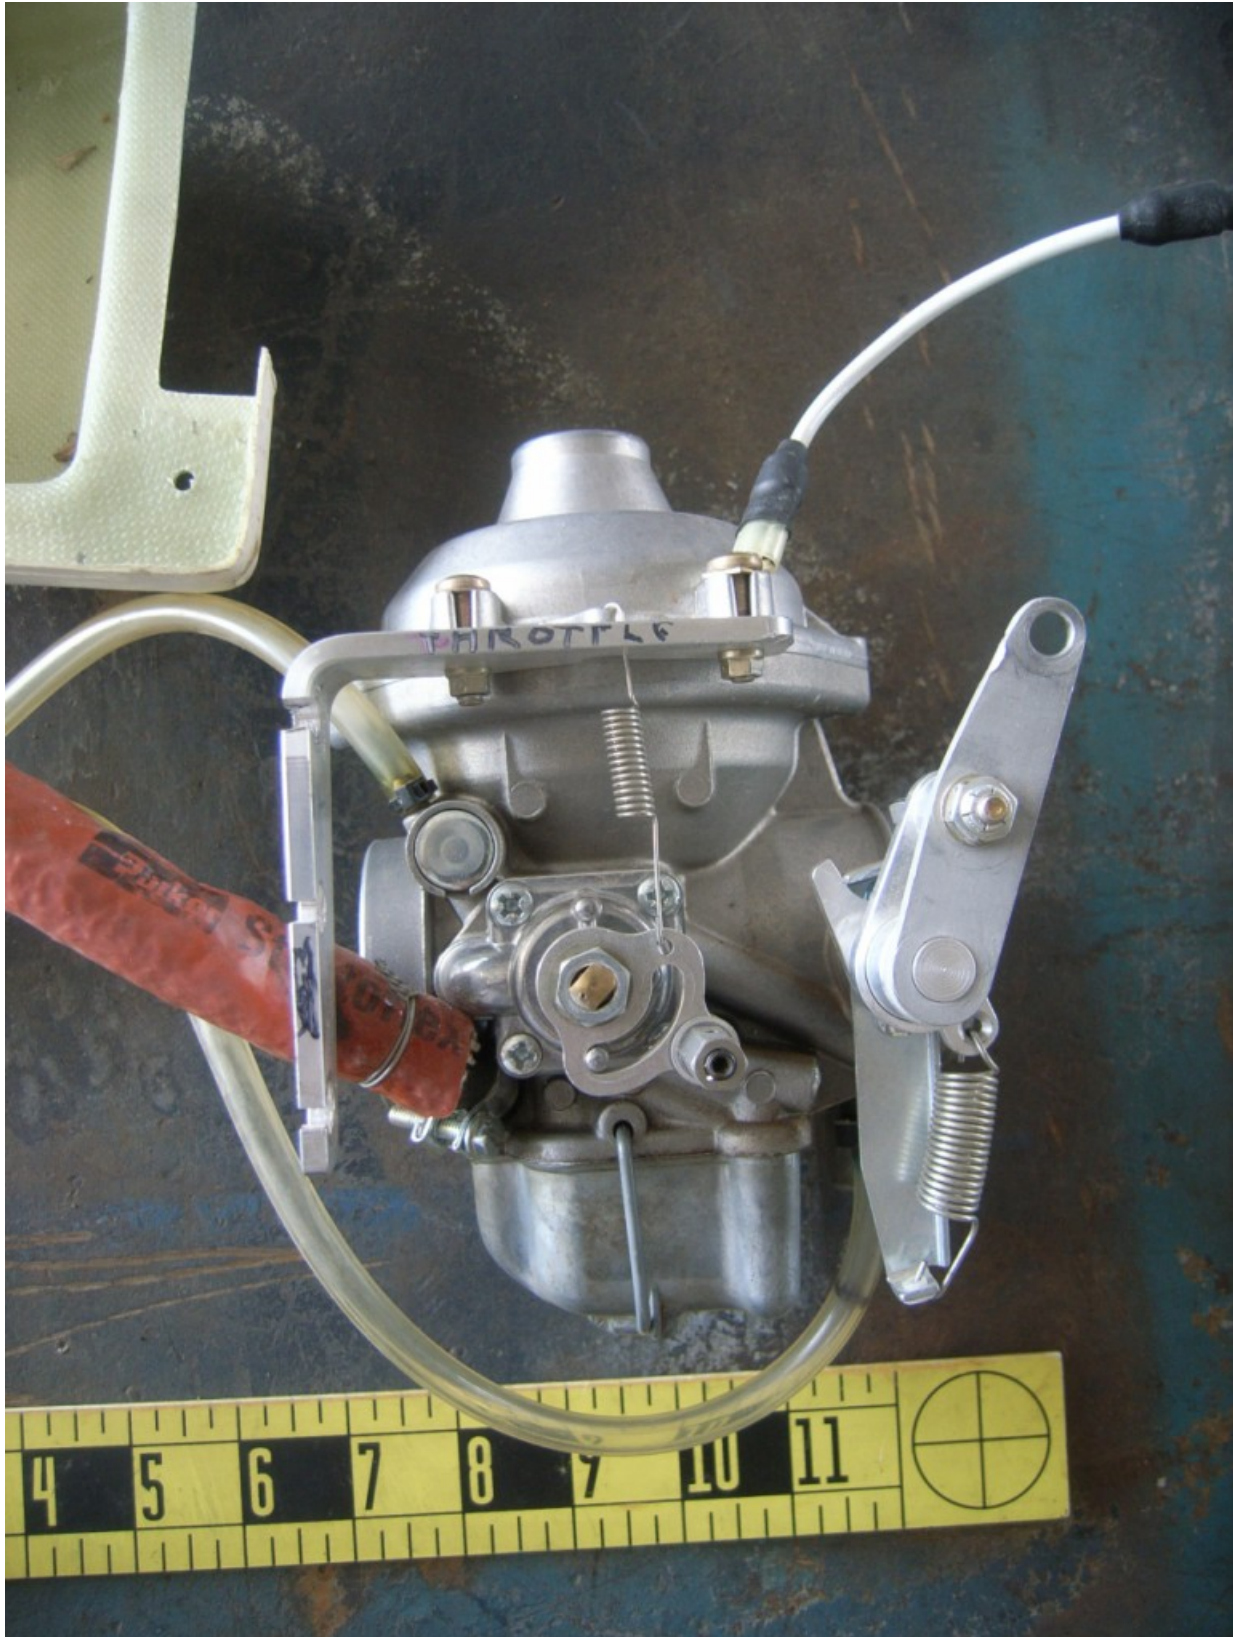
Figure 25 - Carburetor (right side)

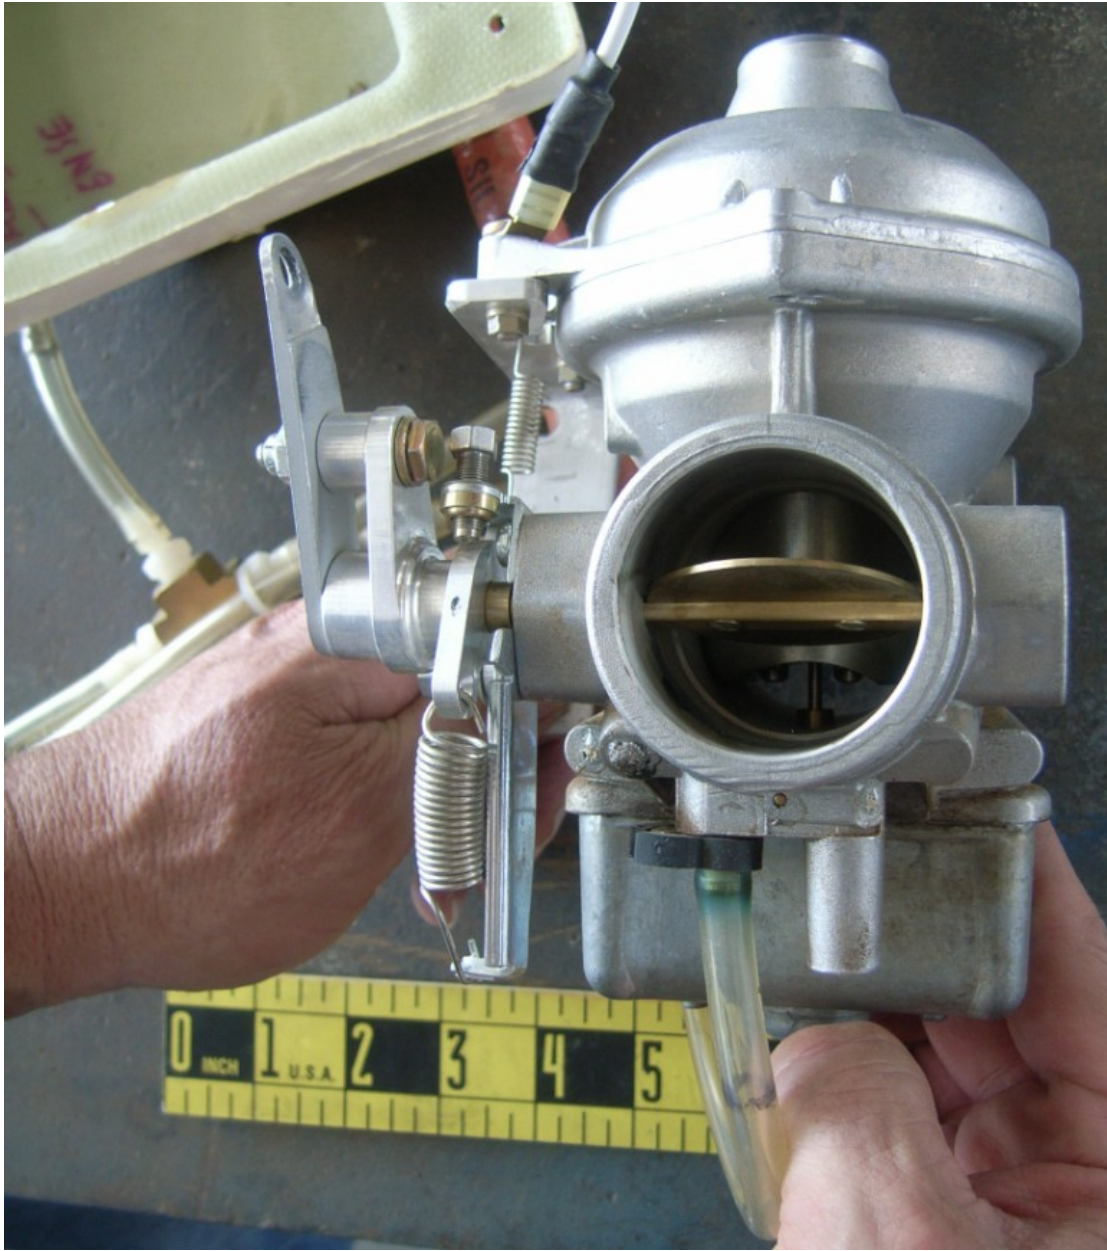
**Figure 26 - Carburetor (forward side; mates to engine)**
