## **NATIONAL TRANSPORTATION SAFETY BOARD**

### **AIRFRAME AND ENGINE EXAMINATION (Rev A)**

**WPR17LA148**

Location: New River, Arizona  
Date: July 10, 2017  
Aircraft: Arion Lightning, N273DB, Serial # 171  
NTSB IIC: Michael Huhn

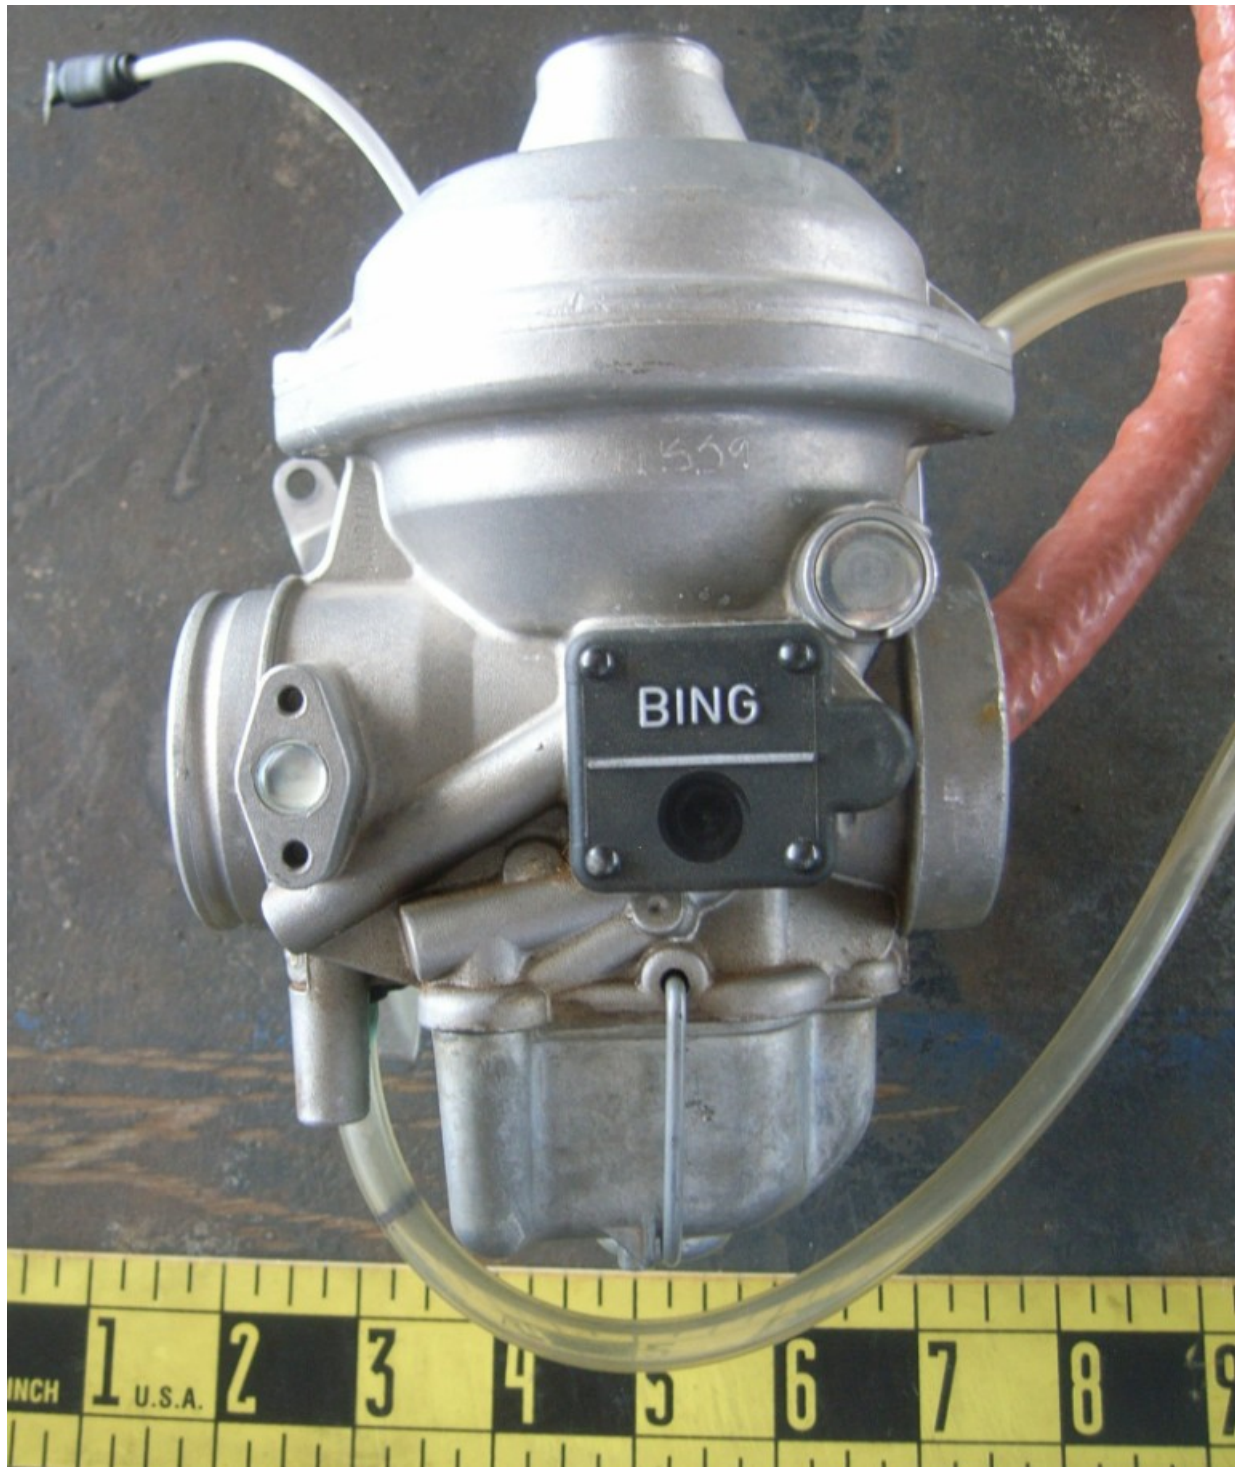
Figure 27 - Carburetor (left side)

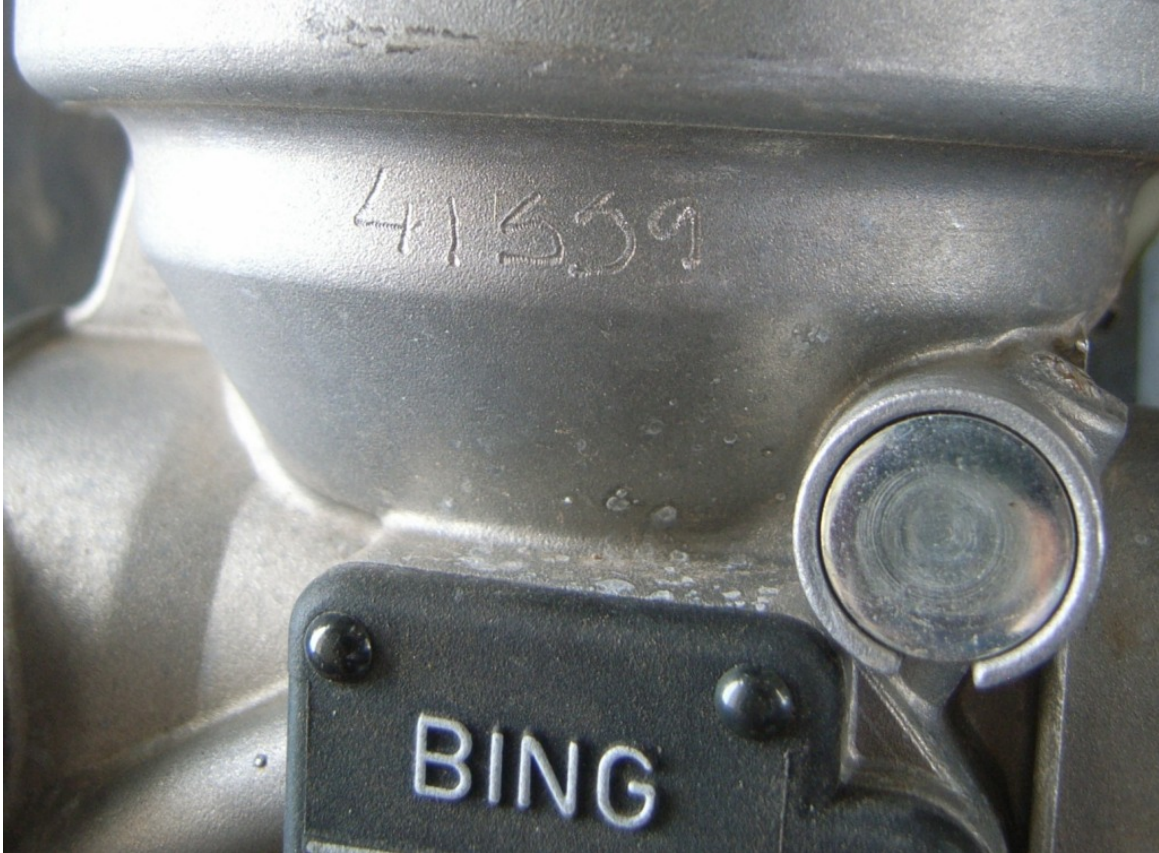
The Jabiru IM stated that a Bing constant-depression type 90/94 carburetor was to be used. The carburetor was a Bing model, and bore an engraved "41559" or "41SS9," plus a stamped "94/40/148." The IM stated that "This carburettor has a minimum delivery pressure of 5 kPa (0.75 Psi) and a maximum pressure of 20 kPa (3 psi). To confirm that the fuel system is capable of delivering this pressure a fuel flow test must be performed." The investigation was unable to determine the fuel system delivery pressure capability. The carburetor was set aside for additional examination and testing.

**Figure 28 - Carburetor Engraved ID Number**

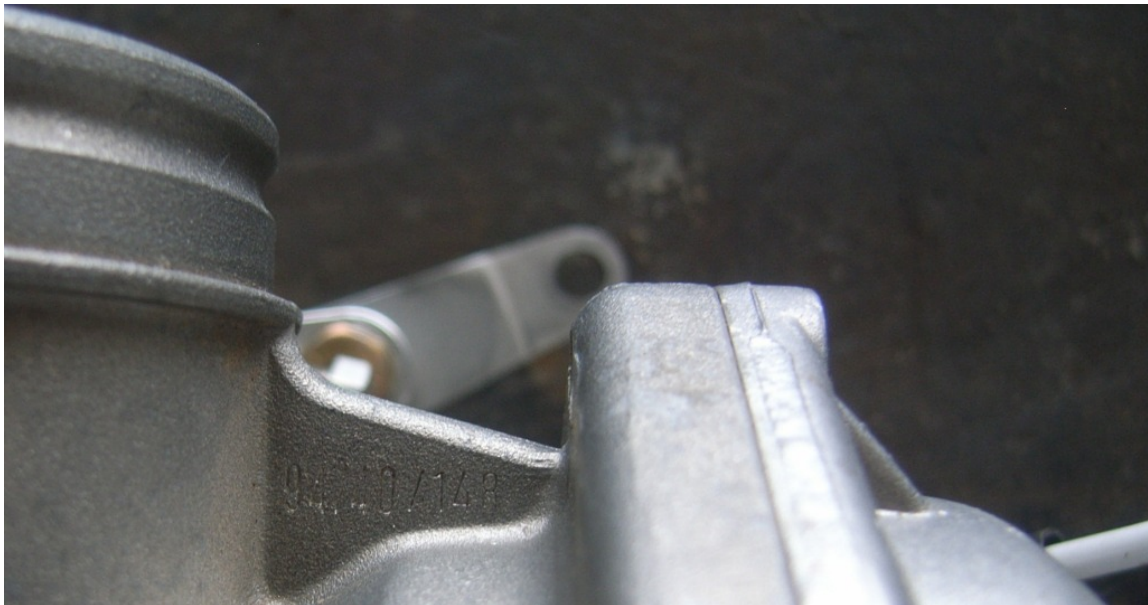
**Figure 29 - Carburetor Stamped ID Number**

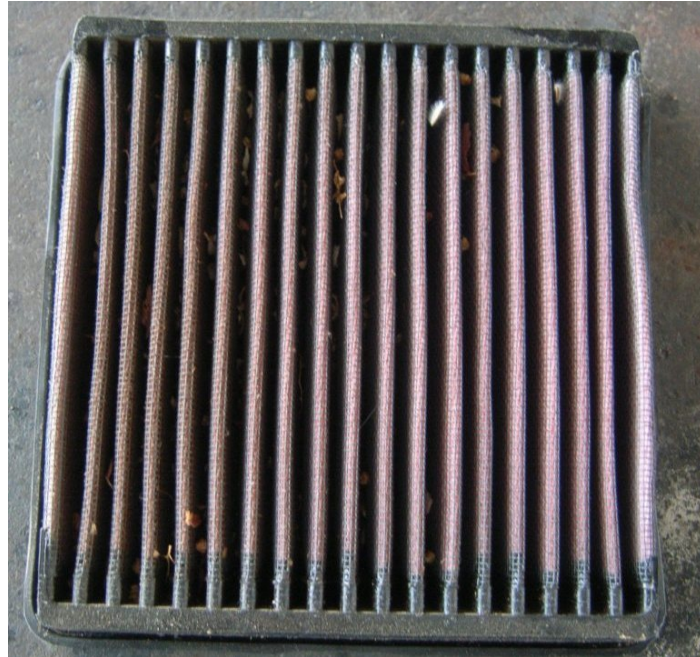
**Figure 30 - Air Filter**

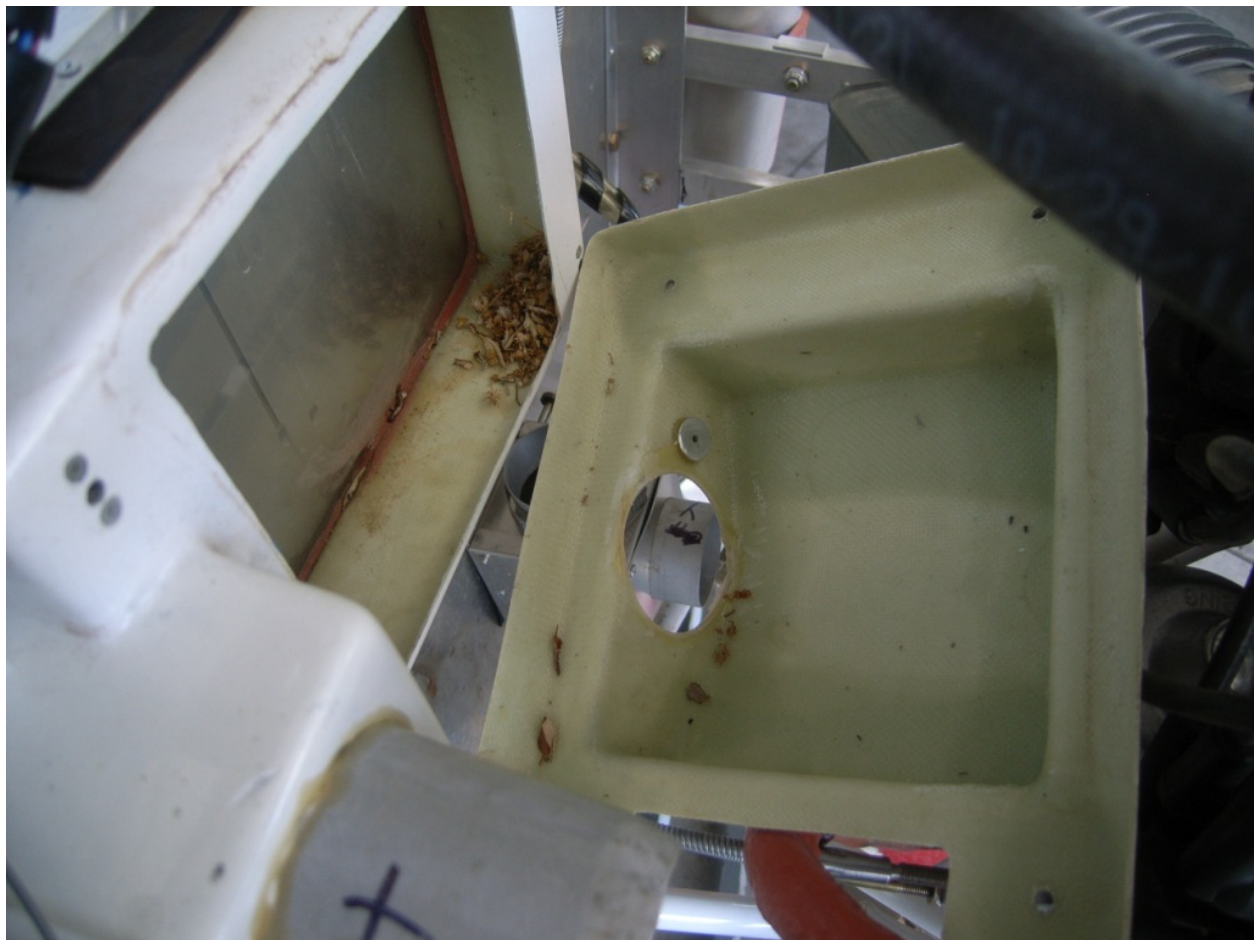
The HACman port (one end of Line C) that was installed on the "clean" side of the air filter box did not appear to be mounted in accordance with the IM; while the IM recommended a location that was in slow-moving air, the actual port was installed adjacent to the filter exit, in a region that would likely be relatively fast-moving airflow. (Figs 24 & 31)

**Figure 31 - Air Filter Airbox with Sense Port (small silver disc)**

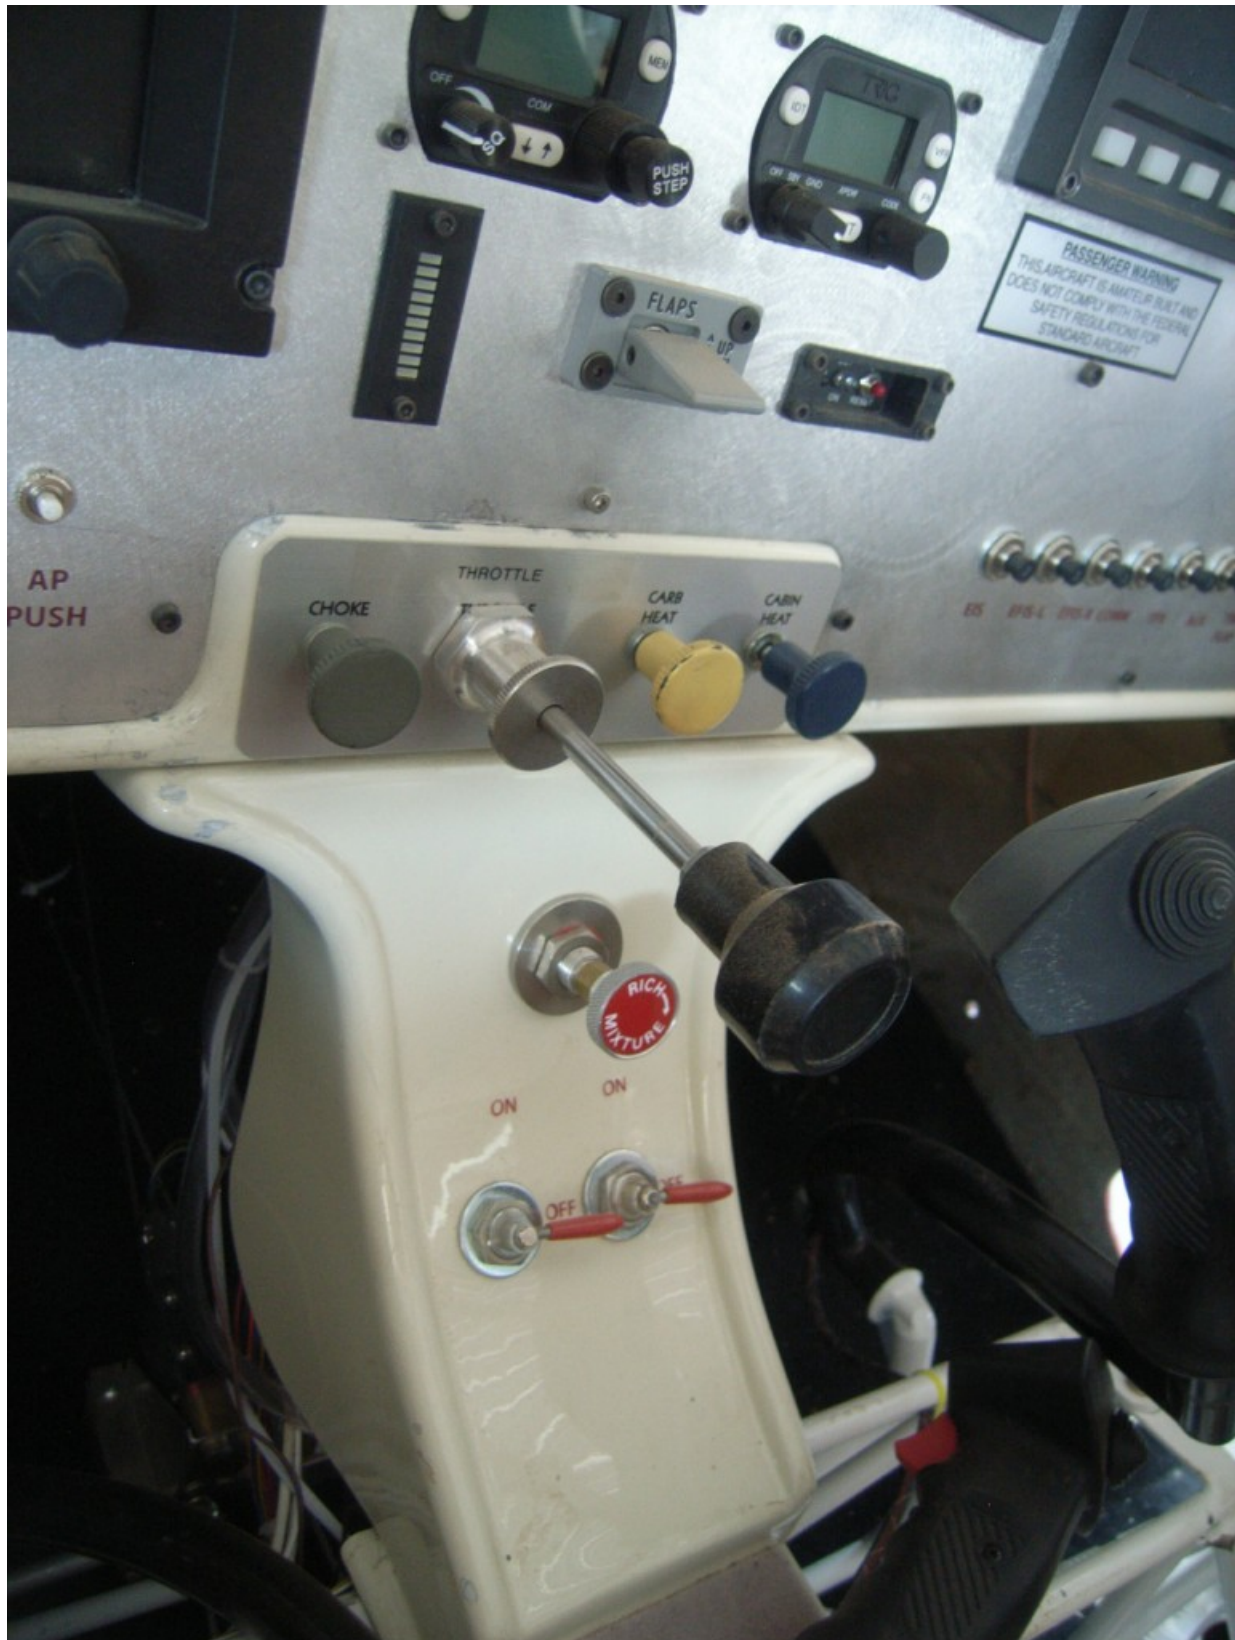
Figure 32 - Center Console

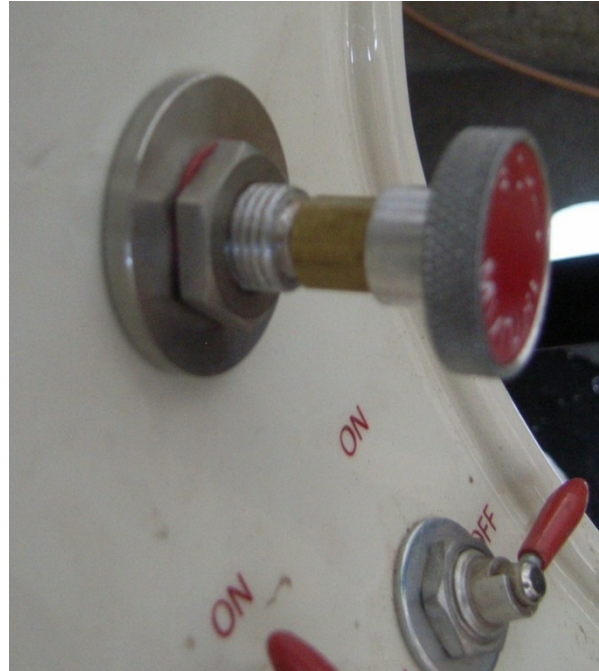
The pilot stated that the HACMan/mixture was full rich during the flight. Its was not sufficiently documented to determine its exact post-accident position/setting.

**Figure 33 - HACman (full rich setting)**

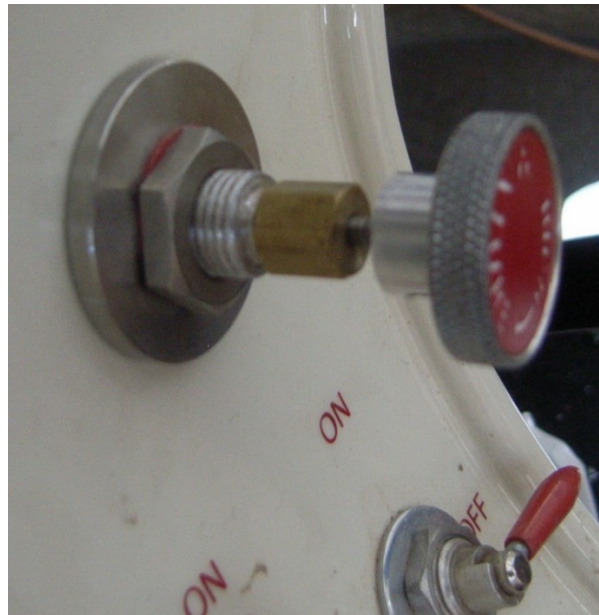
The Jabiru North America representative stated that Jabiru was aware of these HACman devices, and they reportedly smoothed engine operation when operating at altitudes above 6,000 to 8,000 feet, where the carburetor tends to run slightly rich. The representative also reported that at lower altitudes, improper setting (in the lean direction) could result in a fuel/air mixture that would not support engine operation.

**Figure 34 - HACman (leaned setting)**

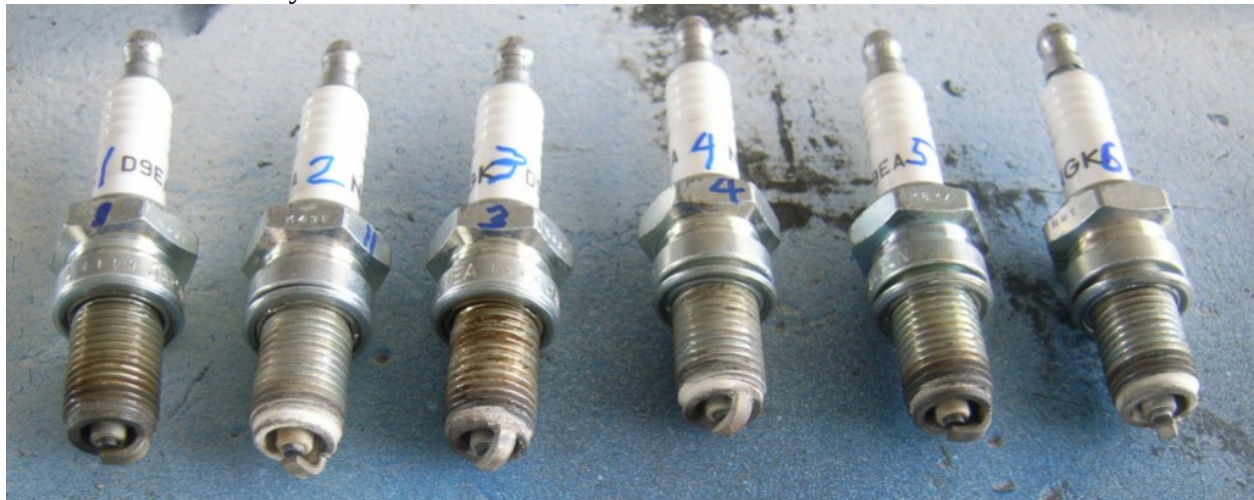
The ignition system was visually examined but not functionally tested. All components and leads were observed to be securely and properly installed. One spark plug from each cylinder was removed, and all electrodes appeared normal. The spark plugs were NKG brand model D9EA, which were as specified by Jabiru. Both distributor caps were removed, and the cap terminals and rotor ends all appeared normal.

Figure 35 - Spark Plugs

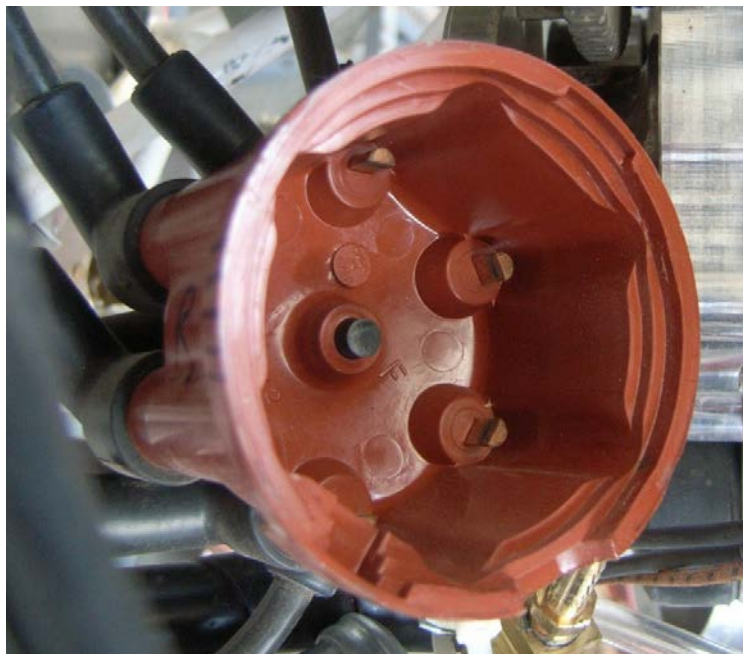
Figure 36 - Distributor Cap (typical)
