## **NATIONAL TRANSPORTATION SAFETY BOARD**

# **AIRFRAME AND ENGINE EXAMINATION**

**WPR17LA158**

Location: Ontario, California  
Date: July 19, 2017  
Aircraft: Enstrom F28C, Registration #5697B, Serial #505-2  
NTSB IIC: Samantha Link

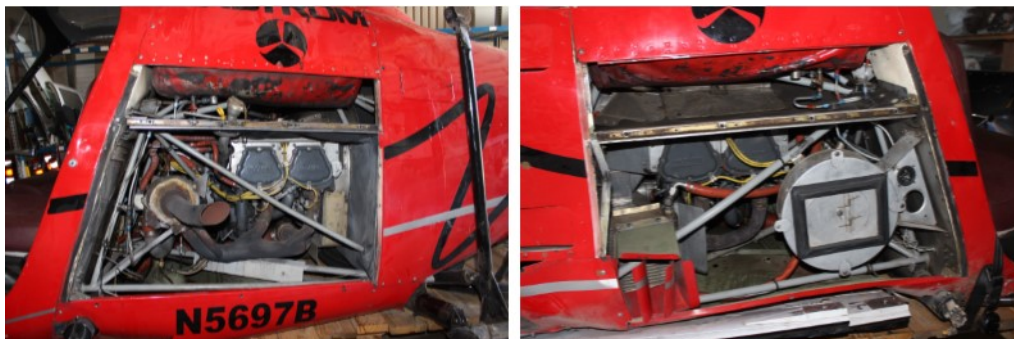
Figure 2: Sides of Engine

- Engine model: HIO-360-E1AD, Serial #L-17611-51A
- The engine cowling was removed
  - The engine remained situated in the helicopter as normal
  - No evidence of catastrophic mechanical malfunction or preimpact fire
- Control continuity was established from the engine controls to the cockpit controls.
- The bottom spark plugs were removed
  - Consistent with normal operations per the Champion check-a-plug chart
  - Free of mechanical damage or discoloration
- The engine was rotated at cooling fan in direction of normal rotation
  - Impulse coupling was heard clicking
  - Thumb compression was established in proper firing order on all 4 cylinders
- Cooling fan rotated freely in both directions
- Spark plugs were reinstalled and the helicopter was prepared to conduct an engine run

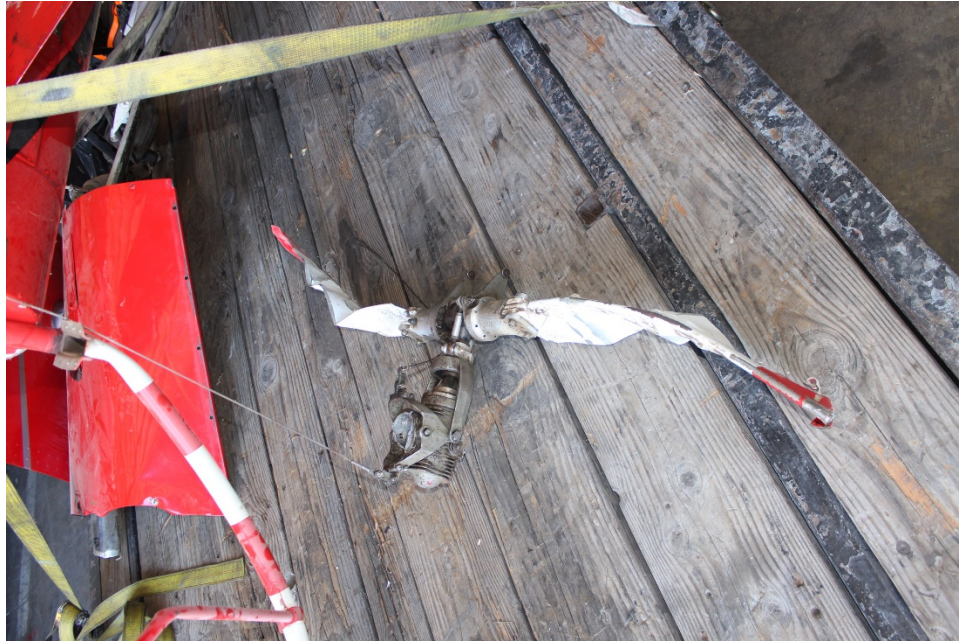
Figure 3: Tail Rotor

- Flight control continuity was established from the cockpit controls to the rotor head
  - One of the pitch change links was fractured at the bellcrank attachment point
    - Fracture was consistent with overload
    - The bellcrank responded accordingly when the cockpit controls were manipulated.
- The tail rotor gearbox housing was fractured and the tail rotor assembly was completely separated from the airframe.
  - The tail rotor blades remained attached to their hub and both sustained damage
- The tail rotor drive shaft was turned and rotation was observed at the tail rotor gear up to the main rotor mast
  - The sprag clutch was intact and was operationally tested

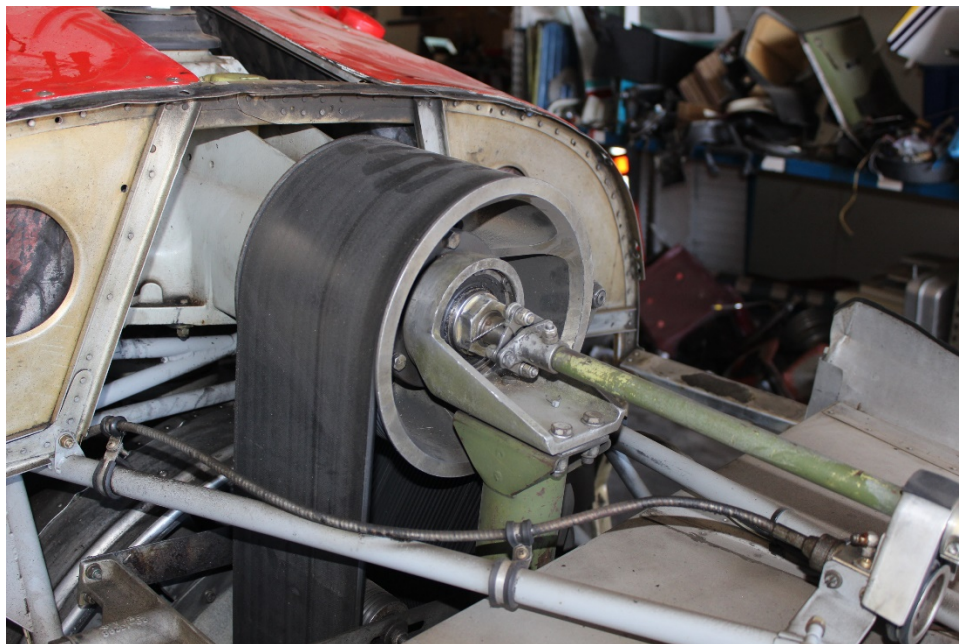
Figure 4: Main Drive Belt

- The rotor tachometer was disconnected at the drive shaft and a drill motor was connected. The gauge was functionally checked.
  - The tachometer drive gearbox “O” rings were intact at their respective pullies
- The main drive belt remained intact, undamaged, and properly positioned. The belt tensioning mechanism remained intact and functional.
- The three main rotor blades remained intact
  - The blades exhibited coning signatures and cordwise scratching striations across the lower blade surface.

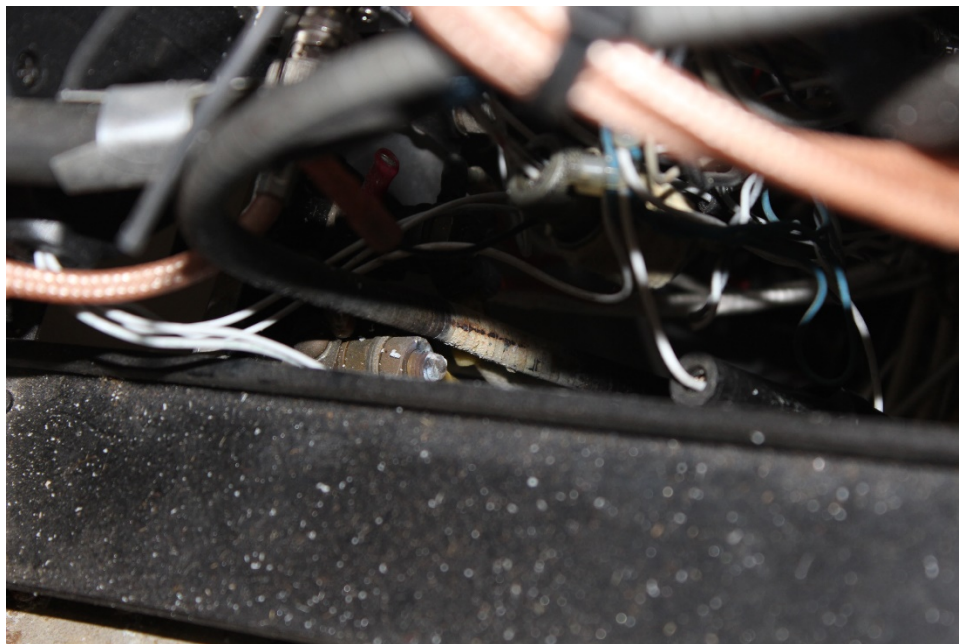
Figure 6: RPM Mechanical Tachometer Cable

- The helicopter was started using normal procedures
  - When the master switch was turned on, smoke came from the instrument panel. The helicopter was shut down and the instrument panel housing was removed
    - Further examination revealed the RPM mechanical tachometer cable was resting, and arcing, against the shunt terminal strip. The wire was discolored and extremely hot to the touch.
    - In addition, there was a nearby antenna in the instrument panel that also exhibited a melted area. It is unknown what this antenna was for.
- The wires were secured away from the terminal strip and the helicopter was started with no difficulty or anomalies.
  - No fuel or oil leaks were observed
  - Operating pressures and temps were normal
