## **NATIONAL TRANSPORTATION SAFETY BOARD**

### **ENGINE/AIRFRAME EXAMINATION SUMMARY**

**WPR17LA163**

Location: Las Vegas, Nevada  
Date: July 24, 2017  
Aircraft: N605GV; BAC STKMSTR MK80  
NTSB Investigator-in-Charge: Albert Nixon

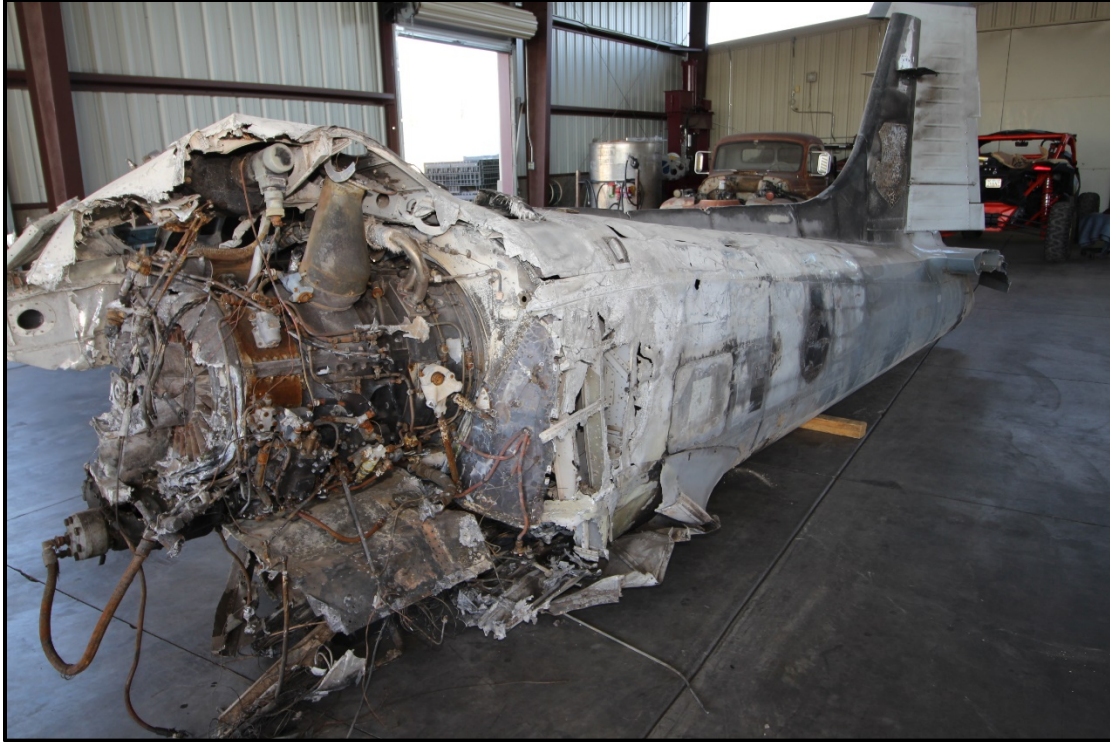
The front housing of the compressor and accessory gearbox was partially consumed by the post-crash fire. The turbine section and tailpipe did not exhibit any evidence of abnormal combustion.

Figure 1: Airplane wreckage prepared for the examination as viewed from the left side.

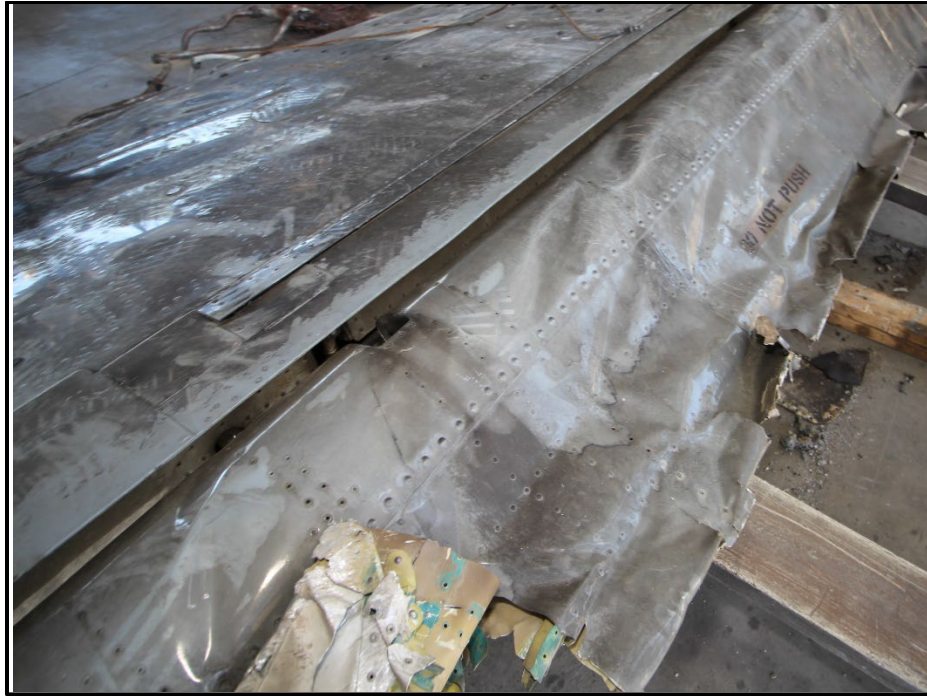
Figure 2: Right wing prepared for examination as viewed from the rear.

The right wing was separated from the fuselage and displayed some post-impact thermal damage at the leading-edge root. The aileron remained attached and some thermal damage was noted. The flap remained attached to the wing and exhibited some post-impact thermal damage. The flap was fully extended and remained attached to the wing and exhibited thermal damage. Soot observed on the leading edge of the flap was consistent with it being in the fully extended position. The spoiler remained attached to the wing and was in the non-deployed position and displayed soot. The soot was constant across the spoiler.

When the right flap was manually actuated, a red fluid was observed coming from the (hydraulic line) flap drive actuator, leaking to the ground where it had been cut during the recovery. Full actuation and flap panel movement was noted. The flap range was operated from the fully extended to the fully retracted position. The flap range of motion was from 1 ¼ (fully extended)

to 3 ½ (fully retracted) when measured at the flap actuator. The landing gear was retracted and locked in the fuselage. The spoiler was manually actuated, and no anomalies were noted.
