## **NATIONAL TRANSPORTATION SAFETY BOARD**

### **AIRFRAME EXAMINATION SUMMARY**

**WPR17LA164**

| Aircraft: | Piper PA-28R-180, N4594J |

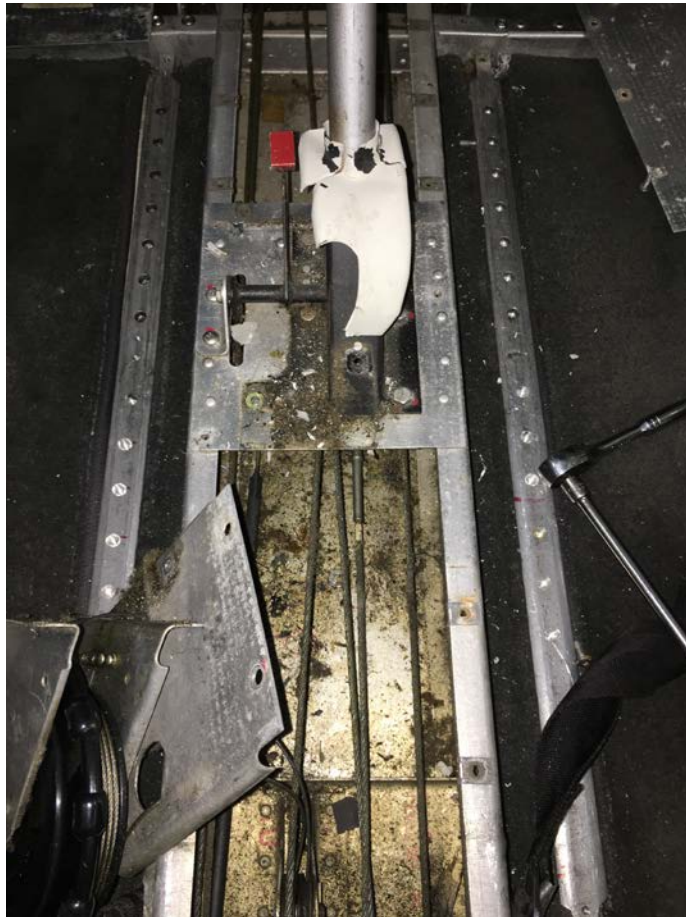
Examination of the recovered airplane revealed that the when the control yoke was rotated for input of right aileron, the left aileron moved upward and the right aileron moved downward. Examination of the aileron cables revealed that they remained attached to the “T” bar aileron control chains. The right aileron control cable was attached to the left side aileron control chain and the left aileron control cable was attached to the right-side aileron control chain. The cables were oriented in a nature that they crossed underneath the flap handle and center console area.

**Photo 1: View of the aileron control cables within the control cable tunnel.**

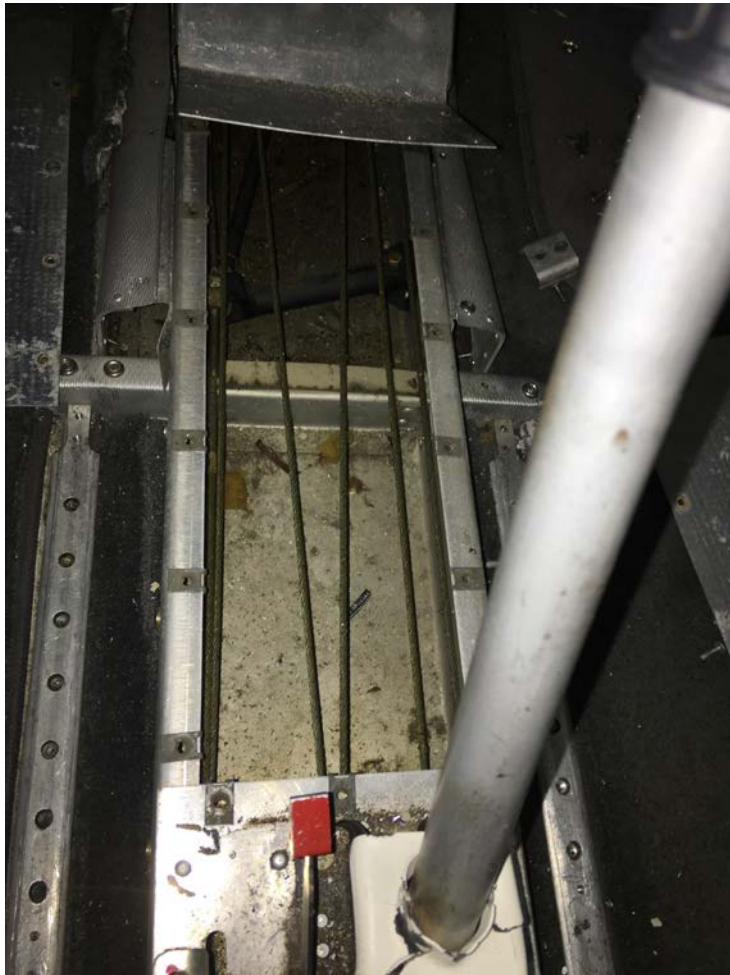
**Photo 2: View of the aileron control cables within the control cable tunnel.**
