**NATIONAL TRANSPORTATION SAFETY BOARD**  
Office of Aviation Safety-Eastern Region  
Ashburn, Virginia 20147  
July 17, 2018

**FUEL INJECTION SERVO EXAMINATION FIELD NOTES**

**Location:** Sutherlin Lake, MT  
**Date:** July 24, 2017  
**Time:** 1930 CST  
**Aircraft:** N233JD, Robinson R44 II

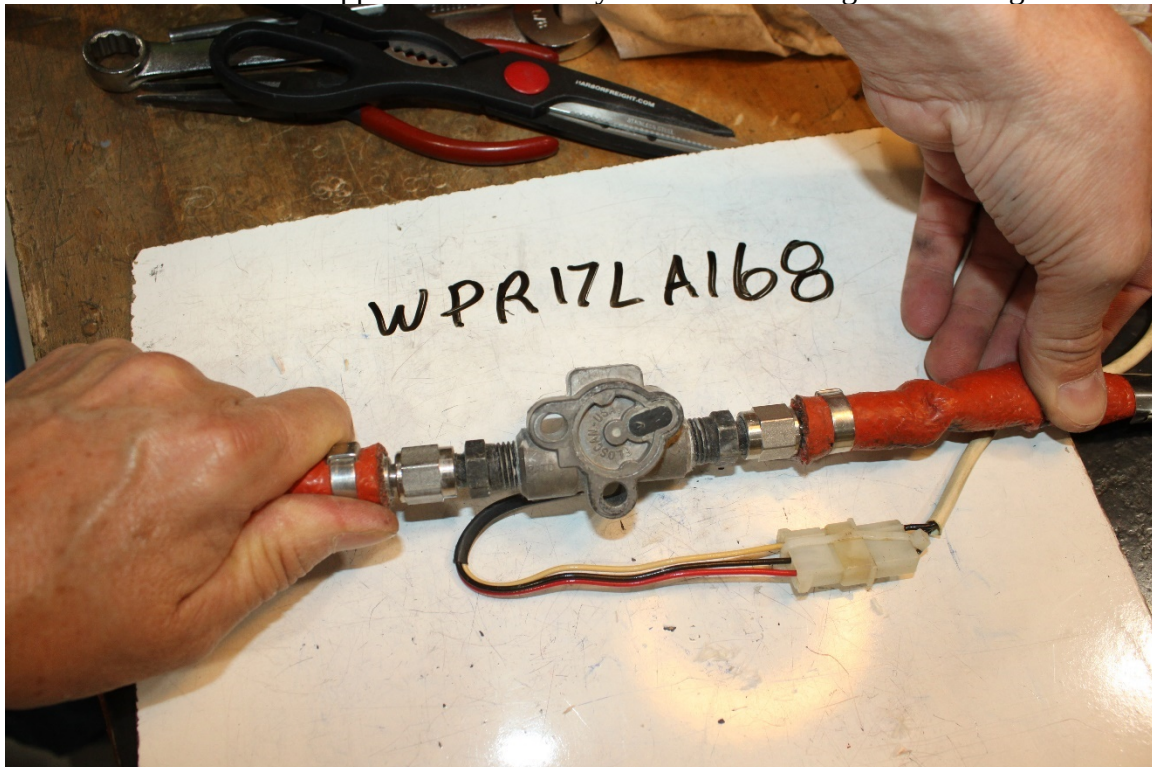
Examination of the Avstar Fuel Systems fuel injection servo, model RSA-10AD1, S/N AV22748451, parts list AV2576630-4 revealed the inlet fitting was not capped and was open to the environment. A flexible fuel hose with fire sleeve and attached fuel flow meter which was covered by a fire sleeve remained connected to the outlet fitting which was also not capped and open to the environment. The fire sleeve that covered the fuel flow meter was cut off exposing the fuel flow meter (Figure 1) which was marked with "Floscan Model 201", stamped with "134626", and marked in permanent marker with "2954." Examination of the fuel inlet strainer revealed slight fuzz about 1 inch inside the strainer. The mixture control spring was in-place, and the idle mixture screw was located towards the lean position. Following partial removal of the data plate, a number engraved on the body of the fuel servo "AV22748481" did not match the S/N engraved on the data plate<sup>1</sup>. The regulator hex plug was stamped with "G" indicating compliance with Precision Airmotive LLC Service Information Letter (SIL) RS-88. The gasket beneath the regulator hex plug was identified as part number 2577258.

Figure 1: View of the fuel flow meter installed onto the outlet flexible fuel hose

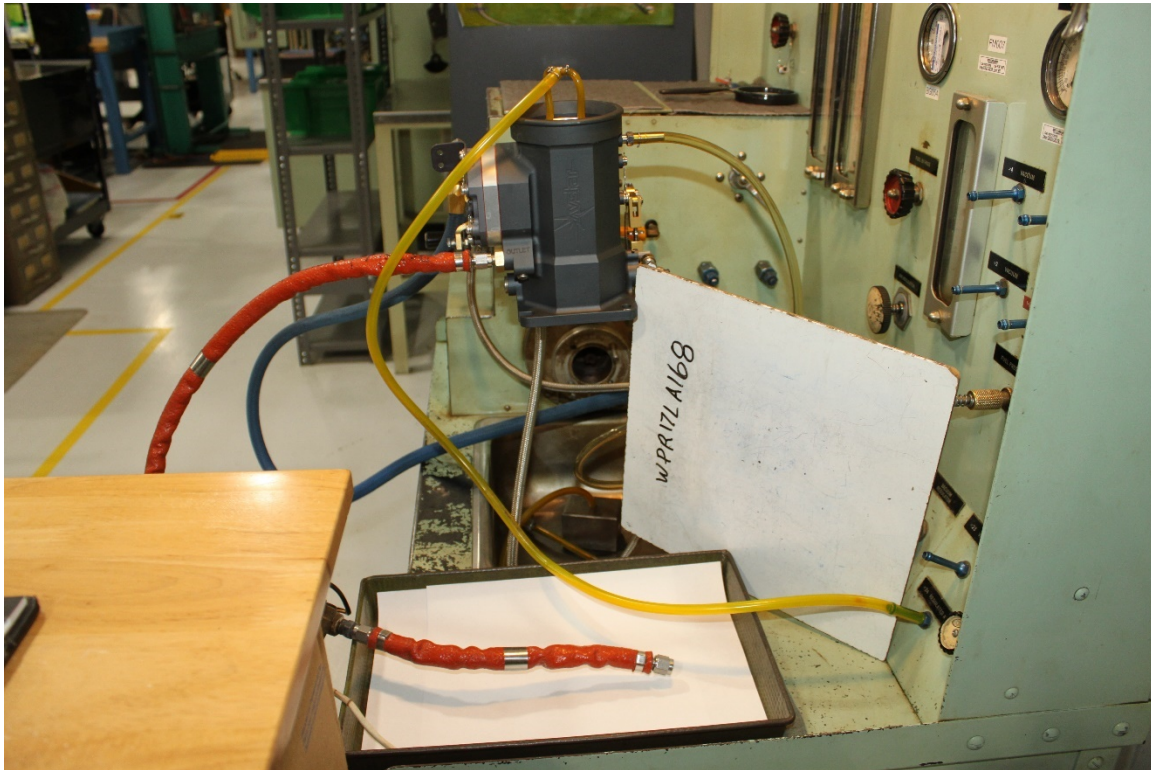
The fuel servo was placed on the test bench as received with a flexible fuel hose with attached fuel flow meter attached to the outlet fitting. The throttle plate was set at 0.036 inch (production units are set to 0.026 inch). The fuel servo manufacture representative indicated that the throttle plate is field adjustable. The fuel servo was flowed onto white paper (Figure 2). No contaminants or water was noted during the first fluid coming from the unit. The unit was subjected to production bench test limits (calibration limits), which consisted of 5 test points<sup>2</sup>. The unit flowed within calibration limits at 3 of the 4 test points (Test Points 3, 4, and 5), but flowed 3.0 pounds-per-hour (PPH) high at Test Point 1 when compared to the production (calibration) limits and 1.95 PPH high when compared with allowed service limits<sup>3</sup>. At Test Point 2, which is a check of idle cut-off, 1 drop in 30 seconds was noted, which calculated to be 2.0 drops in 1 minute (maximum allowed 100 drops in 1 minute). The travel check, pressure and hysteresis checks were satisfactory. The idle fuel flow was recorded to be 17 PPH with the throttle plate set at 0.026 inch, which was 2.0 PPH greater than specified. The bench test results were documented in Attachment 1 to this report.

Figure 2: View of the fuel servo on the test bench before testing. Note the outlet flexible fuel hose in a pan with white paper.

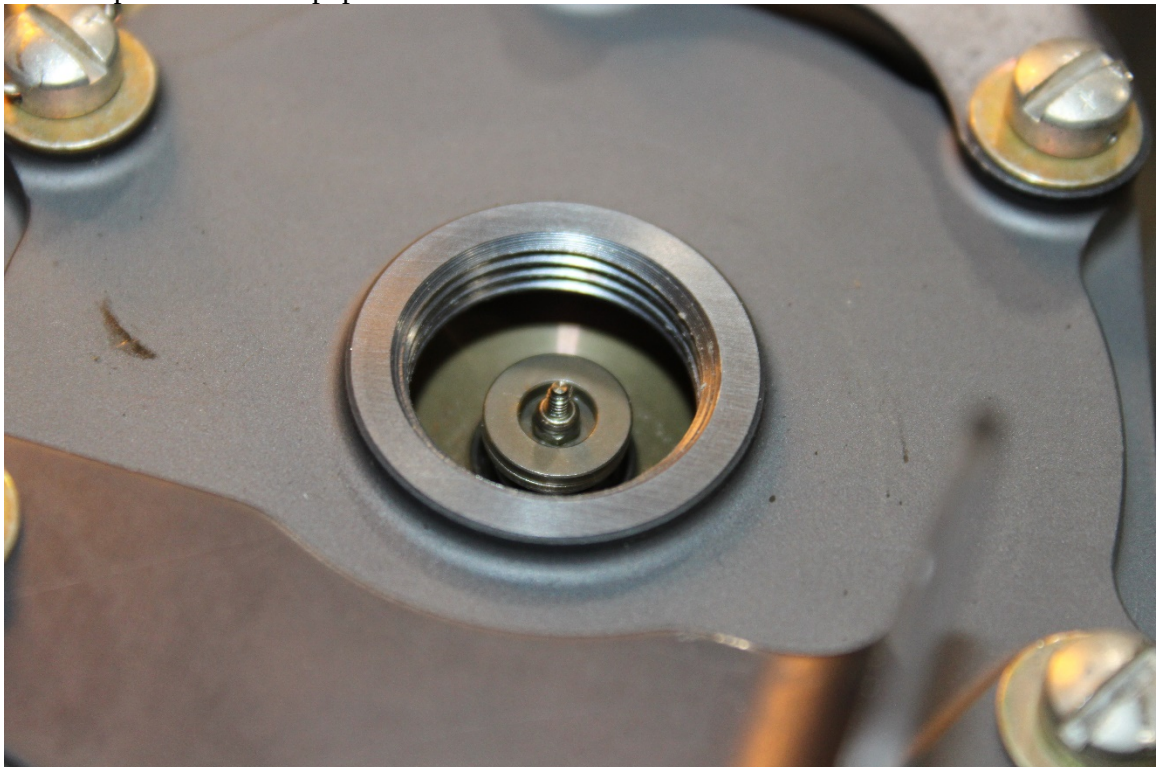
Disassembly examination of the fuel servo revealed the regulator lock nut was in-place (Figure 3). The fuel servo body regulator section exhibited very light contamination. The center body air side had white powder from the impact tubes (Figure 5). The fuel diaphragm stem was intact. The center body and air diaphragm had white contamination and a line consistent with water submersion (Figure 6). The air diaphragm and regulator cover (low pressure area) had residue (Figure 7). The air venturi was clean (Figure 8). The idle valve and mixture valves were satisfactory (Figures 9 and 10), and the valve train area was satisfactory. The unit was loosely reassembled.

Figure 3: View of the Regulator Nut in Place

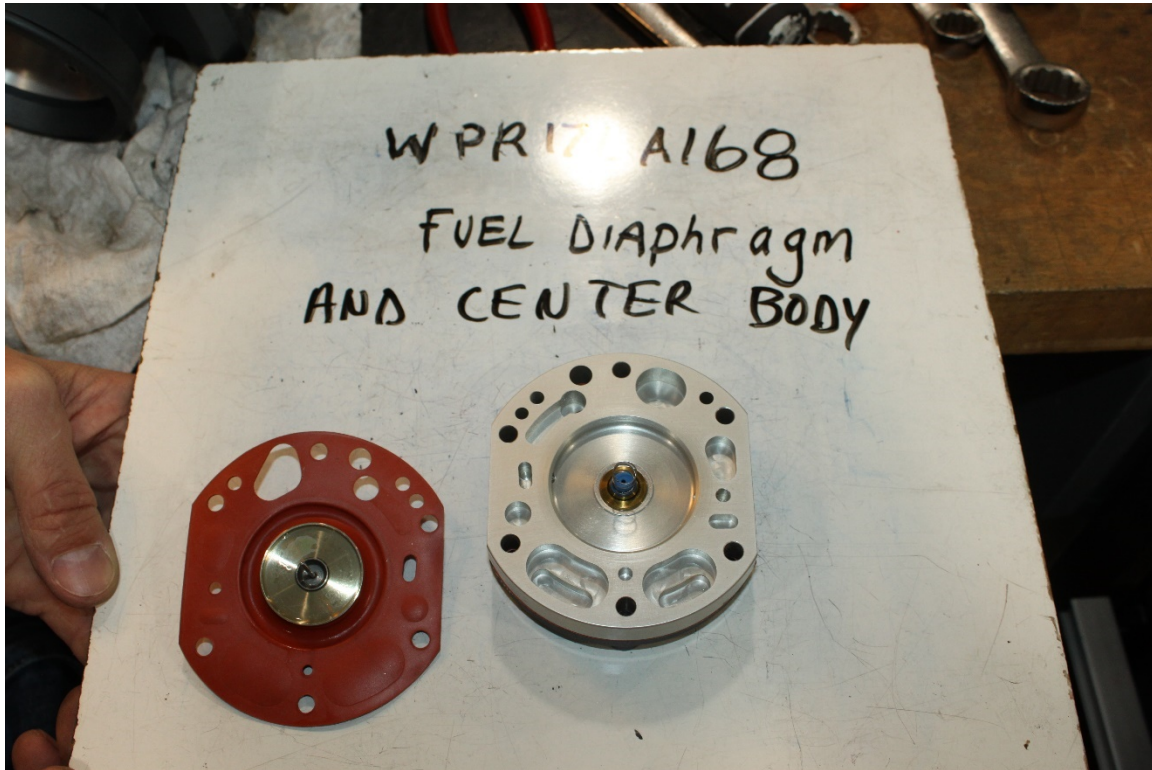
Figure 4: Fuel of the Fuel Diaphragm and Fuel Side of the Center Body

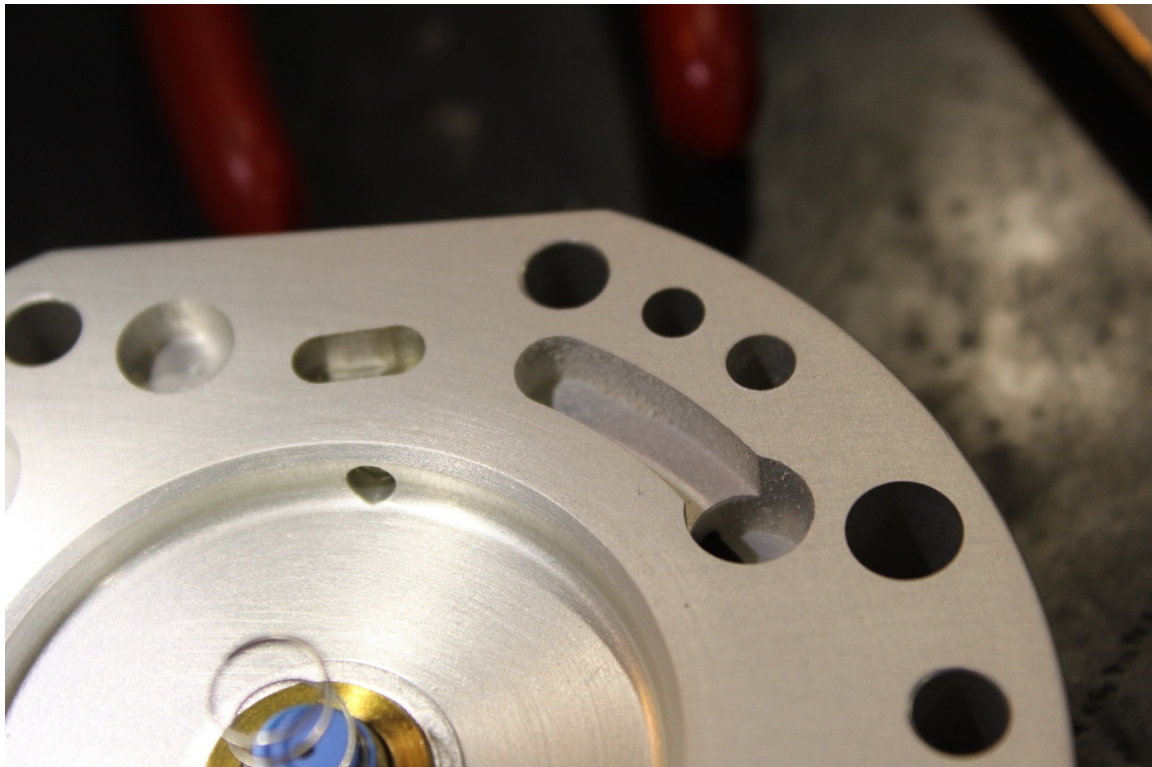
Figure 5: View Showing the White Residue in the Air Side of the Center Body

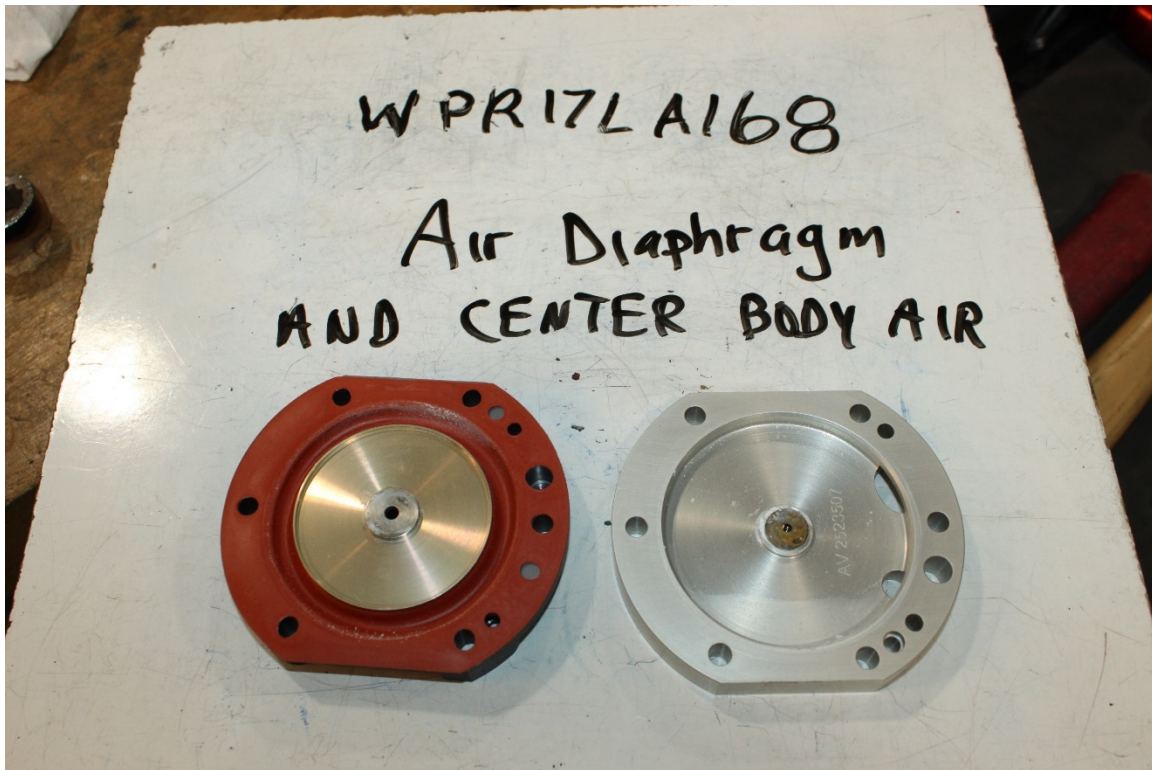
Figure 6: Air Diaphragm and Air Side of the Center Body Showing Contamination and Line.

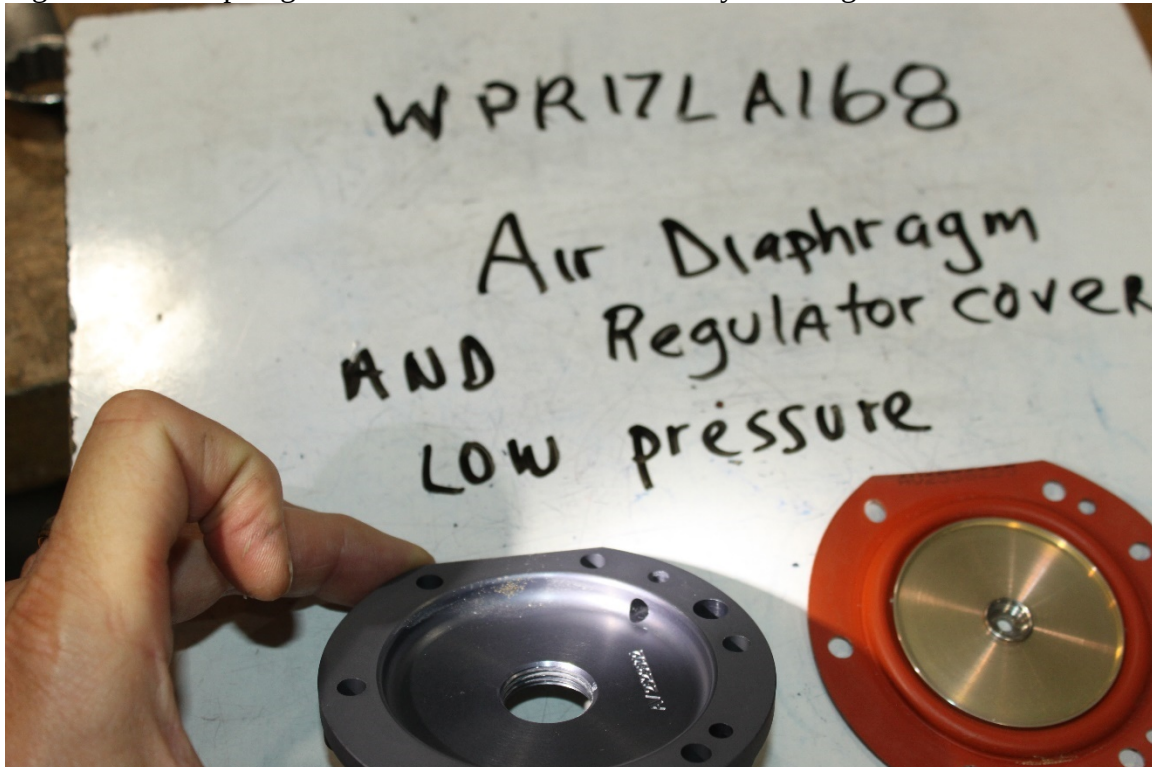
Figure 7: View Showing the Slight Contamination in the Regulator Cover and Air

Diaphragm.

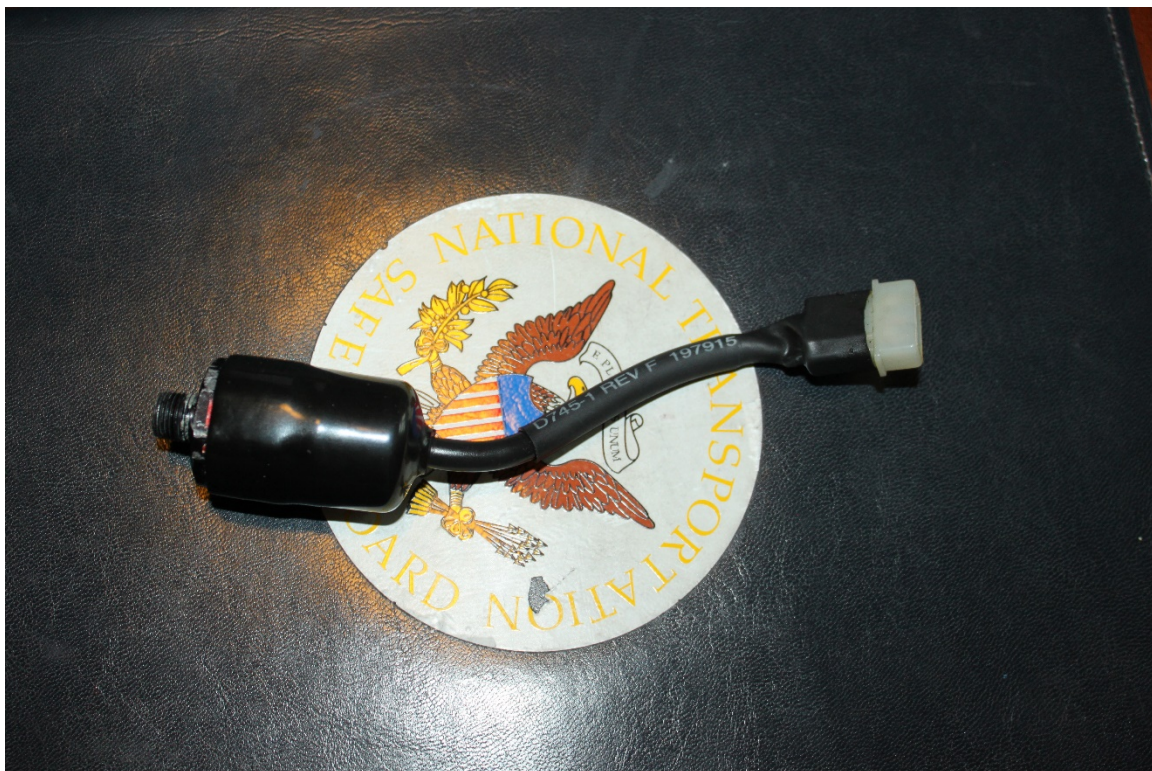
Examination of the separate device shipped with the fuel servo (Figure 11) revealed the thin paper type data plate found around the hexagon shaped sensor portion of the device was damaged but the remains of "Wasco" was readable. The attached electrical lead was covered with black shrink wrap which was marked with "D745-1 Rev F" and "197915".

Figure 11: View of the Wasco Pressure Switch and attached Electrical Lead
