# Continental Motors

## ENGINE EXAMINATION REPORT

| ENGINE MODEL | O300D (6) |
| CMI FILE NUMBER | 17-076 |

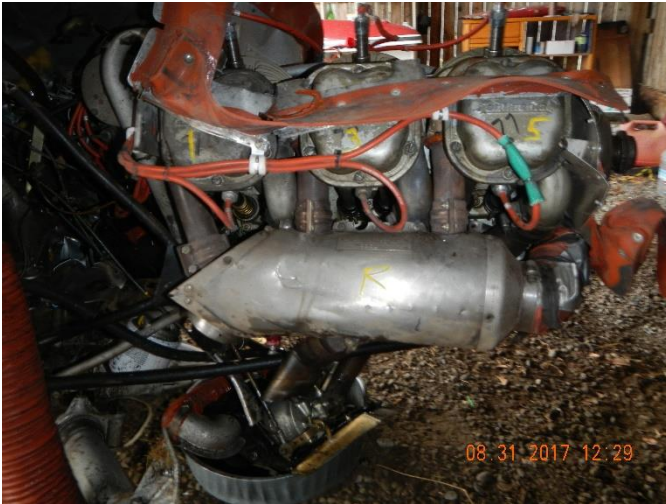
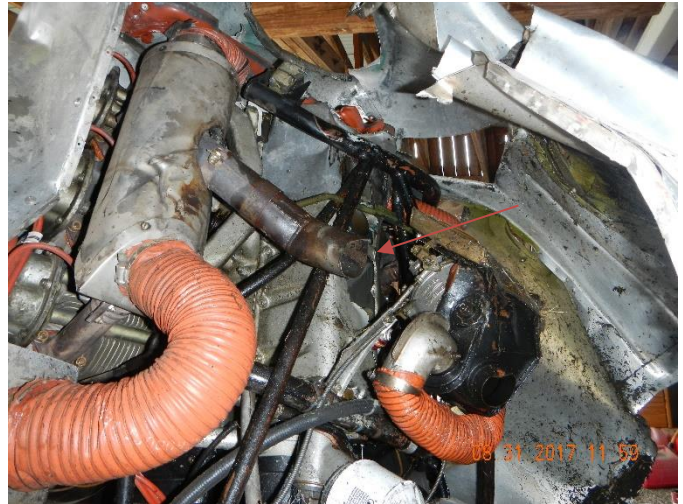
#### EXHAUST SYSTEM

Condition: The left and right muffler remained attached. The tailpipes received impact damage.

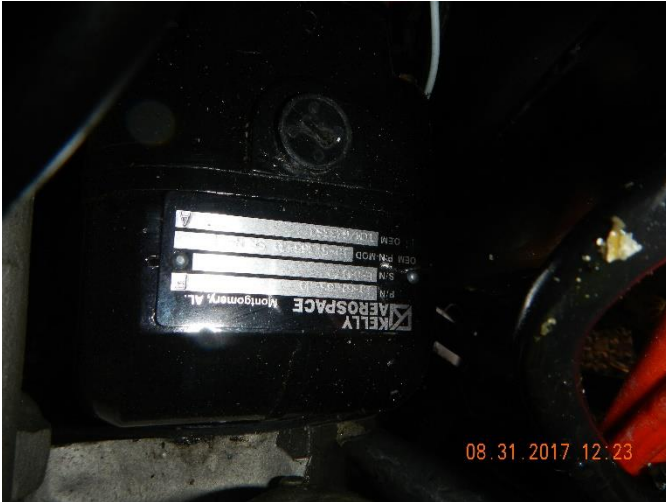
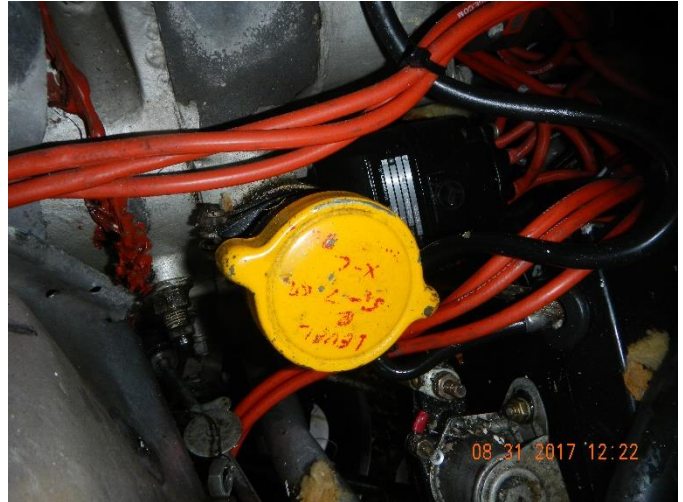
| <b>LEFT MAGNETO</b> | Manufacturer: TCM<br>overhauled by Kelly<br>Aerospace | P/N: 10-51365-39 | S/N: E04172 |

| Condition: | The left magneto exhibited no damage. | | |

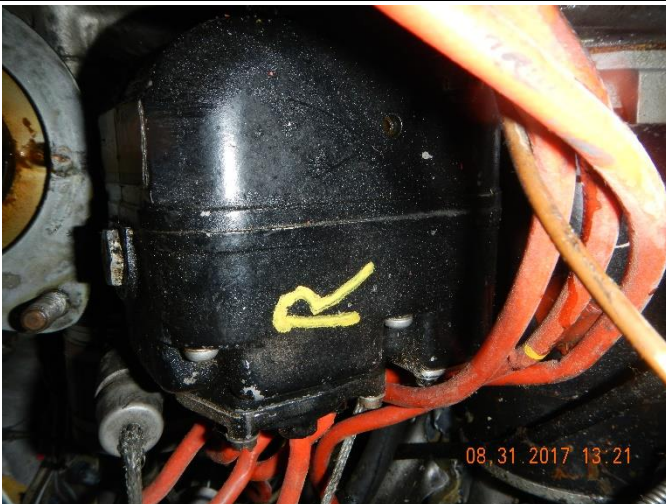
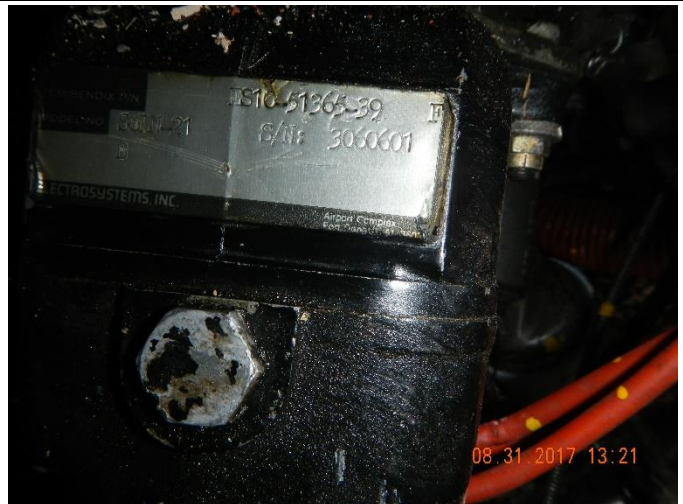
| <b>RIGHT MAGNETO</b> | Manufacturer: TCM<br>overhauled by<br>Electrosystems | P/N: 10-51365-39 | S/N: 3060601 |

| Condition: | The right magneto exhibited no damage. | | |

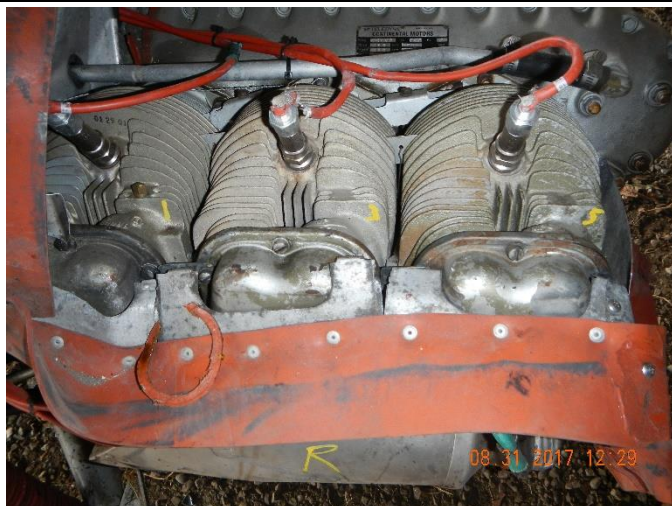
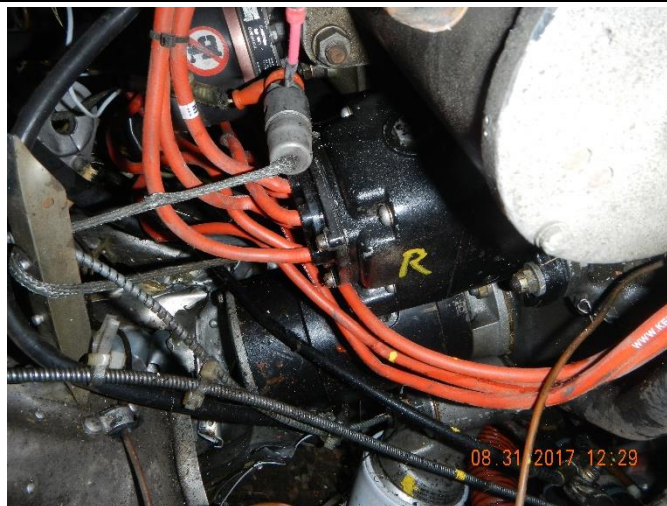
## IGNITION HARNESS

Condition: The ignition harness exhibited impact damage at sparkplug connections on cylinders one, three and five.

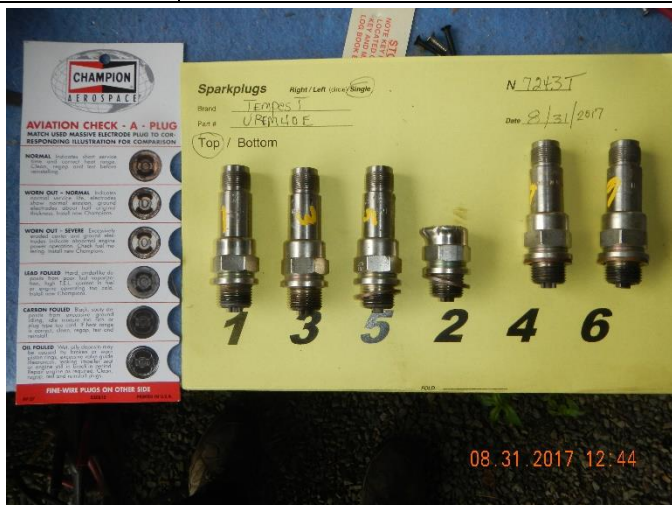
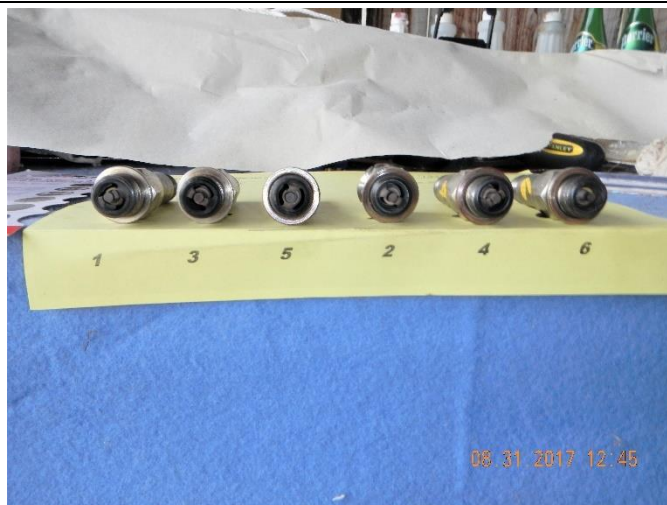
## SPARK PLUGS

Condition: The sparkplugs appeared to be new and were intact with the exception of the top sparkplug removed from cylinder # 2. When compared to a Champion "Check-A-Plug" chart, the conditions were *normal*. All four sparkplugs exhibited a slightly darker than normal color and exhibited an odor consistent with auto fuel.

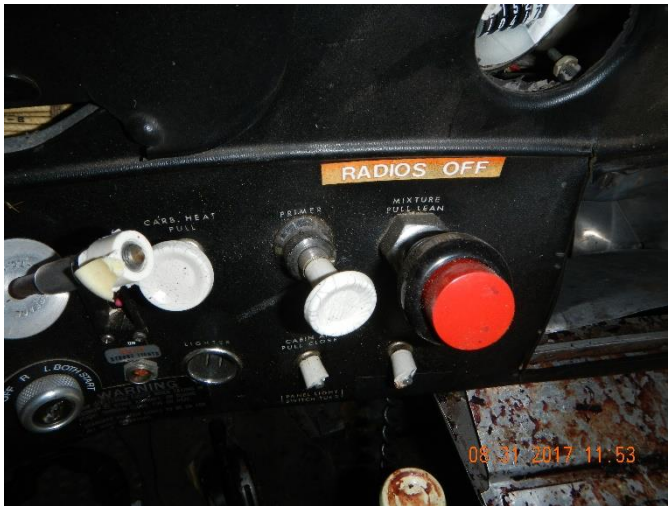
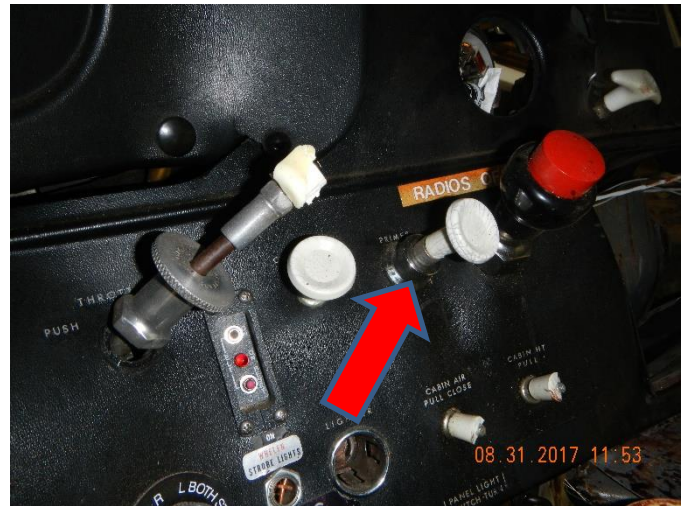
| FUEL PRIMER | Manufacturer: Cessna | P/N: Undetermined | S/N: Undetermined |

| FUEL PRIMER | Manufacturer: Cessna | P/N: Undetermined | S/N: Undetermined |
|---|---|---|---|
| Condition: | This fuel primer is located with other engine controls in the lower center of the cabin instrument panel. The primer was found in an <b>unlocked</b> position. See red arrow. | | |

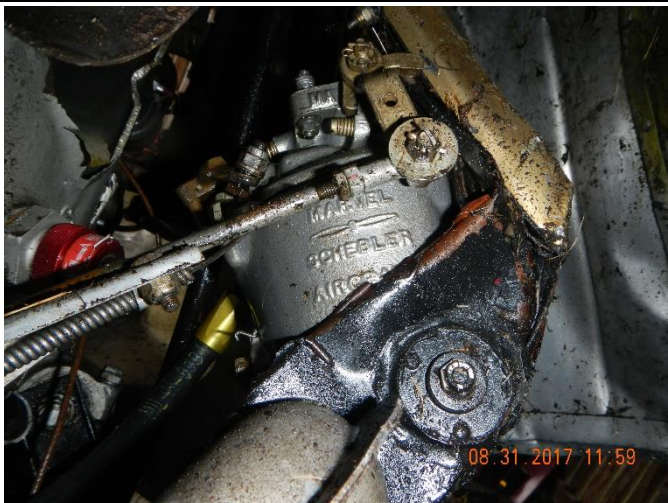
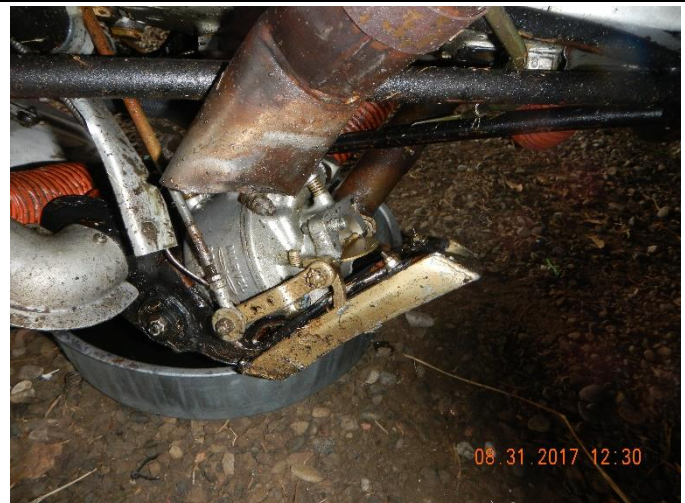
| CARBURETOR | Manufacturer: Marvel Schebler/Precision | P/N: 10-4895-1 | S/N: 545642 |
|---|---|---|---|
| Condition: | The carburetor was undamaged with the exception of the mounting flange which partially separated. The throttle plate was in the wide-open position as was the cabin control. Throttle and mixture arms and cables remained secured. Control cable continuity was confirmed from the instrument panel to the carburetor. The carburetor exhibited an odor consistent with auto fuel. | | |

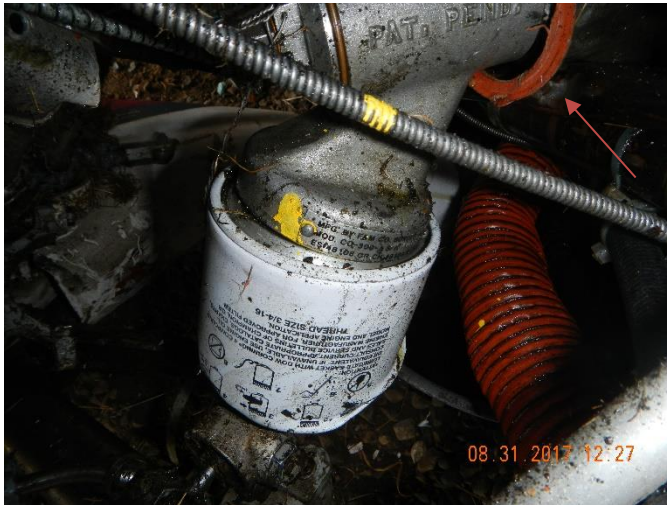
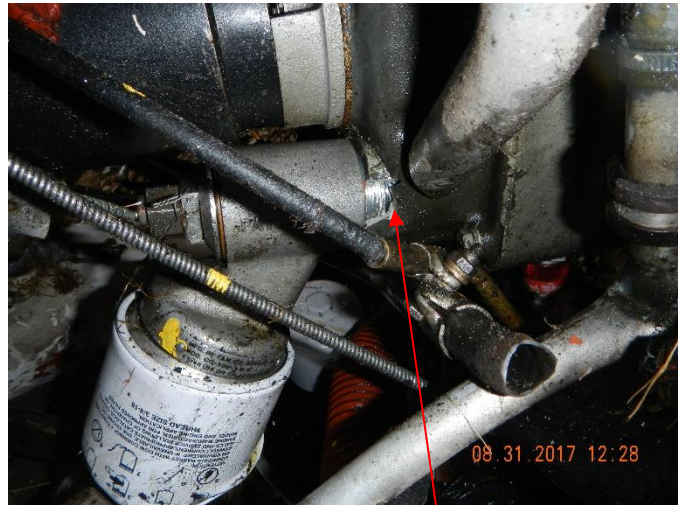
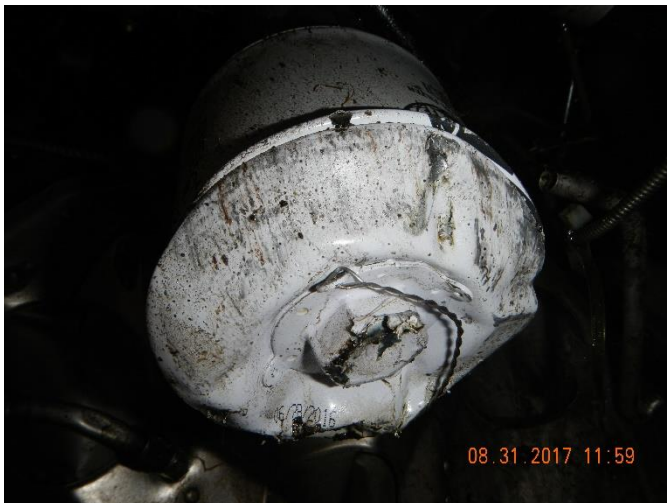
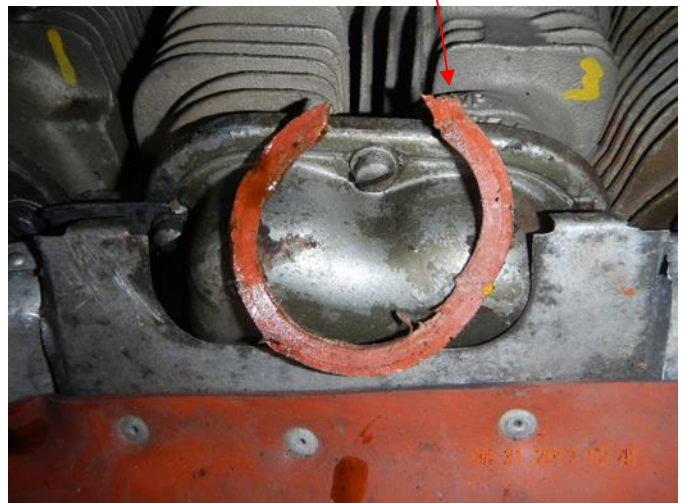
#### OIL FILTER

Condition: The oil sump was impact damaged allowing most of the engine oil to escape.

Condition: The aftermarket spin-on-oil filter and oil filter adapter received impact damage. A red silicone type gasket separated from the oil filter adapter mount.

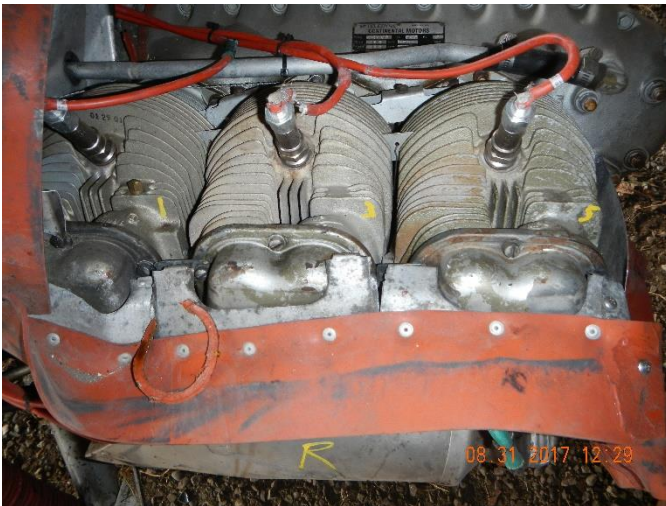
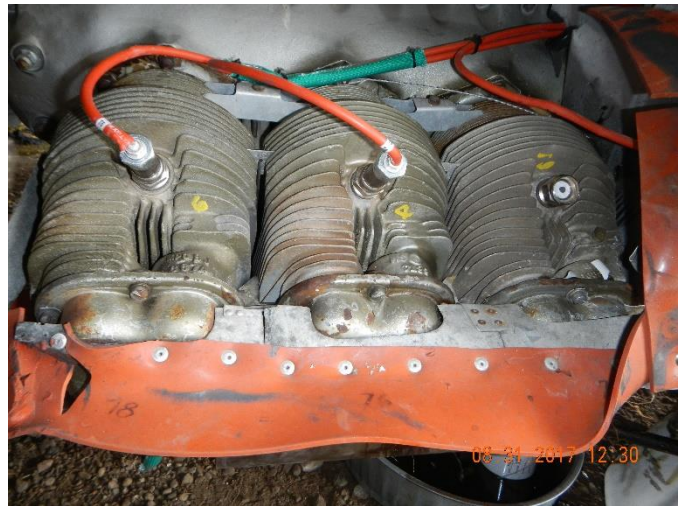
### CYLINDERS

**Condition:** All cylinders remained attached to its respective base and no impact damage was noted. A lighted electronic borescope inspection was performed. All intake and exhaust valves were examined and found intact. Normal to dark combustion signatures were noted on valve faces and piston domes. Rocker covers were removed to observe rocker arm movement

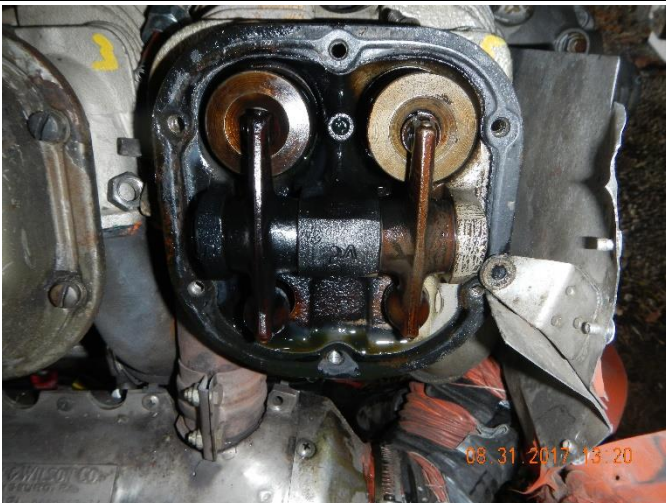
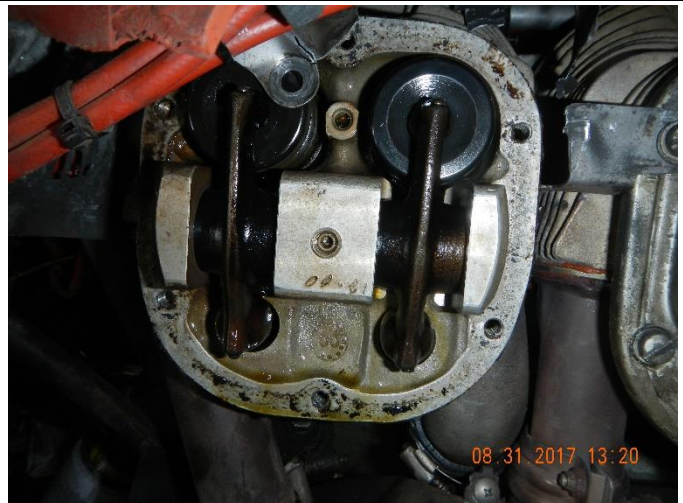
### ROCKER ARMS AND SHAFTS

**Condition:** All rocker arms and shafts were intact and movement was noted when the engine was partially rotated (manually).

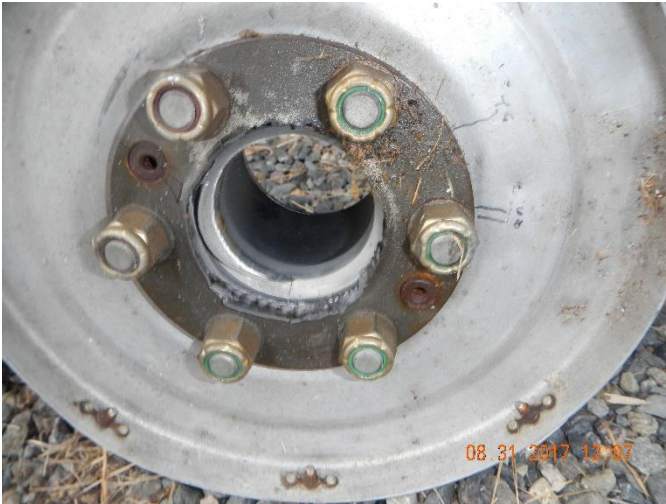
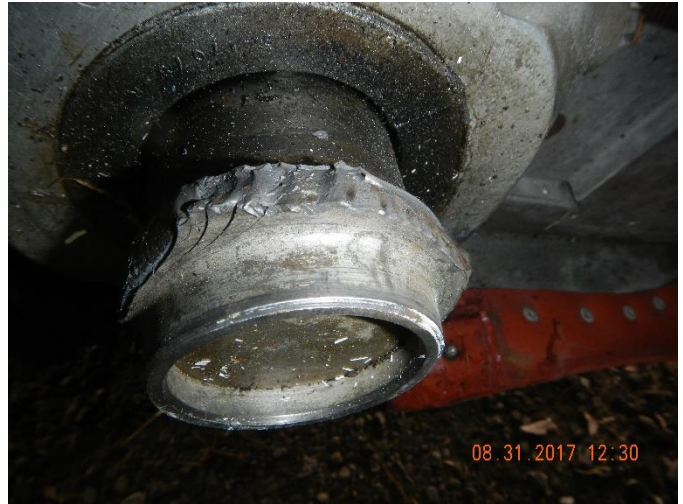
### CRANKSHAFT ASSEMBLY

The two-blade metal, fixed pitch propeller separated from the engine at the crankshaft propeller flange. The propeller flange remained attached to the propeller with what appeared to be improper hardware. The propeller mounting bolt lengths were too short. Threads must protrude two-three threads outboard of the nut in order for the nylon locking feature to operate correctly. The propeller mounting bolt threads were flush with the outer portion of the self-locking nuts with no threads protruding. The fracture surface of the exposed portion of the damaged crankshaft exhibited 45-degree shear lips and diagonal ladder cracks across the radius.

| Condition: | The crankshaft separated at the propeller flange. The break exhibited 45 degree shear lips and ladder cracks around the diameter of the shaft. | | |

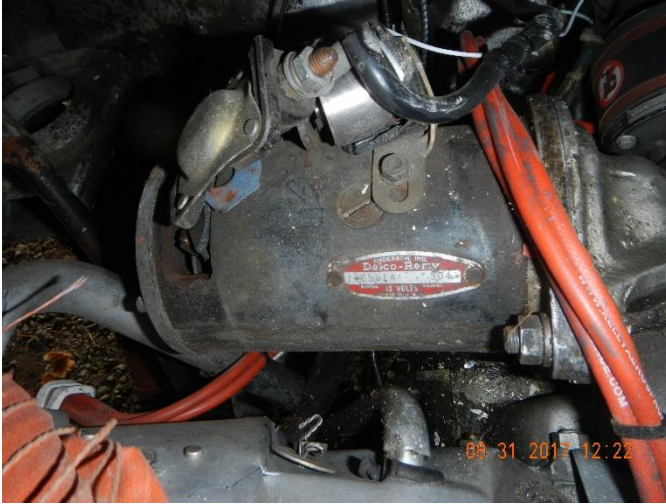
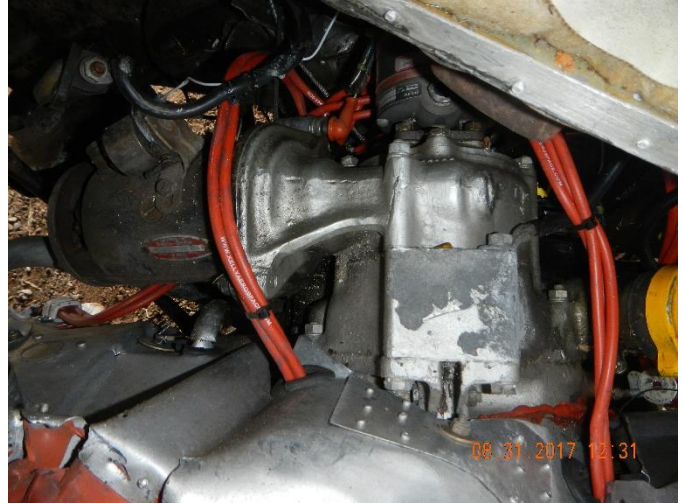
| STARTER | Manufacturer: Delco Remy | M/N: 1109514 | S/N: 304 |

| Condition: | No damage was noted. | | |

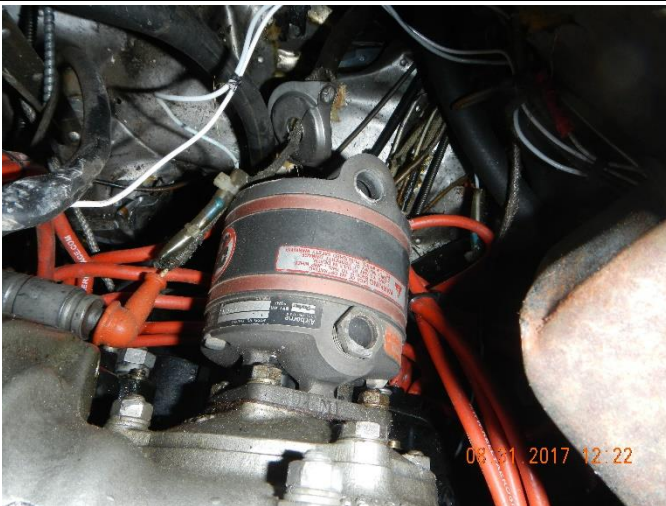
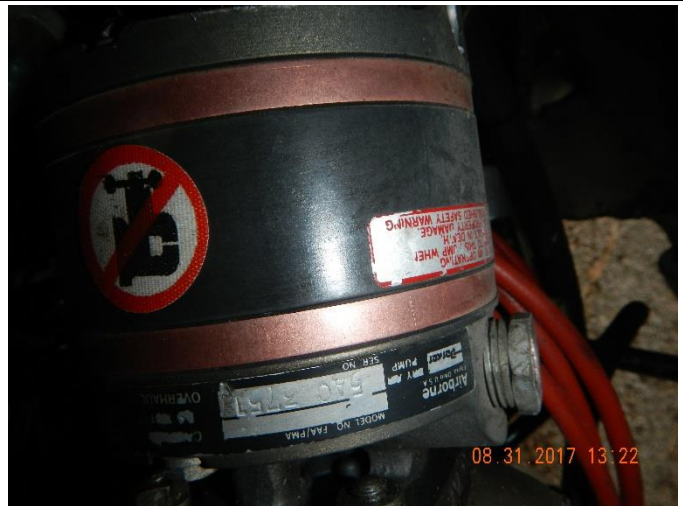
| VACUUM PUMP | Manufacturer: Airborne | P/N: Undetermined | S/N: 5AC-3757 |

| Condition: | The vacuum pump remained intact and attached. The data plate was worn and the model number obscured. The input and output fittings separated. | | |
