## **NATIONAL TRANSPORTATION SAFETY BOARD**

# **AIRFRAME AND ENGINE EXAMINATION**

**WPR17LA172**

Location: Llano, California  
Date: July 31, 2017  
Aircraft: Cessna T-210F, N6109R, Serial # T210-0009  
NTSB IIC: Michael Huhn

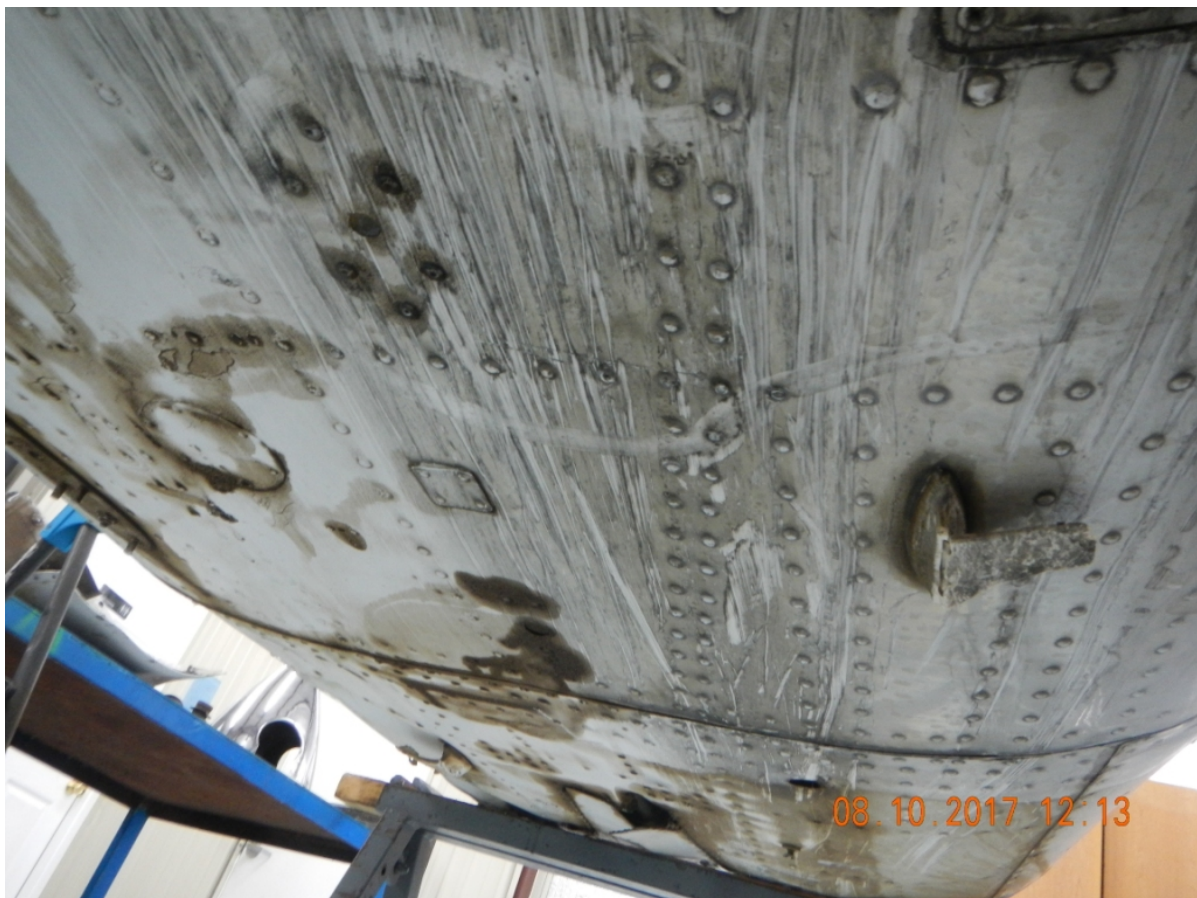
The wings, vertical stabilizer and elevator had been removed by the recovery crew. The engine, propeller and engine cowlings remained intact and in place. An examination of the external fuselage, including the belly, revealed the presence of oil and/or grease on some the surfaces, which had then resulted in an accumulation of dust. The oil/grease was generally consistent with normal in-service levels, particularly on the fuselage sides. The belly accumulation was slightly heavy, but could not on its own be considered as indication/confirmation of an oil leak or overboard venting that would account for the complete loss of engine oil. No oil was dripping from the fuselage. Recovery personnel stated that there was no oil staining on the ground at the accident site, and that no oil had leaked or dripped onto the trailer used to recover the airplane.

**Figure 1 - Oil on Airplane Underside (view forward)**

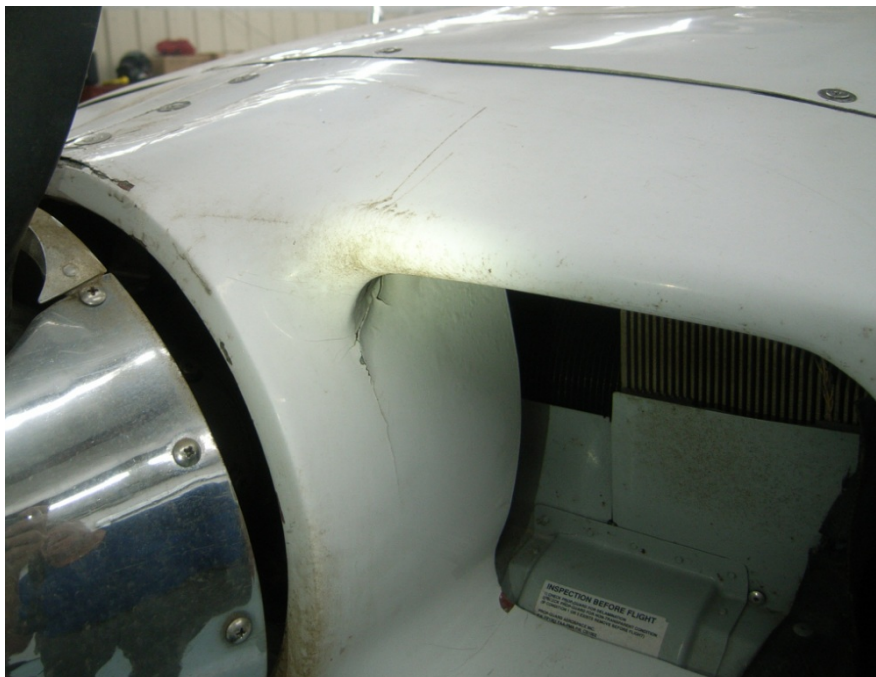
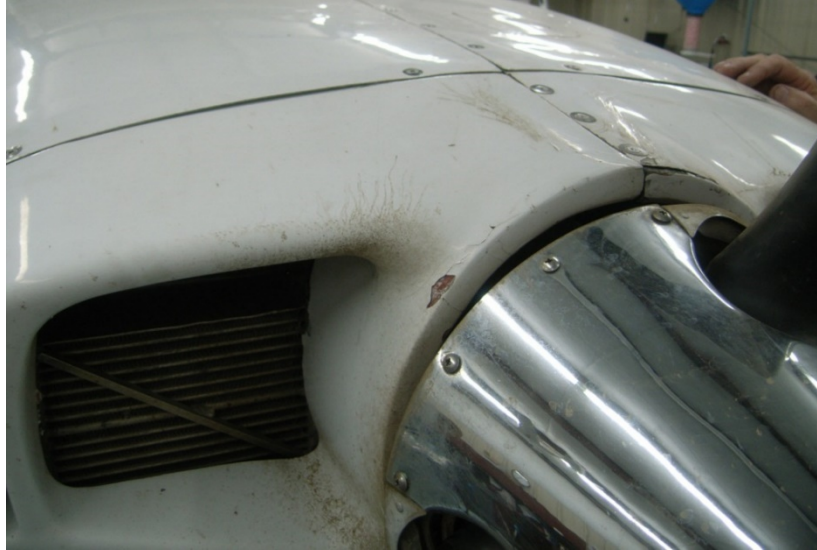
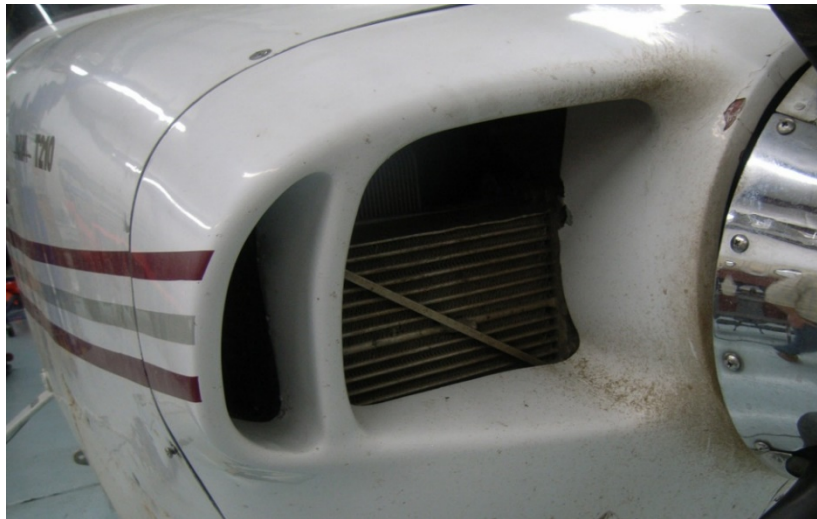
There was some evidence of possible oil on the exterior cowling near the cooling air inlets, and its source was not obvious, nor was it consistent with the complete loss of oil. No oil residue was observed on the wings, horizontal stabilizers, or elevators.

**Figure 6 - Trace Oil Residue on Inlet**

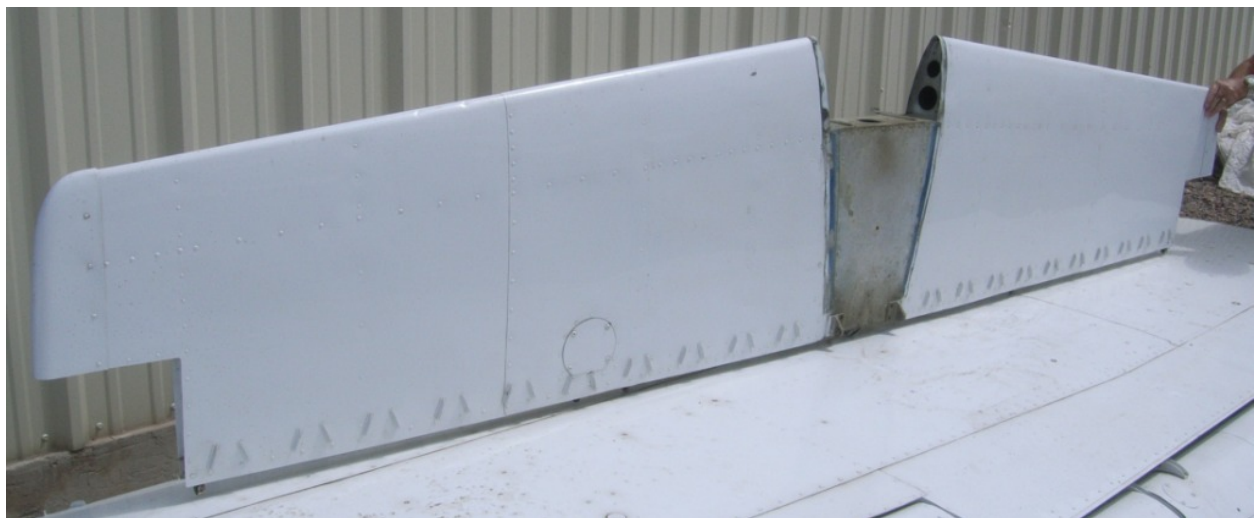
**Figure 9 - Oil-Free Horizontal Stabilizers and Wings**

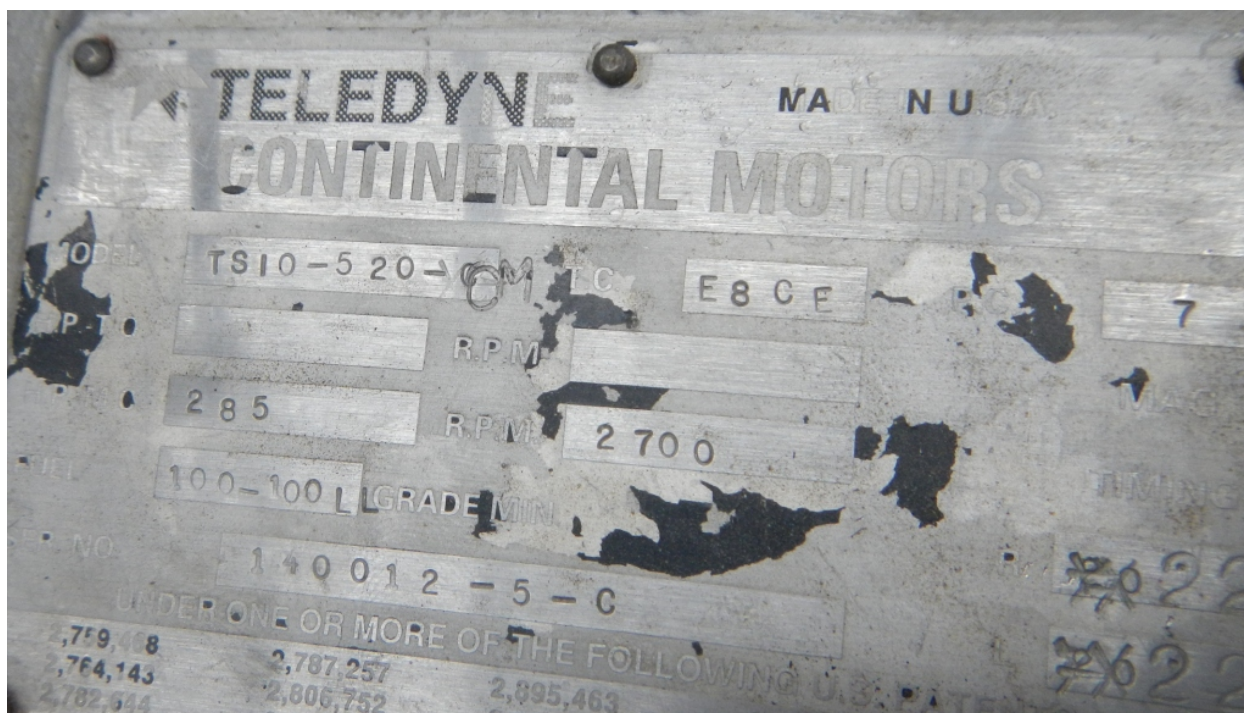
Figure 15 - Engine Data Plate

Model: TSIO-520-C (overstamped with a "C" and an "M")

The "C" overstamp denotes a "field conversion" (modified by other than CMI) of the engine, and the "M" denotes the resulting (new) engine model. The CMI-manufactured TSIO-520C engine is rated at 285 hp at 2700 rpm. The CMI-manufactured TSIO-520M engine is rated at 310 hp for takeoff (5 minutes maximum) at 2700 RPM, 285 hp continuous operation, and 230 hp recommended cruise. The accident airplane data plate was not modified to show these (or any) changes to the power rating.

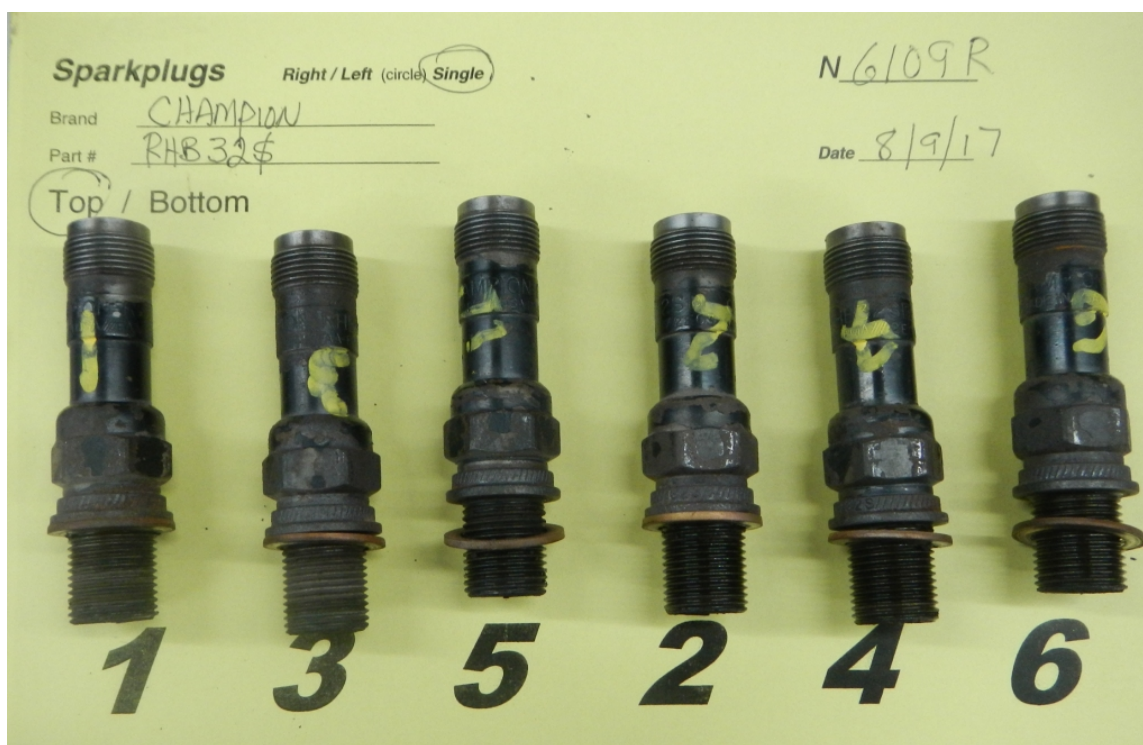
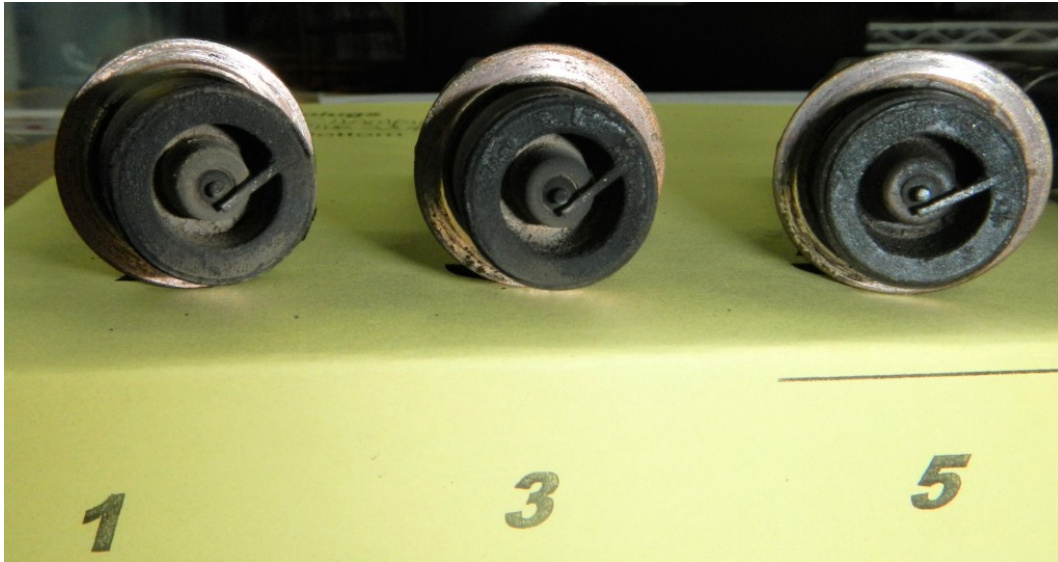
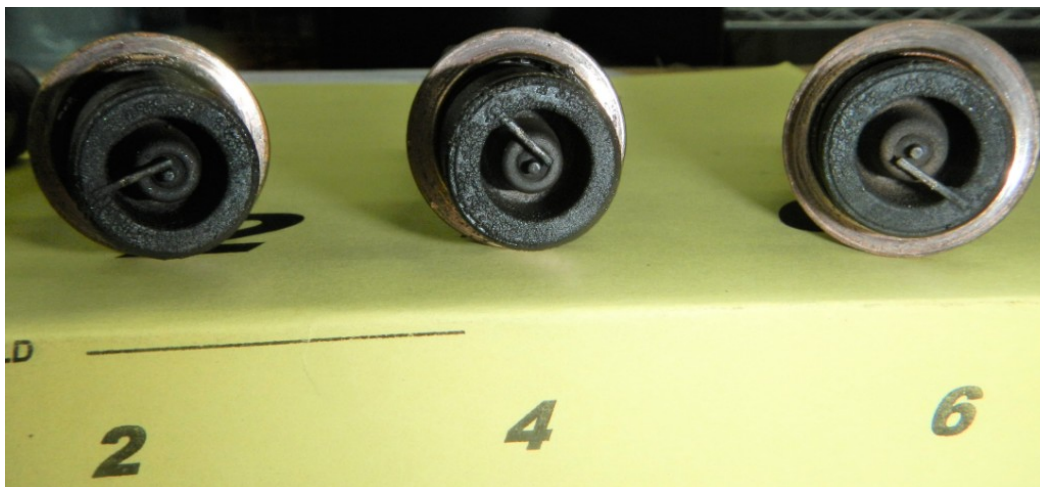
Figure 17 - Top Spark Plugs

The top spark plugs were removed and inspected. All 6 were Champion RHB32S. When compared to a Champion Spark Plug “Check A Plug” chart, all top spark plugs appeared to have normal wear, with a slightly dark coloration. All spark plugs had an odor of fuel present. The porcelain insulator was found fracture-separated in the top spark plug from the No. 1 cylinder. The timing of the fracture was not determined.

The appearance of all 6 top spark plugs was consistent with significantly more than 11 hours in service. Subsequent discussion with the pilot revealed that 3 new spark plugs were purchased and installed for the top overhaul, while 9 were re-used.

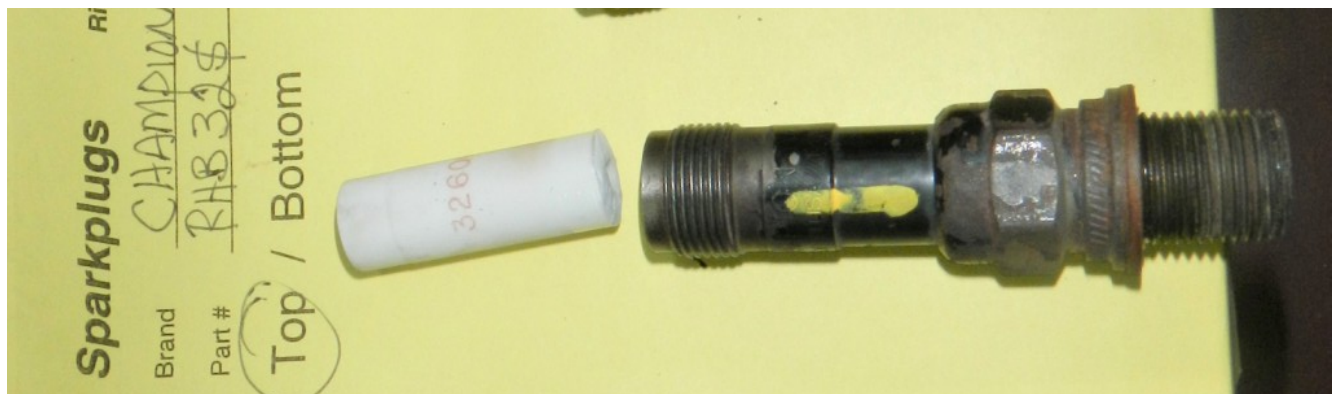
Figure 20 - Fractured Insulator, Top No. 1 Cylinder

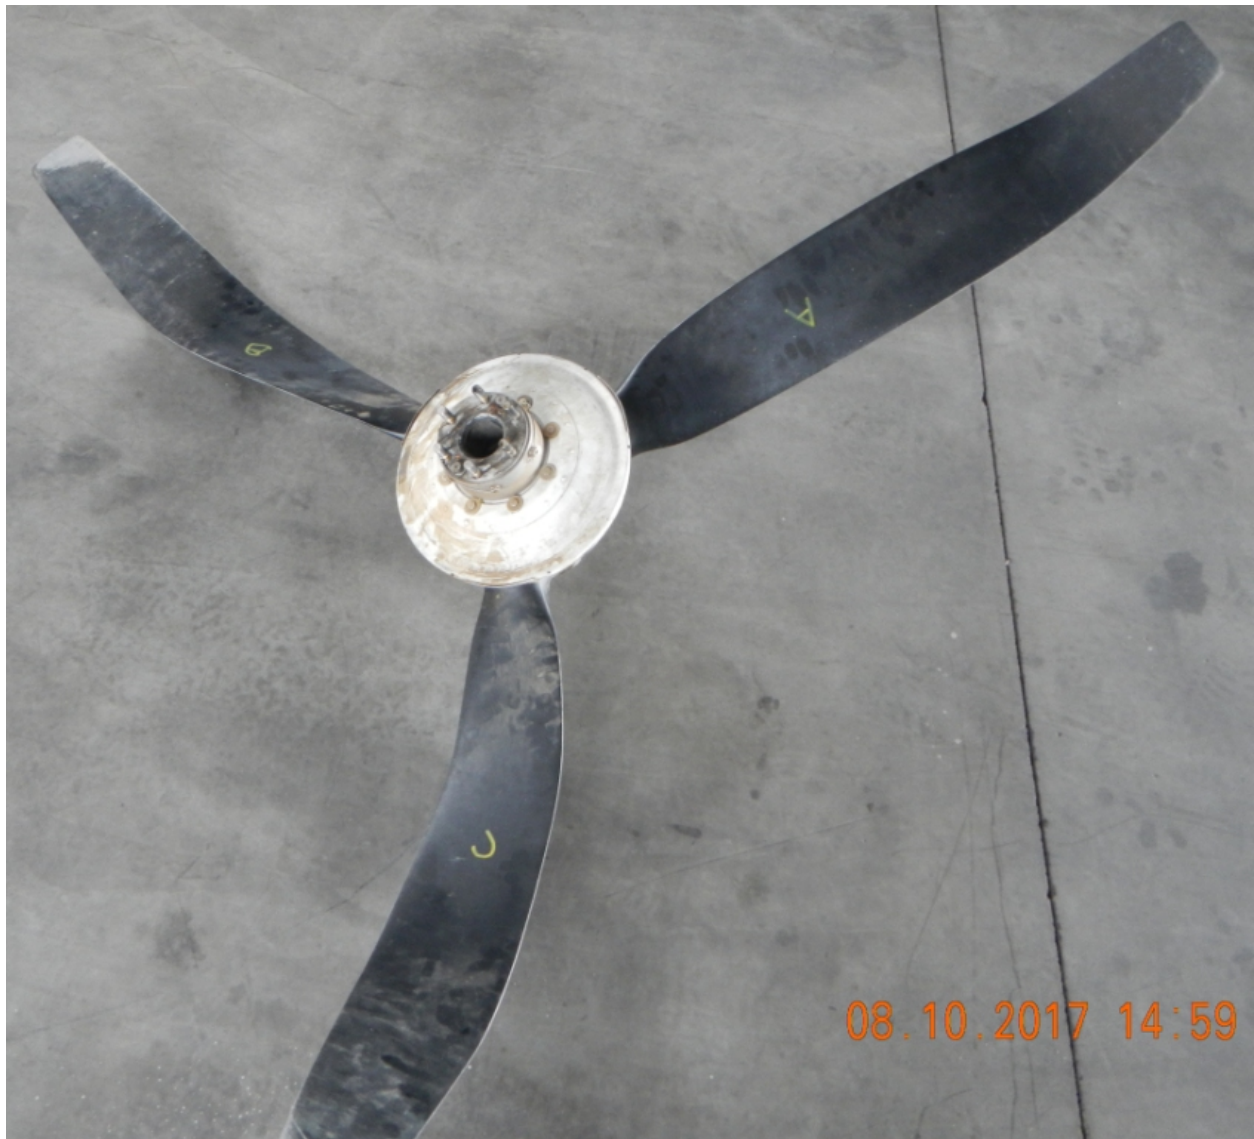
Figure 21 -Blades in Hub

The three-blade constant speed propeller remained attached to the engine crankshaft propeller flange. All three propeller blades exhibited smooth rearward bending at about their 2/3 span points, consistent with ground contact, and little or no engine power. No torsional twisting of the blades was observed. All three propeller blades were free to rotate within the propeller hub.

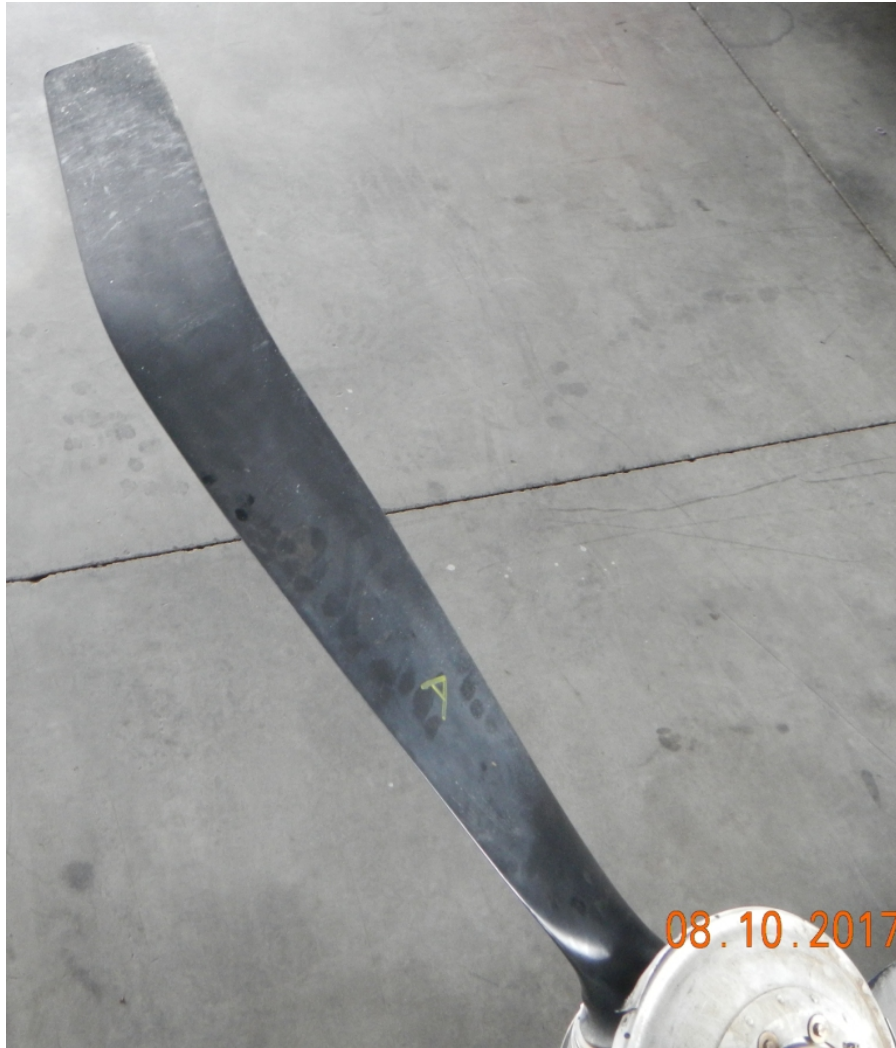
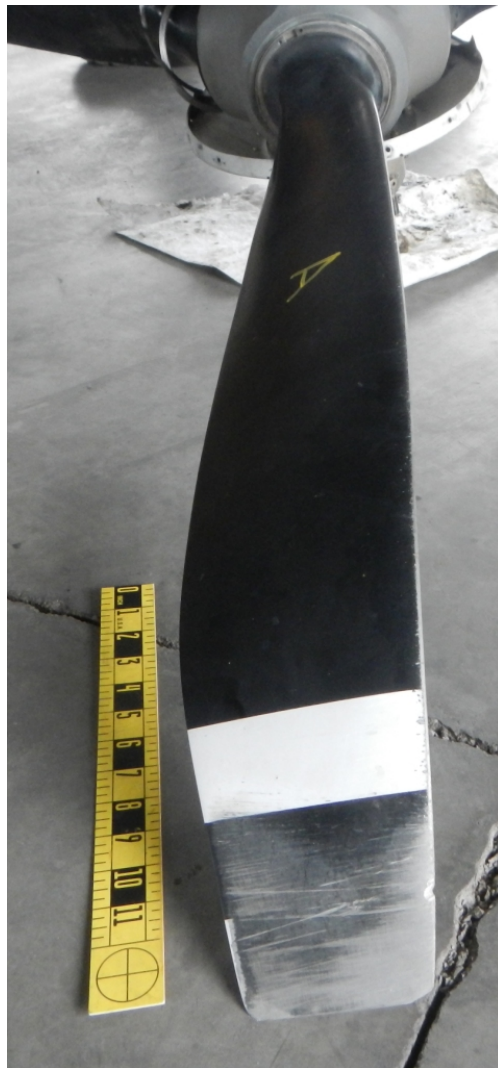
**Figure 22 - Blade 'A' (uncambered side)**

| Letter | Number | Remarks |
|---|---|---|
| A | 3 | Least deformed. Least chordwise scoring. 1/3" LE nick/gouge |

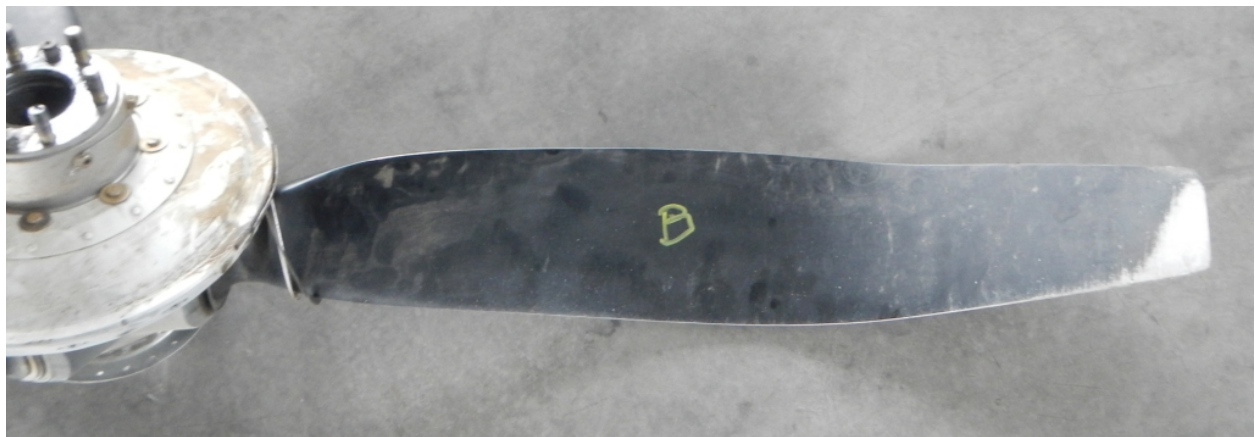
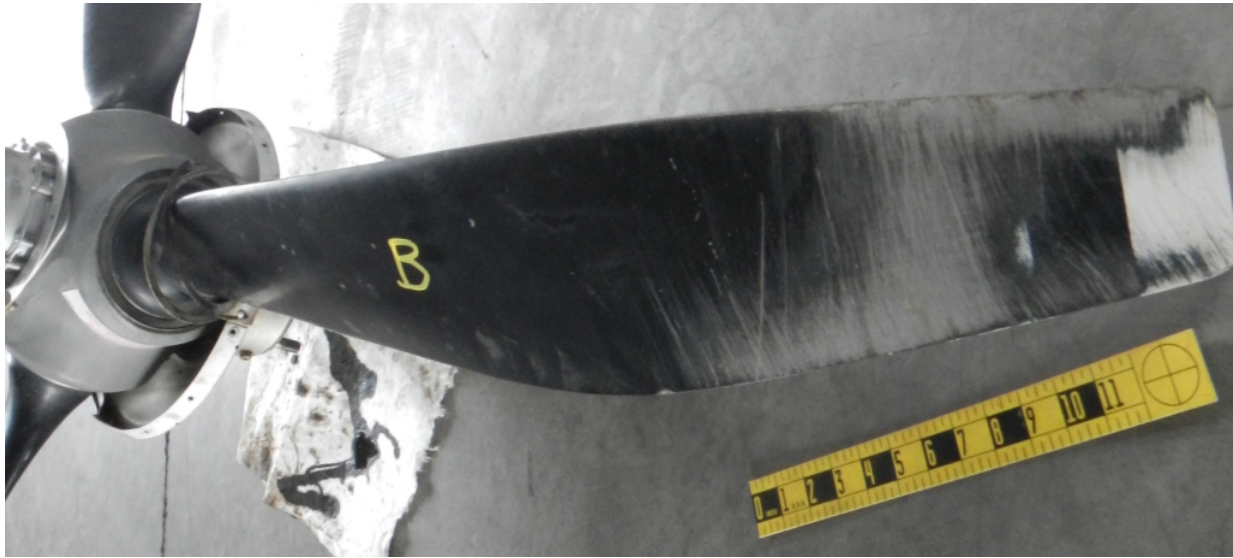
**Figure 23 - Blade 'B' (uncambered side)**

| Letter | Number | Remarks |
|---|---|---|
| B | 1 | Significant chordwise scoring |

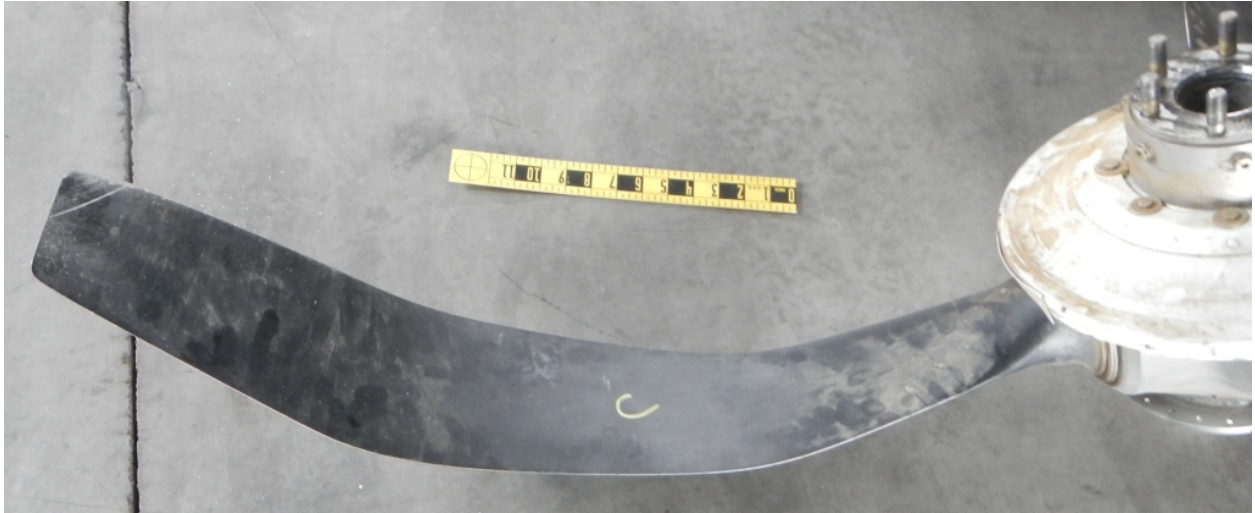
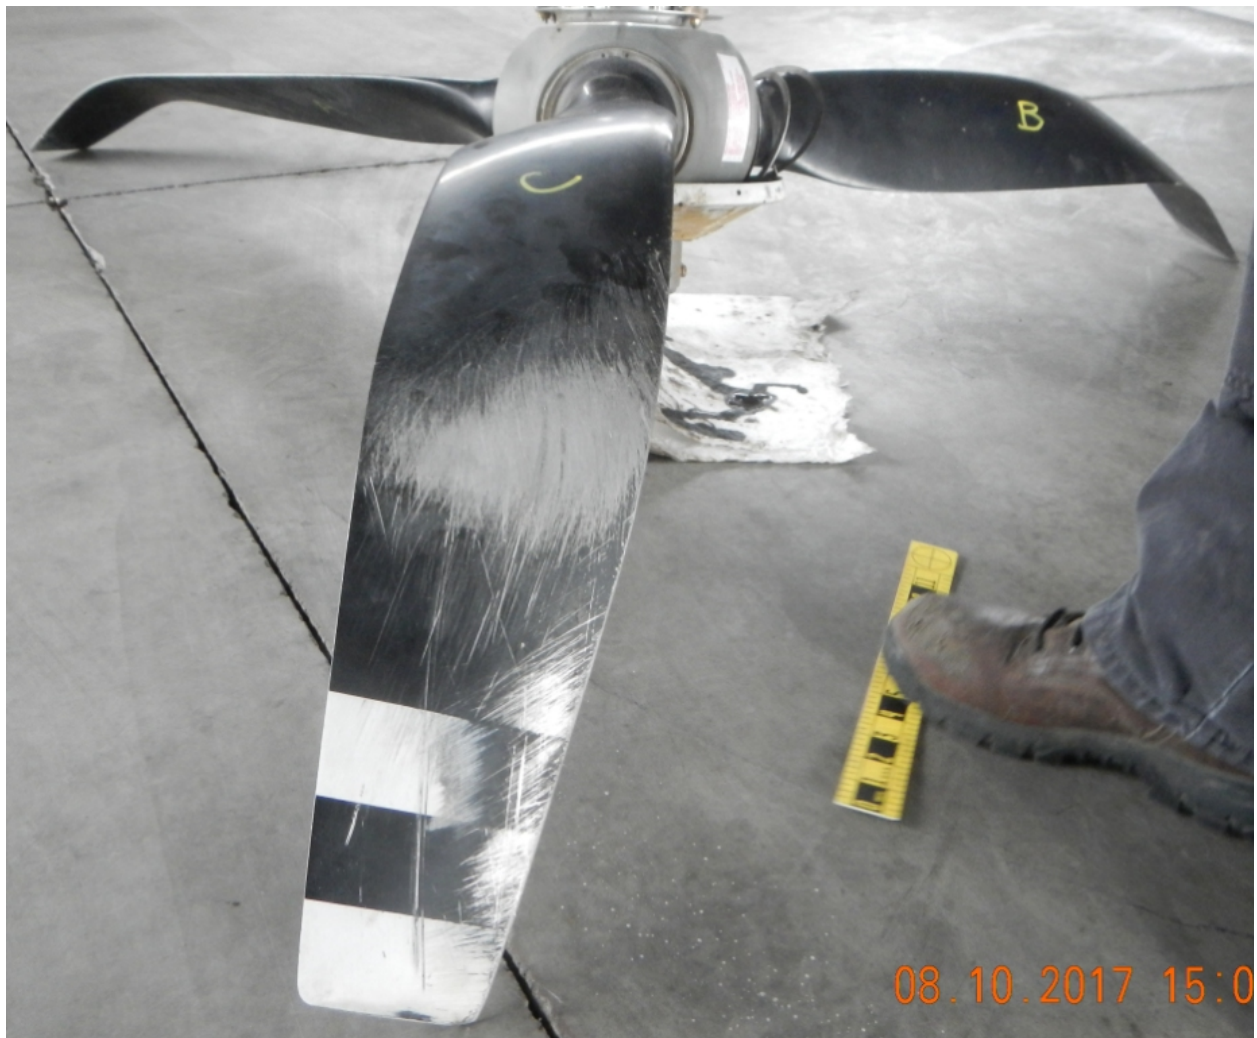
**Figure 24 - Blade 'C' (uncambered side)**

| Letter | Number | Remarks |
|---|---|---|
| C | 2 | Most deformed. Significant chordwise and spanwise scoring |

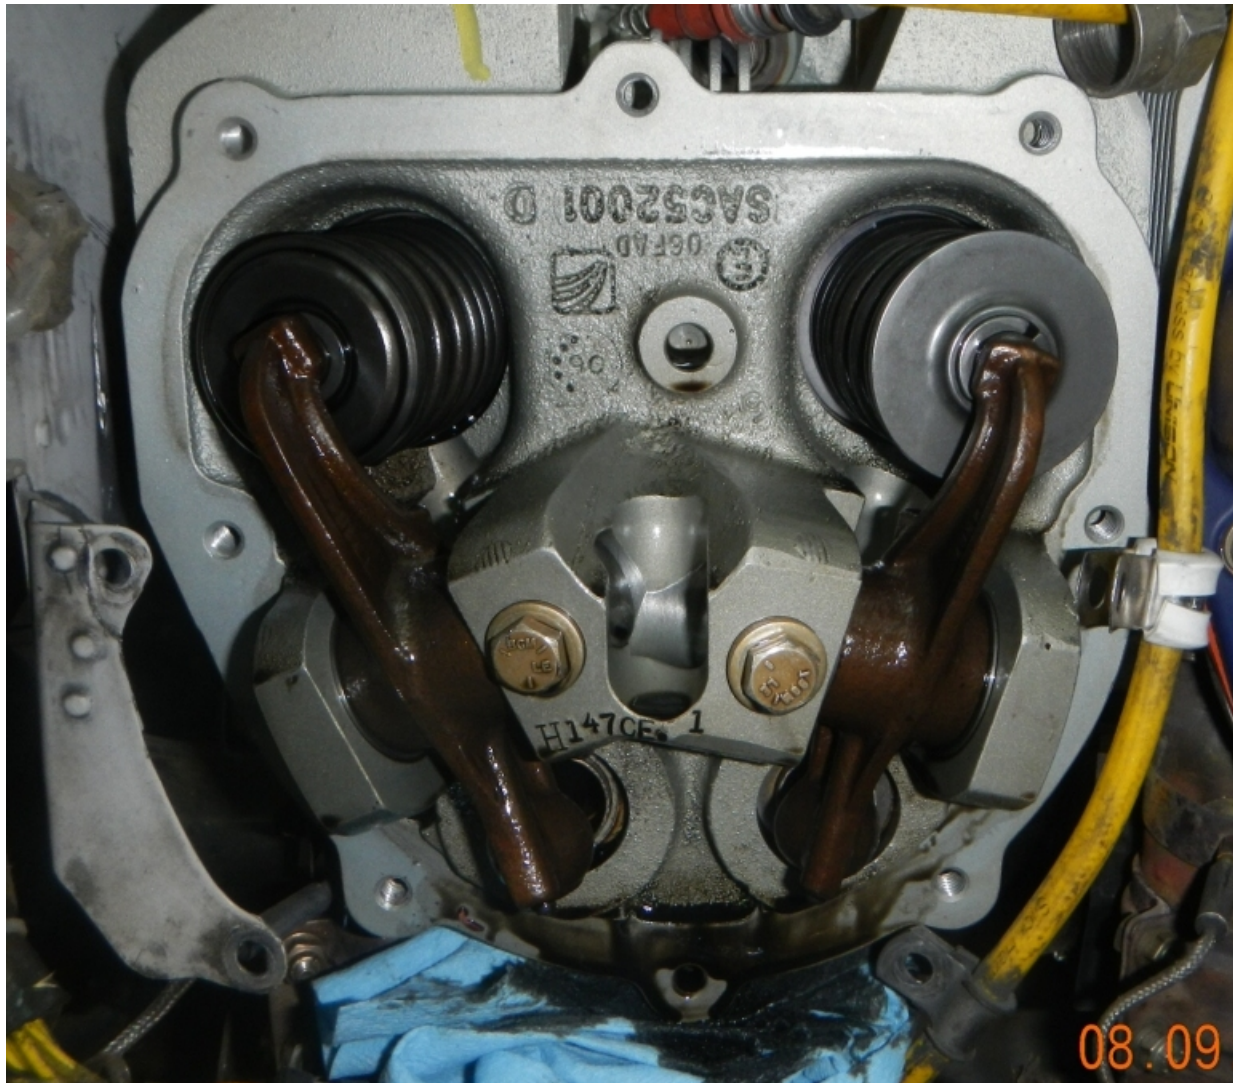
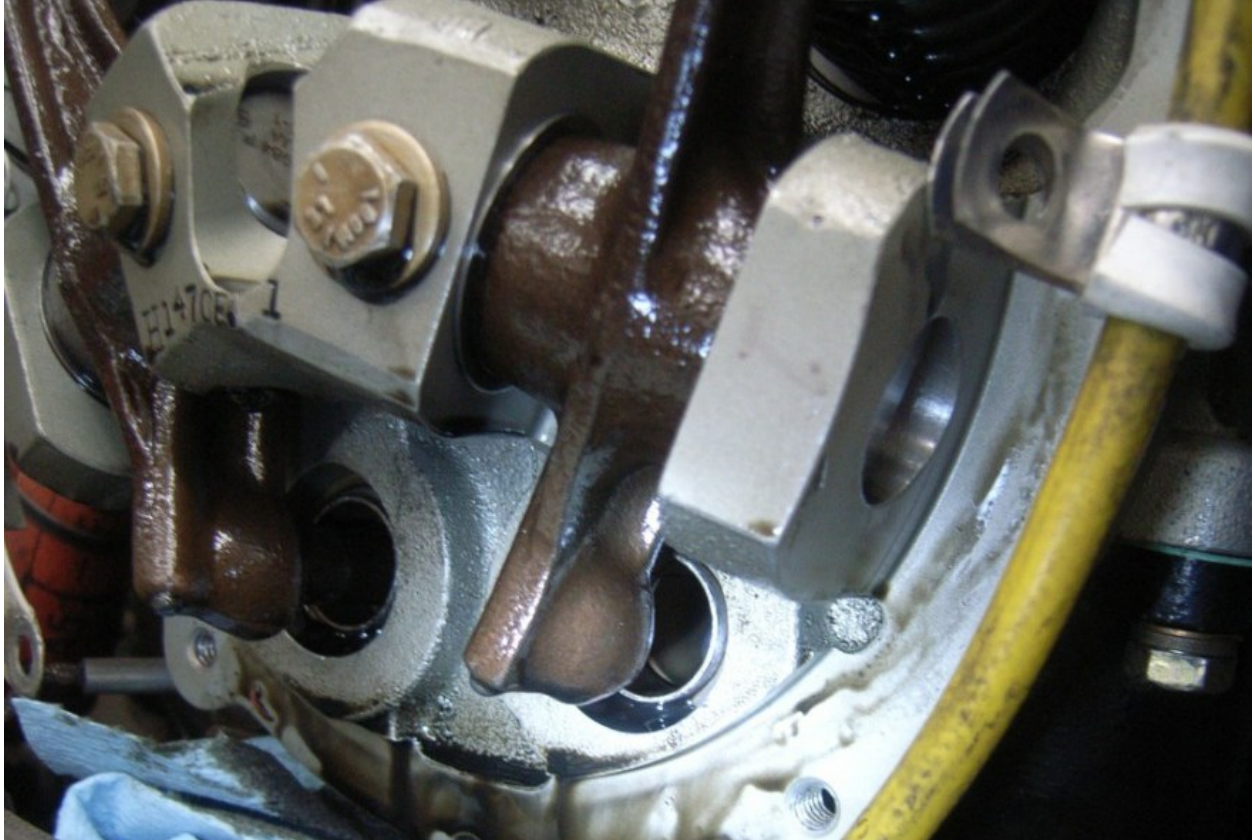
Figure 28 - Rocker Assembly Cylinder No. 1

Crankshaft continuity was confirmed by rotation of the starter adapter PTO drive on the rear of the engine. The No. 1 cylinder rocker box cover was removed. Both rocker arms were intact. The exhaust valve rocker arm was depressing the valve, and the spring tension was not relieved when the engine was rotated. The intake valve pushrod could be seen inside its pushrod tube, but the pushrod did not extend to the rocker arm; there was an approximate  $\frac{3}{4}$ " gap between the two. The cause was not determined.

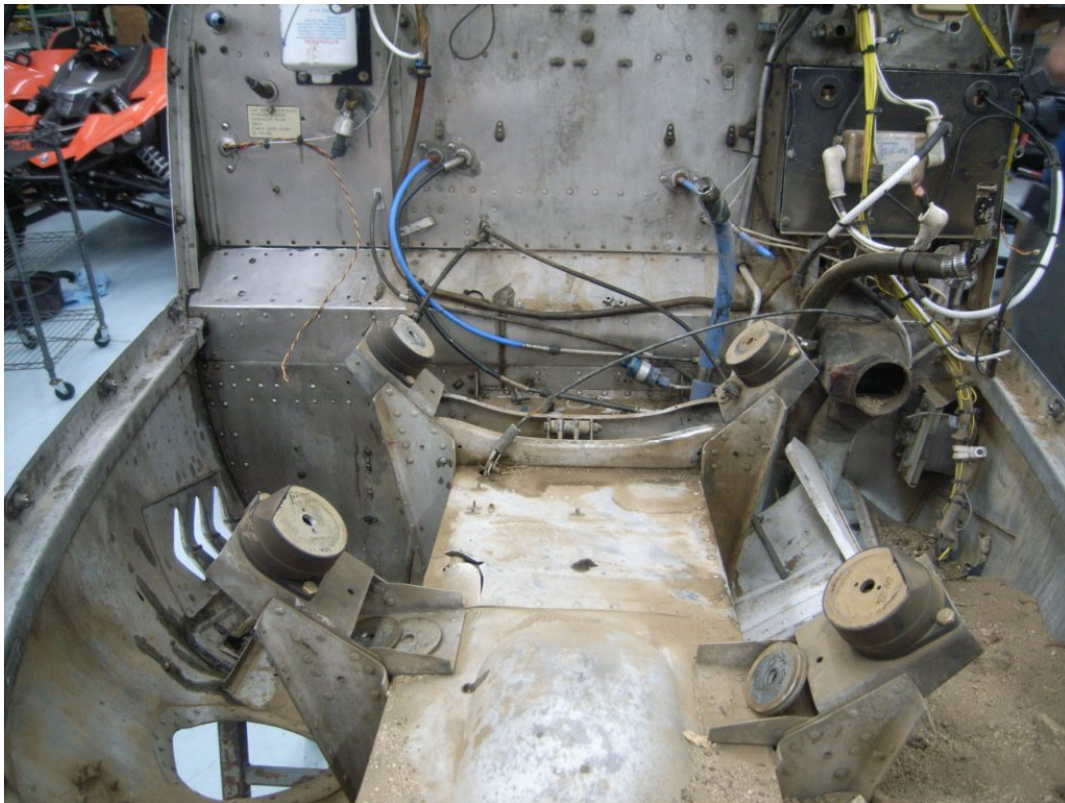
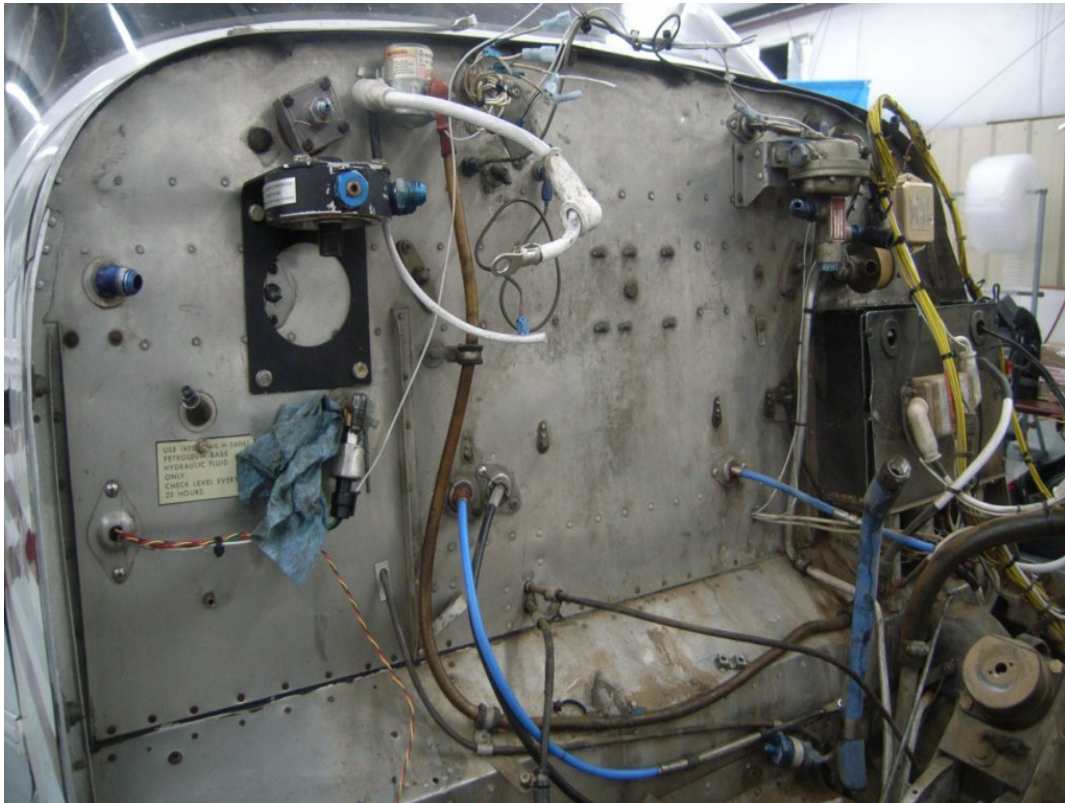
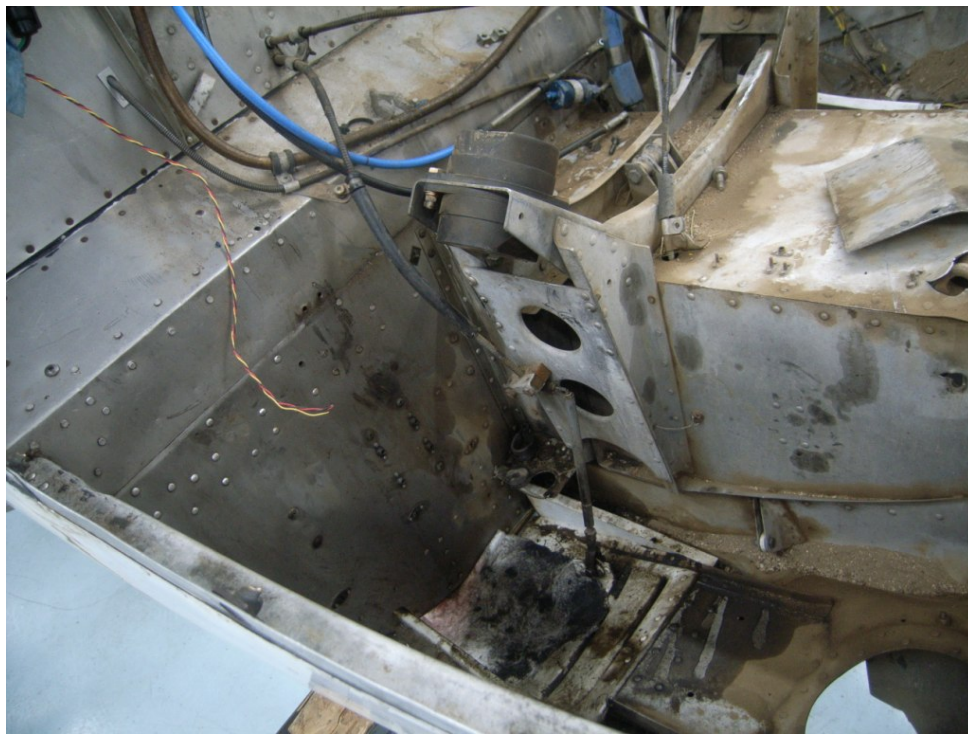
**Figure 30 - Engine Compartment with Engine Removed**

Once the engine was removed from the airplane, the engine compartment was able to be examined in greater detail. With the exception of the right cowl flap and lower cowling area, there were no indications of excessive oil presence in the compartment. The source of the oil stains was not positively determined, but it was directly below the No. 1 cylinder rocker assembly, which leaked oil when the rocker cover was removed. It was also only slightly displaced from being directly below the externally-mounted spin-on oil filter location.

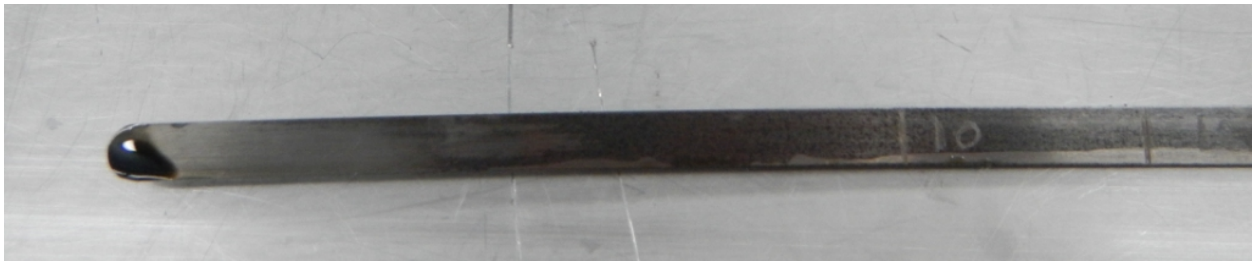
The engine oil quantity rod ("dipstick") was removed, wiped clean, then reinserted in its tube. The oil level on the oil rod indicated that only a small amount (approximately one quart) of oil remained in the engine oil sump. The dipstick tube was undisturbed by the accident, and was oriented nearly horizontally, almost parallel to the airplane lateral axis. The overall tube extension from the side of the engine case measured  $15 \frac{3}{4}$  inches. The dipstick had an overall length (including handle) of about 24 inches. The 'blade' portion of the dipstick measured about 22 inches. The blade was graduated on both sides to 12 quarts; one side contained machine-stamped numbers, while the other side bore hand-engraved numbers. The two scales were congruent. No part number was observed on the dipstick.

Figure 33 - Oil Rod with Trace Oil Quantity

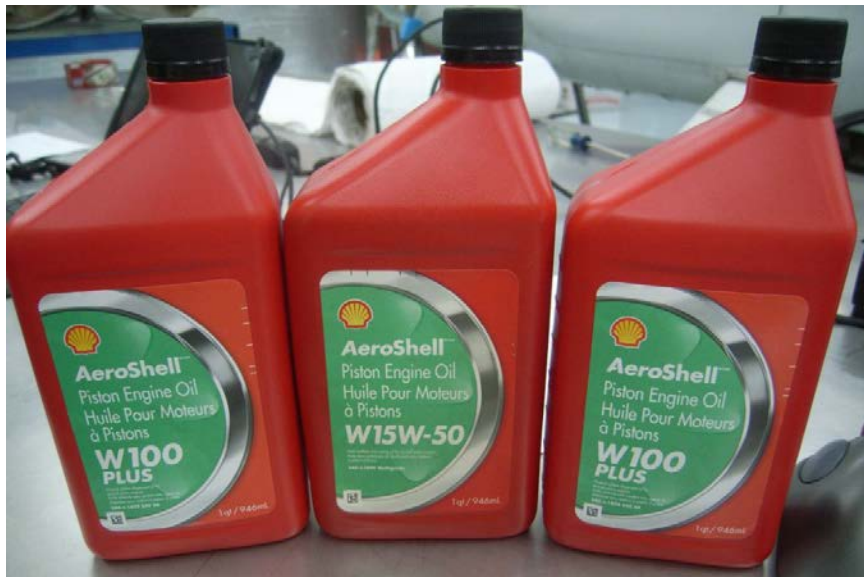
Figure 36 - Oil Containers Recovered from Cabin

Three quart-size unopened containers of AeroShell brand piston engine oil were found in the cabin. Two containers were identified as "W100 Plus," and the third was identified as "W15-50." Two of the containers had date stamps on them; one was dated "21JUL14" and one was dated "27MAR17." The NTSB IIC telephoned the AeroShell customer service line to determine the meaning of the dates stamped on the bottles, and to verify that these items were for ashless dispersant oil, and not the straight mineral oil that is to be used for engine/cylinder break-in. The AeroShell representative stated that the dates were the manufacture date of the oil, and that it was recommended to use the oil within 4 years of manufacture, or else have it tested prior to use. He also stated that the "W" prefix indicated Ashless Dispersant oil, which confirmed that none of the identified containers were for straight mineral oil that is to be used for aviation engine break-in.

The pilot provided a receipt for the purchase of 4 quarts of AeroShell mineral oil from the FBO in Auburn. The evidence indicates that despite requesting it, he was not sold straight mineral oil, but rather Ashless Dispersant oil. According to Shell technical support, aside from slightly changing the engine break-in wear characteristics, there would not be any adverse effects of intermixing the two oil types.

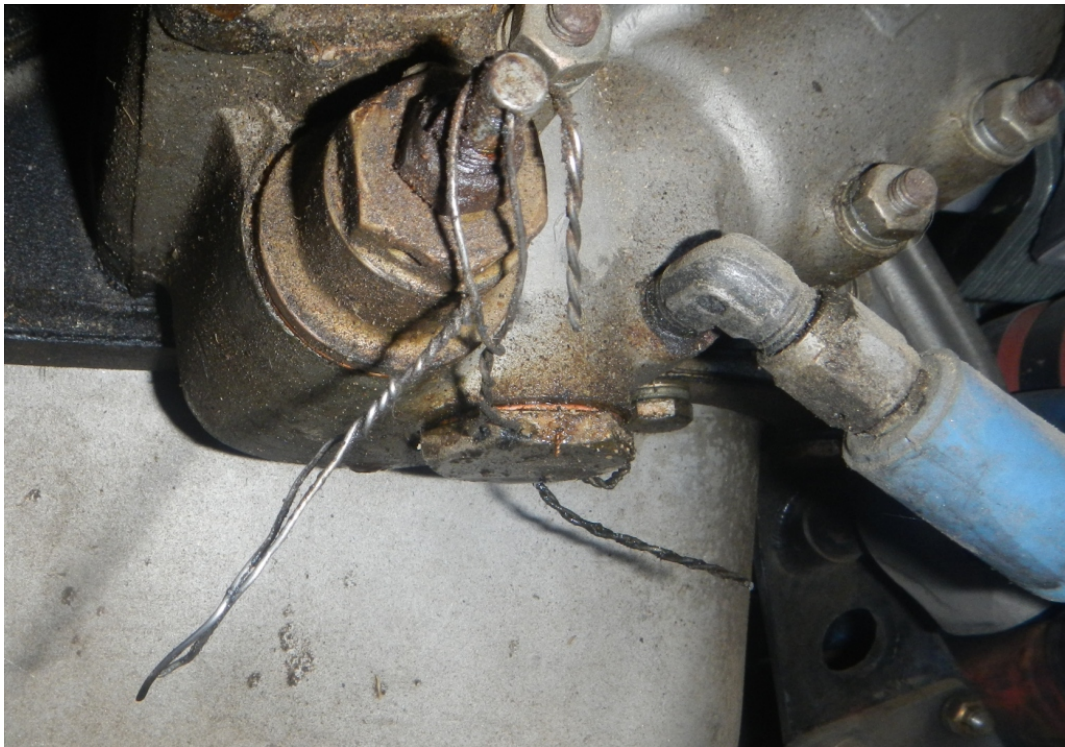
The engine oil pump assembly was installed at the bottom aft of the engine accessory face, a location which inhibits ready physical and visual access. After the engine was extracted from the airplane, two items on the oil pump were found to be partially safetied. These were the oil pressure relief valve (partially/incorrectly safetied) and a plug on the pump lower side (safety wire found cut, consistent with a removal/disassembly step). Based on their appearance, although neither was in accordance with accepted maintenance standards, both items were sufficiently constrained to prevent their unintentional rotation.

Figure 38 - As-Found Cut Safety Wire

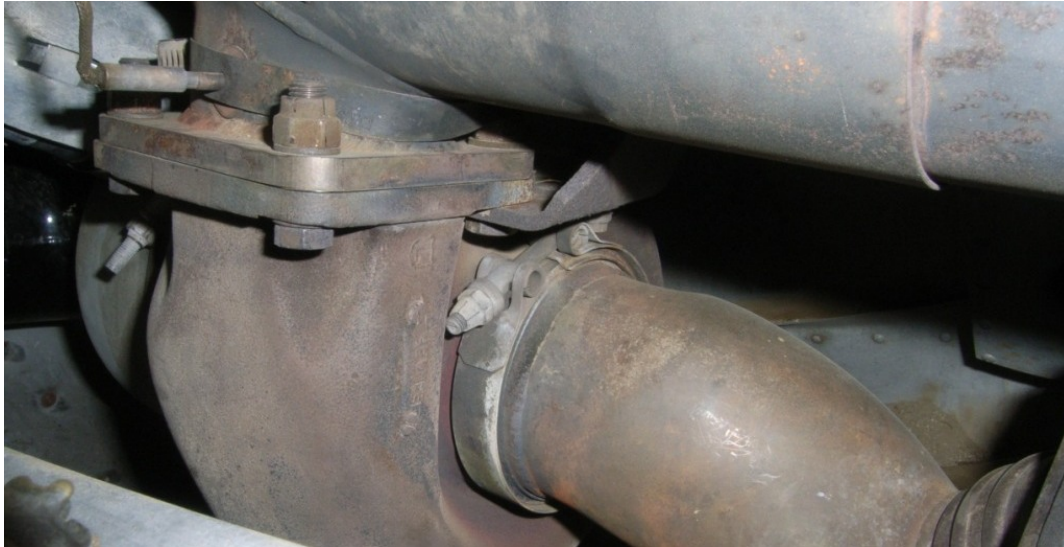
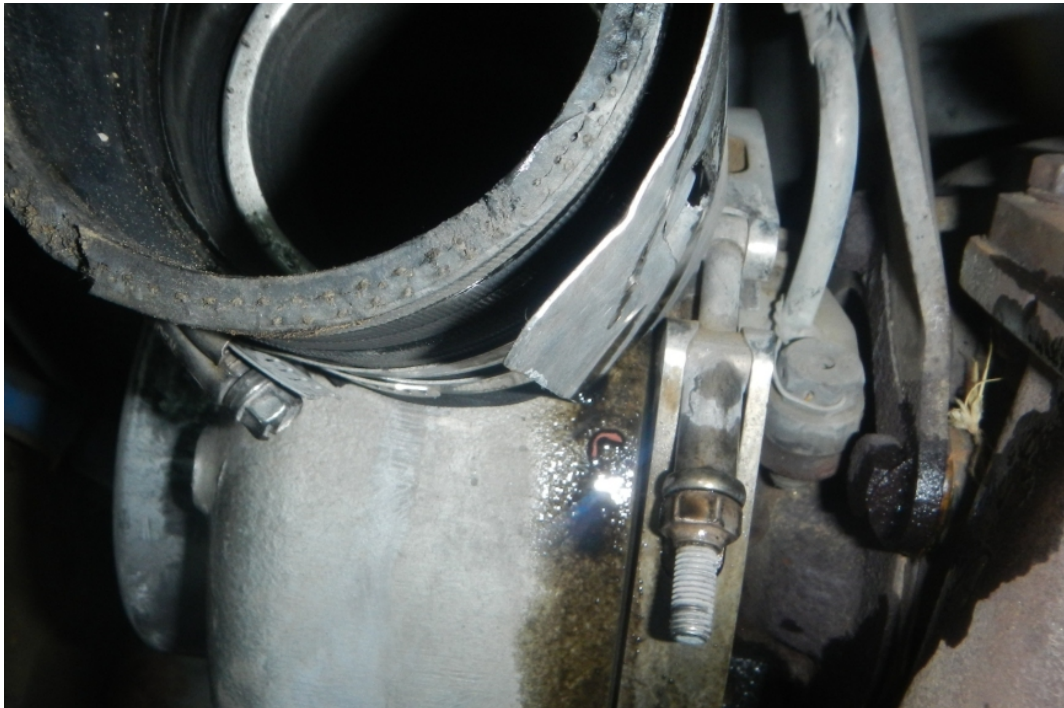
Two clamps (at least one of which was a "V-band" clamp) were secured with metal self-locking nuts, but were not safety-wired.

**Figure 39 - Non Safety-Wired Clamp**
