## **NATIONAL TRANSPORTATION SAFETY BOARD**

# **AIRFRAME AND ENGINE EXAMINATION**

**WPR17LA172**

Location: Llano, California  
Date: July 31, 2017  
Aircraft: Cessna T-210F, N6109R, Serial # T210-0009  
NTSB IIC: Michael Huhn

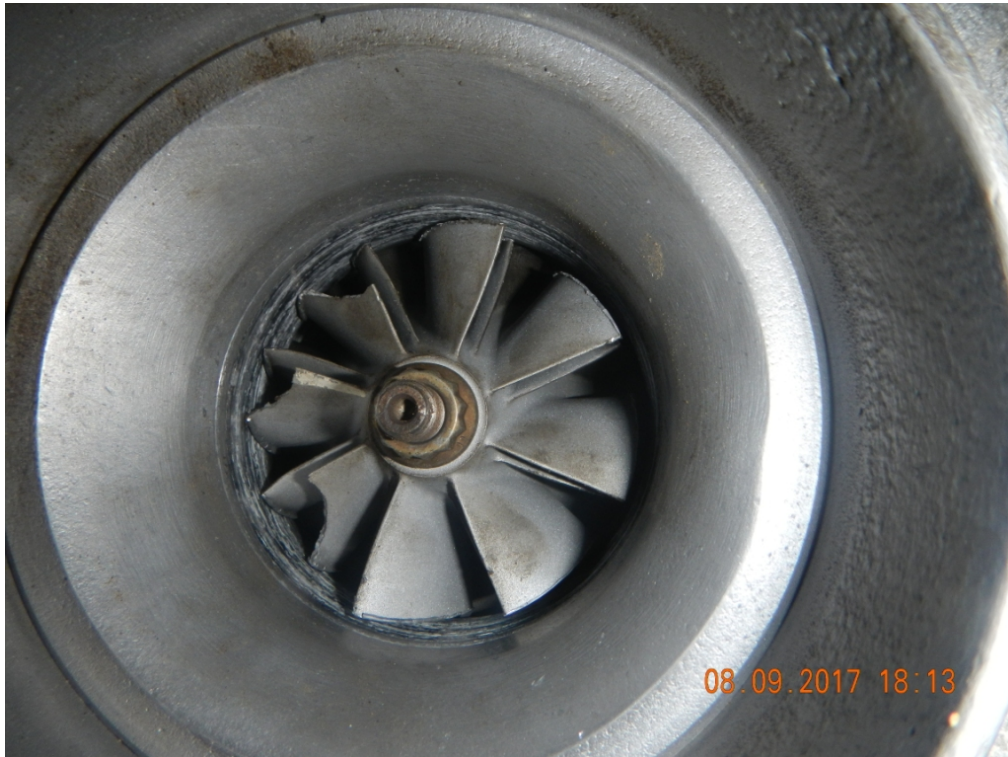
The turbocharger was mounted near the lower aft right side of the engine. Tactile and then visual examination of the turbocharger compressor inlet revealed that several blades were broken. Once the engine, with the turbocharger still attached, was removed, it was observed that three of the eight first stage rotor blades were fractured at about their one-half span

locations, and that the surrounding inlet case was heavily scored. The three fractured blades were adjacent to one another. The blade fragments were not observed in the wreckage. The compressor rotor rotated freely, and had about 1/8" axial and radial freeplay. Preliminary examination did not indicate the timing of the damage relative to the accident.

**Figure 41 - Fractured Turbocharger Compressor Blades**
