## **NATIONAL TRANSPORTATION SAFETY BOARD**

### **ENGINE EXAMINATION**

**WPR17LA172**

Location: Llano, California  
Date: July 31, 2017  
Aircraft: Cessna T-210F, N6109R, Serial # T210-0009  
NTSB IIC: Michael Huhn

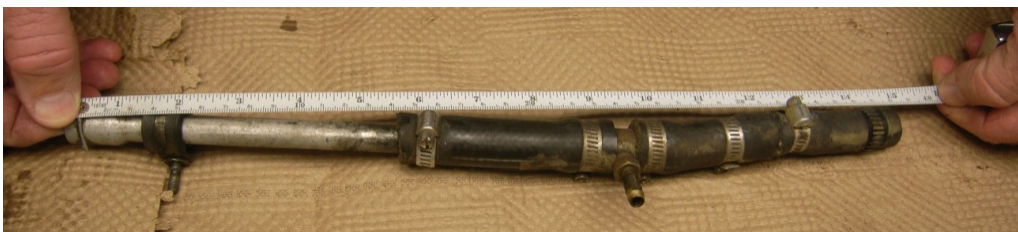
- The external housing for the rod was observed to have 3 segments of flexible tubing/sheathing
  - o The factory version is a single piece aluminum tube with a single flexible fitting/sheath at its base (where it installs into the crankcase)

- o The two additional flex pieces were used to insert a non-aviation, 'homemade' 'T'-fitting into the mid region of the original tube, which had been cut and somewhat shortened

- o The T fitting appeared to be fabricated from soldered copper tubing sections and a nipple
  - o The T fitting accommodated the oil drain/return line from an oil-air separator (from the crankcase breather)

- o The overall length of the as-found housing assembly was about 15.5 inches
- The design length of the CMG housing was about 13.1 inches
- The as-found housing excess length would result in an erroneously low oil quantity reading

Figure 1 - Oil Rod Housing as Removed

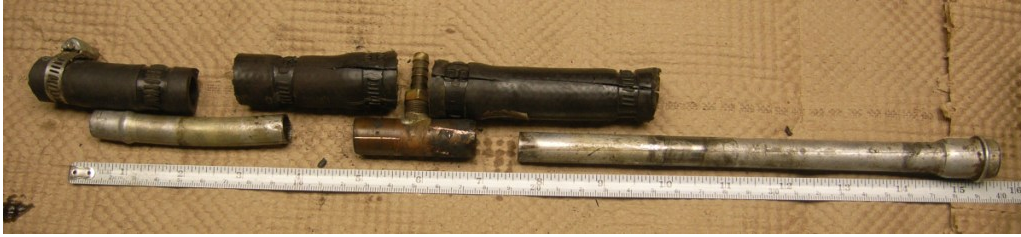
- The oil gage rod was determined to have no part number
- The rod was of appropriate length, but two of the three quantity lines were improperly located

**Figure 2 - Oil Rod Disassembled**

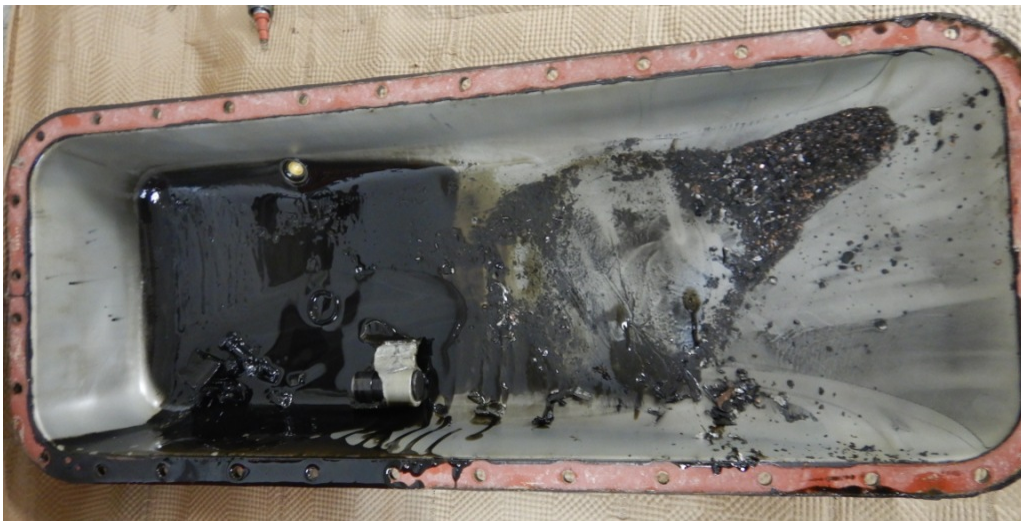
- Its bearing was not located/identified
- The oil sump contained a significant amount of metal flakes/chips of at least three colors: black, brownish-copper, and silver-gray
  - These were likely the remnants of the No. 1 bearing cited above
- Two of the 10 total main bearing halves had different part numbers (653547) than the other 8 (AEC 642720). The part number of those two parts was a direct supercedure of the part number of the other 8.
- The other 5 connecting rods showed varying indications of minor thermal distress
- The connecting rod bearings displayed varying indications of wear and distress of undetermined origin
- The two aft cylinder skirts (No. 1 & No. 2) exhibited some damage (presumed to be from the liberated No. 1 connecting rod components)
- All pistons were intact, with no signs of distress

**Figure 3 - Oil Sump with Debris**

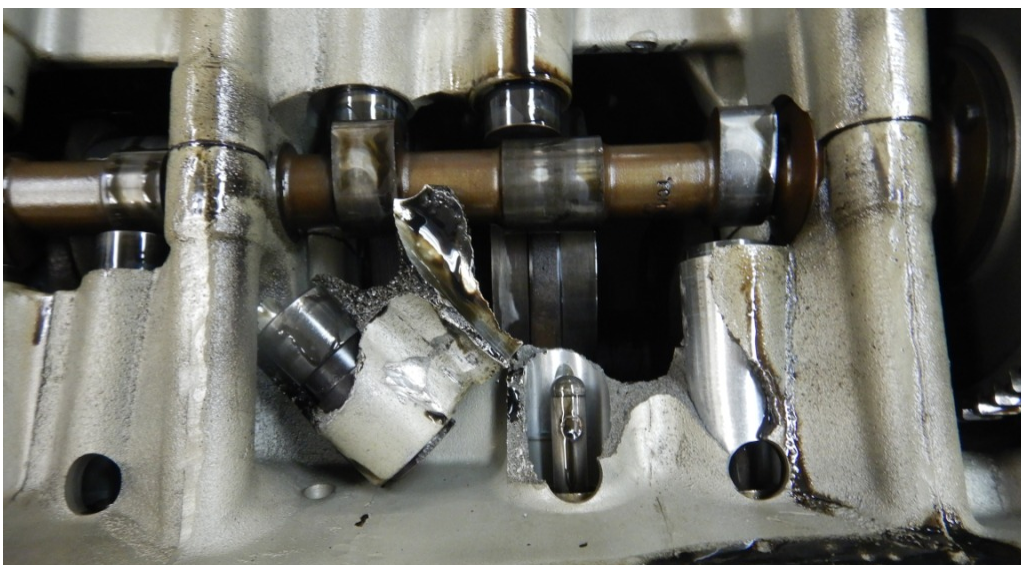
- The No. 1 connecting rod remained attached to its wrist pin and piston
  - The rod moved freely on the wrist pin
- The crankcase bores/housings for the two hydraulic lifters for the No. 1 cylinder were partially fractured, with their liberated sections found in the oil sump

**Figure 4 - Crankcase Lifter Housing Fractures**

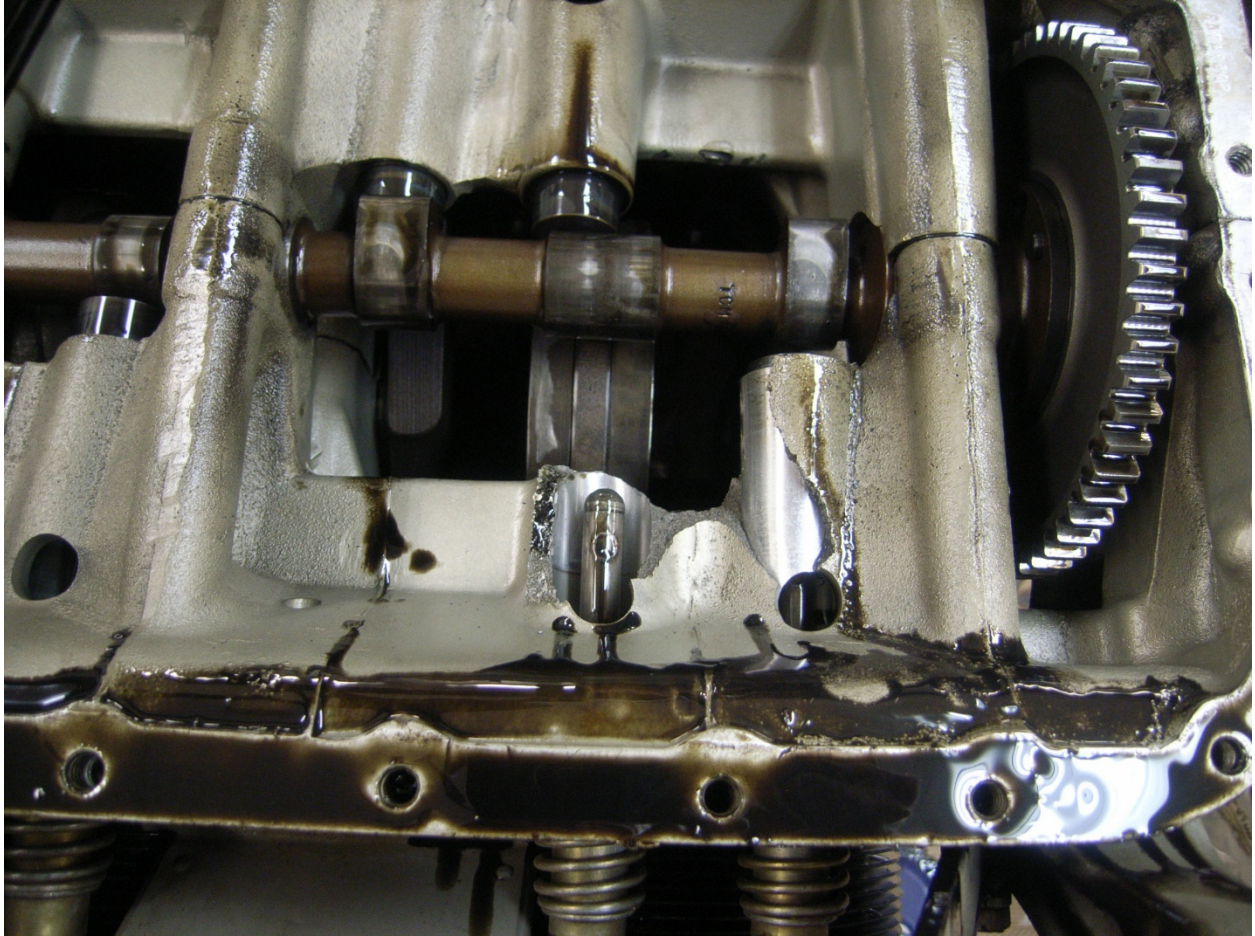
- The pushrods remained in place
- The crankcase interior in the vicinity of the No. 1 connecting rod exhibited gouges and scrapes
- These crankcase fractures, gouges and scrapes were attributed to the failed connecting rod end

**Figure 5 - Fractured Crankcase**

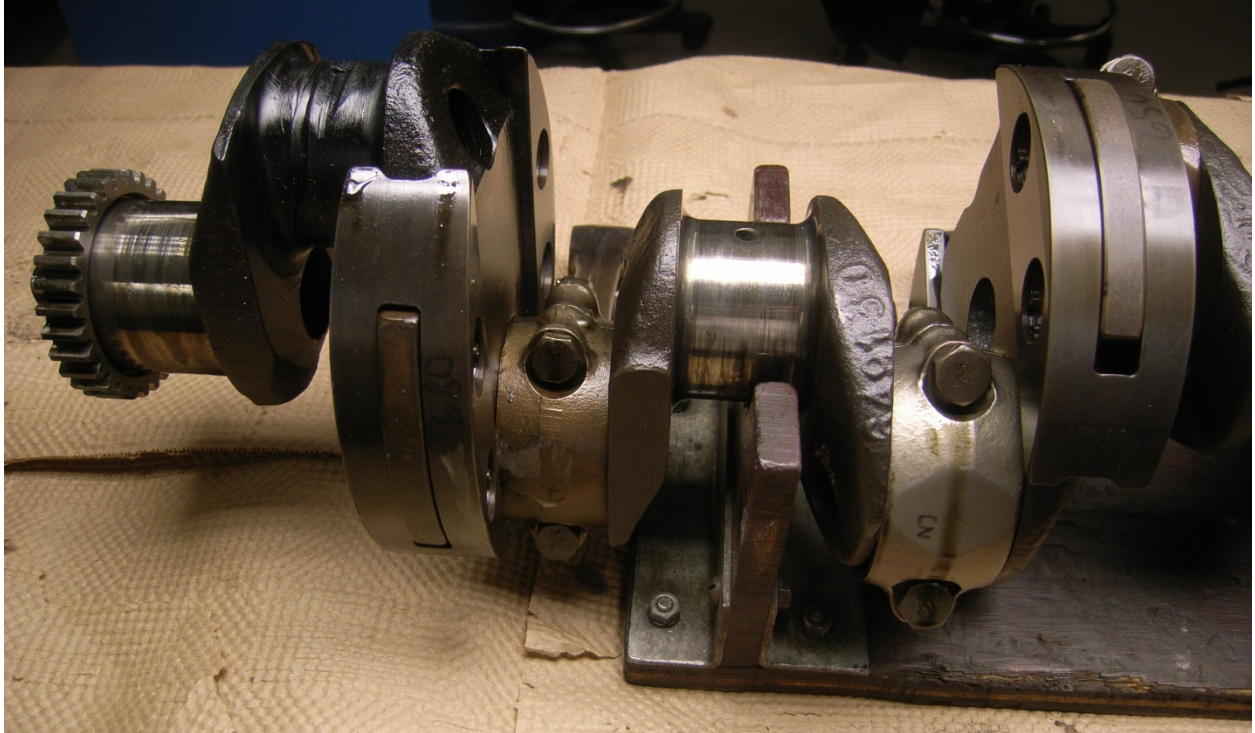
**Figure 7 - Aft Crankshaft with Damaged Rod Journal**

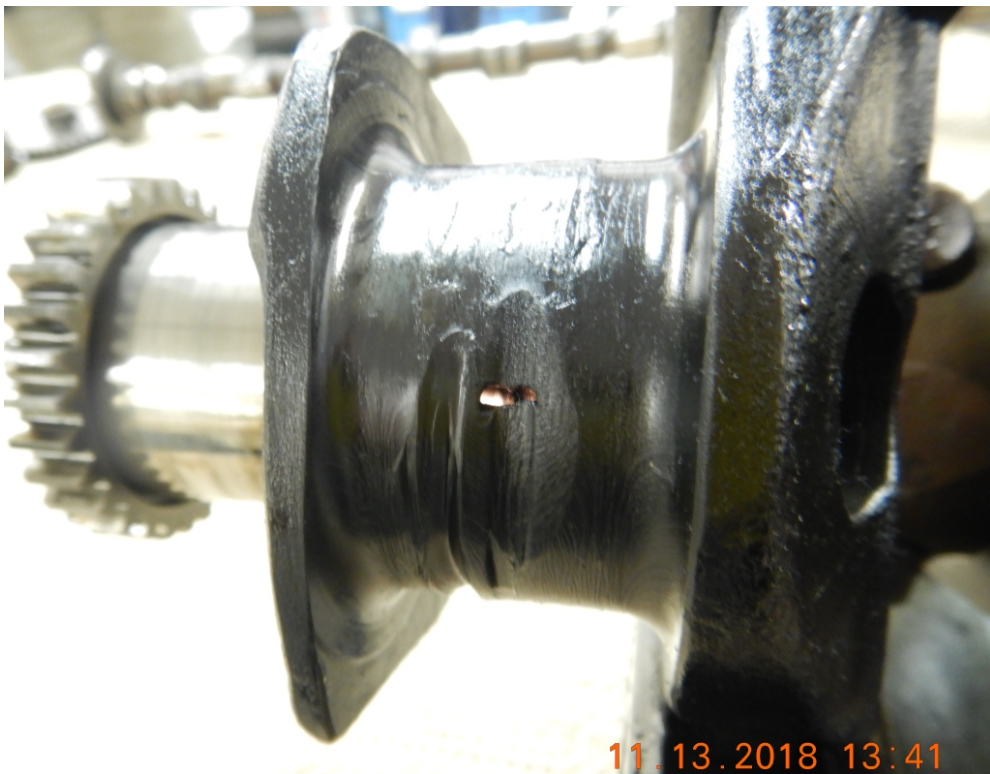
- The crankshaft journal for the No. 1 connecting rod was blackened and scored, gouged and peened

**Figure 8 - No. 1 Connecting Rod Journal on Crankshaft**

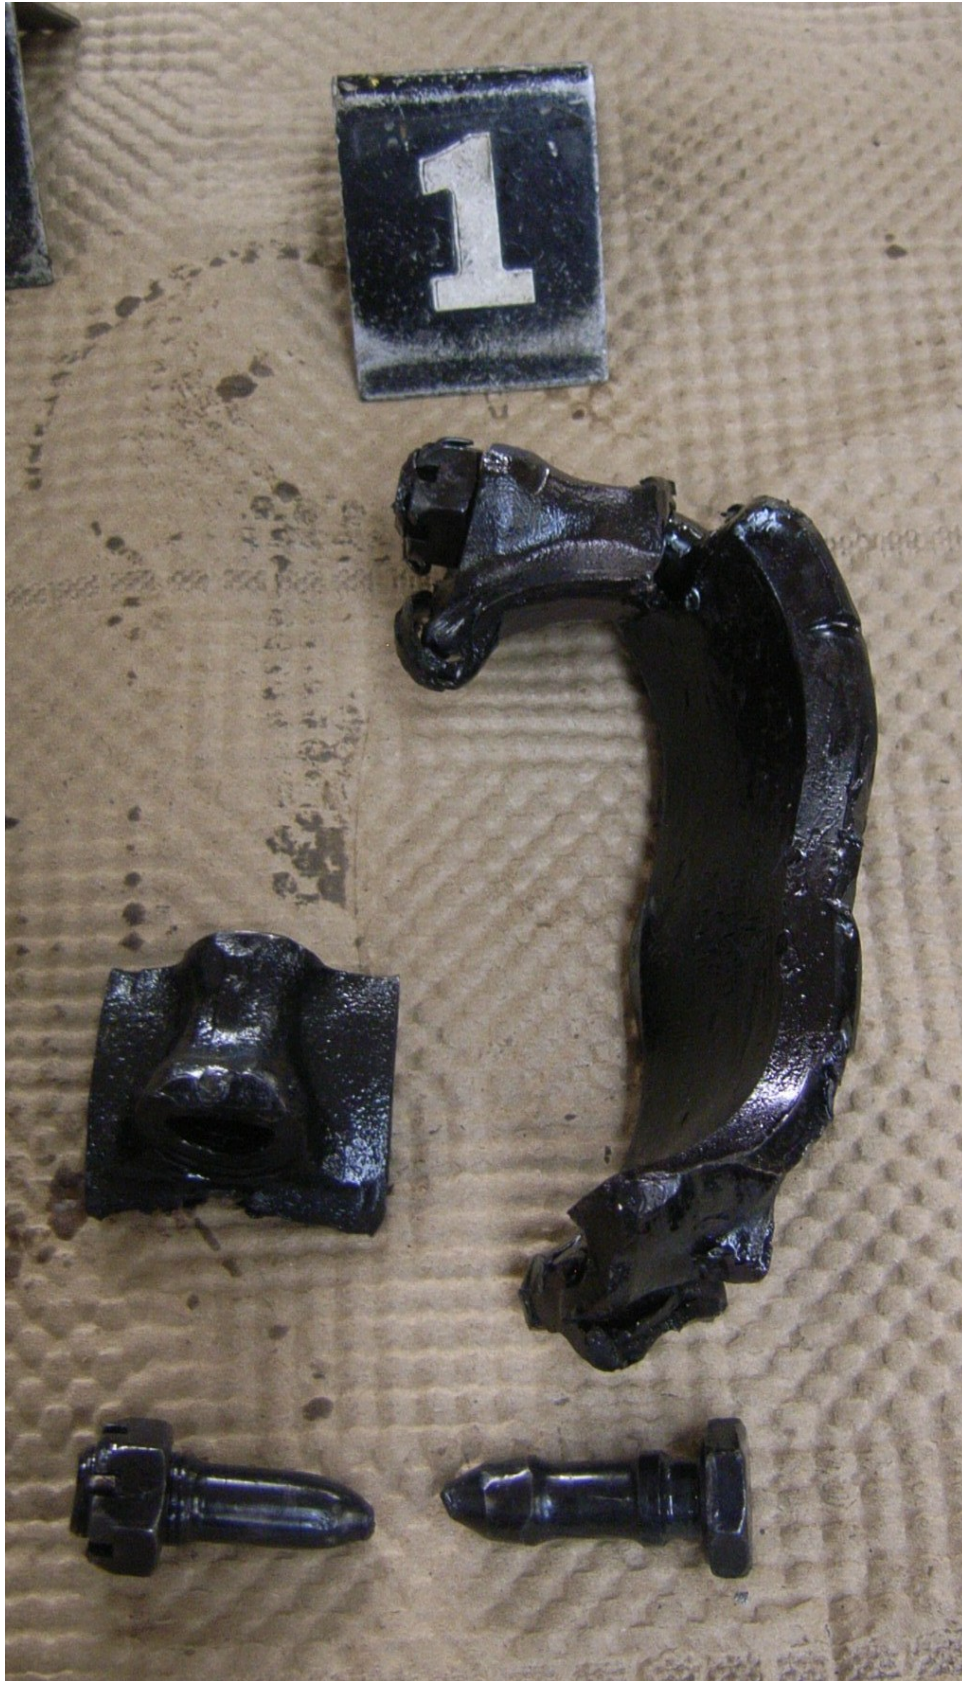
Figure 10 - No. 1 Connecting Rod End Cap

- The cap was blackened and severely damaged
  - The blackening was attributed by the CMG personnel to thermal distress
- One of the two cap bolt/nut assemblies was found in the oil sump

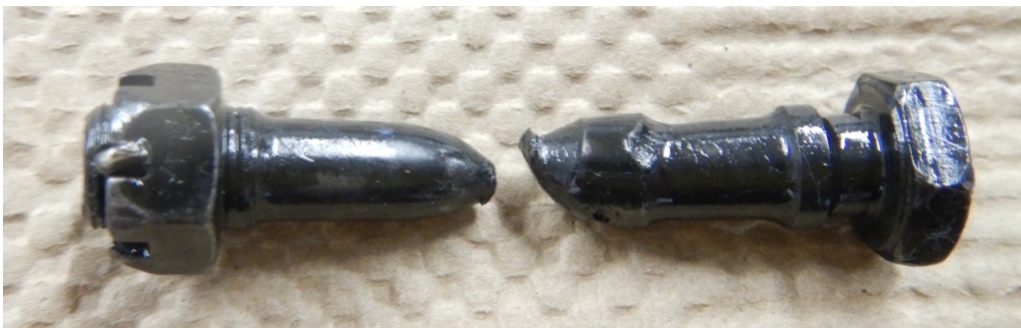
- The bolt was fractured in two, and retained its cotter-pin safetied nut
  - The bolt exhibited severe elongation and necking
  - The bolt was also blackened

**Figure 12 - Necked Connecting Rod Bolt**

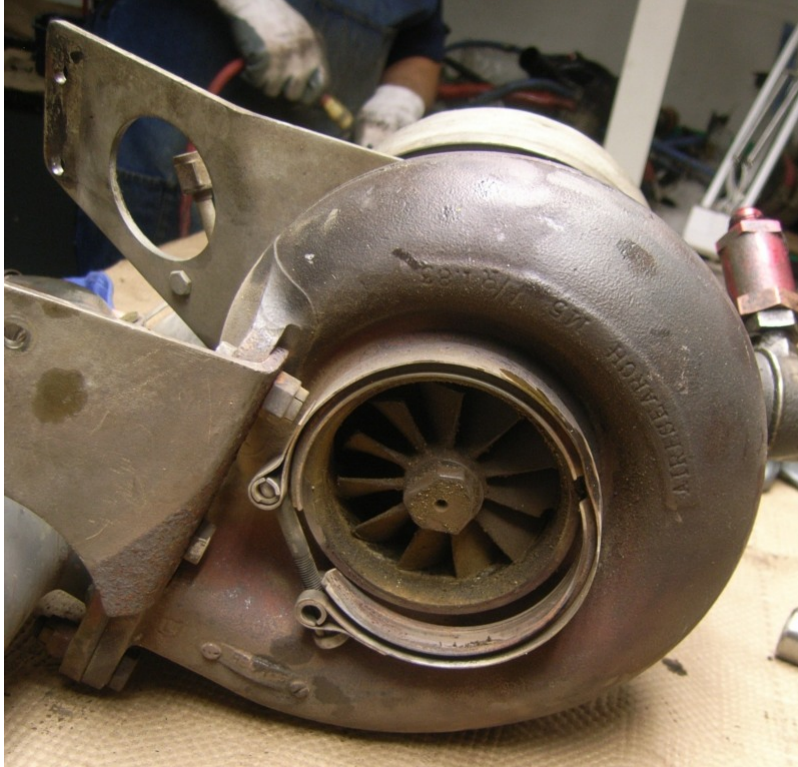
- The turbocharger housing in the vicinity of the location of the shaft bearing (between the two rotors), as well as the turbine blades and outlet case, displayed residue of an undetermined nature, some of which appeared to be dirt affixed by oil, or only oil

**Figure 13 - Turbocharger (turbine outlet)**

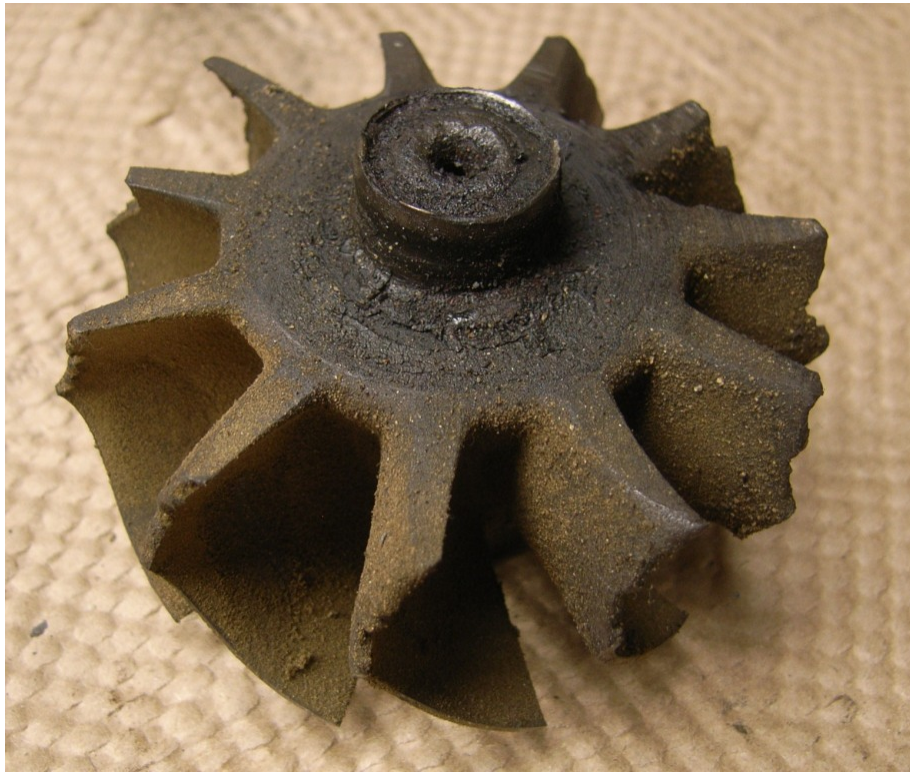
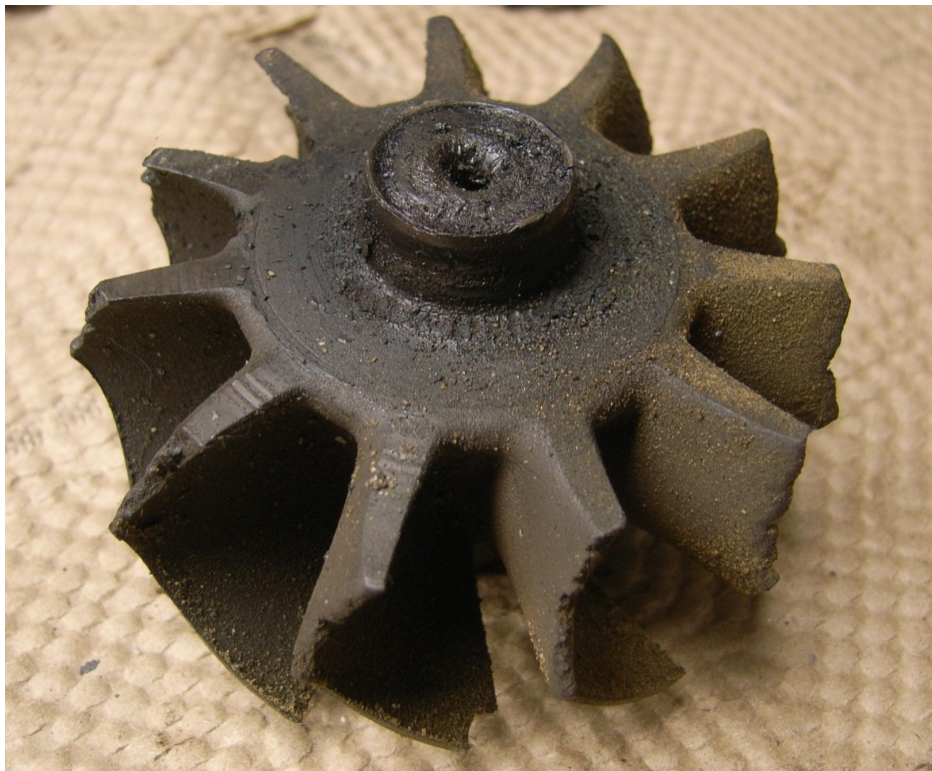
**Figure 15 - Turbine Rotor**

- The timing & source of the blade damage and rotor freeplay was not able to be determined.
- Once the turbocharger was removed from the engine, the turbine blades were observed to have damage similar to the compressor blades, and the turbine rotor had axial and radial freeplay of about 1/4 inch.

- Again the damage and freeplay sources were not identified
- The turbine rotor turned freely, but rotated independent of the compressor rotor. Because the two rotors shared a common shaft, this indicated that the shaft had failed.

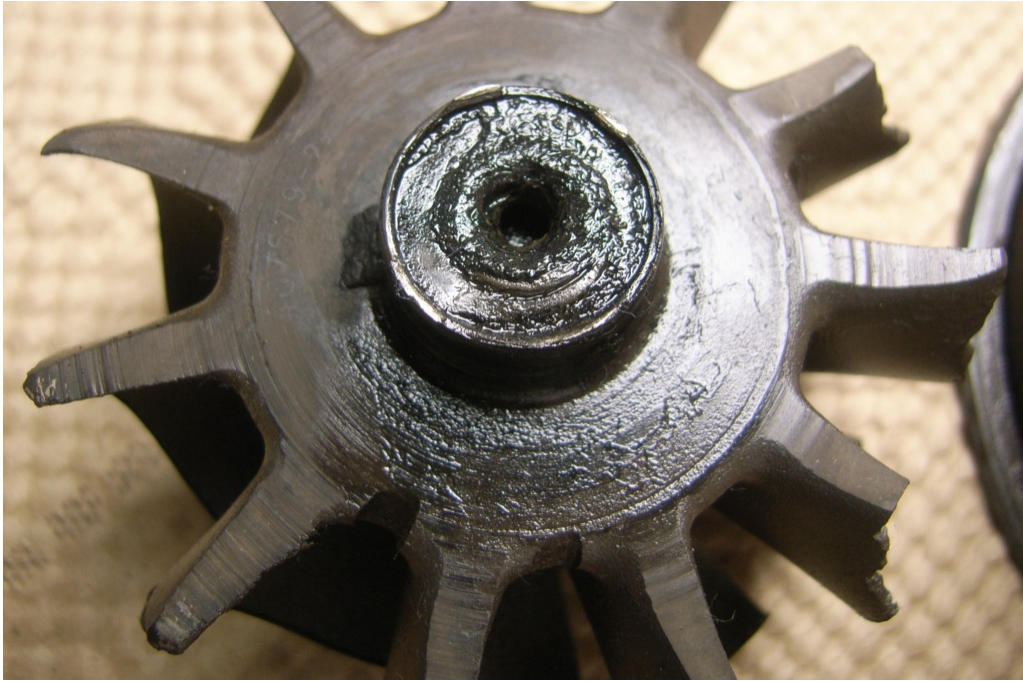
- The two rotor discs were separated, and the shaft was observed to be fractured
  - The shaft fracture end of the turbine was coated with a black substance.

- Attempts to clean/remove this in a wash tank were unsuccessful
- Some shiny, silvery metal fragments were observed near the area where the shaft was mounted in the bearing assembly

**Figure 17 - Turbine Rotor & Shaft Fracture Face**

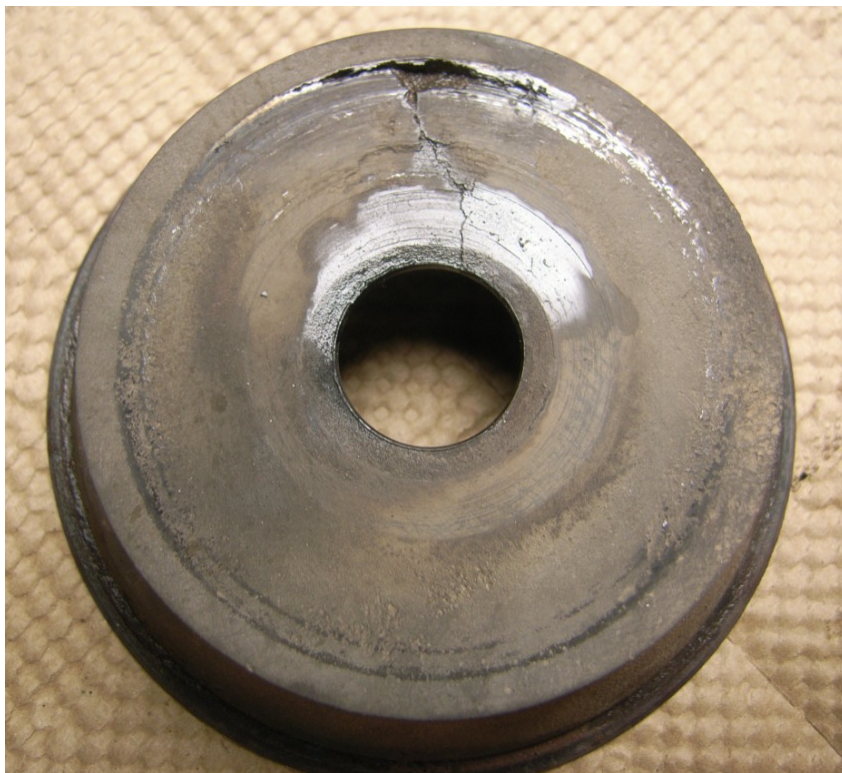
- The end plate of the turbine side of the unit was cracked. This part was also washed to remove some contamination
- It was decided to package these parts (two rotors, bearing housing, and compressor and turbine end plates) for further evaluation by the turbocharger manufacturer or other suitable facility.

**Figure 18 - Turbine End Plate (after cleaning)**

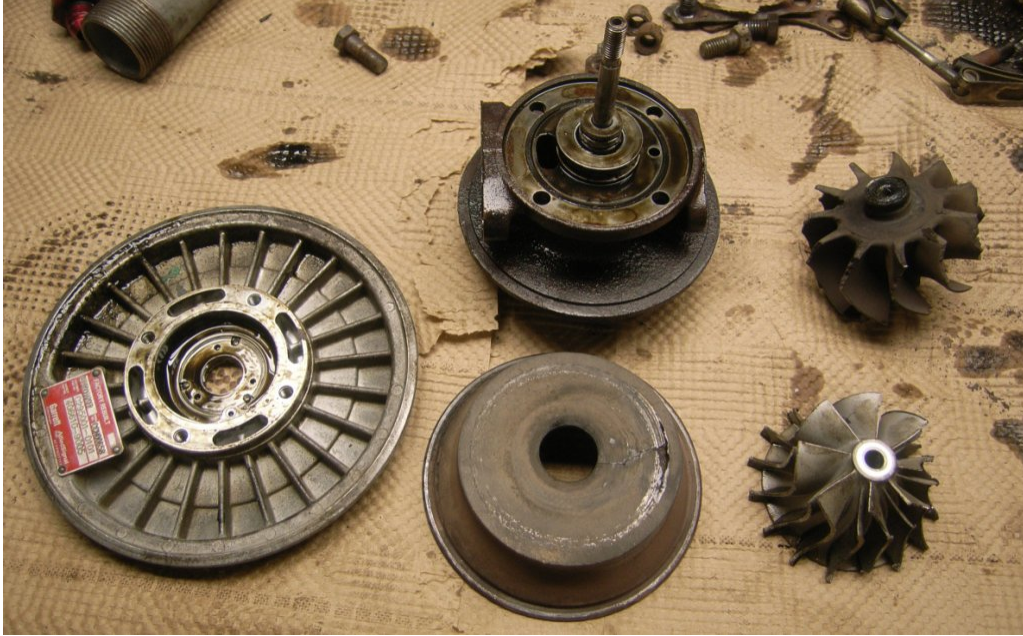
**Figure 23 - Turbocharger Components for Detailed Examination**
