## **NATIONAL TRANSPORTATION SAFETY BOARD**

# **CYLINDER EXAMINATION**

**WPR17LA175**

## **A. ACCIDENT EXAM**

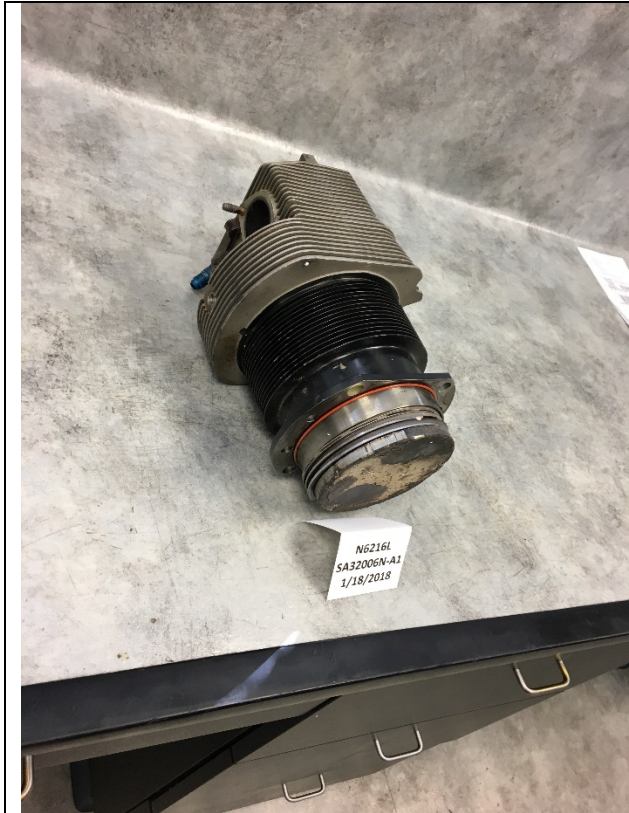
Cylinder after removal from shipping container; The piston was also part of the shipment. The cylinder was absent the push rods and rocker arms.

The intake and exhaust valve were in their respective positions.

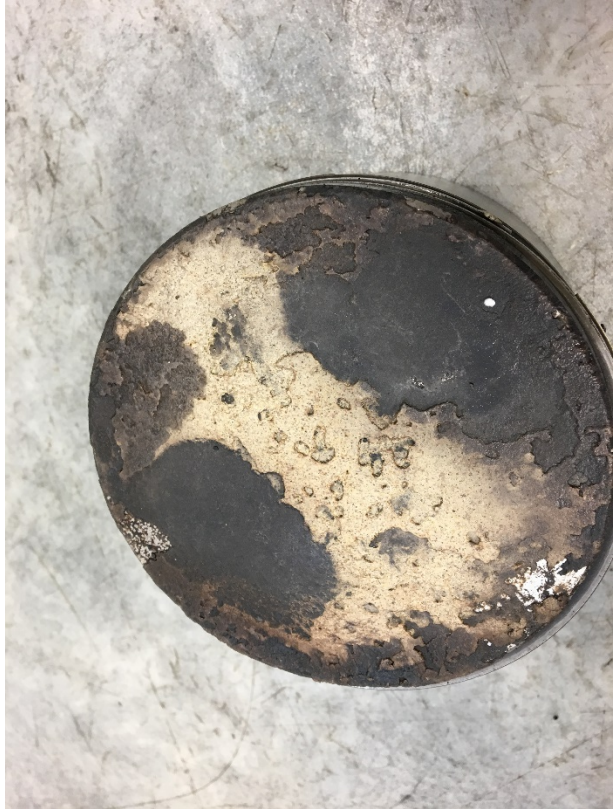
Top piston; heavy combustion deposits are present, also the lack of any signatures that indicate the exhaust valve struck the top of the piston is noted.

The rings appeared normal, and the piston sides were absent any “scuffing” marks.

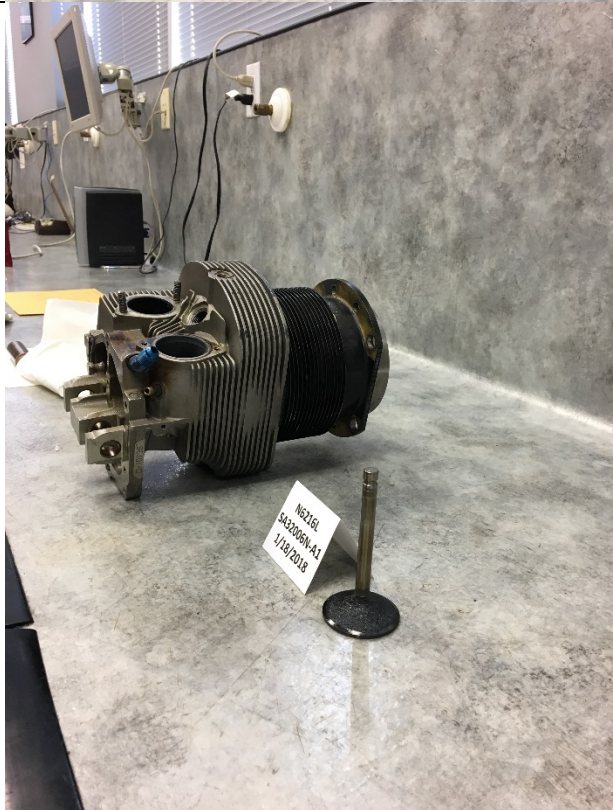
The intake valve was removed from the cylinder. Heavy combustion deposits are noted on the back side of the valve.

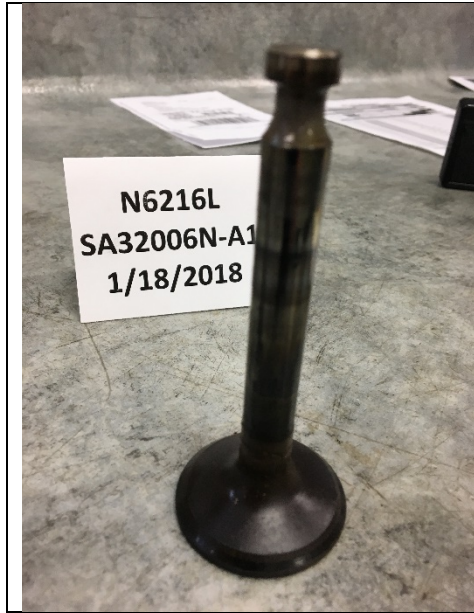
The exhaust valve was stuck in the open position. A “light” tap to the bottom of the valve was applied, in order to close the valve, and remove the valve keepers. A light tap was then required to remove the valve from the cylinder.

A Rockwell hardness test was performed on the valve: The valve was within specifications.

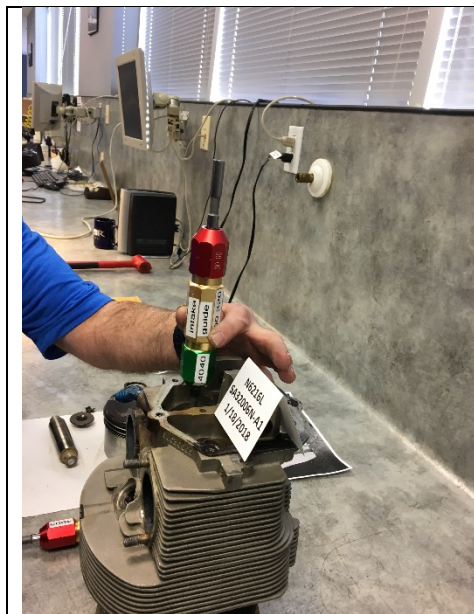
A Go No-Go gauge was applied to the cylinder valve guides. The intake valve guide passed the test. Neither end of the Go No-Go gauge was able to enter the exhaust guide.

A visual look in the exhaust valve guide, revealed what appeared to be material buildup on the inside the guide sidewalls.

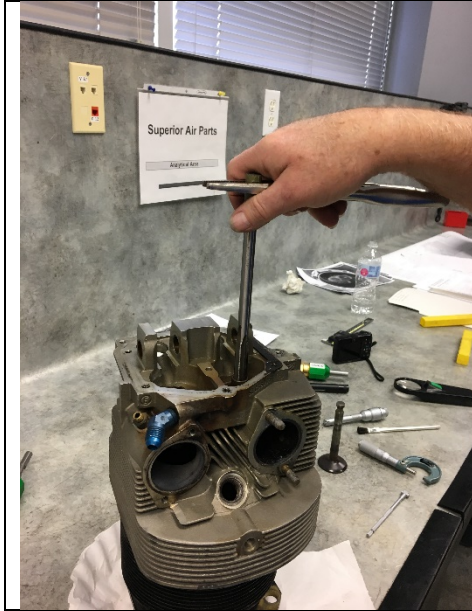
The exhaust valve guide was reamed (Lycoming SB) to remove material from inside the guide.

A visual look inside the guide after reaming, noted that metal material from the sides of the guide were not removed during the process.

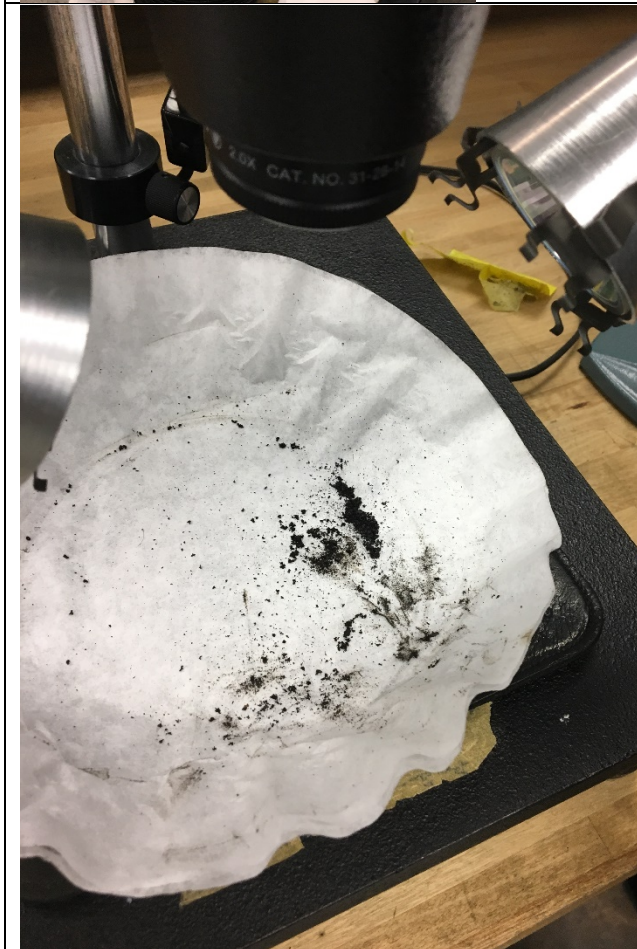
Material removed from the guide was collected. A visual look (including under a microscope) at the material was done. The collected material was consistent with combustion deposits; the absence of guide material was noted.

Results: No pre-accident deficiencies were found with the cylinder. The stuck valve was consistent with combustion deposit buildup in the exhaust valve guide.

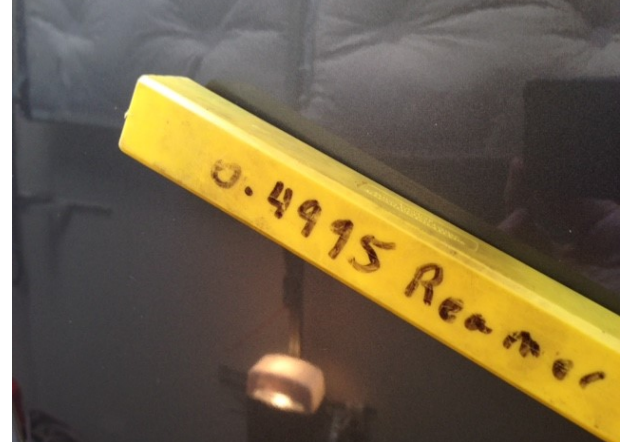
| A close-up photograph of a yellow reamer tool. The tool is angled diagonally across the frame. Handwritten in black marker on the yellow surface are the numbers '0.4975' followed by the word 'Reamer'. The background is dark and out of focus. | Reamer for the exhaust guide. |

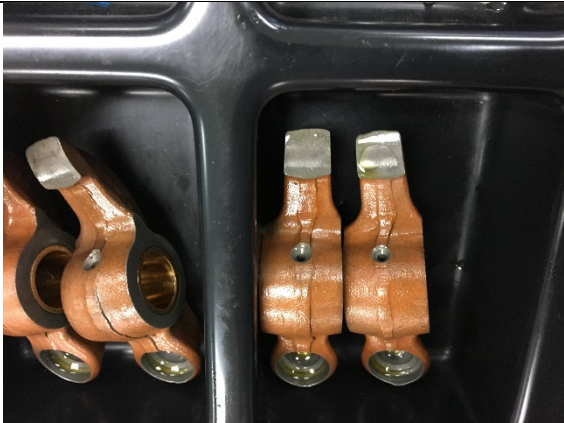
A review of photos, in the case file, noted that the push rod(s) were not bent. Since the exhaust valve was stuck, a bend push rod, maybe expected.

| | <p>Exemplar rockers. Also a review of the case file noted that there did not appear to be a oil hole in the rocker arm.</p> <p>The exemplar rocker arms: note the oil hole in both the intake and exhaust rocker arms.</p> <p>*Rocker arm and push rods were not supplied for the cylinder exam.</p> |
