## **NATIONAL TRANSPORTATION SAFETY BOARD**

### **SUMMARY OF AIRFRAME AND ENGINE EXAMINATION**

**(WPR17LA175)**

| Aircraft: | Grumman American AA-1B, N6216L |

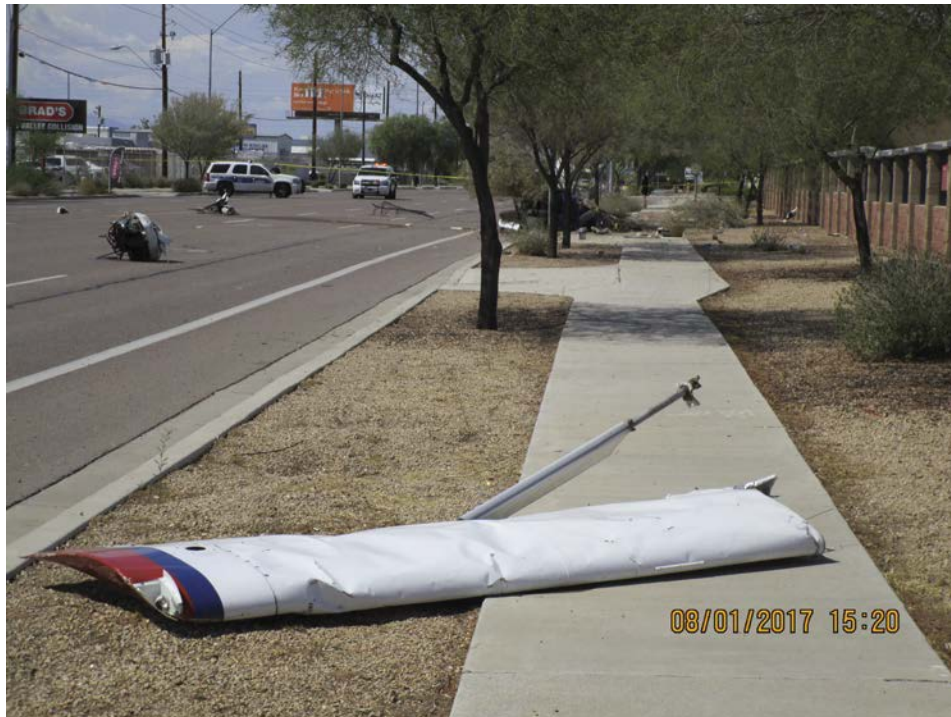
According to a Federal Aviation Administration (FAA) aviation safety inspector who responded to the accident site, several witnesses reported that after the airplane had taken off and was in its initial climb to the west, the wings started to rock back and forth. The airplane subsequently began to descend, struck the airport's western perimeter fence, and collided with terrain before coming to rest on a road that borders the airport on the west. Both wings and the engine had separated from the airplane due to impact forces. The wreckage was recovered to a secured location for further examination.

Figure 1 - view of wreckage site looking north

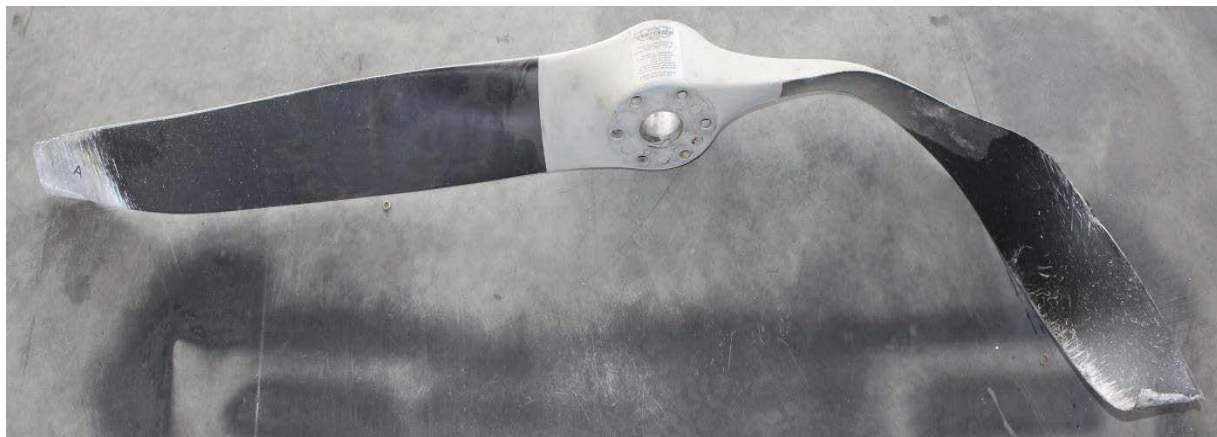
The metal two-bladed fixed pitch propeller remained attached at the crankshaft flange. The fiberglass spinner was attached to the propeller and had sustained impact energy damage. The propeller blades remained attached to the propeller hub. The crankshaft propeller flange was bent due to the absorption of impact energy.

The propeller blade marked as "A" exhibited significant leading-edge gouging at the tip end, chordwise striations across the cambered surface, torsional twisting and trailing edge "S" bending.

The propeller blade marked "B" displayed major leading-edge gouging, torsional twisting, chordwise striations across the cambered surface and trailing edge "S" bending. A portion of the propeller blade tip had been liberated.

**Figure 2 - damaged propeller blades**

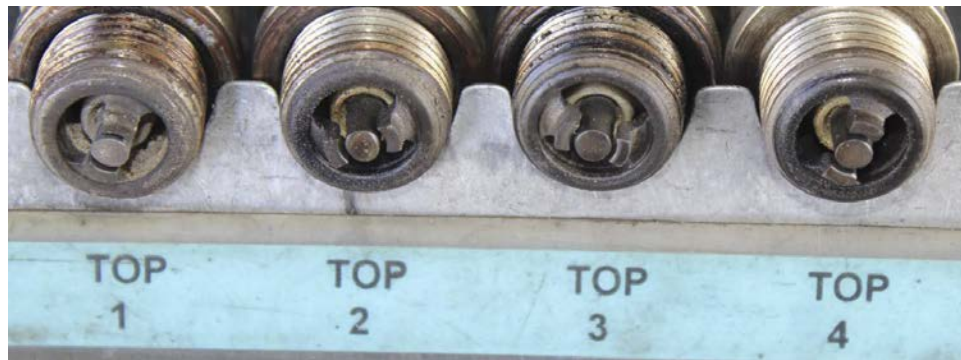
The spark plugs were secure at each position with their respective spark plug lead attached. The spark plugs were removed, examined and photographed. The spark plug electrodes remained mechanically undamaged, and according to the Champion Spark Plugs "Check-A-Plug" chart AV-27, the spark plug electrodes displayed coloration consistent with normal operation. The static oil soaking of the spark plugs (as noted) was attributed to the engine positioning at the mishap site and post recovery.

Figure 3 - condition of upper spark plugs

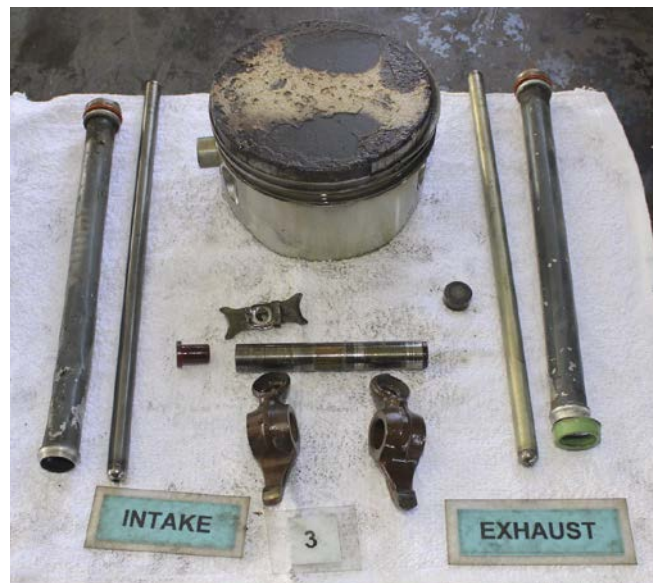
The number 3 cylinder was removed to facilitate further examination. The cylinder assembly was properly secured to the crankcase and appeared free of significant impact energy damage. The intake, exhaust rockers and valve train components within the rockerbox area appeared properly lubricated and free of mechanical damage. The intake and exhaust pushrods remained straight and free of damage. The intake pushrod shroud had sustained superficial impact damage. The intake rocker assembly remained undamaged and exhibited no evidence of lubrication deprivation. There was no intake rocker pin oil hole. The exhaust rocker assembly remained undamaged and exhibited no evidence of lubrication deprivation. The exhaust rocker pin oil hole remained free of obstruction.

Figure 4 - number 3 cylinder and associated parts

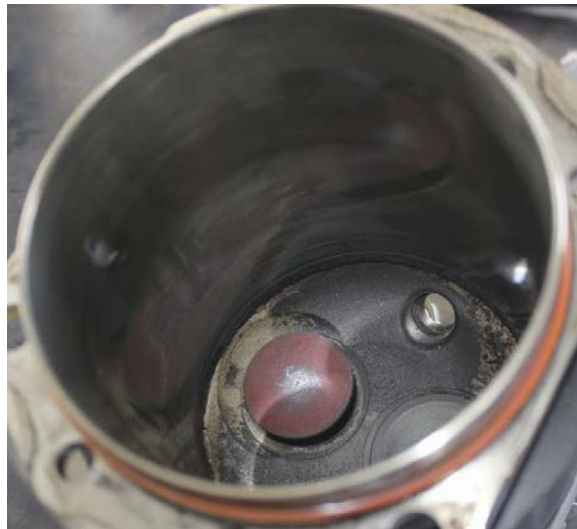
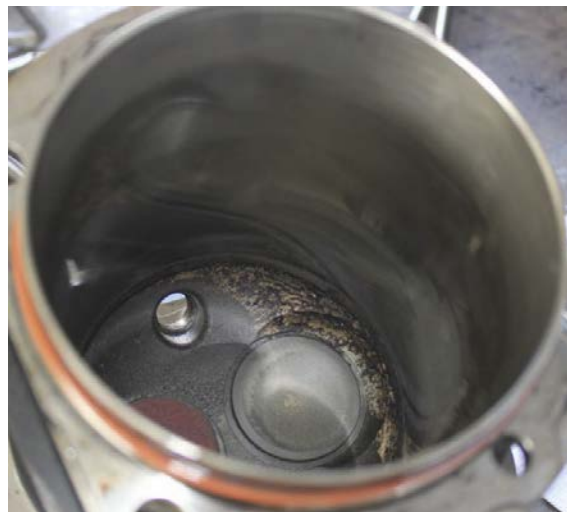
Figure 5 - view 1 of number 3 cylinder and stuck exhaust valve

Figure 6 - view 2 of number 3 cylinder and stuck exhaust valve

The intake and exhaust valves exhibited combustion deposits on the stems close to the rear of the valve face. The exhaust valve was found stuck in the OPEN position with valve spring nearly depressed fully. The valve was tapped on the combustion side with a rubber mallet to close the valve to facilitate removal of the valve keepers and removal of the valve for inspection. With the valve keepers removed, the intake valve was removed with little effort. The exhaust valve required tapping with a rubber mallet and brass drift to remove it from the valve guide. The valve was tested using a Rockwell hardness tester and found to be within specifications.

The exhaust valve stem and guide exhibited heavy combustion deposits. The valve guide diameters were measured with the deposits present. The deposits were then removed using a .4995-inch ream in accordance with Lycoming Service Instruction 1425A titled "Suggested Maintenance Procedures to Reduce the Possibility of Valve Sticking." The guides were remeasured after reaming and found to have an average of .0017-inch buildup of combustion deposits. The deposits were collected into a filter and sealed with the cylinder. All material removed during reaming was combustion deposits and no metallic material was observed.

As a result of number 3-cylinder examination, the NTSB aviation accident investigator who oversaw the examination stated that no preaccident deficiencies were found with the cylinder. The stuck valve was consistent with combustion deposit buildup in the exhaust valve guide.

Lycoming Engines published Service Instruction 1425A, dated January 19, 1988, which outlines Suggested Maintenance Procedures to Reduce the Possibility of Valve Sticking, applicable to all Lycoming direct drive engines.

Additionally, Lycoming Engines published Mandatory Service Bulletin SB-388C, dated November 22, 2004, which outlines Procedure to Determine Exhaust Valve and Guide Condition, applicable to all Lycoming direct drive engines. Time of compliance depends on the engine use as follows:

Lycoming Engines published Mandatory Service Bulletin SB-480E, dated April 13, 2005, which outlines Oil and Filter Change and Screen Cleaning, applicable to all Lycoming direct drive engines. This MSB requires 25-Hour interval oil change, pressure screen cleaning, and oil sump suction screen check for all engines employing a pressure screen system. (Refer to Lycoming Service Bulletin SB-480E, which is appended to the docket for this report.)

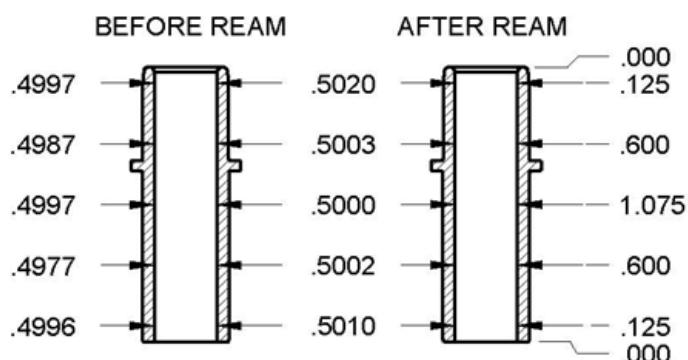
The exhaust valve was found stuck in the open position and there were no valve strike marks on the piston top. The exhaust valve stem and guide exhibited heavy combustion deposits. The valve guide diameters were measured with the deposits present. The deposits were then removed using a .4995" ream in accordance with Lycoming Service Instruction 1425A Titled "Suggested Maintenance Procedures to Reduce the Possibility of Valve Sticking." The guides were re-measured after reaming and found to have an average of .0017" build-up of combustion deposits. The before and after ream dimensions are listed below:

Figure 7 - before and after ream dimensions

All material that was removed during the reaming operation was captured into a filter and contained no metallic particles, only combustion deposits.
