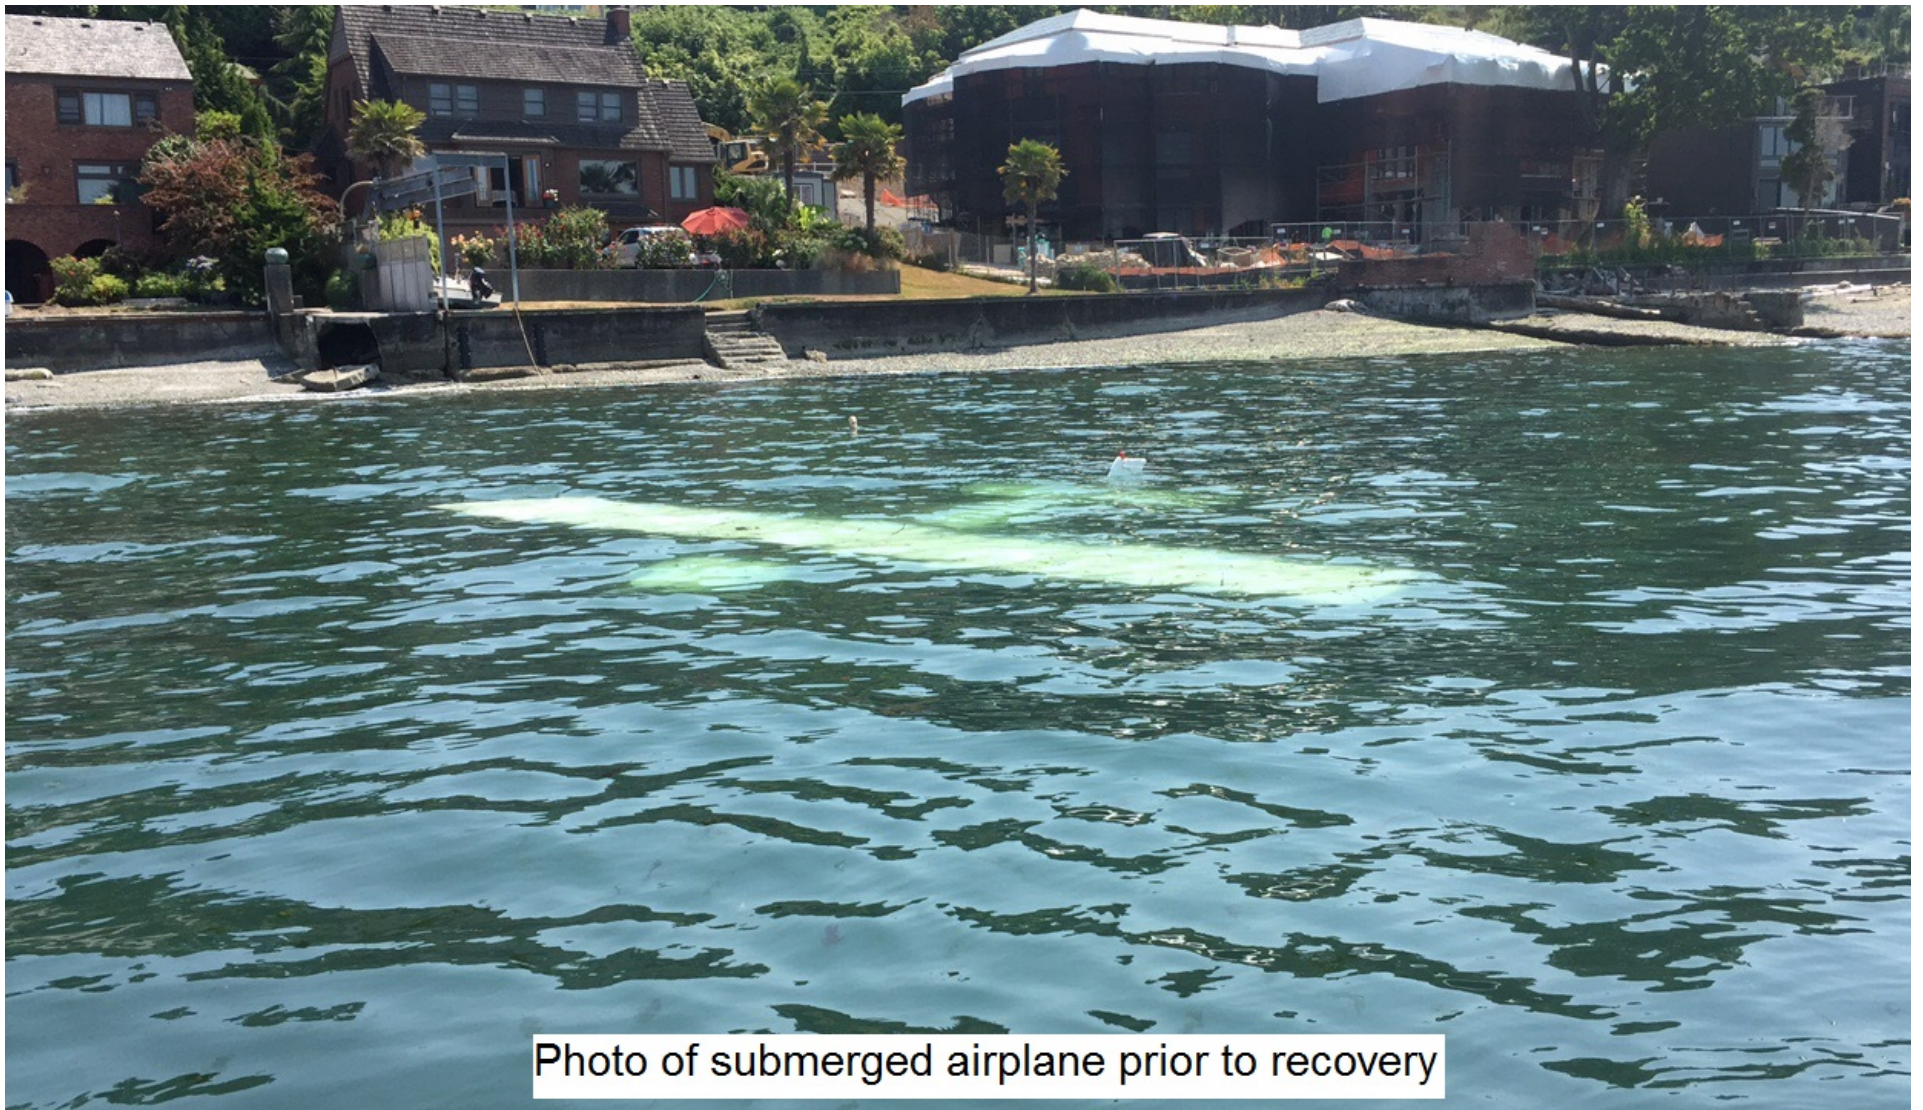
**Photo 1 – photo of submerged airplane prior to recovery**

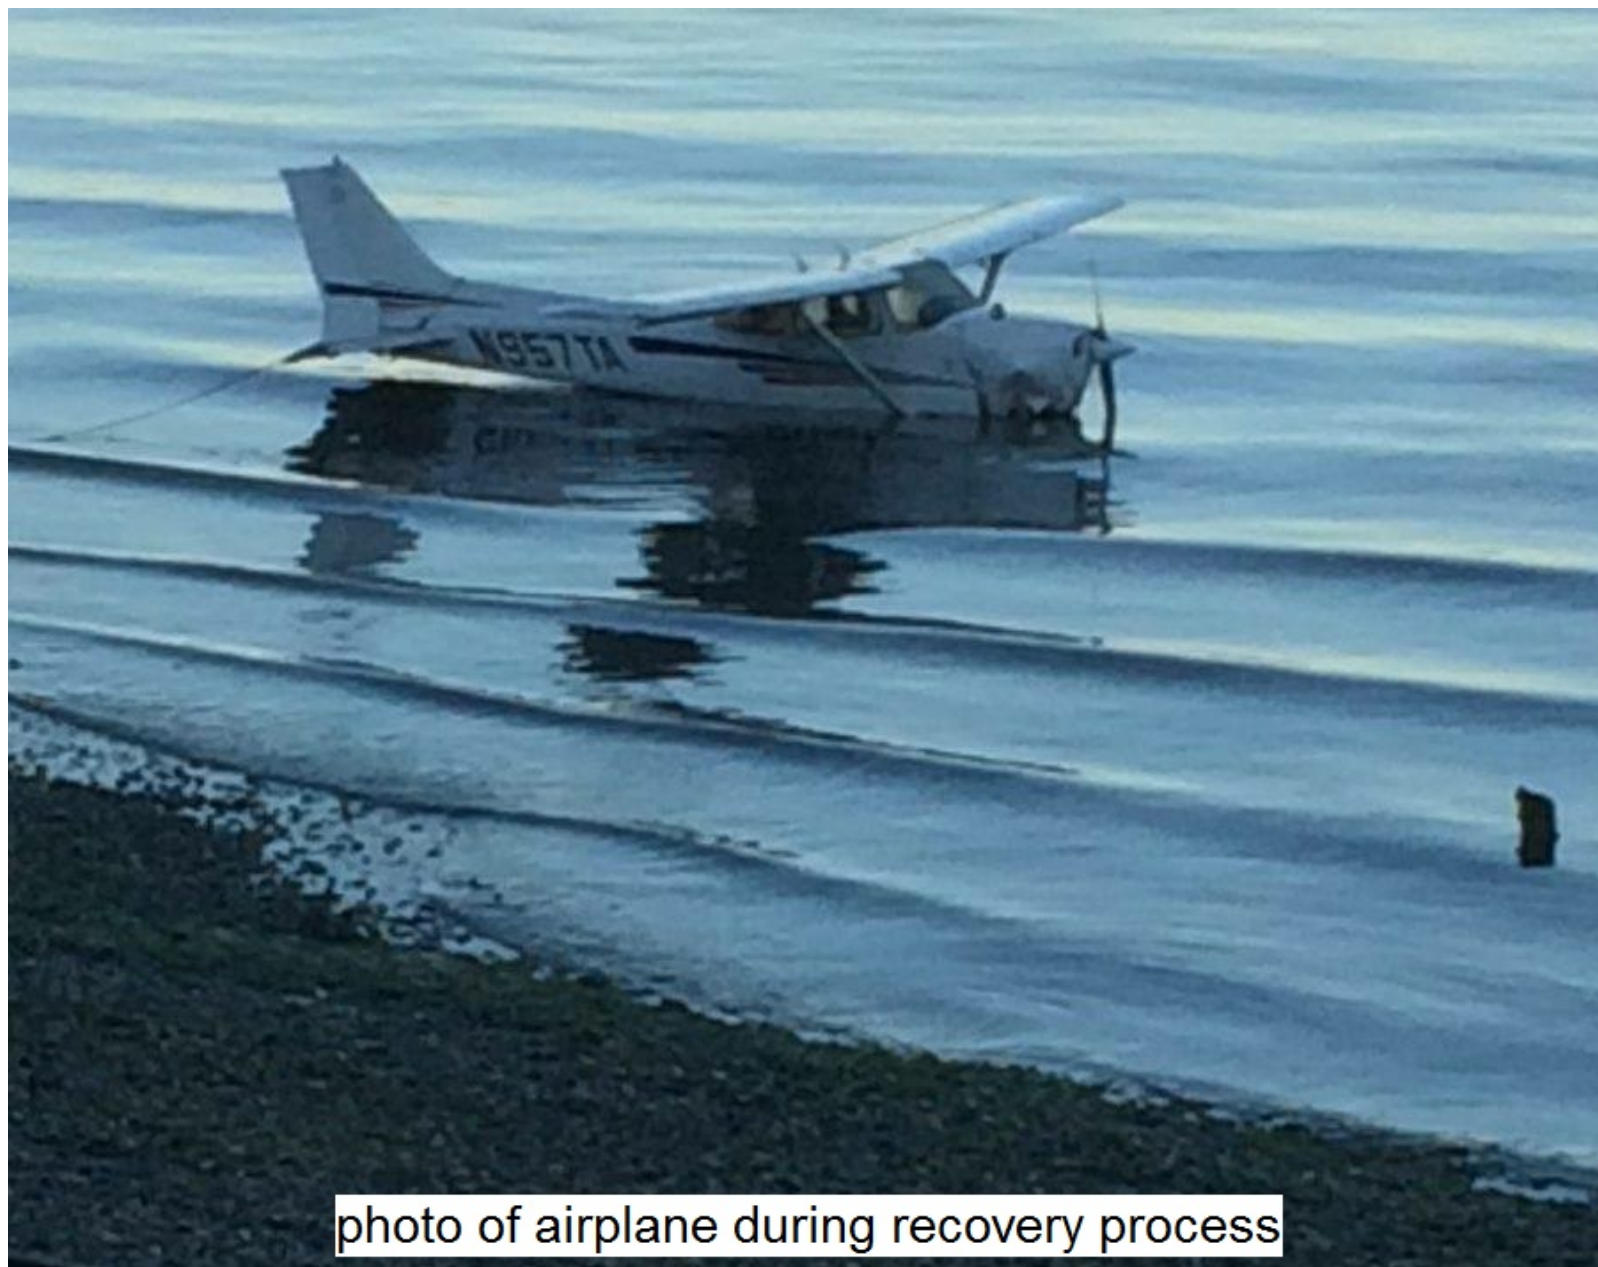
**Photo 2 – photo of airplane during recovery process**

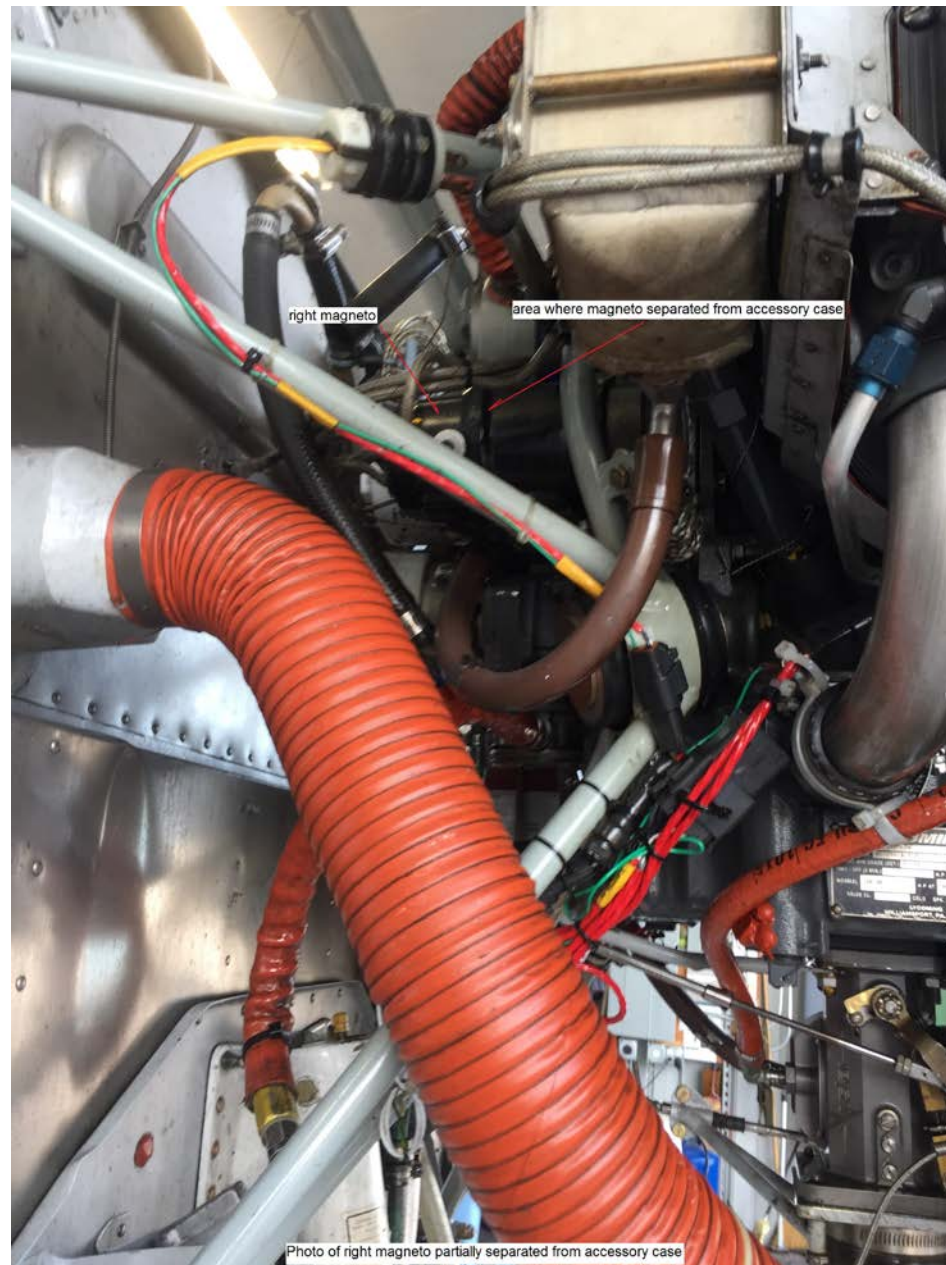
**Photo 3 – photo of right magneto partially separated from accessory case mount**

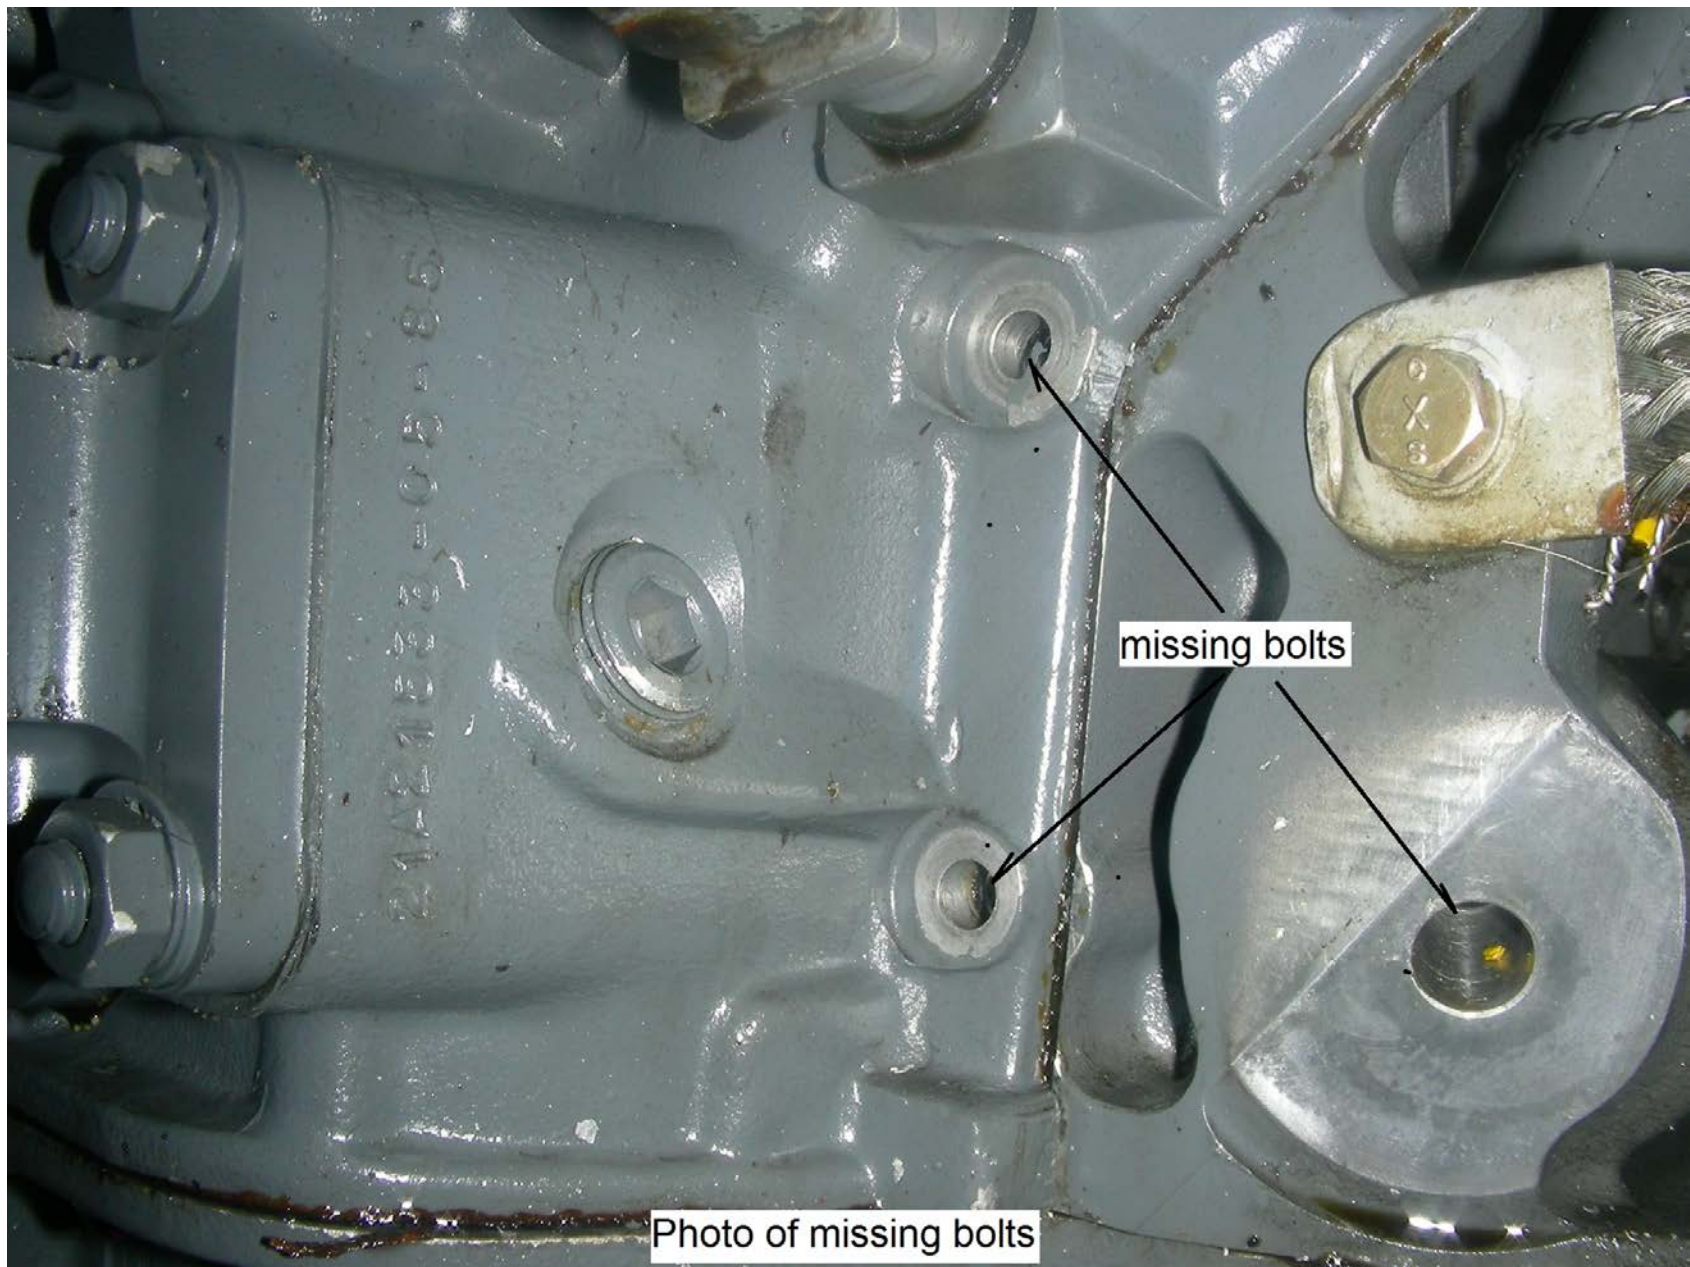
**Photo 4 – photo of missing case bolts**

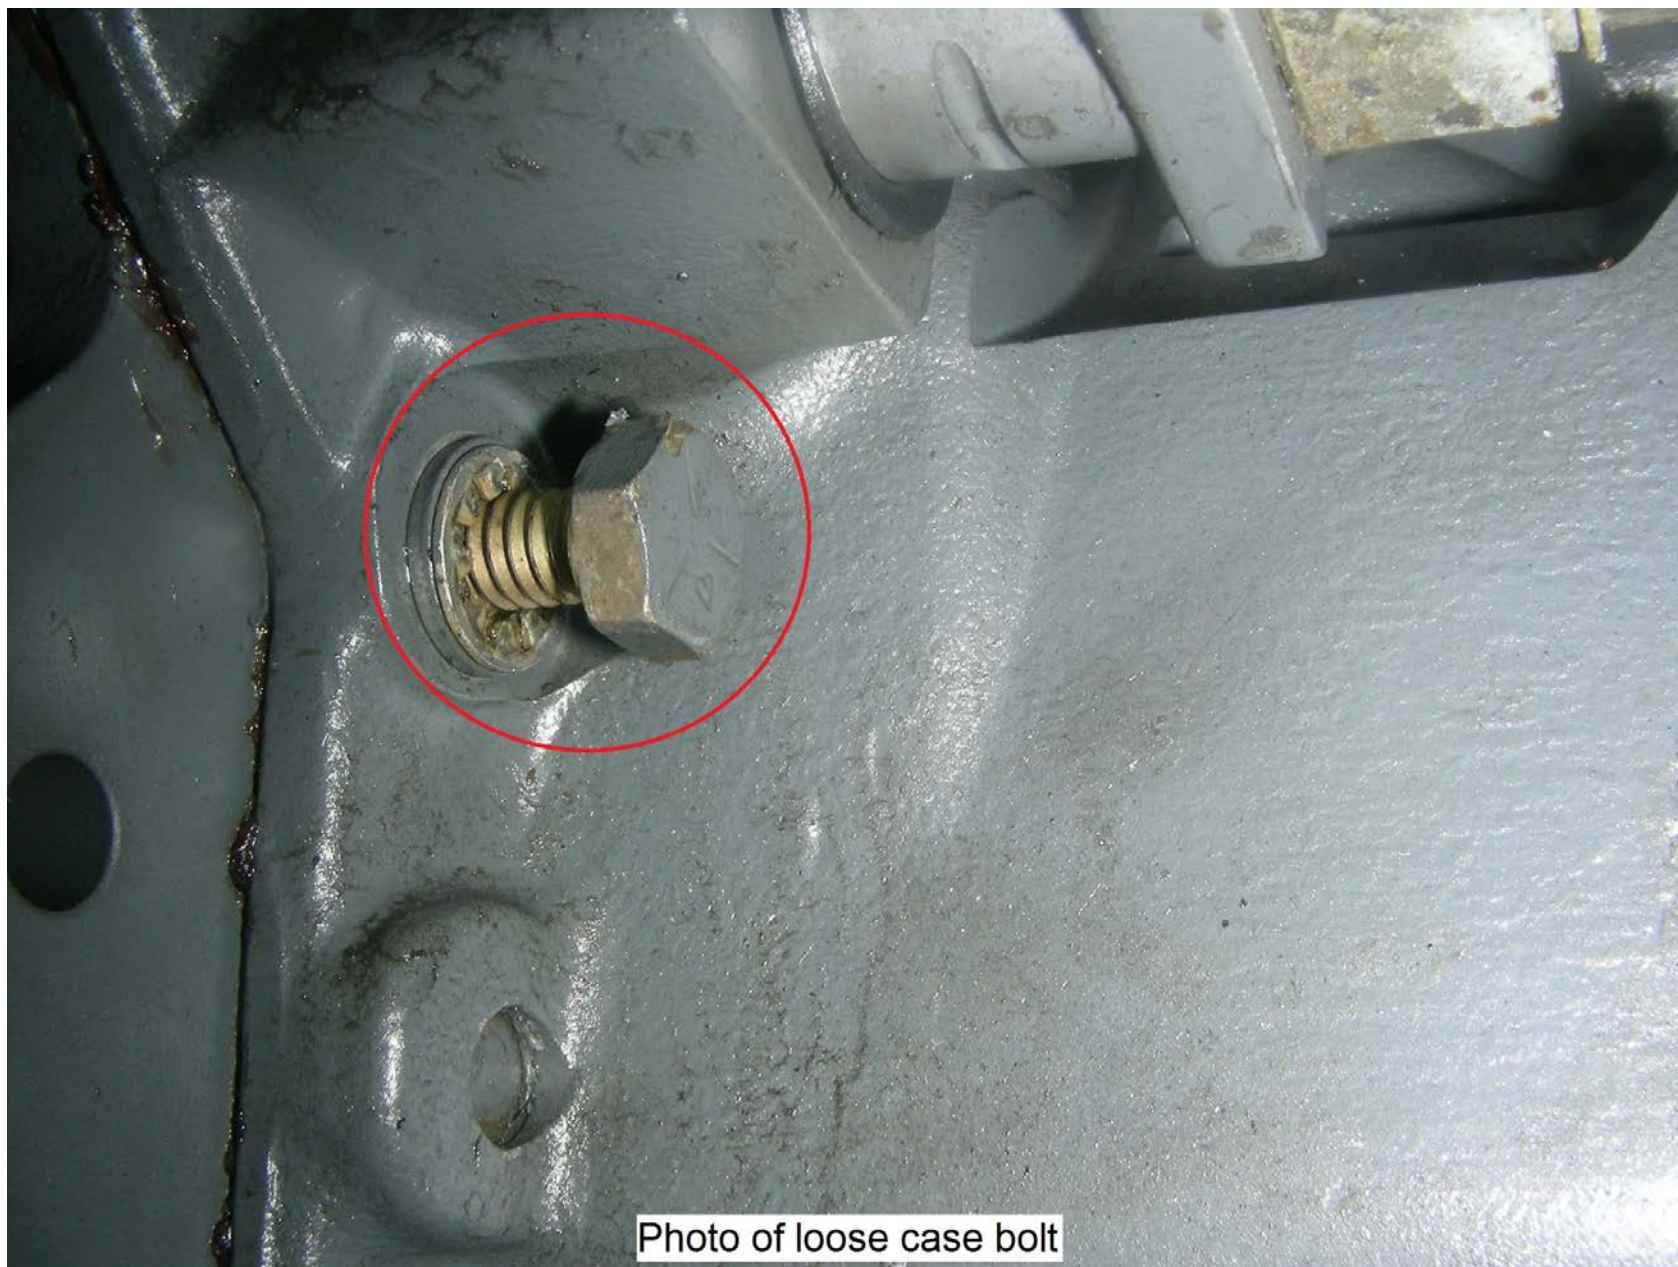
**Photo 5 – photo of loose case bolt**

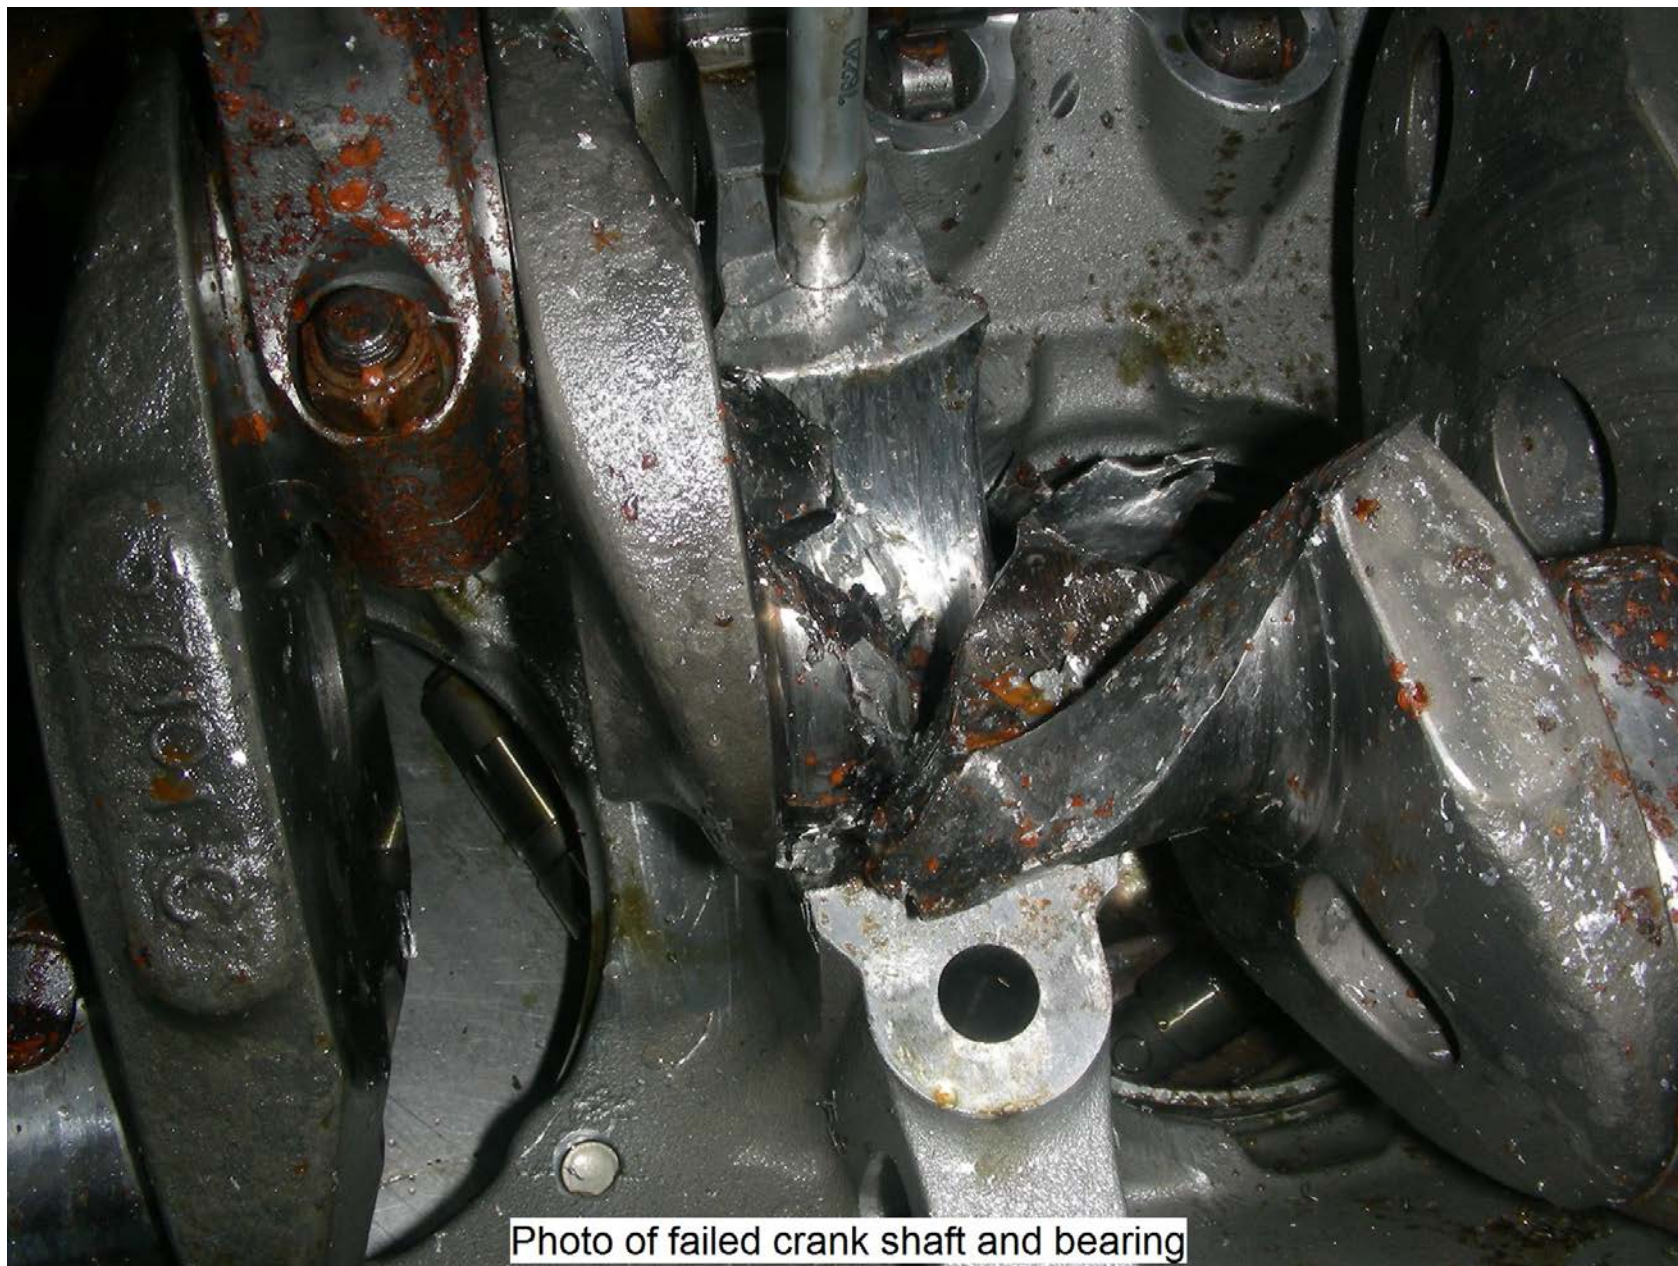
**Photo 6 – photo of failed crank shaft and bearing**
