## **EXAMINATION REPORT & COMPANY INTERVIEWS**

**WPR17LA180**

**Pocatello, Idaho**

**Lockheed P2V-5; N410NA**

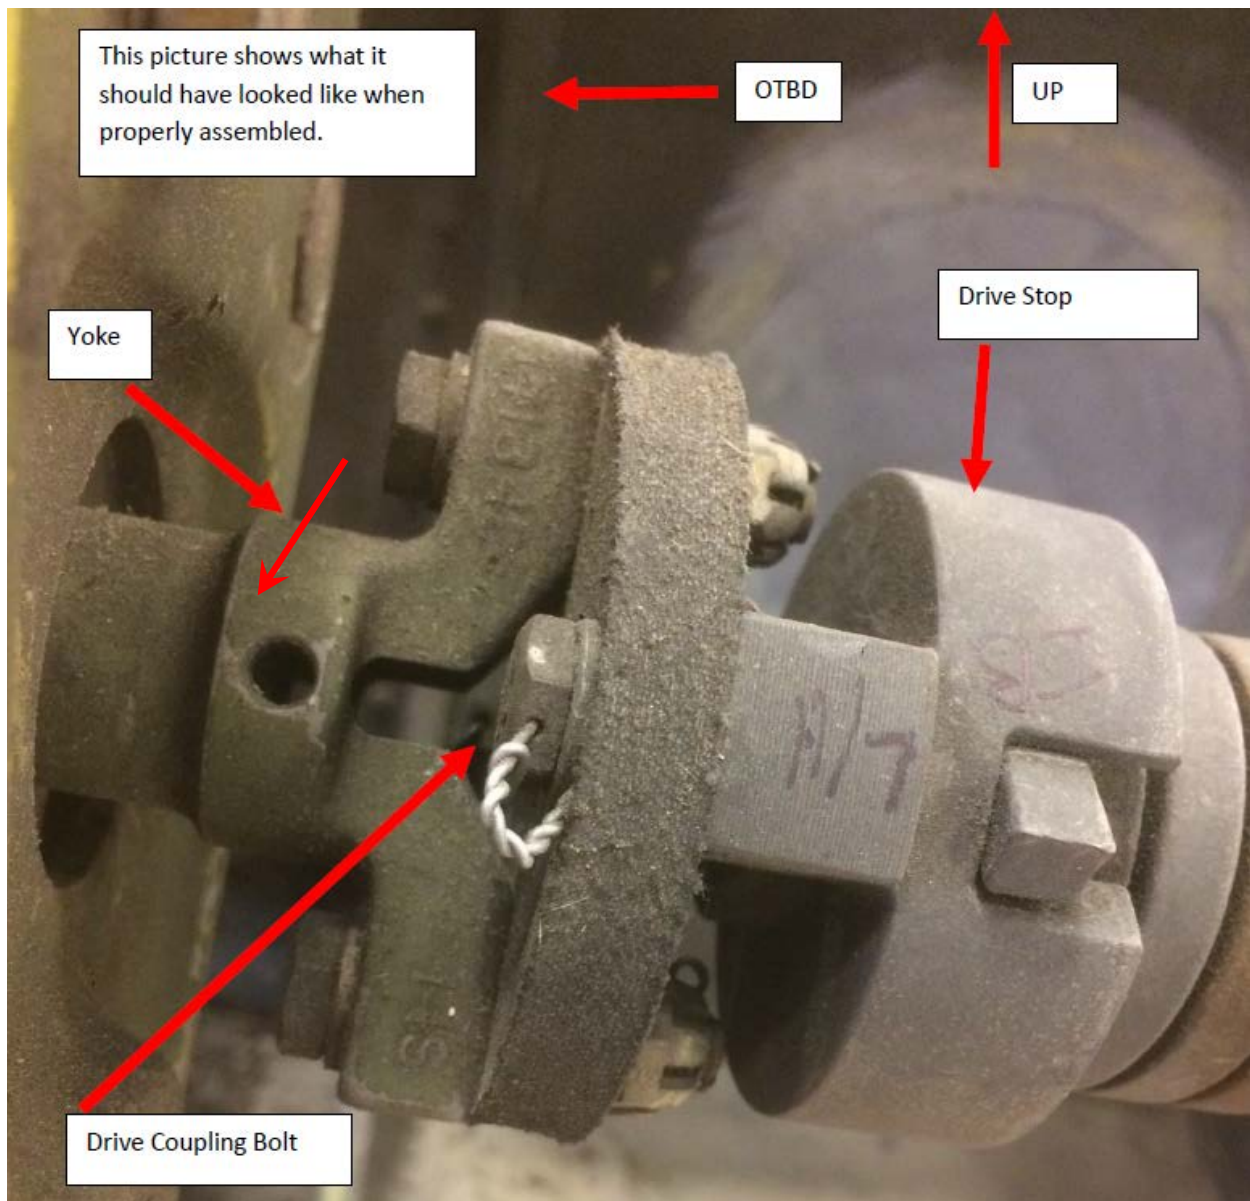
The airplane is equipped with a variable camber (varicam) horizontal stabilizer in place of an elevator trim tab. When an adjustment is made in the cockpit, the varicam drive shaft rotates to move the varicam actuators and the secondary control surface's down or up deflection. The varicam actuators are secured to the drive shaft through universal joints located at the outboard ends, comprised of two bolts that are threaded and safety wired to the drive stop and two bolts with castellated nuts and cotter pins to secure the yoke to the drive coupling (Photo 1).

Figure 1 – Outboard Varicam Drive Shaft with Safety Wire

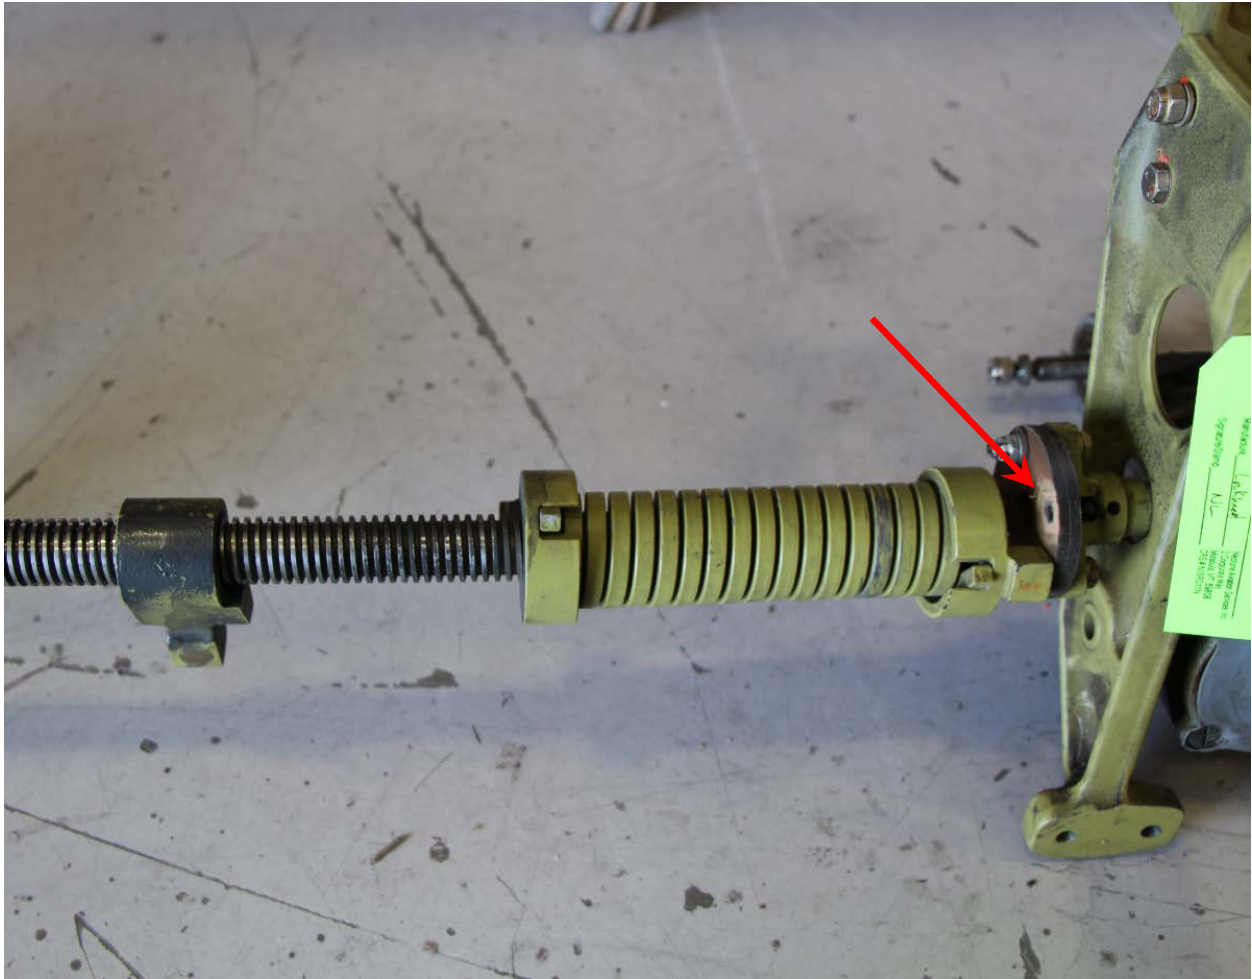
An examination of the varicam's LH outboard drive stop and yoke showed the presence of one bolt that had been secured to the drive coupling. The drive coupling is normally secured to the drive stop with two bolts that are safety wired together; however, the second bolt was missing

from its bolt hole (photo 2). According to the Director of Maintenance, the missing drive coupling bolt was found inside the varicam without any safety wire in the bolt head. Further examination of the varicam did not reveal the presence of safety wire throughout the cavity of the secondary control surface.

An absence of the one of the drive coupling bolts would hinder the torque capabilities of drive shaft; thereby allowing one side of the varicam to move and the other side to remain stationary or turn incrementally.

Figure 2 – Outboard Varicam Drive Stop Mechanism at the Mount Assembly with Missing Drive Coupling Bolt
