## **NATIONAL TRANSPORTATION SAFETY BOARD**

### **ENGINE EXAMINATION SUMMARY**

**WPR17LA187**

Location: Salt Lake City, Utah  
Date: August 24, 2017  
Aircraft: N8170M; Cessna 310I  
NTSB Investigator-in-Charge: Andrew Swick

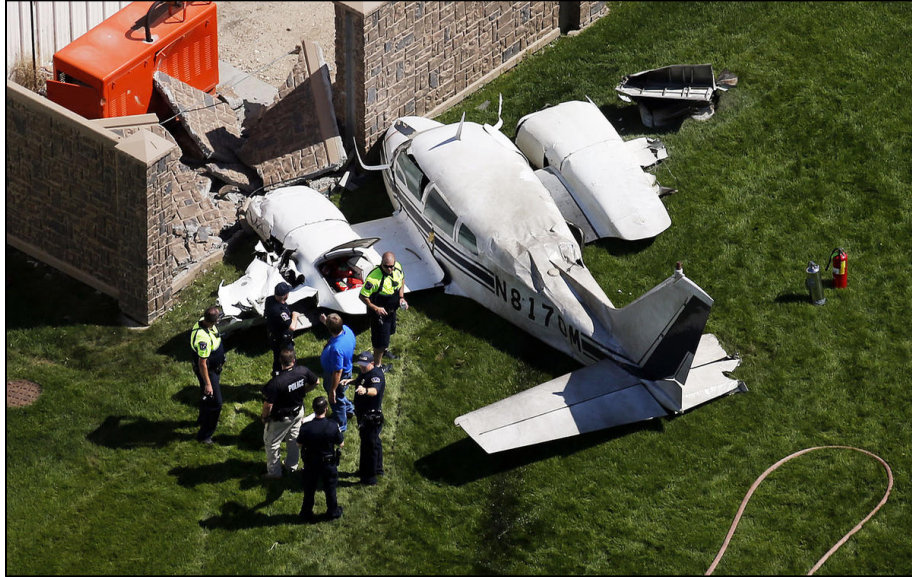
Figure 1-Aerial view of the main wreckage.

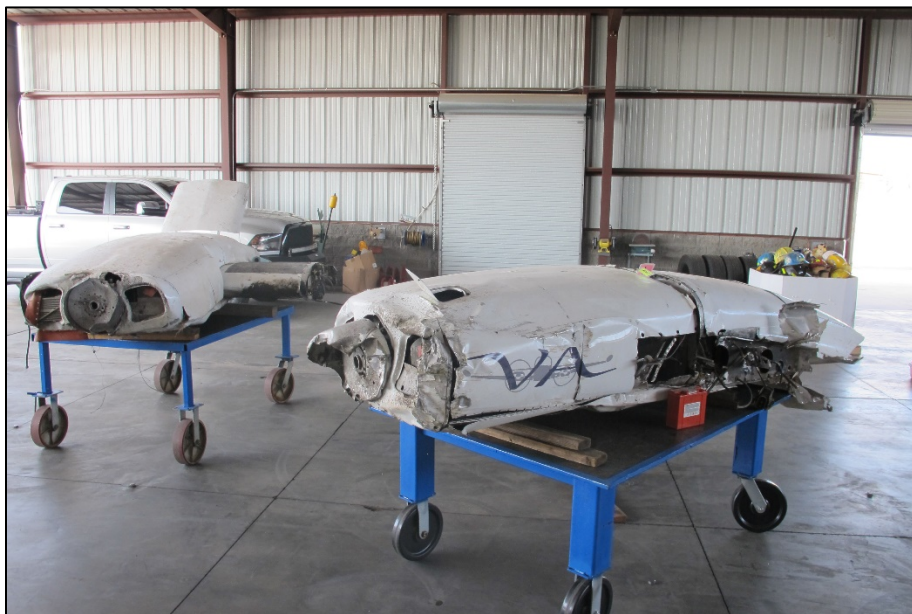
The engines and their nacelles were removed from the main wreckage for the purposes of relocation. The propellers separated from the engines during the accident sequence and were found with the main wreckage. The upper engine cowlings were removed and the interior surfaces of both the upper and lower cowling halves were covered in a dark oily residue. The engines exterior surfaces were clean and undamaged.

Figure 2-Engines, nacelles, and cowlings.

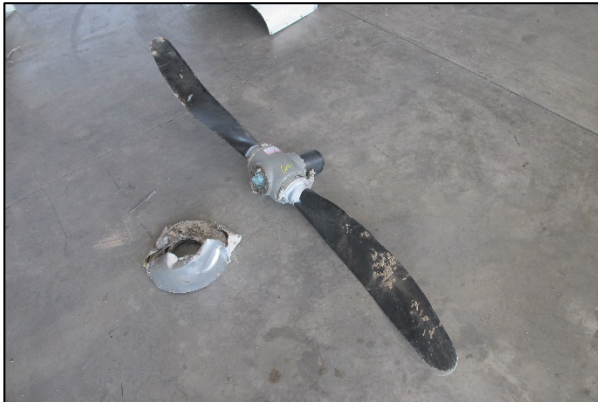
The left propeller was found intact and the spinner and back plate separated. The left propeller blades had scuffing at the propeller blade tips and slight bending of the entire length of the blades.

Figure 3-Left propeller assembly.

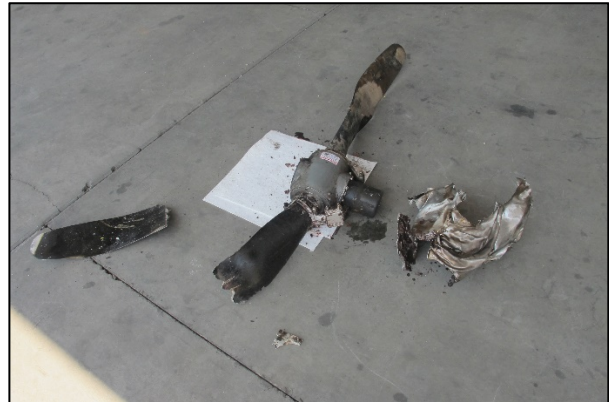
The right propeller was found with one blade separation at the midsection of the blade. The spinner separated from the propeller assembly and was crushed and disfigured. The propeller back plate remained attached to the engine. The separated blade had aft bending near the jagged separation surfaces. The other blade remained attached to the hub and had a decreased pitch twist and scuff marks throughout.

Figure 4-Right propeller assembly.

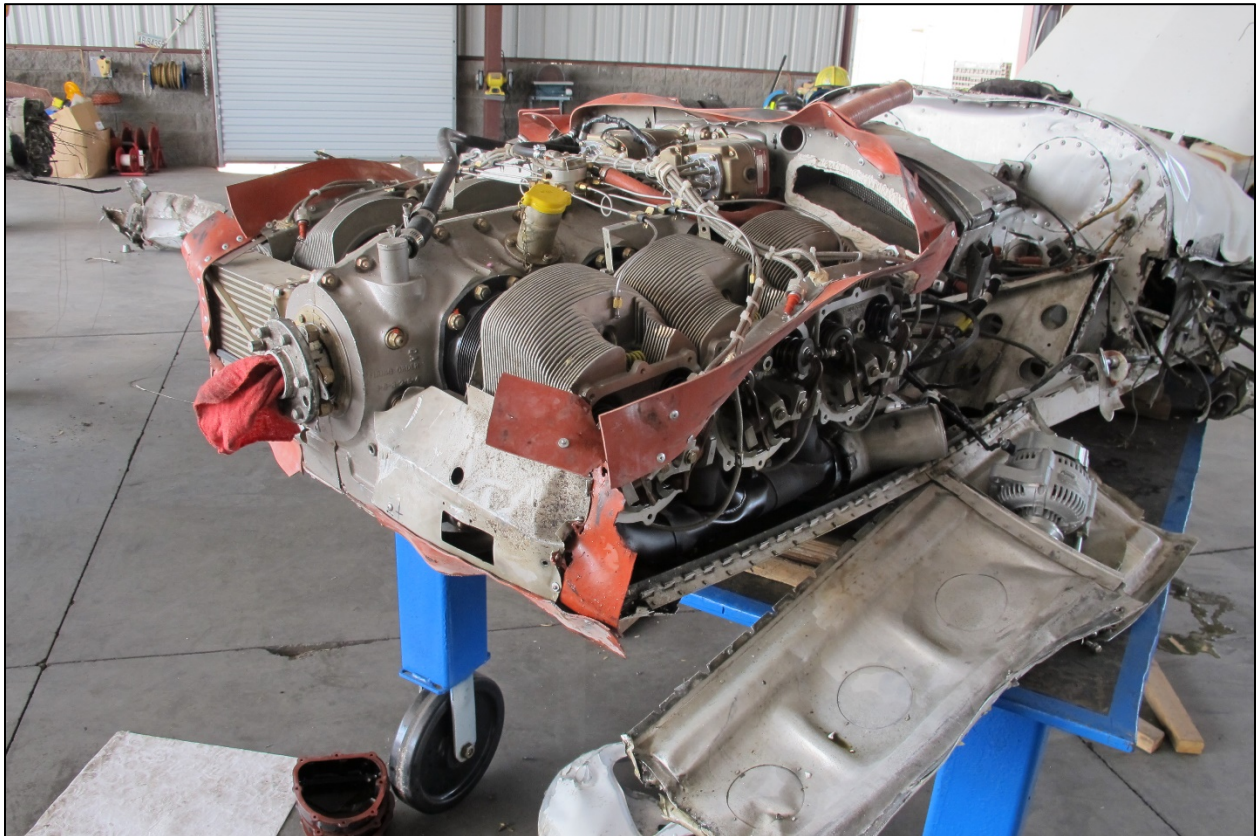
The left engine remained attached to the engine mounts and nacelle. The exhaust was crushed underneath the cylinders. The tachometer drive cannon plug attachment was not attached. The tachometer drive was intact and the cannon plug attachment was undamaged. The fuel pump was removed from the engine and the drive coupling was found intact. The pump drive was rotated freely by hand and no anomalies were noted. The oil screen cap has loose and improperly twisted safety wire. The oil screen was removed and was clear of debris.

Figure 5-Left engine positioned during the examination.

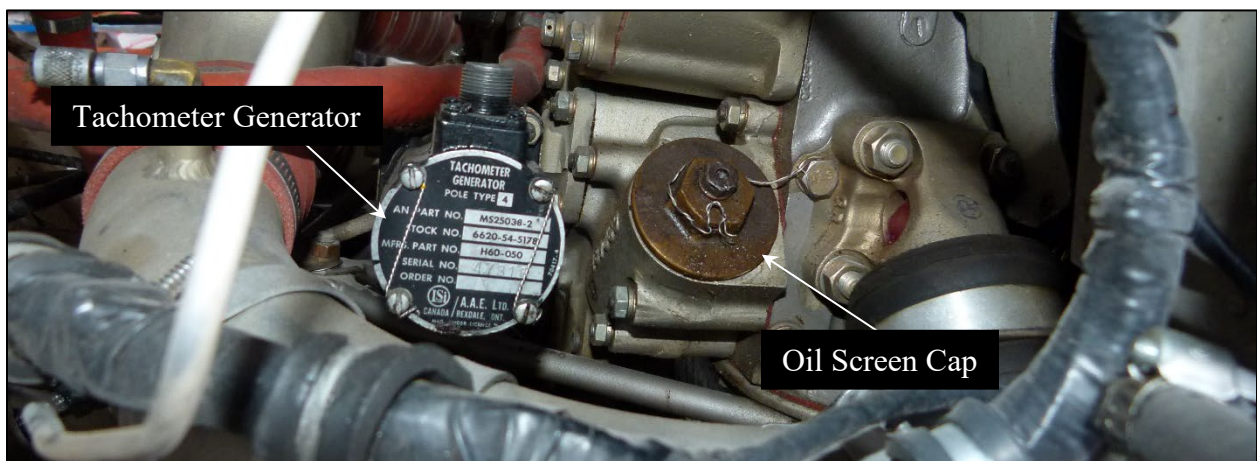
Figure 6-Left Engine tachometer generator and oil screen cap safety wire.

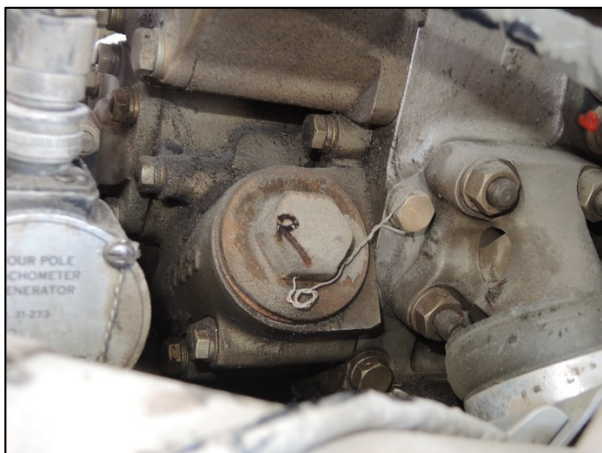
The right engine remained attached to the engine mounts and nacelle. The exhaust was crushed underneath the cylinders. The tachometer drive was undamaged, and the cannon plug was attached. The fuel pump was removed from the engine and the drive coupling was found intact. The pump drive was rotated freely by hand and no anomalies were noted. The oil screen cap has loose and improperly twisted and routed safety wire. The oil screen was removed and was clear of debris.

Figure 7-Right engine oil screen cap and safety wire.

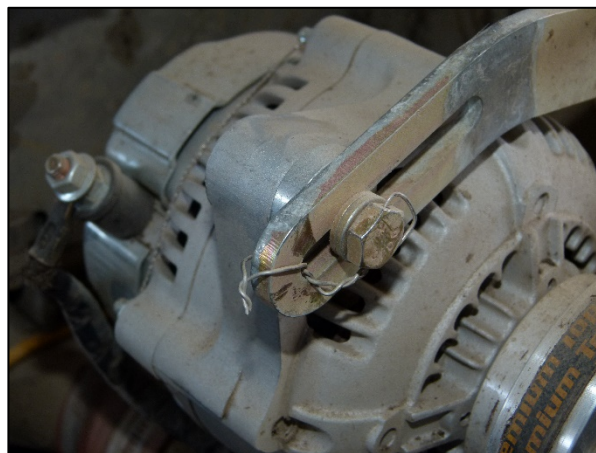
The cylinder rocker box covers were removed and the cylinder overhead components were covered in residual oil and undamaged. The crankshaft was rotated and thumb compression and valve continuity were attained. The magnetos produced spark at each terminal lead. The sparkplugs were removed and the electrode areas were dark in color. The sparkplug electrode had “worn out-normal” wear conditions when compared to the Champion Aviation Check-A-Plug chart. The fuel nozzles were removed and were unobstructed. The fuel manifold valve was disassembled and undamaged. Fuel was in the manifold cavity and the screen was clear of debris. The fuel control fuel inlet screen was removed and had light amounts of fibrous debris. Belt driven alternator loose and improper safety wire.

Figure 8-Right engine alternator safety wire.
