**NATIONAL TRANSPORTATION SAFETY BOARD**

**AIRFRAME & ENGINE EXAMINATION**

**WPR17LA188**

**Robinson R-44; N61NM**

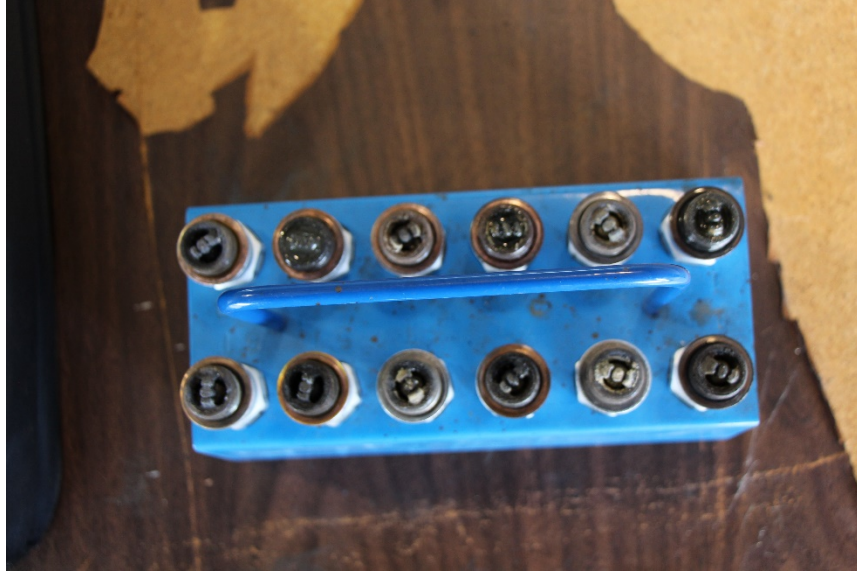
Photograph 1 – Spark Plugs

The ignition harness leads were removed from the spark plugs, most of the leads showed indications of arcing. The ignition lead wires to the cylinder no. 3 and 5 spark plugs were loose and the rim of the upper plug to cylinder no. 1 displayed corrosion. Both the lower and upper spark plugs were manufactured by Champion Aerospace, part number REM38E, and removed and placed in a spark plug tray. Each plug displayed excessive contamination, which consisted of pliable carbon deposits and other debris that caused electrode bridging. When compared to the Champion Aerospace Aviation Service Manual, the plugs were similar to the manual's classification of "severely fouled" plugs. The bottom spark plugs to cylinder nos. 1, 3, and 5

displayed oil fouling, consistent with the helicopter's resting position on its side at the accident site. The engine was rotated by hand using the cooling fan, which showed light compression on all six cylinders. The oil fouled spark plugs were cleaned of oil residue using a spray solvent. A magneto synchronizer was used to measure the magneto timing, which revealed a timing of 10° before top dead center (the manufacturer's specification is 20° before top dead center).

Each spark plug was then cleaned using a sand blaster. A visual inspection of the electrodes after cleaning revealed varying gaps and excessively worn electrodes on some of the plugs. The spark plugs were re-installed and the engine a second engine ground was performed with similar results as the first test.

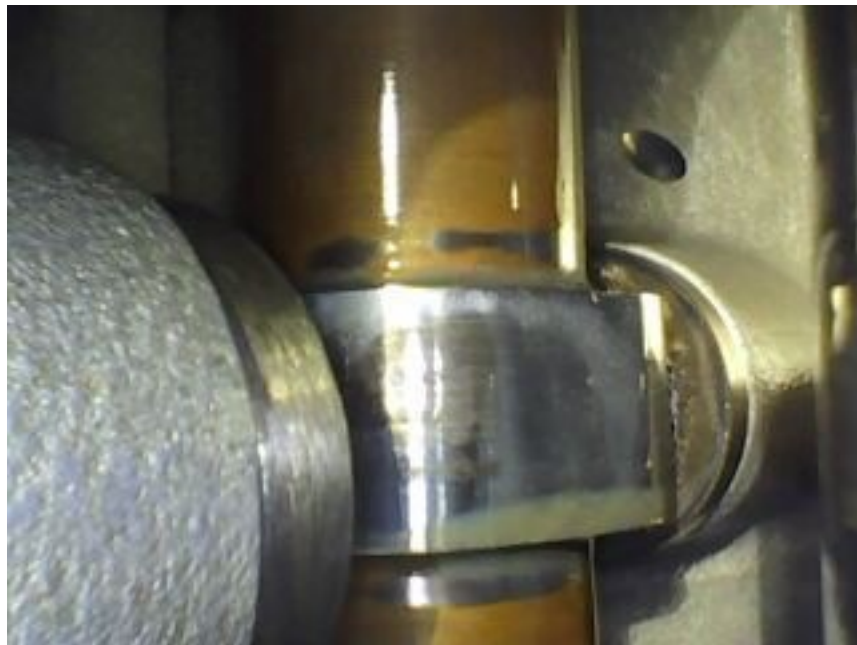
Photograph 2 – Intake Camlobe from Cylinder no. 5

After the airplane wreckage was released, the accident pilot reported that he observed only trace movement from the intake valves for cylinder nos. 5 and 6, which are actuated by the same camlobe at the camshaft. The NTSB IIC subsequently examined the intake valve movement with the accident pilot at his hangar. Initially, the pilot used the started to crank the engine, while the NTSB IIC observed the intake valves, which confirmed that both intake valves for cylinder nos. 5 and 6 did extended about one third the distance of the other intake valves. A dial indicator was

then setup to approximate camlobe lift by measuring the lift from the intake valve. The dial indicator measured 0.112 inches for the cylinder no. 6 intake valve lift when at its highest point. The dial indicator was then placed above the cylinder no. 6 exhaust valve, which measured 0.398 inches of lift at the valve's highest point.

The cam lobe to the intake valves for cylinder nos. 5 and 6 was severely worn and spalled (see photographs 2 & 3).
