# NATIONAL TRANSPORTATION SAFETY BOARD

## MATERIALS LABORATORY FACTUAL REPORT

Report No. 18-038

Place : Santa Paula, California  
Date : September 4, 2017  
Vehicle : Boeing P-17  
NTSB No. : WPR17LA197  
Investigator : Stephen Stein

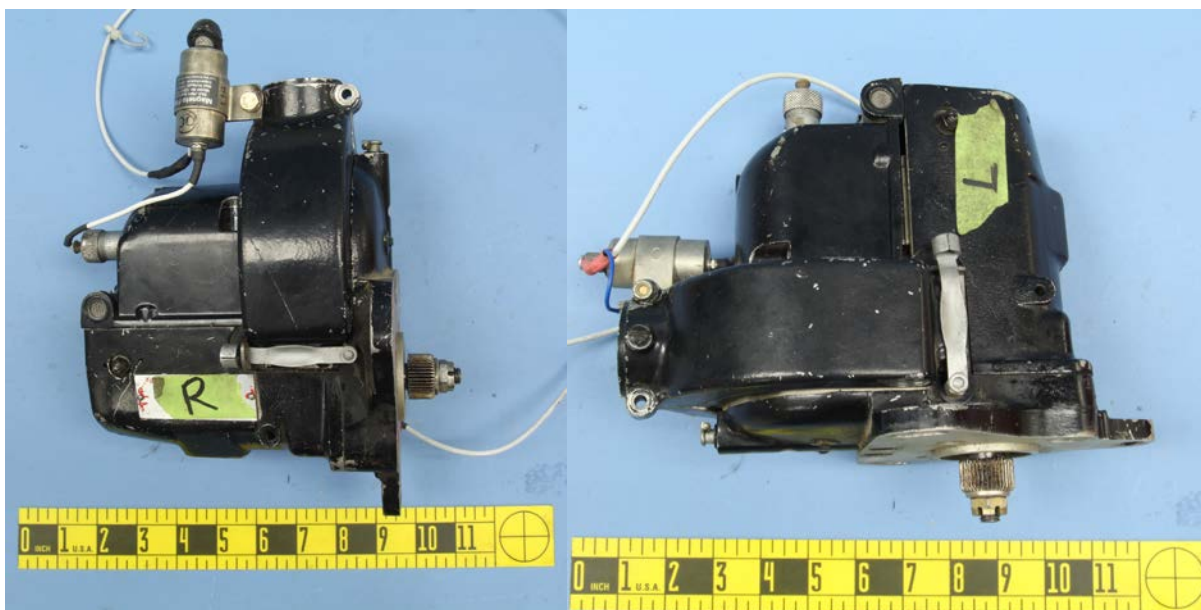
Figure 1: Right and left magnetos.

The magnetos did not exhibit any external damage and their rotors turned smoothly. After removal of the distributor block covers an area of electrical arcing was observed on the distributor rotor of the right magneto (figure 5).

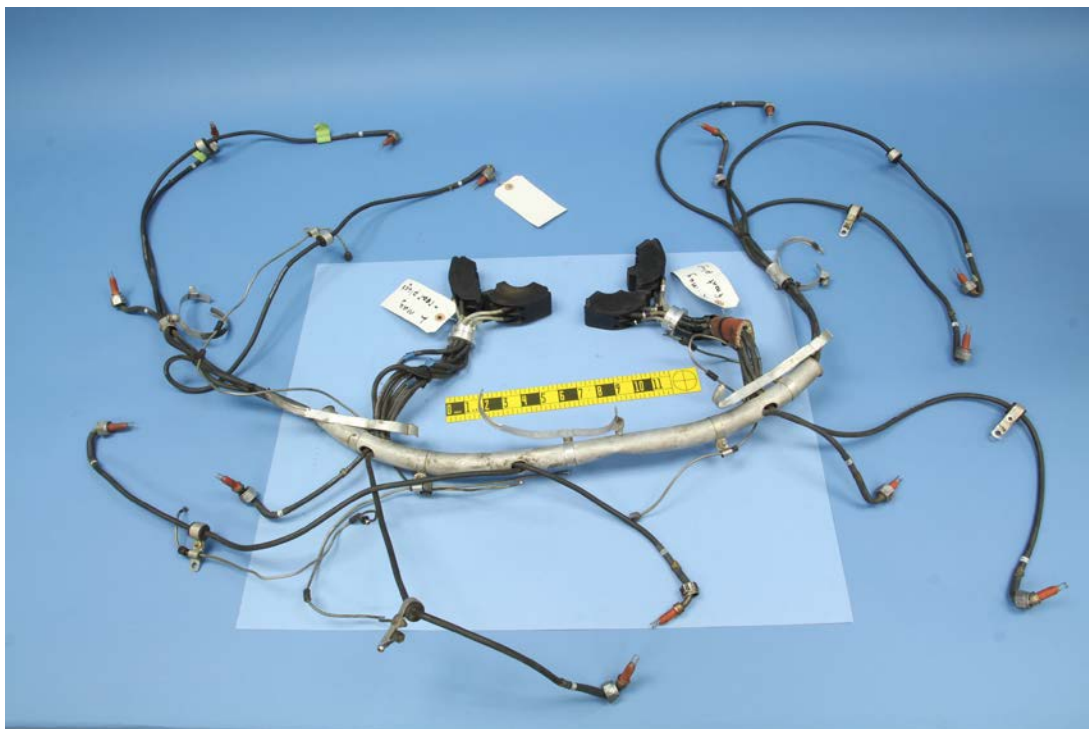
Figure 2: Ignition harness.

The ignition harness was examined for electrical continuity from the magneto terminal block end to the spark plug end of each ignition cable. The electrical continuity was established by making resistance measurements using a digital volt meter. The integrity of the insulation was assessed using a digital mega ohm meter with a test voltage of 1kV and measuring the electrical resistance between the ignition cable conductor and the cable's insulation jacket. The mega ohm meter was also used to measure the resistance between the ignition cable conductors and the elbows at the spark plug ends of the cables. The results of these measurements are listed in table 2. The elbows of the ignition harness were examined, and it was found that the elbows for all the bottom (B numbered) spark plugs were nominally bent at 90-degree angles without evidence of buckling of the brass elbow tubing. The elbows for all the top (T numbered) spark plugs were bent at various angles beyond 90 degrees (table 3) and exhibited buckling and deformation of the brass elbow tubing (figure 4).

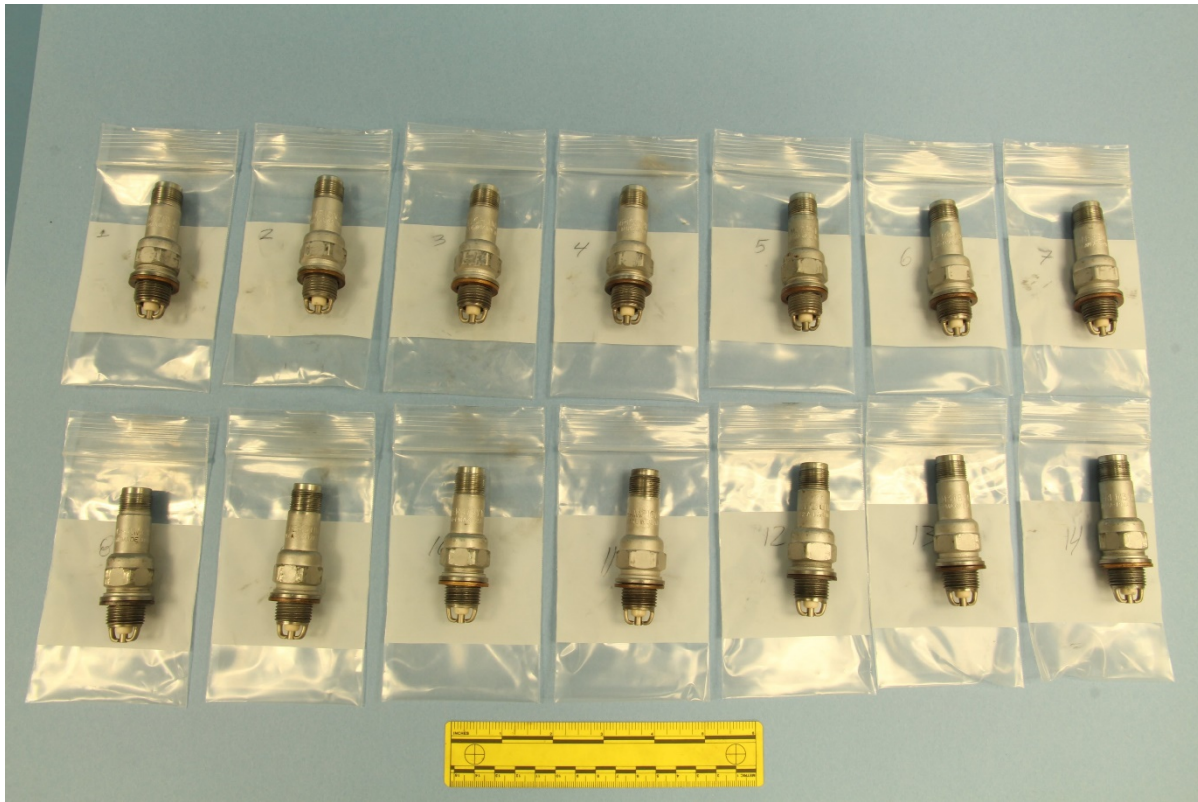
Figure 3: Spark plug set.

Fourteen spark plugs (Champion REM37BY FAA-PMA 2A16) were submitted for examination. The spark plugs were not numbered as to which cylinder they originated from and were therefore arbitrarily assigned numbers from 1 to 14 (figure 2). The electrical resistance of the spark plugs was measured from the terminal to the center electrode and from the center electrode to the ground electrode (table 1). One of the spark plugs (#3) exhibited an open circuit between the terminal and center electrode.

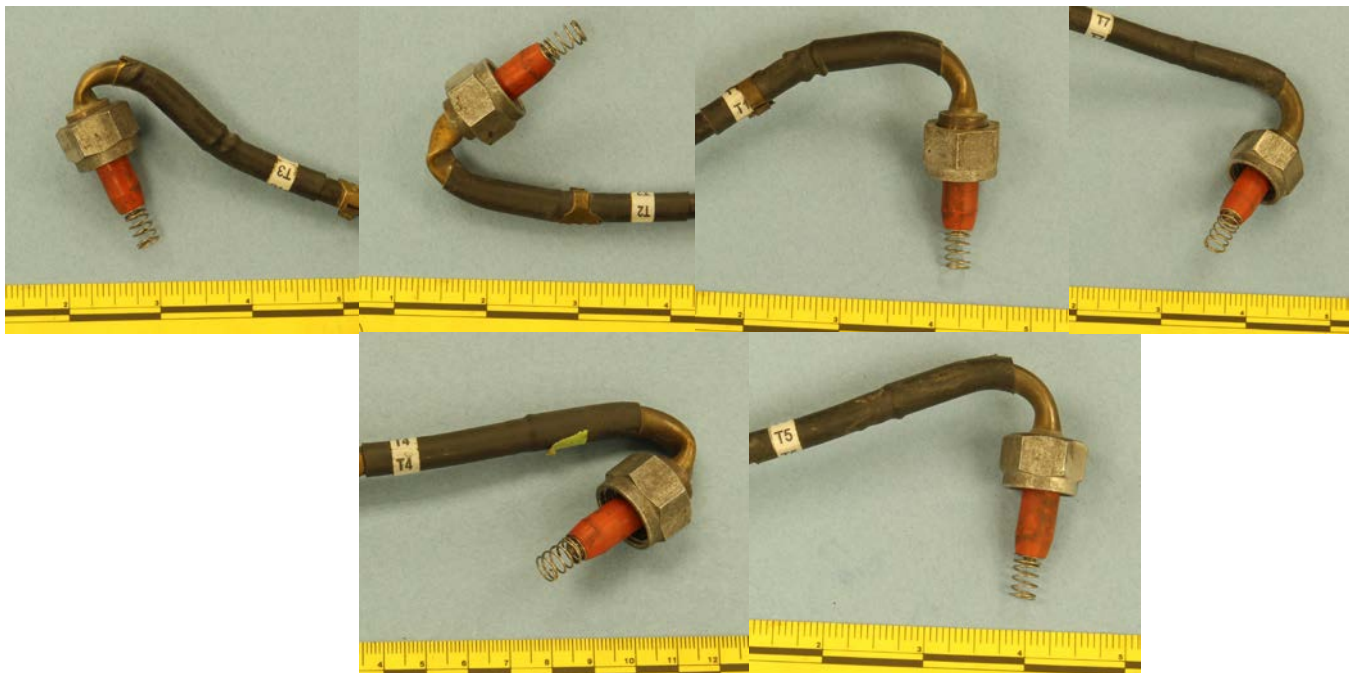
Figure 4: Top (T numbered) spark plug elbows.

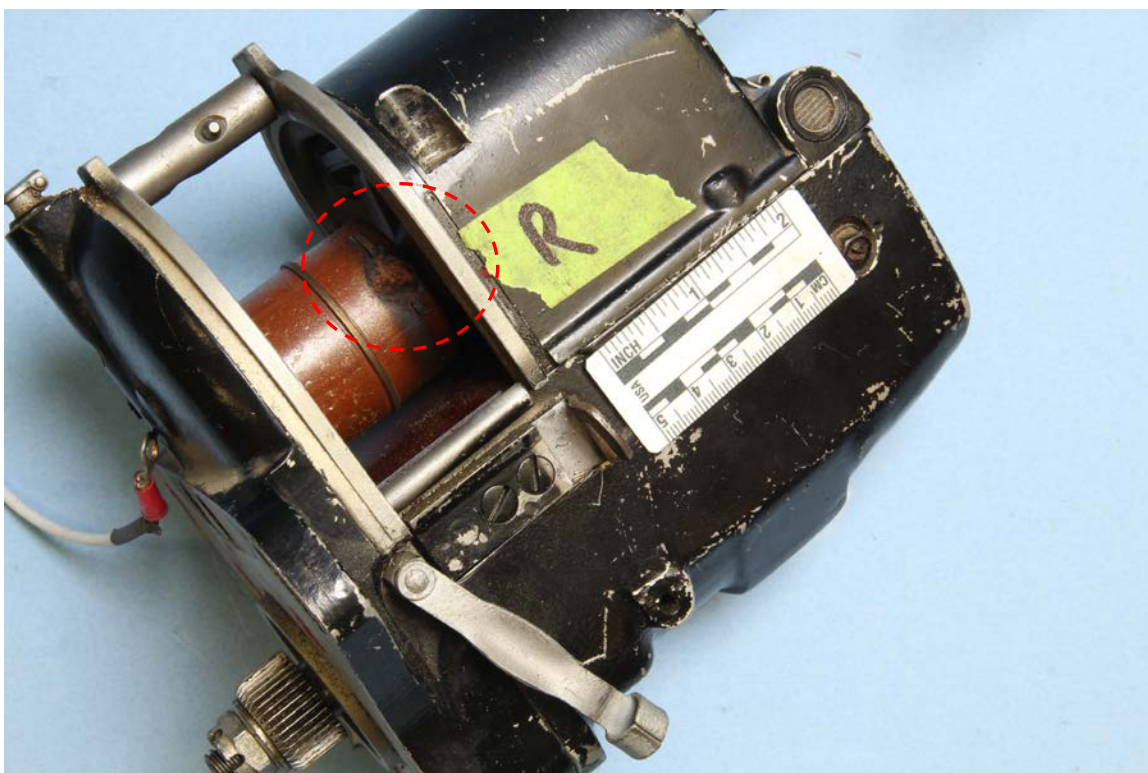
Figure 5: Distributor rotor with evidence of electrical arcing damage (in area circled).
