**NATIONAL TRANSPORTATION SAFETY BOARD**

**AIRPLANE & ENGINE EXAMINATION**

**WPR17LA197**

## **Boeing Stearman A75N1– N75753**

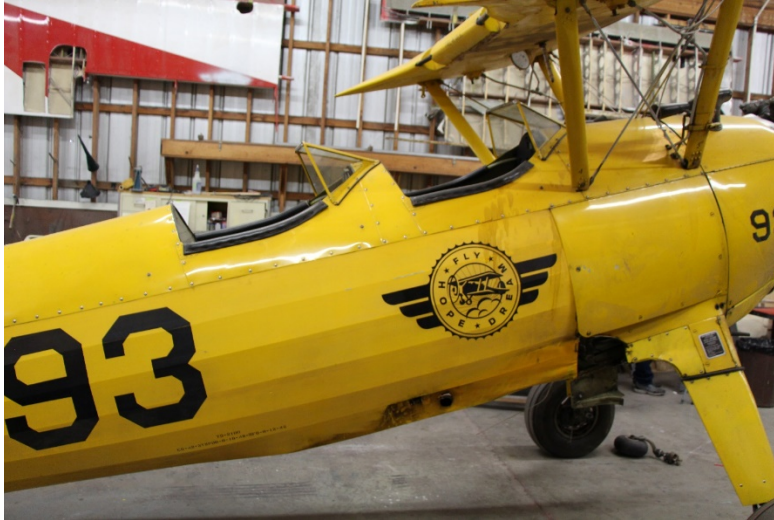
The airplane was photographed in its post-recovery condition with the wings and tail removed. Fuel staining was observed on the bottom trailing edge of the upper wing aft of the fuel tank. Additionally, the fuel sight gage ball measured about 25 gallons. The ball eventually fell to the bottom of the gage after the gage was struck repeatedly with a pen, indicating a fuel load of 0 gallons. Once the airplane's external condition was documented, the engine cowling was removed.

Photograph 1: Airplane Fuselage Prior to Examination

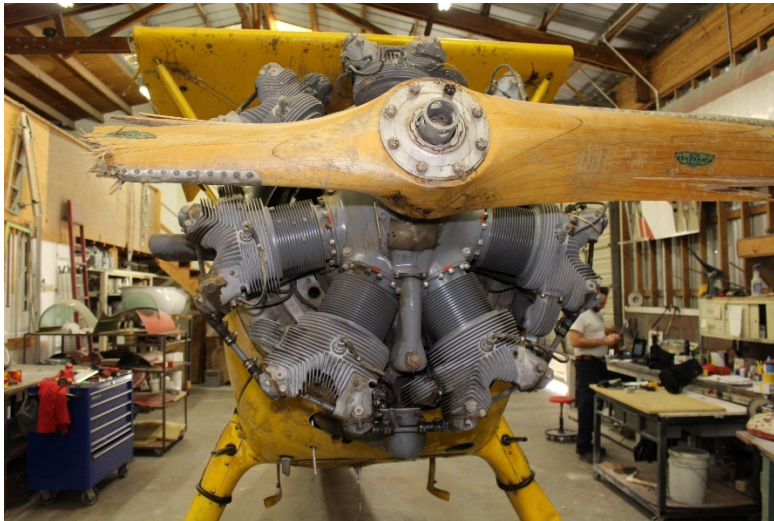
Photograph 2: Airplane Engine Prior to Examination

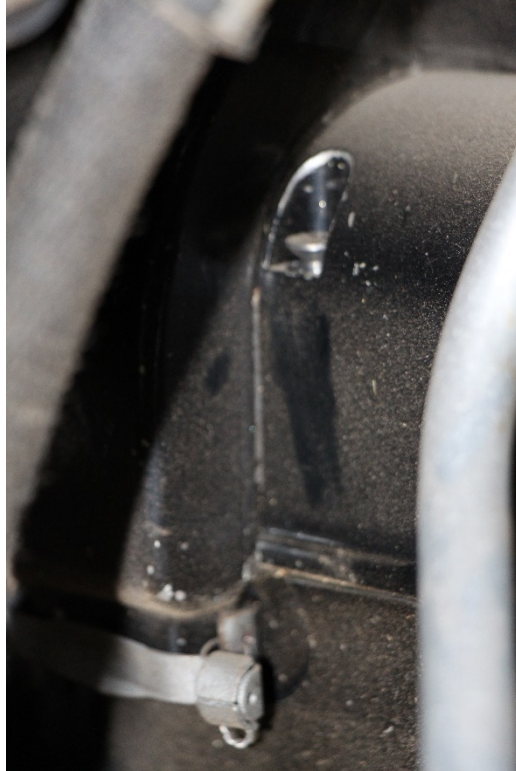
The engine mounts were unremarkable and the engine case was intact. A visual inspection of the accessories revealed that the left magneto top cover was not fully seated as one retaining screw was not secured and the other retaining screw was found on the lower engine cowl. Additionally, the left magneto P lead nut was finger tight. The right magneto P lead was loosened with a wrench. A white wire sheath on the left magneto distributor displayed a tear.

Photograph 3: Left Magneto Top Cover Retaining Screw

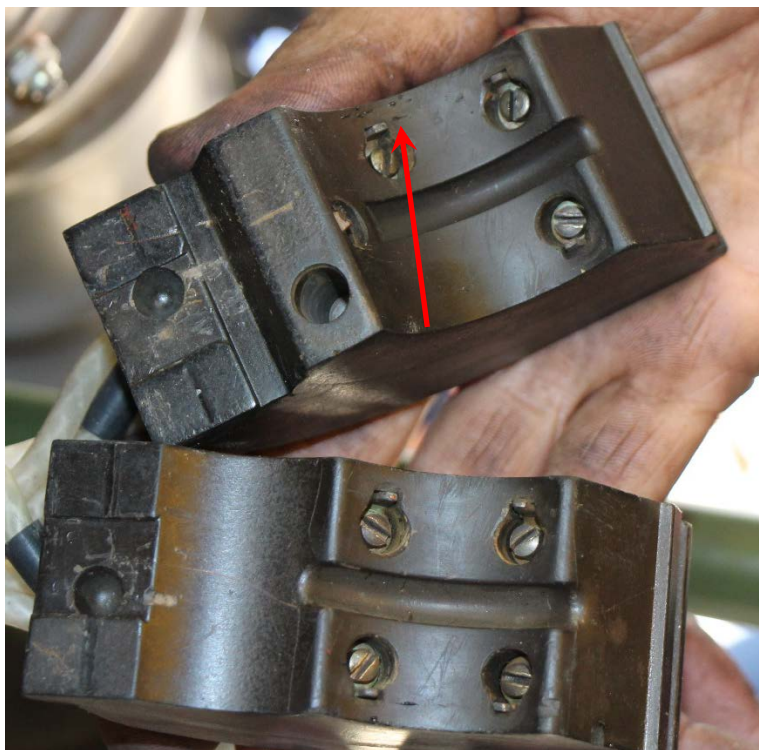
The magnetos and ignition harness were removed from the engine accessory case. The right magneto distributor blocks displayed some grease deposits and the left magneto switch wire had been wired to a ground wire through a rubber shielding. Each magneto was placed on a test bench and tested separately after being connected to a sample set of distributor blocks and ignition harness. All 7 electrodes fired continuously as the right and left magnetos were powered up to about 1,500 rpm.

A member of the investigative team later discovered a burn spot on the distributor cylinder of the right magneto. It could not be determined if this spot appeared during testing or if the magneto condenser was defective. During the engine examination, it was noted that the right magneto distributor blocks exhibited debris near one of the contacts.

Photograph 4: Right Magneto Distributor Blocks

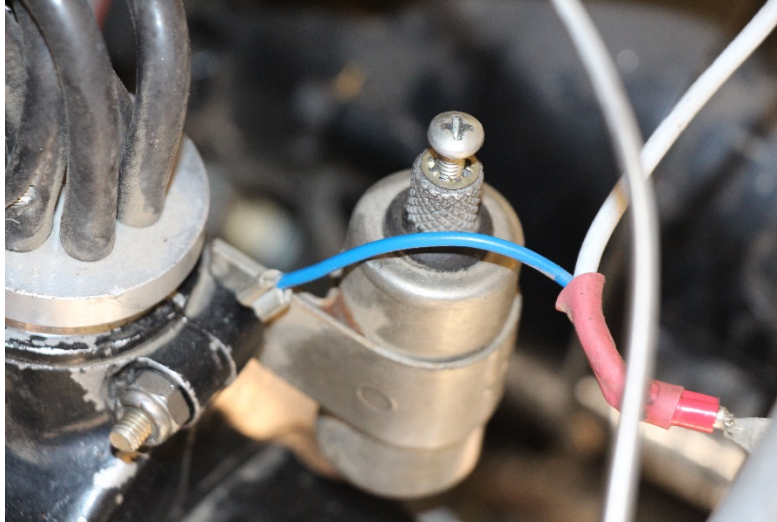
Photograph 5: Left Magneto Switch Wire

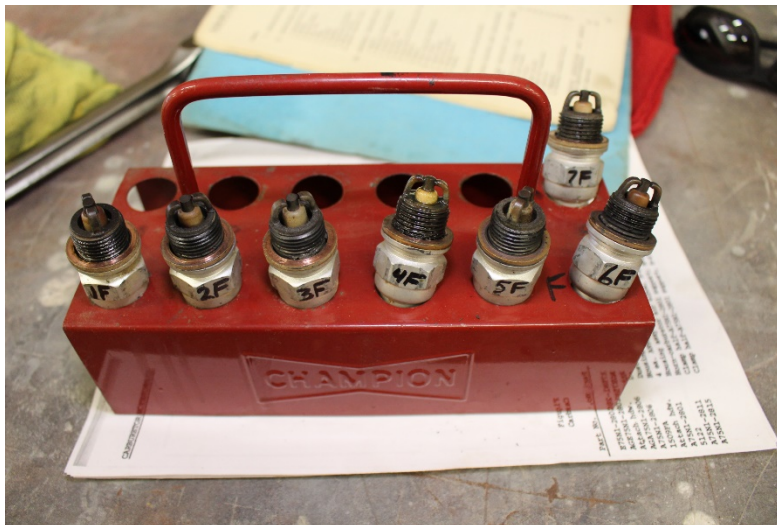
Each of the engine's 7 forward spark plugs were removed and exhibited normal wear when compared to the Champion check a plug chart with the exception of the no. 4 spark plug, which was oil fouled. The no. 4 cylinder sits at the low point of the engine and was later found to have collected oil.

Photograph 6: Front Spark Plugs (7 count)

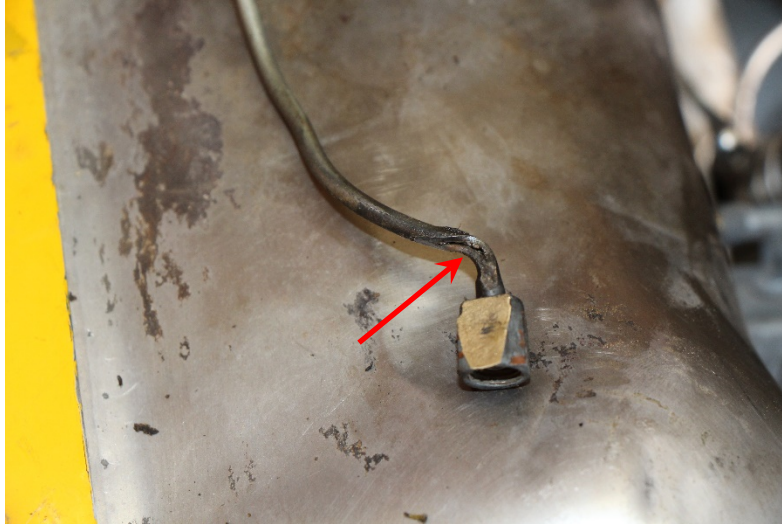
The propeller was turned and 6 shots of primer were delivered to the engine. A fuel leak was discovered at the primer line of the no. 1 cylinder. Visual inspection showed fretting of the prime line and polishing of the exhaust tube next to the prime line. The fuel valve was turned to the ON position, the mixture lever advanced to the full rich position and throttle moved slightly forward of the idle position. The master switch was turned to the ON position, the carburetor heat remained in the OFF position, and the magnetos were turned to the BOTH position. The engine failed to start during this attempt and the subsequent attempt as the throttle was advanced and retarded.

Photograph 7: Cylinder No. 1 Fuel Primer Line (note tear)

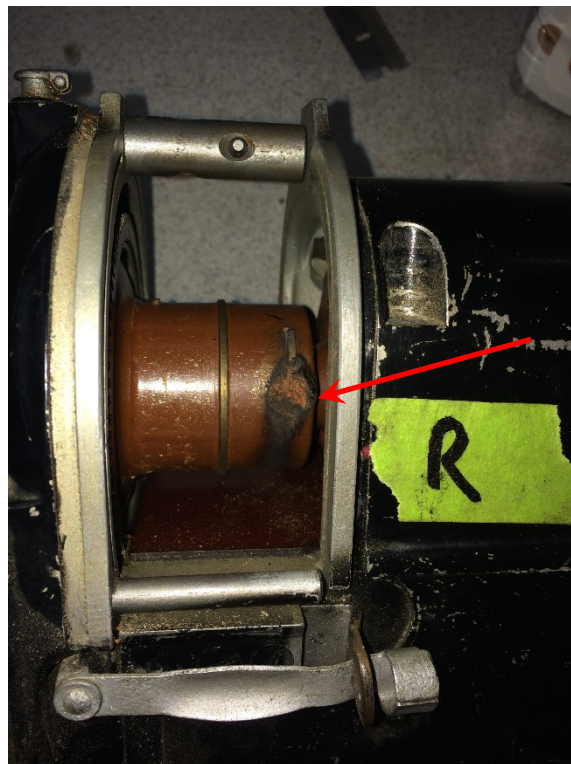
Photograph 8: Right Magneto (note burn spot)
