## RECORD OF CONVERSATION

**Date: September 18, 2017**  
**Person Contacted: Thomas Holden-FAA**  
**NTSB Accident Number: WPR17LA206**

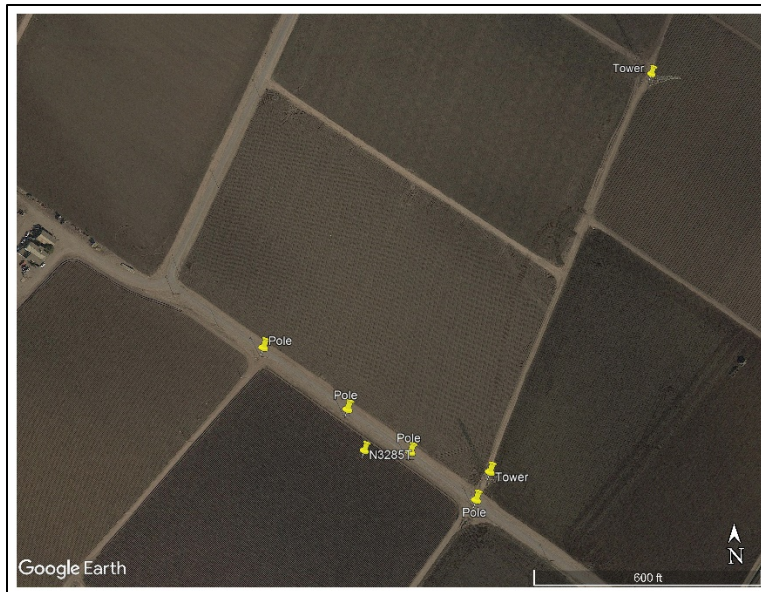
In a phone conversation, Mr. Holden described the accident site and helicopter wreckage. He stated that the helicopter originated its flight from a loading area near the accident site. The large power transmission line towers are positioned from the southwest to the northeast and parallel the southeast edge of the field that was being sprayed. The 40-foot poles that support power, telephone and cable lines, run southeast to a northwest direction and parallel the northeast edge of the field being sprayed. A wire was installed at a height of about

20 feet up the 40-foot poles and is used for attaching a larger cable data line. The data line had not been installed in this stretch of line. The main rotor assembly was observed separated from the helicopter, and remnants of the wire was found wrapped around the main drive shaft. The main wreckage was distorted and found on its side. The main rotor blades had impact damage consistent with ground impact. The examination of the wreckage revealed no evidence of mechanical malfunctions or failures that would have precluded normal operation.

*Figure 1-Aerial view of the accident site.*
