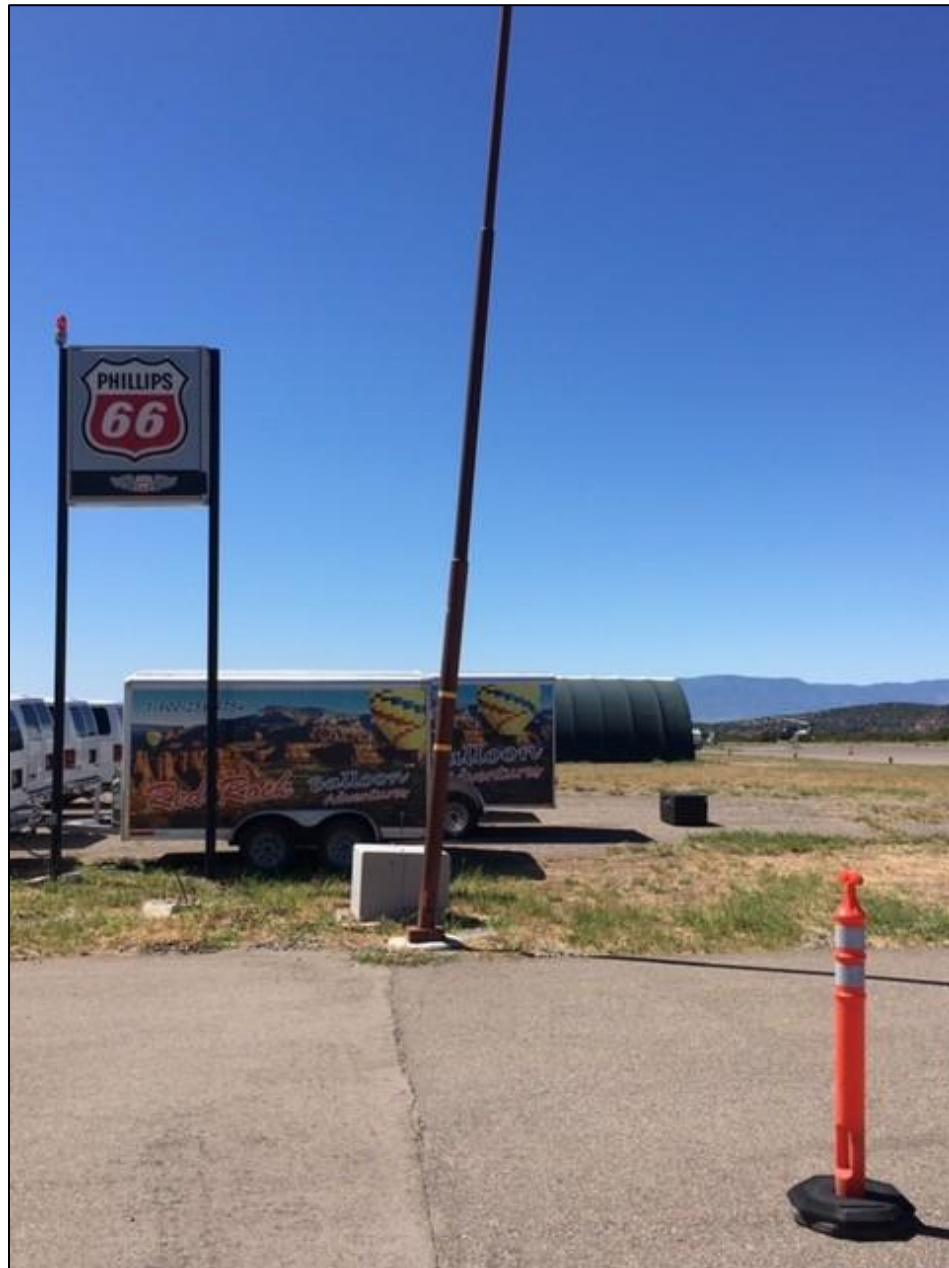
**Photo 1 – Light Pole**

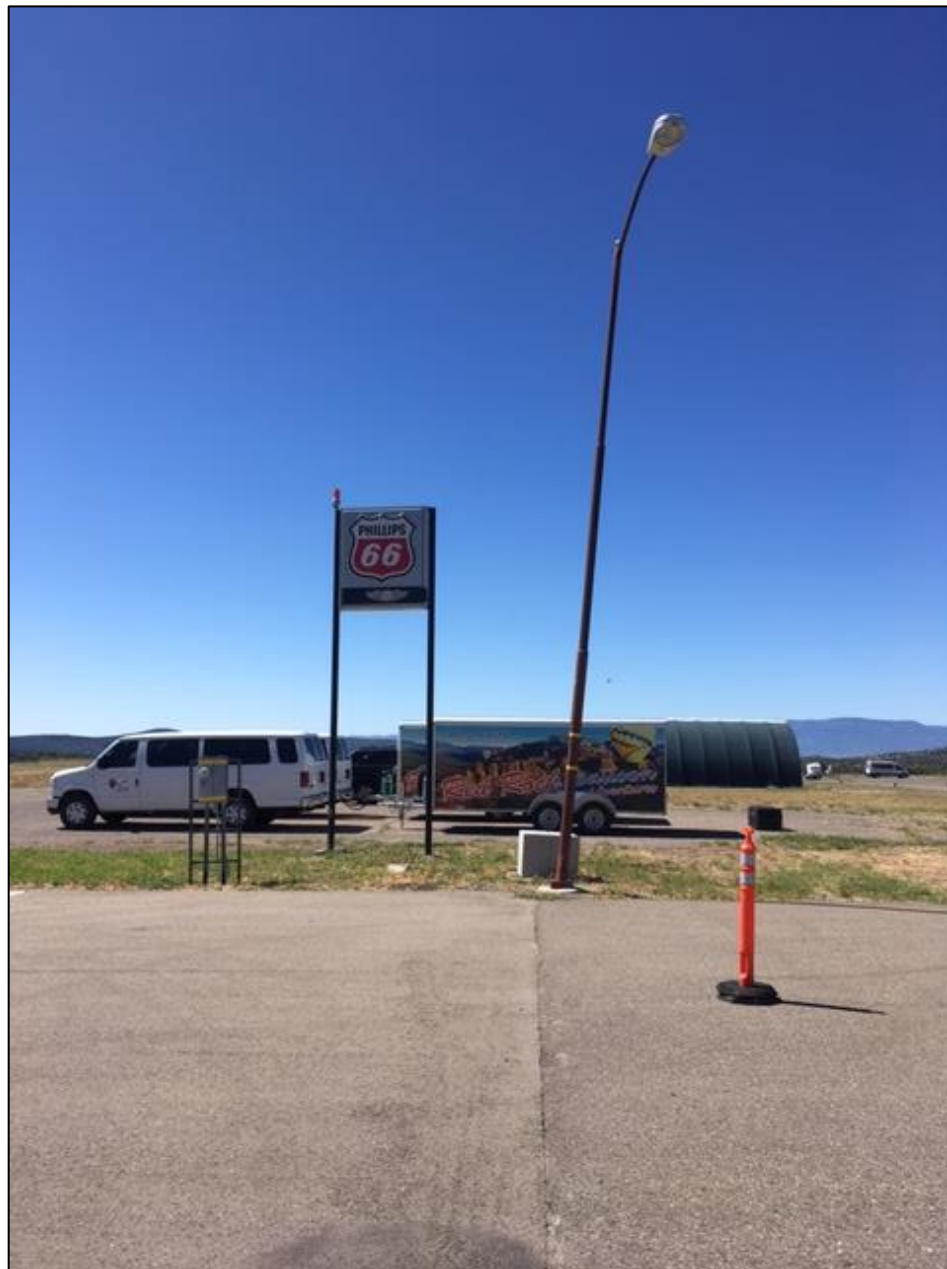
**Photo 2 – Light Pole**

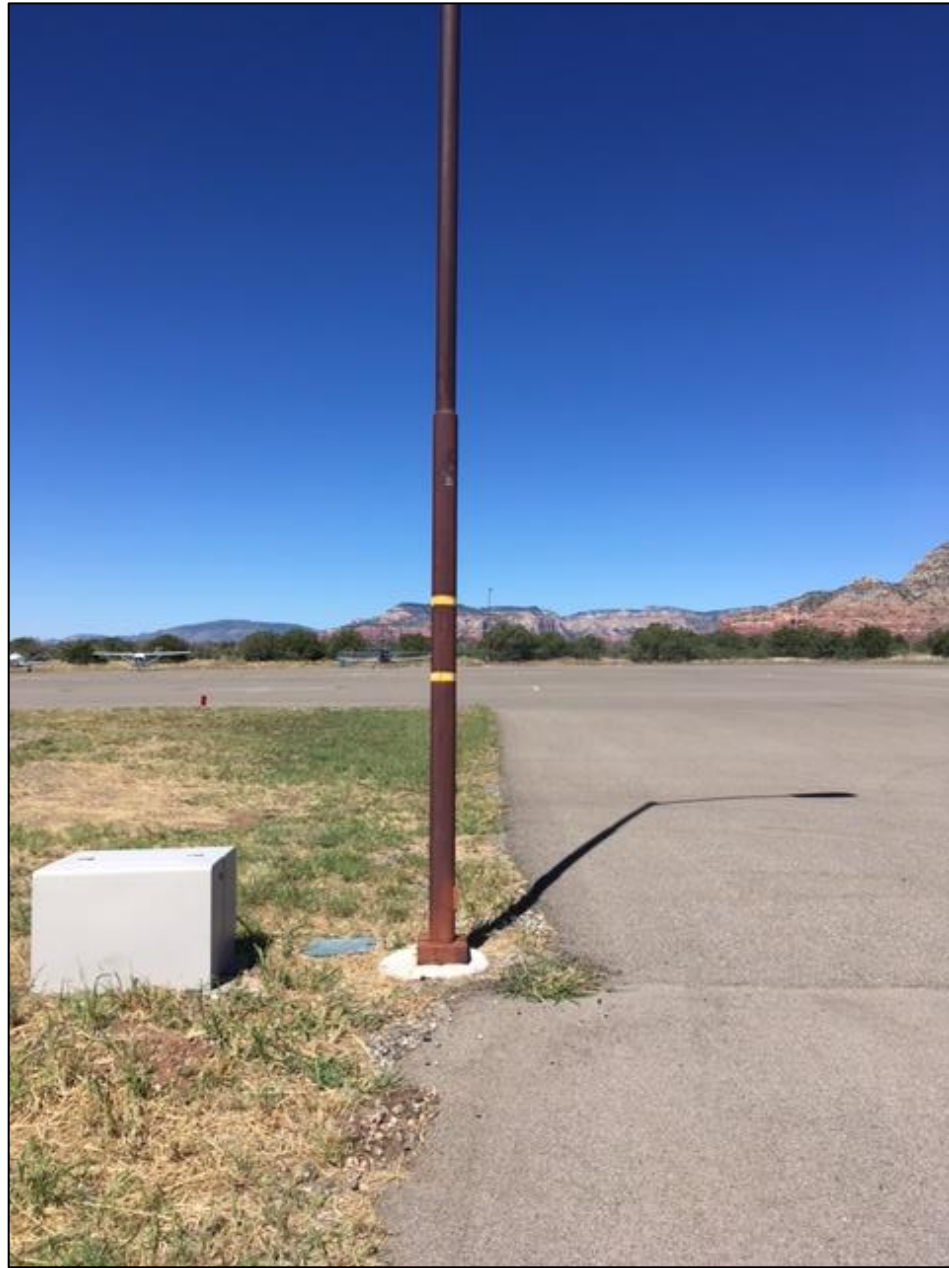
**Photo 3 – Light Pole**

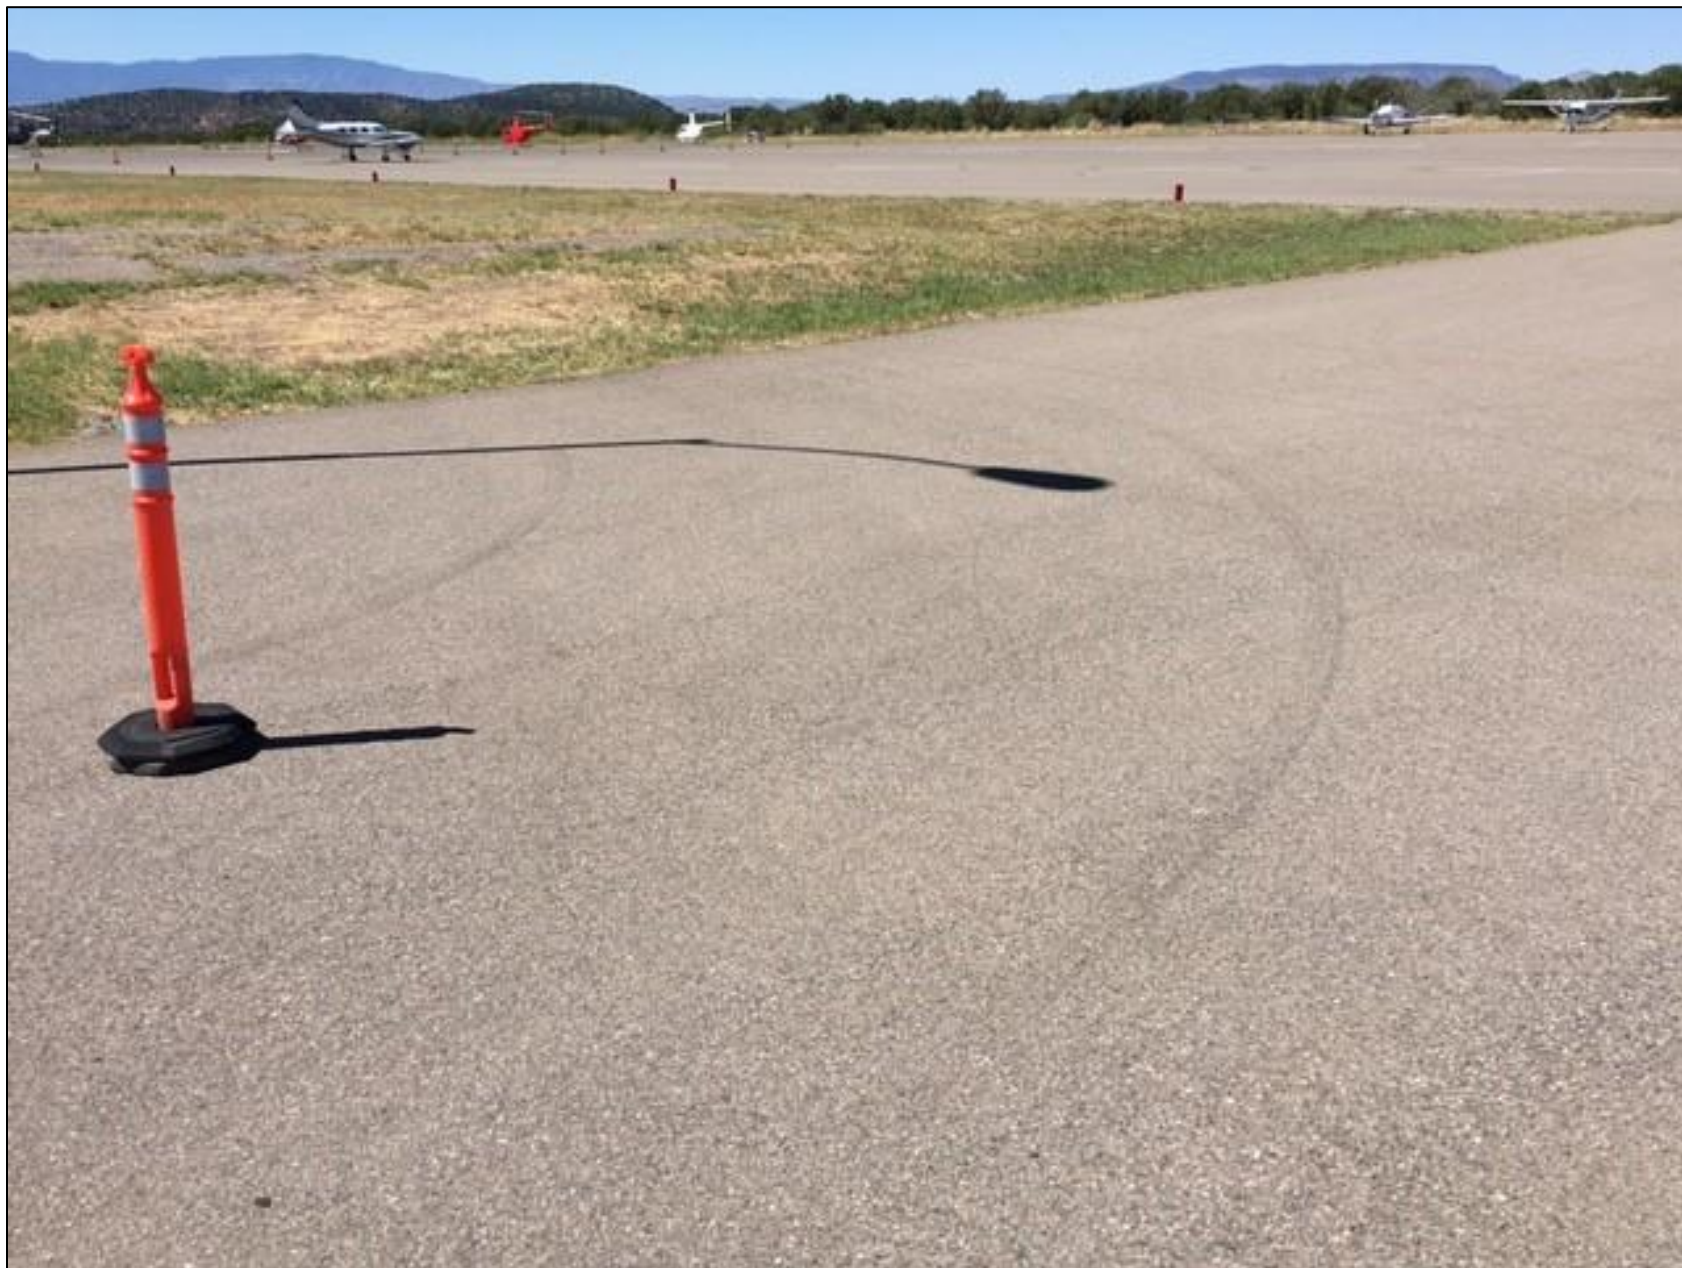
**Photo 4 – Taxiway Surface**

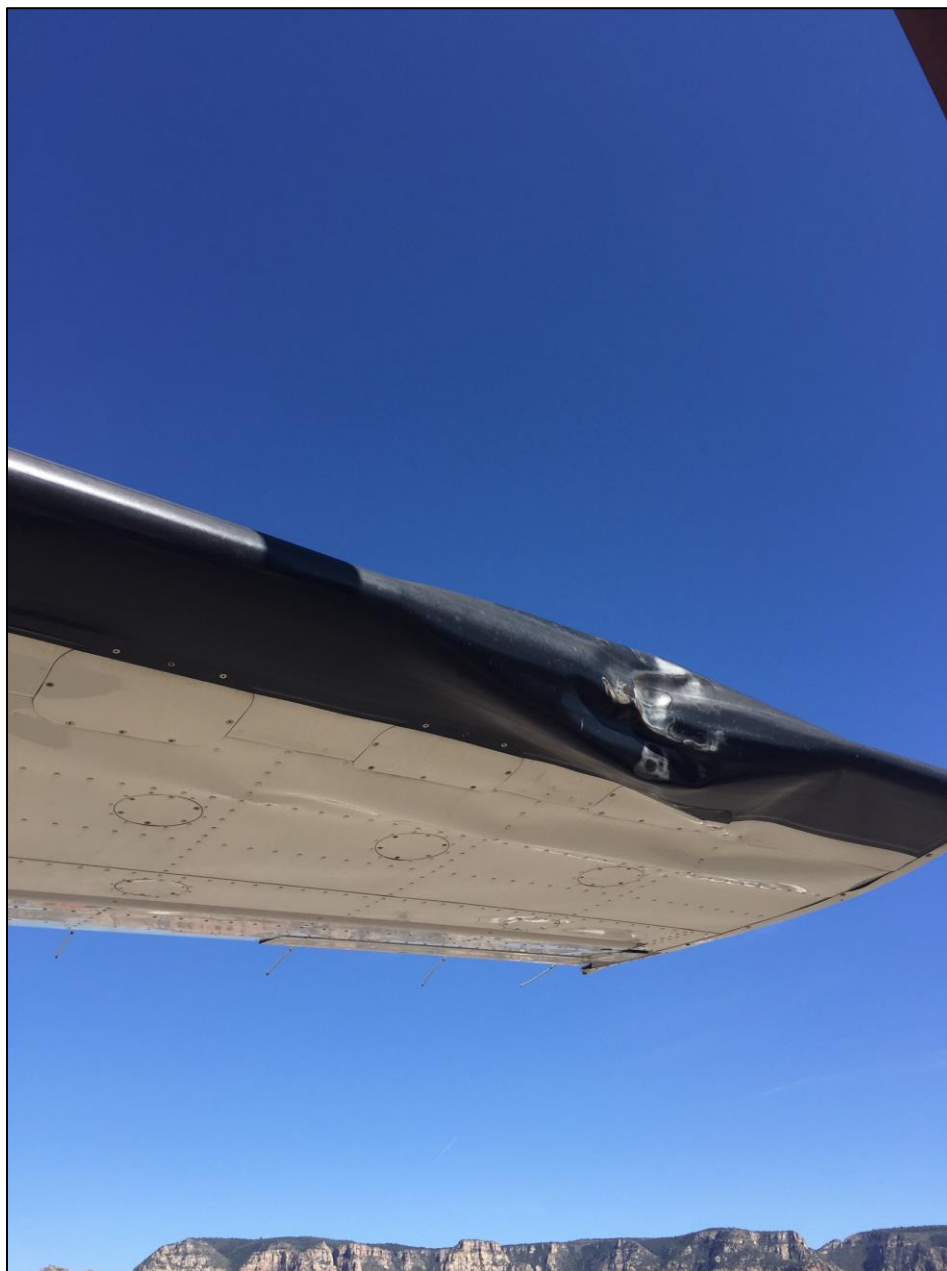
**Photo 5 – Wing Leading Edge Damage**
