## **NATIONAL TRANSPORTATION SAFETY BOARD**

# **ENGINE EXAMINATION**

**WPR17LA208**

Location: El Cajon, CA  
Date: September 17, 2017  
Aircraft: Piper 28-161, Registration N2587X, Serial #28-8516083  
NTSB IIC: Samantha Link

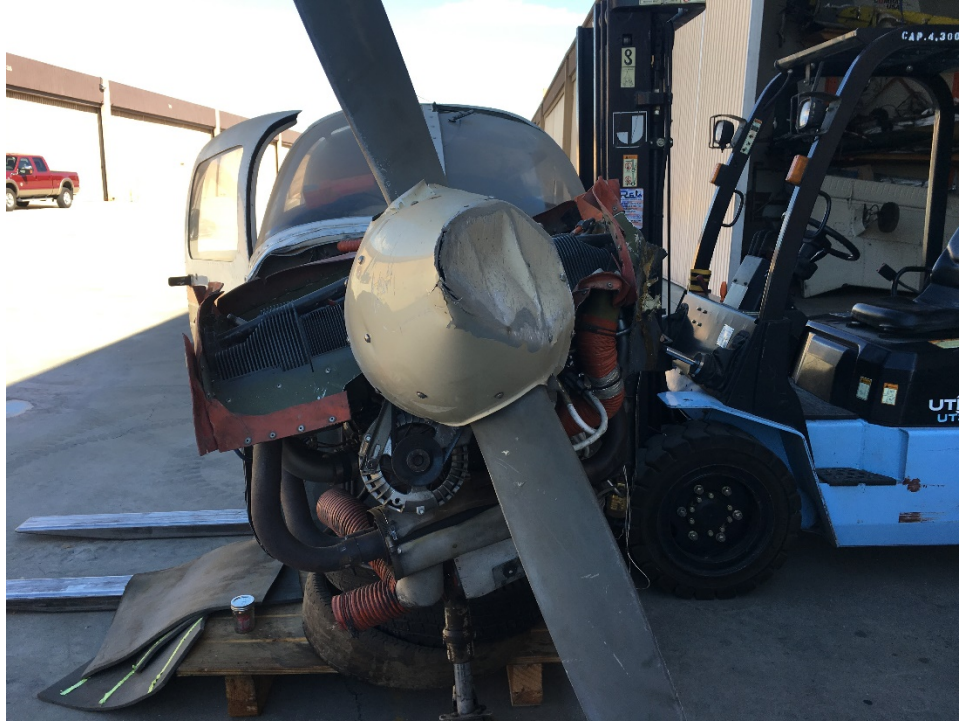
Figure 1: Impact damage to the front of Airplane

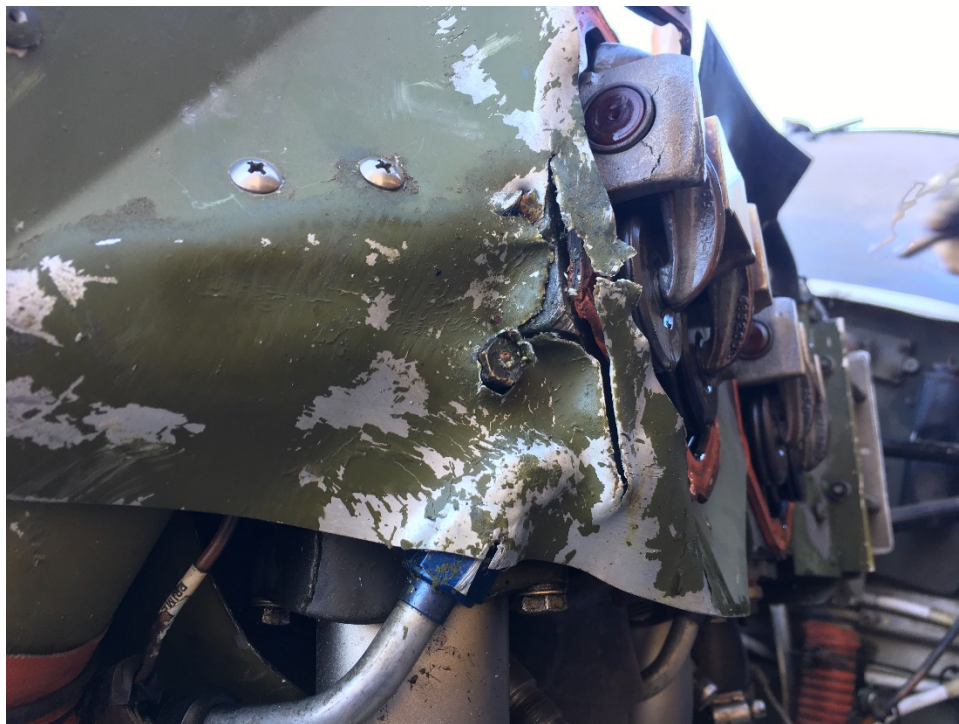
- Further examination of the engine revealed damage to the outside of the #2 cylinder, with a crack along the rocker arm boss. In addition, the lower portion of the boss was bent inward and was resting against the valve arm.

Figure 2: Impact damage to the forward section of Cylinder 2

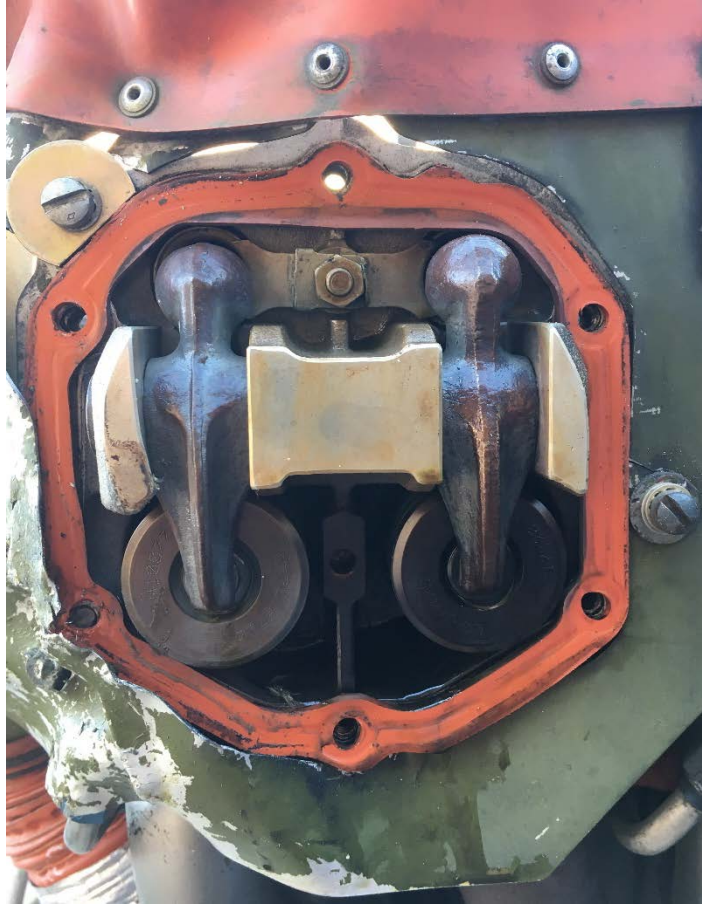
- It appeared the intake valve on the #2 Cylinder was very slightly not seated properly, however, the rest of the cylinder exhibited normal operating signatures

Figure 3: Impact damage to the intake valve of Cylinder #2

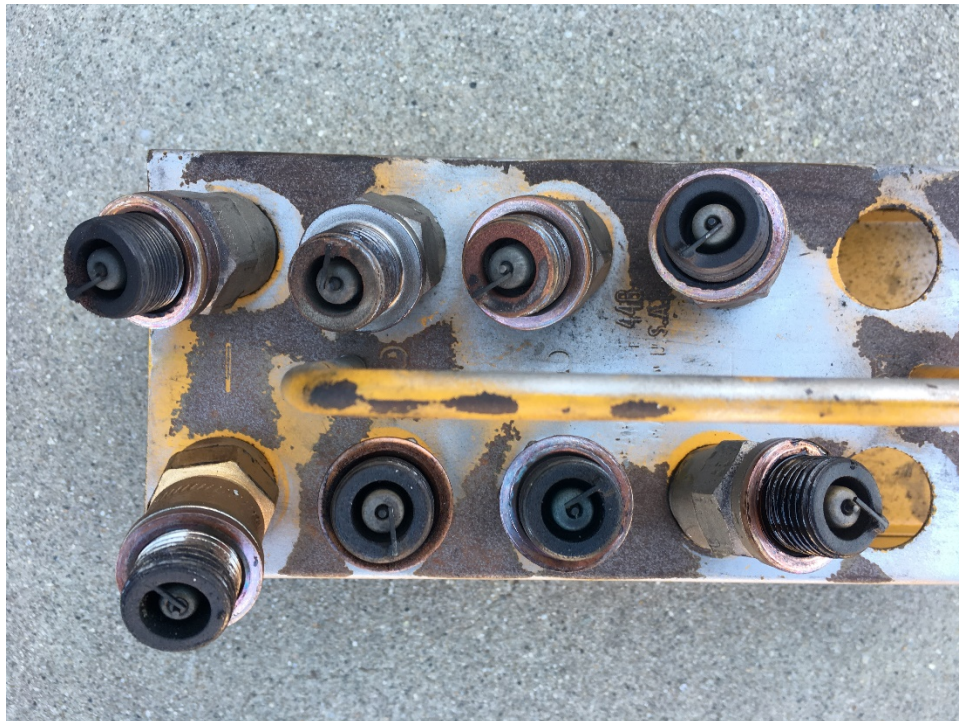
- The upper spark plugs were removed from the engine and were consistent with normal operations per the Champion check-a-plug chart.
  - All gaps were similar

- The lower spark plugs were removed from the engine and were consistent with normal operations per the Champion check-a-plug chart.
- The fuel pump screen was examined and was clear of debris

Figure 4: Spark Plugs

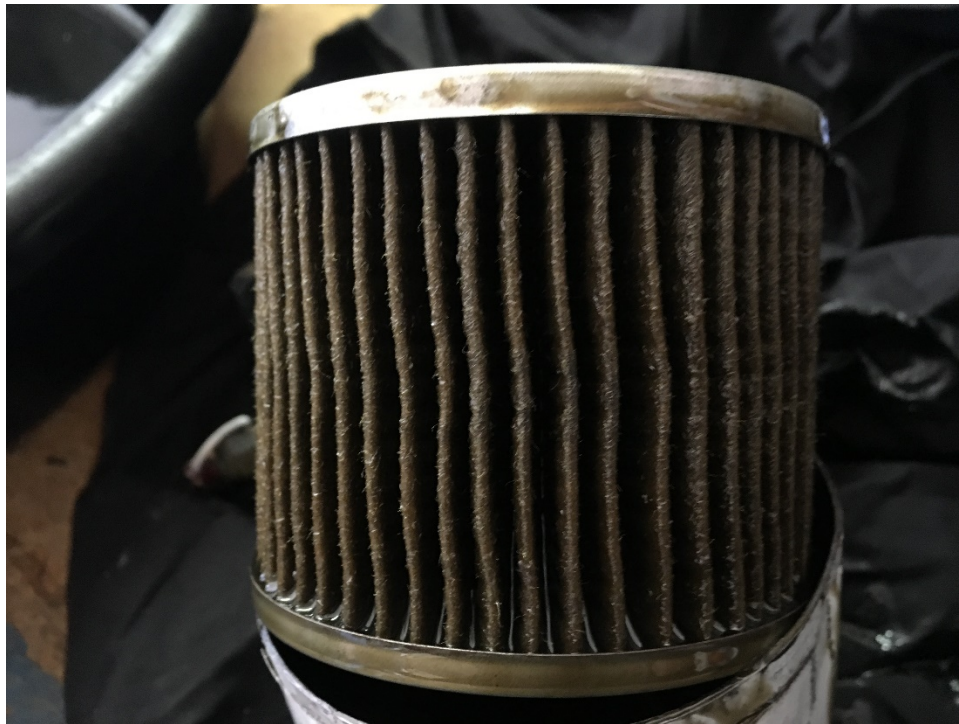
- Initial examination of the engine revealed no obvious visual anomalies
- The fuel selector was found positioned on the left fuel tank
- The gascolator bowl was removed and no fuel was present
  - Screen was clear of debris
- The throttle and mixture levers were manipulated in the cockpit and corresponding motion was noted at the carburetor arms.
  - Both moved freely from stop to stop
  - Both the mixture and throttle levers in the cockpit were found in the full forward position
- An engine run was unable to be completed because the oil filter was fracture separated from the engine.
  - The oil filter was removed and cut open
    - Oil was present within the filter
    - No contaminates or debris was noted

Figure 5: Oil Filter

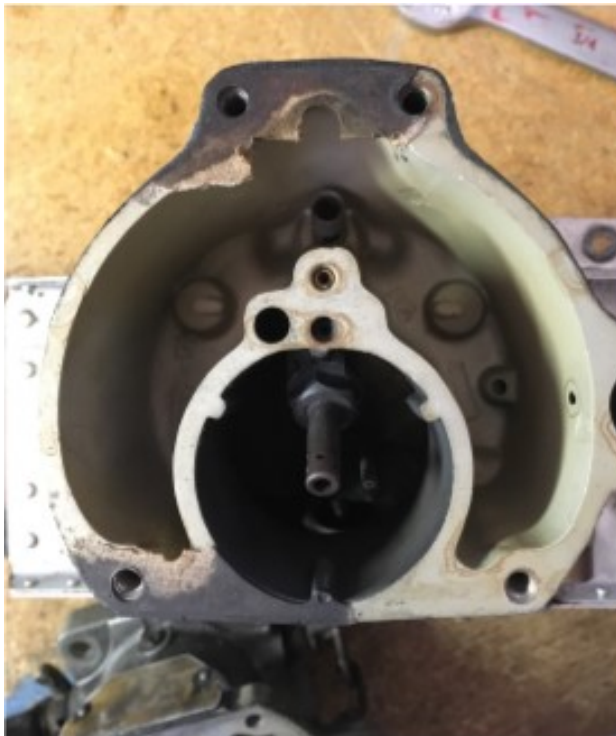
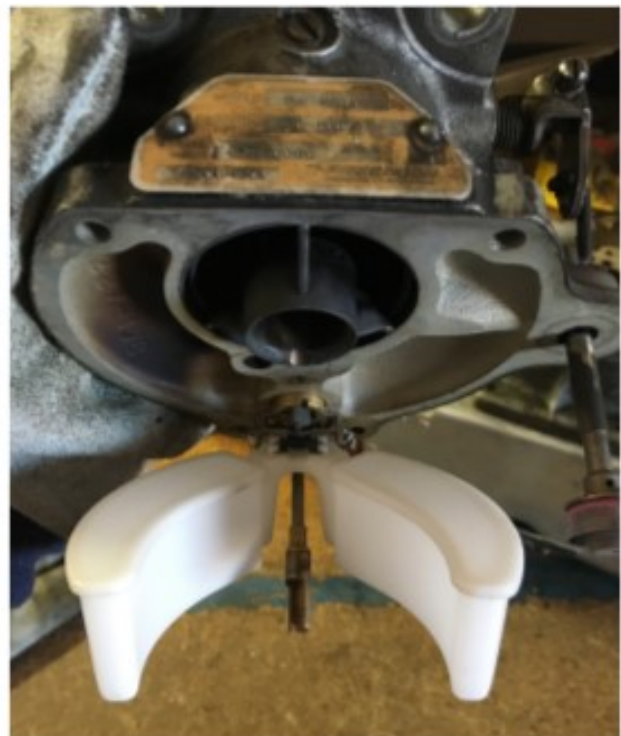
- The fuel screen was clear of debris with no fuel present
  - The carburetor bowl was clear of debris and containments
    - No fuel was present
  - No fuel was present in the accelerator pump well

- The floats were intact and undamaged; no fuel was present within the floats
  - The needle valve moved freely
- Air was blown from the gascolator to the wing routes and all lines were clear of blockages and debris

Figure 6: Carburetor

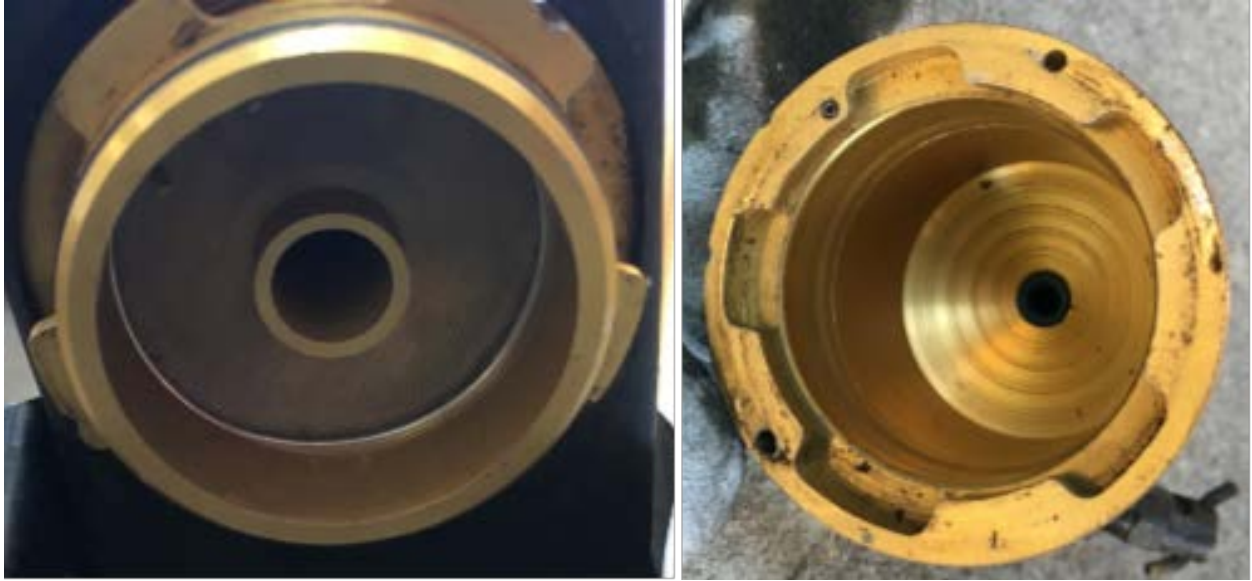
Figure 7: Gascolator
