## **NATIONAL TRANSPORTATION SAFETY BOARD**

# **AIRFRAME AND ENGINE EXAMINATION**

**WPR17LA211**

Location: Long Beach, California  
Date: September 20, 2017  
Aircraft: Robinson Helicopter Company, N7514S, R22 Beta II  
NTSB IIC: Elliott Simpson

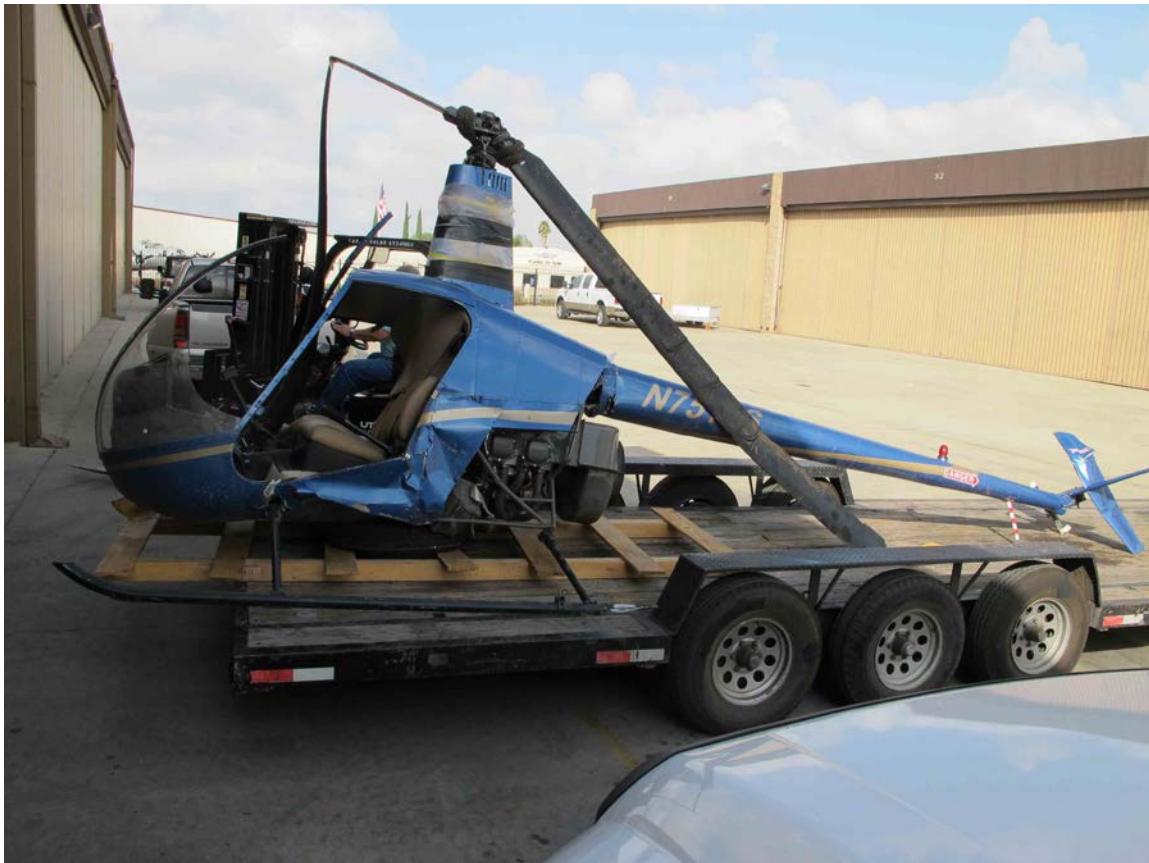
The main cabin sustained crush damage to the belly structure, and the left skid was bent almost level with the belly (Photo 1). The forward right skid was similarly bent and remained attached to the belly frame; the aft section of the skid had separated from the cross tube and aft frame attach point. The forward and aft cross tubes, normally straight, had bowed downwards in the center. Neither door was located, and appeared to have been removed prior to the flight. The canopy bubble plexiglass had fractured into multiple shards, with about 50% remaining in the left frame and small remnants remaining in the right frame. The left seat was largely intact; the right seat exhibited downward deformation focused on the right side of its lower box structure. The tailboom remained partially attached to the rear frame, and exhibited buckling and bending damage to the skin at the

Photo 1 – Helicopter before Examination

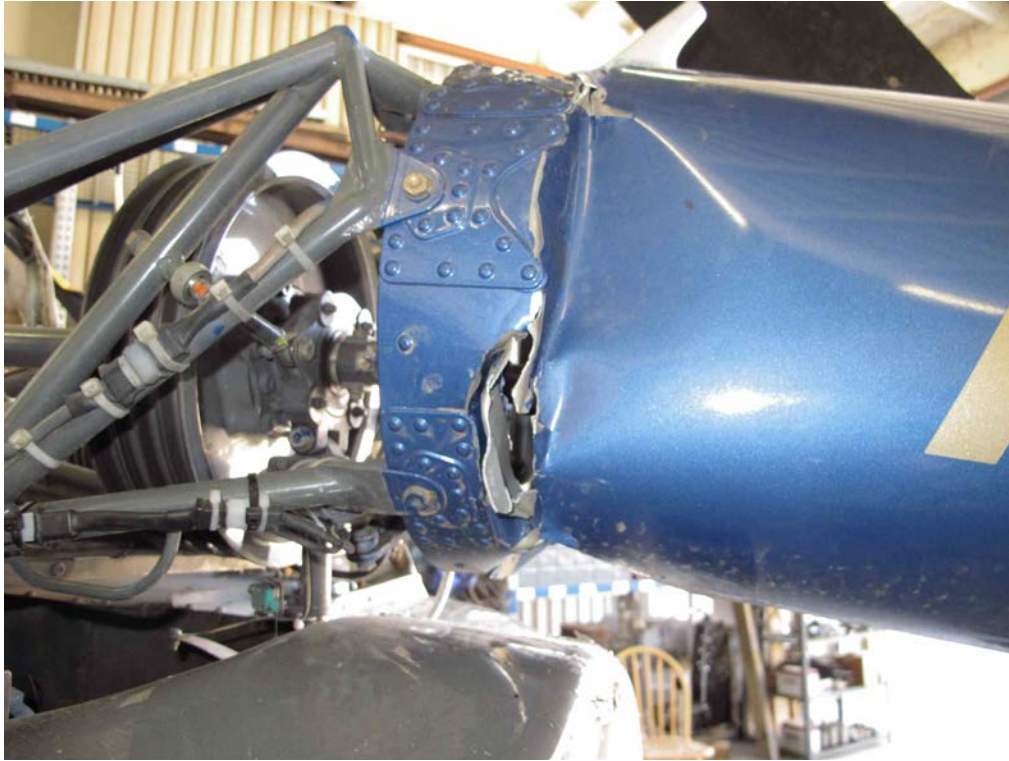
forward mount (Photo 2). The vertical and horizontal stabilizer assembly along with the tail rotor gearbox had detached from the tailcone, and remained partially tethered by the tail rotor drive shaft and control tube. Both tail rotor blades had detached about 4 inches outbound from their roots.

Photo 2 – Tailboom Mount

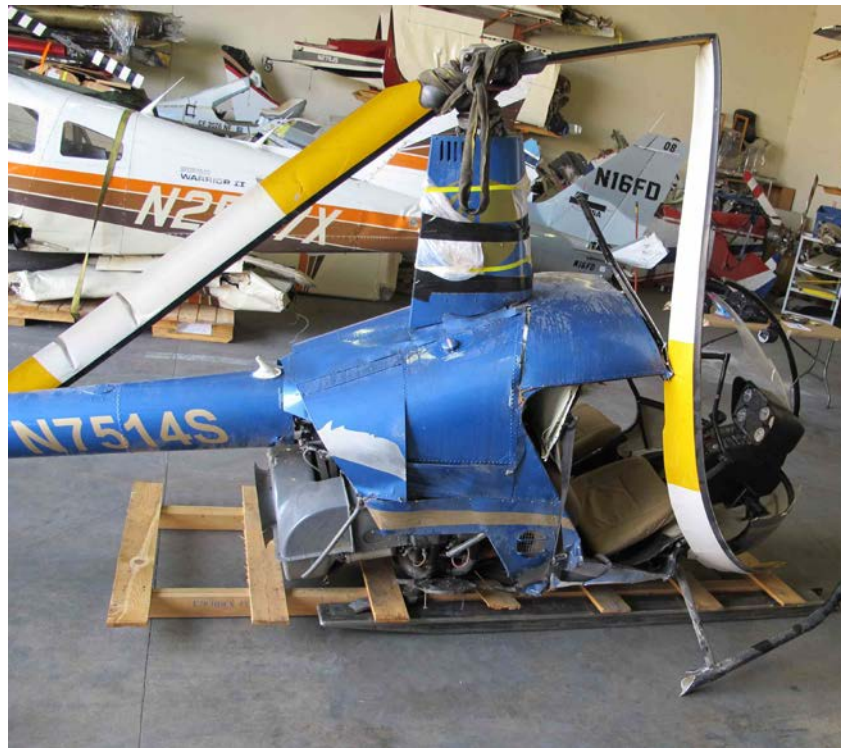
The main rotor mast was intact and remained connected to the cabin structure. Both main rotor blades were still attached to the teetering hinge. The blue blade was bent abruptly up about 110° about 2 ft from the teetering hinge. The remainder of the blade had bowed down in a sweeping arc along its entire length (Photo 3). The red blade was straight, and exhibited minor aft bending. The outboard 18-inch section of the tip had torn away.

Photo 3 – Main Rotor Blade

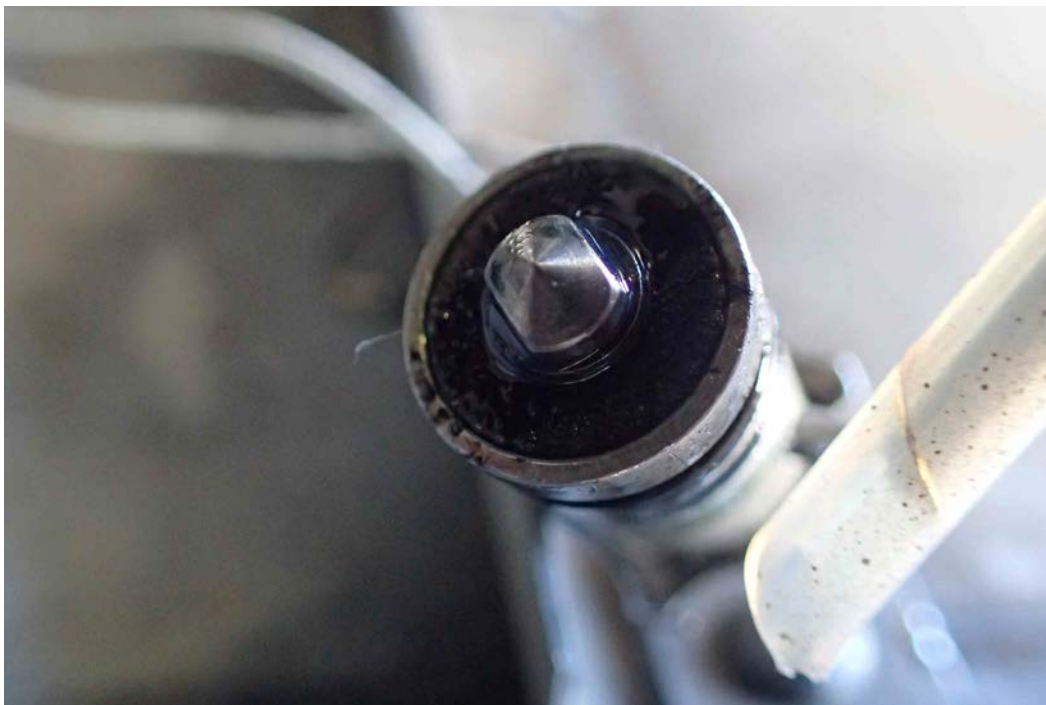
The main rotor gearbox chip detector free of debris (Photo 4), and blue-colored oil observed to the ¼ level in sight glass. The head of the forward left main gearbox Allen bolt had detached, leaving the stud within its gearbox bore; the separation surfaces were brown and appeared to be corroded, consistent with a pre-accident separation.

Photo 4 – Main Rotor Gearbox Chip Detector

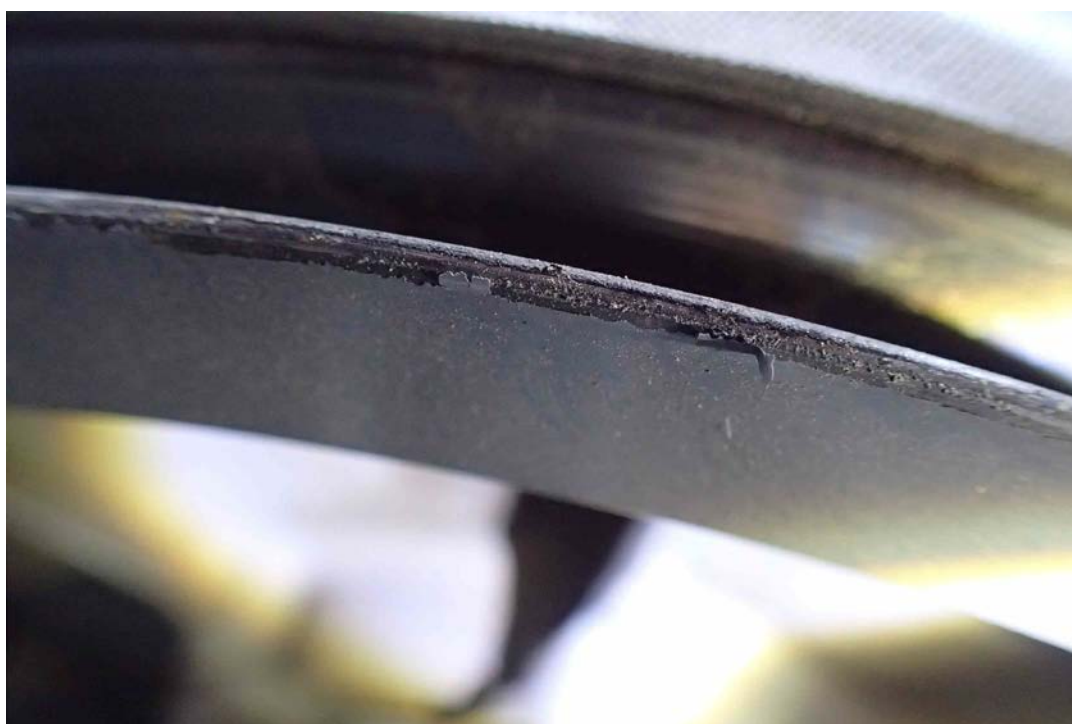
Radial scoring was observed on the outer surfaces of the upper sheave with corresponding scoring to the upper frame tubes and the clutch actuator (Photo 5, 6). The scoring damage was consistent with engine operation at the time of impact.

Photo 5 – Upper Sheave Radial Scoring

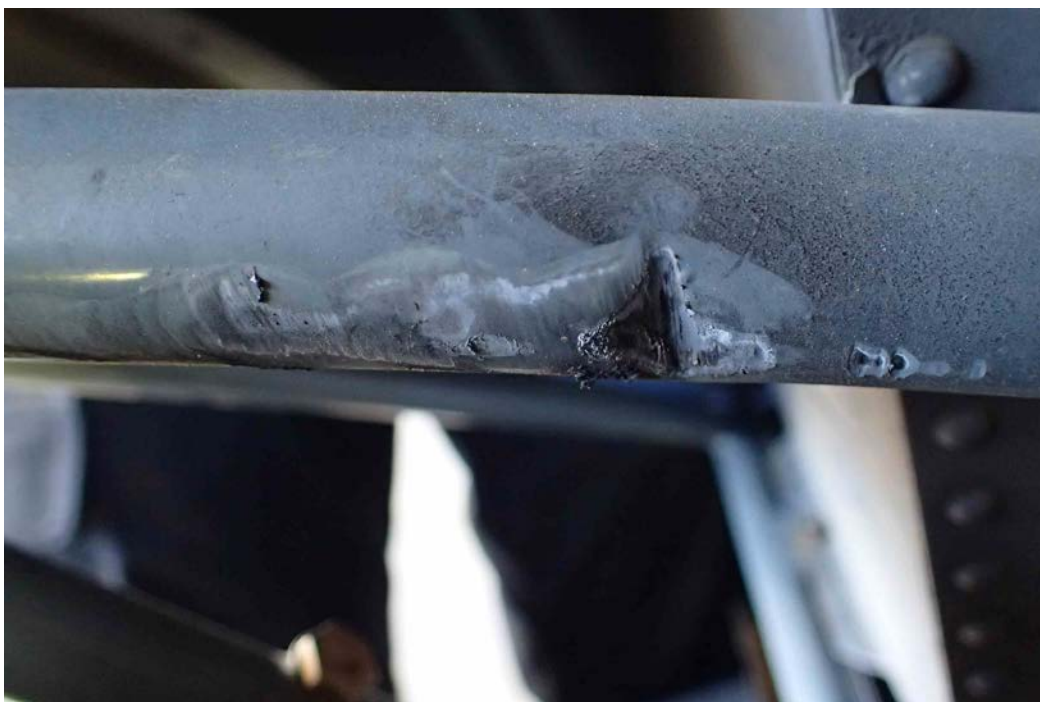
Photo 6 – Upper Frame Scoring at the Clutch Actuator

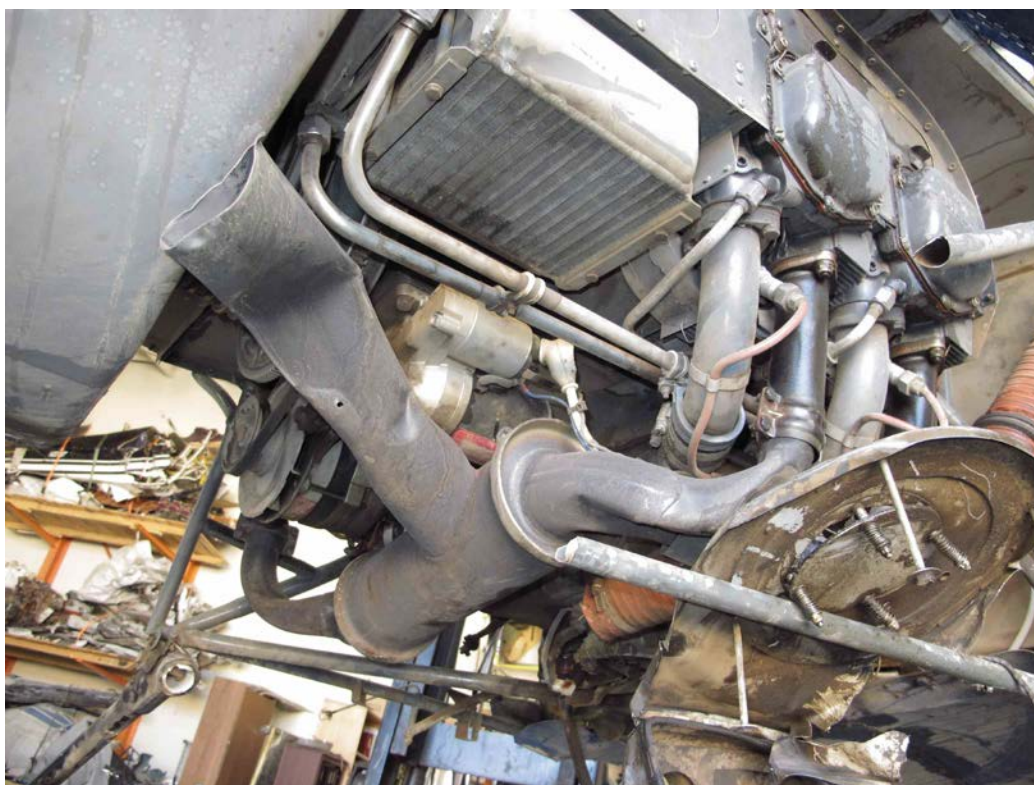
The engine remained attached to the airframe (Photo 7). The airbox sustained crush damage and had detached along with the carburetor bowl. The gascolator sustained damage to the lower drain attachment fitting; the unit contained fuel up to the lower edge of the drain fitting. The carburetor inlet fuel screen was clear and free of debris. The throttle, mixture, and carburetor heat control cables were still attached at their respective control arms. The cables were impinged against the cabin belly, and as such the cabin controls could not be moved.

Photo 7 – Engine

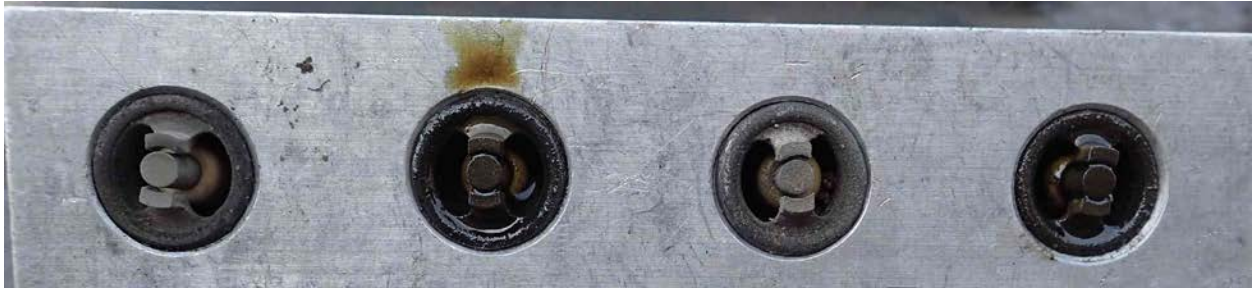
The cylinders were examined internally using a borescope and exhibited grey/brown deposits and coloration, with no indication of internal catastrophic failure. Similar grey/brown deposits were present on the inner surfaces of the exhaust tailpipe. About 2 tablespoons of mud and grass was found within cylinder 1, with similar smaller amounts of debris also present in cylinder 3. The lower spark plugs for cylinders number 2 and 4 were oil soaked. The lower plugs for cylinder 1 and 3 displayed light grey deposits and coloration (Photo 8). All plugs exhibited normal wear signatures when compared to the Champion AV-27 chart.

Photo 8 – Lower Spark Plugs (1 to 4, left to right)
