## **NATIONAL TRANSPORTATION SAFETY BOARD**

# **AIRFRAME AND ENGINE EXAMINATION**

**WPR17LA212**

Location: Glendale, CA  
Date: September 22, 2017  
Aircraft: Mooney M20E, Registration N34BE, S/N 1031  
NTSB IIC: Elliott Simpson

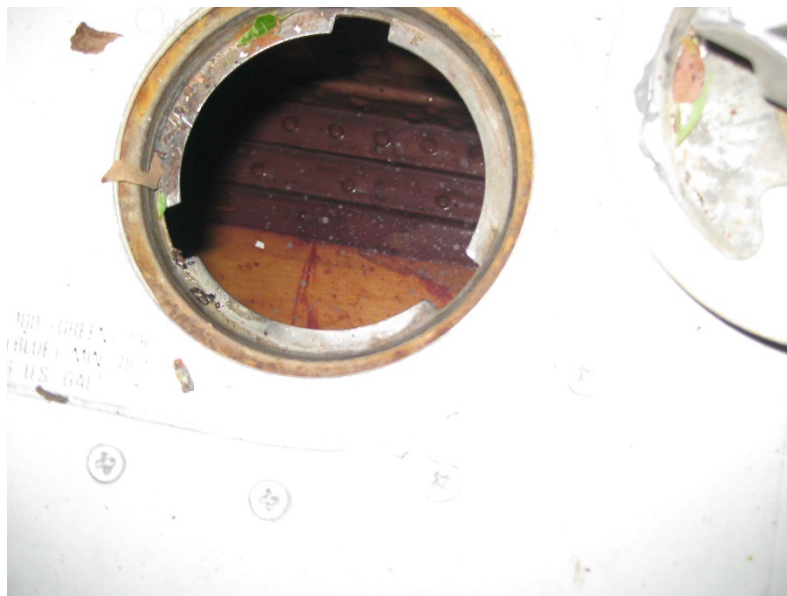
There was no fuel odor, and no fuel was observed in either tank when viewed through their respective filler necks (Photo 1, 2).

Photo 1 – Left Fuel Tank Viewed Through Filler Neck at Accident Site

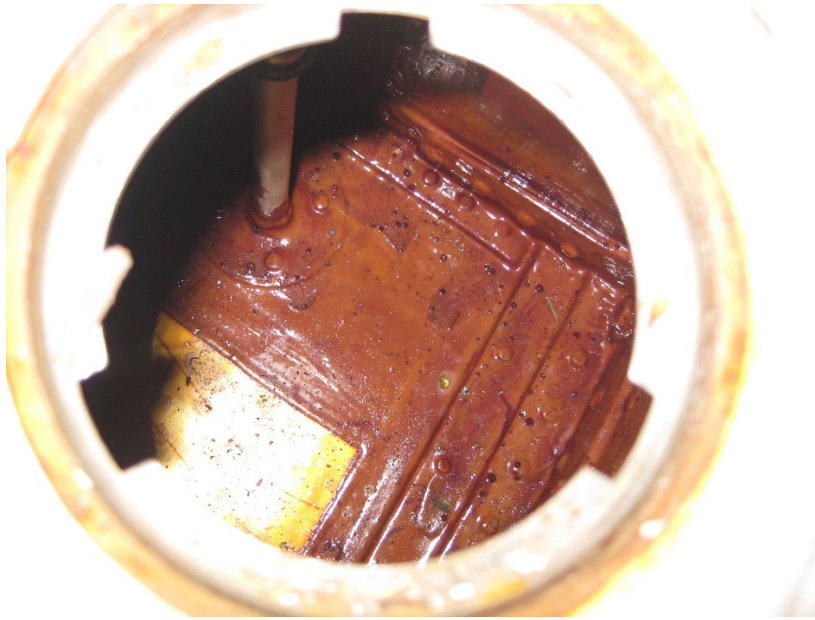
Photo 2 – Right Fuel Tank Viewed Through Filler Neck at Accident Site

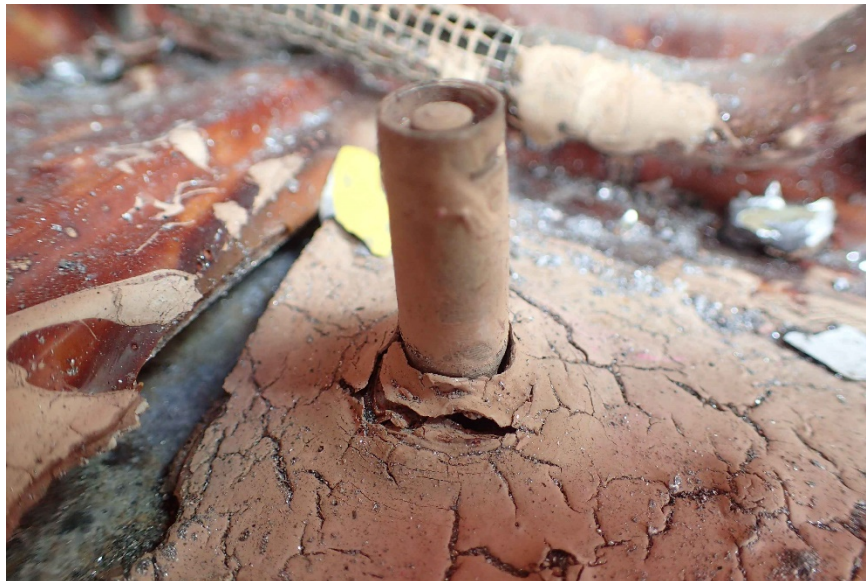
The right tank sustained damage to its underside which caused the lower skin to separate from the inboard rib and lower spar cap in the area adjacent to the sump valve. (Photo 3) Service

Photo 3 – Right Tank Sump Drain

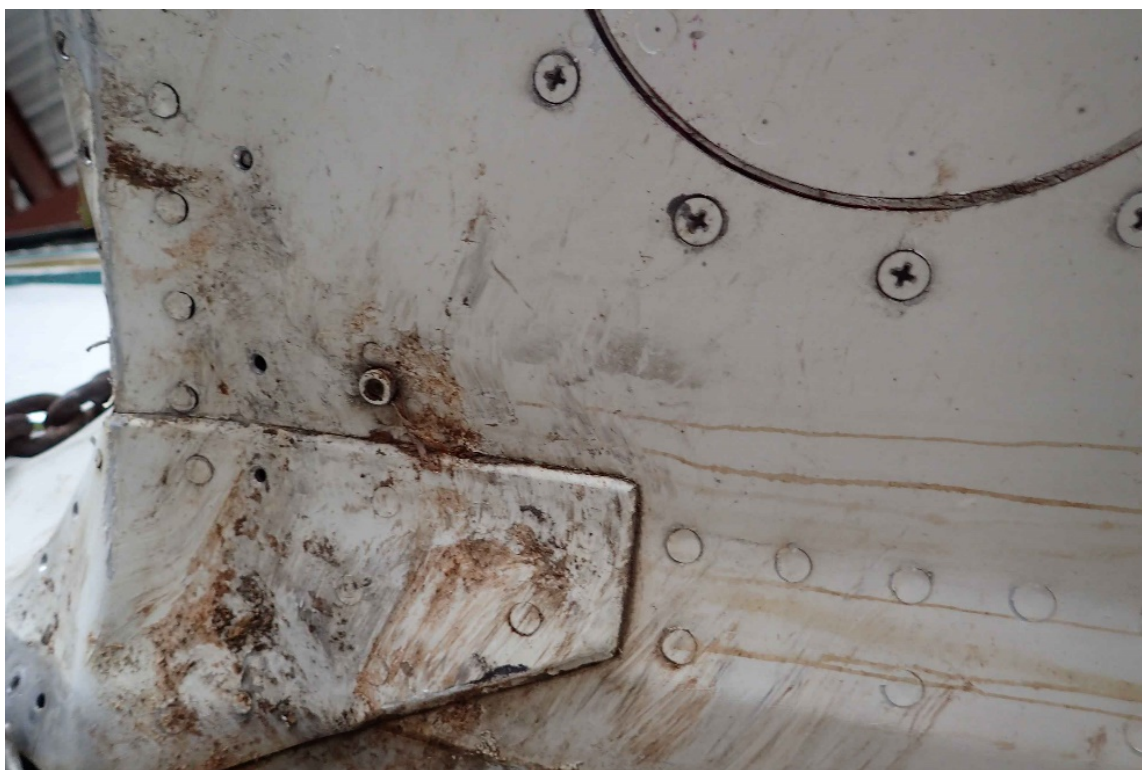
Bulletin M20-188A had not been complied with, and the valve appeared to be original. The valve was in the closed position and opened and closed freely when tested. The valve appeared air-tight when blown from the inside of the tank. The sealant around the valve was cracked and degraded and had a dry chalky appearance. (Photo 3). A series of brown streaks were observed on the external underside skins of the tank emanating aft from the area of the sump valve and the inboard wing doubler (Photo 4). Due to the damage, the integrity of the tank at the time of the accident could not be confirmed.

Photo 4 – Right Tank Sump Drain and Fluid Streaks

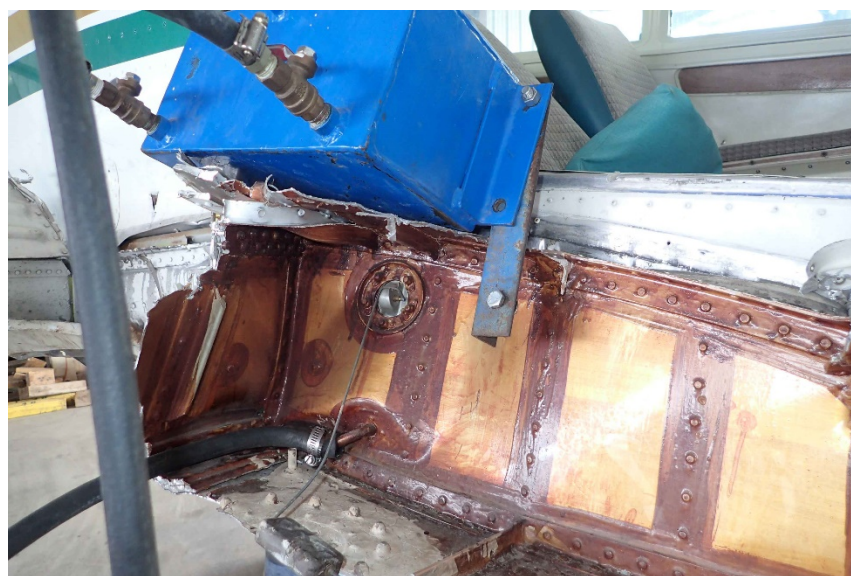
An engine test run was performed utilizing fuel fed from a canister connected to both the left and right tank feed lines at the wing roots (Photo 5). The engine was operated through its full speed range, on both selector valve settings, and no fuel leaks were observed anywhere within the airframe or forward of the firewall.

Photo 5 – Right Tank Fuel Supply for Engine Test Run

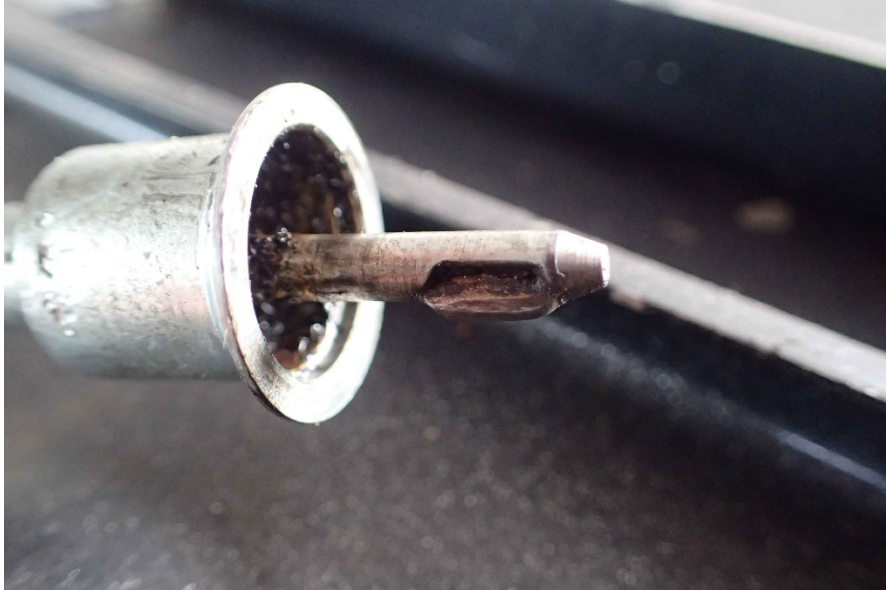
The airplane was equipped with a mechanical cable-driven engine tachometer. The tachometer was removed, and the tachometer cable was examined in place, and no anomalies were noted. The inner drive of the tachometer cable could be rotated freely by hand, and the drive splines at either ended were undamaged (Photo 6, 7).

Photo 6 – Tachometer Cable (Engine End)

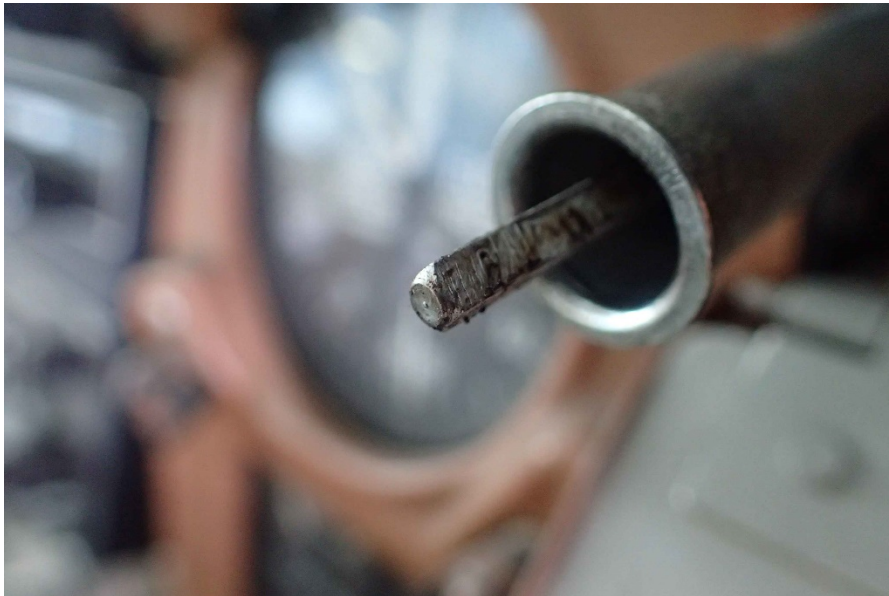
Photo 7 - Tachometer Cable (Instrument End)
