## **NATIONAL TRANSPORTATION SAFETY BOARD**

### **SUMMARY OF AIRPLANE AND ENGINE EXAMINATION**

**(WPR18FA001)**

| Aircraft: | Cirrus SR22, N6083D |

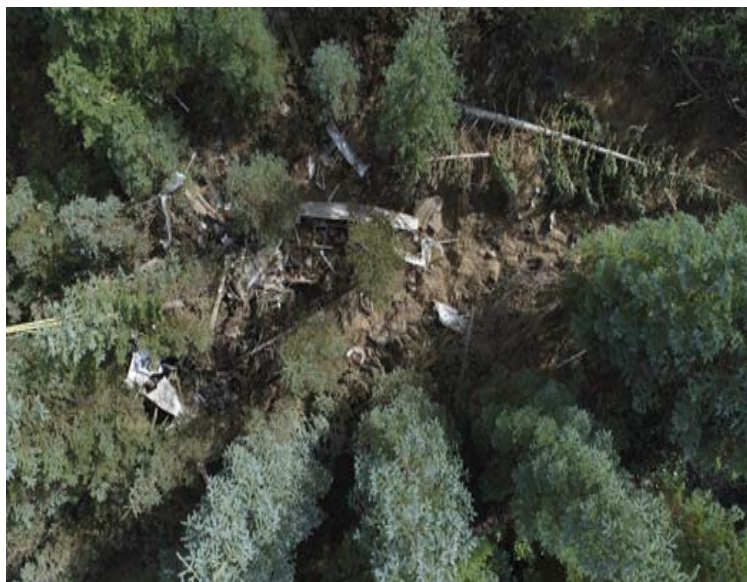
On October 3rd and 4th, representatives from the NTSB, the Federal Aviation Administration, Continental Motors, Inc., and Cirrus Aircraft surveyed the accident site. The airplane had initially impacted a 40-foot tall tree at about the 25-foot level on a northeast heading; the top of the tree was observed severed. The second impact point (main impact crater) was at the base of a another 40-foot tall tree, approximately 40 to 50 feet northeast of the first impact point. The second tree was uprooted by the impact forces. It then continued northeast on about a 15° downslope before coming to rest about 100 ft. from the initial impact point. The airplane was highly fragmented during the accident sequence. The main impact crater at the base of the second tree was estimated to be about 2 to 3 feet in depth and about 6 feet in width. The nose landing gear was located just to the south of the main impact crater. The debris field extended approximately 150 feet on a heading of approximately 055 degrees. The main wreckage came to rest about 60 feet northeast of the main impact crater.

Figure 1 - overhead view of debris field

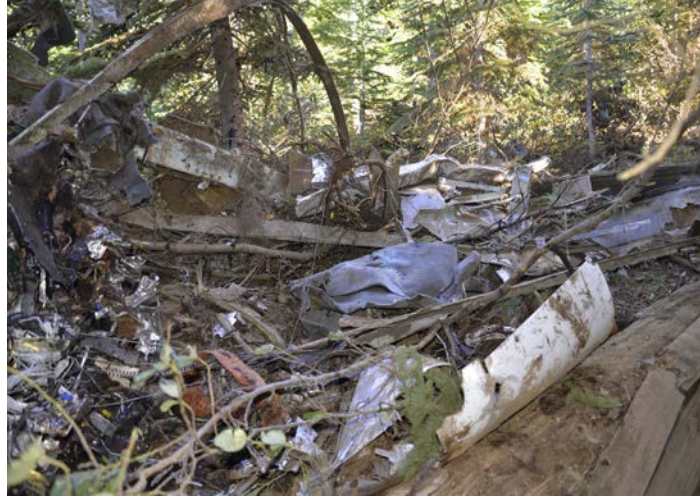
Figure 2 - main wreckage site looking northeast

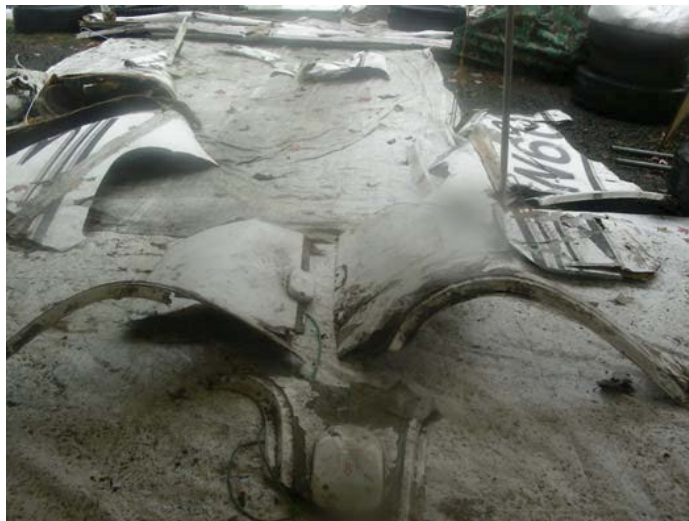
The entire fuselage was destroyed by impact forces, having been extensively fragmented during the accident sequence.

Figure 3 - remnants of the aft fuselage area

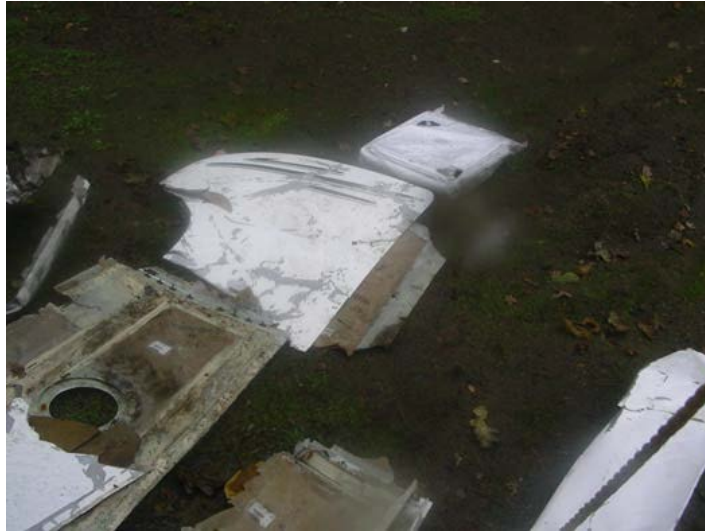
The carry-through wing was destroyed by impact forces. The right wingtip, right aileron, and right flap were located within the debris field. The left aileron and left flap were also located in the debris field.

Figure 4 - right wing

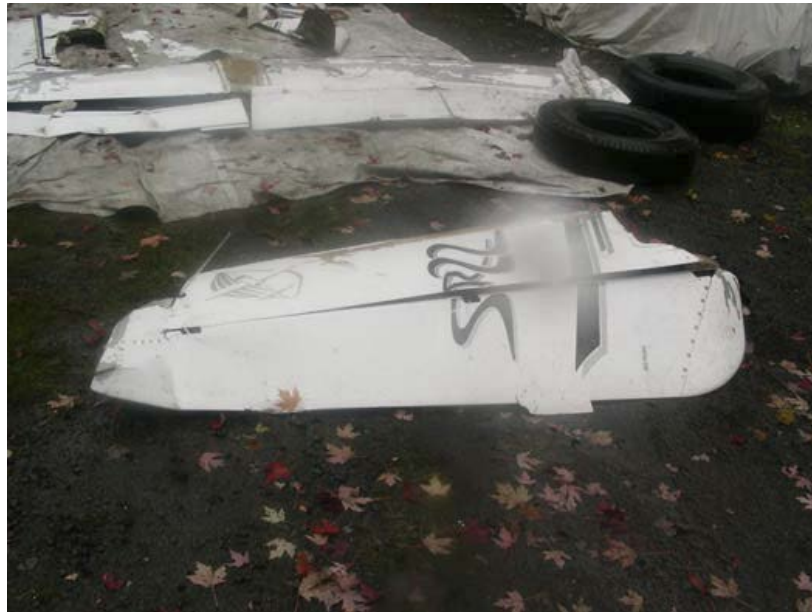
The empennage was destroyed by impact forces. The vertical stabilizer and attached rudder were found in the debris field. The separated horizontal stabilizer was found in the debris field. The left and right elevators were found in the debris field.

Figure 5 - view of the empennage

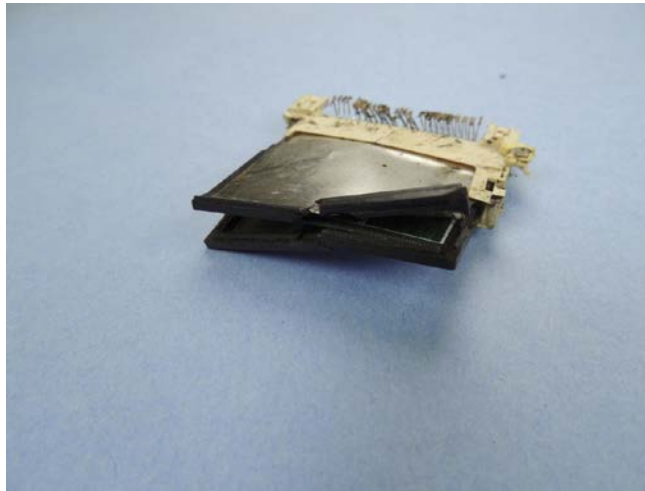
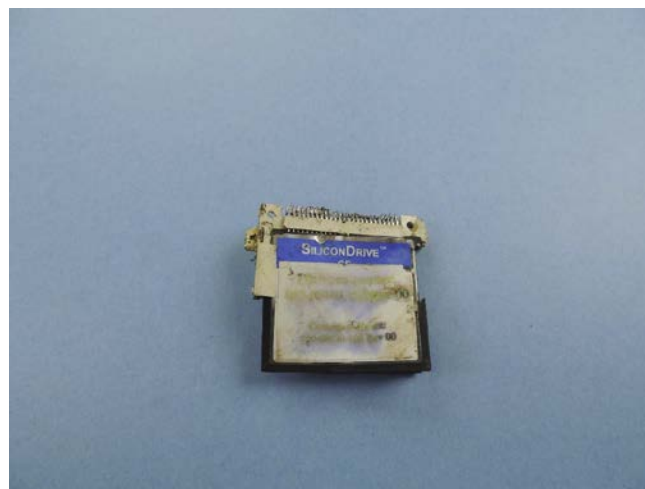
The Multi-Functional Display (MFD) and the Primary Functional Display (PFD) were located in the debris field. The MFD and PFD were destroyed by impact forces. Several loose memory

boards, including the ACR module for the Avidyne PFD and the MFD's flash card were found in the debris field. The MFD's flash memory module was taken into possession by the NTSB IIC to be sent to the NTSB's Vehicle Recorder lab for further examination.

Figure 6 – side view of damaged CF memory card

Figure 7 - top view of damaged CF memory card

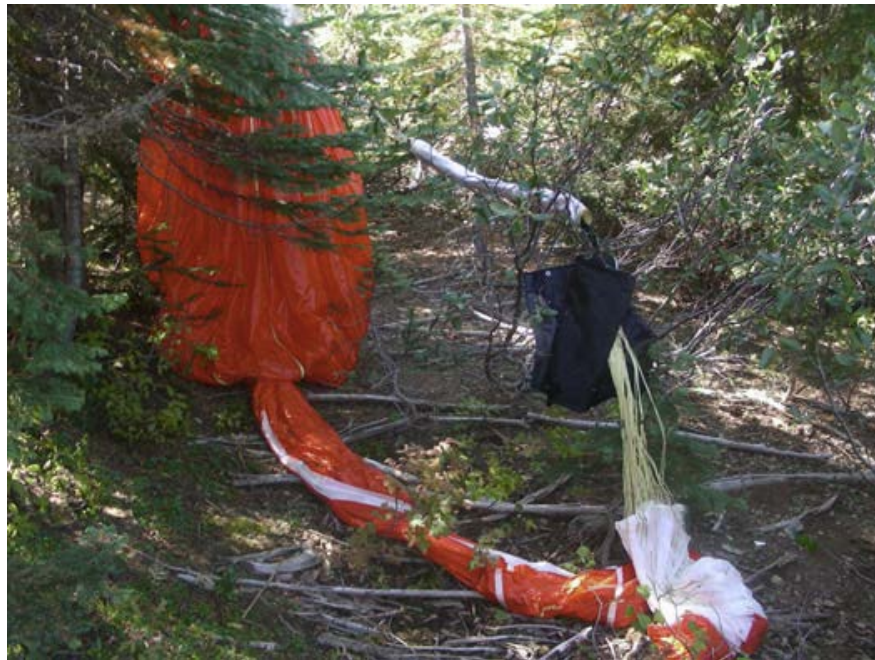
The CAPS parachute was found extracted from aircraft by impact forces. The parachute was unfurled and located about 40 feet northeast of the main wreckage. The parachute, suspension lines and risers were found draped over several trees along a linear debris path. Packing folds were present on the canopy. The slider was located near the base of the canopy.

The rocket motor, lanyards and D-Bag remained attached to the parachute. The rocket motor propellant was not expended. The incremental Bridle remained stowed in the Kevlar sheath.

Figure 8 - view of CAPS parachute

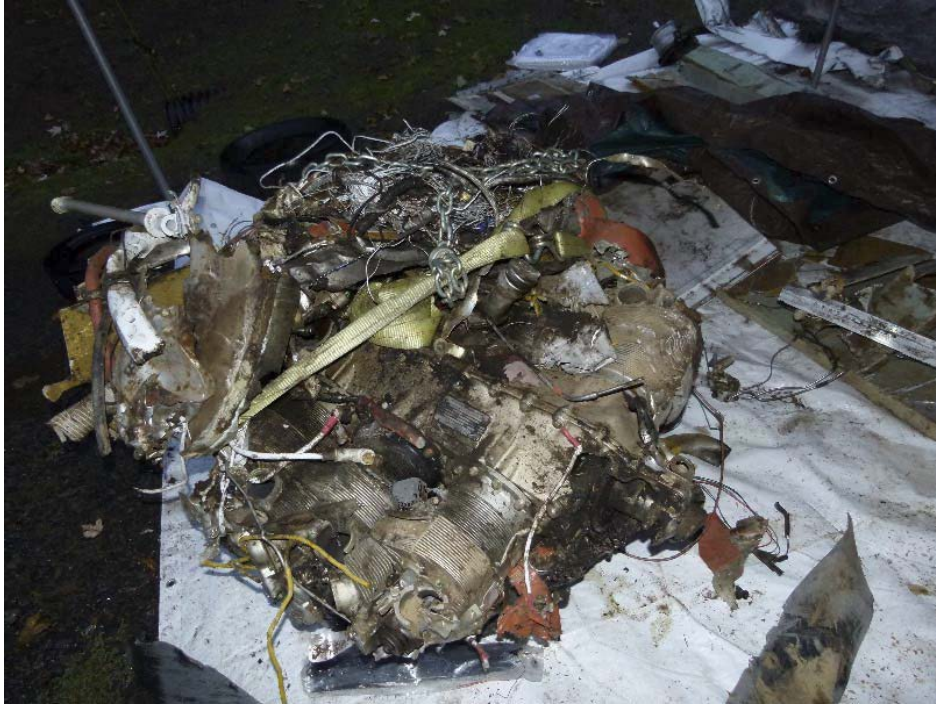
The engine exhibited severe impact damage. Most of the engine accessories had fractured from their mounts and were located within the wreckage. The crankshaft propeller flange had separated and remained attached to the propeller hub. The propeller flange fracture surface exhibited 45° shear lips and radial cracking.

Figure 9 - view of engine post-recovery prior to examination

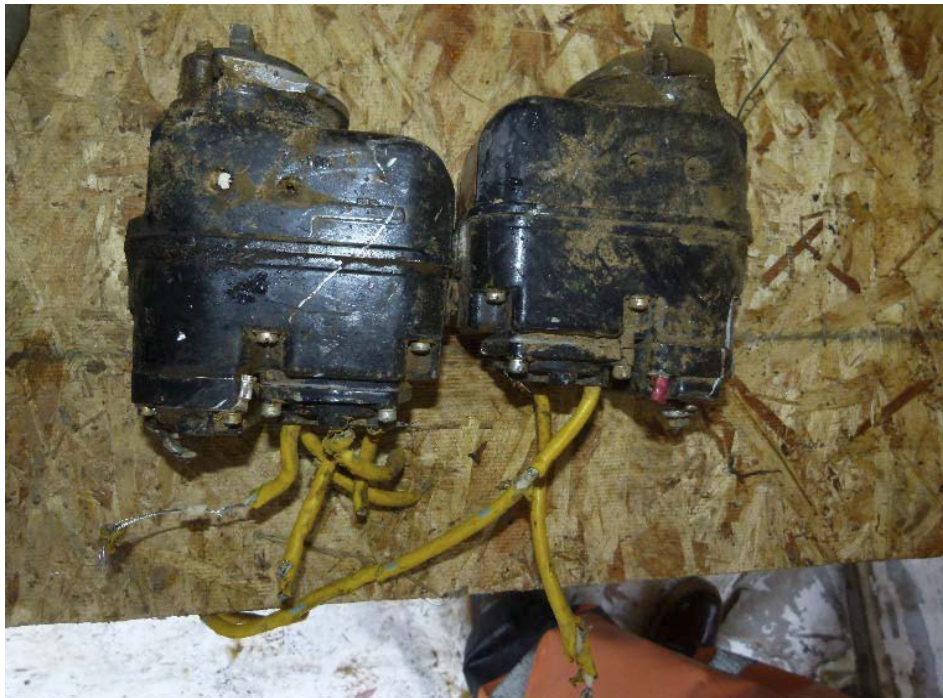
The magnetos were fractured from their mounts on the engine and were located within the aircraft wreckage. Both magnetos exhibited impact damage. One magneto drive turned freely by hand with impulse coupling engagement observed. The magneto produced spark at all six distribution towers. The other magneto would not turn by hand and was disassembled with no preimpact anomalies noted.

Figure 10 - view of airplanes magnetos

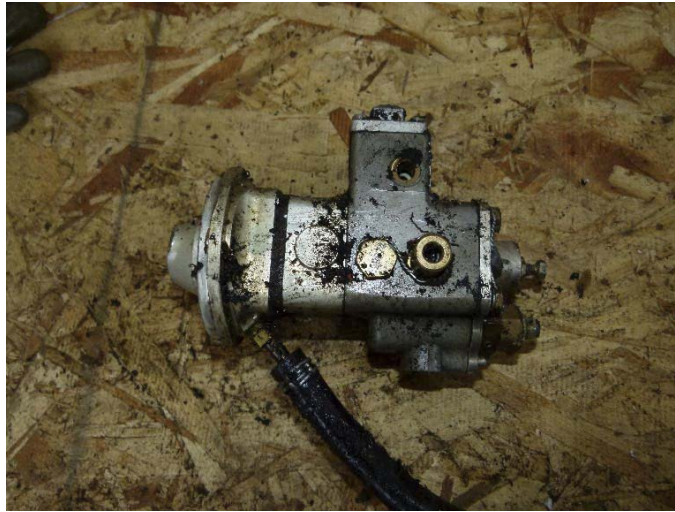
The engine driven fuel pump exhibited impact damage and was partially dislodged from its mount. All fuel line fittings were fractured. The fuel pump drive coupling was broken. The mixture control turned freely by hand from stop to stop. The fuel pump was disassembled with no preimpact anomalies noted.

Figure 11 - engine driven fuel pump

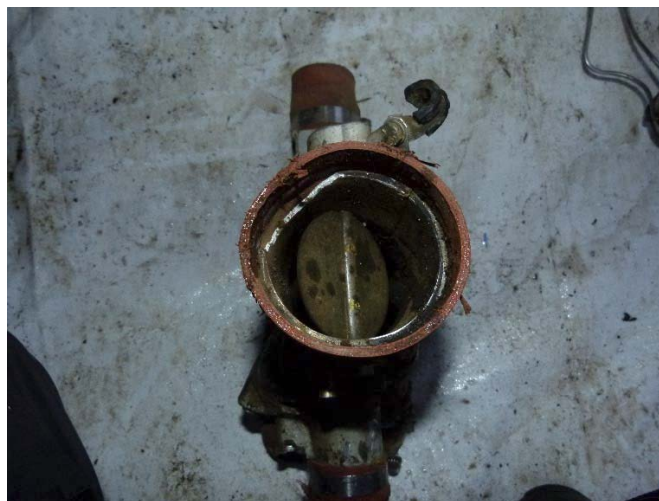
The throttle body was fractured from the engine and located with the aircraft wreckage. The throttle body exhibited impact damage and the throttle control arm was fracture separated and not observed. The metering unit was separated and not observed.

Figure 12 - throttle body

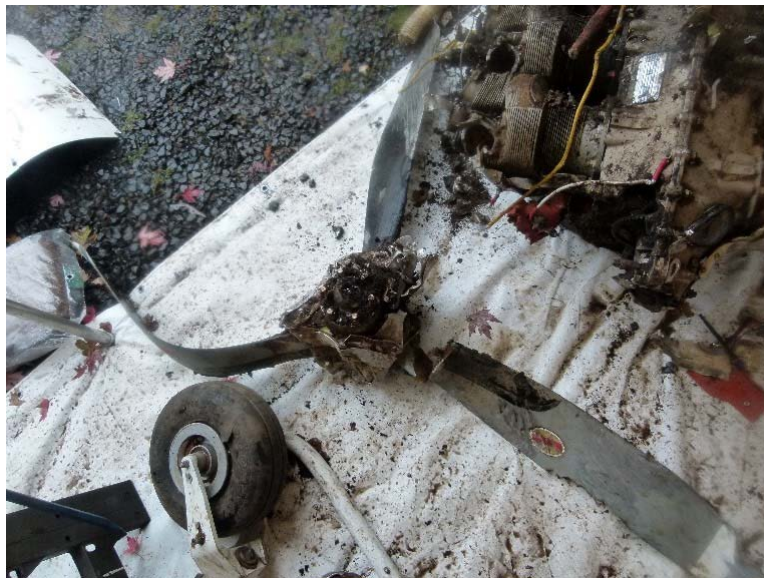
The three-bladed propeller had separated from the engine. The crankshaft propeller flange remained attached to the propeller hub. One propeller blade was fractured near the hub and exhibited multi-direction scratches and large gouges in the leading and trailing edges. Another blade was relatively straight with multidirectional scratches and large gouges to the leading edge. A third blade was bent aft from the hub to the tip with a slight forward bend at the tip and exhibited chordwise scratches.

Figure 13 - damaged propeller
