## TESTS AND RESEARCH

A National Transportation Safety Board investigator and Federal Aviation Administration investigators examined the airplane at both the accident site and that the facilities of Air Transport in Phoenix, Arizona October 20 and 21, 2017.

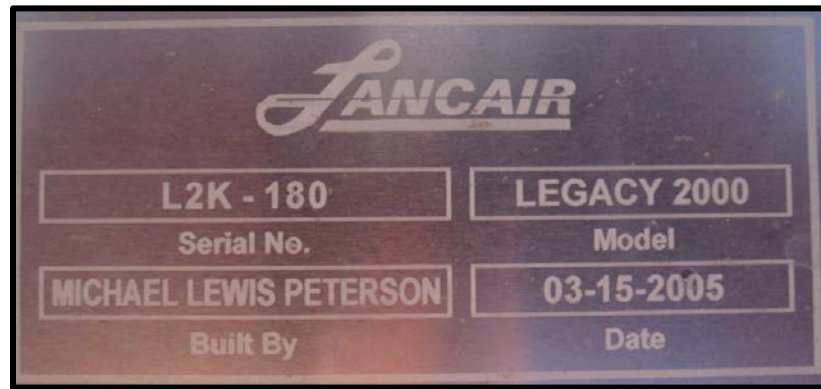
*Picture 01: Airplane's Data Plate*

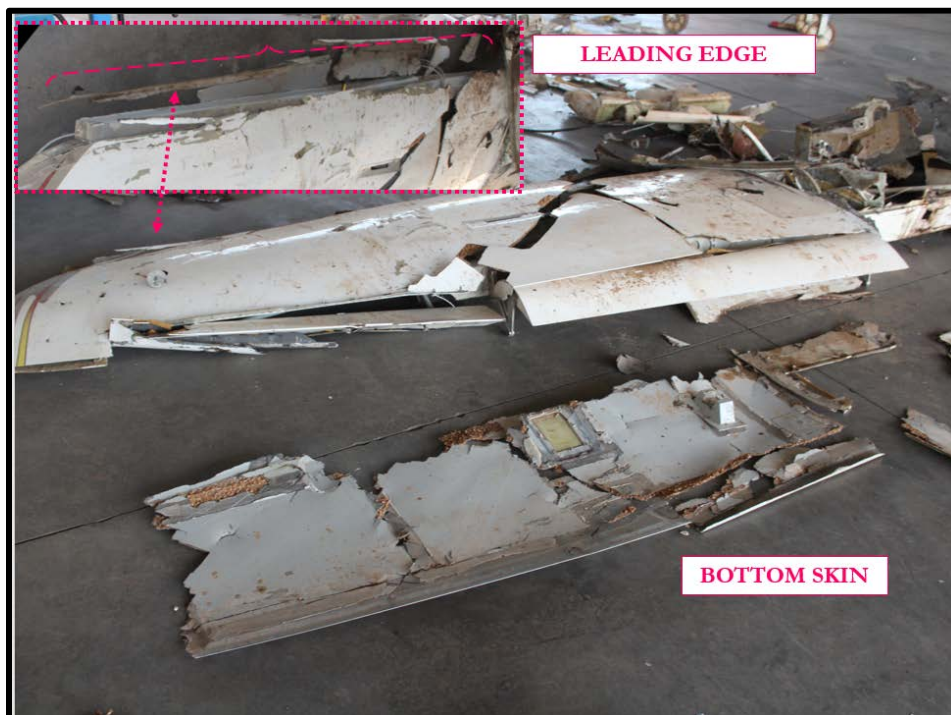
The left wing, found separated from fuselage skin but adjacent to the wreckage in an upright position, had separated into numerous pieces and had not sustained as much crush damage as the right wing. The main spar remained intact and the top wing skin was separated into three major pieces. The majority of the bottom wing skin pieces were severely fragmented and located under the wing partially buried in the dirt. The leading edge was separated into several pieces and located in the area forward of the main wreckage. The aileron and flap control surfaces remained attached at their respective hinges. Fragments of red lens was found forward of the wingtip. The landing gear remained inside the wheel well and portions of the landing gear door were found in the wreckage, consistent with the landing gear being in the retracted position at the time of impact.

Picture 03: Left Wing (upper surface)

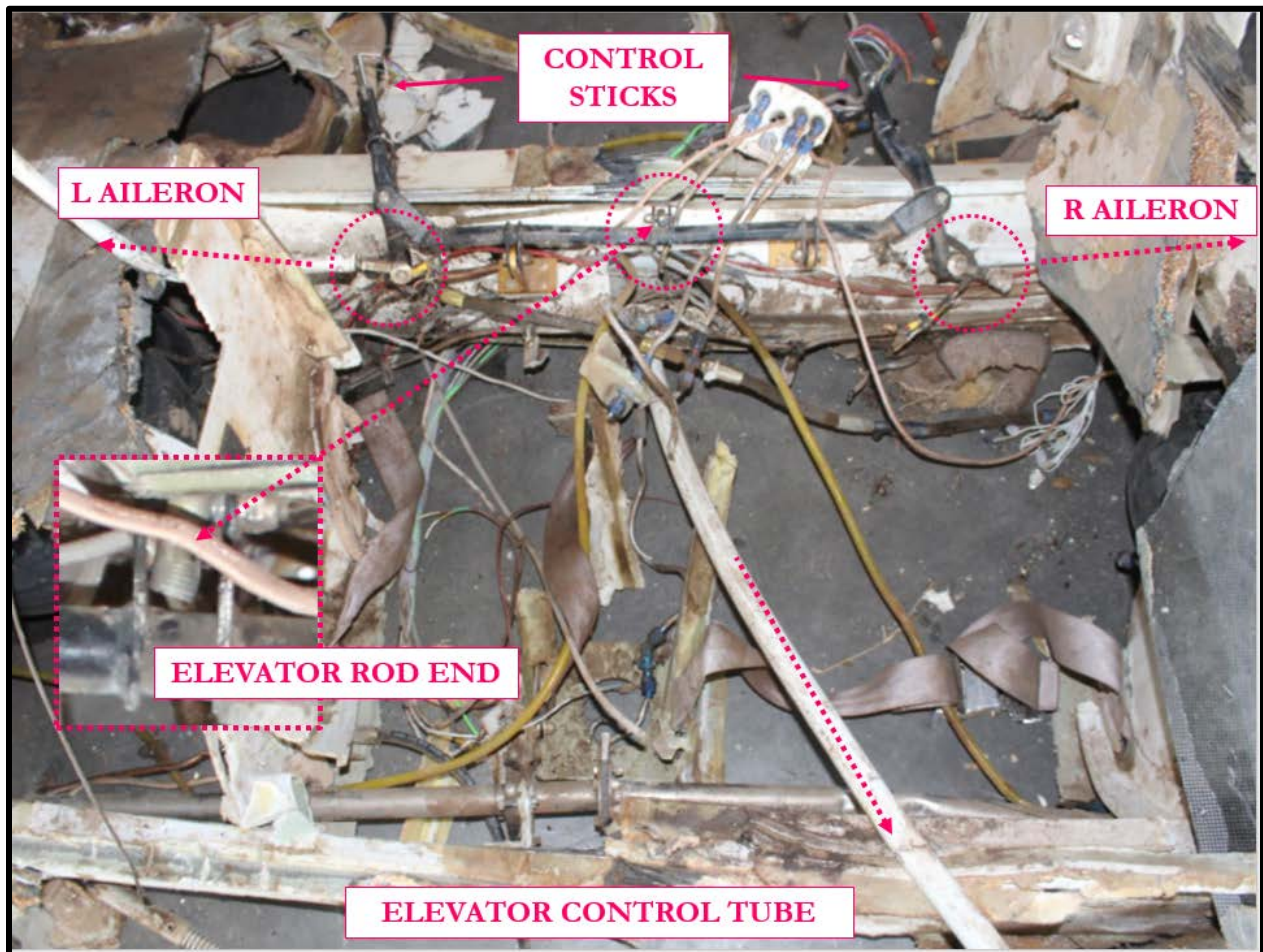
The left aileron control tube remained affixed to the mixer bar in the cockpit; the right aileron control tube had separated at the rod end, with the rivets sheared where the tubing connects. The mixer bar remained attached to the spar and manipulation of the control sticks resulted in output forces to the aileron control rods. The control sticks had exposed wires at the top and the portion covering the sticks was never located. The elevator control tube, found forward of the wreckage near the tree, contains several bends and was disconnected at the mixer bar; the rod end remained attached to the bar and had separated about halfway down the length of the threads consistent with it being attached at the time of impact. The aft elevator attachment bellcrank remain attached to the aft bulkhead. A portion of the control rod was attached continued until it was bent upward into the area with the tail had flipped on the backbone of the tail section.

*Picture 04: Aileron and Elevator Controls from Fuselage*

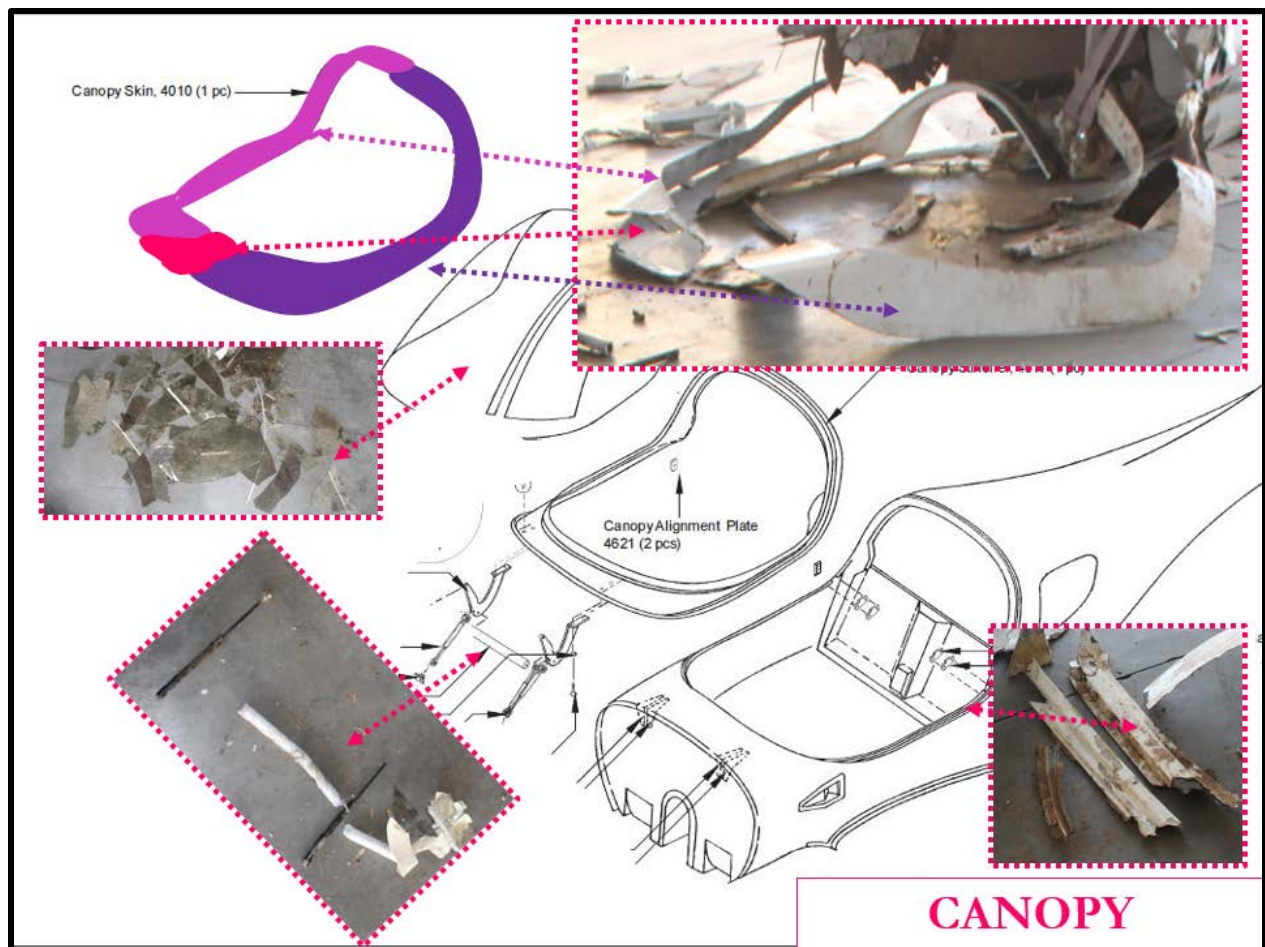
The canopy was fragmented into multiple sections and found within the debris field. The right upper canopy frame had two groups under the hinge receptacle which were consistent in size and shape with that of the latching. The left hinge receptacle was fragmented in the frame. Both signatures were indicative of the canopy being latched at the time of impact. The seatbelts were found unlatched with no evidence of deformation.

Picture 05: Canopy Pieces

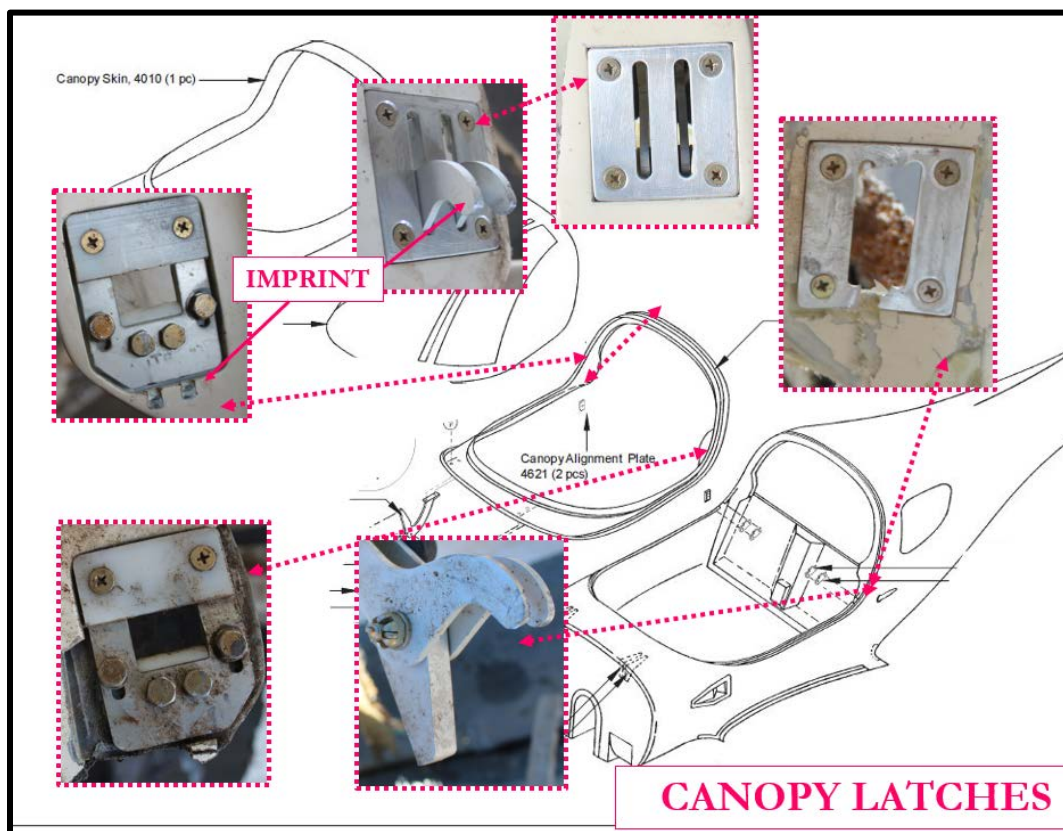
Picture 06: Canopy Latches

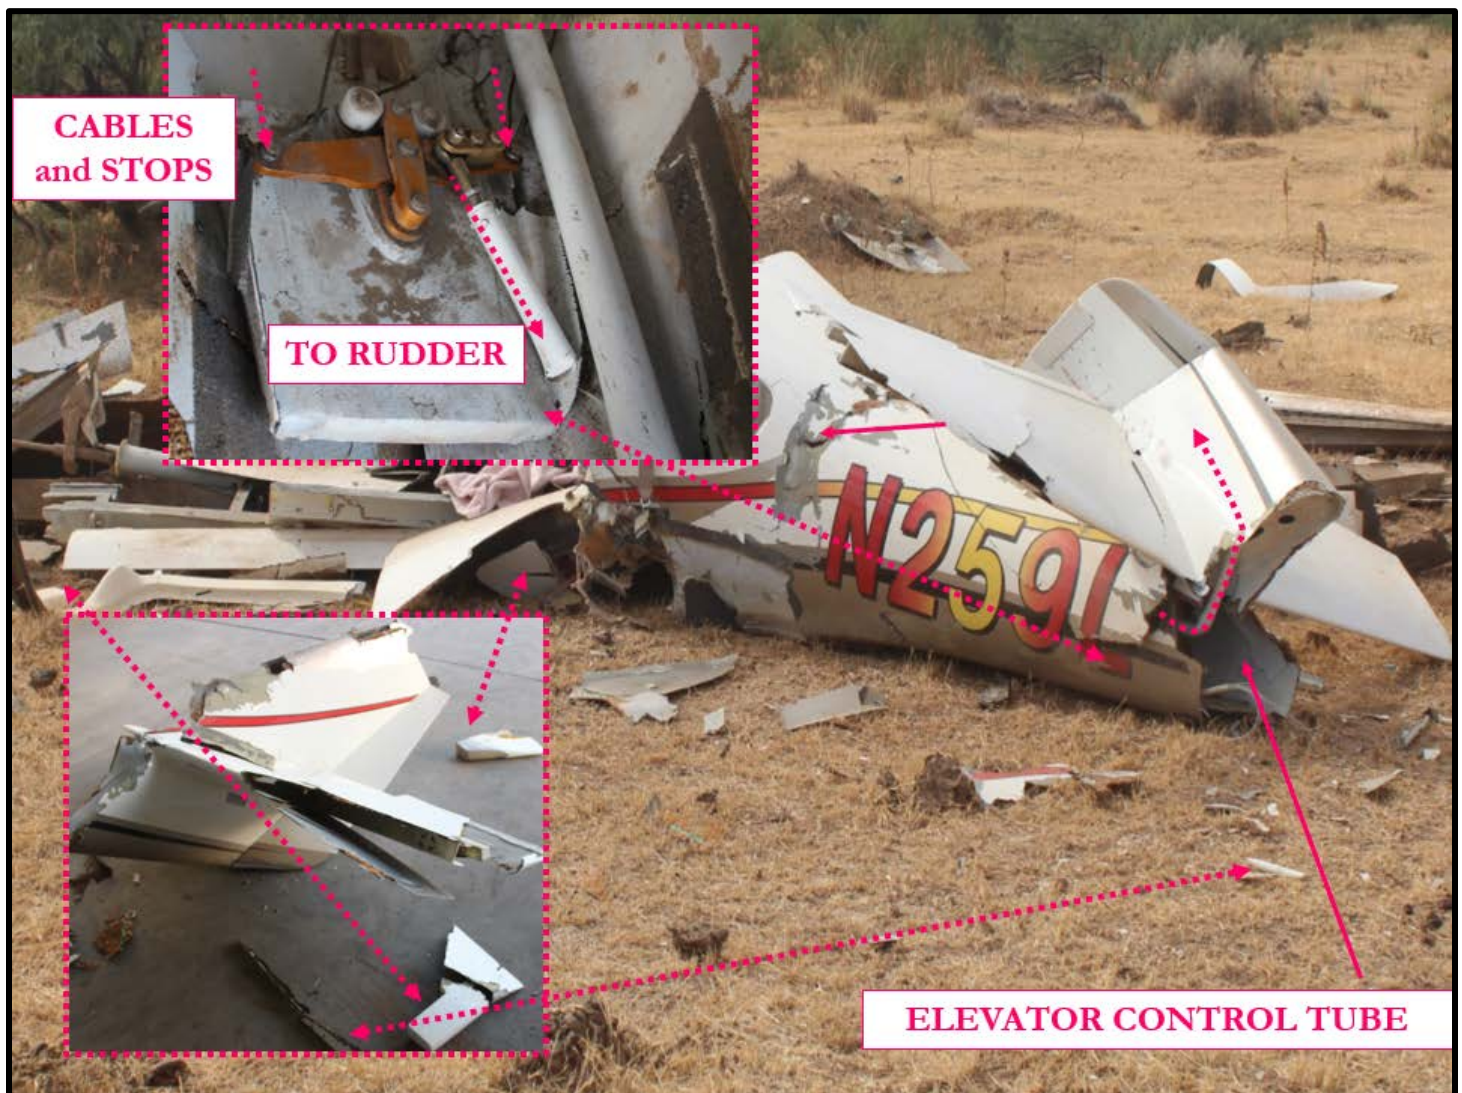
The empennage had separated aft of the aft bulkhead. The vertical stabilizer had come to rest inside the tail cone section splitting down the backbone. The right horizontal stabilizer and elevator remained attached and contact. The left horizontal stabilizer fragmented in the outboard area and the piece of leading edge was found immediately under the wreckage. The elevator had separated at its balance weight which was located on the left side of the wreckage near the wing. The rudder remained attached, with the exception of the upper portion and balance weight which had separated and was located near the left wing.

The rudder pedals were located in the cockpit area and had broken free from the airframe with the exception of a portion of the pilot upper left pedal. The pedals suffered crush deformation and revenge. The control cables were found attached to the pedals and traced through the fuselage skin to the bell crank arms. The platform where the rudder bell crank was located had come free from the empennage skin and was loosely laying in the tail cone section at impact. The control rod was attached to the bell crank and had separated in the area where the tail had separated from the fuselage. The stops were intact and there was no evidence of deformation.

Picture 07: Empennage

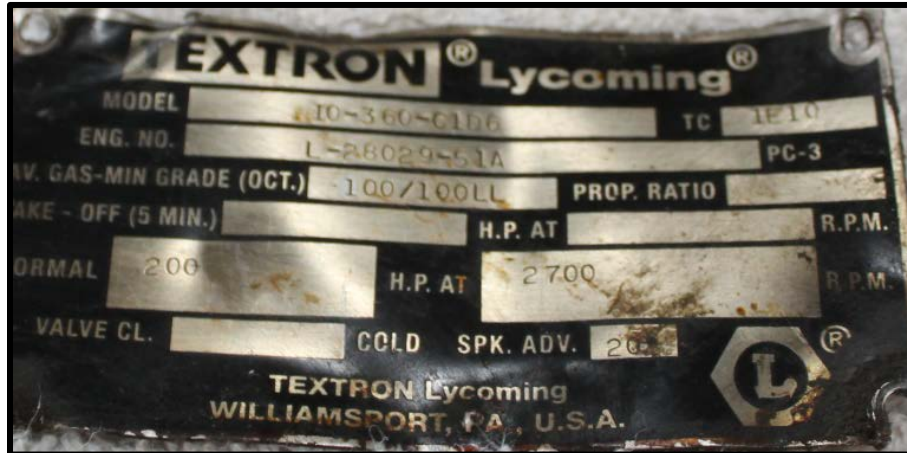
Picture 09: Engine Data Plate

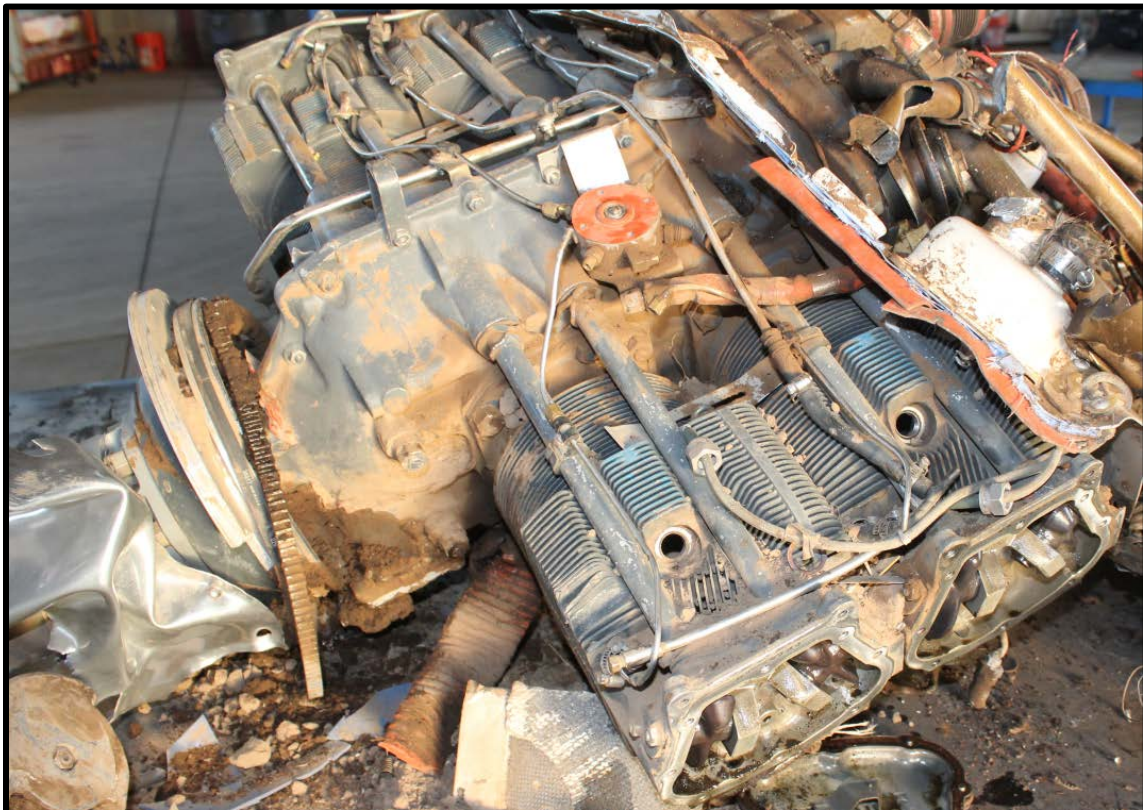
The Lycoming IO-360-C1D6, serial number L-88029-51A, sustained impact damage. Despite several attempts, investigators could not rotate the crankshaft. The top spark plugs were removed revealing a light grey coloration consistent with normal operation. The cylinders were examined through the spark plug holes revealing that the combustion chambers were mechanically undamaged, and there was no evidence of foreign object ingestion or detonation. The valves were intact and undamaged. There was no evidence of valve to piston face contact observed. The gas path and combustion signatures observed at the spark plugs, combustion chambers and exhaust system components displayed coloration that were consistent with normal operation.

Picture 10: Engine

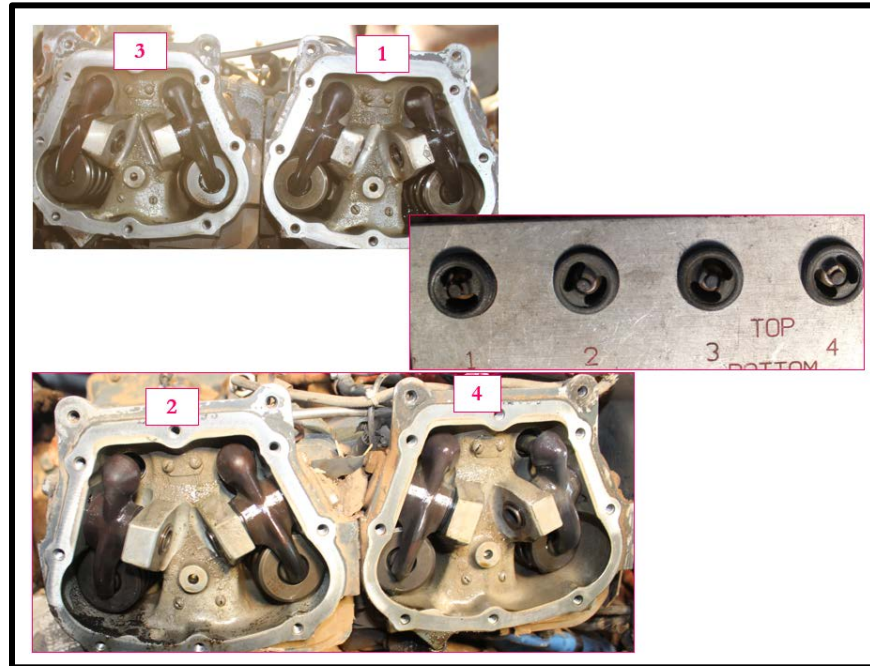
There was no oil residue observed in the exhaust system gas path. Ductile bending and crushing of the exhaust system components was observed consistent with impact. The right and left magnetos were broken from their

flanges and upon removal, were rotated by hand. Spark was obtained at each post during rotation. The Rayco turbo charger was disassembled. Light scoring was observed on the turbine side.

Picture 11: Cylinders (external) and Spark Plugs

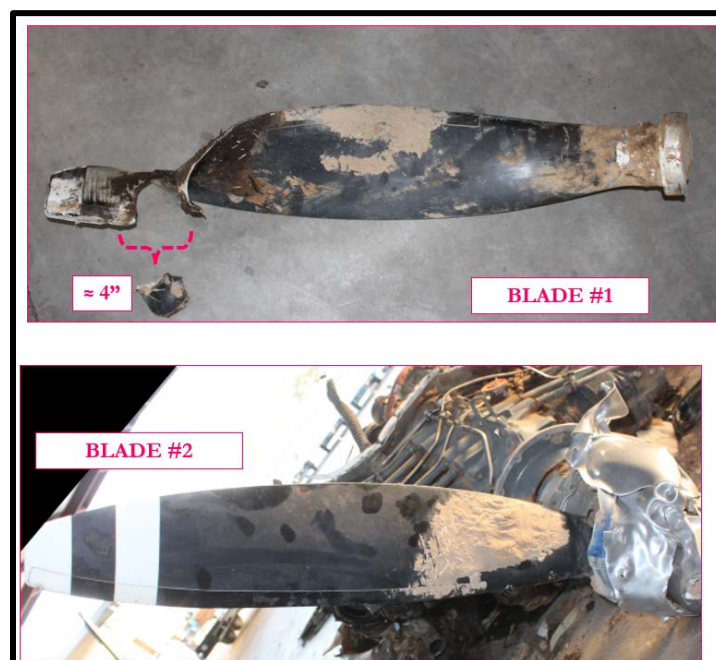
One propeller blade (labeled as number 2) was visible at the accident site. The other blade (labeled as number 1) was buried under the engine and had separated with the tip oriented toward the firewall and the hub near the propeller spinner. Blade number 2 was found relatively straight with no evidence of twisting. Blade number 1 was twisted at the tip and contained a 4 inch gouge where a portion of the outboard leading edge piece had become separated and was found buried near the remainder of the blade. One side of the blade was polished silver and contained numerous chordwise scratches.

Picture 12: Propeller Blades

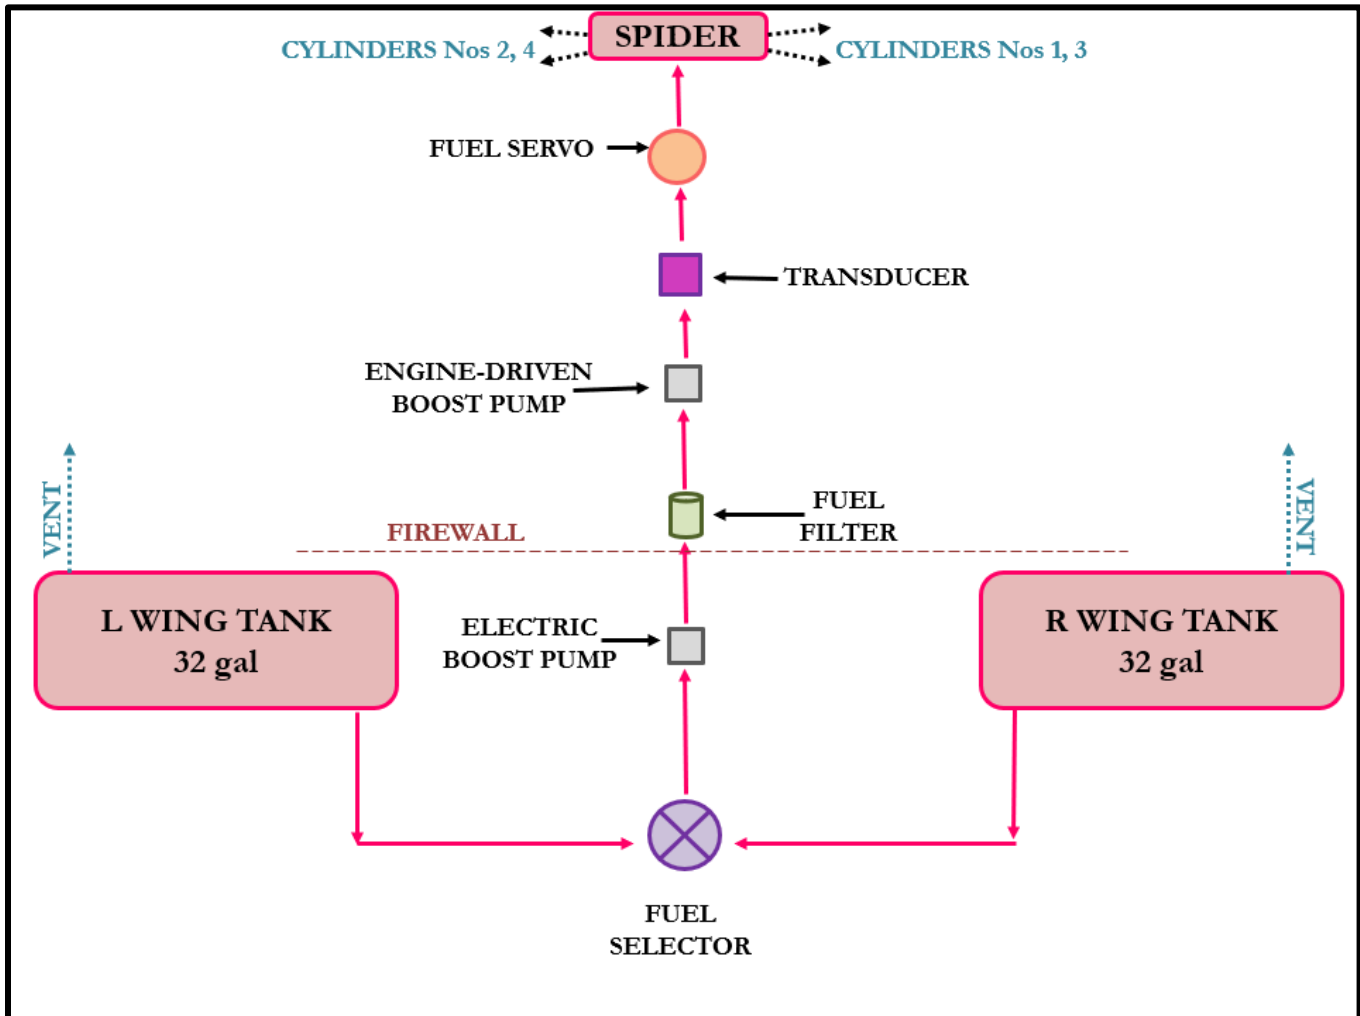
The airplane's fuel system was a gravity-fed design where fuel flowed from the internal wing tanks located in the outboard section of each wing, through a selector valve, and continued to the electric boost pump. From the pump, the fuel was routed to a filter and then to the engine-driven fuel pump. Thereafter, the fuel continued to a transducer which was mounted on the fuel servo which metered the fuel delivered to the fuel distributor (spider).

Picture 13: Fuel System Design

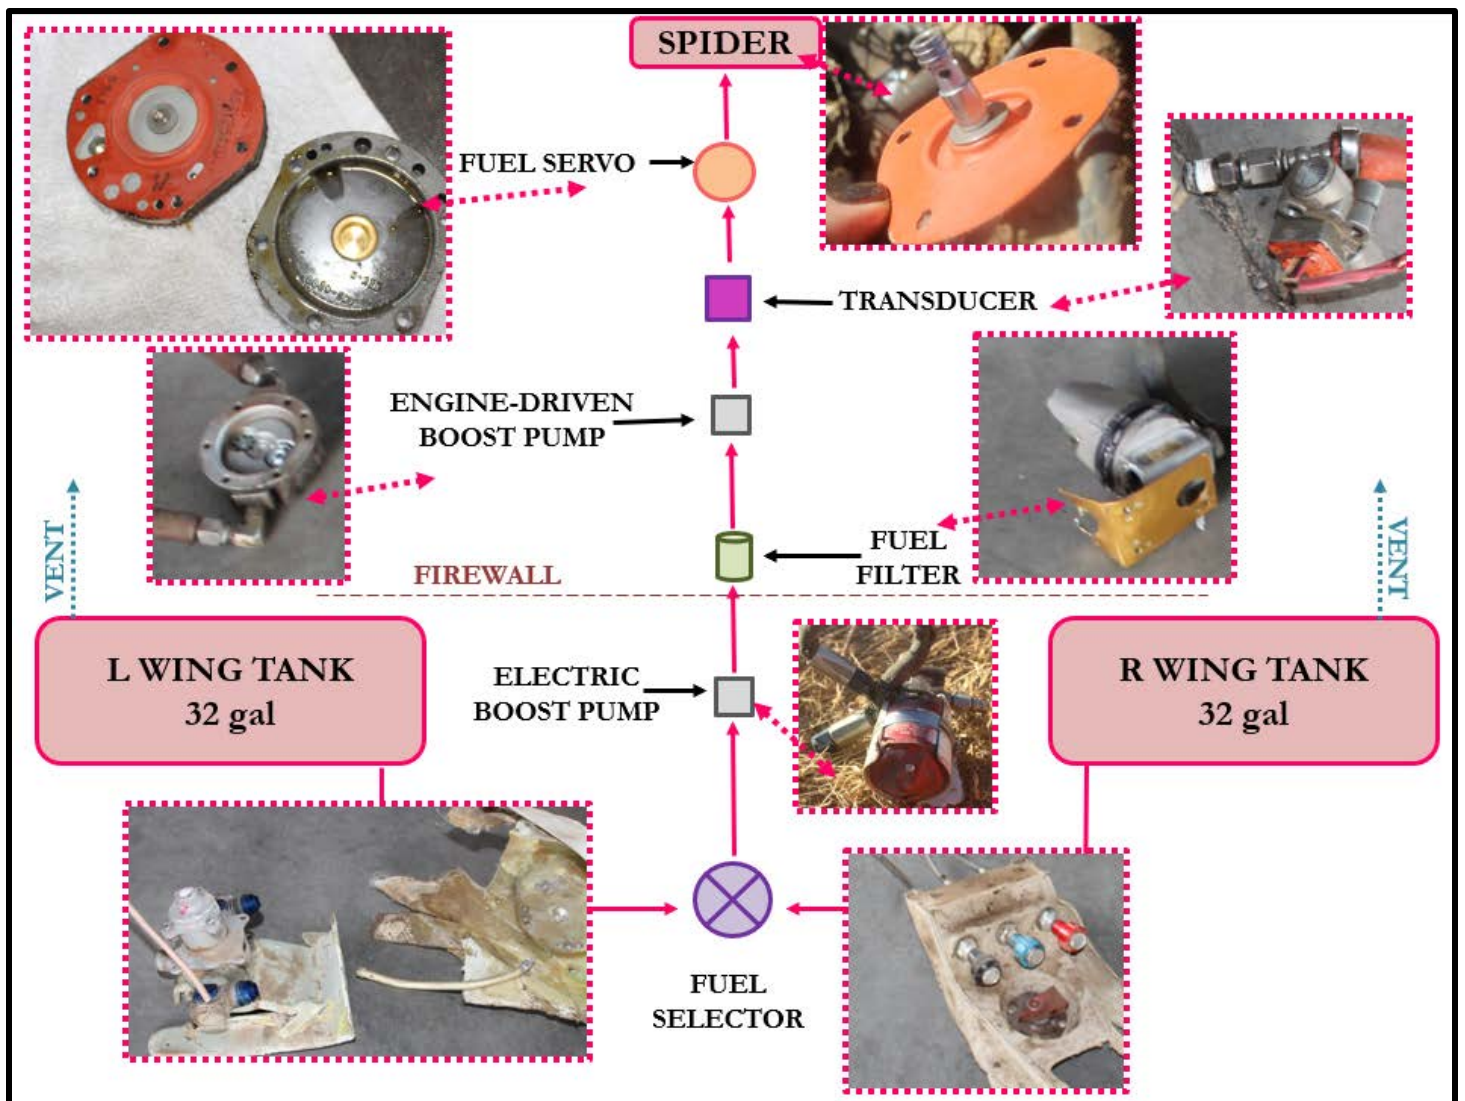
The fuel selector was found with the handle pointing to the “LEFT” tank position. The position of the fuel selector valve, manufactured by Andair, LTD, was in the left position. The selector was found in several pieces: the handle (which was still attached to the airframe), the extender (which was located loosely in the wreckage adjacent to the pilot seat), the valve (which was attached to the spar). The fuel filter was partially disassembled and the screen was found to be clean. The fuel servo was disassembled and found to contain liquid that had a smell akin to AVGAS; the diaphragms were pliable and the valve was intact. The transducer was disassembled and when air was forced through the inlet, the internal wheel could be heard rotating.

Removal of the fuel manifold (spider) revealed no evidence of liquid; the diaphragm was pliable and the spring was intact.

Picture 14: Fuel System
