## Record of NTSB Material Lab findings

**Subject:** WPR18FA016 N8537J, Robinson R22 Alpha, Arlington, WA 10/24/2017  
Examination of fracture surfaces: swashplate arms and main rotor gearbox

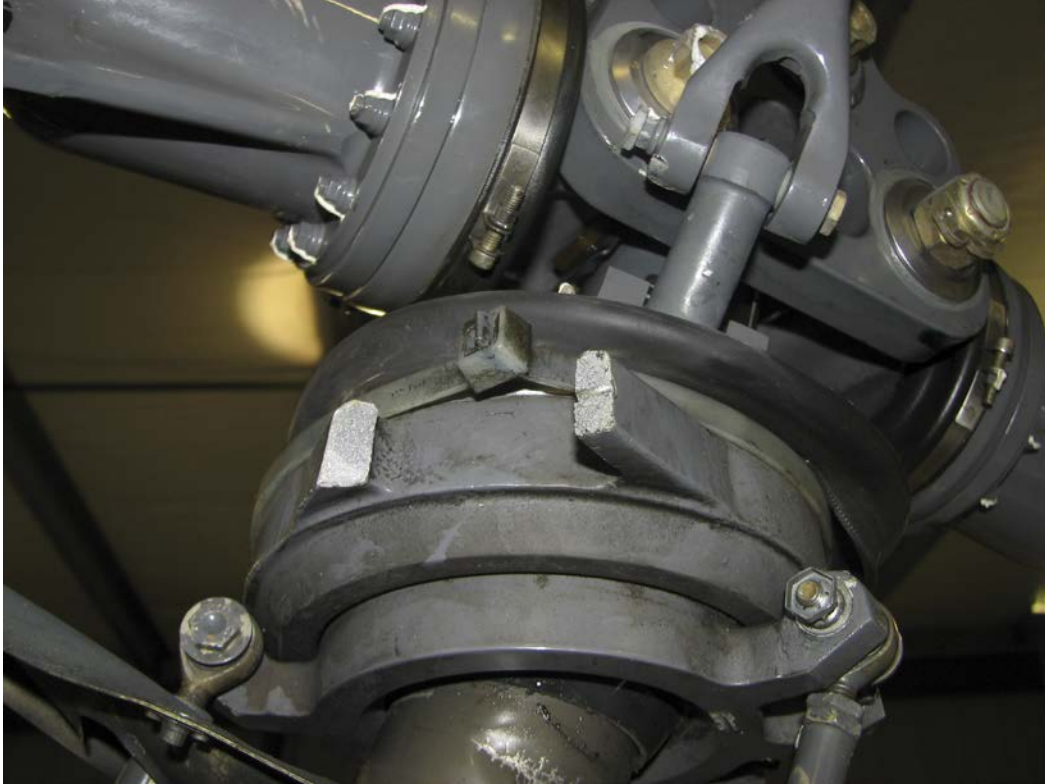
On the above referenced date and time, the IIC submitted pictures of the fracture surfaces for the helicopter's swashplate arms in order to have a visual inspection of the fracture surfaces examined to determine the failure mode of the component. The Chief of the Materials Lab Division subsequently assigned Joe Epperson, an NTSB Senior Materials Laboratory Engineer, to review the pictures and report his findings relative to the failure mode of the component. Mr. Epperson reported that after having viewed the pictures, he didn't see anything suggesting preexisting cracking, and that the fractures looked to be the result of overstress/overload.

*Figure 1- photo 1 of swashplate arms fracture surfaces*

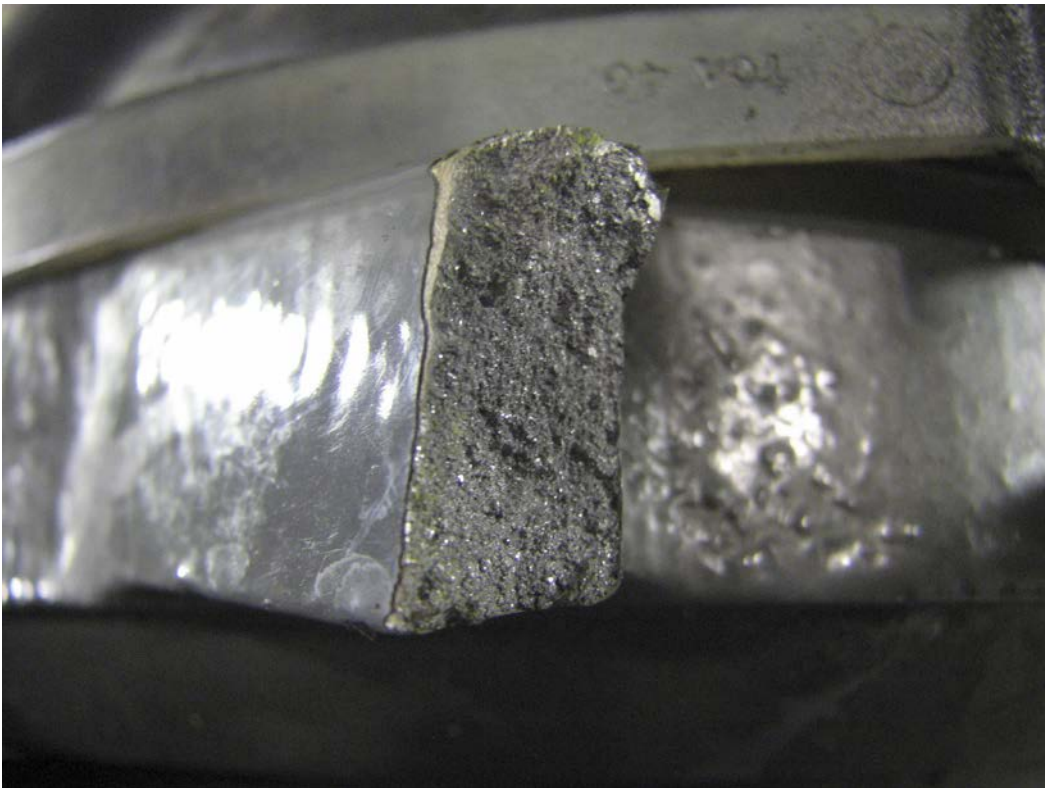
*Figure 2 - photo 2 of swashplate arm fracture surface*

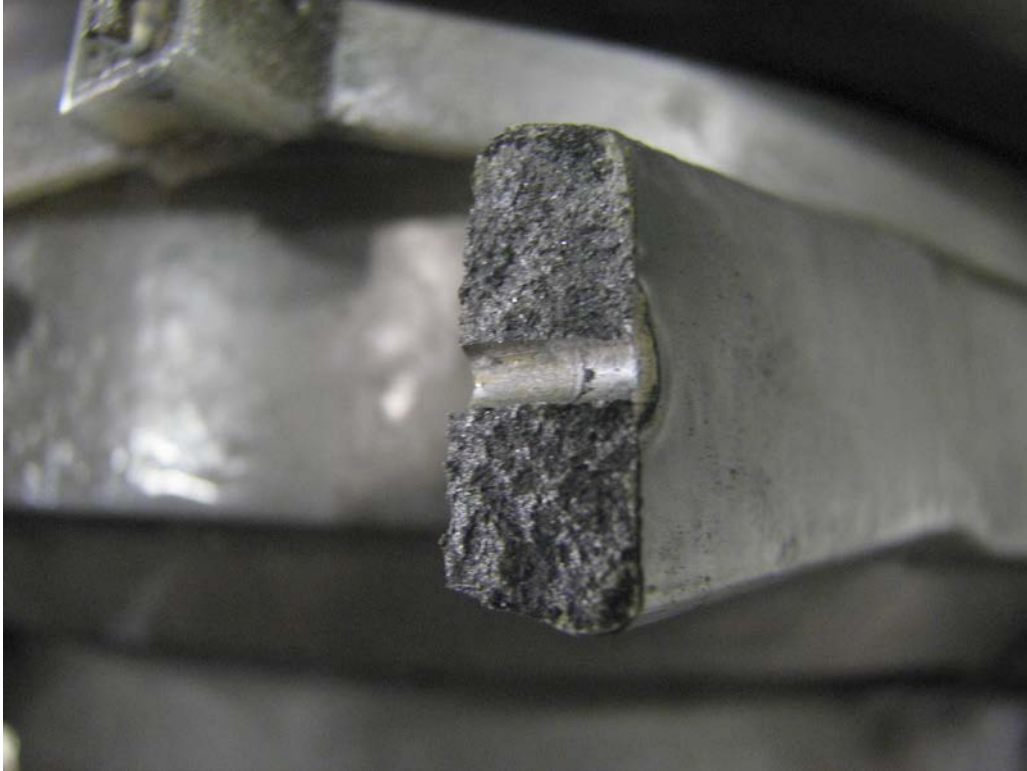
*Figure 3 - photo 3 of swashplate arm fracture surface*

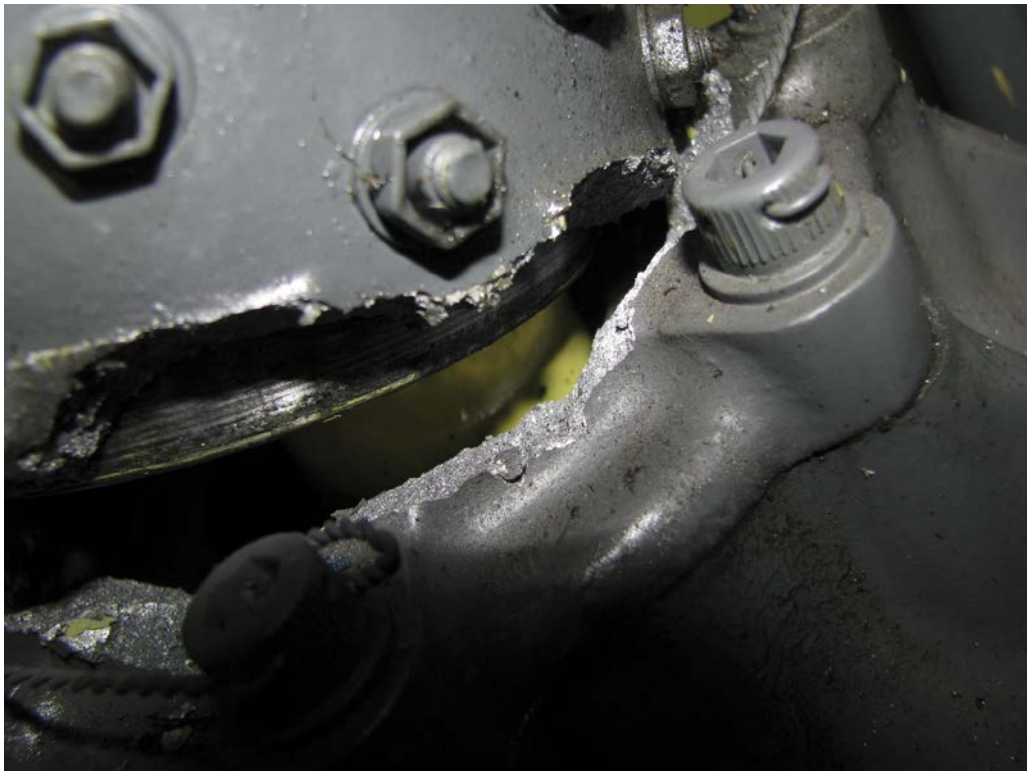
On December 14<sup>th</sup>, after having failed to initially submit pictures of the main rotor gearbox fracture surfaces to Mr. Epperson in my initial email, I called and asked if he could view some pictures of the component while we spoke. Mr. Epperson replied during our conversation that after viewing the fracture surfaces, they appeared to be consistent with those of the swashplate, having failed in overstress/overload, and with no preexisting cracking.

*Figure 4 - photo 1 of main rotor gearbox fracture surfaces*

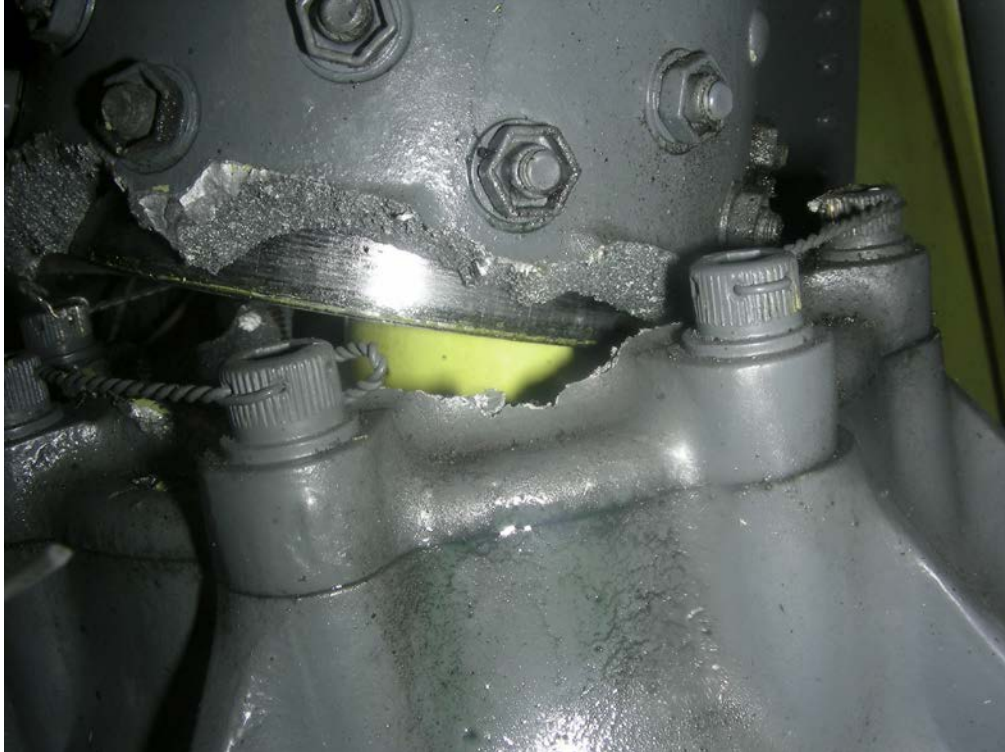
*Figure 5 - photo 2 of main rotor gearbox fracture surfaces*

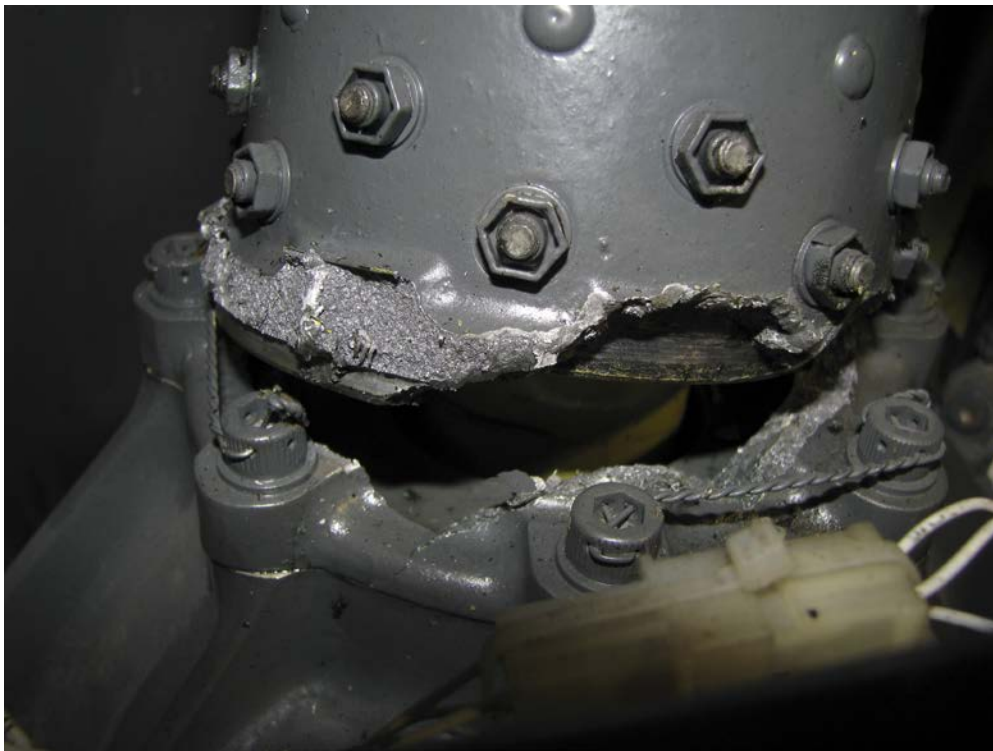
*Figure 6 - photo 3 of main rotor gearbox fracture surfaces*
