## **NATIONAL TRANSPORTATION SAFETY BOARD**

### **SUMMARY OF AIRCRAFT EXAMINATION**

**(WPR18FA016)**

Location: Arlington, Washington  
Date: October 24, 2017  
Aircraft: Robinson R22, N8537J  
NTSB IIC: Thomas M. Little

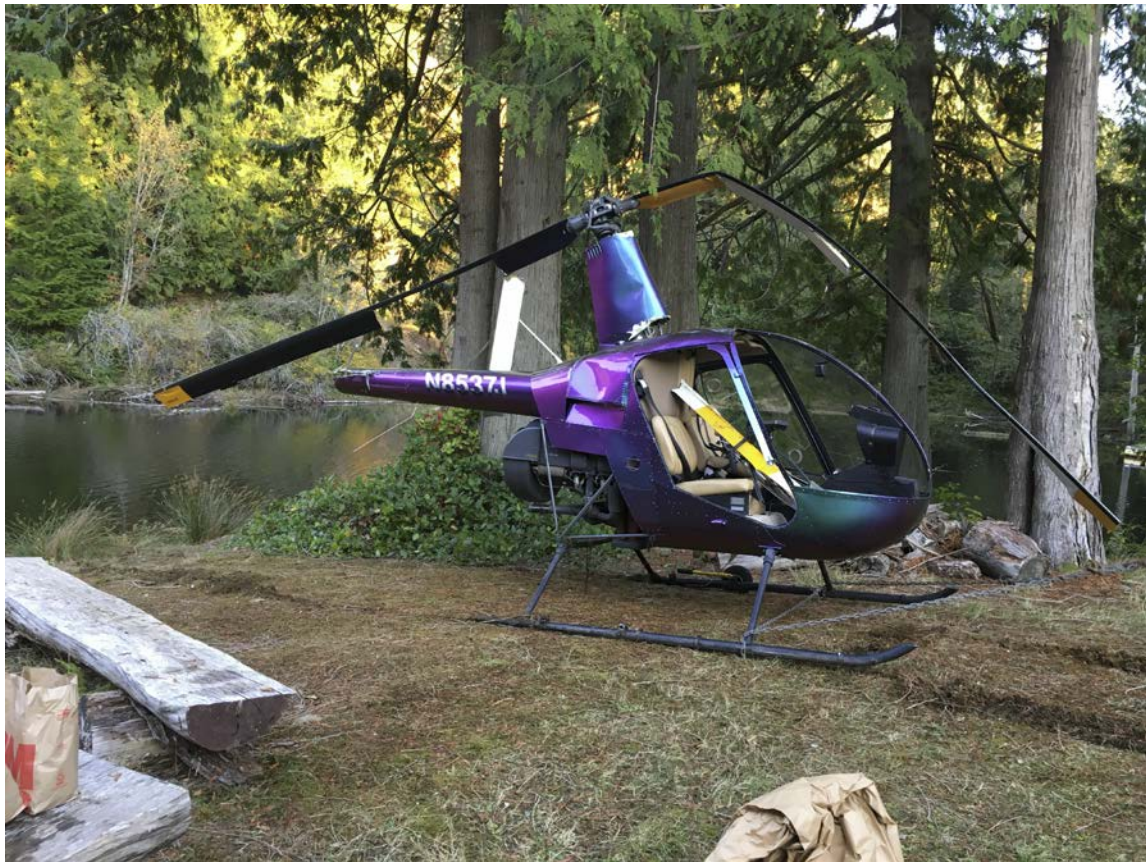
**Figure 1 - picture of helicopter post-recovery from lake**

primarily intact, with the exception of the aft tail boom and right wind screen, each of which had separated during the accident sequence.

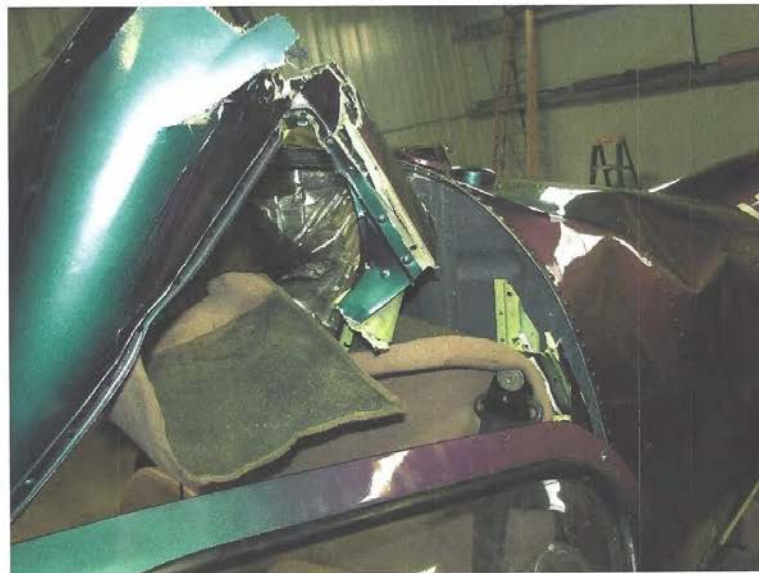
aircraft being recovered from the lake indicate that most of the damage to the cabin roof occurred during aircraft recovery. The fuel tanks were buckled in some areas, and the mast fairing was damaged. Both windshields were fractured, and the pilot door was broken and detached from the aircraft. The tailcone was separated at the aft end of the third bay, and at the forward end of the fifth bay. The fourth bay was not present for the examination. There was scoring, some which penetrated the tailcone skin from the inside, visible in several areas of the tailcone. There was a tear in the tailcone skin on the right side, on the third and fifth bays. The empennage was intact, but there was damage on the upper vertical stabilizer. The tail rotor visual guard and tail skid did not appear to be damaged.

Damage to the cabin roof

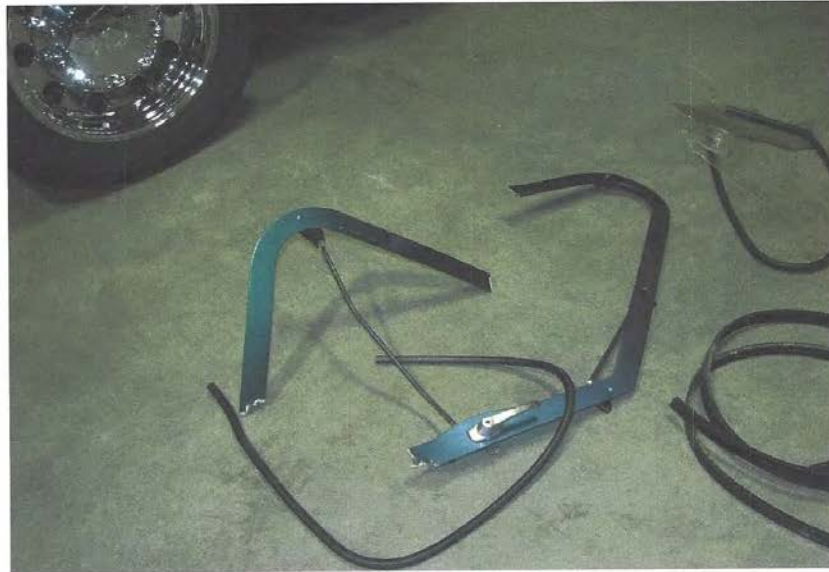
Pilot's side door

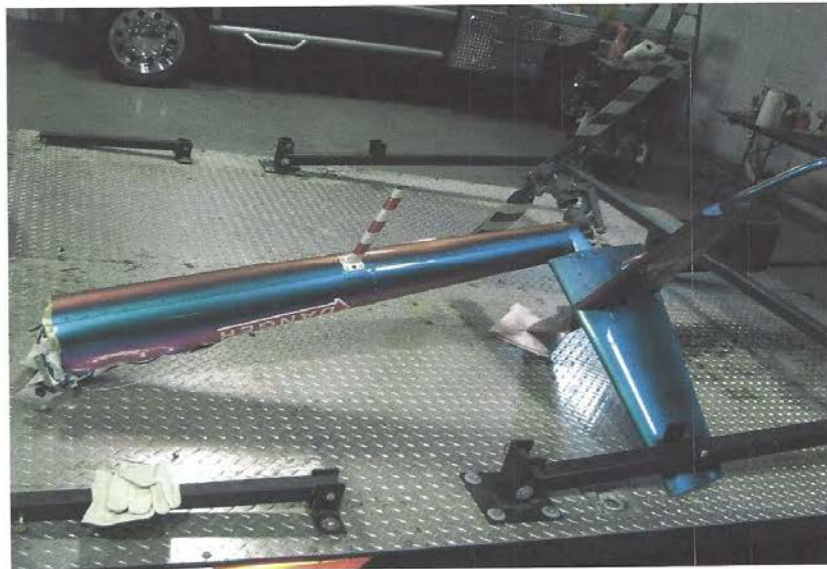
Tailcone and empennage

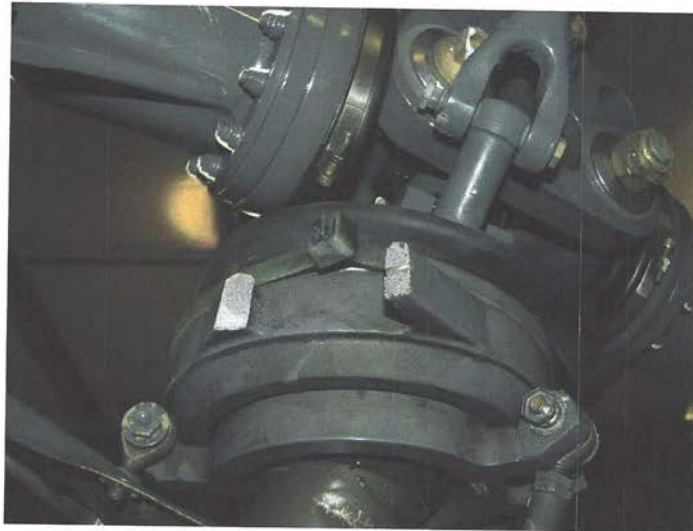
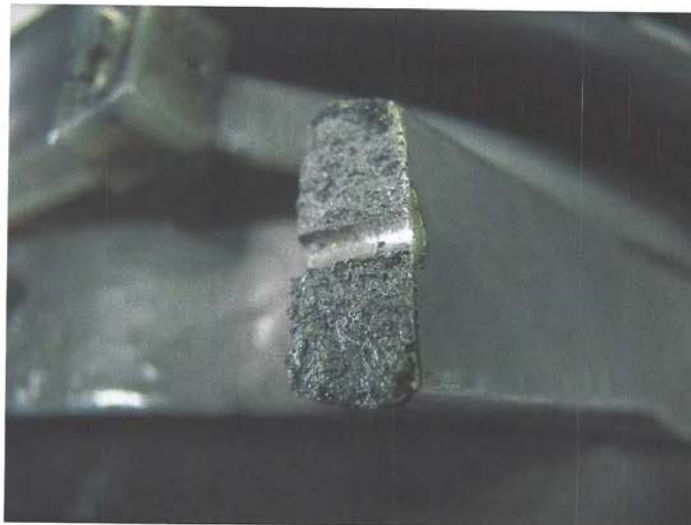
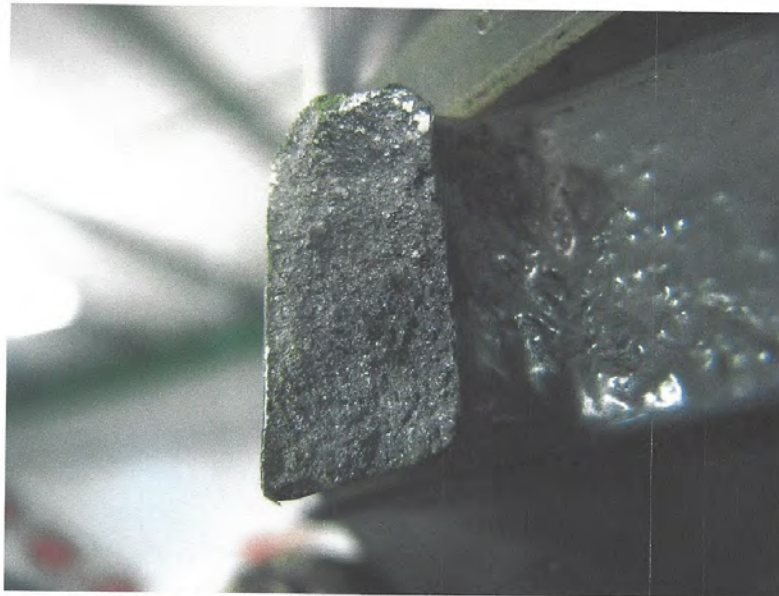
**Figure 9 - Photo of fracture surface of Disconnect C at swashplate arm**

The upper swashplate arm that the drive scissor assembly attached to was fractured and was not present for the examination. (Disconnects C and D). Photos of the mating fracture surface were sent to the NTSB laboratory for examination. The lab concluded that the fractures were overstress, or impact related.

Disconnect C at the swashplate arm

Fracture surface of Disconnect C at the swashplate arm

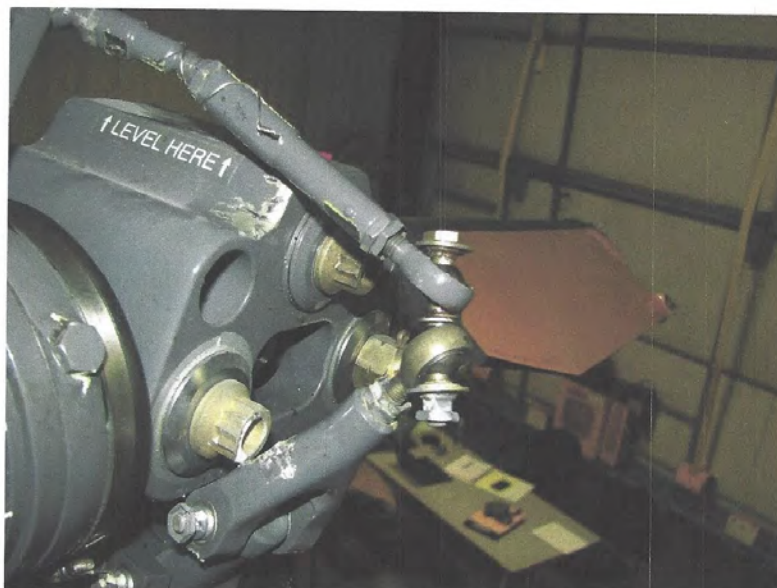
Disconnect D at the swashplate drive scissor and lower pitch control rod bolt

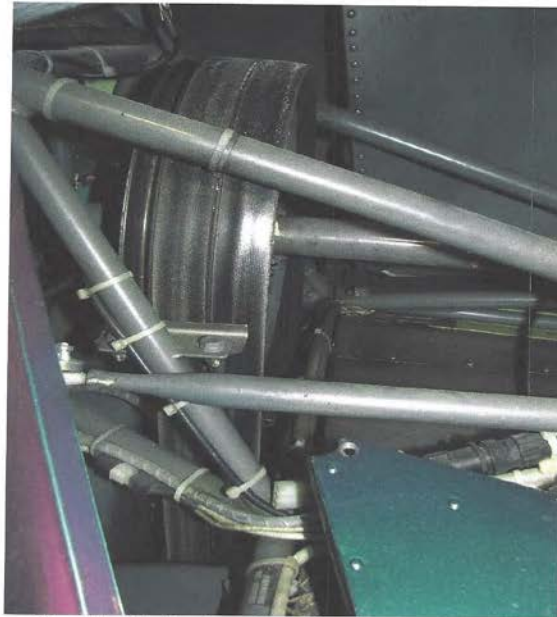
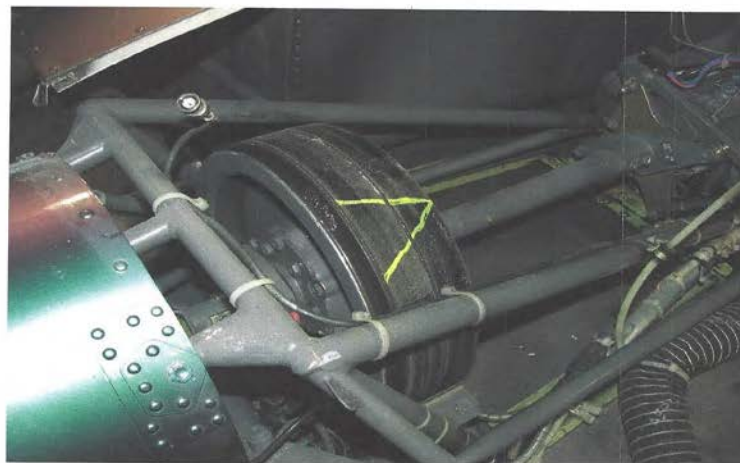
**Figure 11 - photos of drive belts**

The drive belts were intact and showed no signs of rolling and were in place on the lower sheave grooves. The belts were displaced forward at the upper sheave, one strand of the forward belt was off the sheave on the forward side. The belt tension actuator was intact, and the distance between the anti-rotation scissors was approximately 1.5 inches.

The drive belts, from the right side of the aircraft

The drive belts at the upper sheave

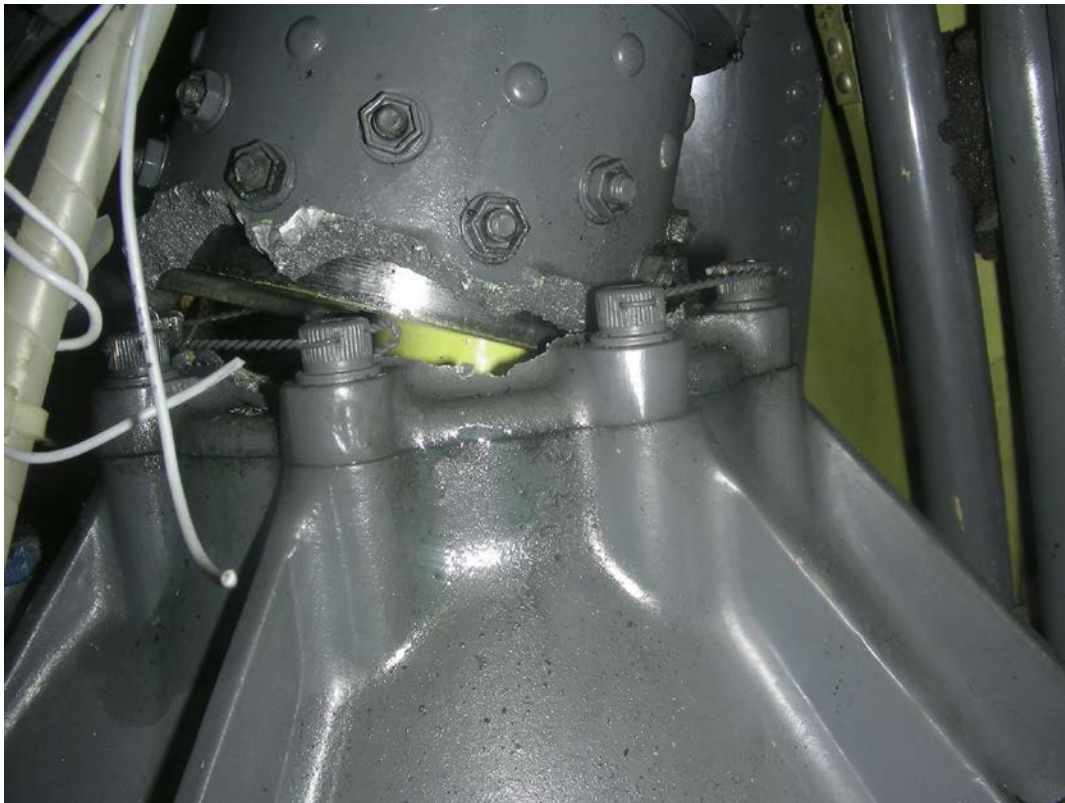
The main rotor gearbox was fractured at the base of the mast tube. Photos of the mating fracture surfaces were sent to the NTSB laboratory for examination. The lab concluded that the fractures were overstress, or impact related.

**Figure 12 - main rotor gearbox fracture**
