# NATIONAL TRANSPORTATION SAFETY BOARD

## MATERIALS LABORATORY FACTUAL REPORT

Report No. 18-100

Place : Murphy, Idaho  
Date : November 3, 2017  
Vehicle : Piper PA-18-150, N43632  
NTSB No. : WPR18FA026  
Investigator : Tealeye Cornejo, AS-WPR

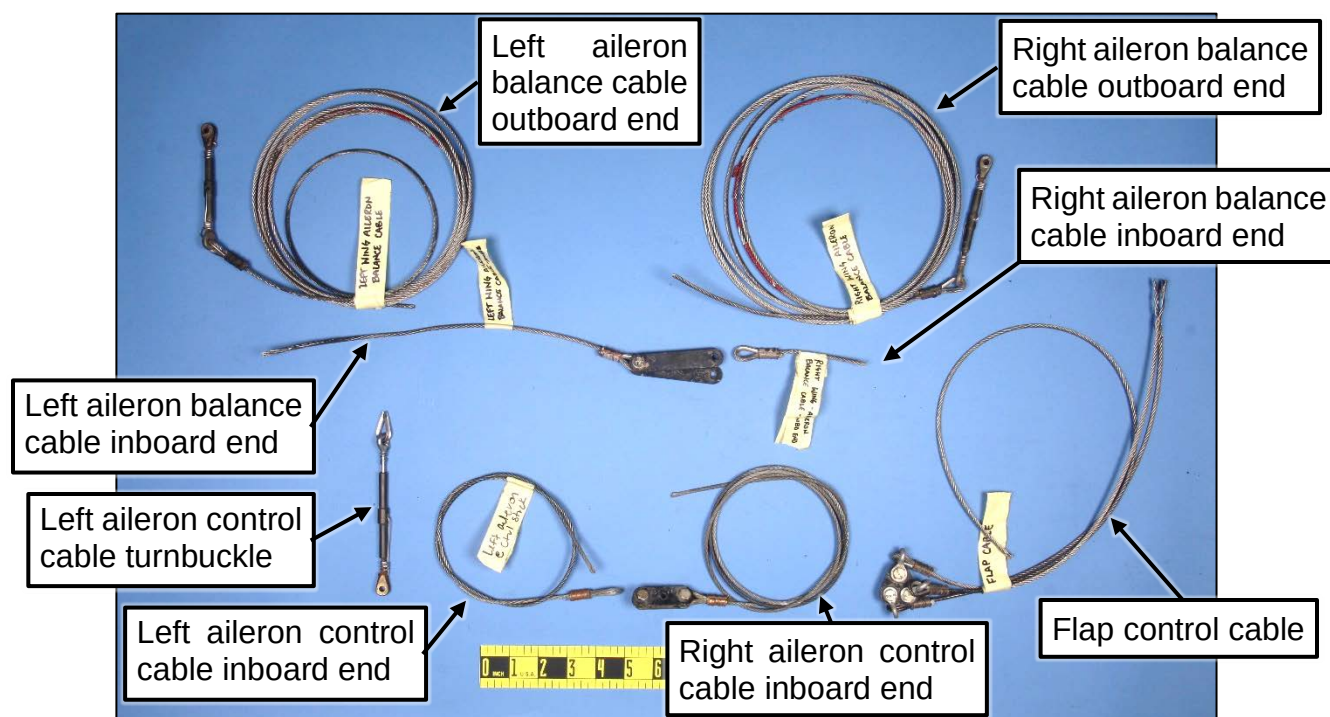
An overall view of the submitted control cables is shown in figure 1. The left aileron control cable was found separated from the turnbuckle, and the separated end was photographed on-scene. However, the outboard end of the left aileron control cable was not included in the submitted components. The ends of the cable segments shown in figure 1 had been cut to facilitate disassembly and shipping. Before taking the photograph shown in figure 1, the inboard end of the control cable was disassembled from the bolted connection and cleaned, and the lock wire on the left aileron balance cable turnbuckle was cut to facilitate documentation of part numbers.

Figure 1. Overall view of the submitted control cable assemblies.

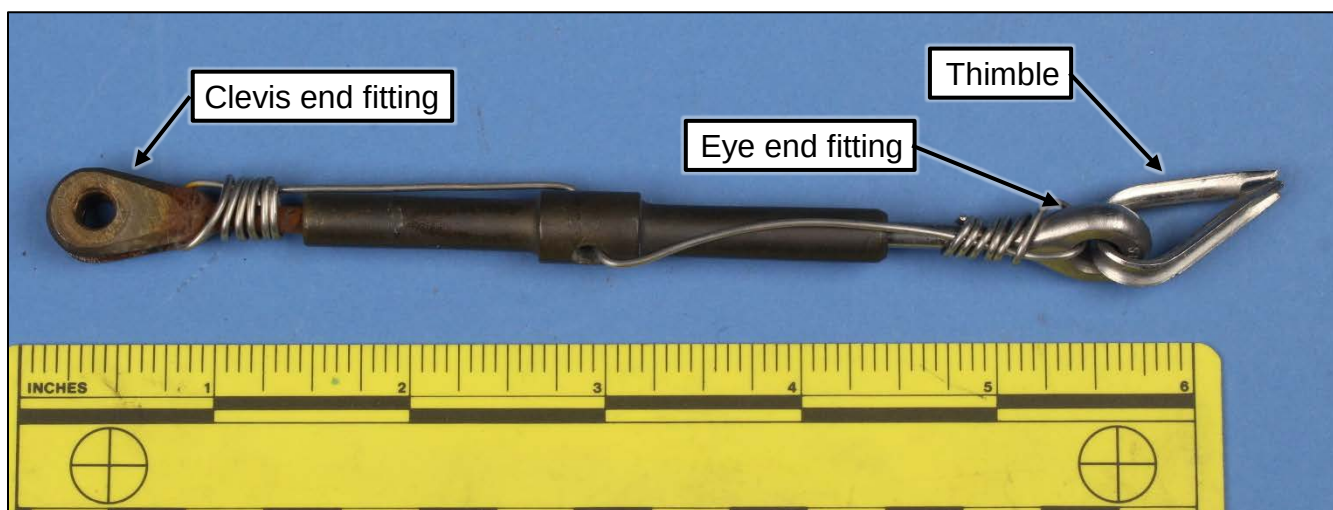
A closer view of the left aileron control cable turnbuckle is shown in figure 2. The turnbuckle had been recovered intact as shown in figure 2 with the clevis end bolted to

the aileron control horn and with the control cable separated from the eye end fitting. The lock wire for the turnbuckle was intact. The thimble associated with the eye at the outboard end of the left aileron control cable remained within the eye.

Figure 2. Closer view of the left aileron control cable turnbuckle. The control cable was separated from the eye end of the turnbuckle, but the thimble remained.

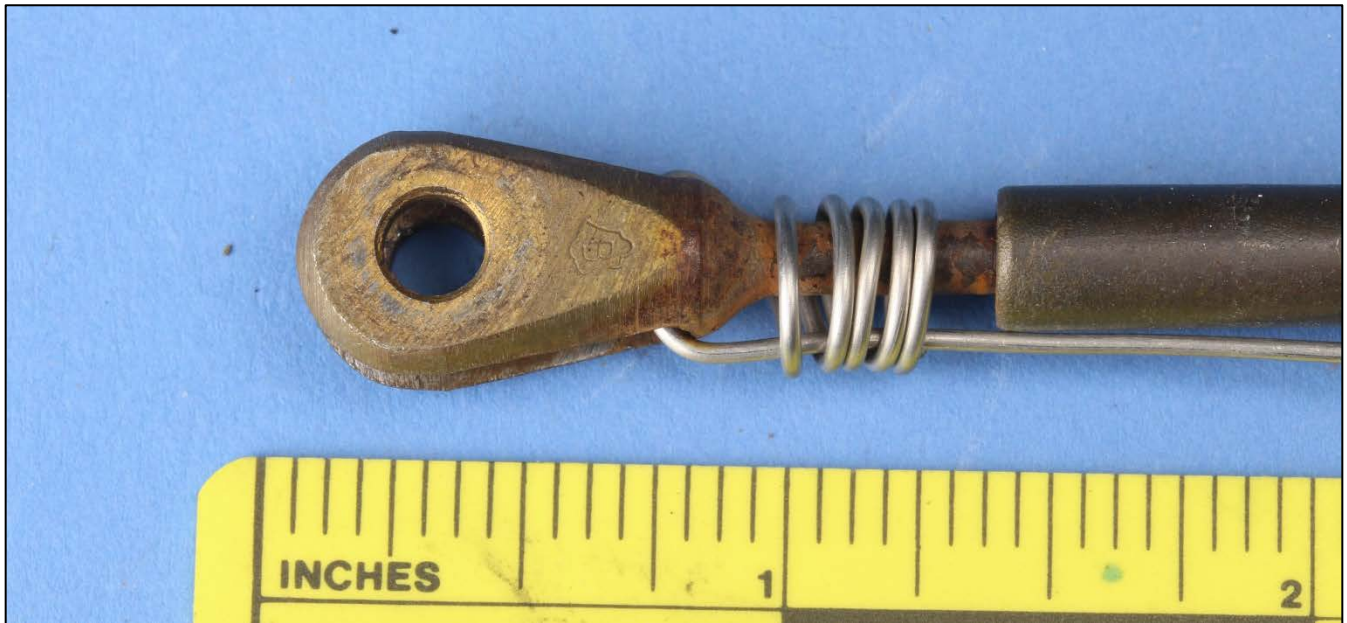
Closer views of the end fittings for the left aileron control cable turnbuckle are shown in figures 3 and 4. The clevis end fitting shown in figure 3 was colored brownish to reddish orange consistent with general oxidation. One face of the clevis was stamped with a "B" inside a bell shape, and the opposite face was stamped "SL-260 16RS". The eye end fitting shown in figure 4 was light gray and appeared free of oxidation or pitting. The flat face of the eye was also stamped with a "B" inside a bell shape, and the same face was also stamped "NAS647". The opposite side of the eye was stamped "16LS".

Figure 3. Closer view of the clevis end fitting on the left aileron control cable turnbuckle.

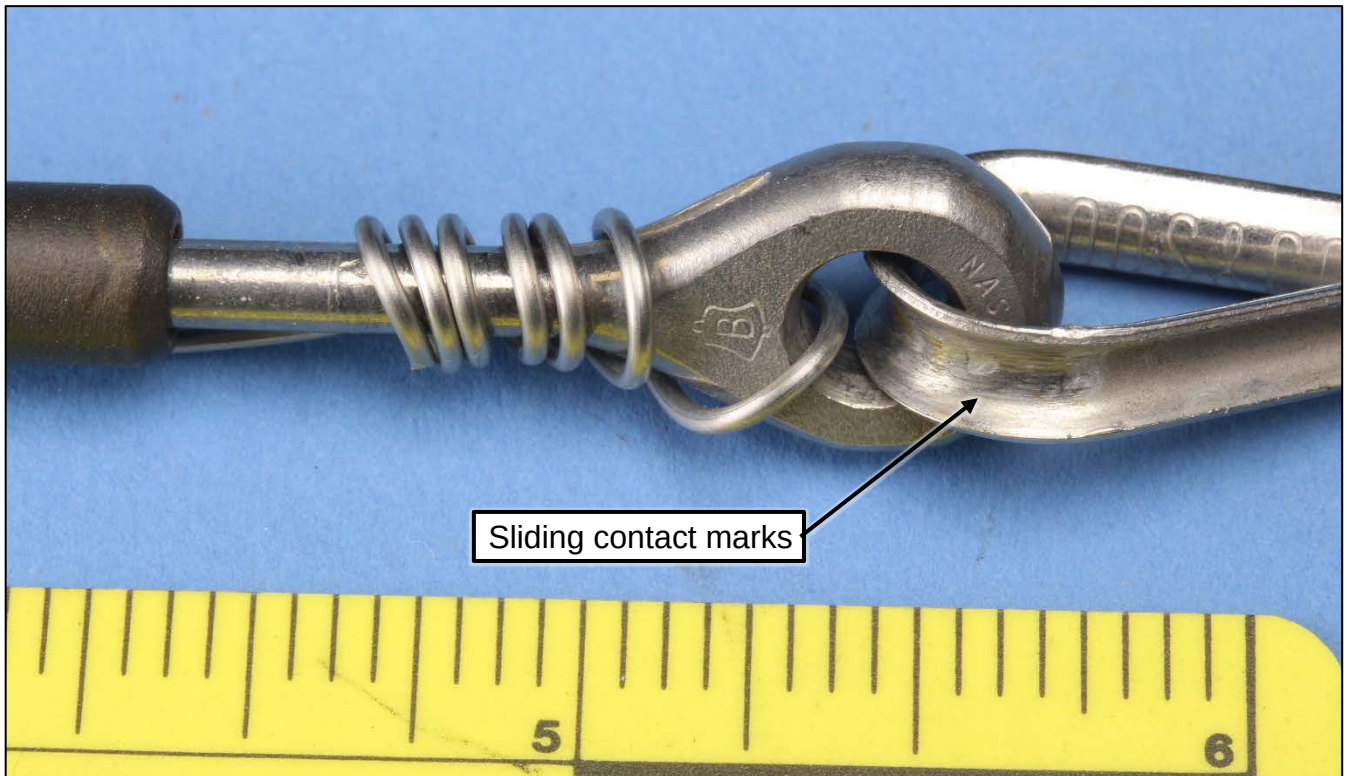
Multiple parallel grooves consistent with sliding contact with the left aileron control cable were observed on the external surface of the thimble on the left aileron control cable turnbuckle as indicated in figure 4. The thimble had a reflective light gray appearance and was relatively free of deposits and oxidation compared to cable eyes at the outboard ends of the left and right wing balance cables (see figure 5). The interior surface of the left aileron control cable thimble at the outboard location was marked "LOOS & CO", which is partially visible in figure 4.

Figure 4. Closer view of the eye end fitting and thimble on the left aileron control cable turnbuckle.

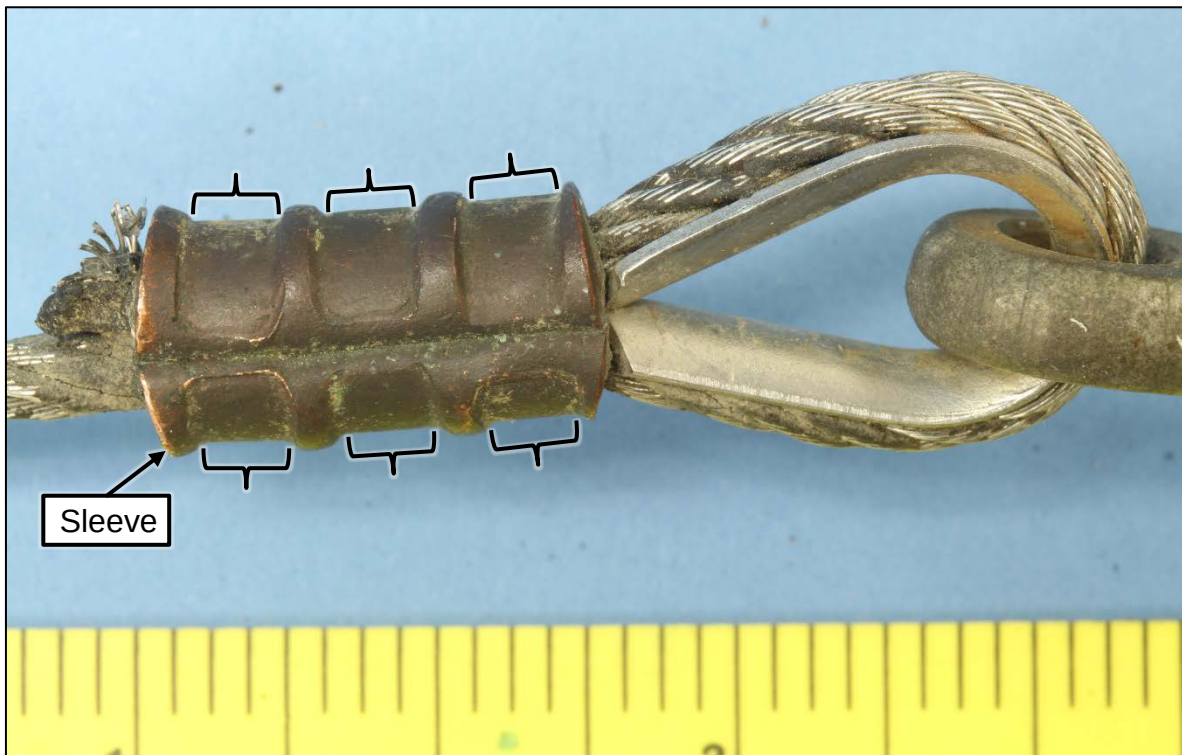
Regular crimp patterns with 3 crimps similar to the end shown in figure 5 were observed on each end of the left and right wing balance cables and on the flap cable ends. The sleeves with a regular crimp pattern fit in the Oval M slot of the Nicopress go/no go gauge.

Figure 5. Close view of the cable eye at the outboard end of the left aileron balance cable. Brackets indicated crimp locations.

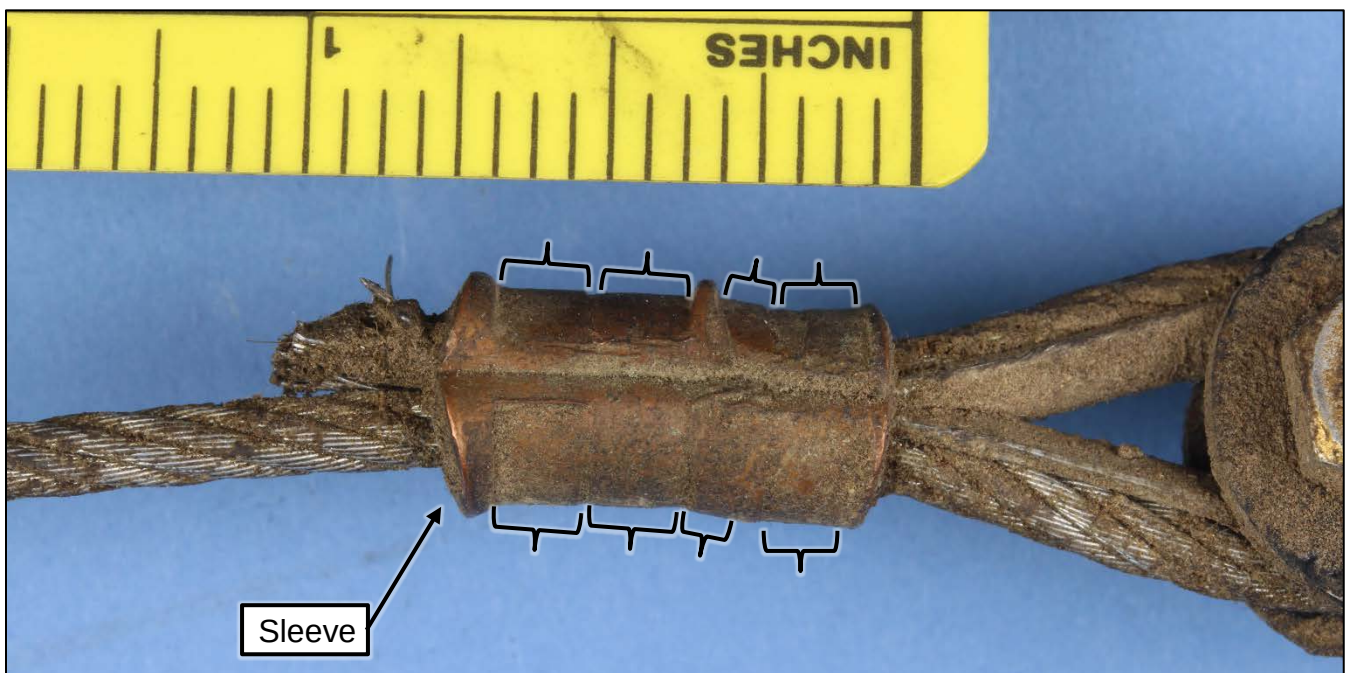
A close view of the inboard end of the left aileron control cable is shown as-received in figure 6. The eye was bolted to the linkage plates, and the components were covered in tan and brown deposits. The sleeve had an irregular crimp pattern as shown in figure 5. Brackets in figure 5 indicate 4 approximately parallel faces at either side of the crimp split line. By comparison, the sleeve for the balance cable at the outboard location had 3 relatively evenly spaced and uniform crimp locations as indicated with unlabeled brackets in figure 5. Partially obscured stamped letters consistent with "NICOPRESS" were observed on the crimped face of the left aileron balance cable outboard end sleeve.

According to Instruction 32 from the National Telephone Supply Company,<sup>1</sup> Nicopress sleeves for 1/8-inch diameter cable require 1, 2, or 3 crimps, depending on the combination of sleeve part number and crimping tool. Properly crimped sleeves should fit within a go/no go gauge. However, Instruction 32 recommends that proof testing should be completed whenever the possibility of personal injury or property damage exists. According to Instruction 32, all Nicopress sleeves with 3 crimps installed on 1/8-inch diameter cable should fit within the Oval M slot in a Nicopress go/no go gauge. Each of the crimp locations associated with the sleeve on the inboard end of the left aileron control cable was able to slide into the Oval M slot in a Nicopress go/no go gauge.

Figure 6. Close view of the sleeve at the inboard end of the left aileron control cable. Brackets indicate likely crimp locations.

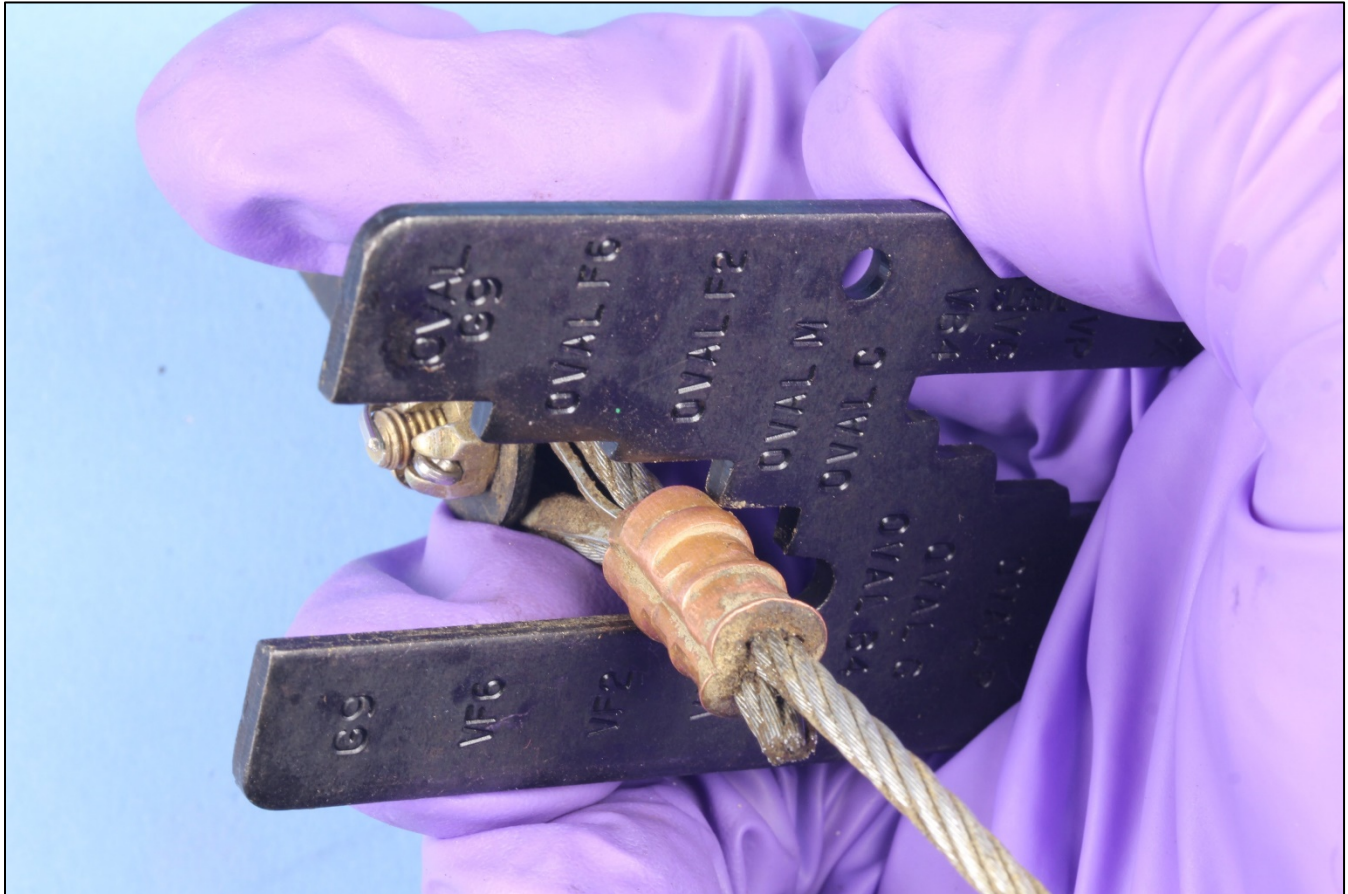
The inboard end of the right aileron control cable also had an irregular crimp pattern with at least 3 crimp locations. A view of the sleeve as it was tested with the Nicopress go/no go gauge is shown in figure 7. The outboard and middle crimp locations fit within the Oval M slot, but the crimp location at the inboard end of the sleeve did not fit in the slot.

Figure 7. Sleeve at the inboard end of the right aileron control cable with a Nicopress go/no go gauge applied against the inboard crimp.
