## **NATIONAL TRANSPORTATION SAFETY BOARD**

# **AIRFRAME AND ENGINE EXAMINATION**

**WPR18FA026**

Location: Murphy, Idaho  
Date: November 3, 2017  
Aircraft: Airplane Piper PA-18-150, Registration Number: N4393z, Serial #: 18-8682  
NTSB IIC: Tealeye Cornejo

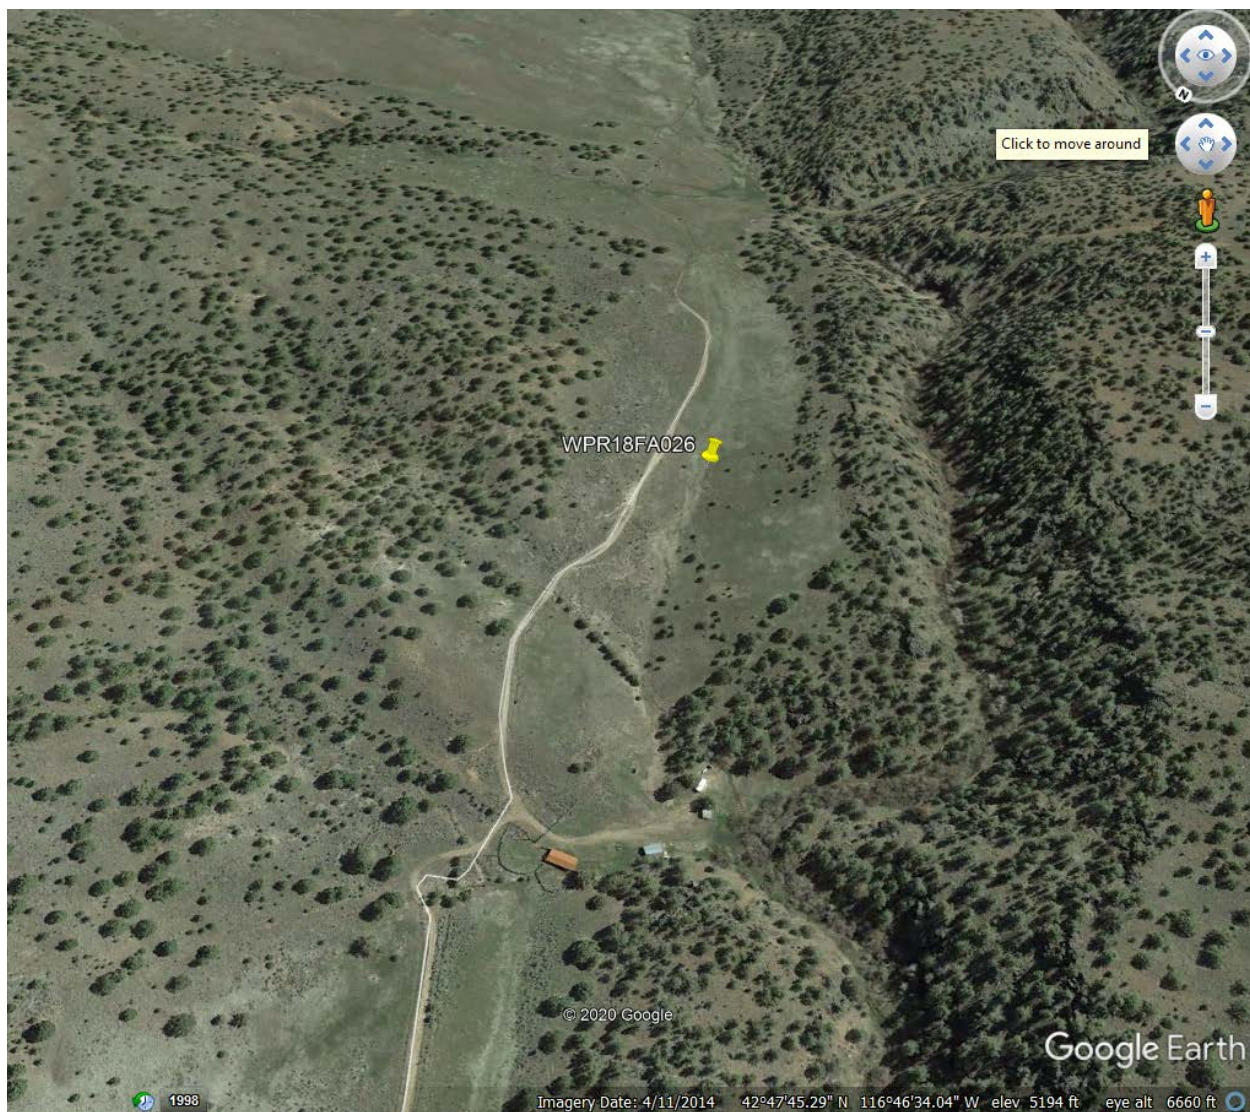
Mountainous terrain surrounded the accident site, with a private dirt airstrip on the valley floor. The airstrip was estimated to be 750 ft by 100 ft at an elevation of 5,194 ft. above ground level. Trees were adjacent to the dirt strip on the west side and varied in height from 75-100 ft. The airplane came to rest inverted about 1,750 ft from the south end of the airstrip.

Photo 01 – Overview of accident site (Google Earth)

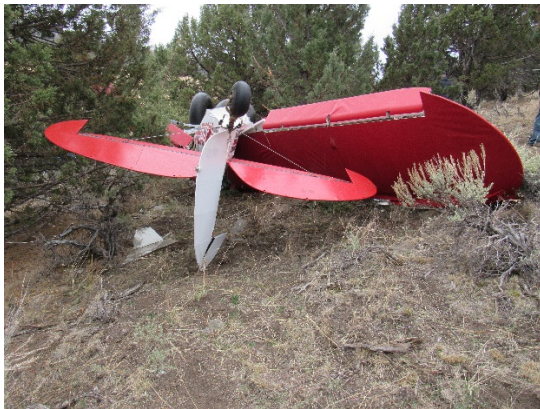
The airplane came to rest inverted. The airplane wings remained attached to the airframe, and the engine remained attached to the engine mounts at the firewall.

Both wings had leading edge crush damage aft to the spar. Both wings remained attached to the fuselage. Flight control separation overloaded at the swage on the left aileron. Left aileron balance cable pulled through swage

Photo 02 – Main Wreckage (Coroner)

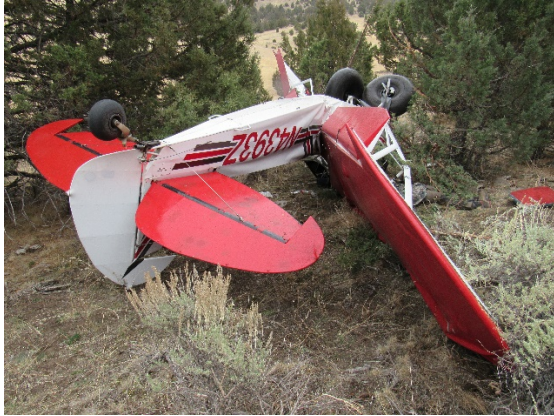
Photo 03 – Main Wreckage (Coroner)

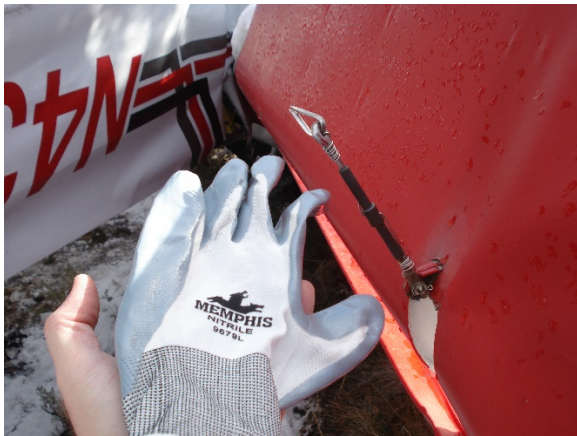
The left-wing aileron cable

Photo 04 – Left Aileron Control Cable (Piper)

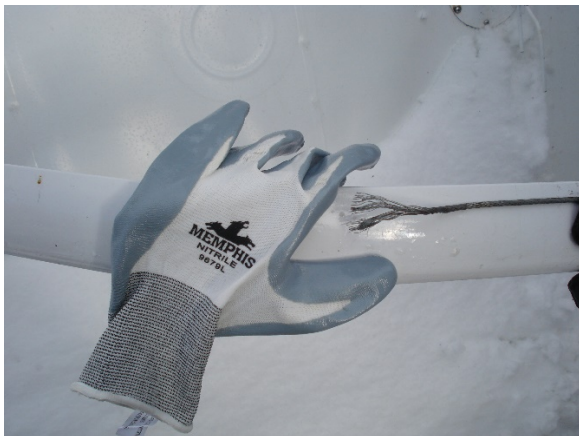
Photo 05- Left Aileron Control Cable (Piper)
