## **NATIONAL TRANSPORTATION SAFETY BOARD**

### **SITE and ON-SCENE INFORMATION**

**NTSB Accident: WPR18FA035  
Accident Date: November 19, 2017**

Location: Tehachapi, California  
Date: November 19, 2017  
Aircraft: Cessna 152, N24987, Serial # 15280496  
NTSB IIC: Michael Huhn

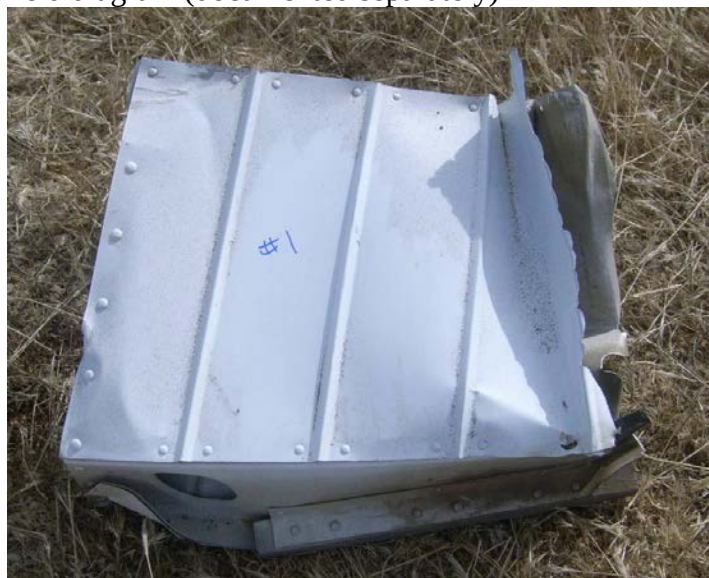
**Figure 1 - Outboard Fragment of Right Aileron**

- Examination of the flap actuator indicated that the flaps were in the retracted position at impact
- Ailerons
  - Both ailerons remained attached to their respective wings. The left aileron was relatively undamaged, while the right one was missing about a 1-foot spanwise section at the outboard end. That section was the first identifiable item in the debris field

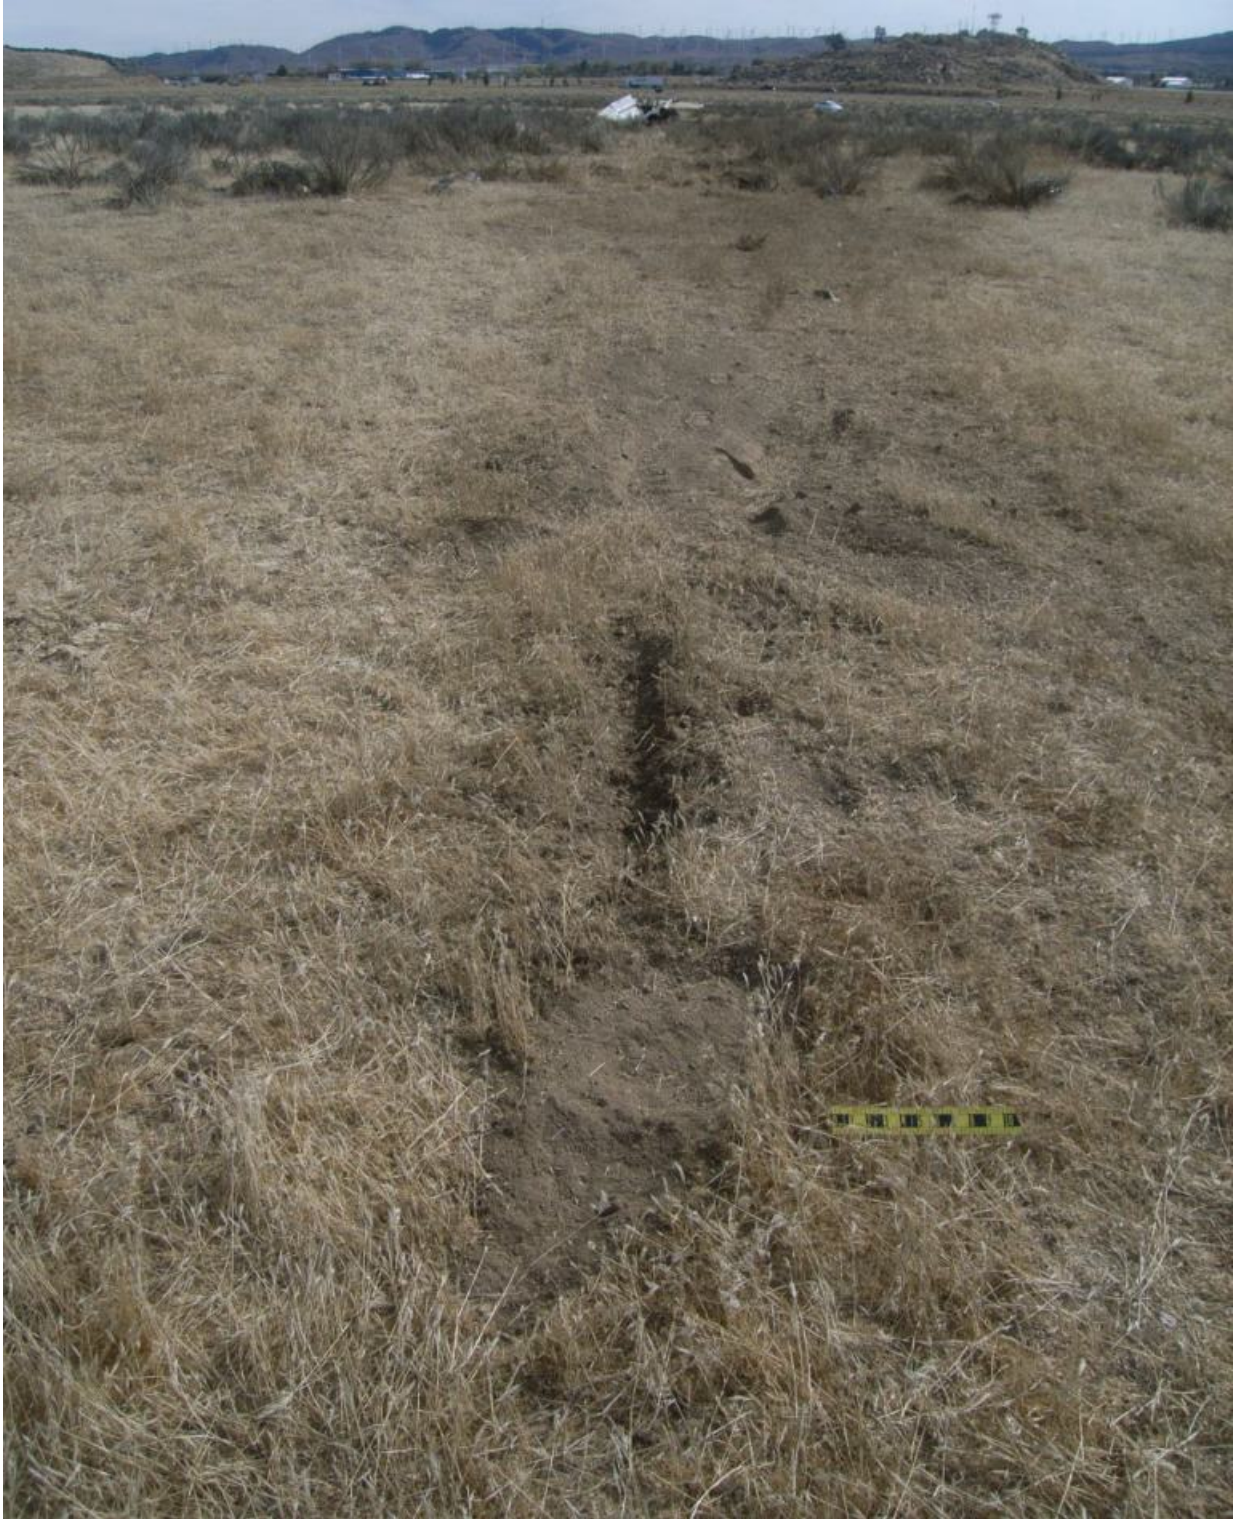
**Figure 3 - Gouge Near Initial Impact Point**

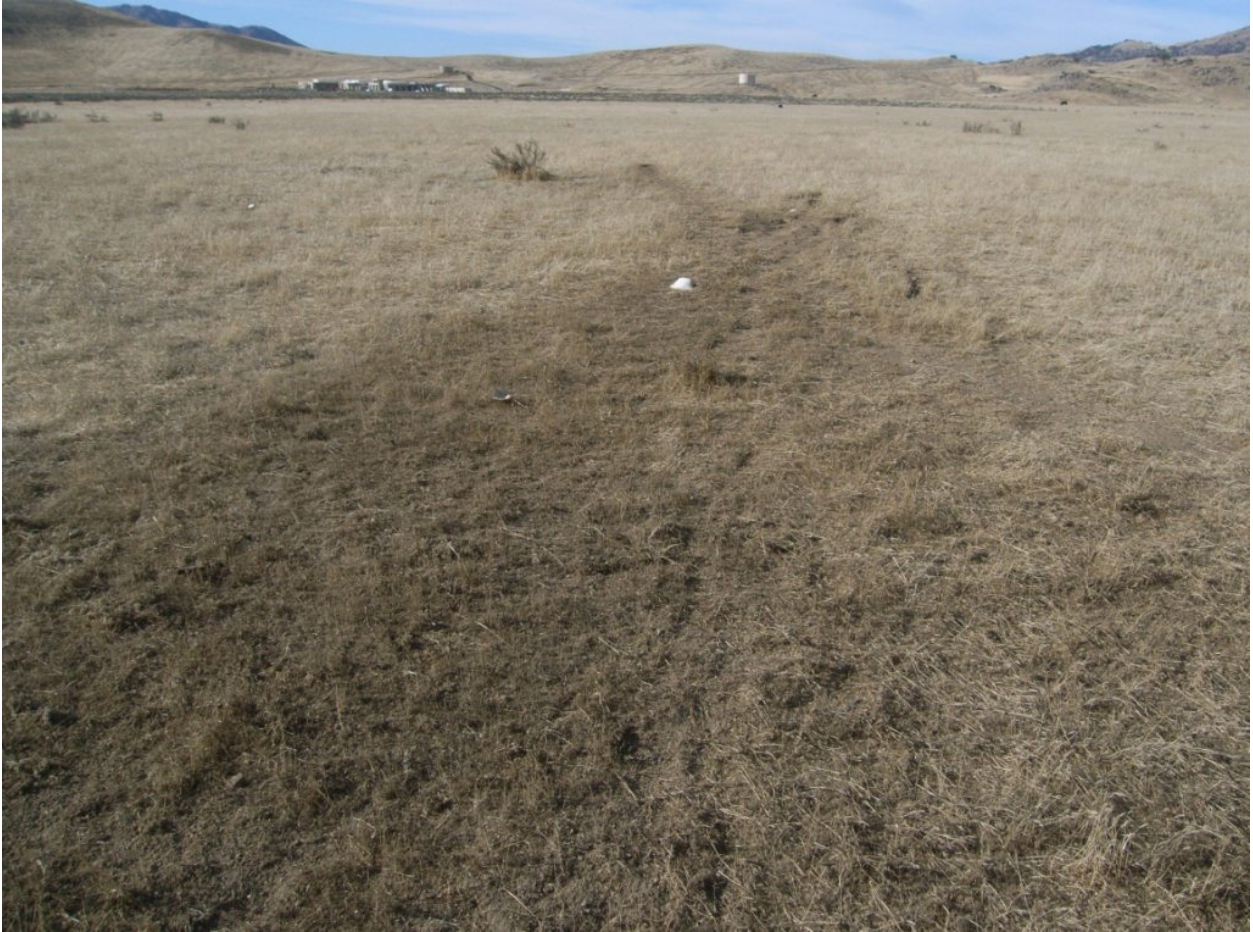
- Ground scars were consistent with the airplane striking the ground in a nose and right wing low attitude
- The right wingtip strike was beginning of the ground scars
  - The earliest identifiable piece of wreckage was an outboard fragment of the right aileron
- A ground scar consistent with the RMLG was located about 20 feet beyond the right wingtip strike
- The nose impact (NLG and/or propeller) was situated about 10 feet beyond the RMLG strike
- The ground scars and airplane damage were consistent with the wreckage tumbling and sliding
- About 26 key components in the debris field were mapped to enable development of a wreckage/debris field diagram (documented separately)

**Figure 4 - Initial Ground Scars (reverse view)**

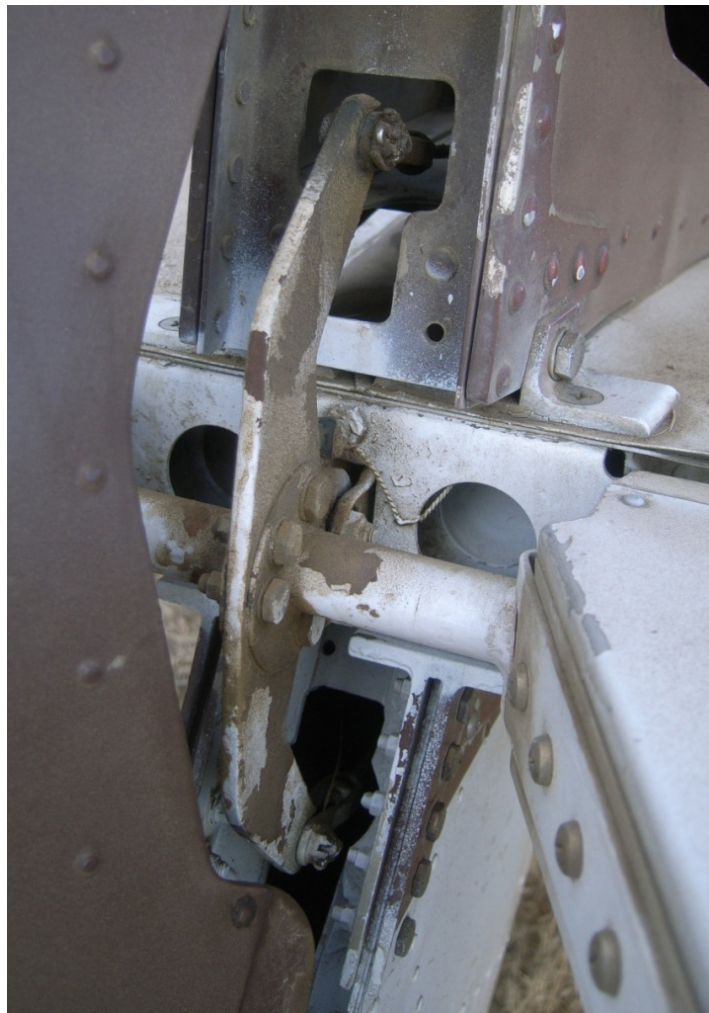
- All wing and empennage control surfaces retained their respective balance weights
- Control continuity was established from both elevators, the pitch trim tab, and the rudder to the fuselage break in the cockpit
- Control continuity was established from both ailerons to the fuselage break in the cockpit
- Aileron Cables
  - All aileron cables were still attached to their respective aileron bellcranks in the wings, and were continuous to the door post and cockpit area
- Flap Cables
  - All flap cables were separated in tensile overload

**Figure 17 - Elevator Control Linkage**

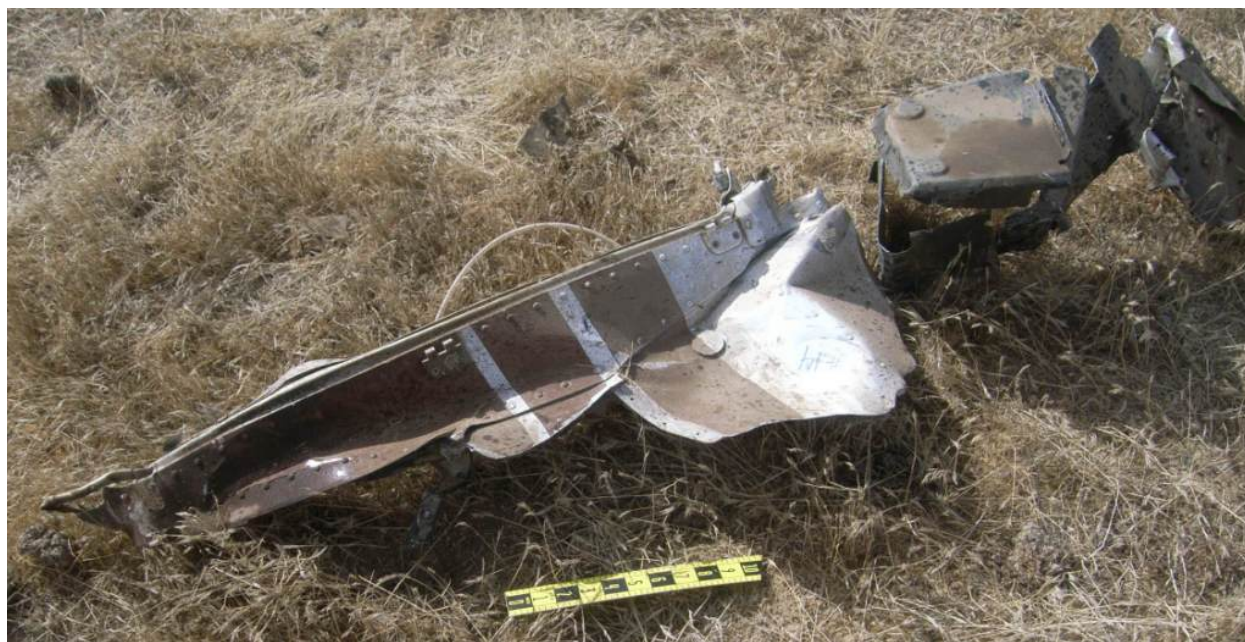
- The cockpit/cabin was torn open early, as evidenced by the structural parts and cabin interior items early in the debris field
  - These items included the windshield and window fragments, the left door post, cockpit instruments and instrument panel section, and airplane manuals

**Figure 18 – Left Doorpost/Frame**

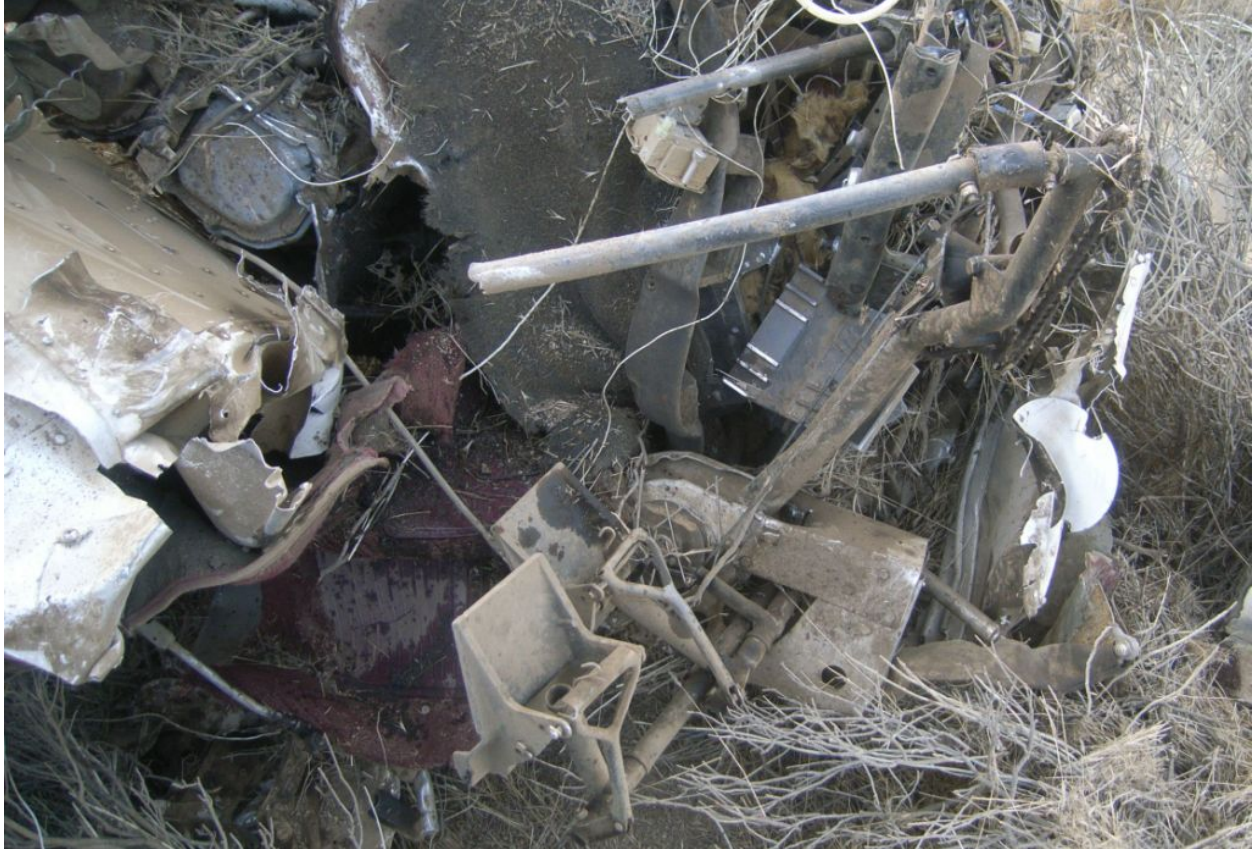
- Portions of the flight control system, including the rudder pedal assembly and the aileron/elevator rods, gears and chain remained partially attached to the aft side of the firewall

**Figure 19 - Rudder Pedal Assembly**

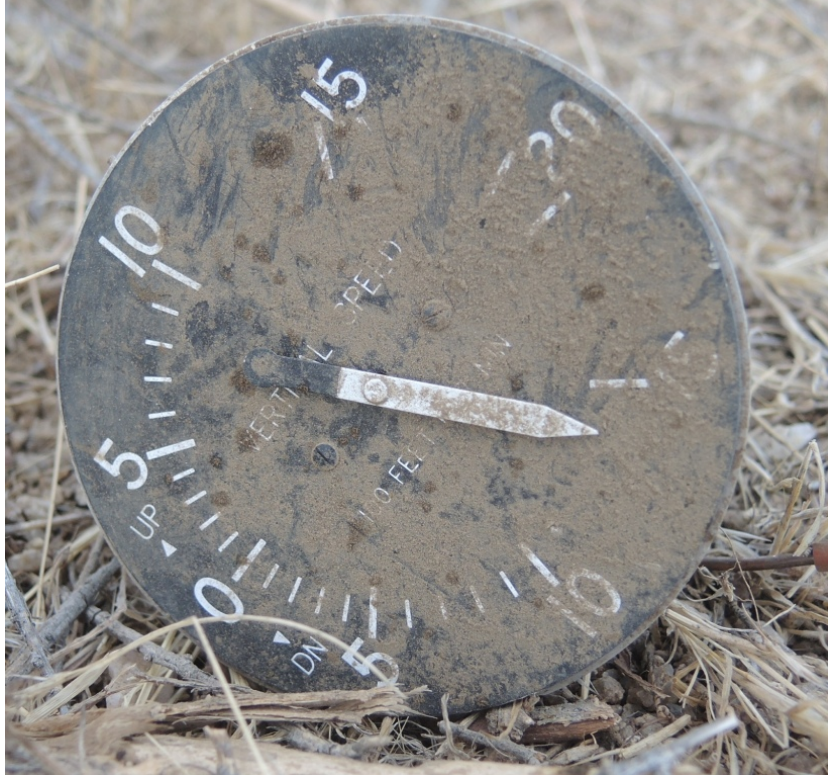
- DG: Fracture-separated from panel, indication not determined
  - VSI: Fracture-separated from panel, 1400fpm down (but needle loose/swings)
  - Tachometer: Fracture-separated from panel, needle absent, hours 1716.6

**Figure 23 - Vertical Speed Indicator**

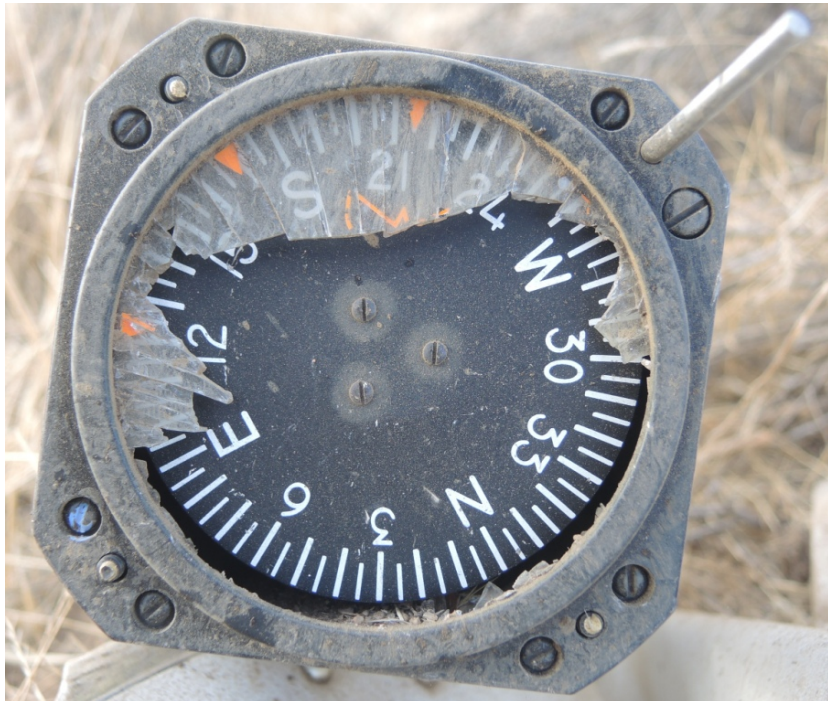
**Figure 24 - Directional Gyro**

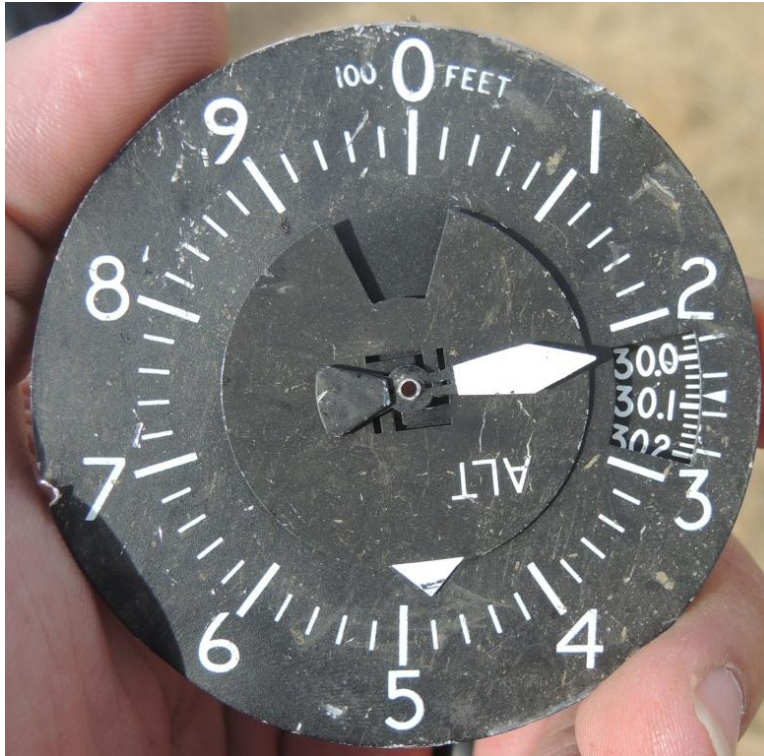
- The gyro rotor case was opened for examination
    - No internal scoring or other damage was observed
  - Altimeter: Fracture-separated from panel, indicator mechanism damaged & one hand missing, indication unreliable, Kollsman 30.08"

Figure 25 - Altimeter

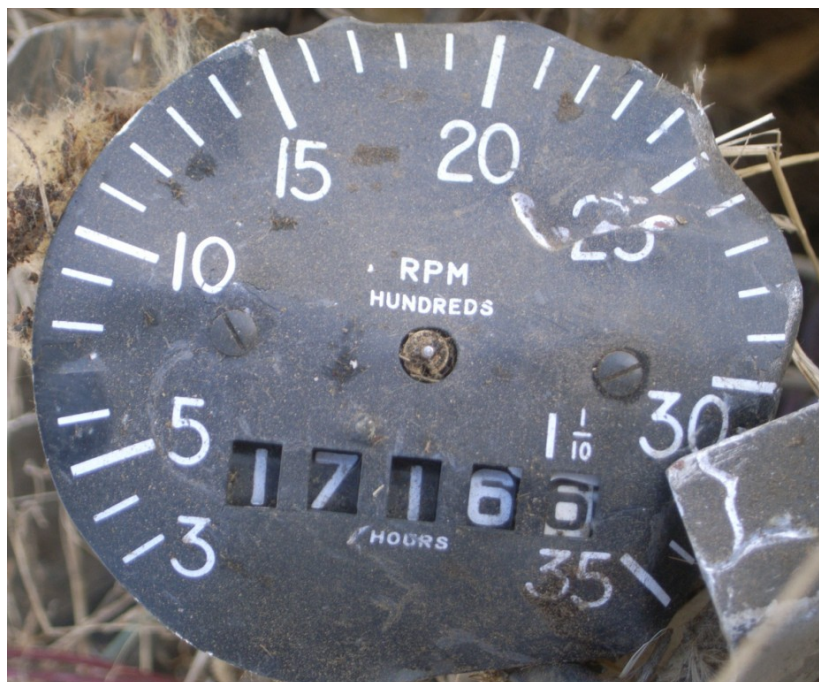
Figure 26 - Tachometer

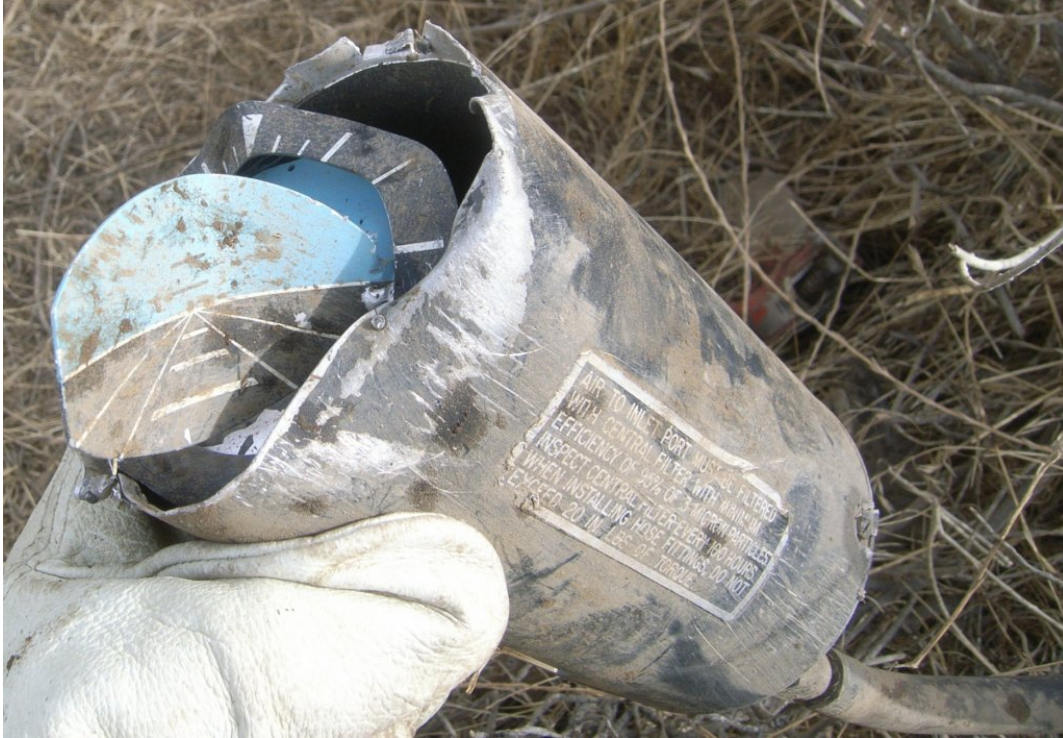
- The following instrument readings were observed
  - Airspeed: In fracture-separated panel segment, 0 kts
  - Artificial Horizon: Fracture-separated from panel, crushed, no display information

**Figure 27 - Artificial Horizon**

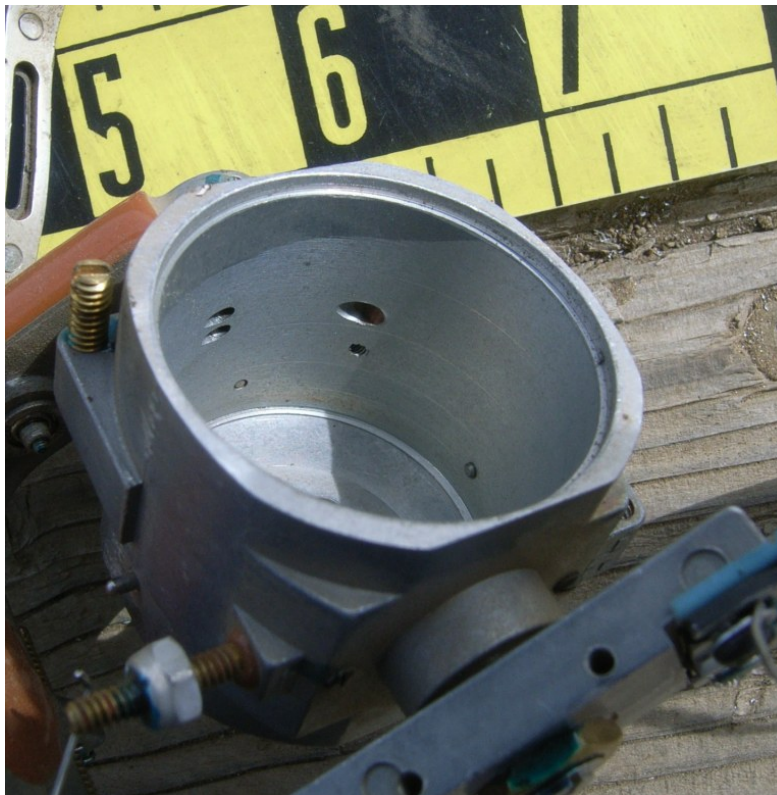
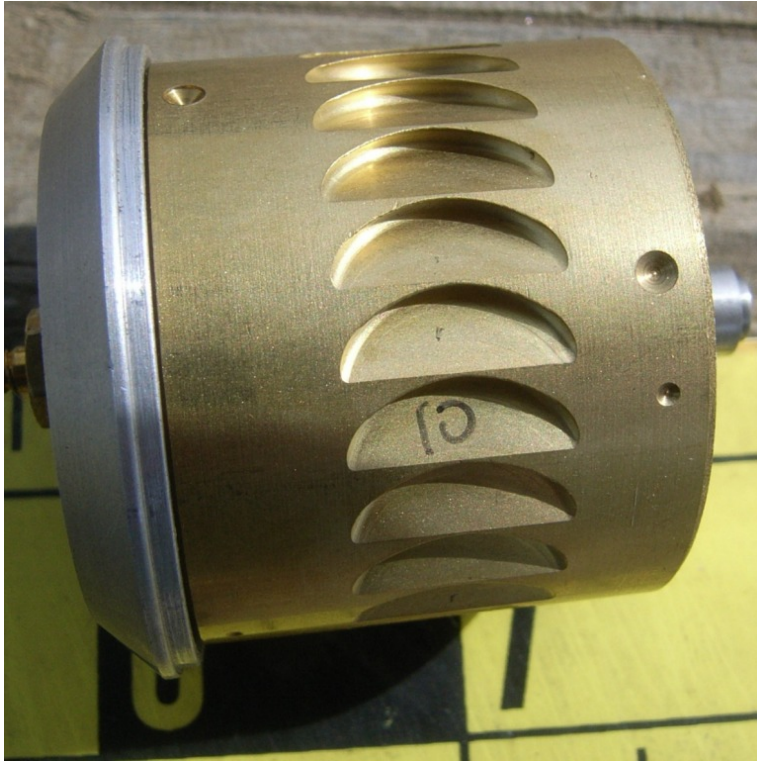
**Figure 28 - Artificial Horizon Gyro Rotor Case**

**Figure 29 - Artificial Horizon Gyro Rotor**

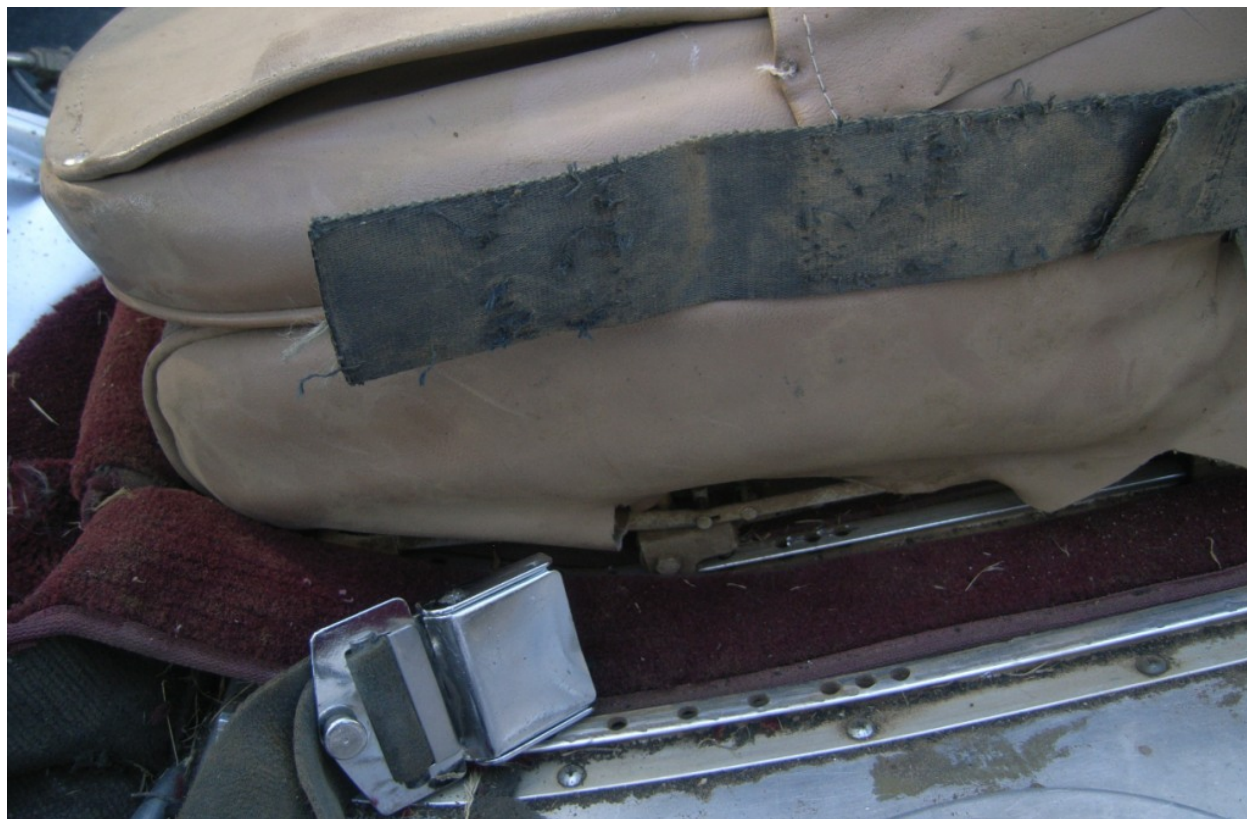
**Figure 32 - Failed Stitching on Left Lap Belt**

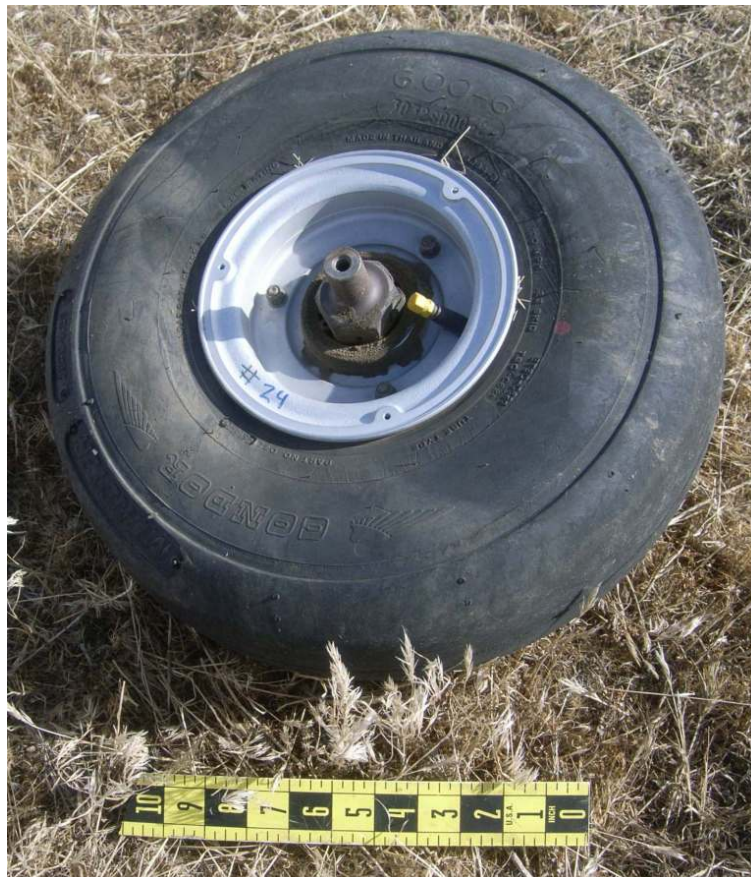
- The RMLG strut remained attached to the fuselage,
  - The wheel and tire assembly was fracture-separated from the strut
  - The wheel and tire assembly was found about 505 feet beyond the main wreckage, on a bearing of approximately 137° true

Figure 33 - RMLG Tire and Wheel

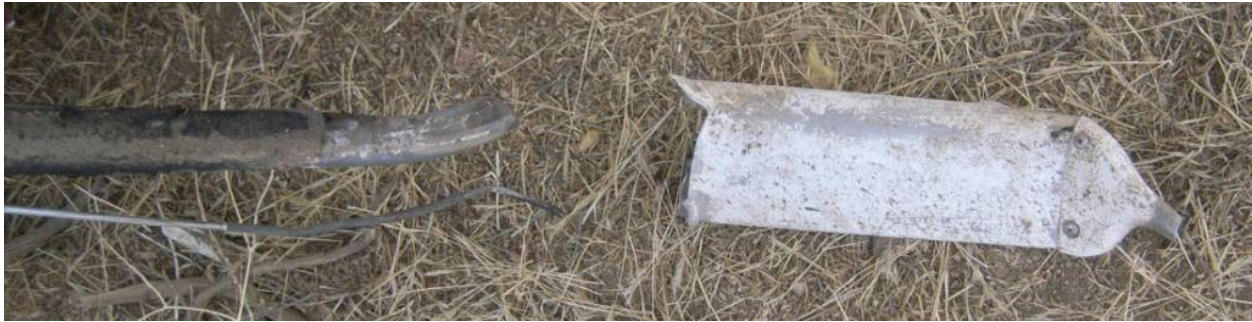
**Figure 34 - Fractured End of RMLG Strut**

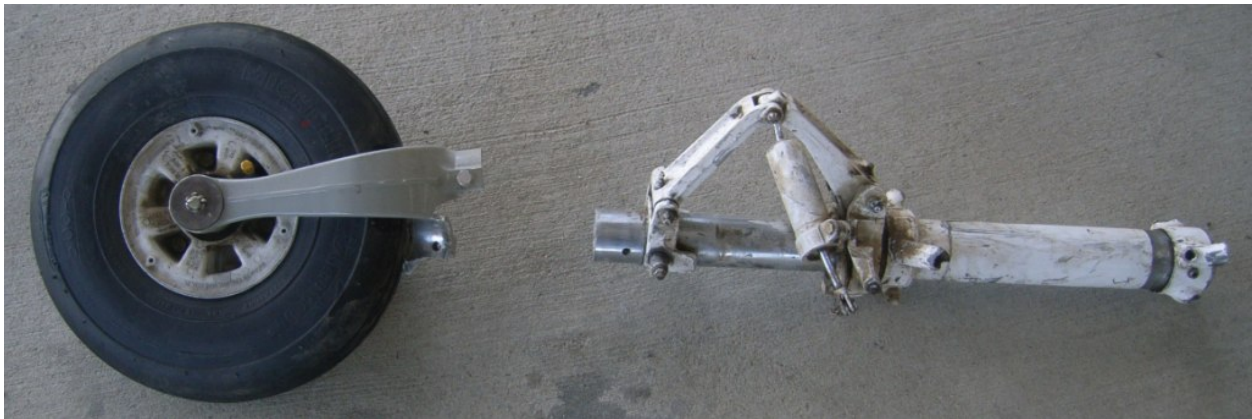
- The lower 10" of the sheet metal strut fairing was fracture-separated from the fairing
- The NLG strut assembly was fracture-separated from the fuselage structure

- The NLG strut assembly was found about 85 feet beyond the main wreckage, on a bearing of approximately 208° true
- The NLG fork and wheel/tire assembly was fracture-separated from the NLG strut

**Figure 35 - NLG Assembly**

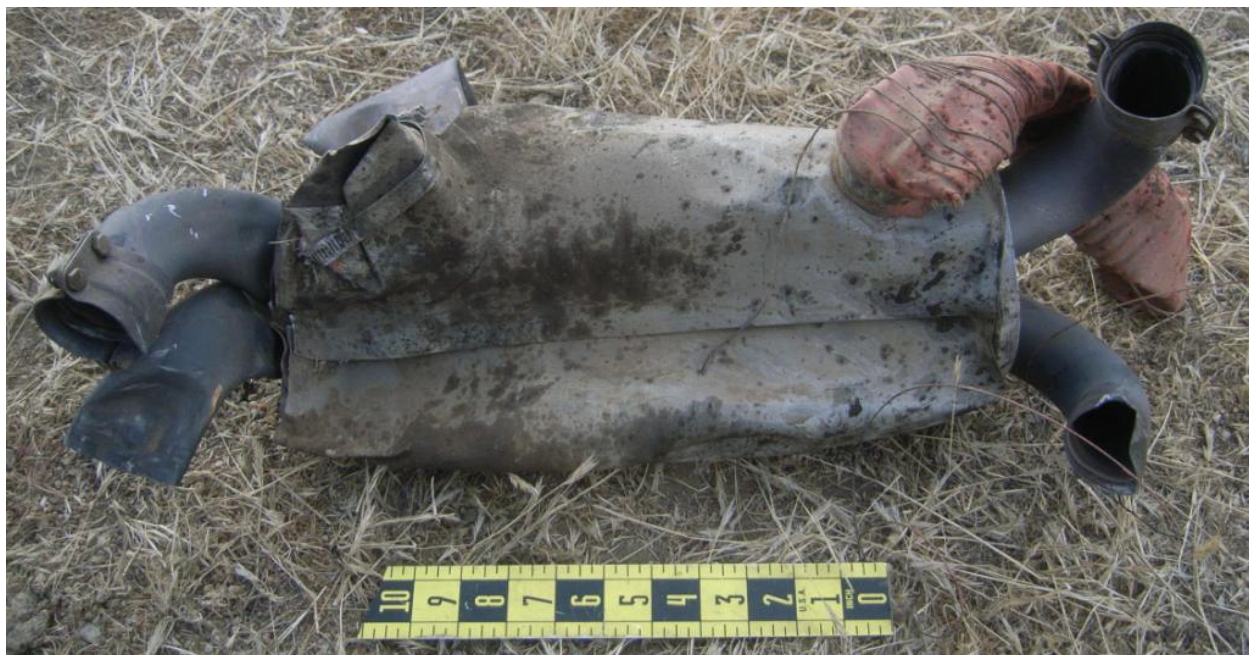
- The muffler exhibited significant crush damage, but was otherwise in good condition.
  - Visible internal components evidenced minimal/normal corrosion

- The exhaust stack inner surface was of normal appearance (grayish-tan)
  - Vigorous shaking of the muffler did not result in any rattling indicative of loose internal parts

**Figure 39 - Muffler**

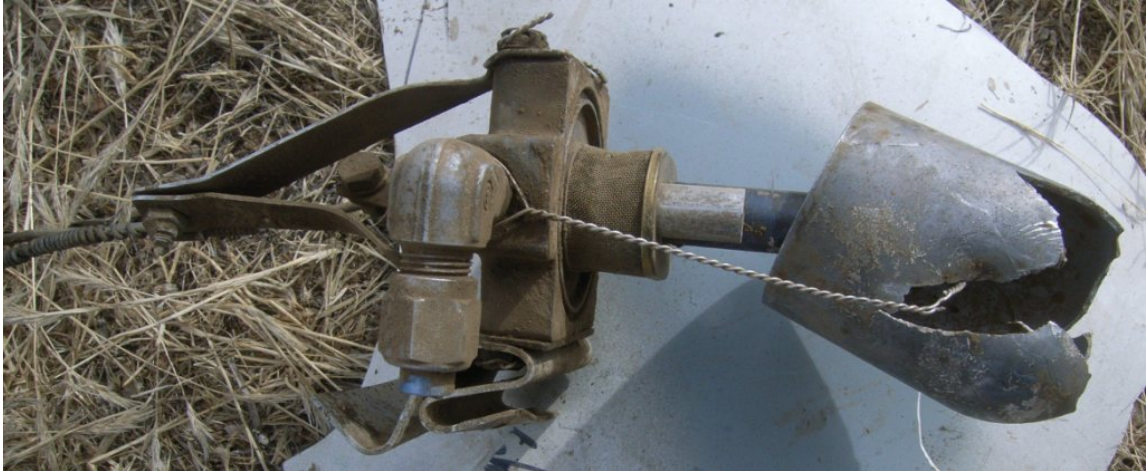
- The fuel strainer (gascolator) was fracture-separated from the firewall
  - The metal bowl was fractured and empty
  - The filter/screen remained attached, and appeared clean except for impact site dirt/dust

**Figure 40 - Fuel Strainer Assembly**

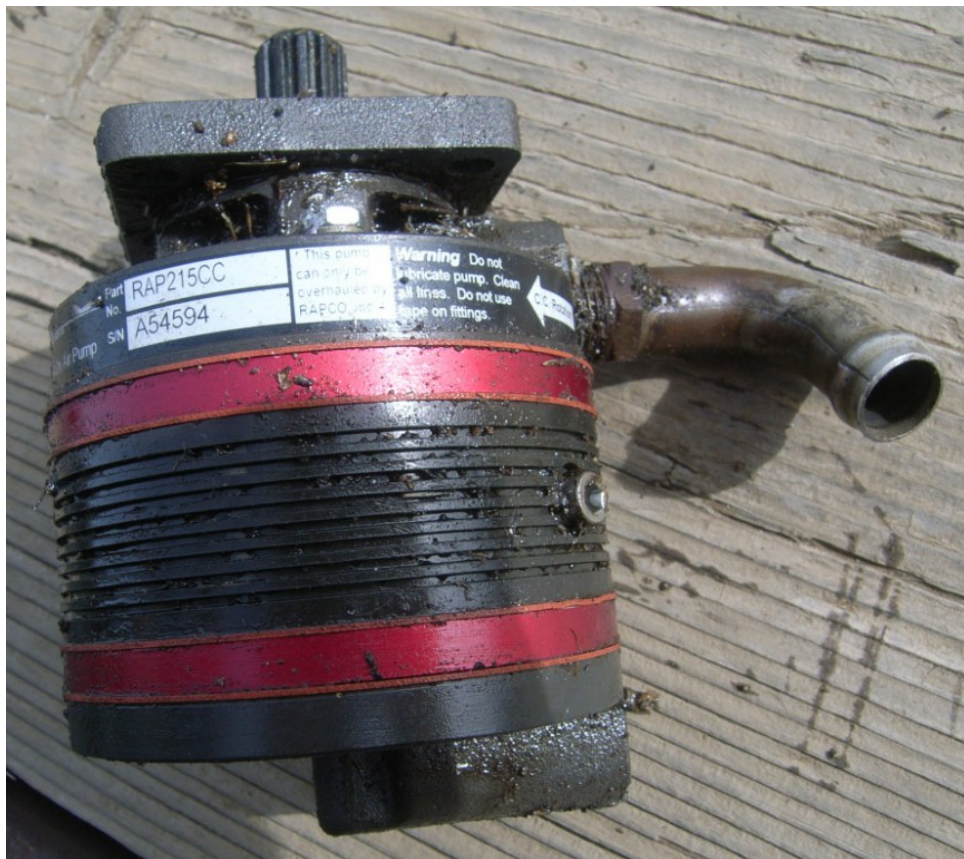
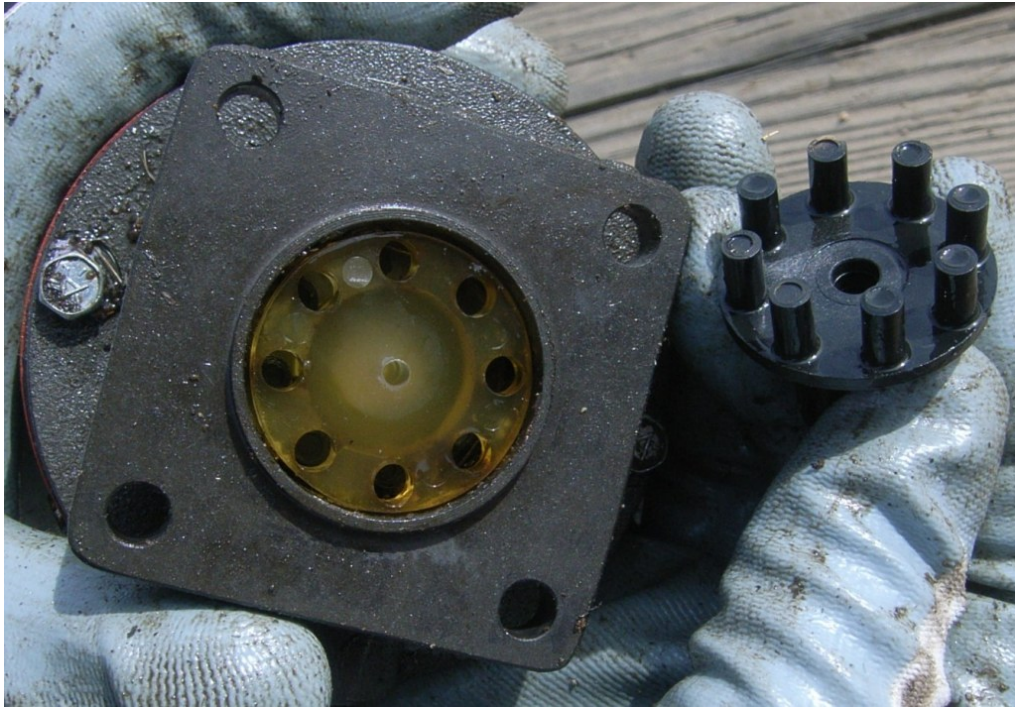
- The vacuum pump remained securely attached to its mounting pad on the engine accessory face
  - The pump was removed and disassembled
  - The shear coupling was intact

**Figure 41 - Vacuum Pump**

**Figure 42 - Vacuum Pump Shear Coupling**

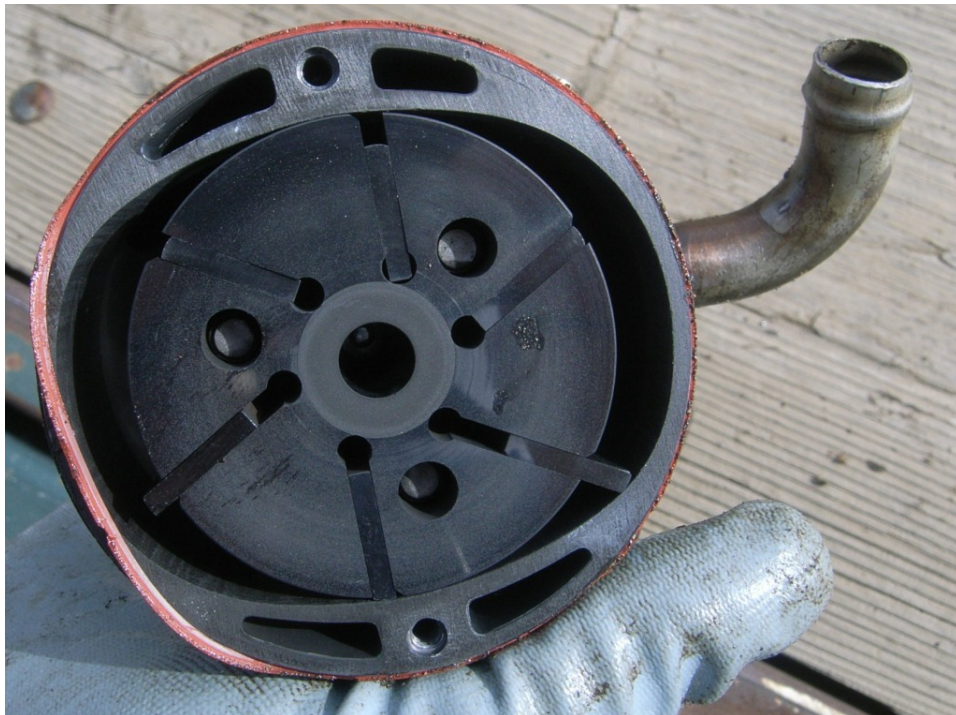
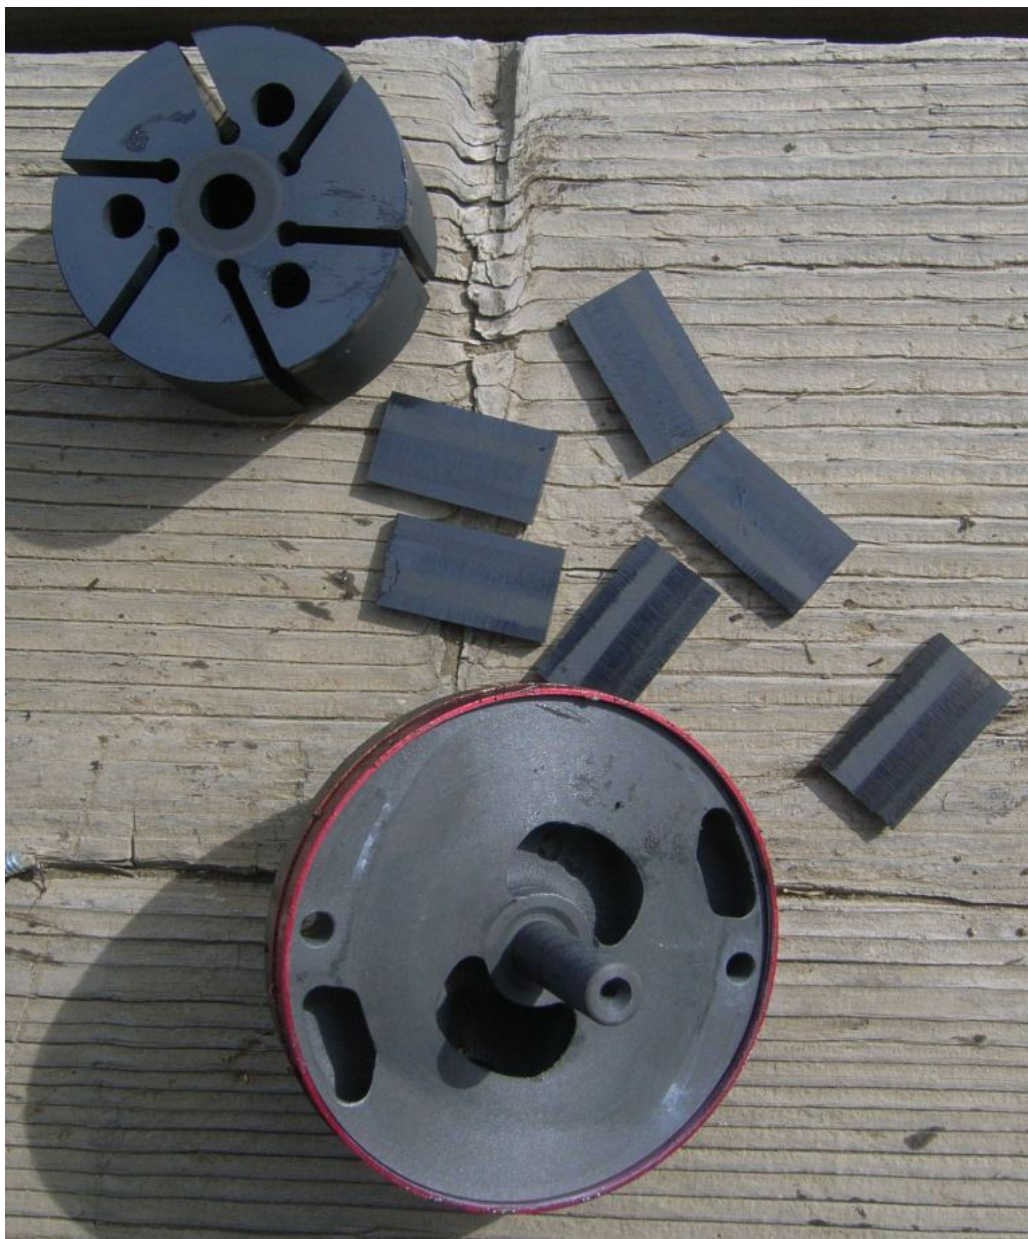
- The rotor and vanes were all intact
  - The rotor rotated freely by hand, and all vanes moved freely in their slots
- The metal upper engine cowling and composite upper nose bowl were found early in the debris field

**Figure 43 - Vacuum Pump Rotor and Vanes**

**Figure 44 - Vacuum Pump Rotor and Vanes**

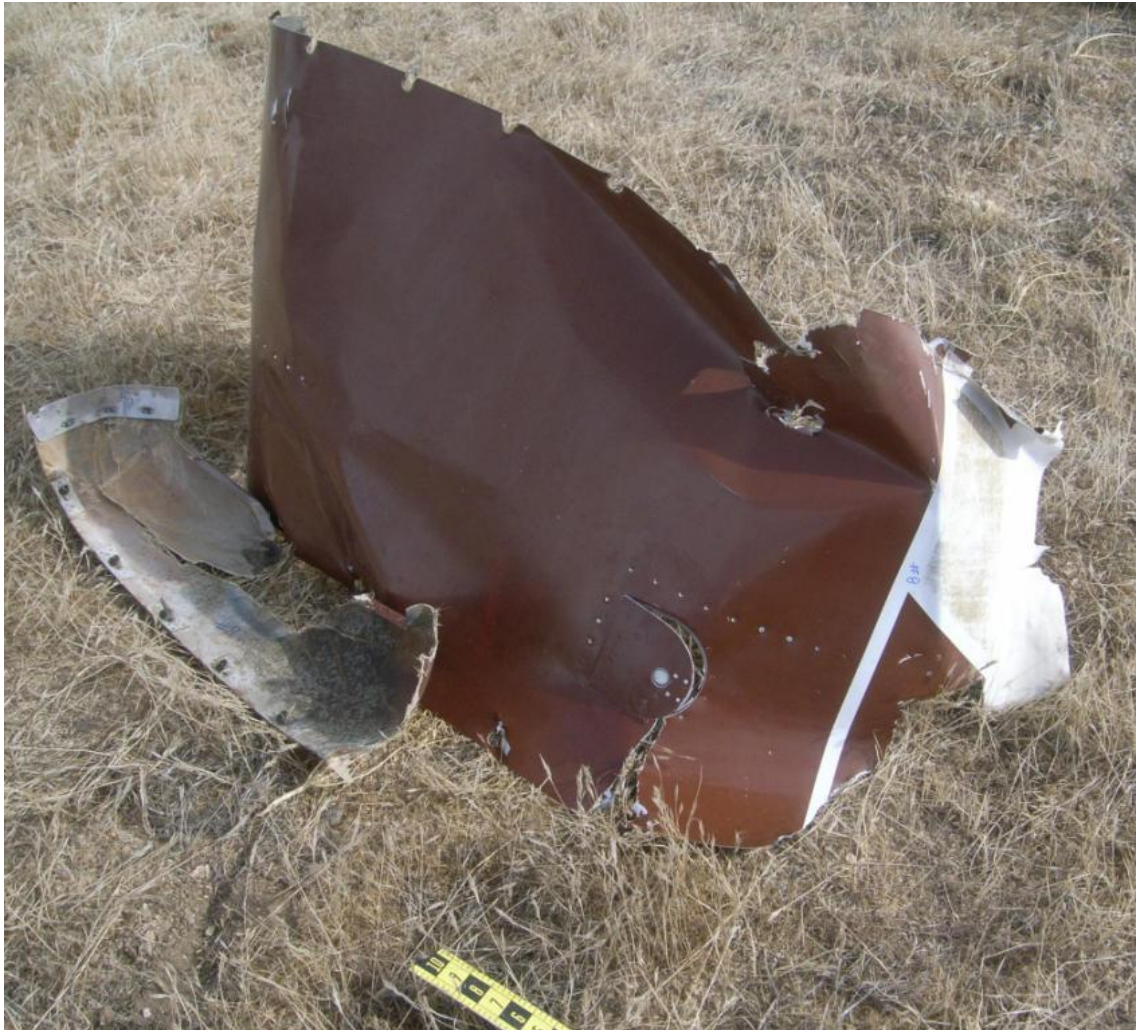
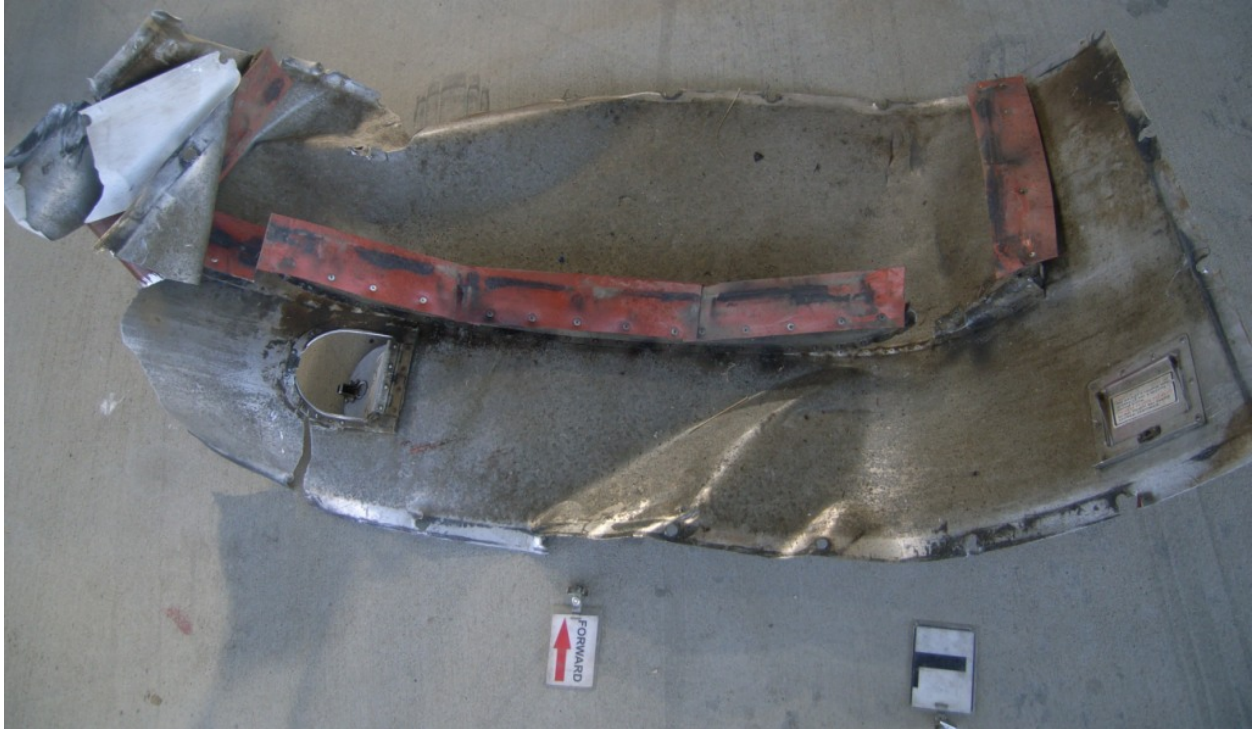
- Neither exhibited any evidence of engine distress such as oil spray, thermal damage, or component liberation
- No evidence of abnormal or heavy external oil streaking observed on airplane skins

**Figure 45 - Cowling**

**Figure 46 - Cowling Underside**

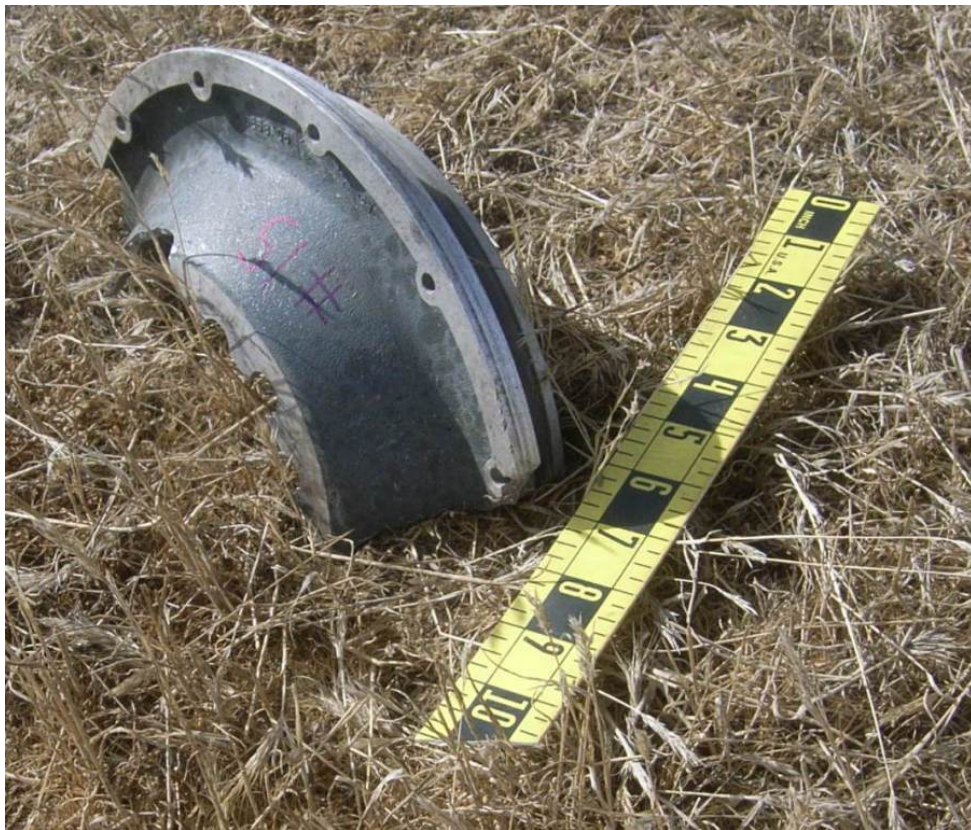
- The propeller was fracture-separated from the engine
  - The starter ring gear was separated from its attach flange
  - That flange was fracture separated from the engine and propeller, and fractured into multiple fragments

**Figure 47 - Propeller Flange Assembly Fragment**
