## **NATIONAL TRANSPORTATION SAFETY BOARD**

### **SITE and ON-SCENE INFORMATION**

**NTSB Accident: WPR18FA035  
Accident Date: November 19, 2017**

Location: Tehachapi, California  
Date: November 19, 2017  
Aircraft: Cessna 152, N24987, Serial # 15280496  
NTSB IIC: Michael Huhn

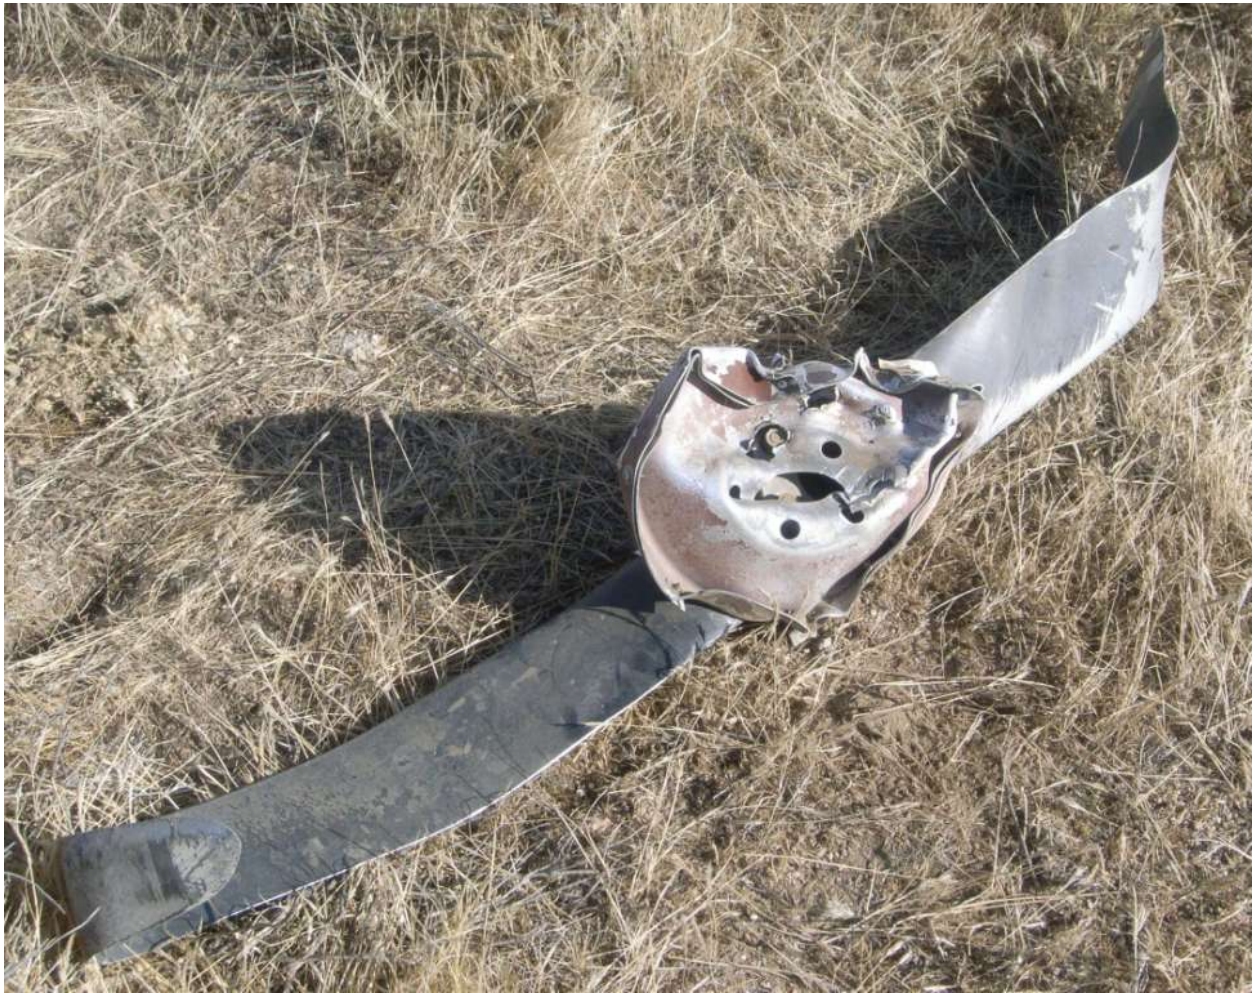
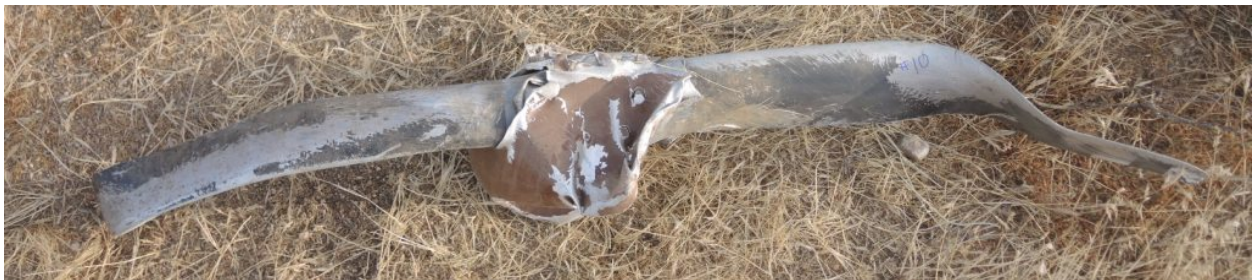
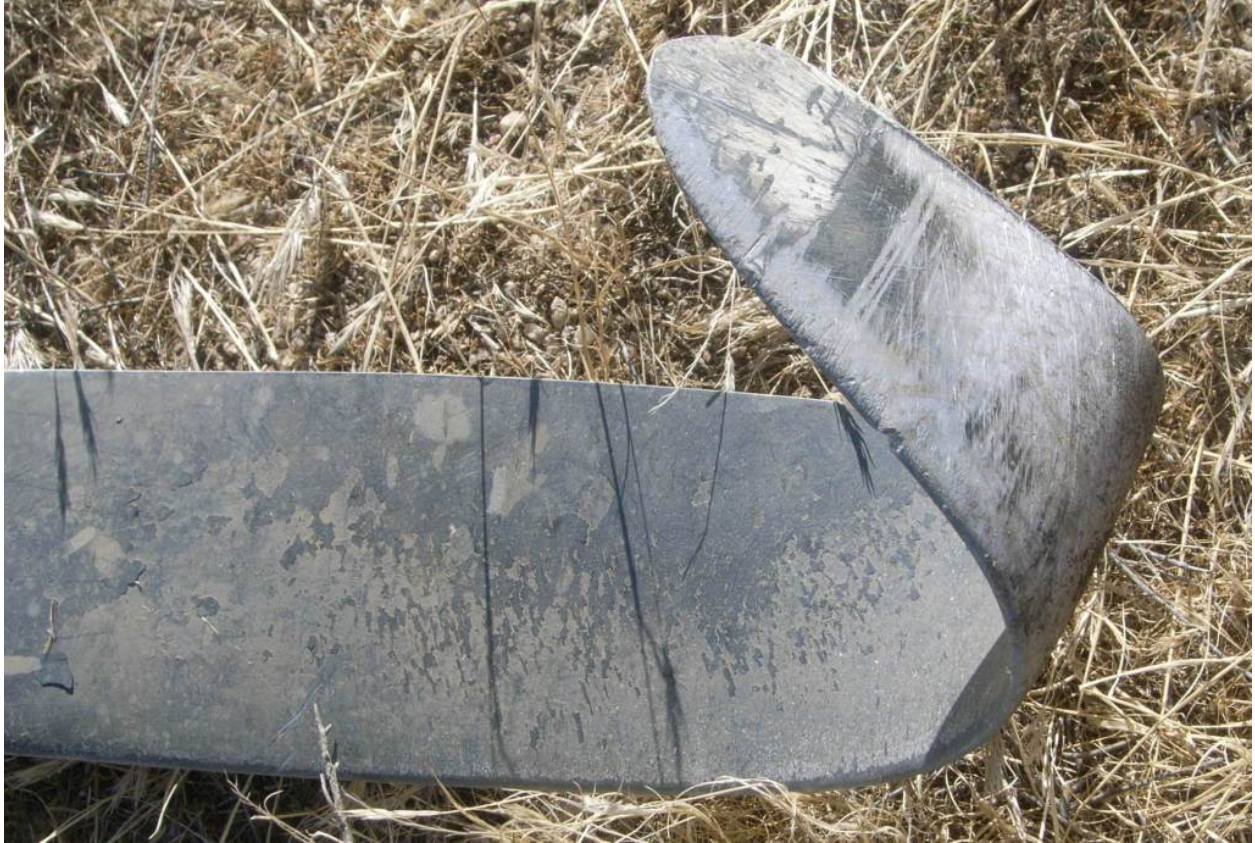
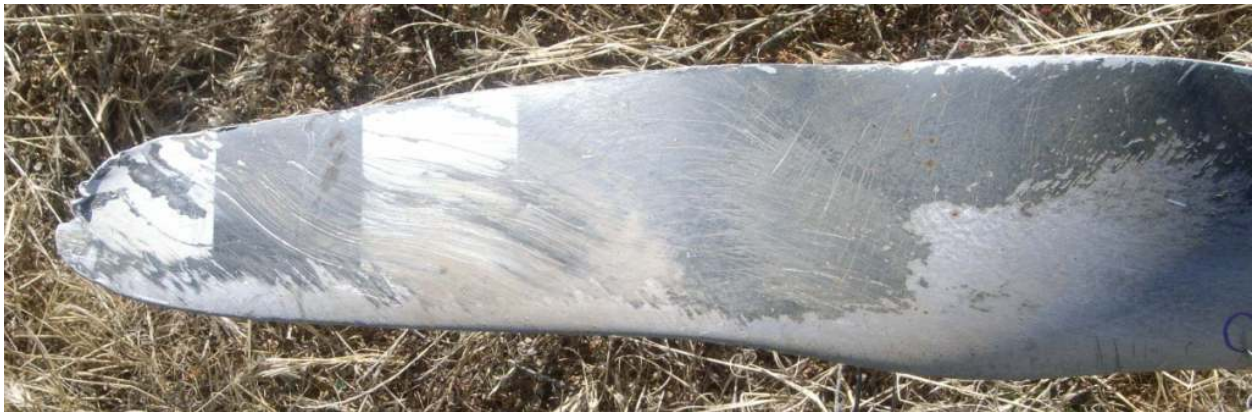
- Both propeller blades exhibited moderate bending/twisting deformation, and scoring

**Figure 48 - Propeller**

**Figure 49 - Propeller**

**Figure 50 - Propeller Tip**

**Figure 51 - Propeller Tip**
