## **NATIONAL TRANSPORTATION SAFETY BOARD**

### **DEBRIS FIELD INFORMATION**

**NTSB Accident: WPR18FA035  
Accident Date: November 19, 2017**

Location: Tehachapi, California  
Date: November 19, 2017  
Aircraft: Cessna 152, N24987, Serial # 15280496  
NTSB IIC: Michael Huhn

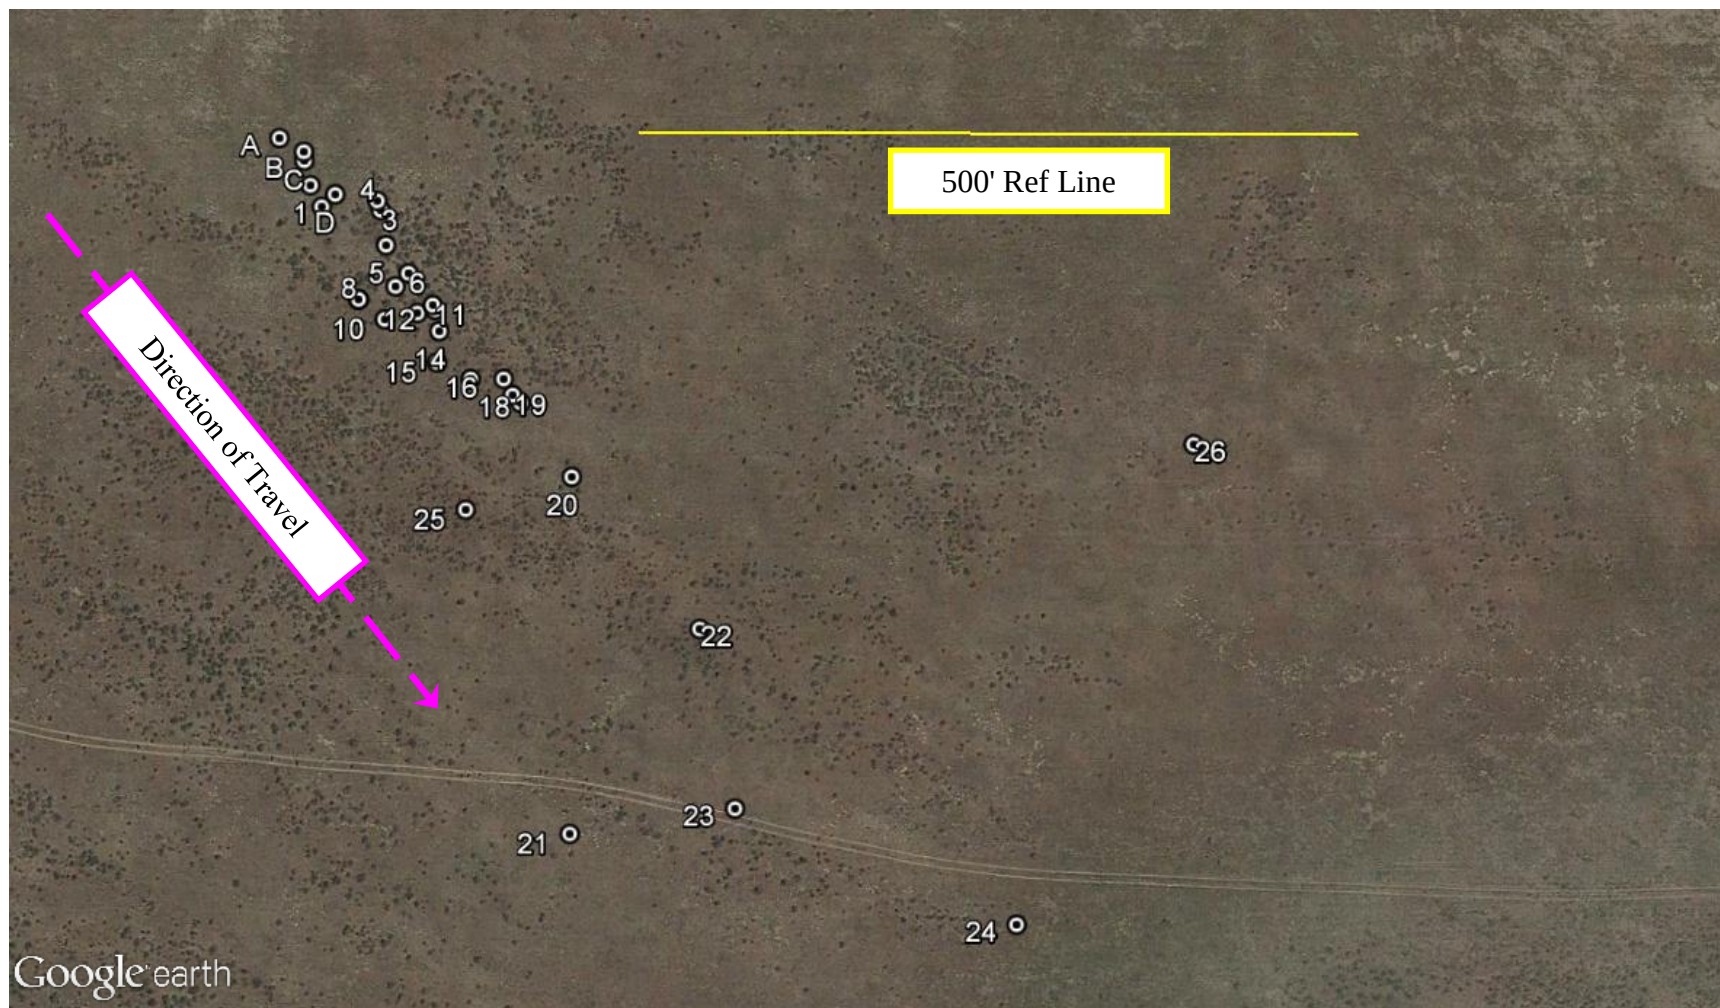
Figure 3 - Debris Field

When plotted, the location of the end of the first ground scar was observed to be in conflict with the photographic evidence and investigator's sketches. Although the reason(s) for that discrepancy could not be determined, the coordinates for that point ('B') were revised to match the physical evidence.
