# **NATIONAL TRANSPORTATION SAFETY BOARD**

## **ENGINE EXAMINATION**

**NTSB Accident: WPR18FA035  
Accident Date: November 19, 2017**

Location: Tehachapi, California  
Date: November 19, 2017  
Aircraft: Cessna 152, N24987, Serial # 15280496  
NTSB IIC: Michael Huhn

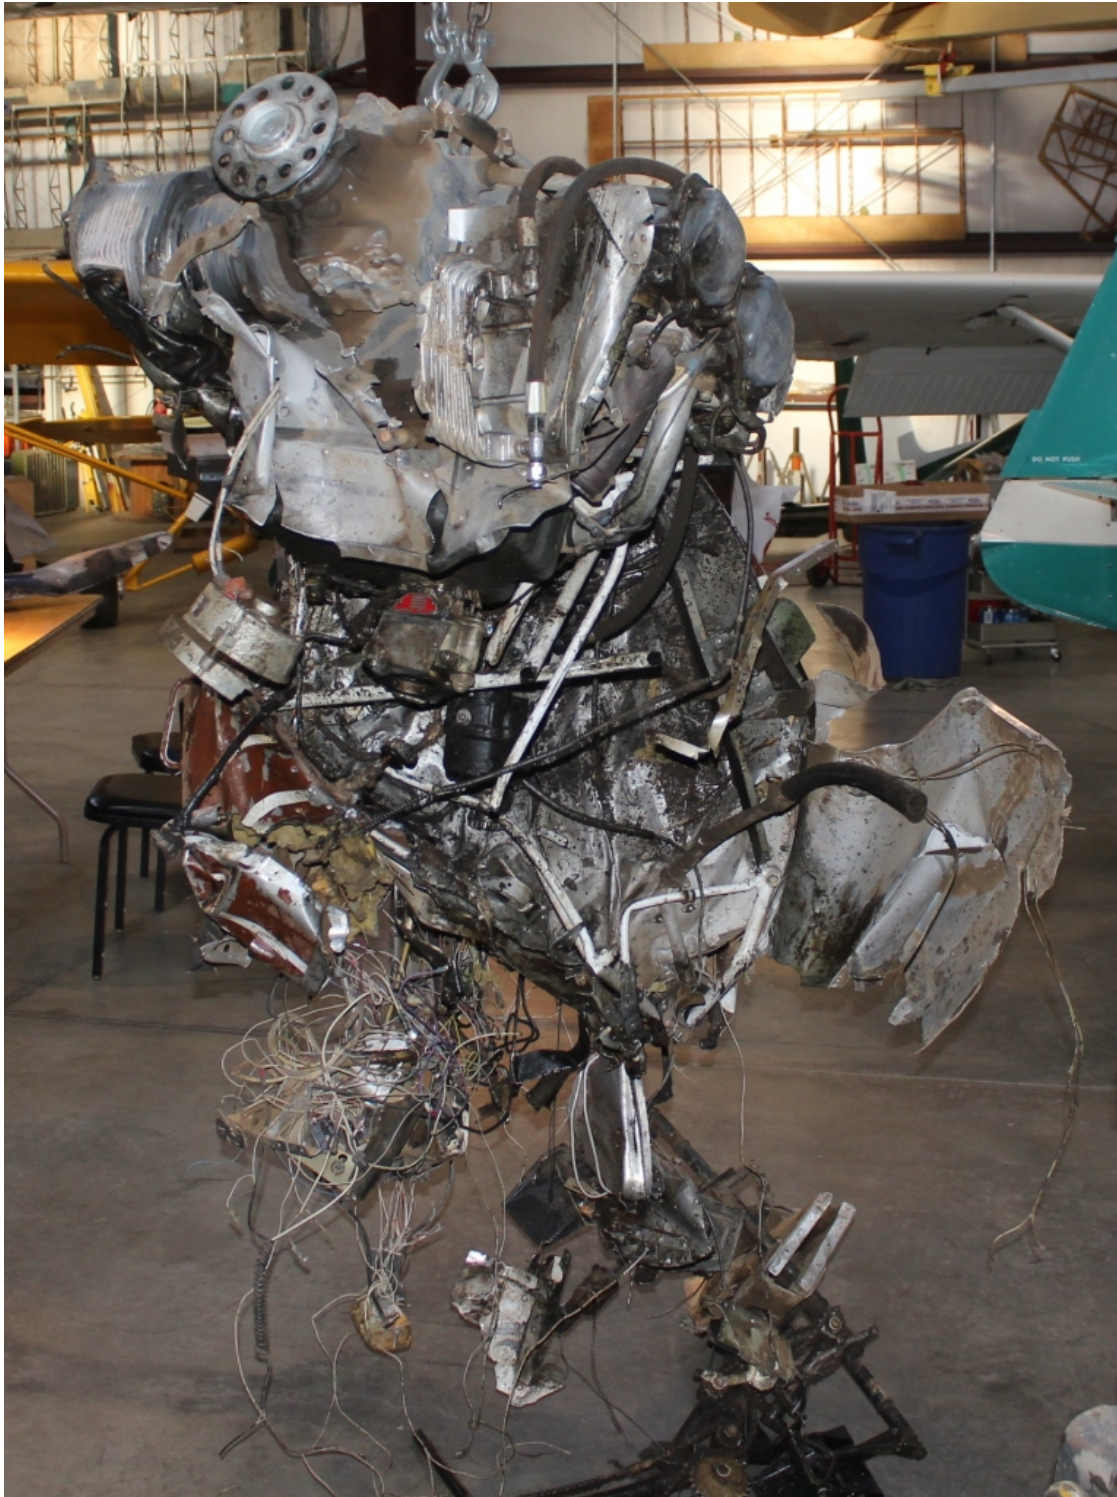
The engine remained attached to the airframe by the engine mount. The engine and attached mount structure had sustained significant impact deformation, which liberated the propeller, alternator, starter, exhaust system and right magneto. Visual examination of the engine revealed no evidence of pre-impact catastrophic mechanical malfunction or fire.

**Figure 1 - Engine with Firewall and Other Components**

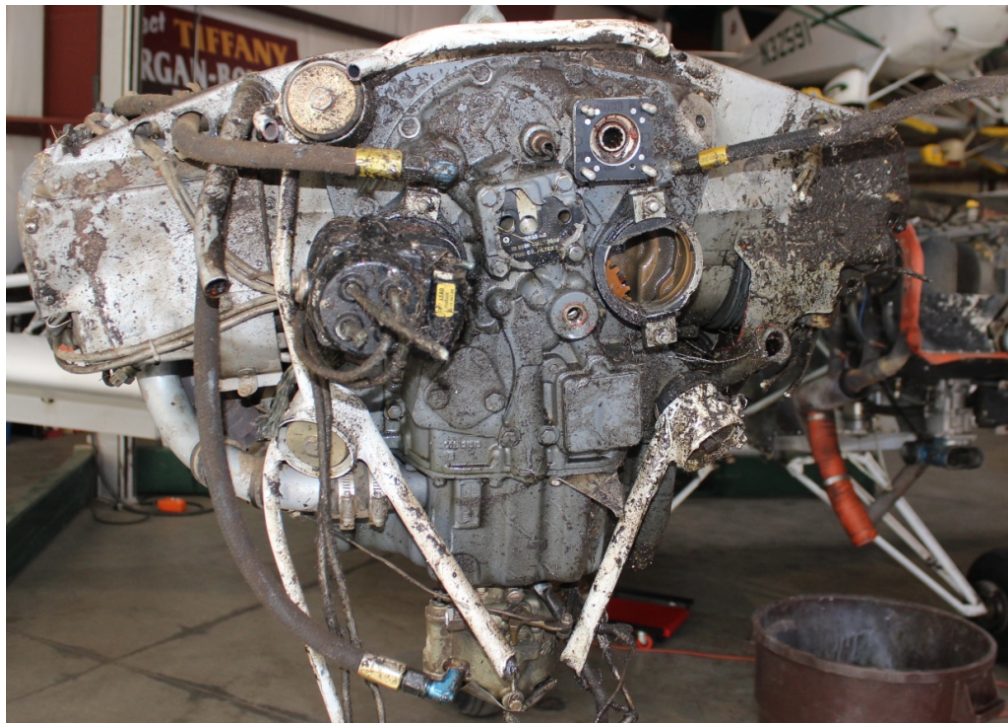
**Figure 3 - Engine Accessory Face**

The engine was separated from the attached wreckage to facilitate further examination. The top spark plugs were removed, examined and photographed. The vacuum pump was removed, and the crankshaft was rotated by hand through the drive pad utilizing a drive tool. The crankshaft was free and easy to rotate in both directions. "Thumb" compression was observed in proper order on all four cylinders. The complete valve train was observed to operate in proper order, and appeared to be free of any pre-mishap mechanical malfunction. Normal "lift action" was observed at each rocker assembly. Clean, uncontaminated oil was observed at all four rockerbox areas. Mechanical continuity was established throughout the rotating group, valve train and accessory section during hand rotation of the crankshaft.

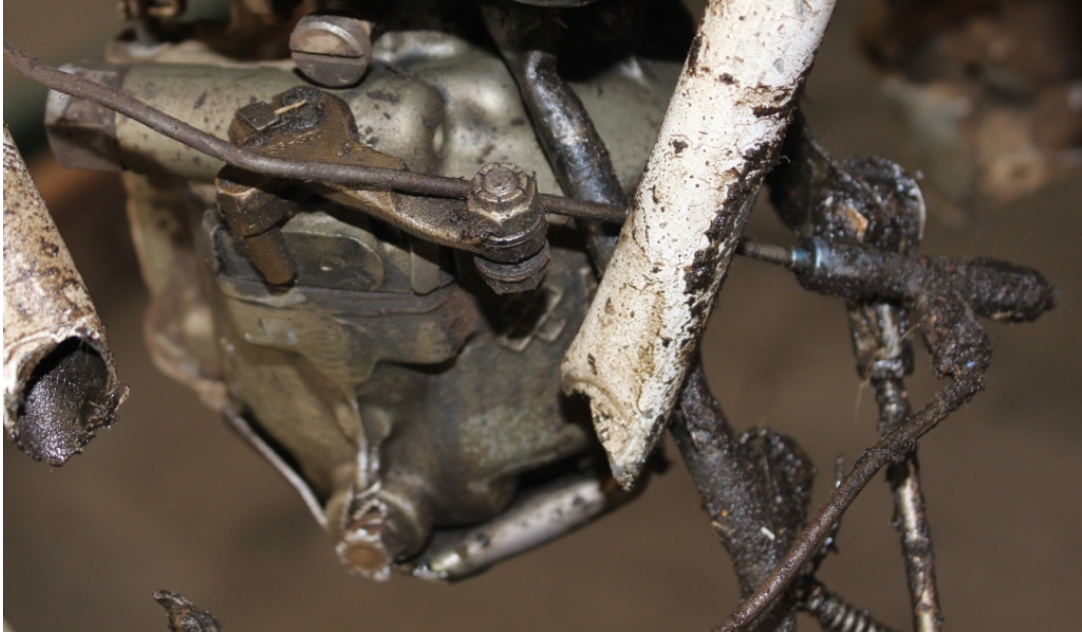
The carburetor remained undamaged and securely attached at the mounting flange. The engine compartment fuel line was found to be in place and secure at its respective “B” nuts; however, the fitting at the carburetor inlet had been fracture-separated. The fracture surface signatures were consistent with overload. The throttle control was found securely attached to the control arm of the carburetor. The mixture cable had been pulled from the end of its control arm. Reliable positions of the mixture and throttle settings at the time of impact could not be determined. The castellated nut and cotter pin remained secure and the serrated interface at the throttle arm remained securely mated.

**Figure 6 - Carburetor on Engine**

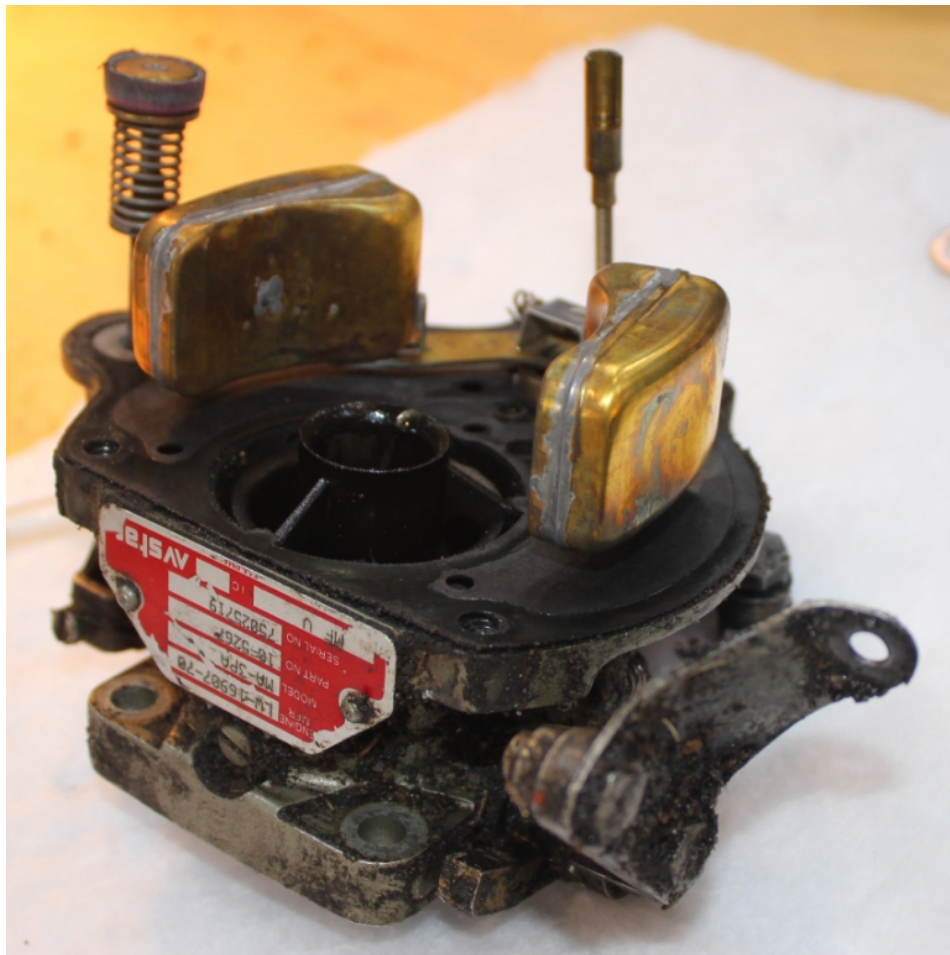
The carburetor was opened for examination. The fuel bowl was free of visible contaminants. The float assembly remained secure at the mounting and free of damage. The metal float pontoons exhibited no evidence of rubbing against the wall of the bowl. The right float exhibited slight hydrodynamic crushing on each side. The left float appeared normal. No external fuel staining was observed on the carburetor. All internal locking tabs and safety devices of the carburetor were in place and properly secured.

**Figure 7 - Partly Disassembled Carburetor**

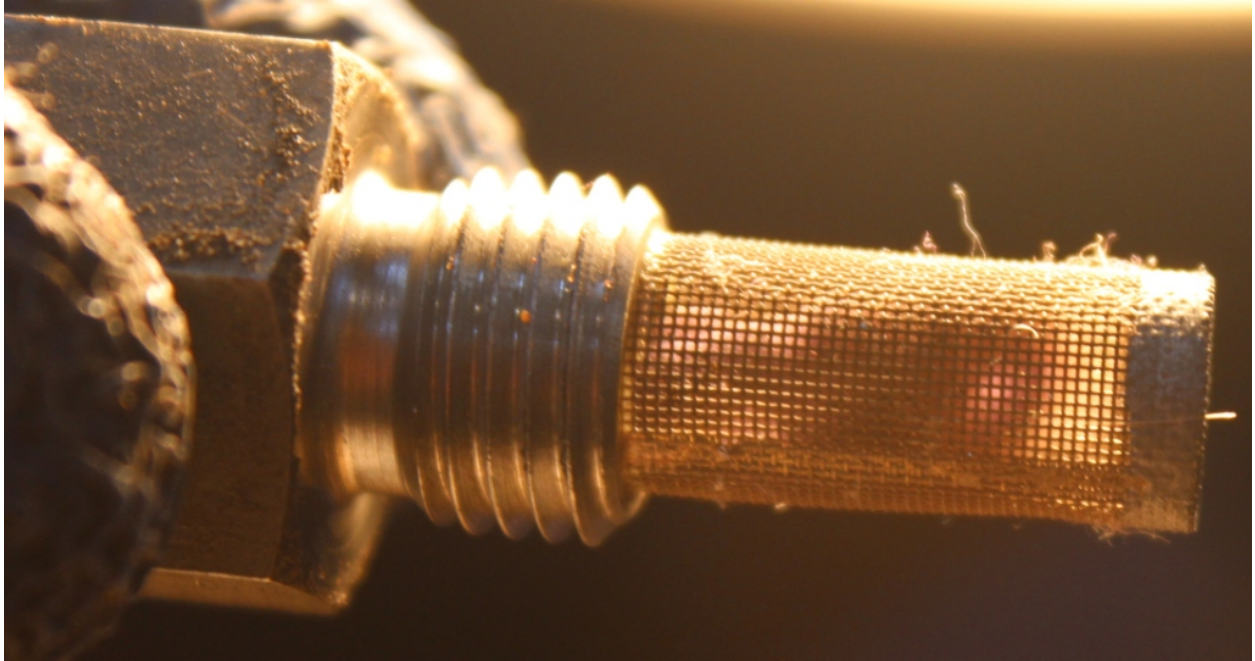
The fuel inlet screen was found properly installed. The filter contained a material consistent with loosely-packed lint that constituted approximately 50% of the screen internal volume.

**Figure 8 - Carburetor Fuel Inlet Screen**

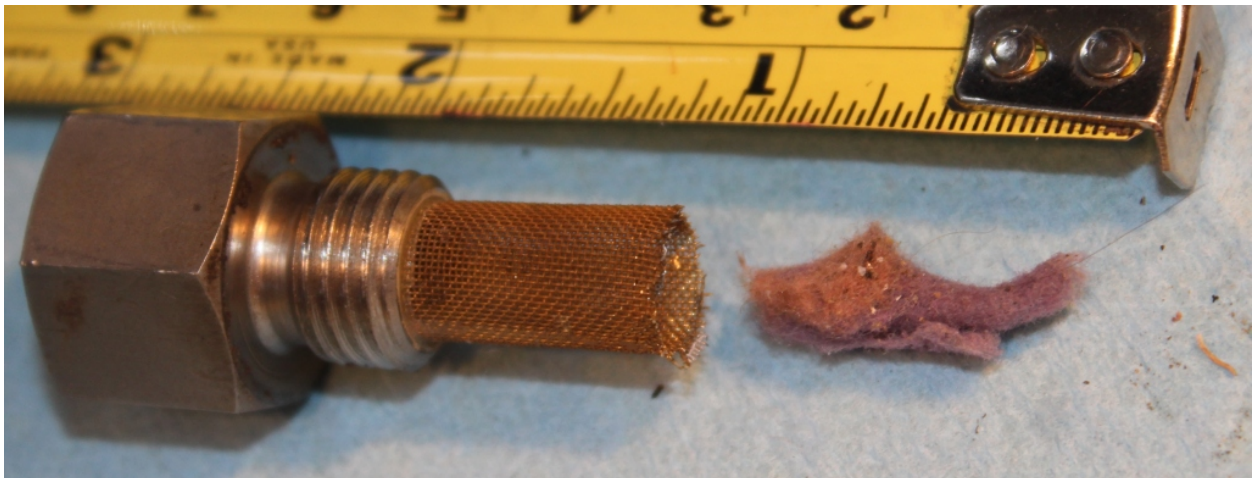
**Figure 9 - Carburetor Inlet Screen & Debris**

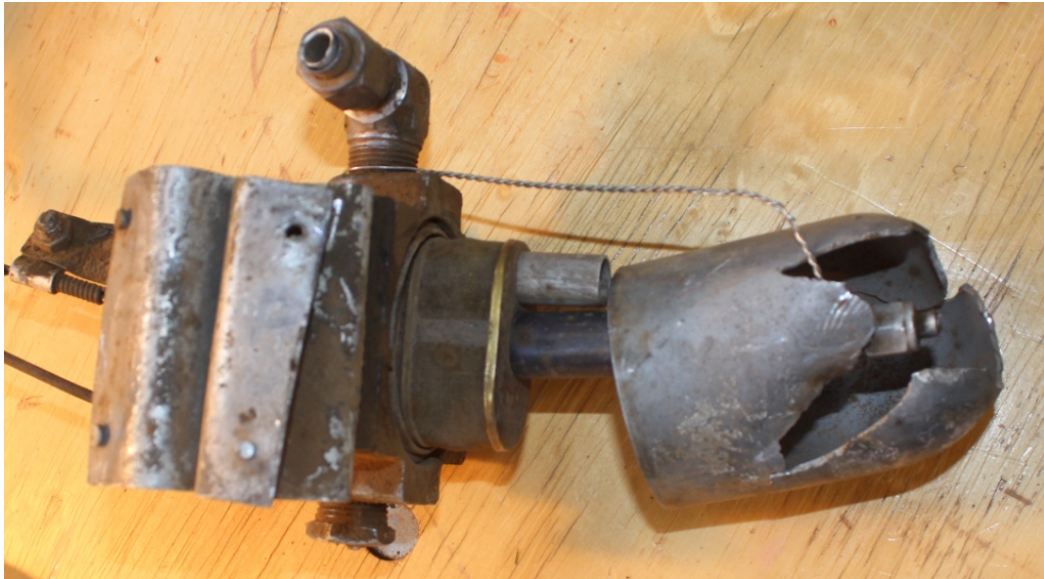
**Figure 10 - Gascolator**

Additional examination of the gascolator screen and the forward and aft strainers at each wing tank found no visible contaminants.

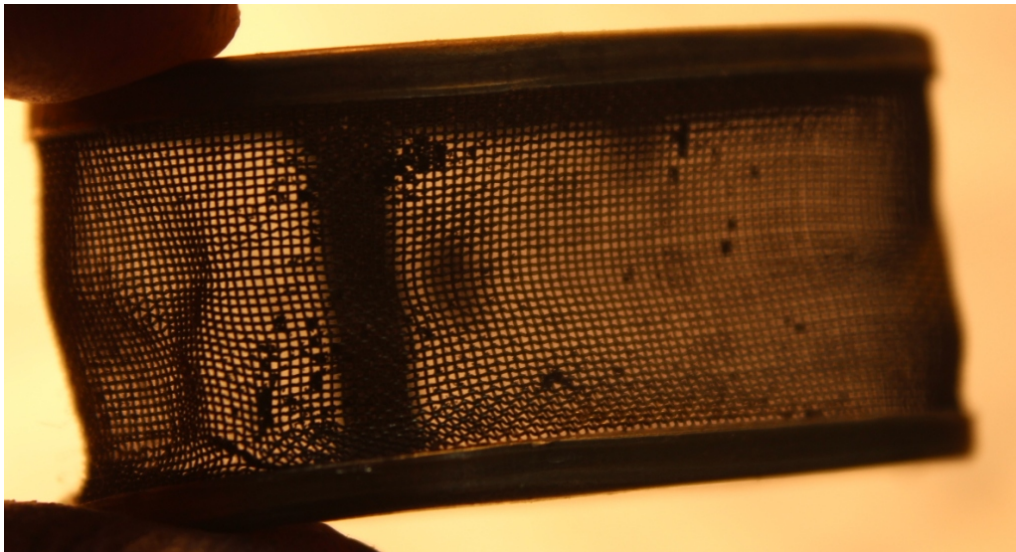
**Figure 11 - Gascolator Screen with no Blockage**

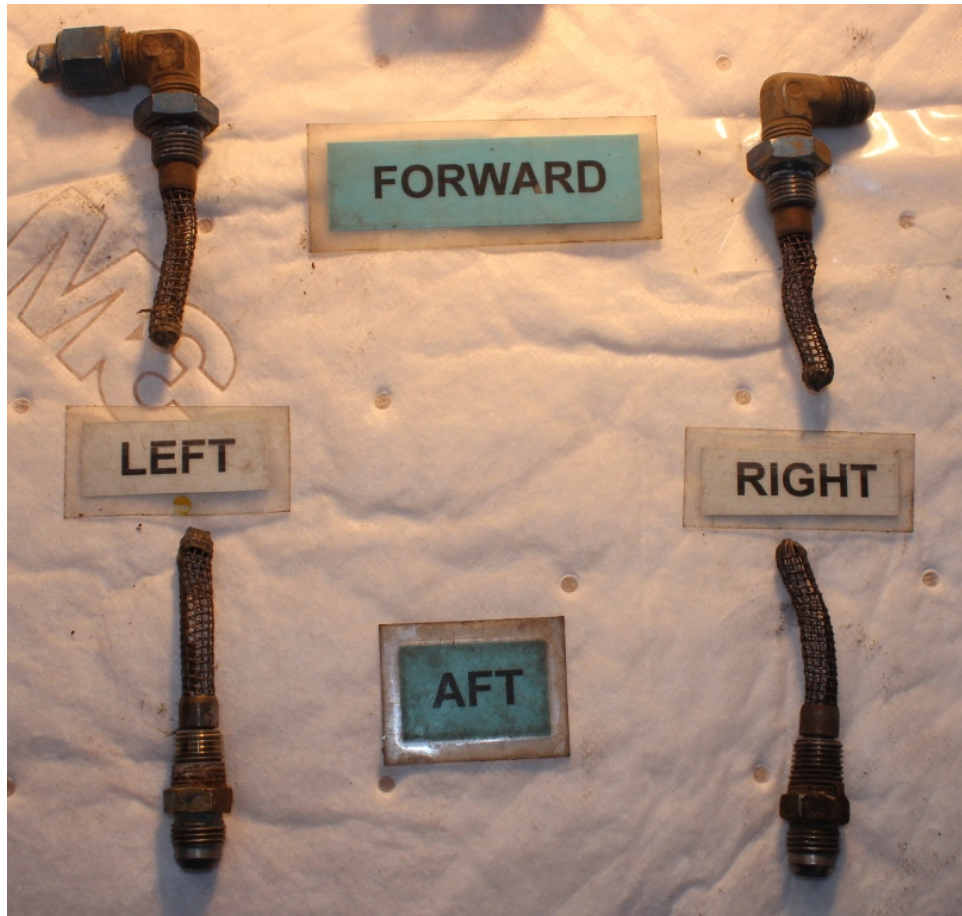
Figure 12 - Four Fuel Tank Finger Screens

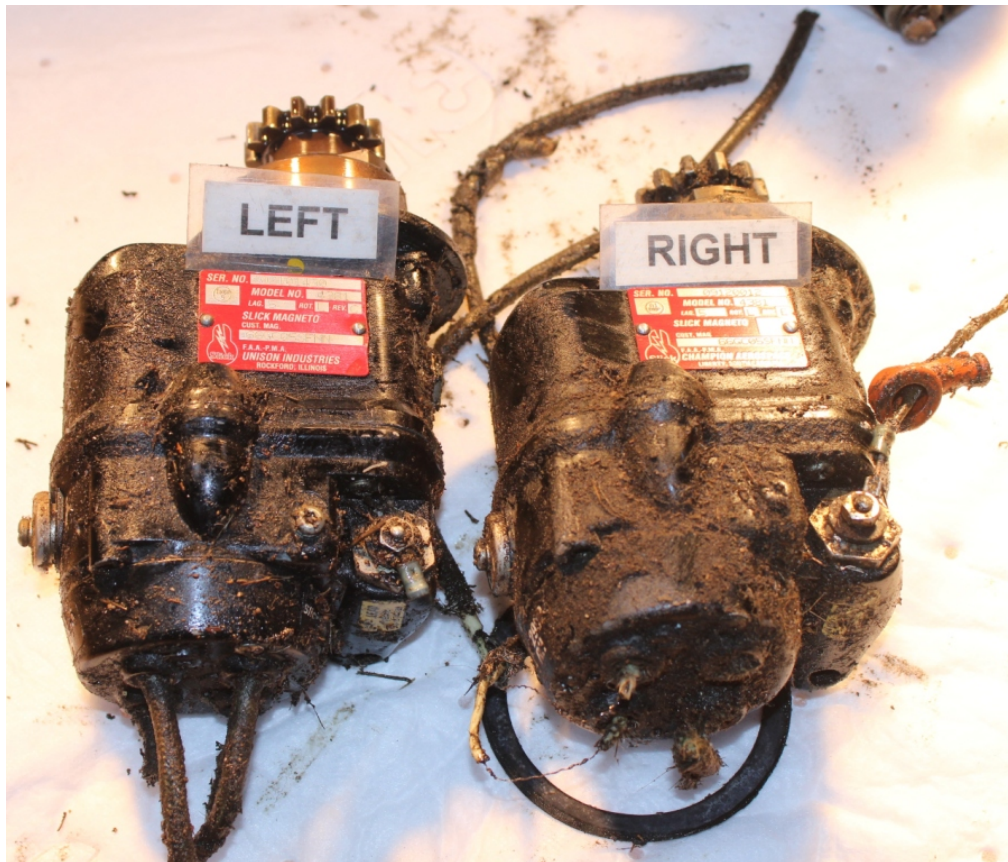
Figure 13 - Magnetos

The left magneto was found securely clamped to its engine mounting pad. Magneto to engine timing could not be ascertained, due to the destruction of the flywheel. The magneto was removed for examination. The magneto was observed to produce spark at all four plug leads during hand rotation of the drive. The impulse coupler drive was observed to be intact and properly safetied.

The right magneto had sustained impact damage, and was fracture-separated from its engine mounting pad. The fracture surface signatures at the magneto-mounting flange were consistent with overload. The pieces of magneto flange that remained at the mounting pad were securely clamped. Magneto to engine timing could not be ascertained. The right magneto would not produce spark when hand rotated at the drive. Investigation revealed that the right magneto had sustained impact damage that displaced the top cover, which repositioned internal components, rendering the magneto inoperative. The impulse coupler drive was observed to be intact and properly safetied.

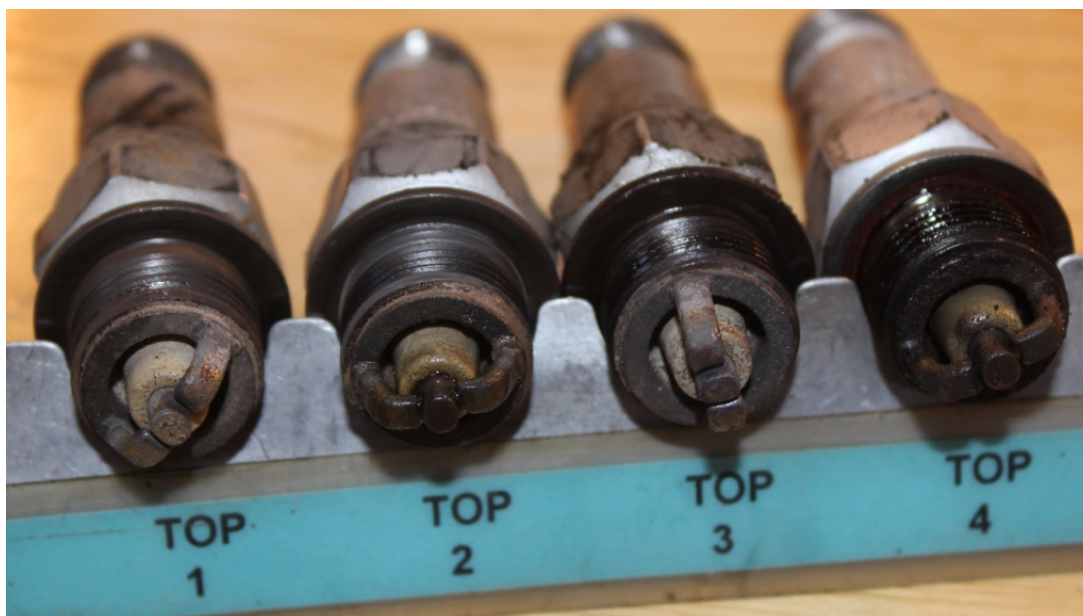
Figure 14 - Top Spark Plugs

The spark plugs were secure at each position. The spark plugs (as noted) were removed, examined and photographed. The spark plug electrodes remained mechanically undamaged, and according to the Champion Spark Plugs "Check-A-Plug" chart AV-27, the spark plug electrodes displayed coloration consistent with normal operation. The static oil soaking of the spark plugs (as noted) was attributed to the engine orientation at the accident site and post recovery.

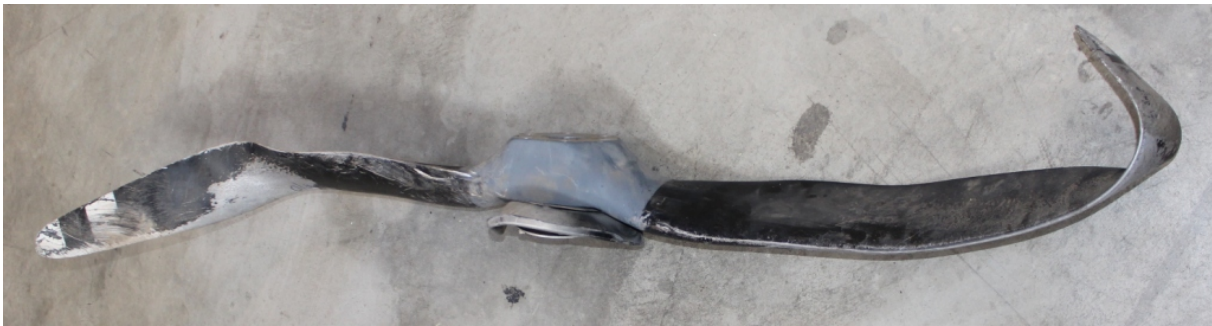
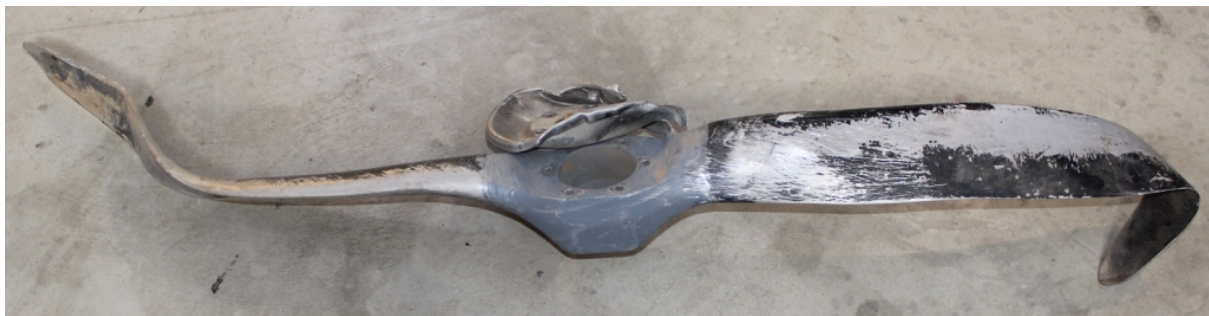
Figure 15 - Propeller

The single-piece, all-aluminum, two-bladed, fixed-pitch propeller was fracture-separated from the engine at the crankshaft flange. The fracture surfaces exhibited signatures consistent with overload due to rotation. The propeller blades displayed leading edge gouging, torsional twisting, chordwise striations across the cambered surfaces, and trailing edge “S” bending. The signatures were consistent with the rotational energy being applied to the crankshaft at the time of impact.
