## **NATIONAL TRANSPORTATION SAFETY BOARD**

### **ACCIDENT SITE / AIRFRAME / ENGINE EXAMINATION SUMMARY**

**WPR18FA045**

Location: Geneva, Florida  
Date: December 8, 2017  
Aircraft: Beech C90, N19LW  
NTSB Investigator-in-Charge: Joshua Cawthra

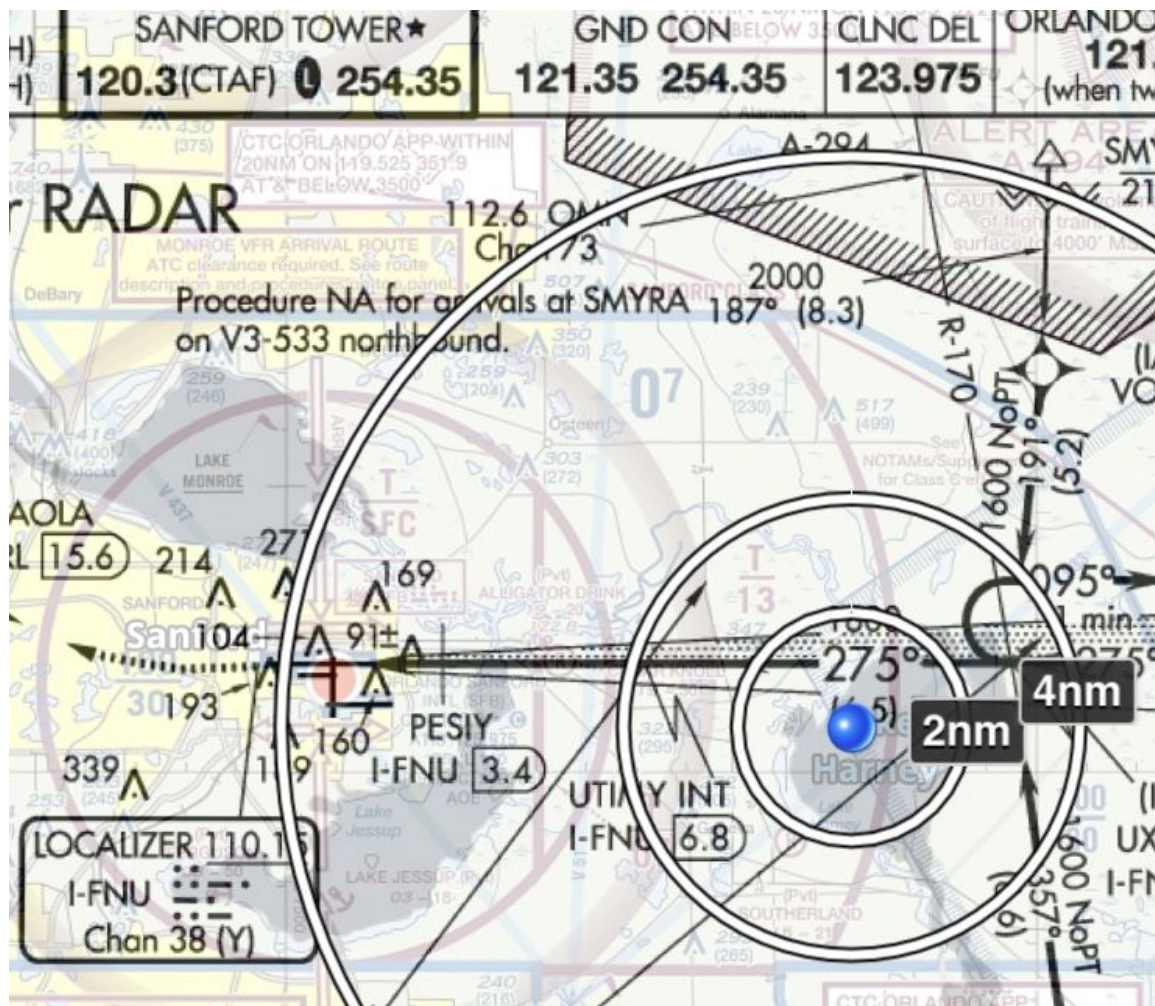
Examination of the accident site revealed that the airplane impacted the waters of Lake Harney near the northwestern shoreline, just south of the final approach course for the ILS Runway 27R instrument approach. Wreckage was spread throughout a 200 square ft area along the bottom of the lake. The reported water depth of 10 feet.

Figure 1: Accident location overlaid over a sectional map and instrument approach plate.
