**Aircraft:** Beechcraft C90 King Air

**Registration No.:** N19LW

**Written by:** Les Doud  
Air Safety Investigator – Hartzell Propeller Inc.

**PROPELLER TEARDOWN REPORT**

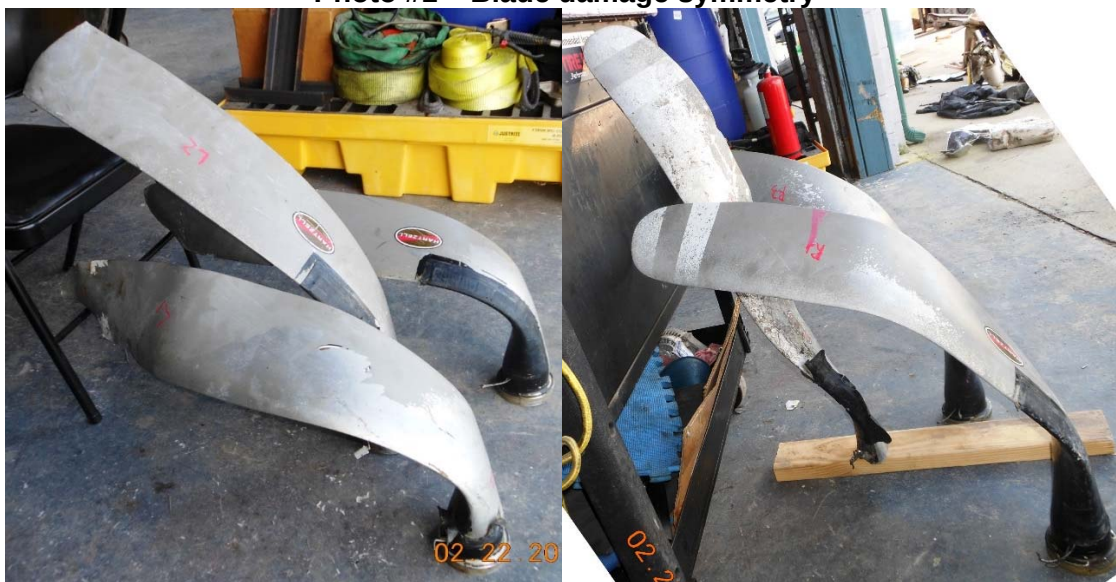
**Photo #1 – Blade damage symmetry**

Both propellers exhibited similar damage; blades bent aft, bent opposite rotation and twisted leading edge down (Photo #1). Additionally, the hydraulic unit and spinner dome were separated from both propellers in a similar fashion.

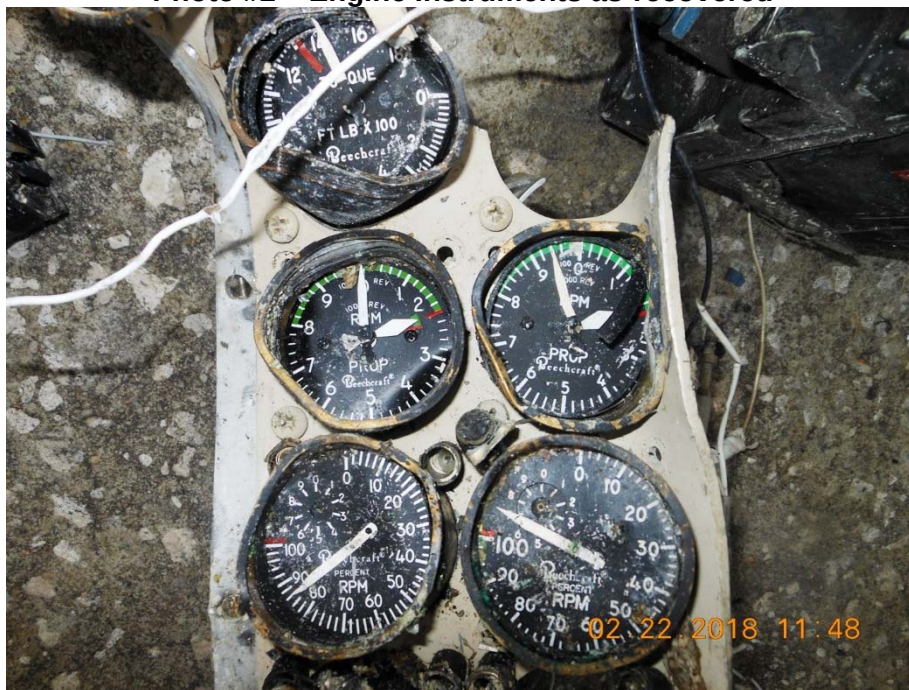
**Photo #2 – Engine Instruments as-recovered**

In addition to examining the propellers, the engine controls and instruments were examined for power and RPM information. The engine instruments suggested power and RPM at the time of impact with the tachometers frozen at 2000 RPM for left and 1940 for the right propellers (Photo #2).

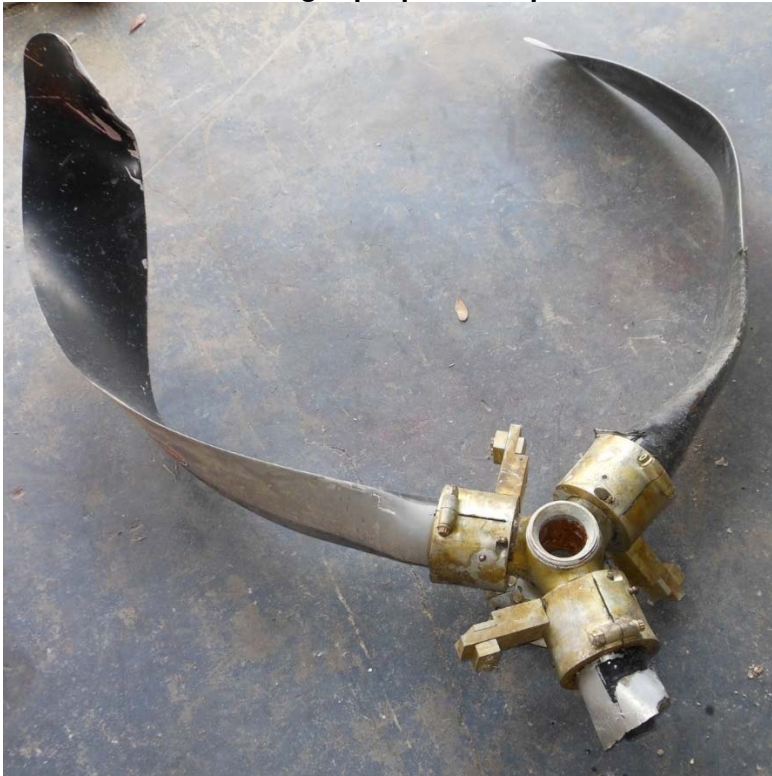
**Photo #3 – Right propeller as-presented**

**“As Received” Condition:** The right propeller as recovered and presented for examination is shown in Photo #3. The propeller had fractured from the engine propeller shaft; the propeller shaft flange remained attached to the propeller with all bolts present and saftied. The hydraulic unit, spinner components and all the beta system hardware had separated and were not recovered. Blade R2 fractured from the assembly near the top of the balance bore and the fractured portion of the blade was recovered at the crash scene aircraft wreckage field. Blades R1 and R3 appeared to be bent aft and twisted leading edge down. Blade R3 appeared to have slipped in the clamp approximately 180°.

**Hydraulic Unit and Pitch Change Mechanism:** As shown in Photo #3, the hydraulic unit (cylinder and piston) and all pitch change mechanism (pitch change rod, pitch stops, link arms, beta rods and beta ring) hardware was missing and presumed not recovered. One feathering spring assembly was recovered on the lake bed but it wasn't determined which propeller it came from (Photo #5).

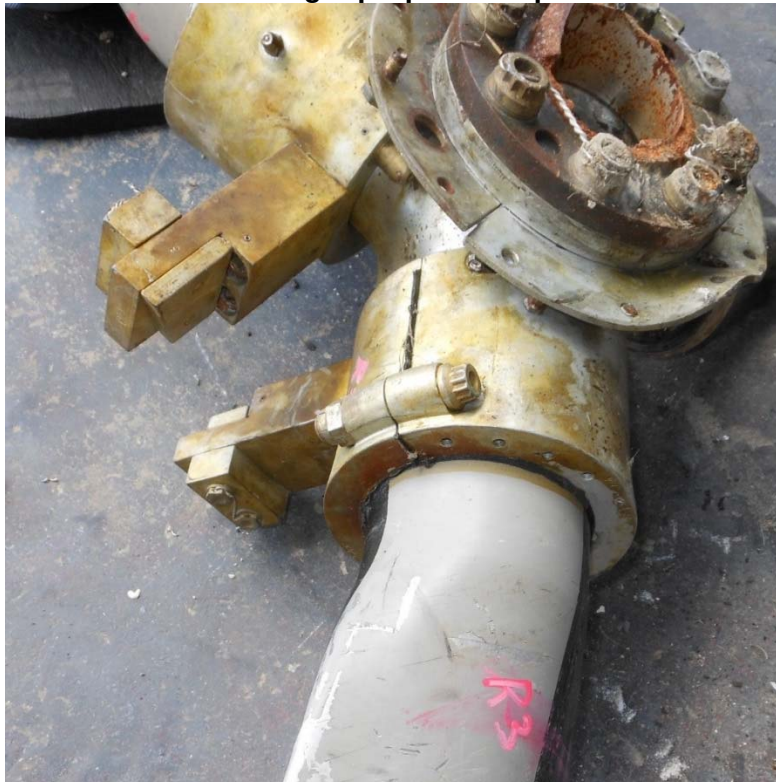
**Photo #4 – Right propeller as-presented**

| Blade | Blade/clamp Angle As-Received | Blade Slip in Clamp? | Rotation of clamp possible? |
|---|---|---|---|
| R3 | Clamp/counterweight was near the feathered position. | The blade appeared to have slipped approximately 180° towards low pitch (Photo #4) | Yes |

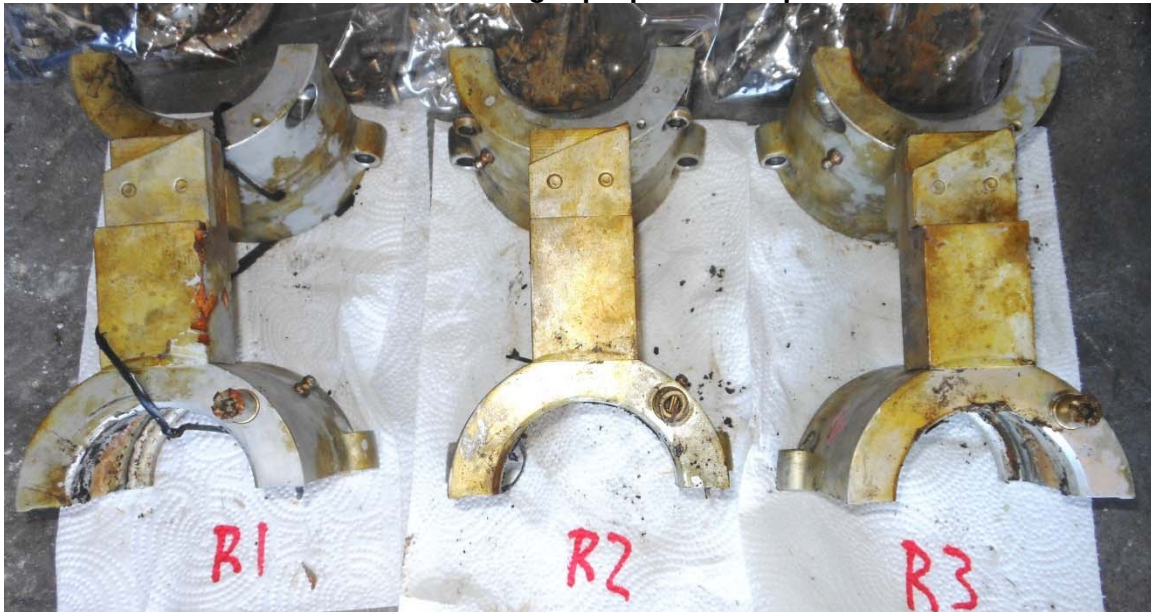
**Photo #6 – Right propeller clamps**

**Clamps and Counterweight Condition:** (Photo #6). All the clamps appeared to be coated with a brownish-yellow substance that was not identified.

| Clamp Pos. | Clamp S/N | Clamp Condition | Counterweight Condition |
|---|---|---|---|
| R1 | EK6387 | Intact, all bolts safetied, top of link screw sheared towards low pitch | Intact, gouges on inboard, trailing edge corner/edge |
| R2 | EK6535 | Intact, all bolts safetied, head of link arm cotter pin sheared | Intact |
| R3 | EK6544 | Intact, all bolts safetied, top of link screw sheared towards low pitch | Intact, gouge on inboard, trailing edge corner/edge |

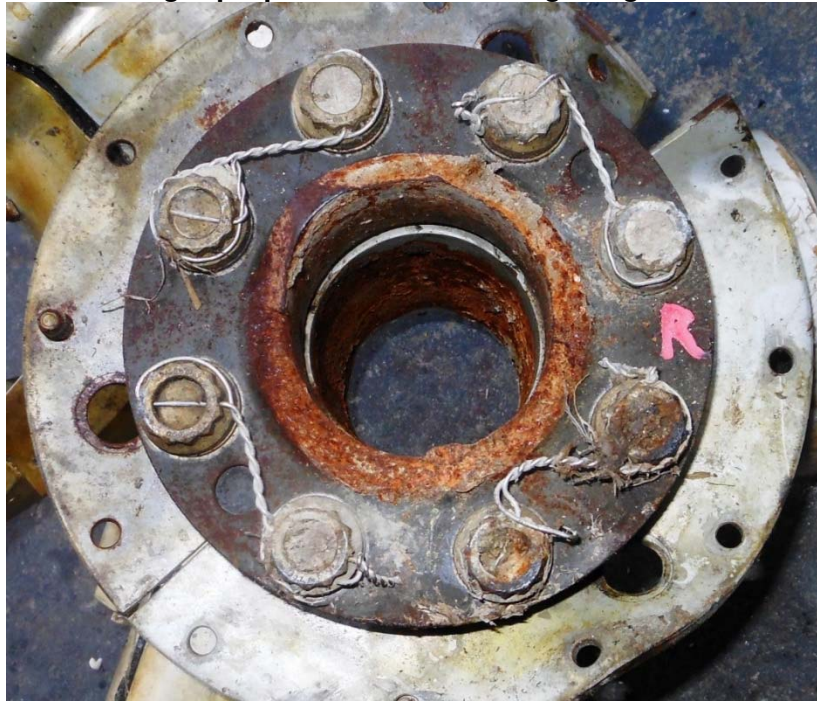
Photo #7 – Right propeller shaft mounting flange and hardware

**Engine/Propeller Mounting:** The engine propeller shaft flange fractured from the propeller shaft and remained attached to the propeller. The propeller mounting flange appeared to be intact with all six mounting bolts present and safety-wired.

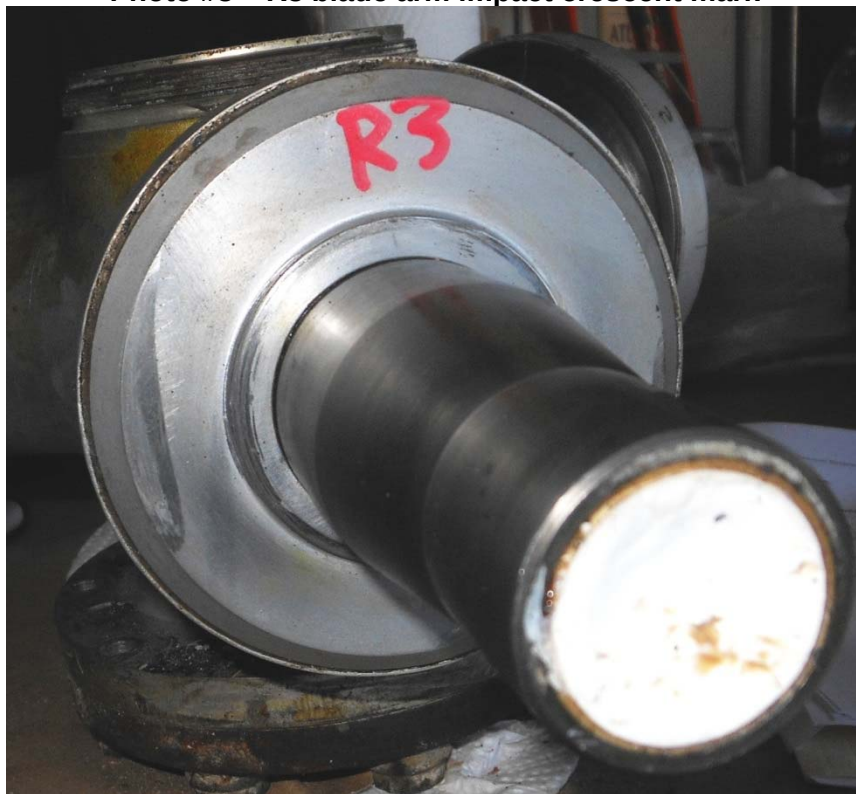
Photo #8 – R3 blade arm impact crescent mark

There were several material transfer marks from blade butts. There was an impact crescent mark in the trailing edge quadrant on the R3 blade arm flange (Photo #8). There were crescent impact marks in the trailing edge and leading edge of the R1 blade arm flange. The pilot tube was jammed into the blade butt/shank of the R1 blade and pulled out of the hub arm when the blade shank was removed from the assembly. There were impact crescents in the aft/face/trailing edge quadrant on the R1 blade arm flange.

The impact marks on blade butt and hub arms were evaluated for possible determination of pre-impact blade angle. None of the marks were considered useful for pre-impact blade angle determination due to the amount of blade-clamp slippage that occurred during the impact sequence.

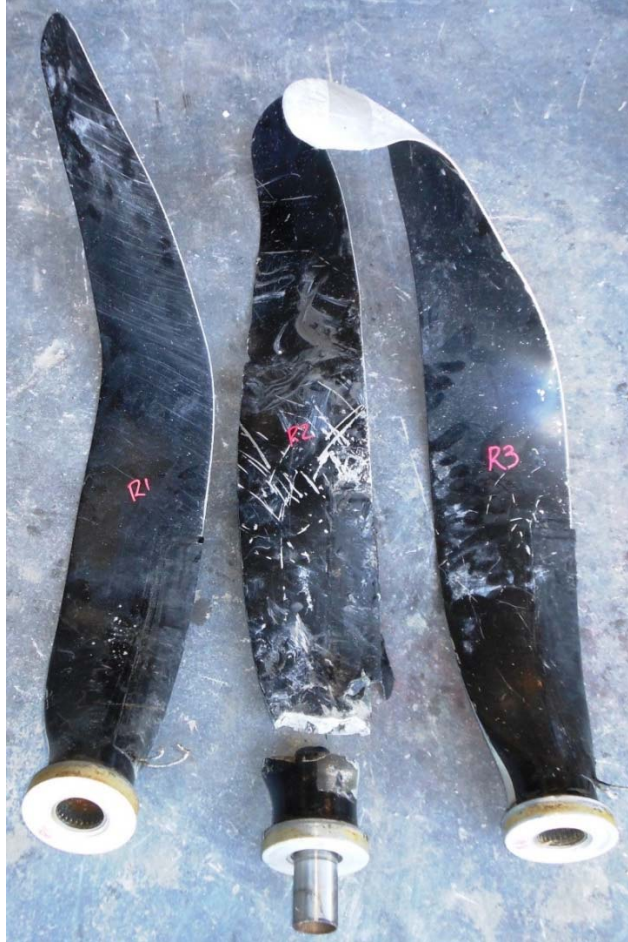
**Photo #9 – Right propeller blades face side view**

**Blade Properties:** Photos #9 through #11

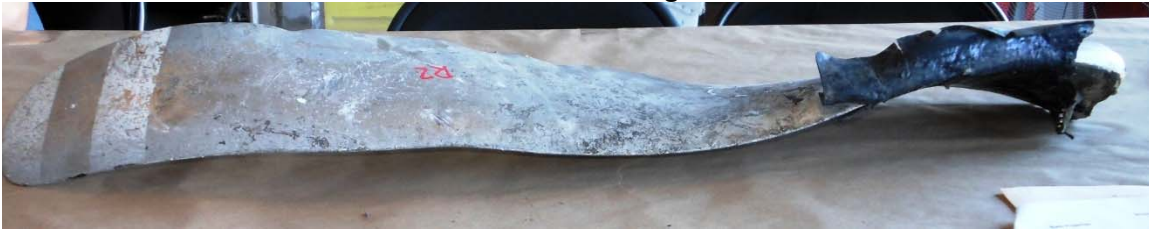
**Photo #11 – Blade R2 bending characteristics**

| Bend | S-bending characteristics (Photo #11) |

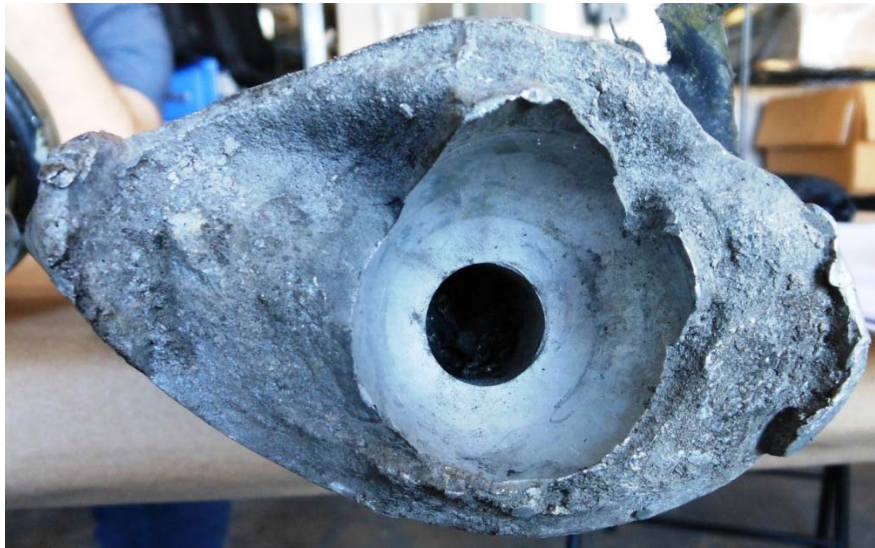
**Photo #12 – Blade R2 fracture surface**

Blade # R2 – This blade was fractured 3.5-4.5" from the blade butt, it appeared to be an overload fracture in the aft direction (Photo #12)

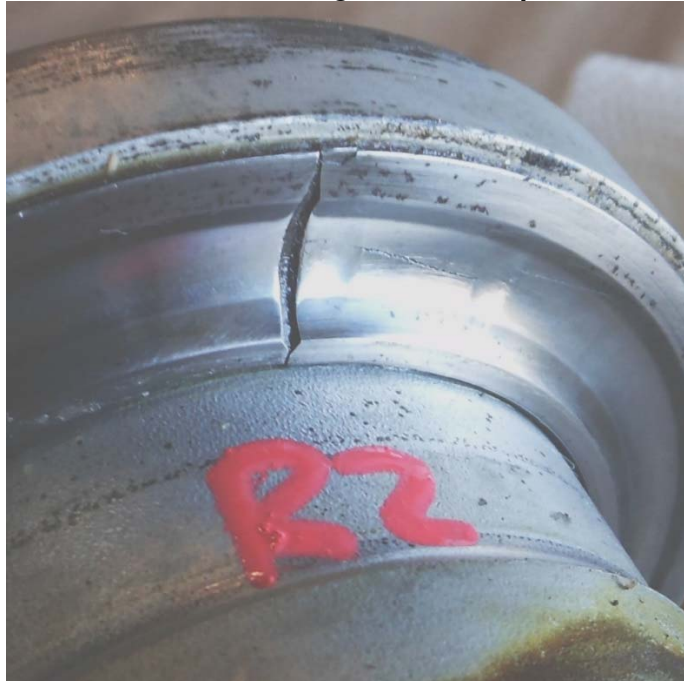
**Photo #13 – Blade R2 bearing race ball imprints and cracks**

| Blade bearings | Hub-side races fracture/crack with ball imprints in the forward/leading edge quadrant (Photo #13) |

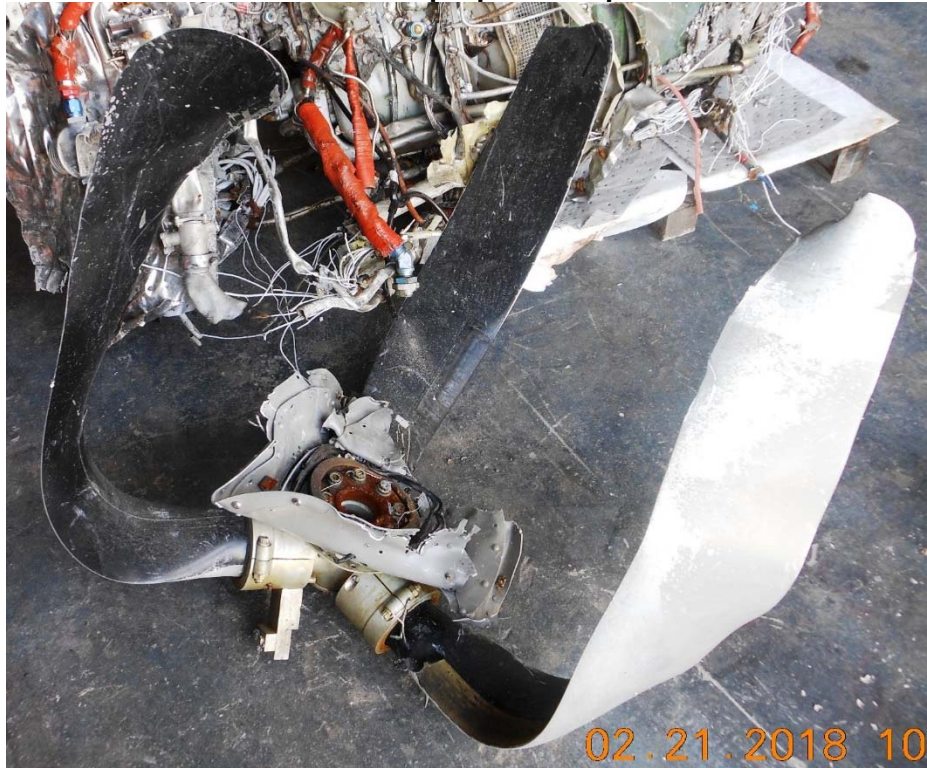
**Photo #14 – Left propeller as-presented**

**“As Received” Condition:** The left propeller as recovered and presented for examination is shown in Photos #14 and #15. The propeller had fractured from the engine propeller shaft; the propeller shaft flange remained attached to the propeller with all bolts present; some bolt heads and safety wire were damaged. The hydraulic unit, spinner dome and most of the beta system hardware had separated and were not recovered (Photo #16). All three blades were bent aft, twisted leading edge down and appeared to have slipped in the clamps towards low pitch. Blade L2 had a fractured tip; the fractured segment was not recovered. Blades L1 and L3 had leading edge gouges.

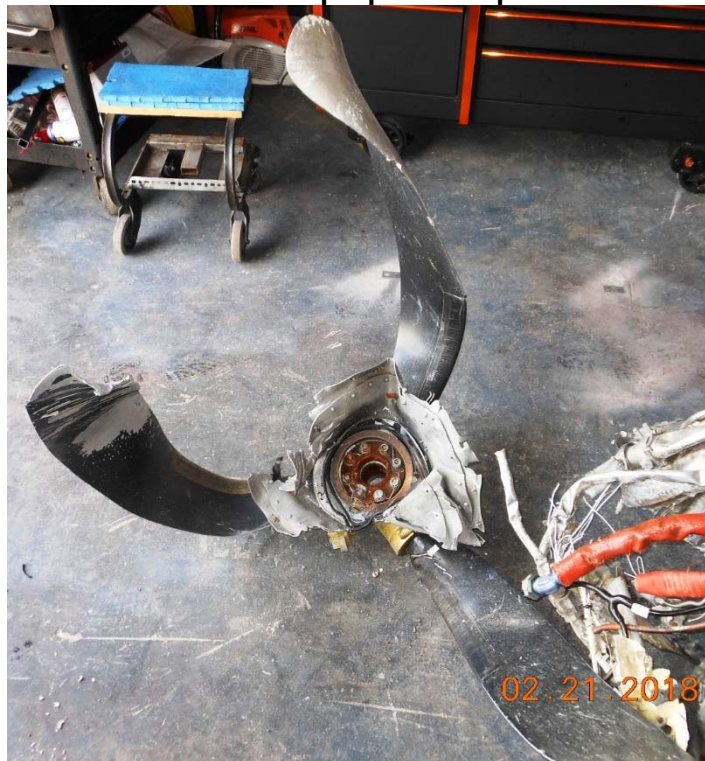
**Photo #15 – Left propeller as-presented**

**Spinner Bulkhead:** The spinner bulkhead and de-ice slip-ring remained attached to the propeller assembly but were torn and bent as show in Photos #15 and #18. There was a clamp bolt gouge in the spinner bulkhead adjacent to blade L2.

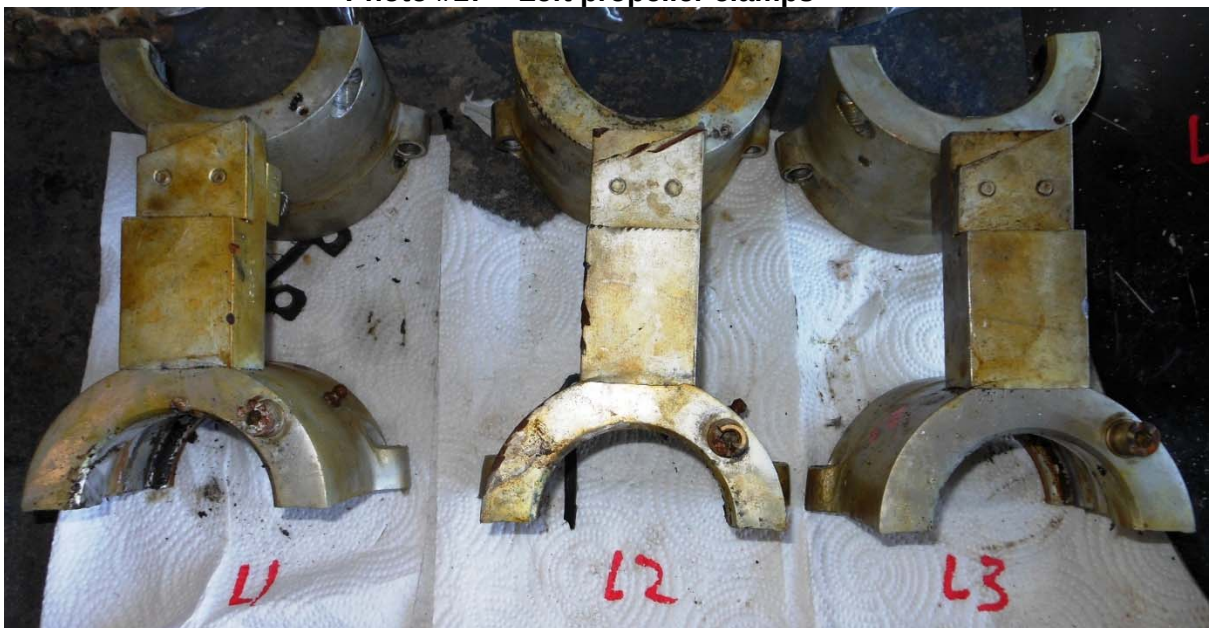
Photo #17 – Left propeller clamps

**Clamps and Counterweights:** (Photo #17). All the clamps appeared to be coated with a brownish-yellow substance that was not identified.

| Clamp Pos. | Clamp S/N | Clamp Condition | Counterweight Condition |
|---|---|---|---|
| L1 | EL8131 | Intact, all bolts safetied, top of link screw sheared towards low pitch | Intact, nick on inboard, trailing edge corner/edge |
| L2 | EL8063 | Intact, all bolts safetied, top of link screw fractured toward low pitch | Intact, nicks and gouges on inboard leading edge corner |
| L3 | EL8076 | Intact, all bolts safetied, top of link screw sheared towards low pitch | Intact, gouge on inboard, trailing edge corner/edge |

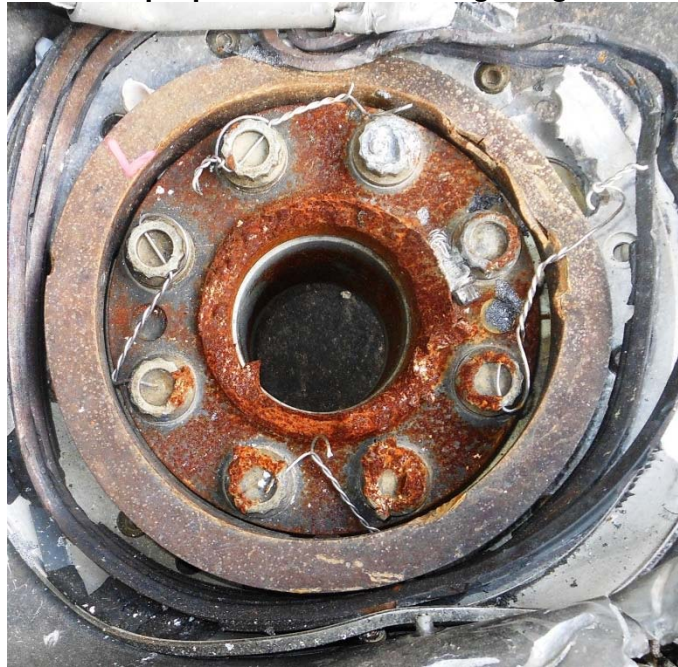
**Photo #18 – Left propeller shaft mounting flange and hardware**

**Engine/Propeller Mounting:** The engine propeller shaft flange fractured from the propeller shaft and remained attached to the propeller. The propeller mounting flange appeared to be intact with all six mounting bolts present but with damage to the bolt heads and some safety wire (Photo #18). There was severe corrosion on the flange and some mounting bolts.

**Hydraulic Unit and Pitch Change Mechanism:** Similar to the right propeller, the hydraulic unit (cylinder and piston) and all pitch change mechanism (pitch change rod, pitch stops, link arms, and beta rods) hardware was missing and presumably not recovered (Photo #16). The beta ring remained jammed in between the propeller mounting flange and the de-ice slip ring conductors and was bent and smashed in some areas as shown Photo #18.

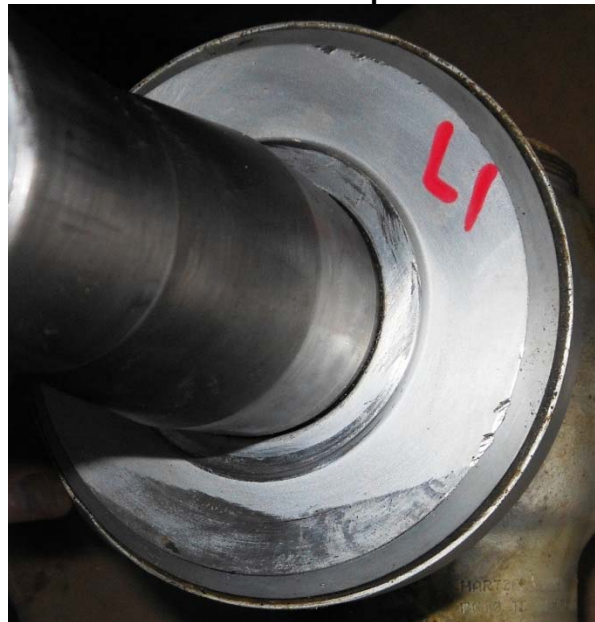
**Photo #19 – L1 blade arm impact crescent mark**

There were several impression marks from blade butts. There was an impact crescent mark in the aft/face and aft/face leading edge quadrant on the L3 blade arm flange. There were crescent impact marks in the aft/face trailing edge and leading edge quadrants of the L1 blade arm flange as shown in Photo #19. There were impact crescents in the aft/face/leading edge quadrant on the L2 blade arm flange.

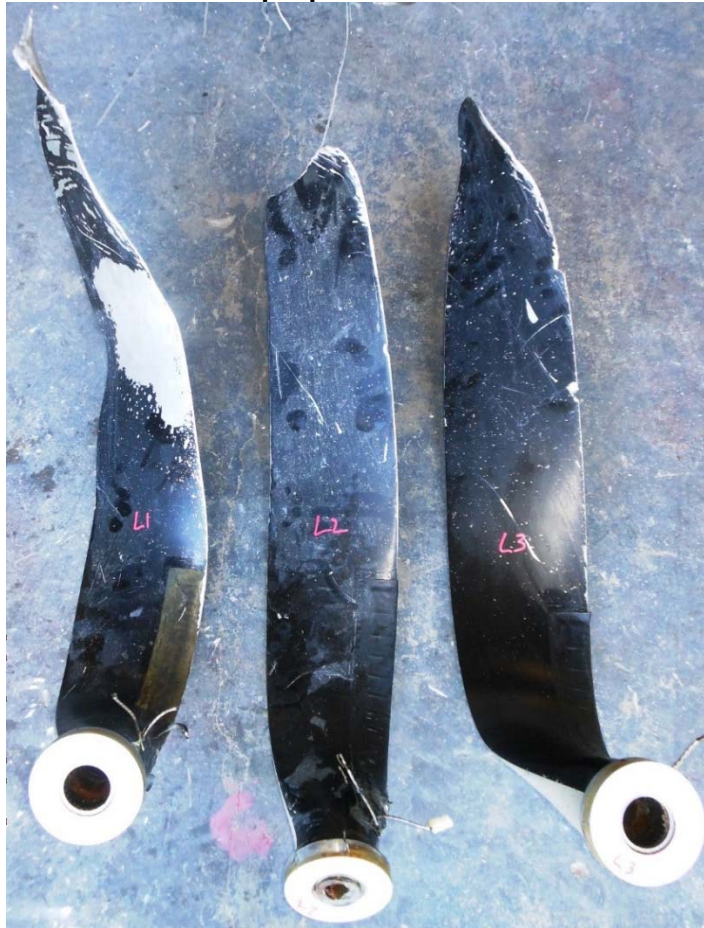
**Photo #20 – Left propeller blades face side view**

**Blade Properties:** Photos #20 through #22

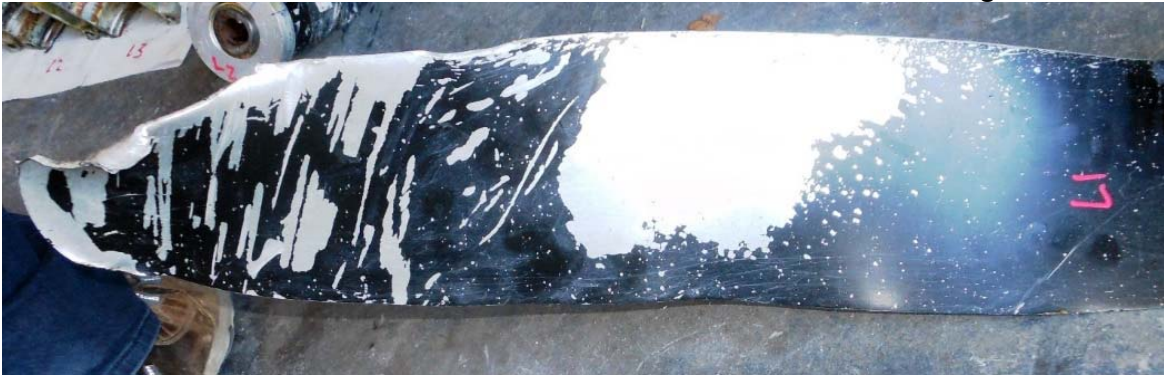
Photo #22 – Blade L1 face side chordwise/rotational scoring

| Face side | Chordwise/rotational scoring tip area (Photo #22), paint abrasion mid-blade |

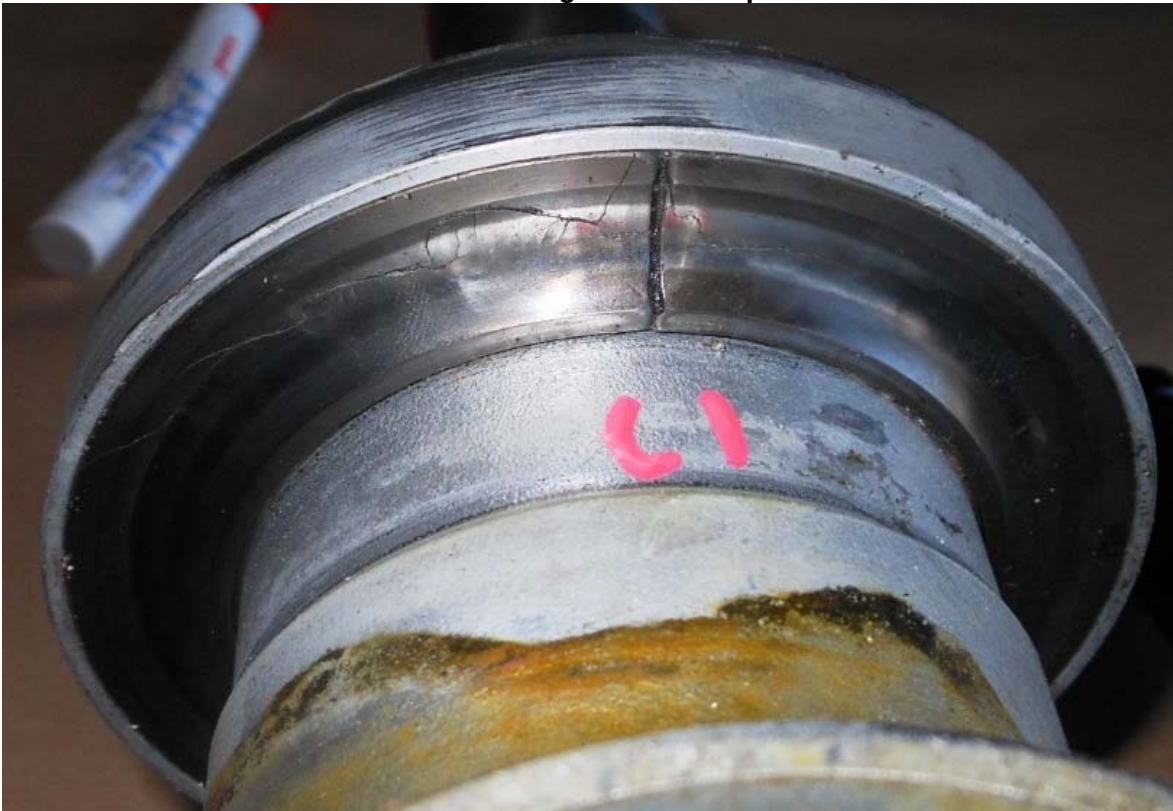
Photo #23 – Blade L1 bearing race ball imprints and cracks

| Blade bearings | Hub side race fractured, ball imprints on camber side (Photo #23) |
